Pavement Condition Report

Roseau Municipal Airport/Rudy Billberg Field (ROX)

December 2017

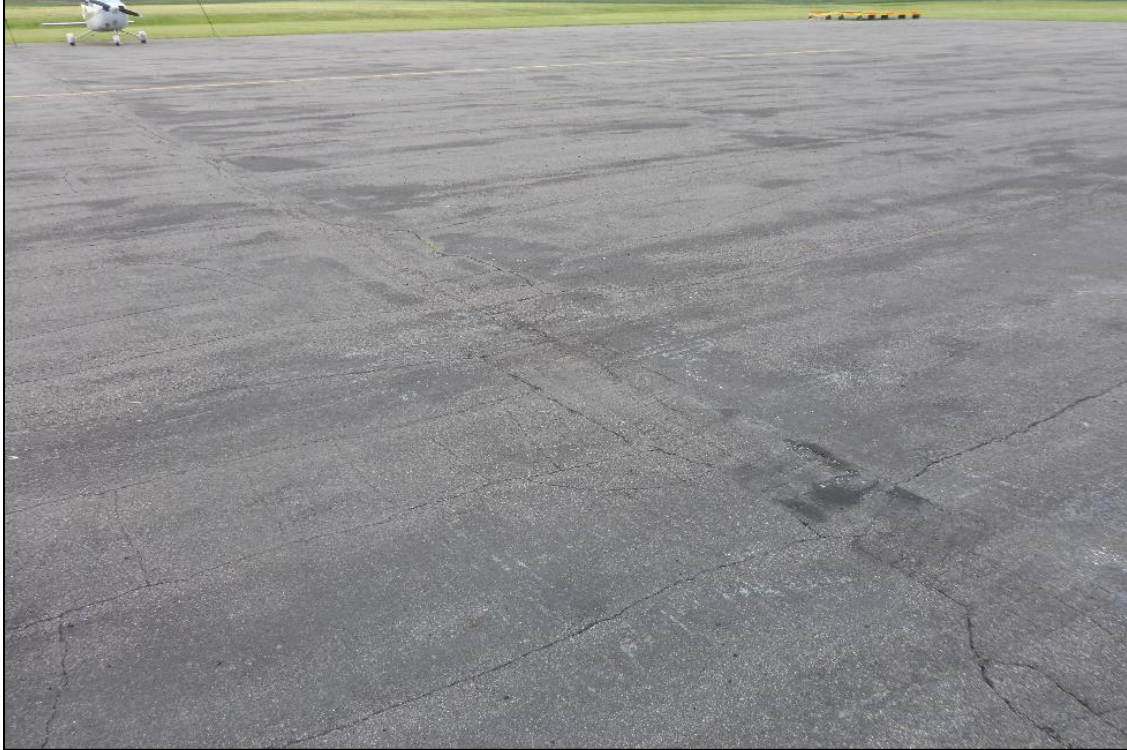
ROX APA 001 (PCI = 28)

Network:	ROX	Name:	ROSEAU						
Branch:	APA	Name:	APRON A	Use:	APRON	Area:	76,750 SqFt		
Section:	001	of 3	From:	300	To:	411	Last Const.:	9/30/1975	
Surface:	AC	Family:	MN2013 Asphalt Aprons	Zone:	N	Category:	1	Rank:	S
Area:	55,250 SqFt	Length:	325 Ft	Width:	170 Ft				
Slabs:	Slab Length:	Ft	Slab Width:	Ft	Joint Length:	Ft			
Shoulder:	Street Type:		Grade:	0	Lanes:	0			
Section Comments:	section appears to have been overlaid since 1975								
Last Insp. Date:	6/13/2017	TotalSamples:	11	Surveyed:	3				
Conditions:	PCI: 28								
Inspection Comments:									
Sample Number:	400	Type:	R	Area:	5000.00 SqFt	PCI:	31		
Sample Comments:									
45	DEPRESSION	L	16.00	SqFt					
43	BLOCK CR	H	165.00	SqFt					
57	WEATHERING	M	5000.00	SqFt					
48	L & T CR	L	74.00	Ft					
48	L & T CR	M	56.00	Ft					
43	BLOCK CR	M	4100.00	SqFt					
48	L & T CR	H	54.00	Ft					
Sample Number:	404	Type:	R	Area:	5000.00 SqFt	PCI:	22		
Sample Comments:

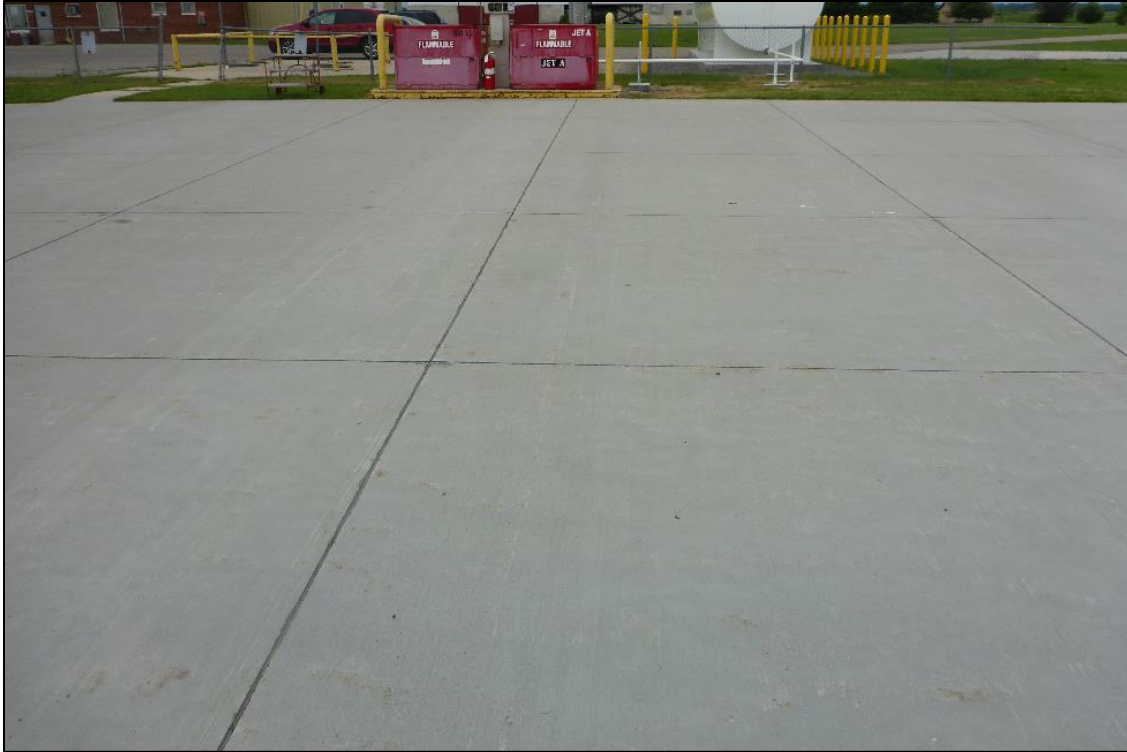
ROX APA 003 (PCI = 96)

Network:	ROX	Name:	ROSEAU						
Branch:	APA	Name:	APRON A	Use:	APRON	Area:	76,750 SqFt		
Section:	003	of 3	From:	100	To:	101	Last Const.:	9/30/2013	
Surface:	PCC	Family:	MN2013 PCC	Zone:	N	Category:	1	Rank:	S
Area:	4,200 SqFt	Length:	70 Ft	Width:	60 Ft				
Slabs:	42	Slab Length:	10 Ft	Slab Width:	10 Ft	Joint Length:	710 Ft		
Shoulder:		Street Type:		Grade:	0	Lanes:	0		
Section Comments:									
Last Insp. Date:	6/13/2017	TotalSamples:	2	Surveyed:	1				
Conditions:	PCI: 96								
Inspection Comments:									
Sample Number:	100	Type:	R	Area:	21.00 Slabs	PCI:	96		
Sample Comments:									
75	CORNER SPALL	L	1.00	Slabs					
65	JT SEAL DMG	L	21.00	Slabs

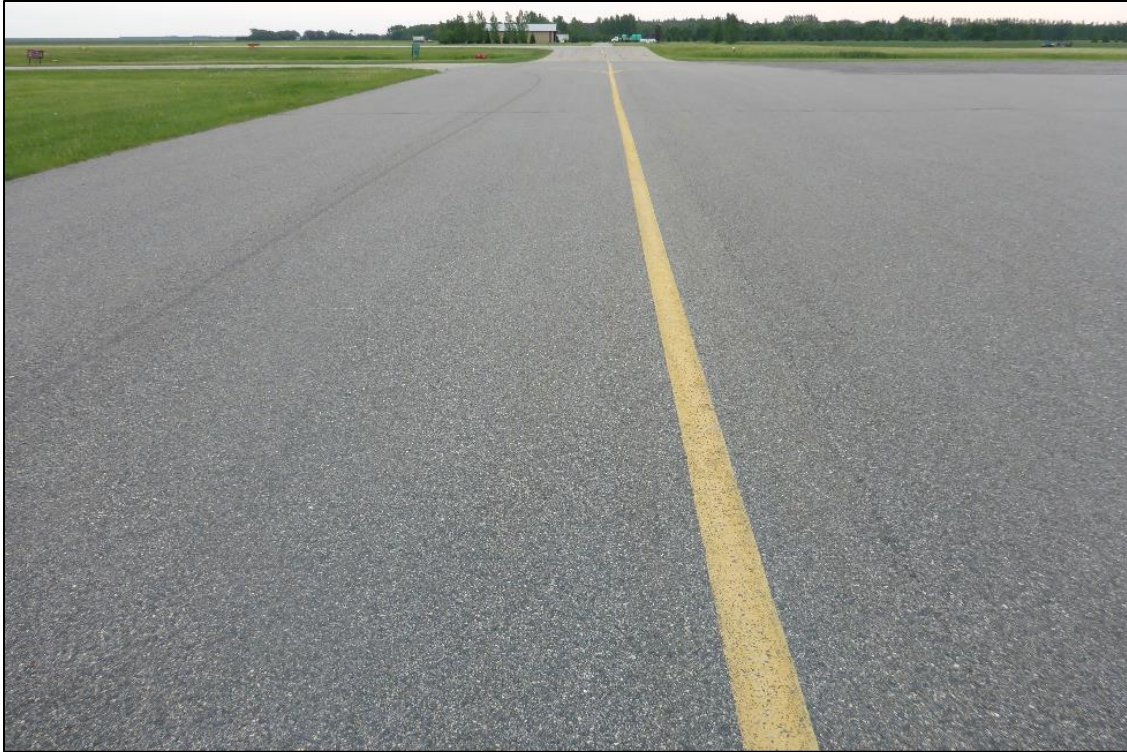
ROX CTA 002 (PCI = 95)

Network:	ROX	Name:	ROSEAU						
Branch:	CTA	Name:	CONNECTING TAXIWAY A	Use:	TAXIWAY	Area:	35,300 SqFt		
Section:	002	of 2	From:	103	To:	106	Last Const.:	6/30/2015	
Surface:	AC	Family:	MN2013 Asphalt Taxiways	Zone:	N	Category:	1	Rank:	P
Area:	21,500 SqFt	Length:	430 Ft	Width:	50 Ft				
Slabs:		Slab Length:	Ft	Slab Width:	Ft	Joint Length:	Ft		
Shoulder:		Street Type:		Grade:	0	Lanes:	0		
Section Comments:									
Last Insp. Date:	6/13/2017	TotalSamples:	4	Surveyed:	2				
Conditions:	PCI: 95								
Inspection Comments:									
Sample Number:	103	Type:	R	Area:	5000.00 SqFt	PCI:	97		
Sample Comments:									
57	WEATHERING	L		1000.00	SqFt				
Sample Number:	105	Type:	R	Area:	5000.00 SqFt	PCI:	93		
Sample Comments:									
48	L & T CR	L		50.00	Ft				
57	WEATHERING	L		800.00	SqFt

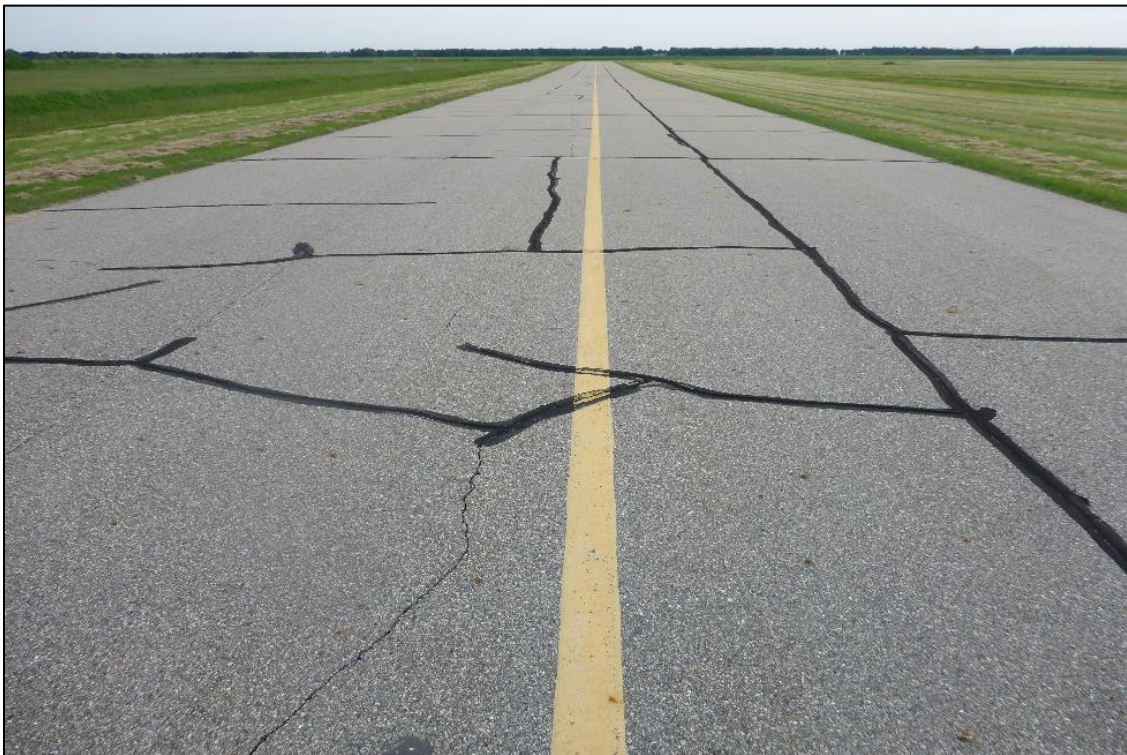
ROX PTA 001 (PCI = 65)

Network:	ROX	Name:	ROSEAU						
Branch:	PTA	Name:	PARALLEL TAXIWAY A	Use:	TAXIWAY	Area:	196,000 SqFt		
Section:	001	of 1	From:	100	To:	146	Last Const.:	10/23/2006	
Surface:	AAC	Family:	MN2013 Asphalt Taxiways	Zone:	N	Category:	1	Rank:	P
Area:	196,000 SqFt	Length:	4,900 Ft	Width:	40 Ft	Joint Length:	Ft		
Slabs:		Slab Length:	Ft	Slab Width:	Ft	Joint Length:	Ft		
Shoulder:		Street Type:		Grade:	0	Lanes:	0		
Section Comments:									
Last Insp. Date:	6/13/2017	TotalSamples:	49	Surveyed:	5				
Conditions:	PCI: 65	Inspection Comments:							
Sample Number:	104	Type:	R	Area:	4000.00 SqFt	PCI:	63		
Sample Comments:									
48	L & T CR	L		531.00	Ft				
48	L & T CR	M		26.00	Ft				
57	WEATHERING	L		4000.00	SqFt				
Sample Number:	114	Type:	R	Area:	4000.00 SqFt	PCI:	65		
Sample Comments:									
48	L & T CR	L		453.00	Ft				
57	WEATHERING	L		4000.00	SqFt				
48	L & T CR	M		131.00	Ft				
Sample Number:	124	Type:	R	Area:	4000.00 SqFt	PCI:	64

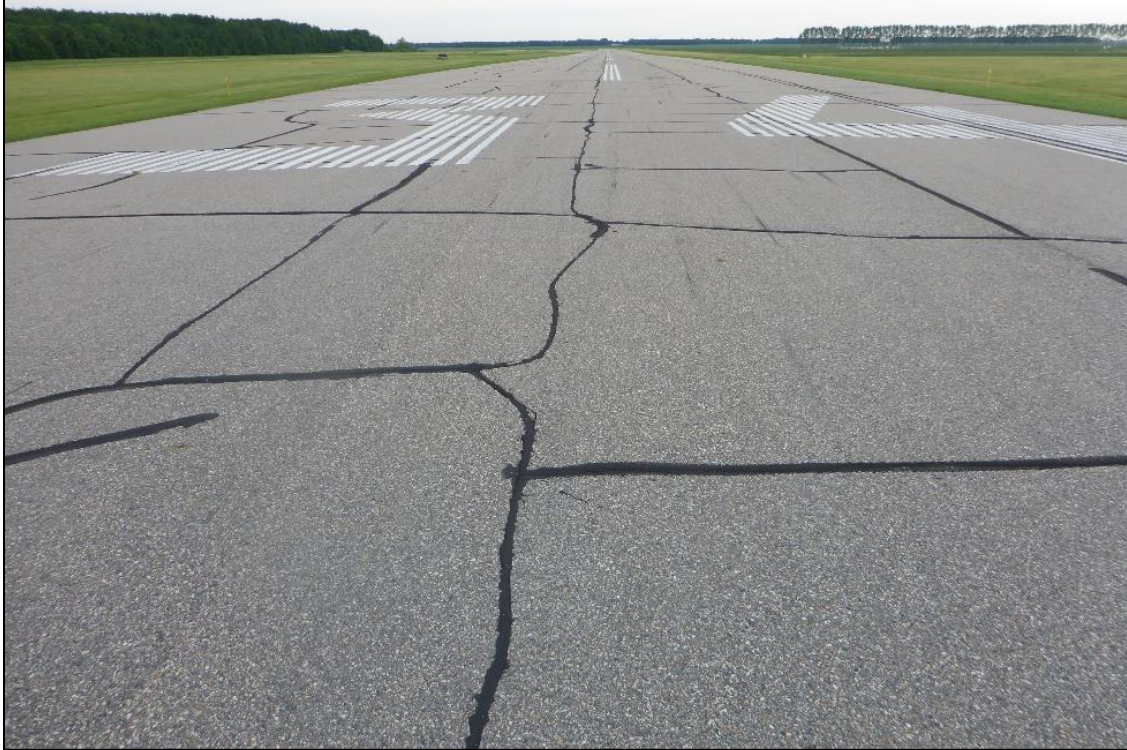
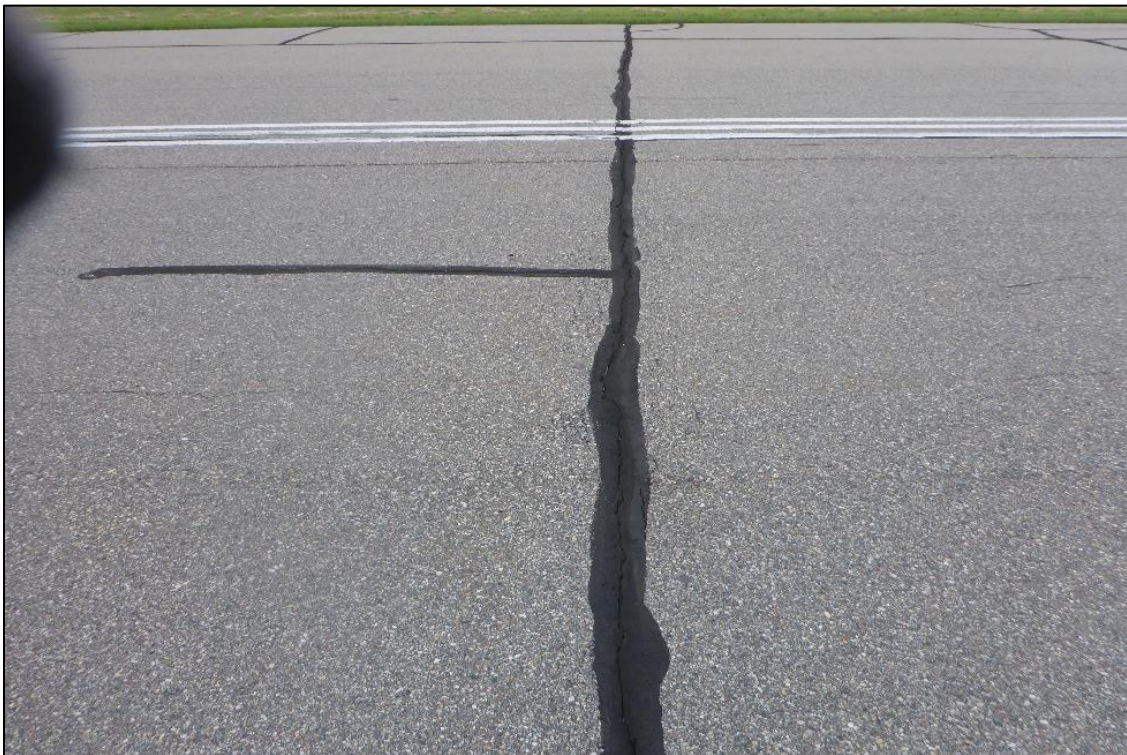
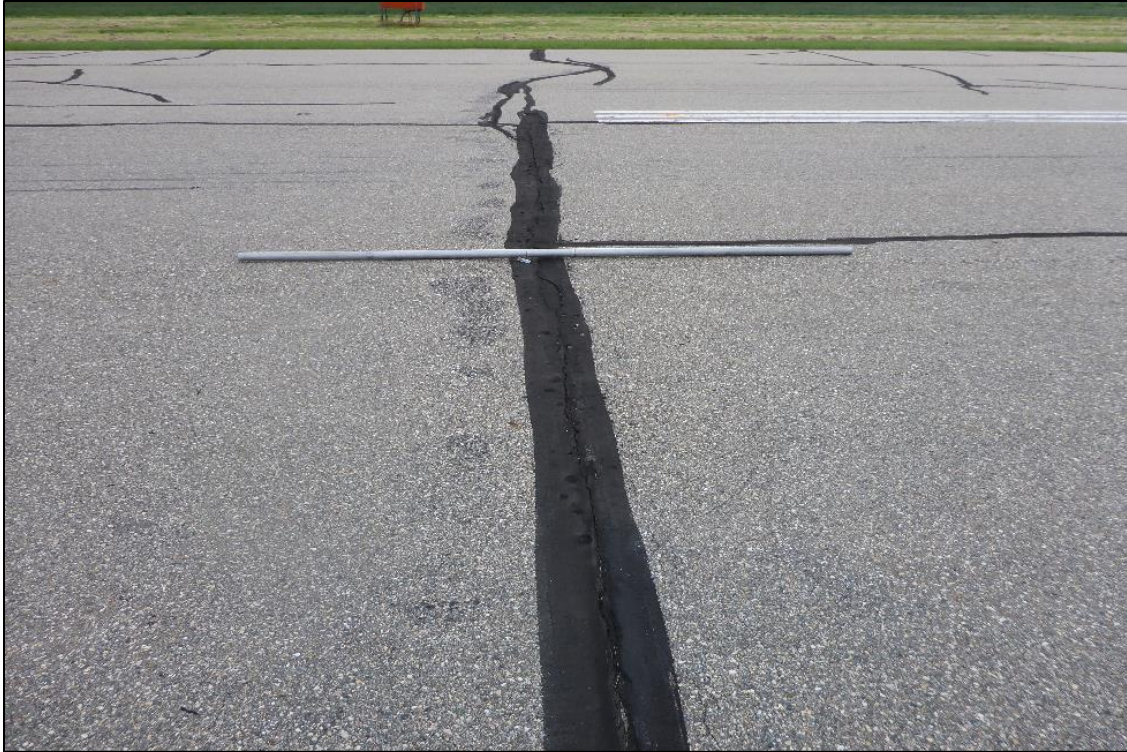
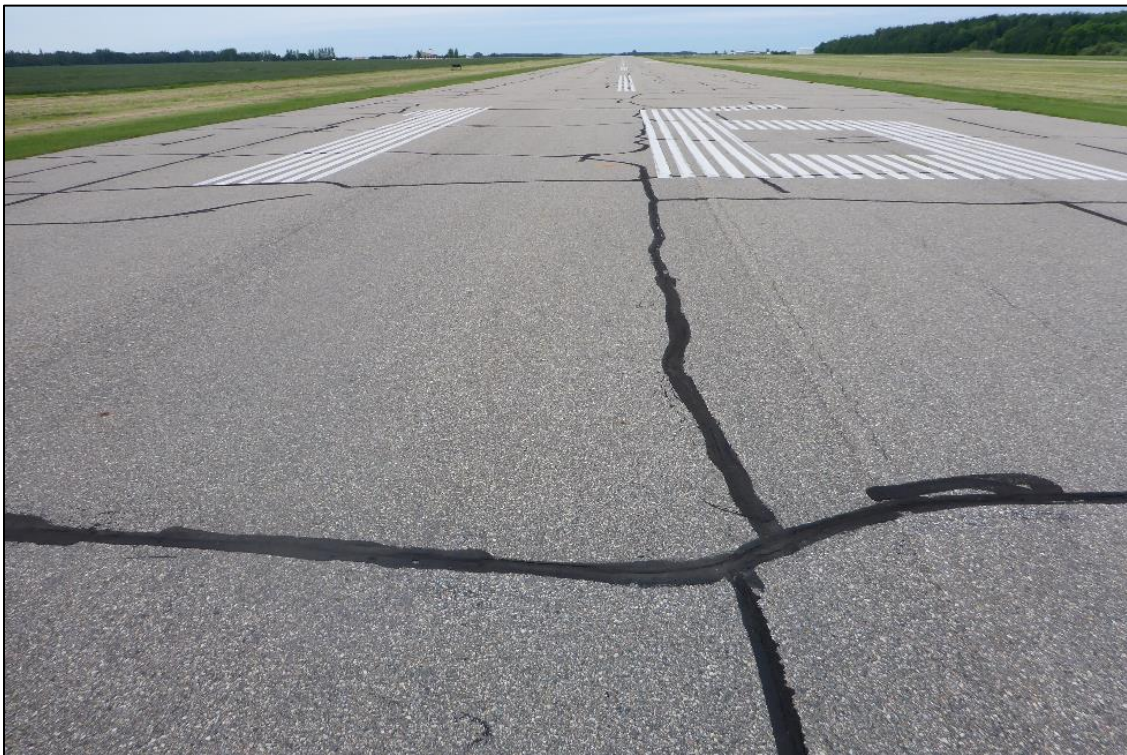
ROX RY1634 001 (PCI = 58)

Network:	ROX	Name:	ROSEAU						
Branch:	RY1634	Name:	RUNWAY 16-34	Use:	RUNWAY	Area:	330,000 SqFt		
Section:	001	of 1	From:	100	To:	187	Last Const.:	10/27/2006	
Surface:	AC	Family:	MN2013 Asphalt Runways	Zone:	N	Category:	1	Rank:	P
Area:	330,000 SqFt	Length:	4,400 Ft	Width:	75 Ft				
Slabs:	Slab Length:	Ft	Slab Width:	Ft	Joint Length:	Ft			
Shoulder:	Street Type:		Grade:	0	Lanes:	0			
Section Comments:									
Last Insp. Date:	6/13/2017	TotalSamples:	88	Surveyed:	9				
Conditions:	PCI: 58								
Inspection Comments:									
Sample Number:	104	Type:	R	Area:	3750.00 SqFt	PCI:	62		
Sample Comments:									
48	L & T CR	L	547.00	Ft					
48	L & T CR	M	5.00	Ft					
57	WEATHERING	L	2000.00	SqFt					
Sample Number:	114	Type:	R	Area:	3750.00 SqFt	PCI:	58		
Sample Comments:									
48	L & T CR	L	256.00	Ft					
48	L & T CR	L	278.00	Ft					
48	L & T CR	M	46.00	Ft					
48	L & T CR	M	20.00	Ft					
48	L & T CR	H	6.00	Ft

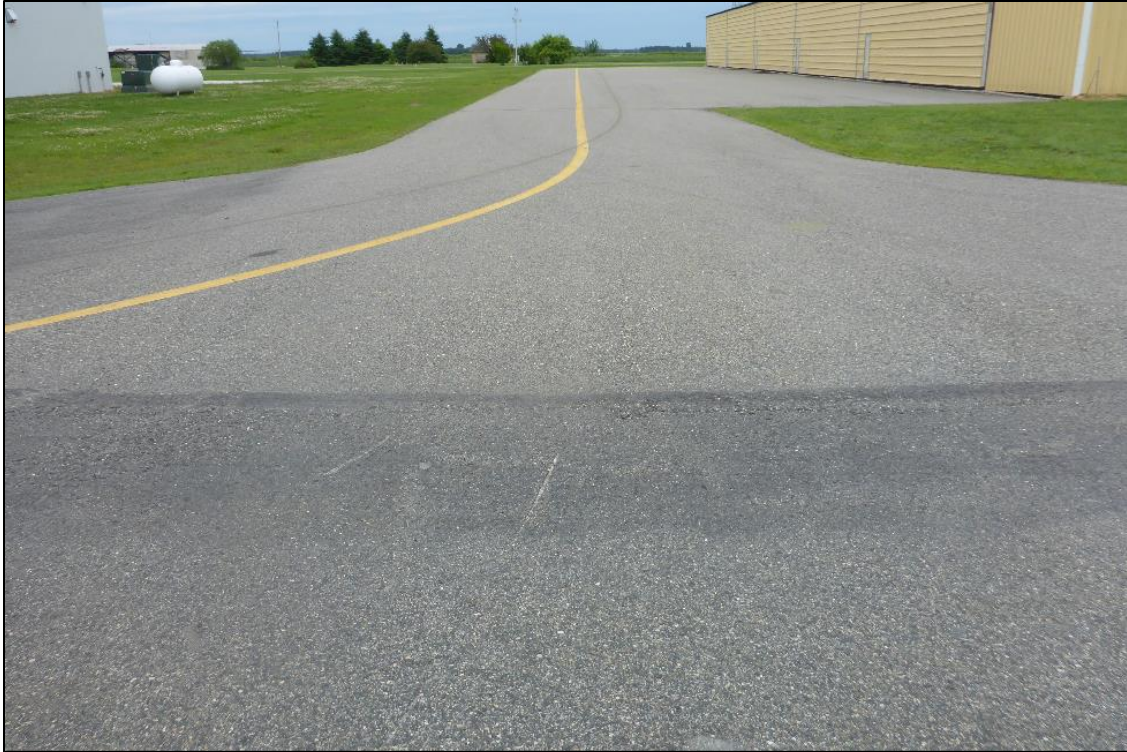
ROX TLA 001 (PCI = 97)

Network:	ROX	Name:	ROSEAU				
Branch:	TLA	Name:	TAXILANE A	Use:	TAXILANE	Area:	48,300 SqFt
Section:	001	of 2	From:	-	To:	-	Last Const.: 6/30/2015
Surface:	AC	Family:	MN2013 Asphalt Taxilanes	Zone:	N	Category:	1
Area:	32,200 SqFt	Length:	155 Ft	Width:	290 Ft	Joint Length:	Ft
Slabs:		Slab Length:	Ft	Slab Width:	Ft	Joint Length:	Ft
Shoulder:		Street Type:		Grade:	0	Lanes:	0
Section Comments:	estimated LCD						
Last Insp. Date:	6/13/2017	TotalSamples:	9	Surveyed:	3		
Conditions:	PCI: 97						
Inspection Comments:							
Sample Number:	100	Type:	R	Area:	2500.00 SqFt	PCI:	95
Sample Comments:							
48	L & T CR	L	3.00	Ft			
57	WEATHERING	L	500.00	SqFt			
Sample Number:	104	Type:	R	Area:	5000.00 SqFt	PCI:	98
Sample Comments:							
57	WEATHERING	L	800.00	SqFt			
Sample Number:	107	Type:	R	Area:	5000.00 SqFt	PCI:	97
Sample Comments:							
57	WEATHERING	L	1000.00	SqFt

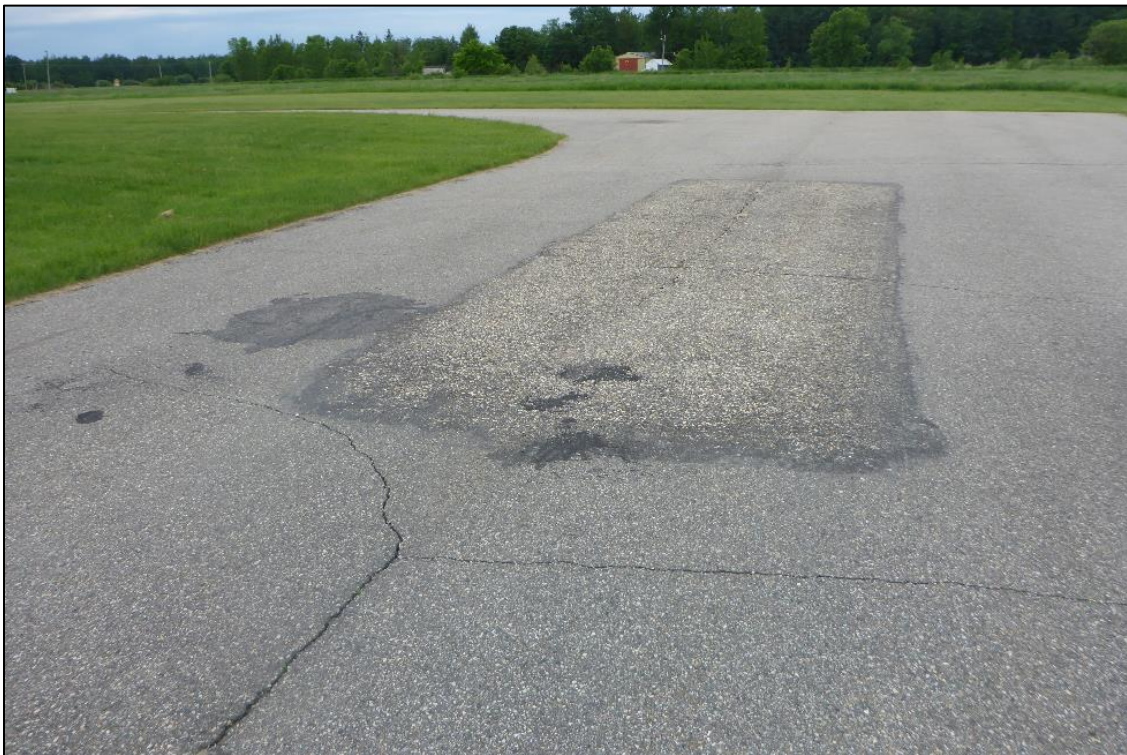
ROX TLA 002 (PCI = 78)

Network:	ROX	Name:	ROSEAU				
Branch:	TLA	Name:	TAXILANE A	Use:	TAXILANE	Area:	48,300 SqFt
Section:	002	of 2	From:	-	To:	-	Last Const.: 5/3/2003
Surface:	AC	Family:	MN2013 Asphalt Taxilanes	Zone:	N	Category:	1
Area:	16,100 SqFt	Length:	500 Ft	Width:	20 Ft	Joint Length:	Ft
Slabs:		Slab Length:	Ft	Slab Width:	Ft	Joint Length:	Ft
Shoulder:		Street Type:		Grade:	0	Lanes:	0
Section Comments:	estimated LCD						
Last Insp. Date:	6/13/2017	Total Samples:	3	Surveyed:	2		
Conditions:	PCI: 78						
Inspection Comments:							
Sample Number:	100	Type:	R	Area:	4635.00 SqFt	PCI:	63
Sample Comments:							
48	L & T CR	M	131.00	Ft			
48	L & T CR	L	46.00	Ft			
50	PATCHING	M	22.00	SqFt			
50	PATCHING	L	378.00	SqFt			
57	WEATHERING	L	2000.00	SqFt			
Sample Number:	102	Type:	R	Area:	6070.00 SqFt	PCI:	88
Sample Comments:							
48	L & T CR	M	20.00	Ft			
57	WEATHERING	L	3000.00	SqFt
