Pavement Condition Report

Eveleth-Virginia Municipal Airport (EVM)

December 2018

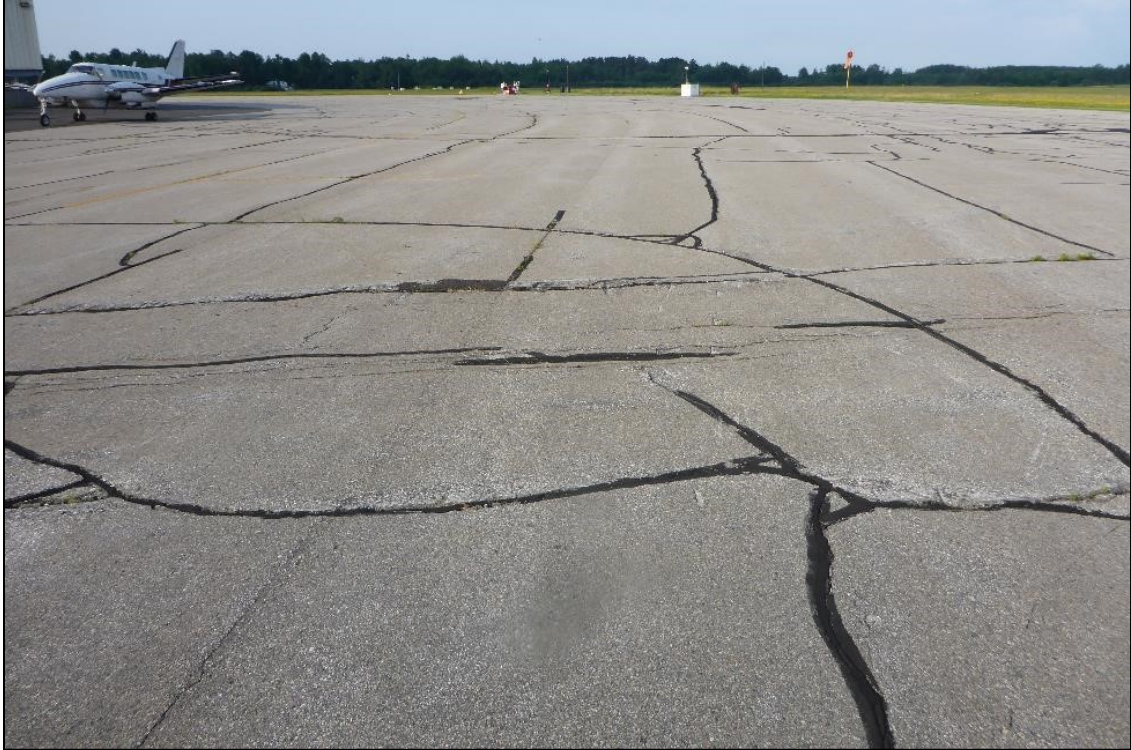
EVM APA 001 (PCI = 46)

Network:	EVM		Name:	EVELETH-VIRGINIA					
Branch:	APA	Name:	APRON A	Use:	APRON	Area:	158,937 SqFt		
Section:	001	of 2	From:	208	To:	417	Last Const.:	6/1/2000	
Surface:	AAC	Family:	MN2018 Asphalt Aprons	Zone:	N	Category:	2	Rank:	S
Area:	120,309 SqFt	Length:	900 Ft	Width:	150 Ft				
Slabs:	Slab Length:	Ft	Slab Width:	Ft	Joint Length:	Ft			
Shoulder:	Street Type:		Grade:	0	Lanes:	0			
Last Insp. Date:	6/29/2018	TotalSamples:	24	Surveyed:	4				
Conditions:	PCI: 46								
Sample Number:	209	Type:	R	Area:	5000.00 SqFt	PCI:	58		
56	SWELLING	L		45.00	SqFt				
48	L & T CR	H		8.00	Ft				
48	L & T CR	L		523.00	Ft				
48	L & T CR	M		111.00	Ft				
52	RAVELING	H		3.00	SqFt				
Sample Number:	211	Type:	R	Area:	4200.00 SqFt	PCI:	35		
48	L & T CR	H		32.00	Ft				
48	L & T CR	L		335.00	Ft				
41	ALLIGATOR CR	L		120.00	SqFt				
41	ALLIGATOR CR	M		20.00	SqFt				
45	DEPRESSION	L		56.00	SqFt				
48	L & T CR	M		96.00	Ft				
56	SWELLING	L		20.00	SqFt

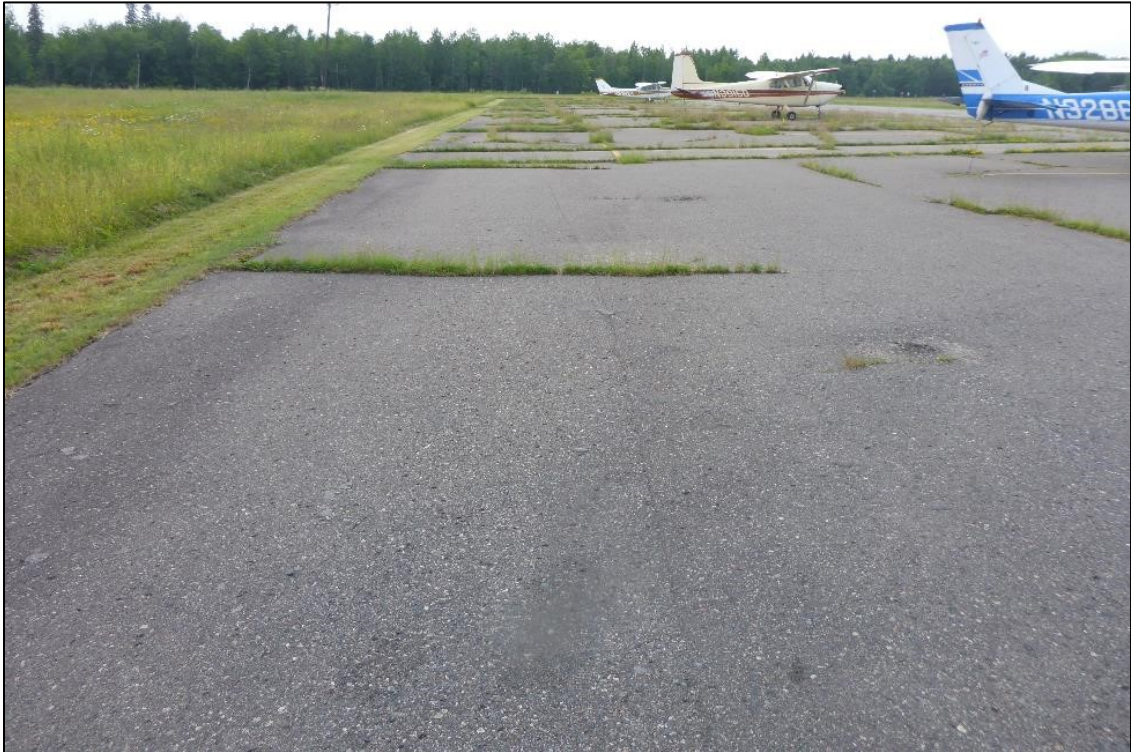
EVM APA 002 (PCI = 28)

Network: EVM						Name: EVELETH-VIRGINIA
Branch: APA	Name: APRON A	Use: APRON	Area: 158,937 SqFt			
Section: 002	of 2	From: 218	To: 322+32	Last Const.: 9/30/1998		
Surface: AC	Family: MN2018 Asphalt Aprons	Zone: N	Category: 2	Rank: S		
Area: 38,628 SqFt	Length: 490 Ft	Width: 80 Ft				
Slabs:	Slab Length: Ft	Slab Width: Ft	Joint Length: Ft			
Shoulder:	Street Type:	Grade: 0	Lanes: 0			
Last Insp. Date: 6/29/2018	TotalSamples: 10	Surveyed: 2				
Conditions: PCI: 28						
Sample Number: 219	Type: R	Area: 5000.00 SqFt	PCI: 33			
48	L & T CR	L	450.00	Ft		
48	L & T CR	H	5.00	Ft		
43	BLOCK CR	L	150.00	SqFt		
48	L & T CR	M	107.00	Ft		
52	RAVELING	L	3000.00	SqFt		
50	PATCHING	M	100.00	SqFt		
43	BLOCK CR	H	50.00	SqFt		
56	SWELLING	L	100.00	SqFt		
50	PATCHING	L	400.00	SqFt		
43	BLOCK CR	M	600.00	SqFt		
Sample Number: 221	Type: R	Area: 5000.00 SqFt	PCI: 24			
52	RAVELING	L	3000.00	SqFt		
48	L & T CR	L	200.00	Ft		
41	ALLIGATOR CR	L	75.00	SqFt

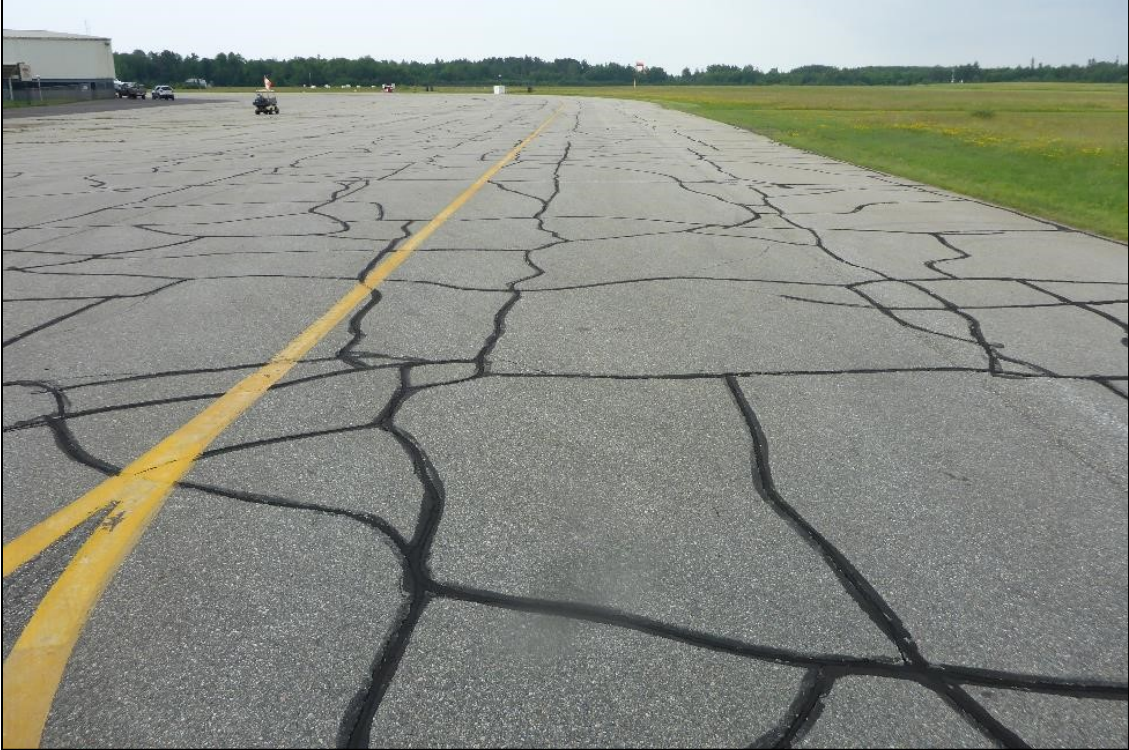
EVM CTA 001 (PCI = 47)

Network:	EVM	Name:	EVELETH-VIRGINIA						
Branch:	CTA	Name:	CONNECTING TAXIWAY A	Use:	TAXIWAY	Area:	81,600 SqFt		
Section:	001	of 2	From:	100	To:	118	Last Const.: 6/1/2000		
Surface:	AAC	Family:	MN2018 Asphalt Runway- Taxiways	Zone:	N	Category:	2	Rank:	P
Area:	58,050 SqFt	Length:	1,600 Ft	Width:	50 Ft				
Slabs:		Slab Length:	Ft	Slab Width:	Ft	Joint Length:	Ft		
Shoulder:		Street Type:		Grade:	0	Lanes:	0		
Last Insp. Date:	6/29/2018	TotalSamples:	15	Surveyed:	3				
Conditions:	PCI: 47								
Sample Number:	108	Type:	R	Area:	5000.00 SqFt	PCI:	55		
43	BLOCK CR		M	1750.00	SqFt				
43	BLOCK CR		L	3250.00	SqFt				
Sample Number:	110	Type:	R	Area:	5000.00 SqFt	PCI:	42		
43	BLOCK CR		L	3000.00	SqFt				
41	ALLIGATOR CR		L	90.00	SqFt				
56	SWELLING		L	50.00	SqFt				
43	BLOCK CR		M	1000.00	SqFt				
48	L & T CR		L	20.00	Ft				
Sample Number:	115	Type:	R	Area:	5000.00 SqFt	PCI:	43		
48	L & T CR		H	2.00	Ft				
43	BLOCK CR		M	250.00	SqFt

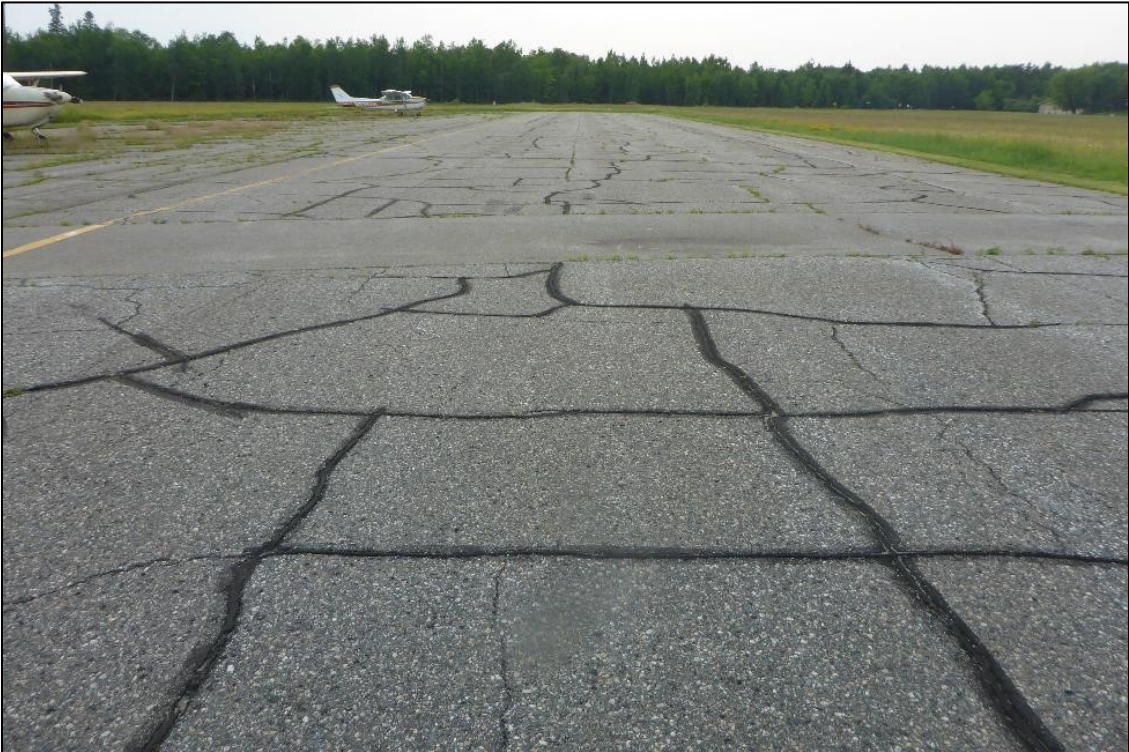
EVM CTA 002 (PCI = 38)

Network:	EVM	Name:	EVELETH-VIRGINIA						
Branch:	CTA	Name:	CONNECTING TAXIWAY A	Use:	TAXIWAY	Area:	81,600 SqFt		
Section:	002	of 2	From:	119	To:	122+32	Last Const.:	9/30/1987	
Surface:	AC	Family:	MN2018 Asphalt Runway- Taxiways	Zone:	N	Category:	2	Rank:	S
Area:	23,550 SqFt	Length:	432 Ft	Width:	50 Ft				
Slabs:	Slab Length:	Ft	Slab Width:	Ft	Joint Length:	Ft			
Shoulder:	Street Type:	Grade:	0	Lanes:	0				
Last Insp. Date:	6/29/2018	TotalSamples:	4	Surveyed:	1				
Conditions:	PCI: 38								
Sample Number:	120	Type:	R	Area:	5000.00 SqFt	PCI:	38		
56	SWELLING	L		50.00 SqFt					
43	BLOCK CR	L		1500.00 SqFt					
43	BLOCK CR	M		3500.00 SqFt					
52	RAVELING	L		5000.00 SqFt

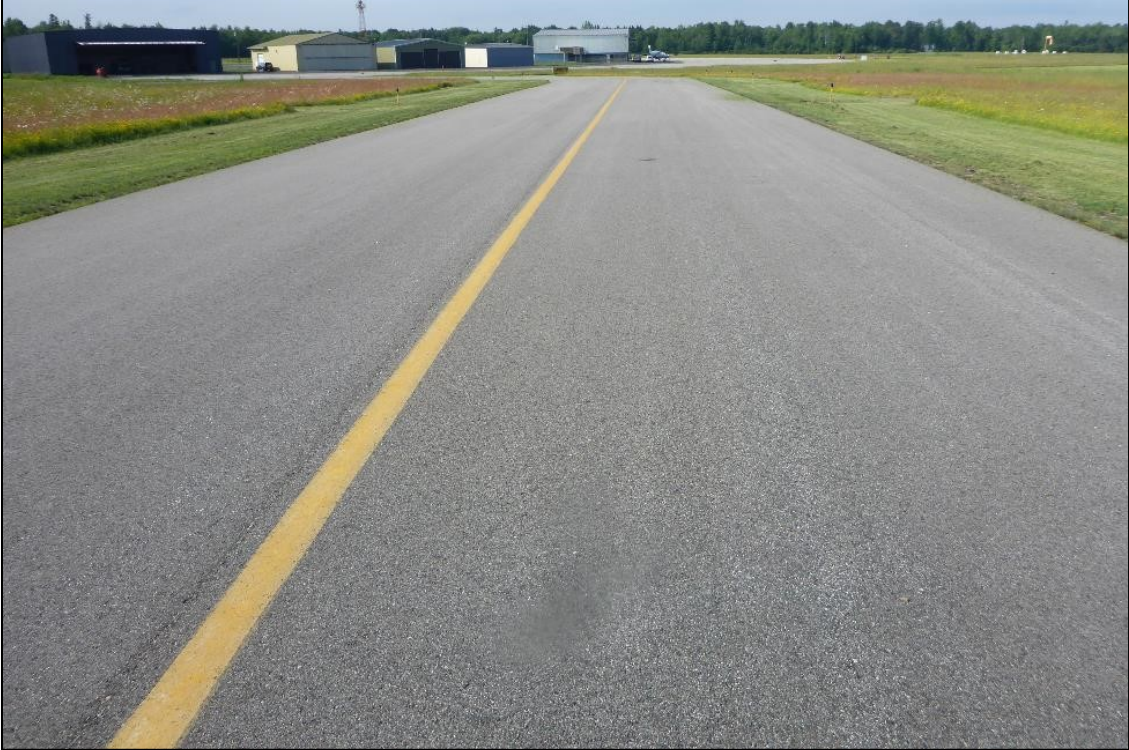
EVM CTB 001 (PCI = 100)

Network:	EVM	Name:	EVELETH-VIRGINIA						
Branch:	CTB	Name:	CONNECTING TAXIWAY B	Use:	TAXIWAY	Area:	22,992 SqFt		
Section:	001	of 1	From:	100	To:	107	Last Const.:	11/1/2013	
Surface:	AC	Family:	MN2018 Asphalt Runway- Taxiways	Zone:	N	Category:	2	Rank:	P
Area:	22,992 SqFt	Length:	460 Ft	Width:	50 Ft	Joint Length:	Ft		
Slabs:		Slab Length:	Ft	Slab Width:	Ft	Joint Length:	Ft		
Shoulder:		Street Type:		Grade:	0	Lanes:	0		
Last Insp. Date:	6/29/2018	TotalSamples:	6	Surveyed:	2				
Conditions:	PCI: 100								
Sample Number:	101	Type:	R	Area:	4000.00 SqFt	PCI:	100		
<No Distress>									
Sample Number:	103	Type:	R	Area:	4000.00 SqFt	PCI:	100		
<No Distress>

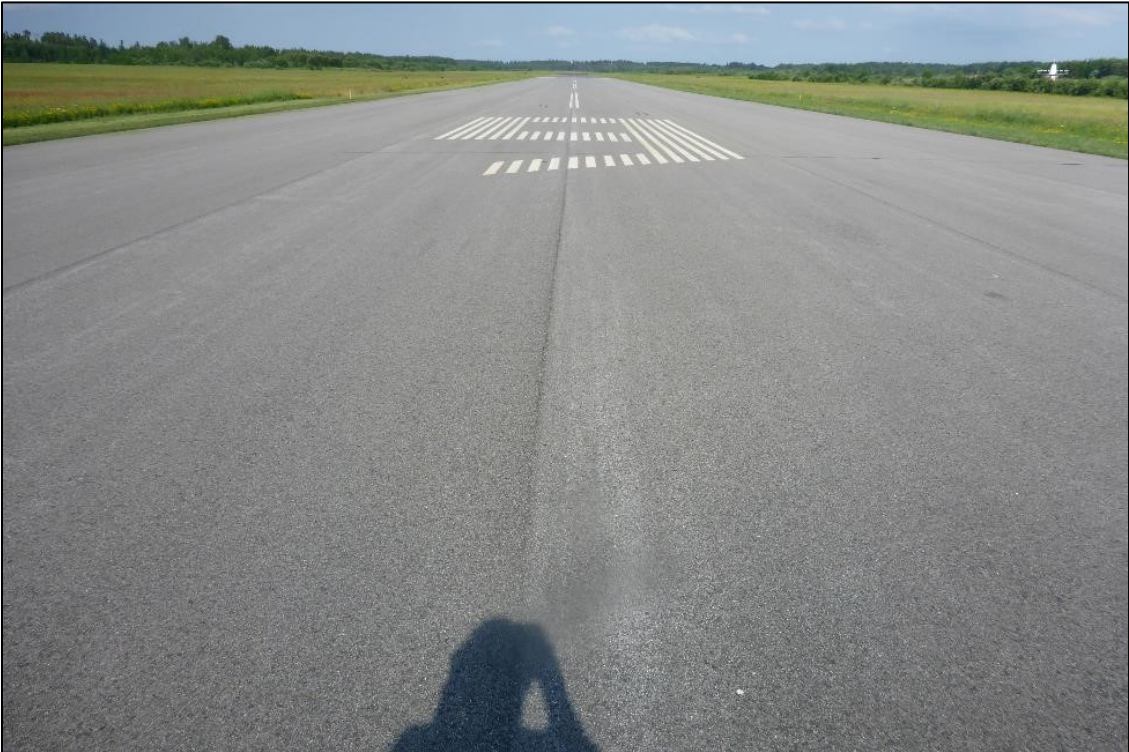
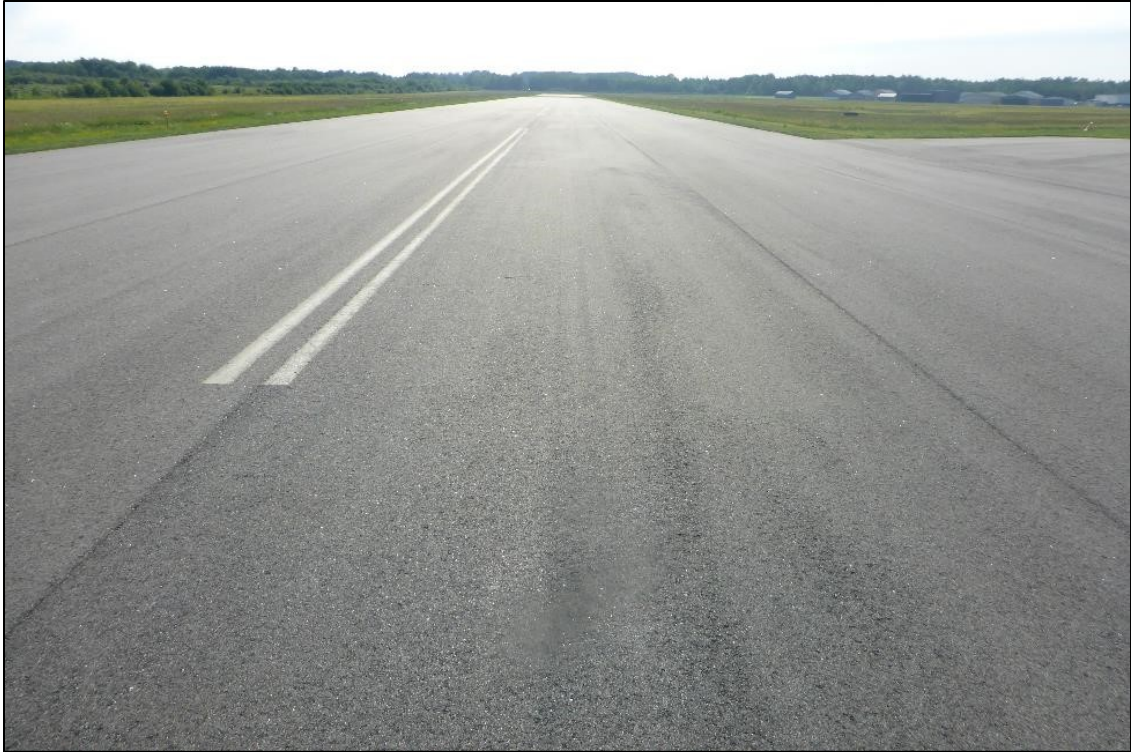
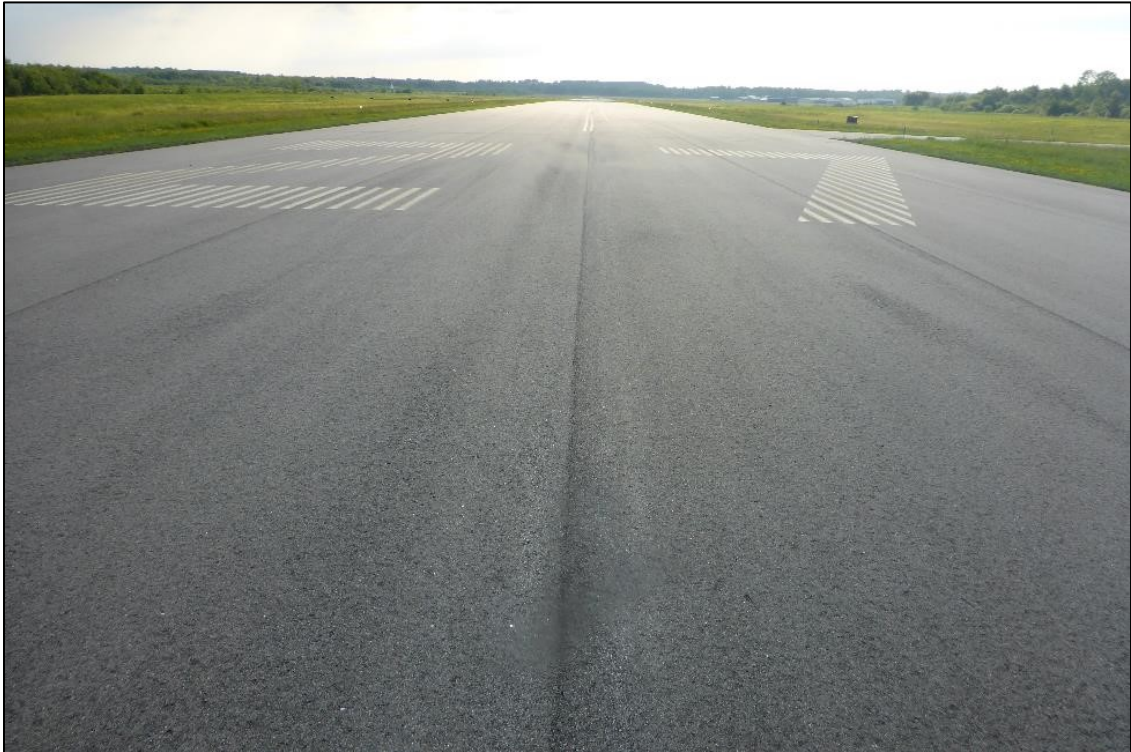
EVM RY927 001 (PCI = 96)

Network:	EVM		Name:	EVELETH-VIRGINIA					
Branch:	RY927	Name:	RUNWAY 9-27	Use:	RUNWAY	Area:	300,117 SqFt		
Section:	001	of 1	From:	100	To:	193+(291,292)	Last Const.:	11/1/2013	
Surface:	AC	Family:	MN2018 Asphalt Runway-Taxiways	Zone:	N	Category:	2	Rank:	P
Area:	300,117 SqFt	Length:	4,000 Ft	Width:	75 Ft				
Slabs:		Slab Length:	Ft	Slab Width:	Ft	Joint Length:	Ft		
Shoulder:		Street Type:		Grade:	0	Lanes:	0		
Section Comments:									
Last Insp. Date:	6/29/2018	TotalSamples:	99	Surveyed:	9				
Conditions:	PCI: 96								
Inspection Comments:									
Sample Number:	101	Type:	R	Area:	3750.00 SqFt	PCI:	97		
Sample Comments:									
48	L & T CR	L	6.00	Ft					
Sample Number:	110	Type:	R	Area:	3750.00 SqFt	PCI:	93		
Sample Comments:									
48	L & T CR	L	71.00	Ft					
Sample Number:	119	Type:	R	Area:	3750.00 SqFt	PCI:	100		
Sample Comments:	nd								
<No Distress>									
Sample Number:	128	Type:	R	Area:	3750.00 SqFt	PCI:	94

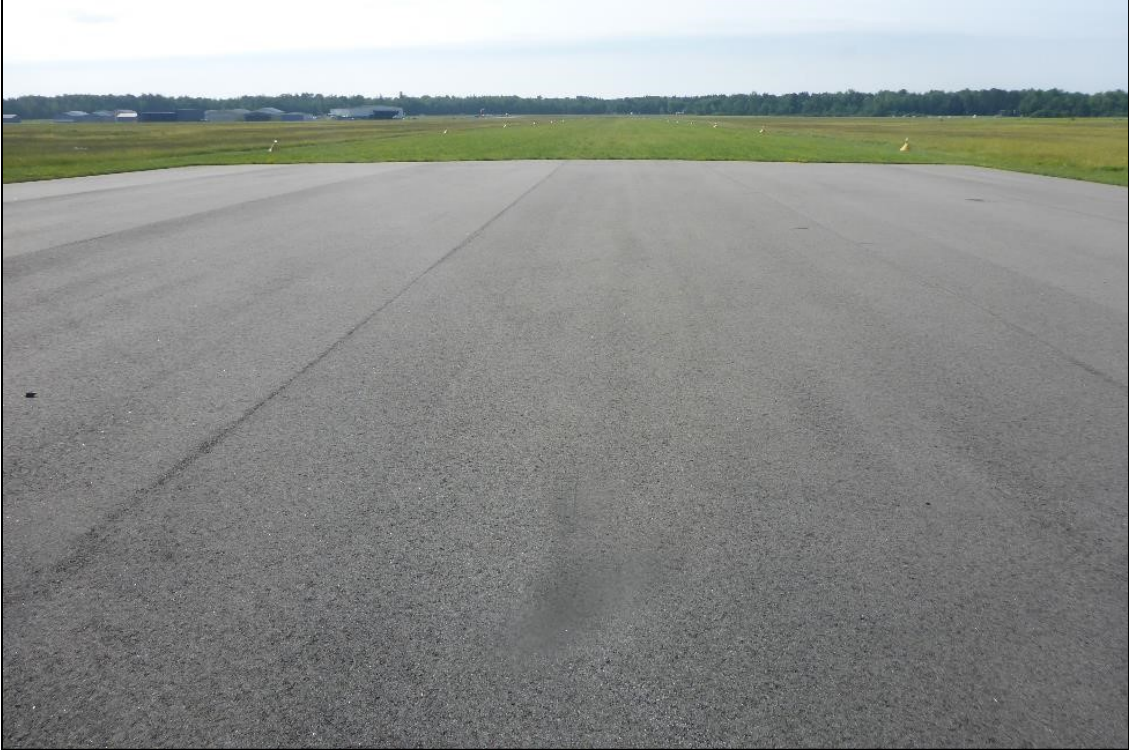
EVM RY1432 001 (PCI = 100)

Network:	EVM	Name:	EVELETH-VIRGINIA						
Branch:	RY1432	Name:	RUNWAY 14-32	Use:	RUNWAY	Area:	19,327 SqFt		
Section:	001	of 1	From:	100	To:	148	Last Const.:	11/1/2013	
Surface:	AAC	Family:	MN2018 Asphalt Runway- Taxiways	Zone:	N	Category:	2	Rank:	S
Area:	19,327 SqFt	Length:	195 Ft	Width:	100 Ft				
Slabs:		Slab Length:	Ft	Slab Width:	Ft	Joint Length:	Ft		
Shoulder:		Street Type:		Grade:	0	Lanes:	0		
Section Comments:									
Last Insp. Date:	6/29/2018	TotalSamples:	8	Surveyed:	1				
Conditions:	PCI: 100								
Inspection Comments:									
Sample Number:	100	Type:	R	Area:	5000.00 SqFt	PCI:	100		
Sample Comments:	nd

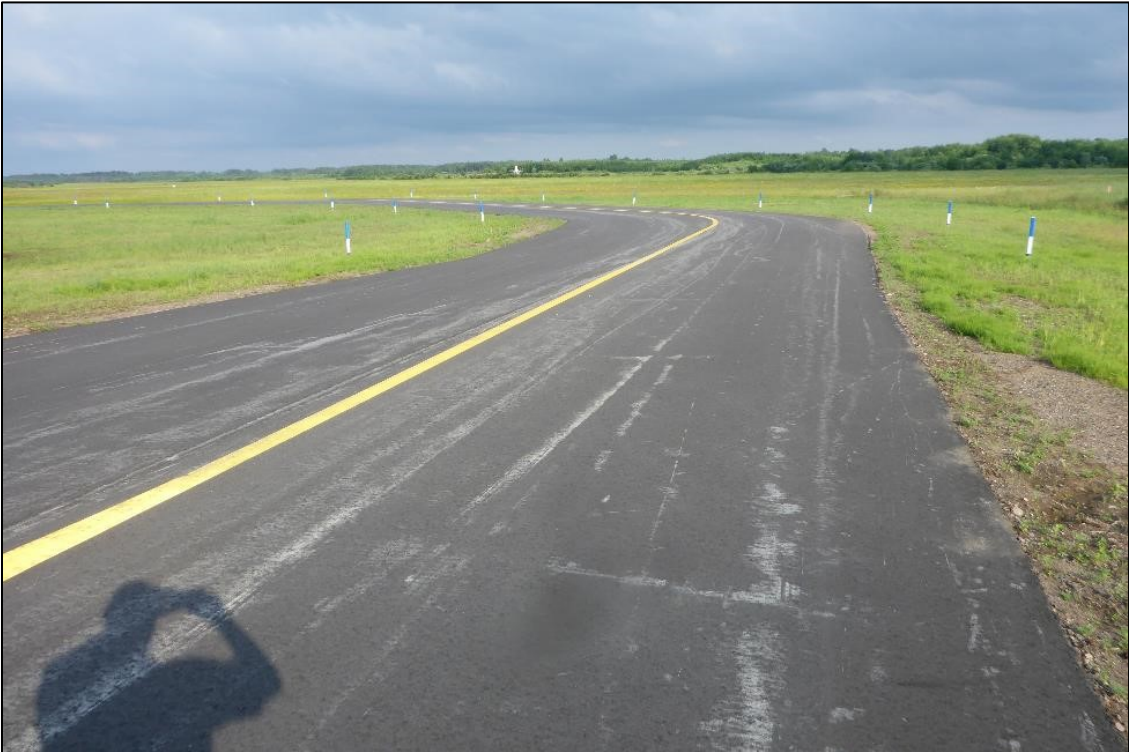
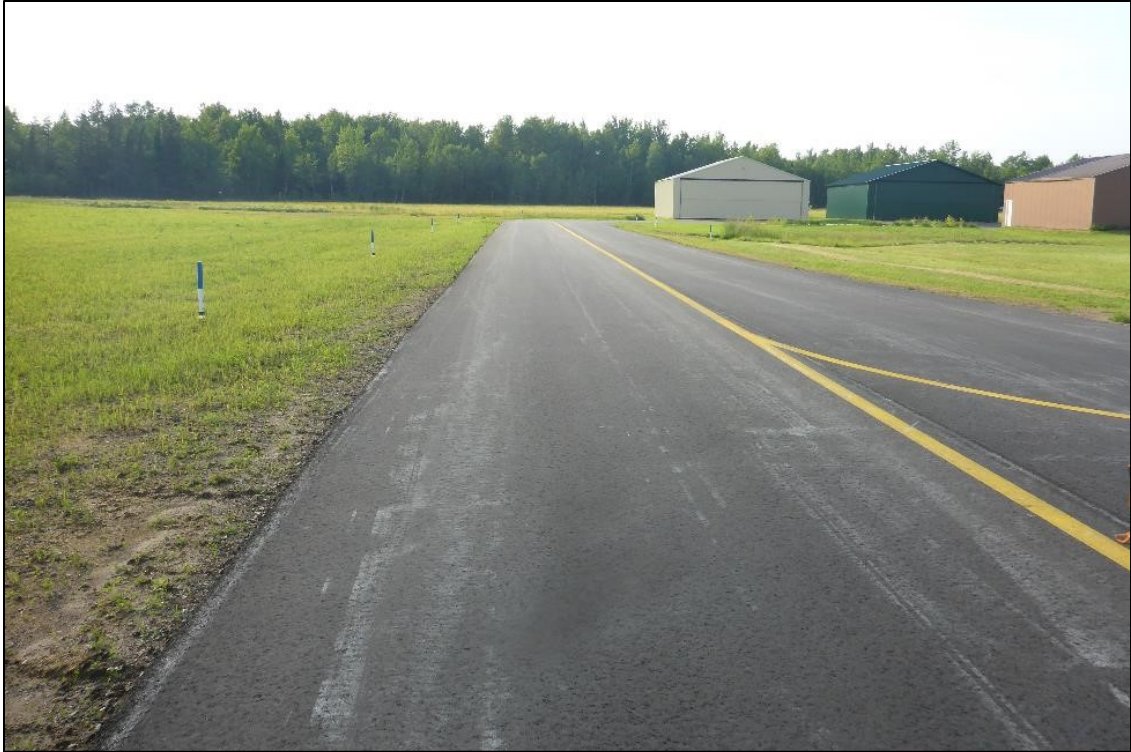
EVM TLA 001 (PCI = 100)

Network:	EVM	Name:	EVELETH-VIRGINIA						
Branch:	TLA	Name:	TAXILANE AREA A	Use:	TAXILANE	Area:	84,400 SqFt		
Section:	001	of 1	From:	100	To:	108	Last Const.: 9/30/1983		
Surface:	AC	Family:	MN2018 Asphalt Taxilanes	Zone:	N	Category:	2	Rank:	T
Area:	84,400 SqFt	Length:	750 Ft	Width:	40 Ft				
Slabs:	Slab Length:	Ft	Slab Width:	Ft	Joint Length:	Ft			
Shoulder:	Street Type:		Grade:	0	Lanes:	0			
Section Comments:	estimated LCD								
Last Insp. Date:	6/29/2018	TotalSamples:	21	Surveyed:	6				
Conditions:	PCI: 100								
Inspection Comments:									
Sample Number:	101	Type:	R	Area:	4000.00 SqFt	PCI:	100		
Sample Comments:	nd								
<No Distress>									
Sample Number:	105	Type:	R	Area:	4000.00 SqFt	PCI:	100		
Sample Comments:	nd								
<No Distress>									
Sample Number:	108	Type:	R	Area:	4000.00 SqFt	PCI:	100		
Sample Comments:	nd								
<No Distress>									
Sample Number:	201	Type:	R	Area:	5000.00 SqFt	PCI:	100

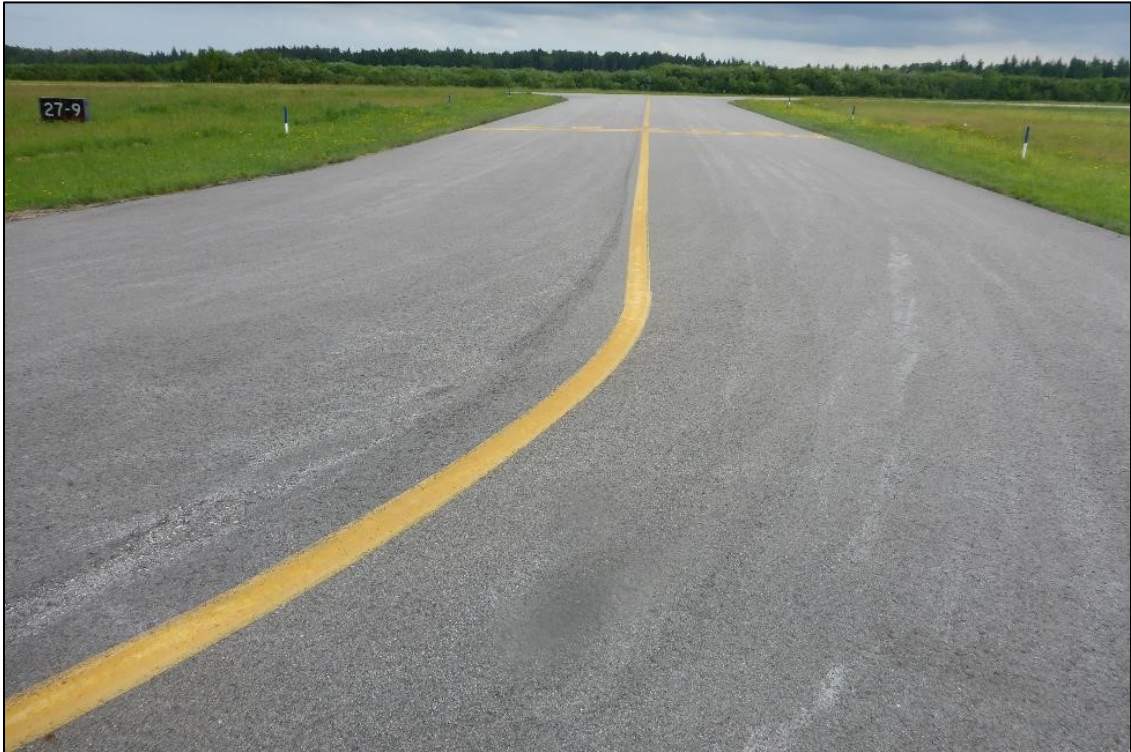
EVM TWD 001 (PCI = 98)

Network:	EVM	Name:	EVELETH-VIRGINIA						
Branch:	TWD	Name:	RY 27 TURNAROUND	Use:	TAXIWAY	Area:	29,244 SqFt		
Section:	001	of 1	From:	100	To:	107	Last Const.:	11/1/2013	
Surface:	AC	Family:	MN2018 Asphalt Runway- Taxiways	Zone:		Category:		Rank:	P
Area:	29,244 SqFt	Length:	1,000 Ft	Width:	25 Ft				
Slabs:		Slab Length:	Ft	Slab Width:	Ft	Joint Length:	Ft		
Shoulder:		Street Type:		Grade:	0	Lanes:	0		
Section Comments:									
Last Insp. Date:	6/29/2018	TotalSamples:	8	Surveyed:	2				
Conditions:	PCI: 98								
Inspection Comments:									
Sample Number:	101	Type:	R	Area:	3500.00 SqFt	PCI:	100		
Sample Comments:	nd								
<No Distress>									
Sample Number:	107	Type:	R	Area:	3500.00 SqFt	PCI:	95		
Sample Comments:									
48	L & T CR	L		35.00	Ft
