Pavement Condition Report

Hutchinson Municipal Airport (HCD)

December 2019

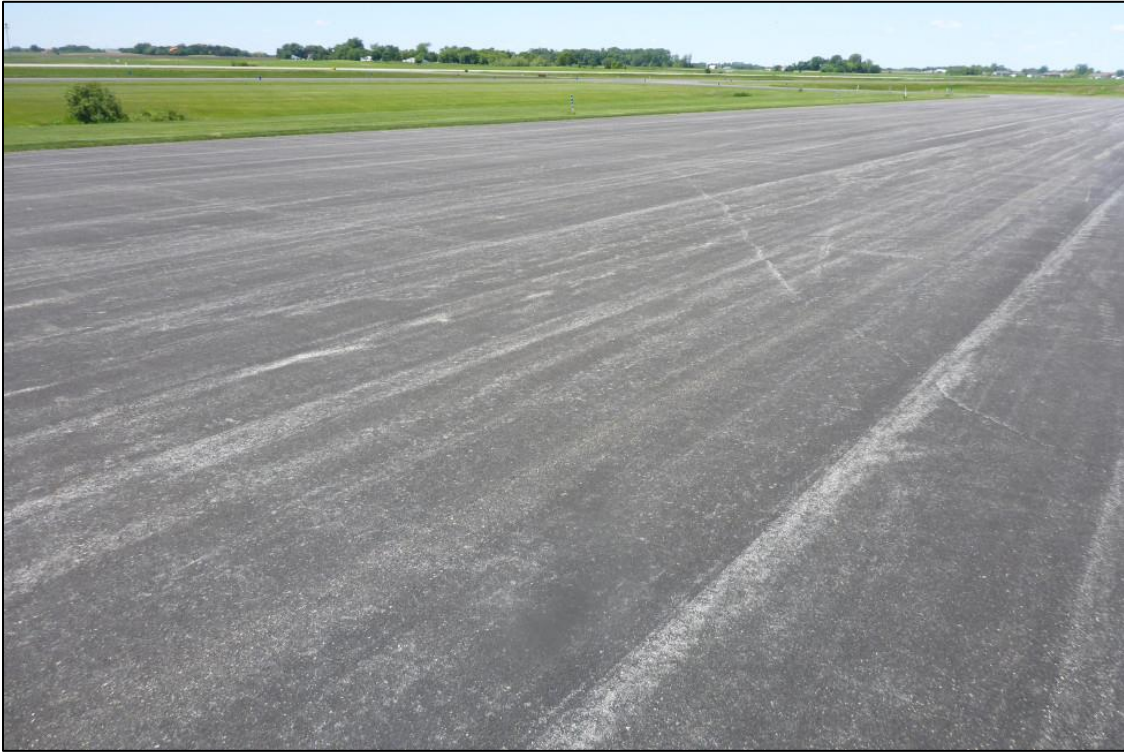
HCD APB 001 (PCI = 91)

Conditions: PCI: 91

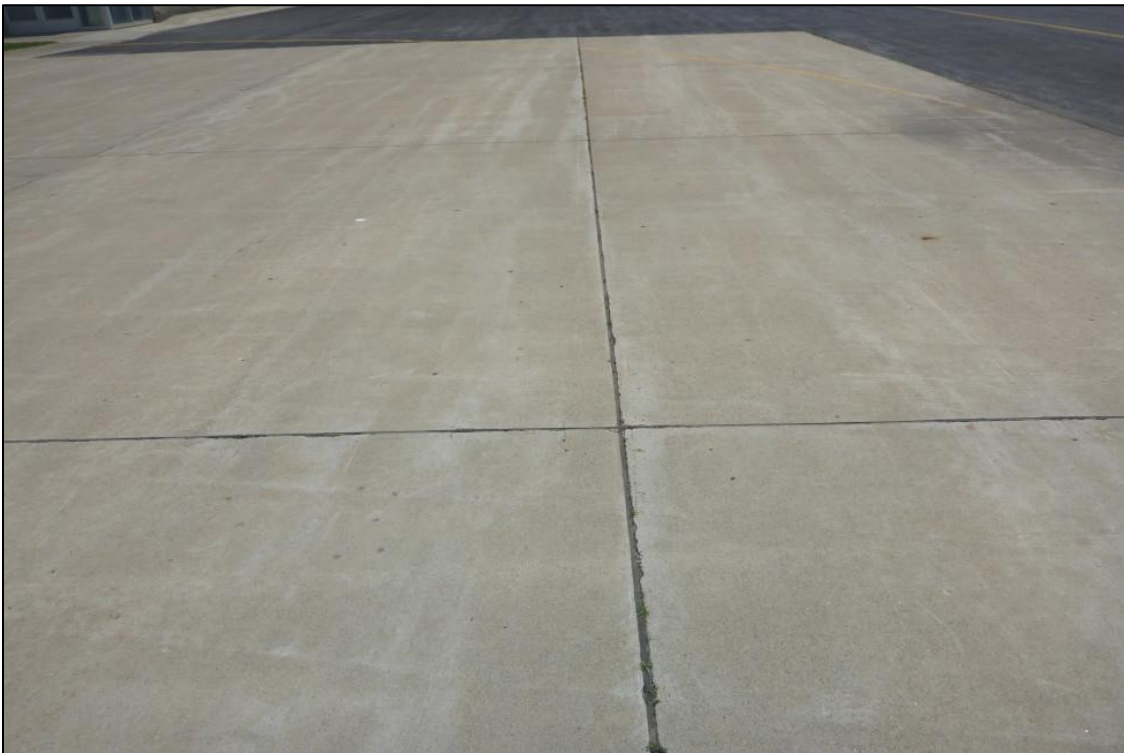
HCD APB 002 (PCI = 76)

Conditions: PCI: 76

65	JT SEAL DMG	M	20.00	Slabs
71	FAULTING	L	1.00	Slabs
74	JOINT SPALL	L	1.00	Slabs
74	JOINT SPALL	M	2.00	Slabs
75	CORNER SPALL	H	1.00	Slabs

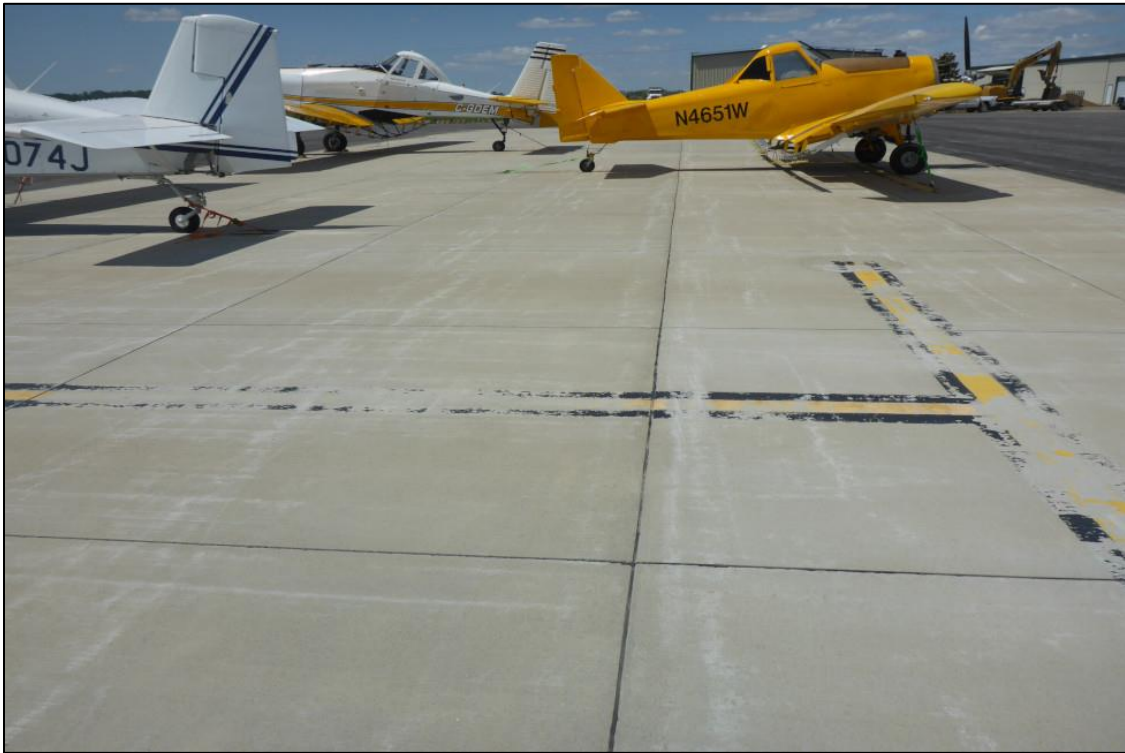
HCD APB 003 (PCI = 98)

Network:	HCD		Name:	HUTCHINSON					
Branch:	APB	Name:	APRON B (NORTH APRON)	Use:	APRON	Area:	129,600 SqFt		
Section:	003	of 3	From:	A	To:	B	Last Const.:	10/1/2015	
Surface:	PCC	Family:	MN2018 PCC	Zone:		Category:		Rank:	S
Area:	15,600 SqFt	Length:	260 Ft	Width:	60 Ft				
Slabs:	156	Slab Length:	10 Ft	Slab Width:	10 Ft	Joint Length:	2,800 Ft		
Shoulder:		Street Type:		Grade:	0	Lanes:	0		
Section Comments:									
Last Insp. Date:	6/11/2019		TotalSamples:	8		Surveyed:	2		
Conditions:	PCI:	98							
Inspection Comments:									
Sample Number:	101	Type:	R	Area:	18.00 Slabs	PCI:	98		
Sample Comments:									
65	JT SEAL DMG	L		18.00	Slabs				
Sample Number:	105	Type:	R	Area:	18.00 Slabs	PCI:	98		
Sample Comments: p275									
65	JT SEAL DMG	L		18.00	Slabs

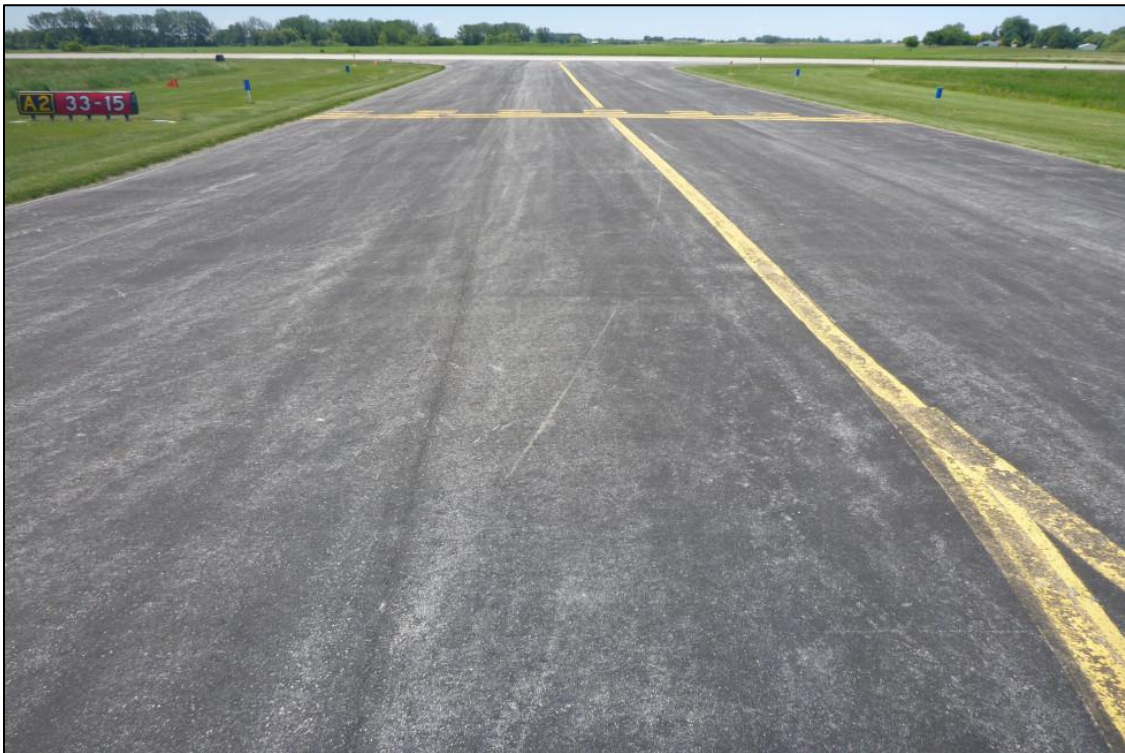
HCD CTA2 001 (PCI = 95)

Network:	HCD		Name:	HUTCHINSON					
Branch:	CTA2	Name:	CONNECTING TAXIWAY A2	Use:	TAXIWAY	Area:	10,950 SqFt		
Section:	001	of 1	From:	400	To:	401	Last Const.:	10/1/2015	
Surface:	AC	Family:	MN2018 Asphalt Runway- Taxiways	Zone:	S	Category:	3	Rank:	S
Area:	10,950 SqFt	Length:	240 Ft	Width:	40 Ft				
Slabs:		Slab Length:	Ft	Slab Width:	Ft	Joint Length:	Ft		
Shoulder:		Street Type:		Grade:	0	Lanes:	0		
Section Comments:	maint. (R&E?) CS								
Last Insp. Date:	6/11/2019		TotalSamples:	3		Surveyed:	2		
Conditions:	PCI:	95							
Inspection Comments:									
Sample Number:	400	Type:	R	Area:	4000.00 SqFt	PCI:	89		
Sample Comments:	p268								
48	L & T CR	L	130.00	Ft					
Sample Number:	401	Type:	R	Area:	4000.00 SqFt	PCI:	100		
Sample Comments:	p267								
<No Distress>

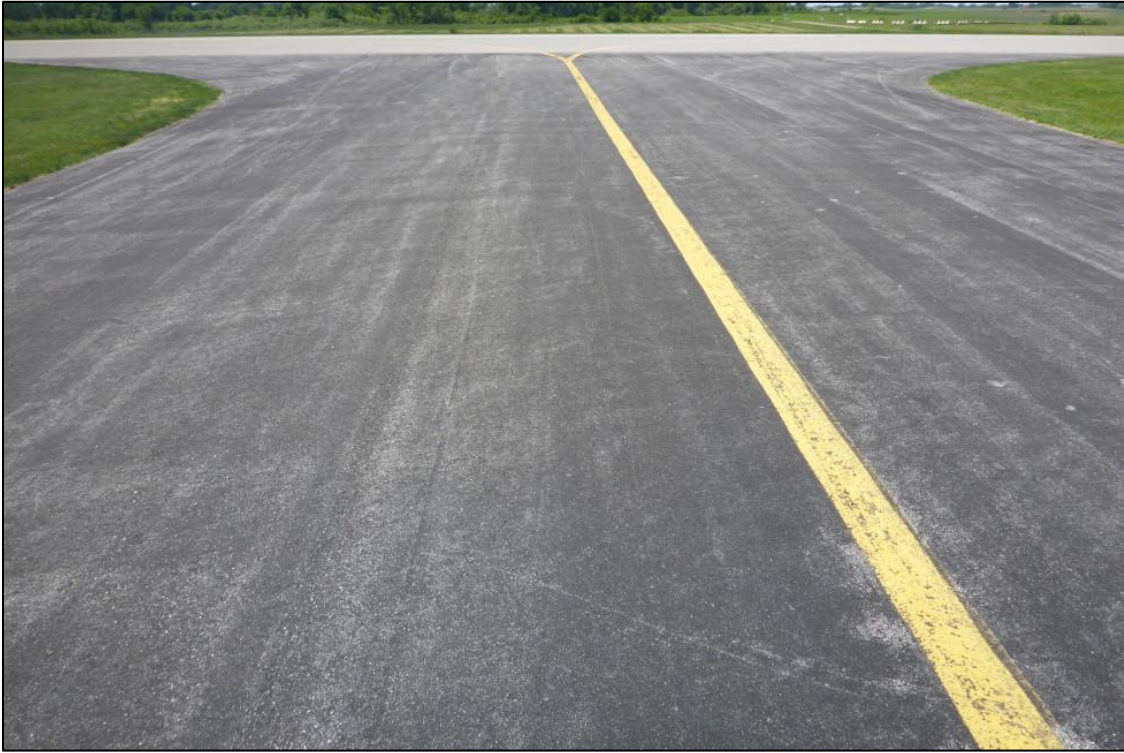
HCD CTA3 001 (PCI = 96)

Network:	HCD		Name:	HUTCHINSON					
Branch:	CTA3	Name:	CONNECTING TAXIWAY A3	Use:	TAXIWAY	Area:	28,640 SqFt		
Section:	001	of 2	From:	300	To:	301	Last Const.:	10/1/2015	
Surface:	AC	Family:	MN2018 Asphalt Runway- Taxiways	Zone:	S	Category:	3	Rank:	P
Area:	10,950 SqFt	Length:	240 Ft	Width:	40 Ft				
Slabs:		Slab Length:	Ft	Slab Width:	Ft	Joint Length:	Ft		
Shoulder:		Street Type:		Grade:	0	Lanes:	0		
Section Comments:	maint. (R&E?) CS								
Last Insp. Date:	6/11/2019		TotalSamples:	3		Surveyed:	2		
Conditions:	PCI:	96							
Inspection Comments:									
Sample Number:	300	Type:	R	Area:	4000.00 SqFt	PCI:	93		
Sample Comments:	p270								
48	L & T CR	L	74.00	Ft					
Sample Number:	301	Type:	R	Area:	4000.00 SqFt	PCI:	100		
Sample Comments:									
<No Distress>

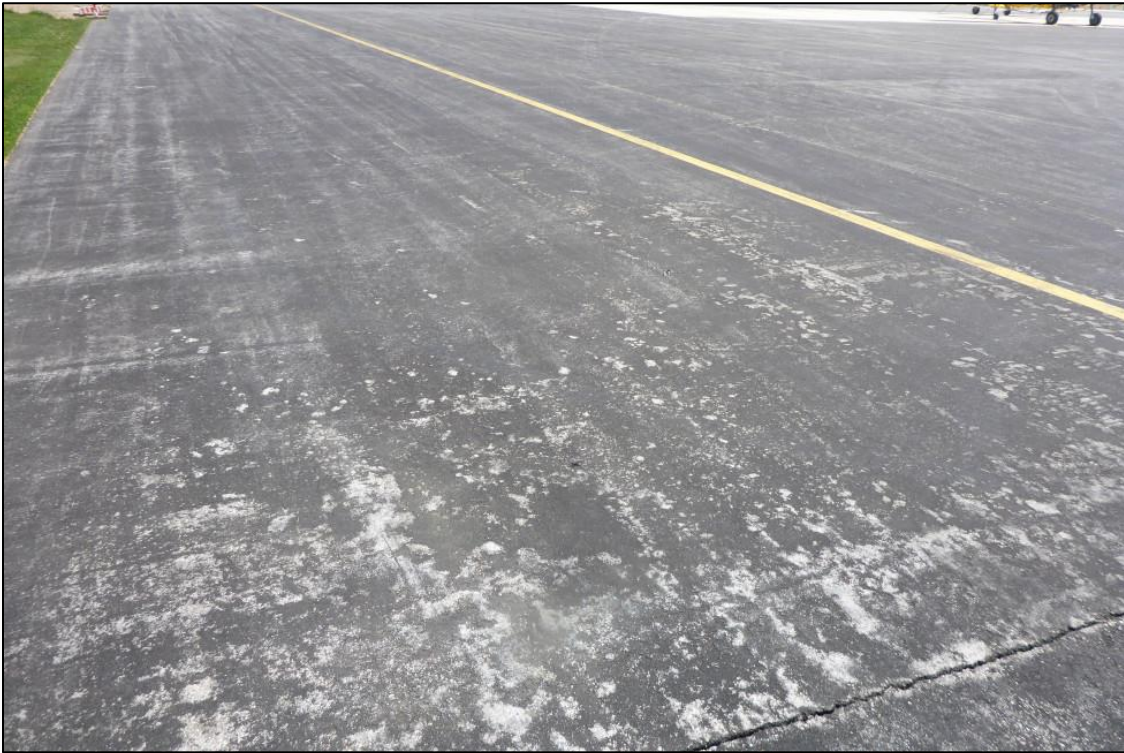
HCD CTA3 002 (PCI = 83)

Conditions: PCI: 83

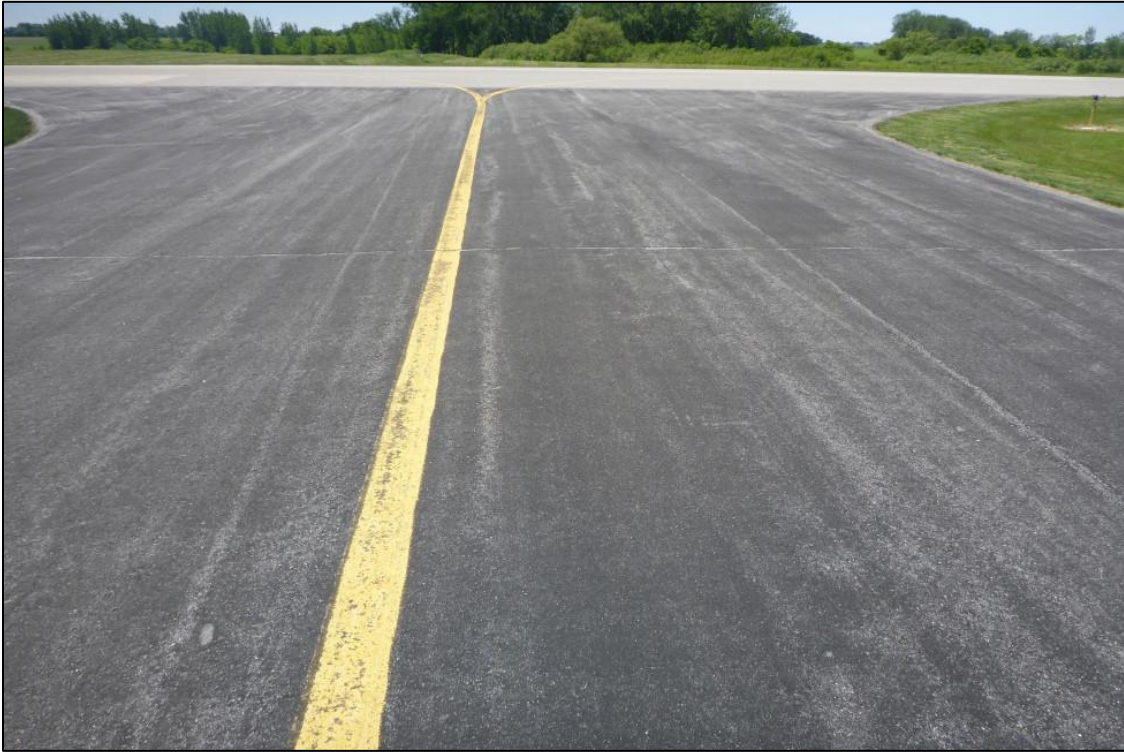
HCD CTA4 001 (PCI = 95)

Network:	HCD		Name:	HUTCHINSON					
Branch:	CTA4	Name:	CONNECTING TAXIWAY A4	Use:	TAXIWAY	Area:	10,950 SqFt		
Section:	001	of 1	From:	200	To:	201	Last Const.:	10/1/2015	
Surface:	AC	Family:	MN2018 Asphalt Runway- Taxiways	Zone:	S	Category:	3	Rank:	S
Area:	10,950 SqFt	Length:	240 Ft	Width:	40 Ft				
Slabs:		Slab Length:	Ft	Slab Width:	Ft	Joint Length:	Ft		
Shoulder:		Street Type:		Grade:	0	Lanes:	0		
Section Comments:	maint. (R&E?) CS								
Last Insp. Date:	6/11/2019		TotalSamples:	3		Surveyed:	2		
Conditions:	PCI:	95							
Inspection Comments:									
Sample Number:	200	Type:	R	Area:	4000.00 SqFt	PCI:	95		
Sample Comments:	p271								
48	L & T CR		L	44.00	Ft				
Sample Number:	201	Type:	R	Area:	4000.00 SqFt	PCI:	95		
Sample Comments:									
48	L & T CR		L	40.00	Ft

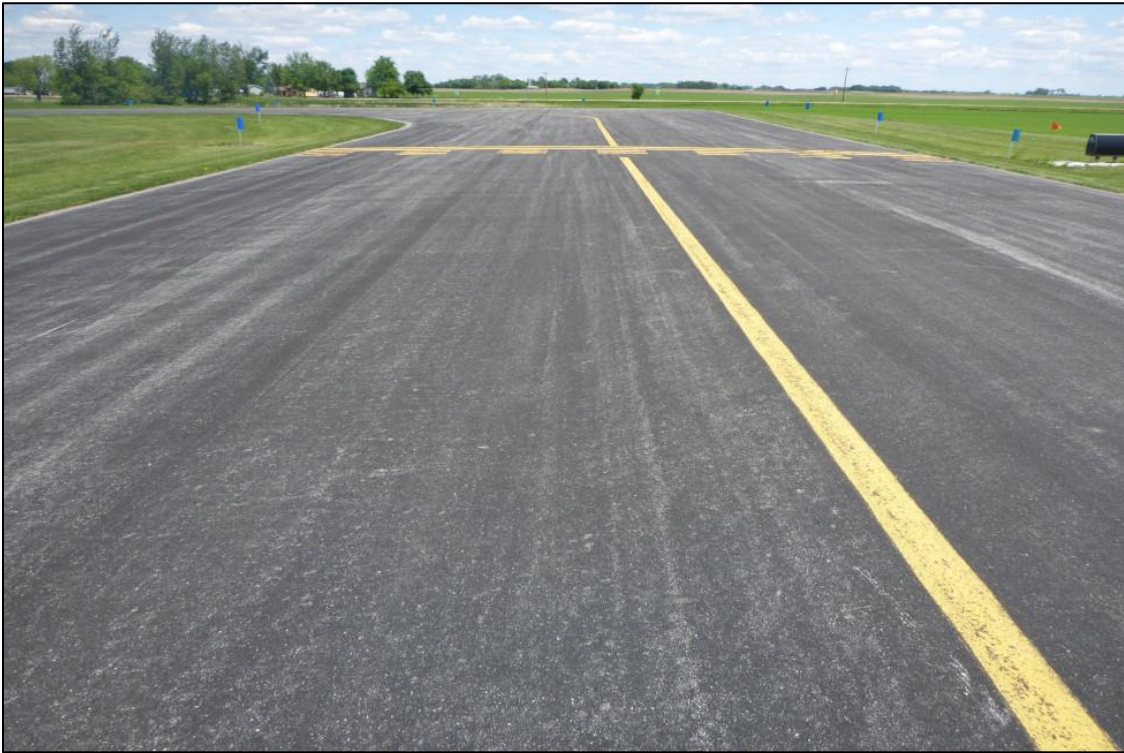
HCD PTA 001 (PCI = 96)

Network:	HCD	Name:	HUTCHINSON						
Branch:	PTA	Name:	PARALLEL TAXIWAY A	Use:	TAXIWAY	Area:	184,690 SqFt		
Section:	001	of 3	From:	100	To:	101+82	Last Const.:	10/1/2015	
Surface:	AC	Family:	MN2018 Asphalt Runway- Taxiways	Zone:	S	Category:	3	Rank:	P
Area:	7,615 SqFt	Length:	182 Ft	Width:	40 Ft				
Slabs:		Slab Length:	Ft	Slab Width:	Ft	Joint Length:	Ft		
Shoulder:		Street Type:		Grade:	0	Lanes:	0		
Section Comments:	maint. (R&E?) CS								
Last Insp. Date:	6/11/2019	TotalSamples:	2	Surveyed:	1				
Conditions:	PCI: 96								
Inspection Comments:									
Sample Number:	100	Type:	R	Area:	4335.00 SqFt	PCI:	96		
Sample Comments:	p274								
48	L & T CR	L	21.00	Ft

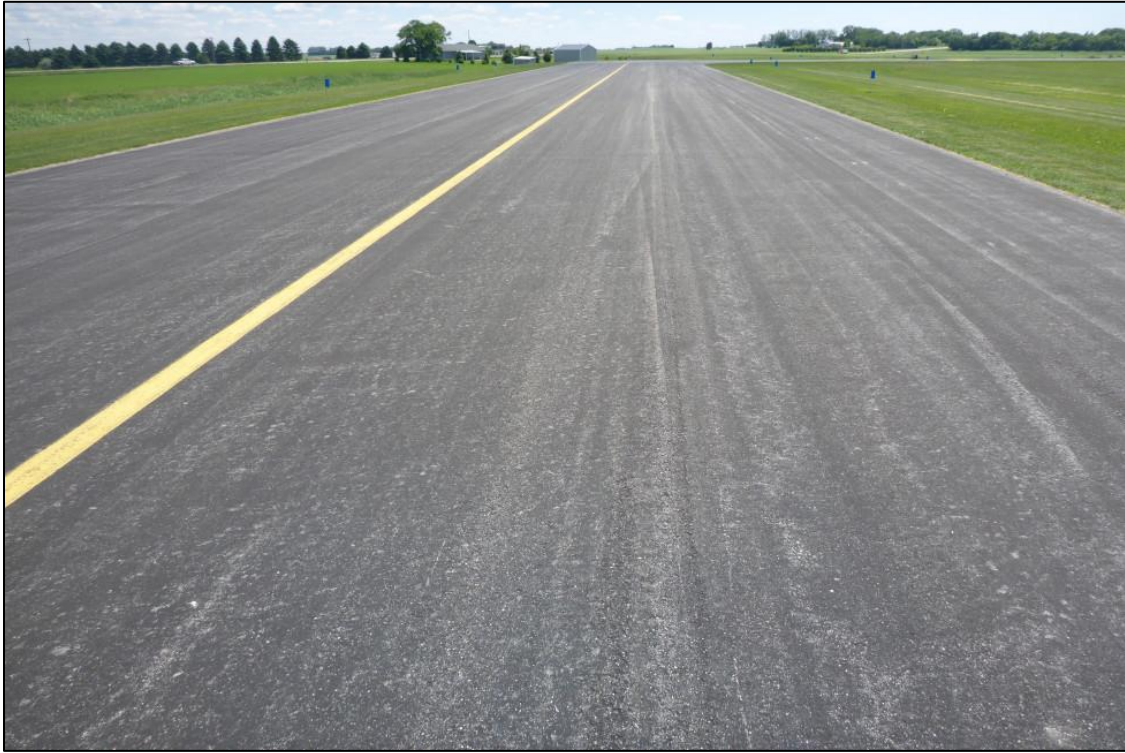
HCD PTA 002 (PCI = 86)

Network:	HCD	Name:	HUTCHINSON						
Branch:	PTA	Name:	PARALLEL TAXIWAY A	Use:	TAXIWAY	Area:	184,690 SqFt		
Section:	002	of 3	From:	101+82	To:	112+40	Last Const.:	10/1/2015	
Surface:	AC	Family:	MN2018 Asphalt Runway- Taxiways	Zone:	S	Category:	3	Rank:	P
Area:	46,800 SqFt	Length:	1,040 Ft	Width:	40 Ft				
Slabs:		Slab Length:	Ft	Slab Width:	Ft	Joint Length:	Ft		
Shoulder:		Street Type:		Grade:	0	Lanes:	0		
Section Comments:	maint. (R&E?) CS								
Last Insp. Date:	6/11/2019	TotalSamples:	10	Surveyed:	2				
Conditions:	PCI: 86								
Inspection Comments:									
Sample Number:	106	Type:	R	Area:	4000.00 SqFt	PCI:	84		
Sample Comments:	p273								
48	L & T CR	L	225.00	Ft					
Sample Number:	111	Type:	R	Area:	4000.00 SqFt	PCI:	87		
Sample Comments:	p272								
48	L & T CR	L	167.00	Ft

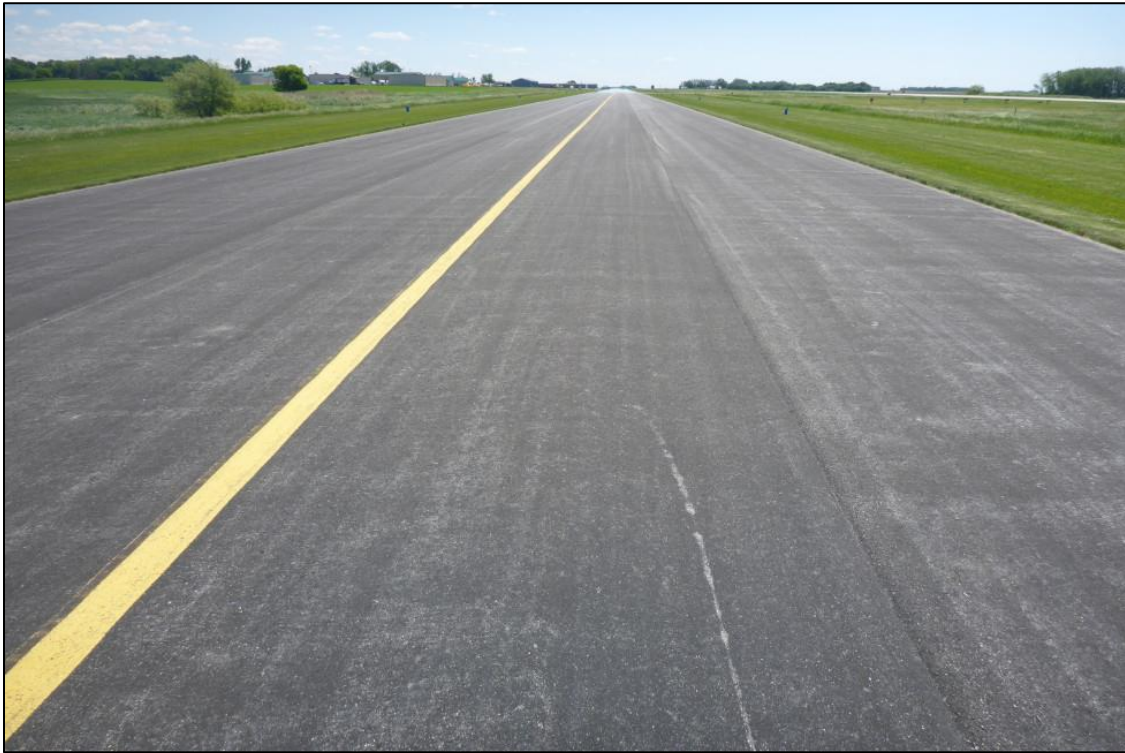
HCD PTA 003 (PCI = 94)

Conditions: PCI: 94

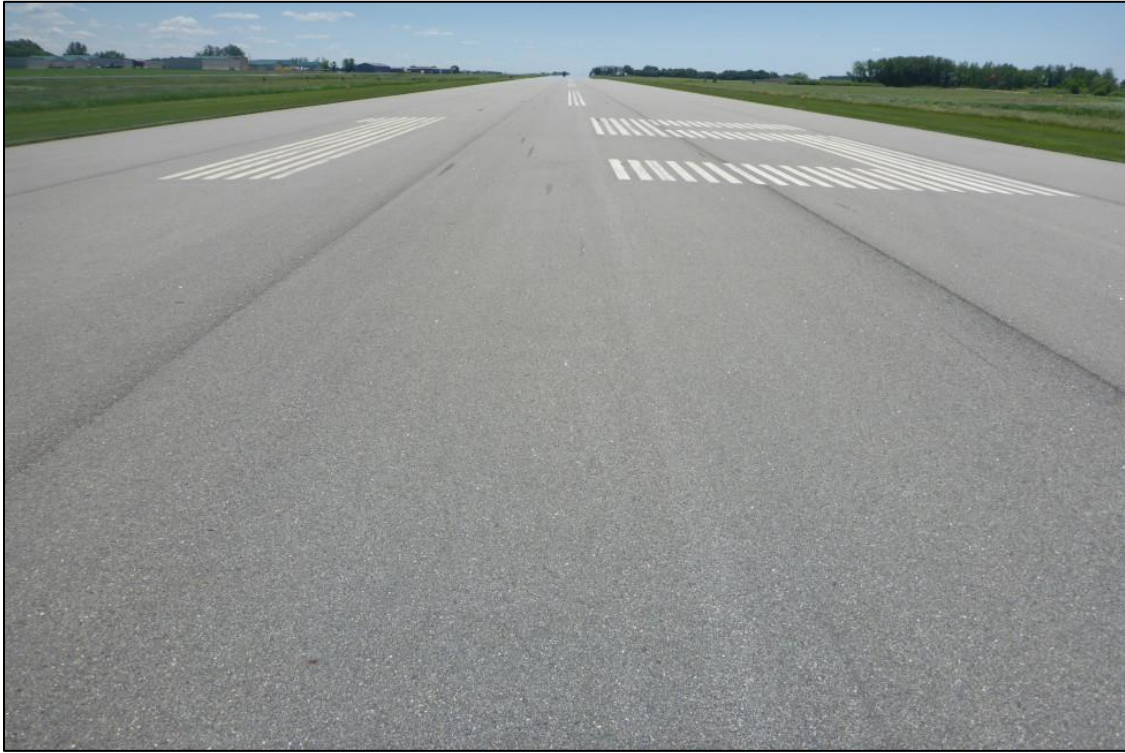
HCD RY1533 001 (PCI = 88)

Network:	HCD		Name:	HUTCHINSON					
Branch:	RY1533	Name:	RUNWAY 15-33	Use:	RUNWAY	Area:	300,000 SqFt		
Section:	001	of 1	From:	100	To:	179	Last Const.:	10/1/2015	
Surface:	AC	Family:	MN2018 Asphalt Runway- Taxiways	Zone:	S	Category:	3	Rank:	P
Area:	300,000 SqFt	Length:	4,000 Ft	Width:	75 Ft				
Slabs:		Slab Length:	Ft	Slab Width:	Ft	Joint Length:	Ft		
Shoulder:		Street Type:		Grade:	0	Lanes:	0		
Section Comments:	maint. (R&E?) CS								
Last Insp. Date:	6/11/2019		TotalSamples:	80		Surveyed:	8		
Conditions:	PCI:	88							
Inspection Comments:									
Sample Number:	104	Type:	R	Area:	3750.00 SqFt	PCI:	85		
Sample Comments:	p263 numbers								
48	L & T CR	L	191.00 Ft						
Sample Number:	114	Type:	R	Area:	3750.00 SqFt	PCI:	87		
Sample Comments:									
48	L & T CR	L	165.00 Ft						
Sample Number:	124	Type:	R	Area:	3750.00 SqFt	PCI:	85		
Sample Comments:	p264								
48	L & T CR	L	200.00 Ft						
Sample Number:	134	Type:	R	Area:	3750.00 SqFt	PCI:	87

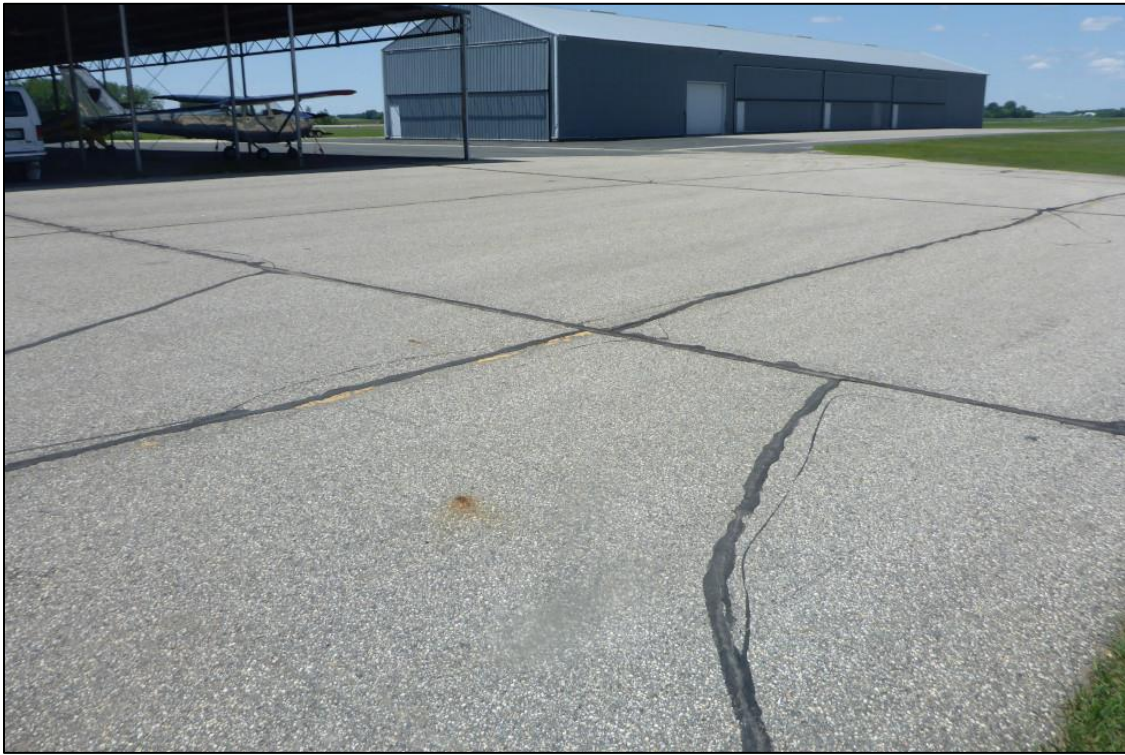
HCD TLA 002 (PCI = 63)

Conditions: PCI: 63

Sample Comments: p864 most of crack seal looks good

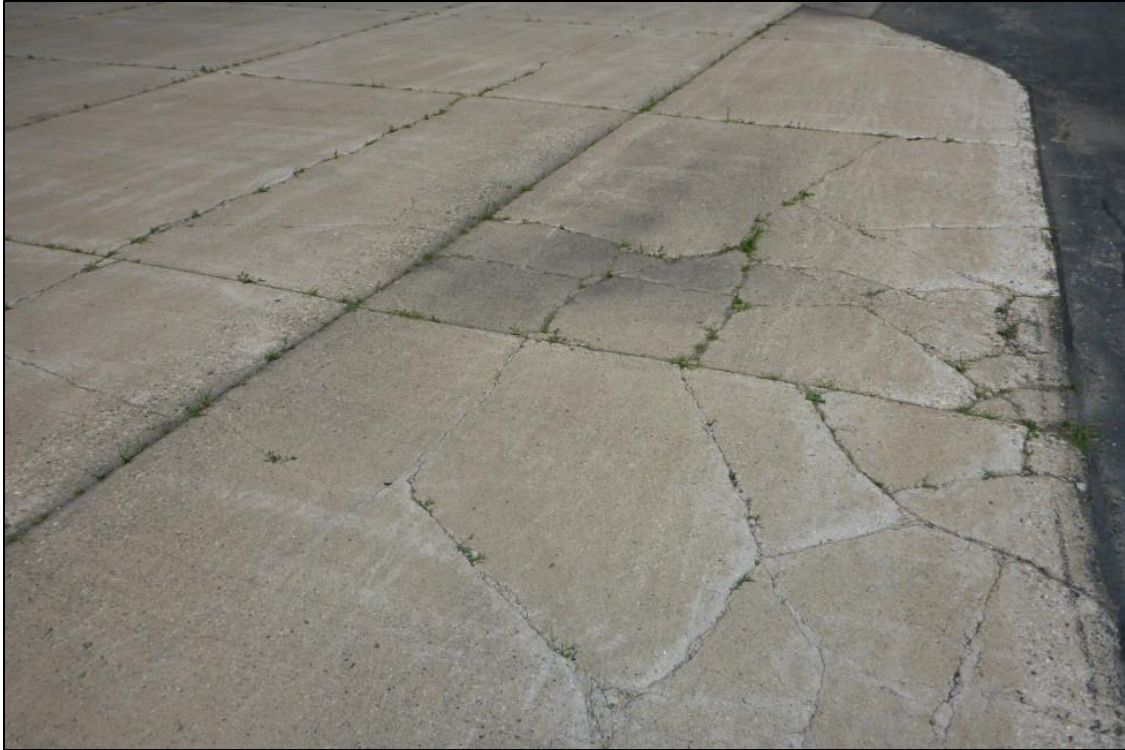
HCD TLA 004 (PCI = 26)

Conditions: PCI: 26

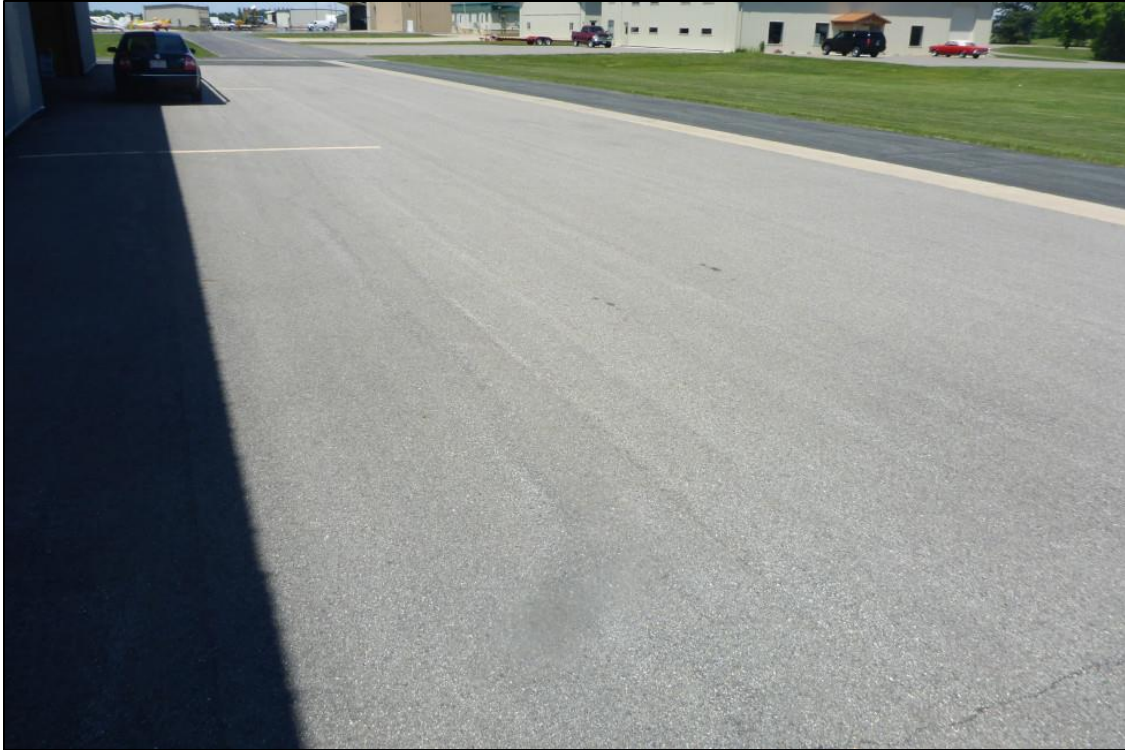
HCD TLA 006 (PCI = 92)

Conditions: PCI: 92
