Pavement Condition Report

Rush City Regional Airport (ROS)

January 2016

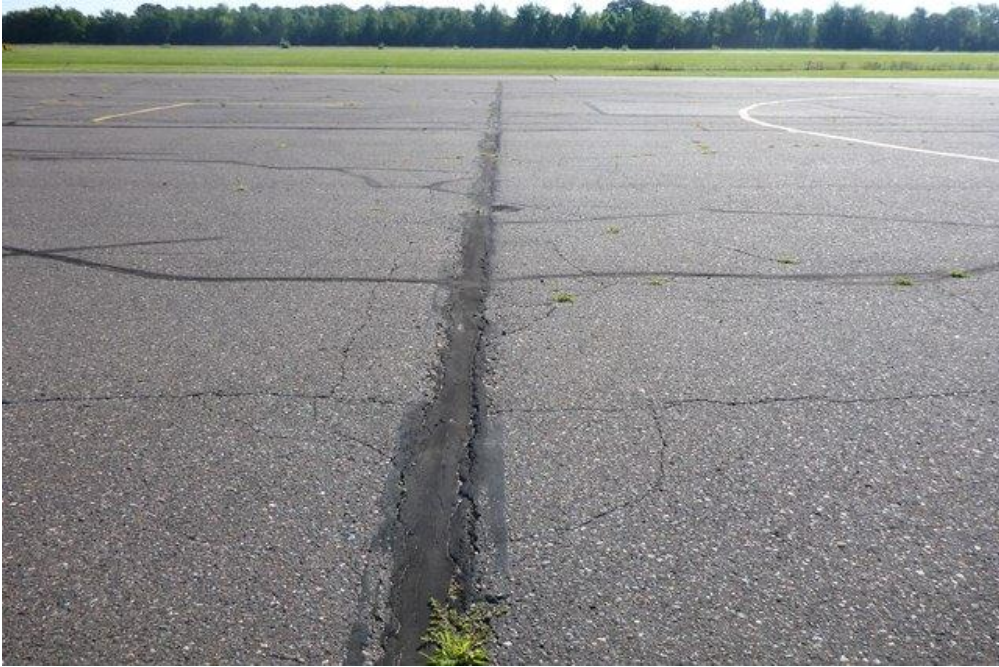
ROS APA 001 (PCI =17)

Conditions: PCI: 17

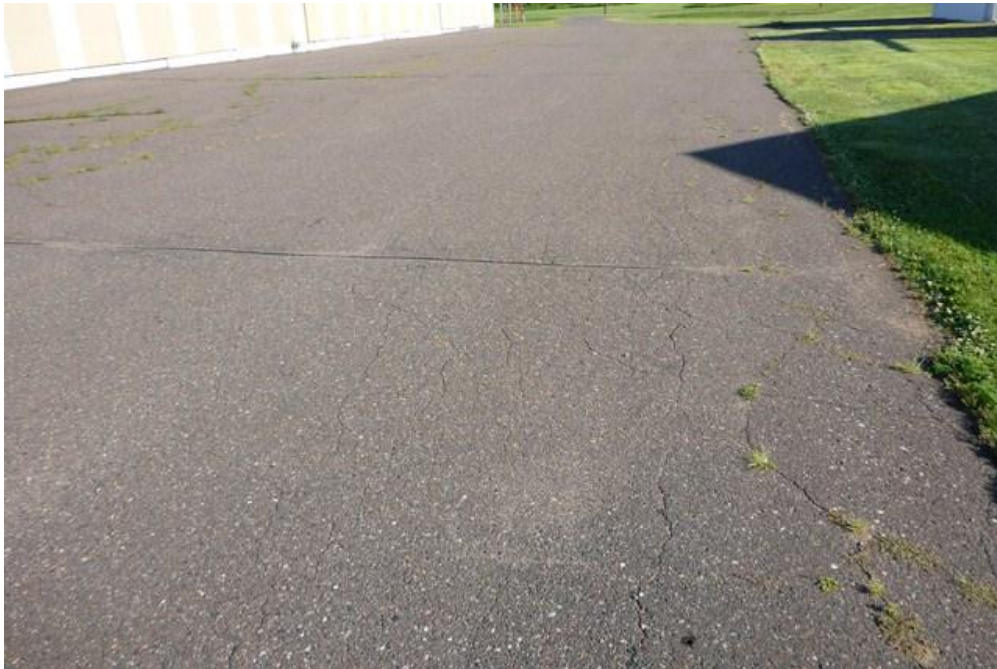
ROS TLA 001 (PCI =21)

Conditions: PCI: 21

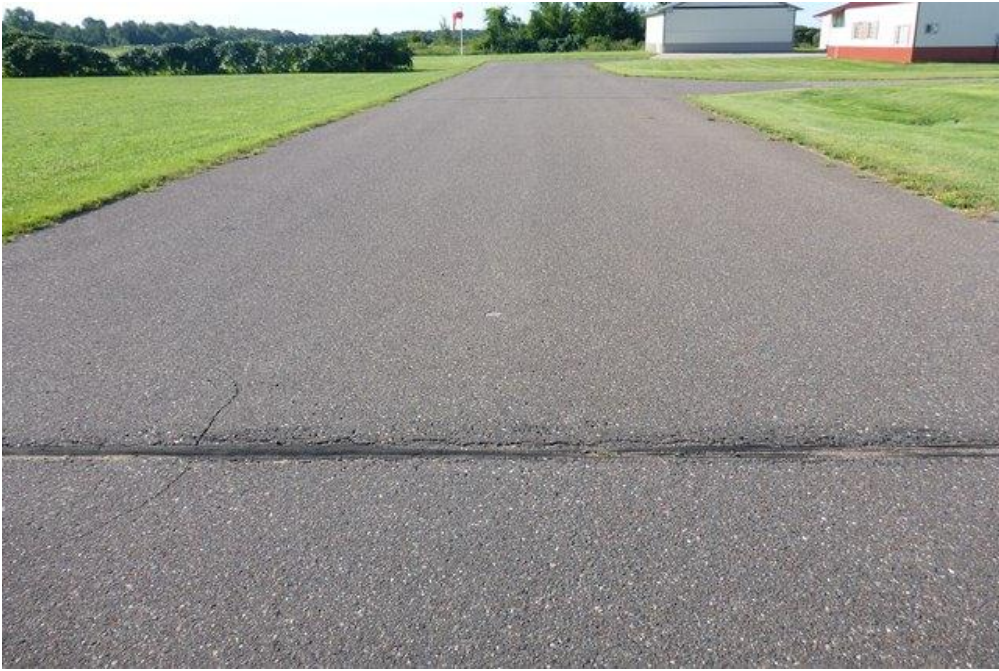
ROS TLA 002 (PCI =51)

Conditions: PCI: 51
