Pavement Condition Report

Albert Lea Municipal Airport (AEL)

December 2016

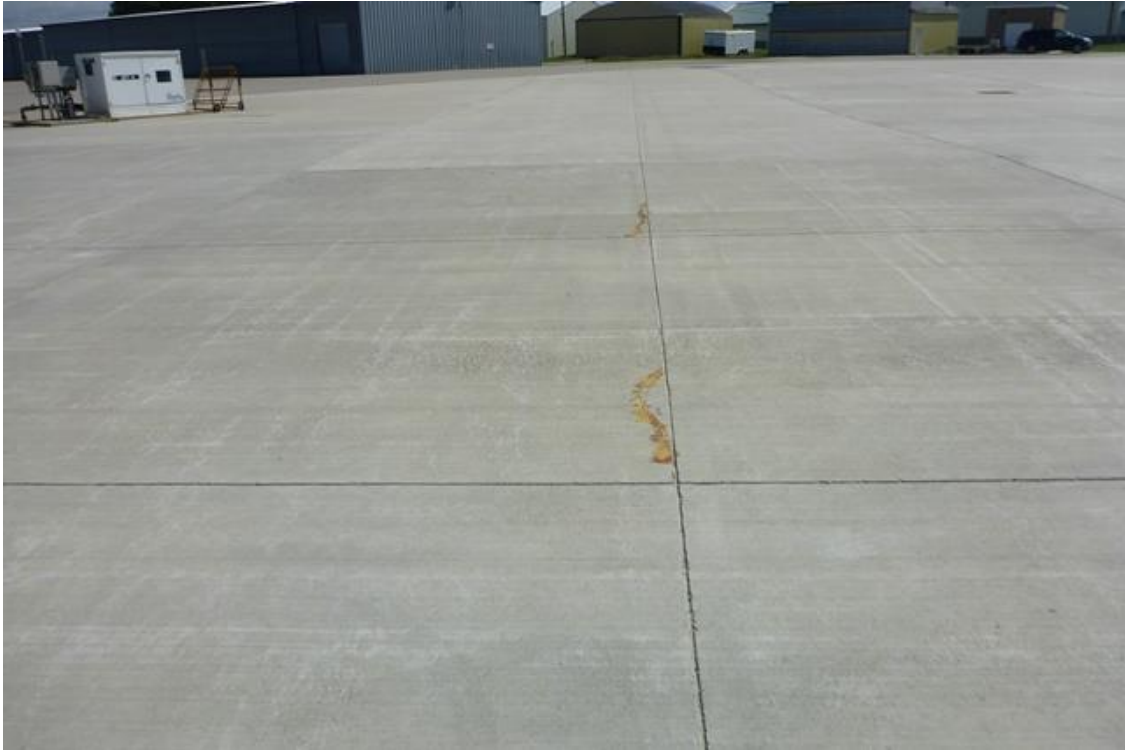
AEL APA 001 (PCI = 98)

Sample Number:	206	Type:	R	Area:	20.00 Slabs	PCI:	94		
Sample Comments:									
74	JOINT SPALL		M	1.00	Slabs				
74	JOINT SPALL		L	1.00	Slabs				
Sample Number:	302	Type:	R	Area:	20.00 Slabs	PCI:	95		
Sample Comments:									
63	LINEAR CR		L	1.00	Slabs				
Sample Number:	306	Type:	R	Area:	20.00 Slabs	PCI:	100		
Sample Comments:	<No Distress>

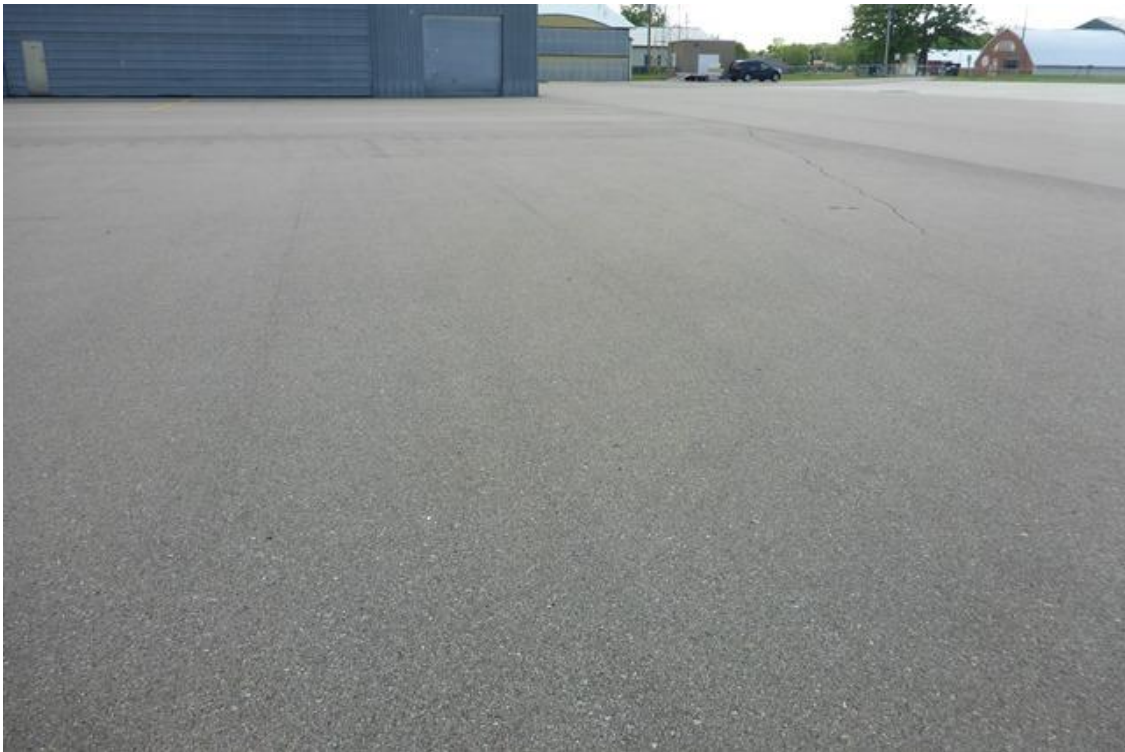
AEL APA 002 (PCI = 91)

Network:	AEL		Name:	ALBERT LEA					
Branch:	APA	Name:	APRON A	Use:	APRON	Area:	131,030 SqFt		
Section:	002	of 2	From:	99	To:	103	Last Const.:	8/1/2013	
Surface:	AC	Family:	MN2013 Asphalt Aprons	Zone:		Category:		Rank:	S
Area:	28,000 SqFt	Length:	300 Ft	Width:	60 Ft				
Slabs:		Slab Length:	Ft	Slab Width:	Ft	Joint Length:	Ft		
Shoulder:		Street Type:		Grade:	0	Lanes:	0		
Section Comments:	defined as a new section for 2013 recon project								
Last Insp. Date:	5/29/2016		TotalSamples:	5		Surveyed:	2		
Conditions:	PCI:	91							
Inspection Comments:									
Sample Number:	101	Type:	R	Area:	5900.00 SqFt	PCI:	92		
Sample Comments:									
48	L & T CR	M	7.00	Ft					
48	L & T CR	L	32.00	Ft					
Sample Number:	102	Type:	R	Area:	5900.00 SqFt	PCI:	90		
Sample Comments:									
50	PATCHING	L	293.00	SqFt

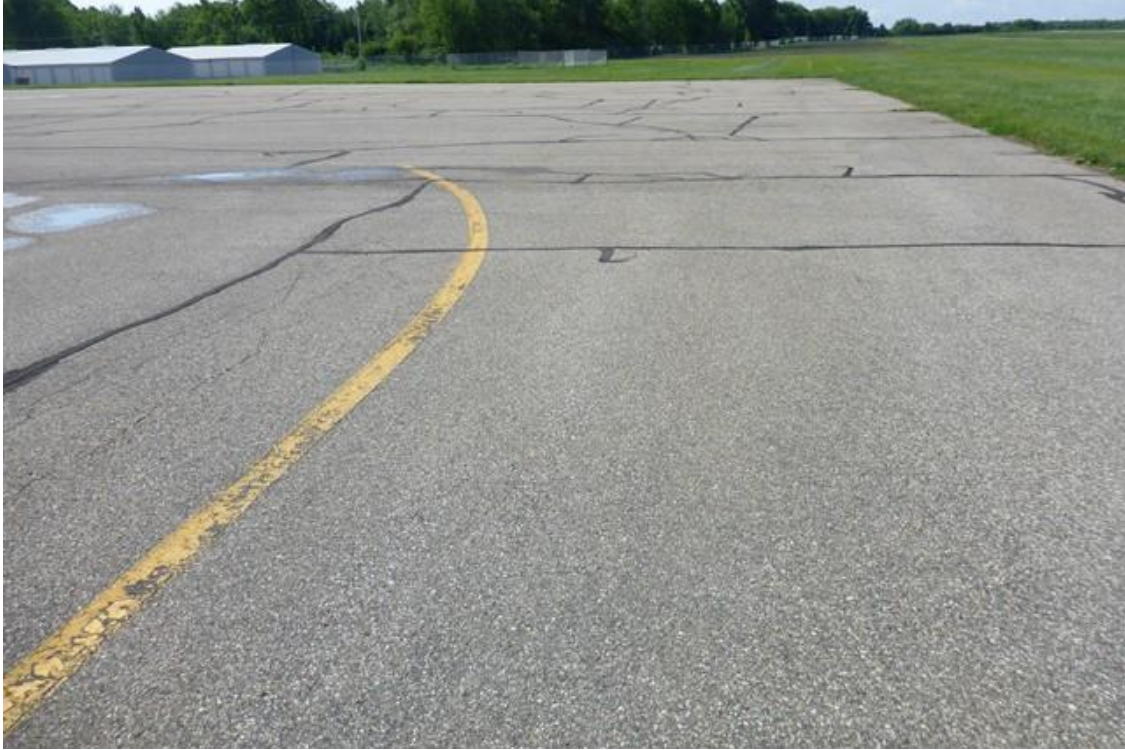
AEL APB 001 (PCI = 68)

Network:	AEL		Name:	ALBERT LEA					
Branch:	APB	Name:	APRON B	Use:	APRON	Area:	37,600 SqFt		
Section:	001	of 1	From:	101	To:	400	Last Const.:	9/30/1993	
Surface:	AAC	Family:	MN2013 Asphalt Aprons	Zone:	S	Category:	3	Rank:	S
Area:	37,600 SqFt	Length:	220 Ft	Width:	145 Ft				
Slabs:	Slab Length:	Ft	Slab Width:	Ft	Joint Length:	Ft			
Shoulder:	Street Type:	Grade:	0	Lanes:	0				
Section Comments:	no repairs planned								
Last Insp. Date:	5/29/2016	TotalSamples:	8	Surveyed:	3				
Conditions:	PCI: 68								
Inspection Comments:									
Sample Number:	101	Type:	R	Area:	5750.00 SqFt	PCI:	72		
Sample Comments:									
57	WEATHERING	M	3000.00	SqFt					
48	L & T CR	L	425.00	Ft					
48	L & T CR	M	2.00	Ft					
Sample Number:	300	Type:	R	Area:	4500.00 SqFt	PCI:	74		
Sample Comments:									
48	L & T CR	L	387.00	Ft					
57	WEATHERING	M	1500.00	SqFt					
Sample Number:	400	Type:	A	Area:	5000.00 SqFt	PCI:	35		
Sample Comments:

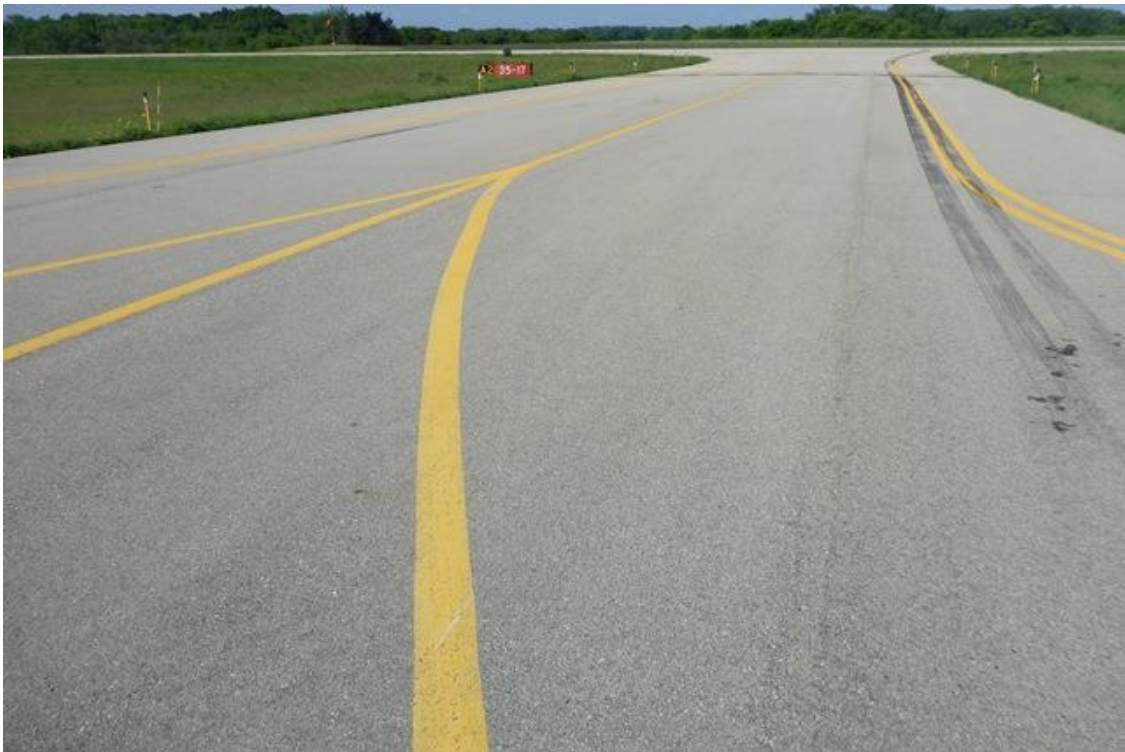
AEL CTA2 001 (PCI = 91)

Network:	AEL		Name:	ALBERT LEA					
Branch:	CTA2	Name:	CONNECTING TAXIWAY A2	Use:	TAXIWAY	Area:	28,530 SqFt		
Section:	001	of 2	From:	100	To:	102	Last Const.:	9/29/2010	
Surface:	AC	Family:	MN2013 Asphalt Taxiways	Zone:	S	Category:	3	Rank:	P
Area:	16,740 SqFt	Length:	330 Ft	Width:	35 Ft				
Slabs:		Slab Length:	Ft	Slab Width:	Ft	Joint Length:	Ft		
Shoulder:		Street Type:		Grade:	0	Lanes:	0		
Section Comments:	new pavement built in 2010								
Last Insp. Date:	5/29/2016	TotalSamples:	3	Surveyed:	1				
Conditions:	PCI: 91								
Inspection Comments:									
Sample Number:	101	Type:	R	Area:	3500.00 SqFt	PCI:	91		
Sample Comments:									
48	L & T CR	M	4.00 Ft						
48	L & T CR	L	31.00 Ft

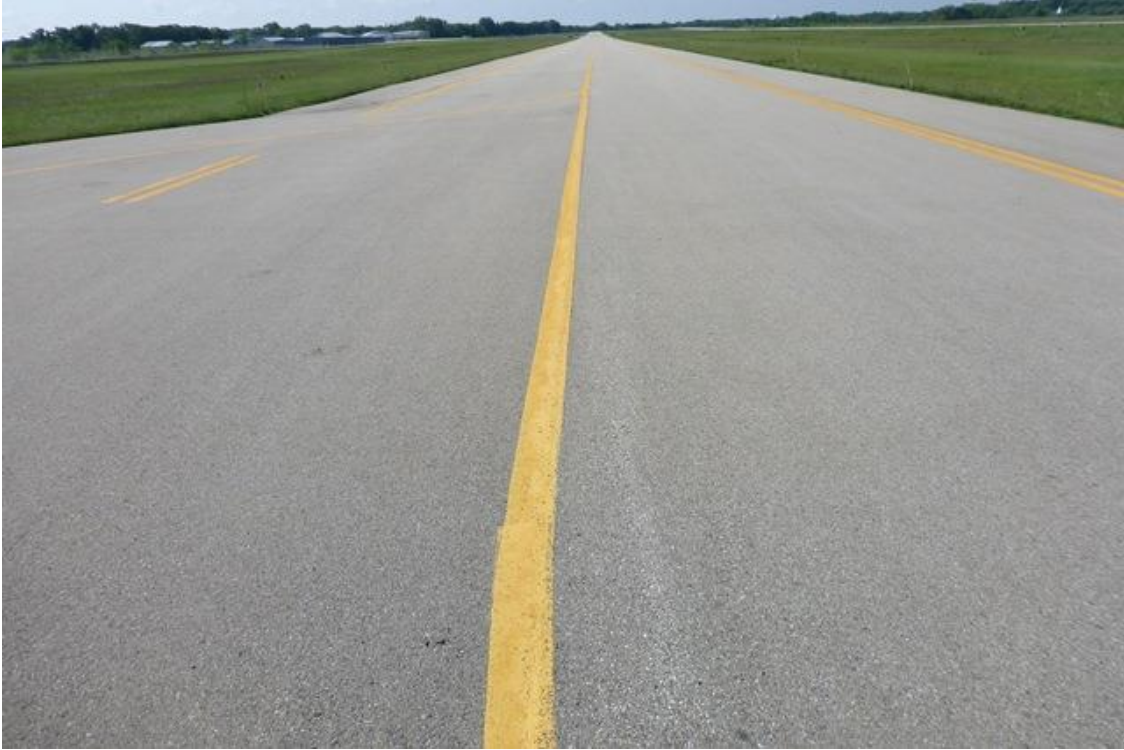
AEL PTA 001 (PCI = 94)

Network:	AEL		Name:	ALBERT LEA					
Branch:	PTA	Name:	Parallel Taxiway A	Use:	TAXIWAY	Area:	216,310 SqFt		
Section:	001	of 3	From:	RY 17	To:	PTA-002	Last Const.:	9/29/2010	
Surface:	AC	Family:	MN2013 Asphalt Taxiways	Zone:	S	Category:	3	Rank:	P
Area:	30,900 SqFt	Length:	520 Ft	Width:	35 Ft				
Slabs:		Slab Length:	Ft	Slab Width:	Ft	Joint Length:	Ft		
Shoulder:		Street Type:		Grade:	0	Lanes:	0		
Section Comments:									
Last Insp. Date:	5/29/2016		TotalSamples:	7		Surveyed:	2		
Conditions:	PCI: 94								
Inspection Comments:									
Sample Number:	101	Type:	R	Area:	3500.00 SqFt	PCI:	89		
Sample Comments:									
48	L & T CR	M	12.00	Ft					
48	L & T CR	L	23.00	Ft					
Sample Number:	103	Type:	R	Area:	3500.00 SqFt	PCI:	100		
Sample Comments:									
<No Distress>

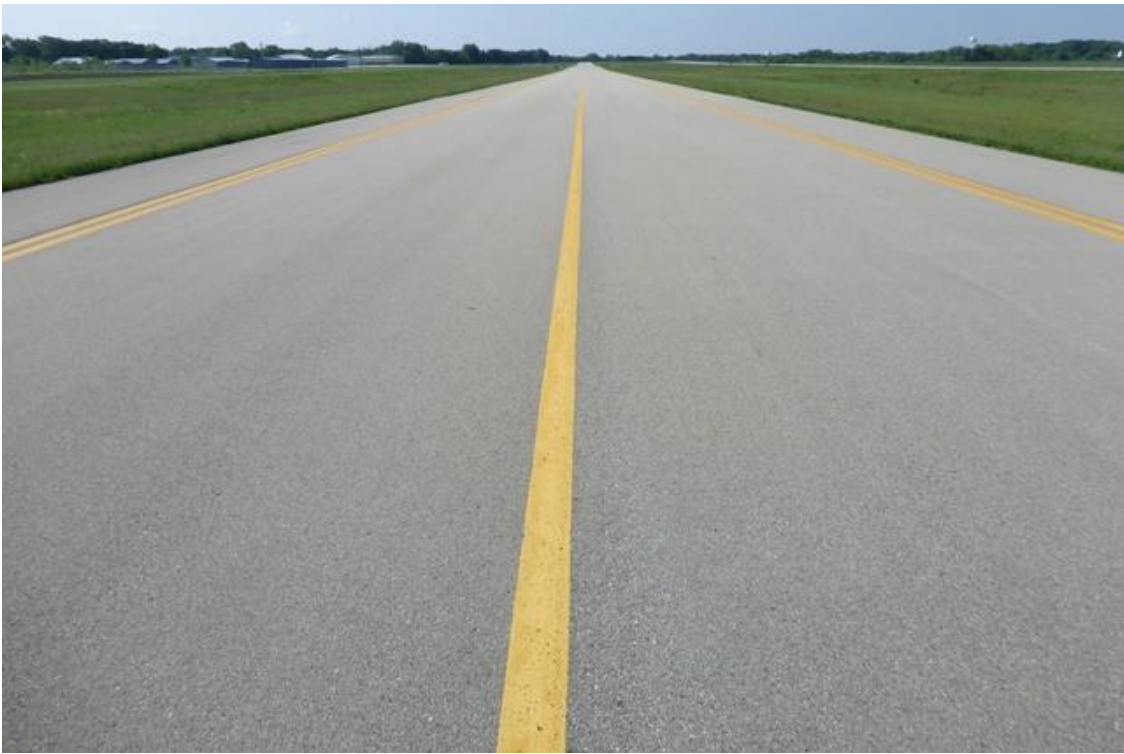
AEL PTA 002 (PCI = 100)

Network:	AEL		Name:	ALBERT LEA					
Branch:	PTA	Name:	Parallel Taxiway A		Use:	TAXIWAY	Area:	216,310 SqFt	
Section:	002	of 3	From:	105	To:	149	Last Const.:	9/1/2011	
Surface:	AC	Family:	MN2013 Asphalt Taxiways	Zone:	S	Category:	3	Rank:	P
Area:	152,650 SqFt	Length:	4,500 Ft	Width:	35 Ft				
Slabs:		Slab Length:	Ft	Slab Width:	Ft	Joint Length:	Ft		
Shoulder:		Street Type:		Grade:	0	Lanes:	0		
Section Comments:									
Last Insp. Date:	5/29/2016		TotalSamples:	45	Surveyed:	8			
Conditions:	PCI:	100							
Inspection Comments:									
Sample Number:	106	Type:	R	Area:	3500.00 SqFt	PCI:	100		
Sample Comments:									
<No Distress>									
Sample Number:	109	Type:	R	Area:	3500.00 SqFt	PCI:	100		
Sample Comments:									
<No Distress>									
Sample Number:	116	Type:	R	Area:	3500.00 SqFt	PCI:	100		
Sample Comments:									
<No Distress>									
Sample Number:	122	Type:	R	Area:	3500.00 SqFt	PCI:	100		
Sample Comments:

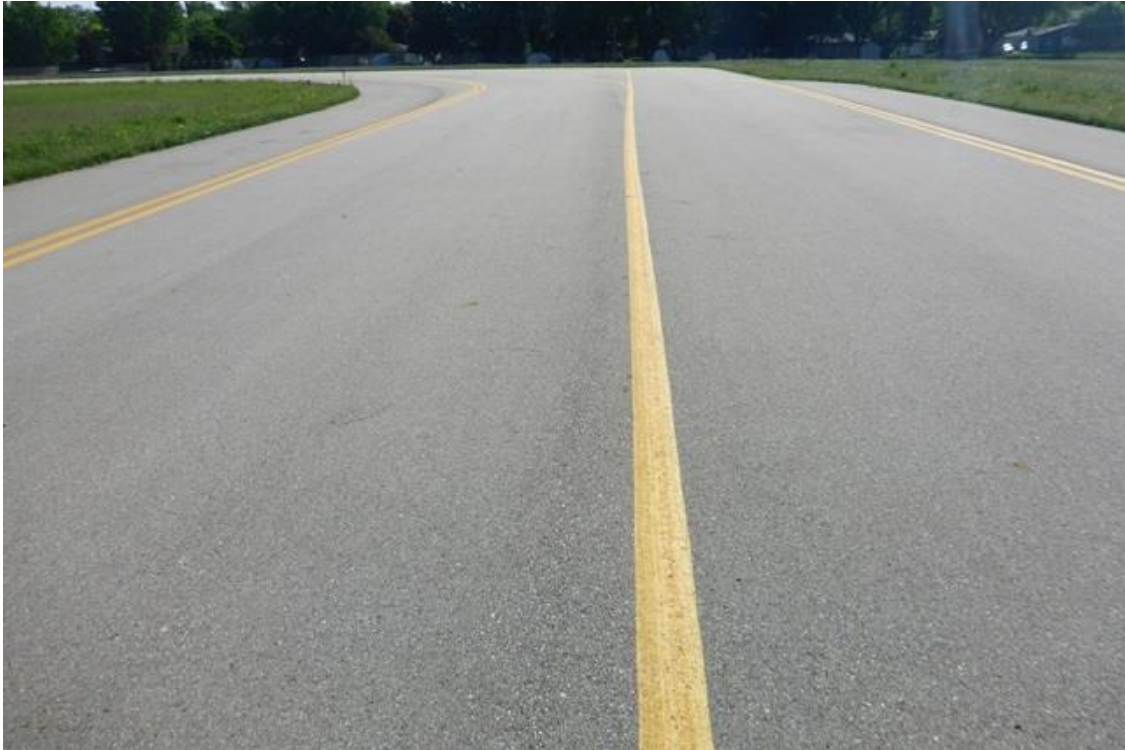
AEL PTA 003 (PCI = 100)

Network:	AEL	Name:	ALBERT LEA						
Branch:	PTA	Name:	Parallel Taxiway A	Use:	TAXIWAY	Area:	216,310 SqFt		
Section:	003	of 3	From:	150	To:	RY 35	Last Const.:	9/29/2010	
Surface:	AC	Family:	MN2013 Asphalt Taxiways	Zone:	S	Category:	3	Rank:	P
Area:	32,760 SqFt	Length:	500 Ft	Width:	35 Ft				
Slabs:		Slab Length:	Ft	Slab Width:	Ft	Joint Length:	Ft		
Shoulder:		Street Type:		Grade:	0	Lanes:	0		
Section Comments:	signed as A3								
Last Insp. Date:	5/29/2016	TotalSamples:	7	Surveyed:	2				
Conditions:	PCI: 100								
Inspection Comments:									
Sample Number:	151	Type:	R	Area:	3500.00 SqFt	PCI:	100		
Sample Comments:									
<No Distress>									
Sample Number:	153	Type:	R	Area:	3500.00 SqFt	PCI:	100		
Sample Comments:									
<No Distress>
