Pavement Condition Report

Aitkin Municipal Airport (AIT)

December 2016

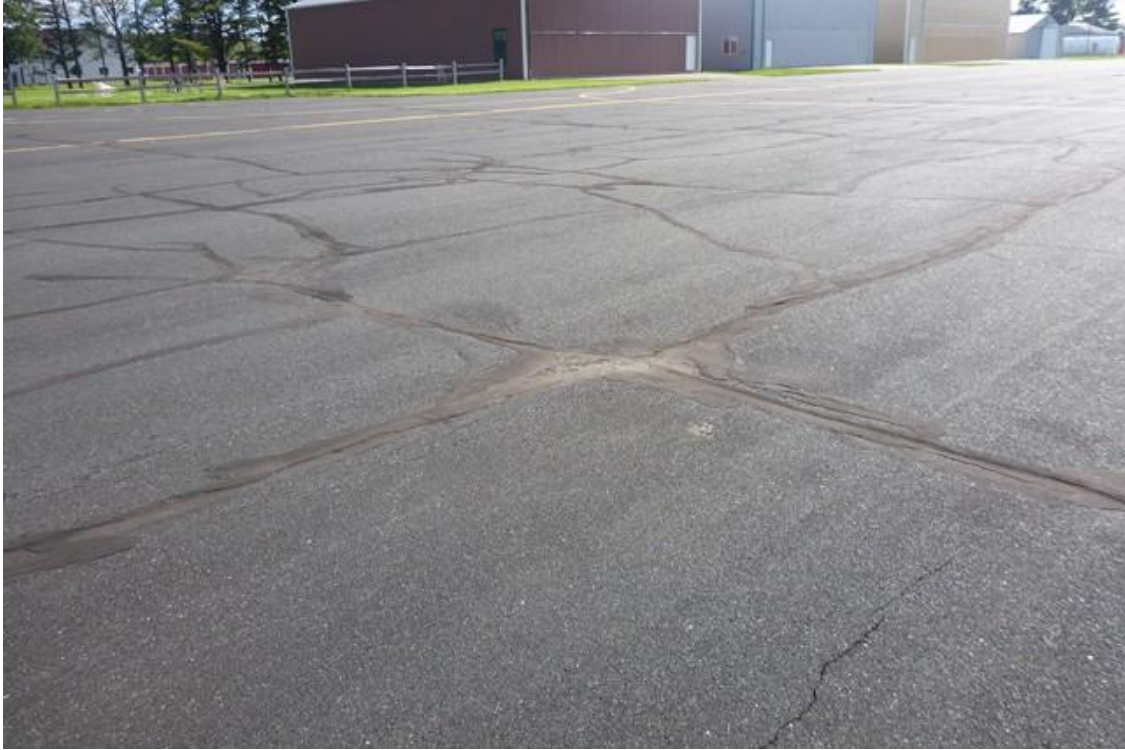
AIT APA 001 (PCI = 62)

Network:	AIT		Name:	AITKIN					
Branch:	APA	Name:	APRON A	Use:	APRON	Area:	112,550 SqFt		
Section:	001	of 5	From:	113	To:	317	Last Const.:	9/30/1992	
Surface:	AC	Family:	MN2013 Asphalt Aprons	Zone:	E	Category:	3	Rank:	S
Area:	75,000 SqFt	Length:	500 Ft	Width:	150 Ft				
Slabs:	Slab Length:	Ft	Slab Width:	Ft	Joint Length:	Ft			
Shoulder:	Street Type:		Grade:	0	Lanes:	0			
Section Comments:	maint. (R&E) slurry & CS portions								
Last Insp. Date:	7/12/2016	TotalSamples:	15	Surveyed:	4				
Conditions:	PCI: 62								
Inspection Comments:									
Sample Number:	103	Type:	R	Area:	5000.00 SqFt	PCI:	65		
Sample Comments:									
48	L & T CR	L	105.00	Ft					
43	BLOCK CR	L	3000.00	SqFt					
Sample Number:	200	Type:	A	Area:	5000.00 SqFt	PCI:	43		
Sample Comments:									
53	RUTTING	L	29.00	SqFt					
41	ALLIGATOR CR	M	120.00	SqFt					
48	L & T CR	M	72.00	Ft					
56	SWELLING	L	31.00	SqFt					
48	L & T CR	L	912.00	Ft

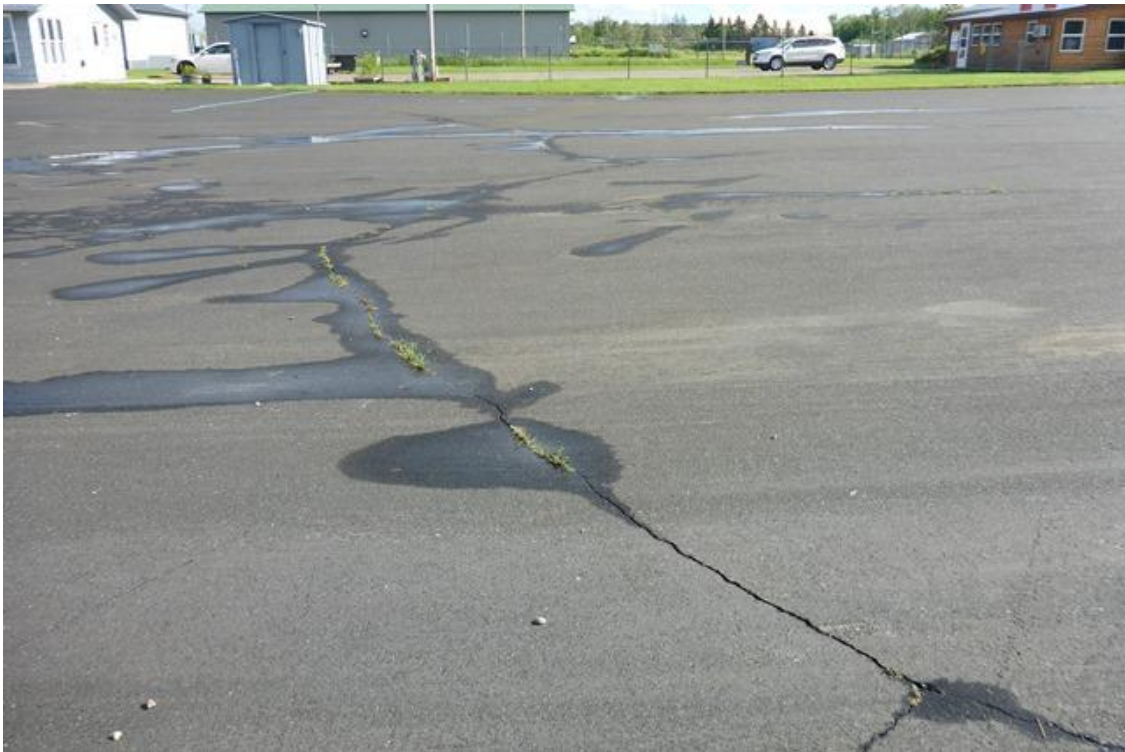
AIT APA 002 (PCI = 85)

Network:	AIT		Name:	AITKIN					
Branch:	APA	Name:	APRON A	Use:	APRON	Area:	112,550 SqFt		
Section:	002	of 5	From:	500	To:	601	Last Const.:	6/2/2008	
Surface:	AC	Family:	MN2013 Asphalt Aprons	Zone:	E	Category:	3	Rank:	S
Area:	17,800 SqFt	Length:	180 Ft	Width:	110 Ft				
Slabs:	Slab Length:	Ft	Slab Width:	Ft	Joint Length:	Ft			
Shoulder:	Street Type:	Grade:	0	Lanes:	0				
Section Comments:	maint. (R&E) slurry								
Last Insp. Date:	7/12/2016	TotalSamples:	4	Surveyed:	2				
Conditions:	PCI: 85								
Inspection Comments:									
Sample Number:	500	Type:	R	Area:	5000.00 SqFt	PCI:	86		
Sample Comments:									
48	L & T CR	L	234.00	Ft					
Sample Number:	600	Type:	R	Area:	5630.00 SqFt	PCI:	84		
Sample Comments:									
48	L & T CR	L	308.00	Ft

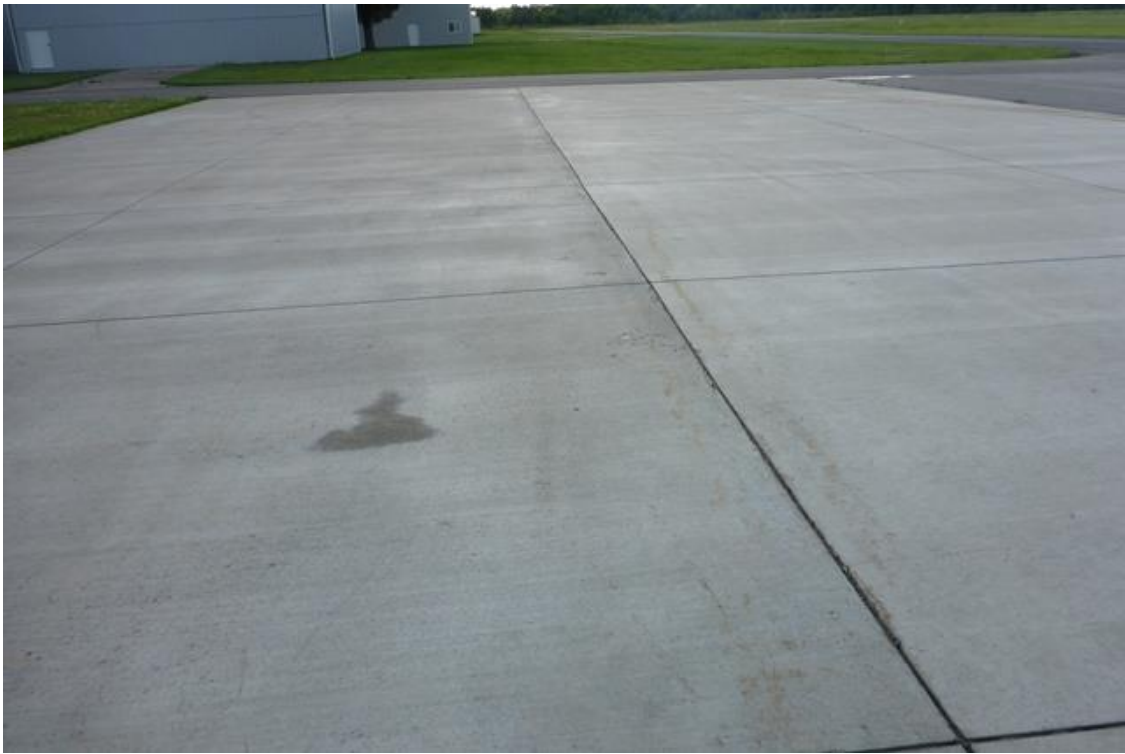
AIT APA 004 (PCI = 100)

Network:	AIT		Name:	AITKIN			
Branch:	APA	Name:	APRON A	Use:	APRON	Area:	112,550 SqFt
Section:	004	of 5	From:	-	To:	-	Last Const.: 6/1/2012
Surface:	PCC	Family:	MN2013 PCC	Zone:		Category:	Rank: S
Area:	4,992 SqFt	Length:	96 Ft	Width:	52 Ft		
Slabs:	36	Slab Length:	11 Ft	Slab Width:	13 Ft	Joint Length:	718 Ft
Shoulder:		Street Type:		Grade:	0	Lanes:	0
Section Comments:							
Last Insp. Date:	7/12/2016	TotalSamples:	2	Surveyed:	2		
Conditions:	PCI: 100						
Inspection Comments:							
Sample Number:	100	Type:	R	Area:	18.00 Slabs	PCI:	100
Sample Comments:							
<No Distress>							
Sample Number:	101	Type:	R	Area:	18.00 Slabs	PCI:	100
Sample Comments:							
<No Distress>

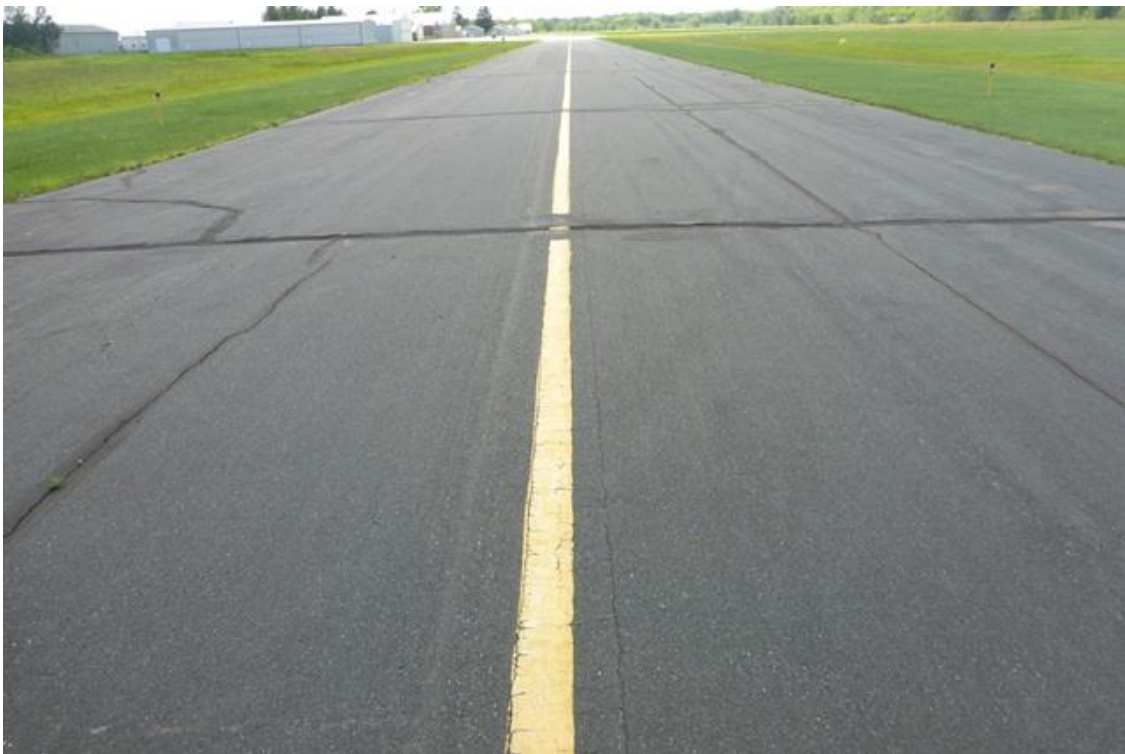
AIT CTA 001 (PCI = 66)

Network:	AIT		Name:	AITKIN					
Branch:	CTA	Name:	CONNECTING TAXIWAY A	Use:	TAXIWAY	Area:	59,460 SqFt		
Section:	001	of 1	From:	100	To:	112	Last Const.:	9/28/1998	
Surface:	AC	Family:	MN2013 Asphalt Taxiways	Zone:	E	Category:	3	Rank:	P
Area:	59,460 SqFt	Length:	1,230 Ft	Width:	40 Ft				
Slabs:		Slab Length:	Ft	Slab Width:	Ft	Joint Length:	Ft		
Shoulder:		Street Type:		Grade:	0	Lanes:	0		
Section Comments:	maint. (R&E) slurry & CS								
Last Insp. Date:	7/12/2016	TotalSamples:	15	Surveyed:	4				
Conditions:	PCI: 66								
Inspection Comments:									
Sample Number:	102	Type:	R	Area:	4000.00 SqFt	PCI:	66		
Sample Comments:									
48	L & T CR		H	18.00	Ft				
48	L & T CR		L	419.00	Ft				
48	L & T CR		M	91.00	Ft				
Sample Number:	106	Type:	R	Area:	4000.00 SqFt	PCI:	70		
Sample Comments:									
48	L & T CR		L	444.00	Ft				
48	L & T CR		M	46.00	Ft				
Sample Number:	110	Type:	R	Area:	4000.00 SqFt	PCI:	70

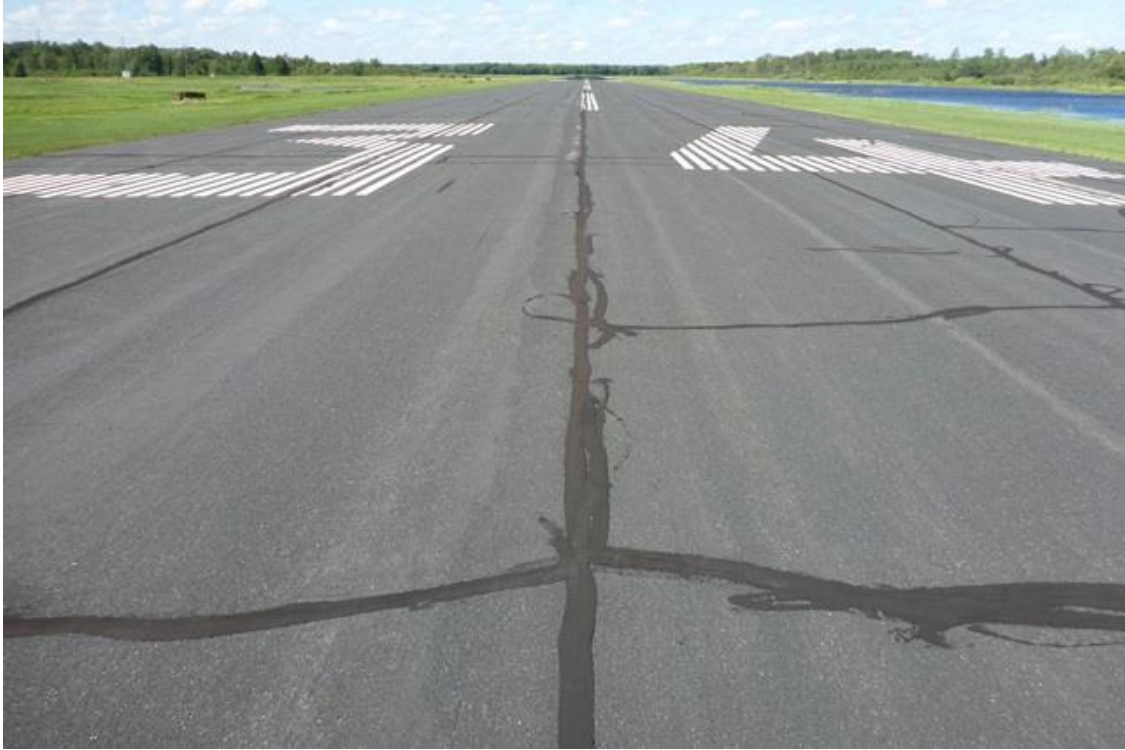
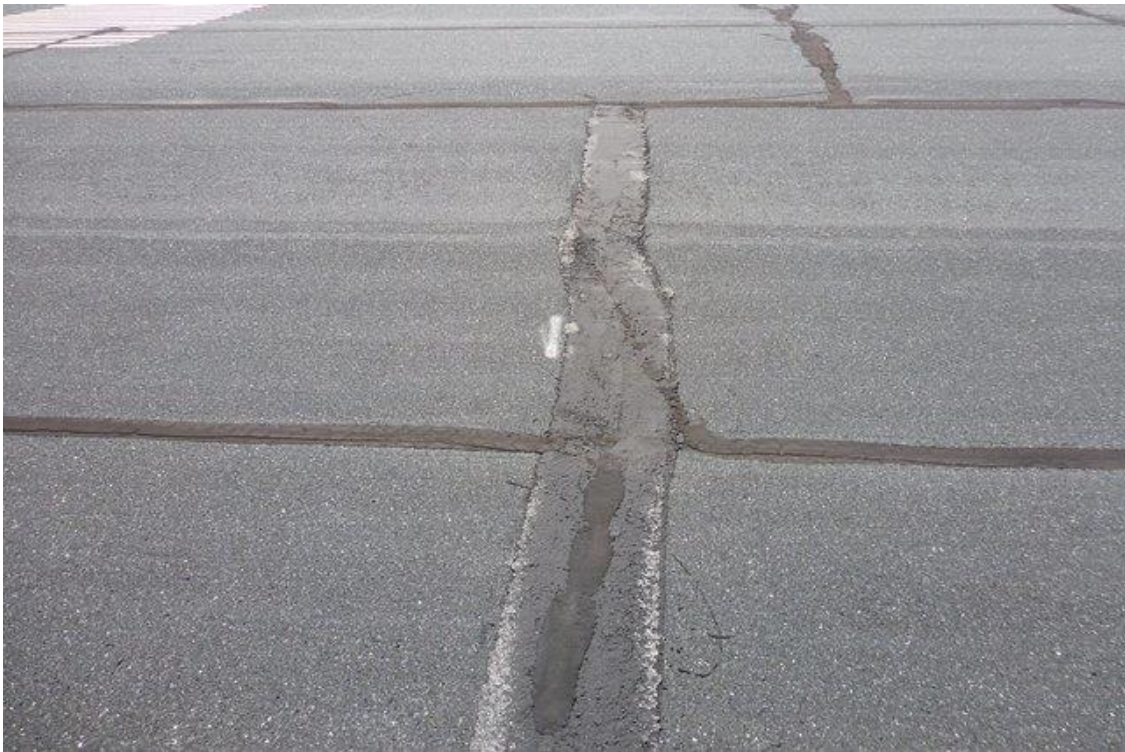
AIT RY1634 001 (PCI = 66)

Network:	AIT		Name:	AITKIN					
Branch:	RY1634	Name:	RUNWAY 16-34	Use:	RUNWAY	Area:	301,350 SqFt		
Section:	001	of 1	From:	100	To:	179	Last Const.:	9/28/1998	
Surface:	AC	Family:	MN2013 Asphalt Runways	Zone:	E	Category:	3	Rank:	P
Area:	301,350 SqFt	Length:	4,018 Ft	Width:	75 Ft				
Slabs:		Slab Length:	Ft	Slab Width:	Ft	Joint Length:	Ft		
Shoulder:		Street Type:		Grade:	0	Lanes:	0		
Section Comments:	maint. (R&E) slurry								
Last Insp. Date:	7/12/2016		TotalSamples:	80		Surveyed:	8		
Conditions:	PCI: 66								
Inspection Comments:	Good Crack Seal and Slurry Seal-Patching is similar to poly patch								
Sample Number:	104	Type:	R	Area:	3750.00 SqFt	PCI:	69		
Sample Comments:									
50	PATCHING	L	34.00	SqFt					
48	L & T CR	L	527.00	Ft					
Sample Number:	114	Type:	R	Area:	3750.00 SqFt	PCI:	70		
Sample Comments:									
48	L & T CR	L	424.00	Ft					
48	L & T CR	M	7.00	Ft					
Sample Number:	124	Type:	R	Area:	3750.00 SqFt	PCI:	69

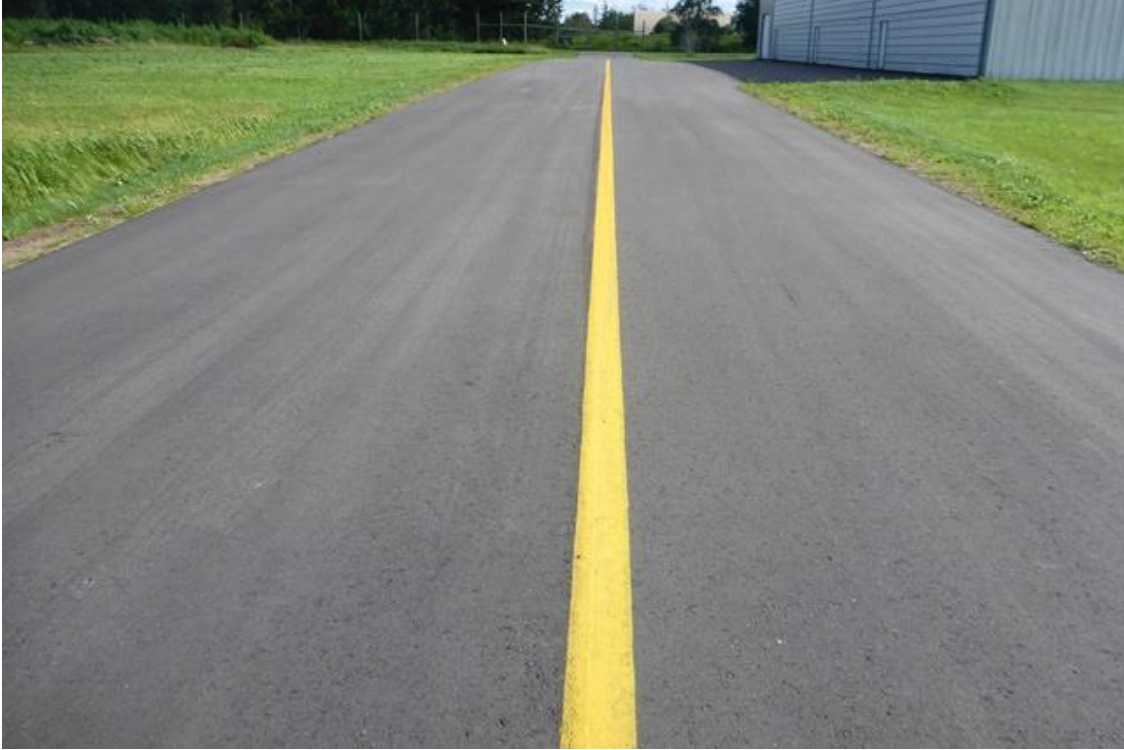
AIT TLA 001 (PCI = 100)

Network:	AIT		Name:	AITKIN					
Branch:	TLA	Name:	TAXILANE A	Use:	TAXILANE	Area:	19,400 SqFt		
Section:	001	of 1	From:	100	To:	105	Last Const.:	10/1/2015	
Surface:	AC	Family:	MN2013 Asphalt Taxilanes	Zone:	E	Category:	3	Rank:	T
Area:	19,400 SqFt	Length:	530 Ft	Width:	30 Ft				
Slabs:		Slab Length:	Ft	Slab Width:	Ft	Joint Length:	Ft		
Shoulder:		Street Type:		Grade:	0	Lanes:	0		
Section Comments:	maint. (R&E) slurry								
Last Insp. Date:	7/12/2016	TotalSamples:	6	Surveyed:	3				
Conditions:	PCI: 100								
Inspection Comments:									
Sample Number:	101	Type:	R	Area:	3000.00 SqFt	PCI:	100		
Sample Comments:	<No Distress>								
Sample Number:	103	Type:	R	Area:	3000.00 SqFt	PCI:	100		
Sample Comments:	<No Distress>								
Sample Number:	104	Type:	R	Area:	3000.00 SqFt	PCI:	100		
Sample Comments:	<No Distress>

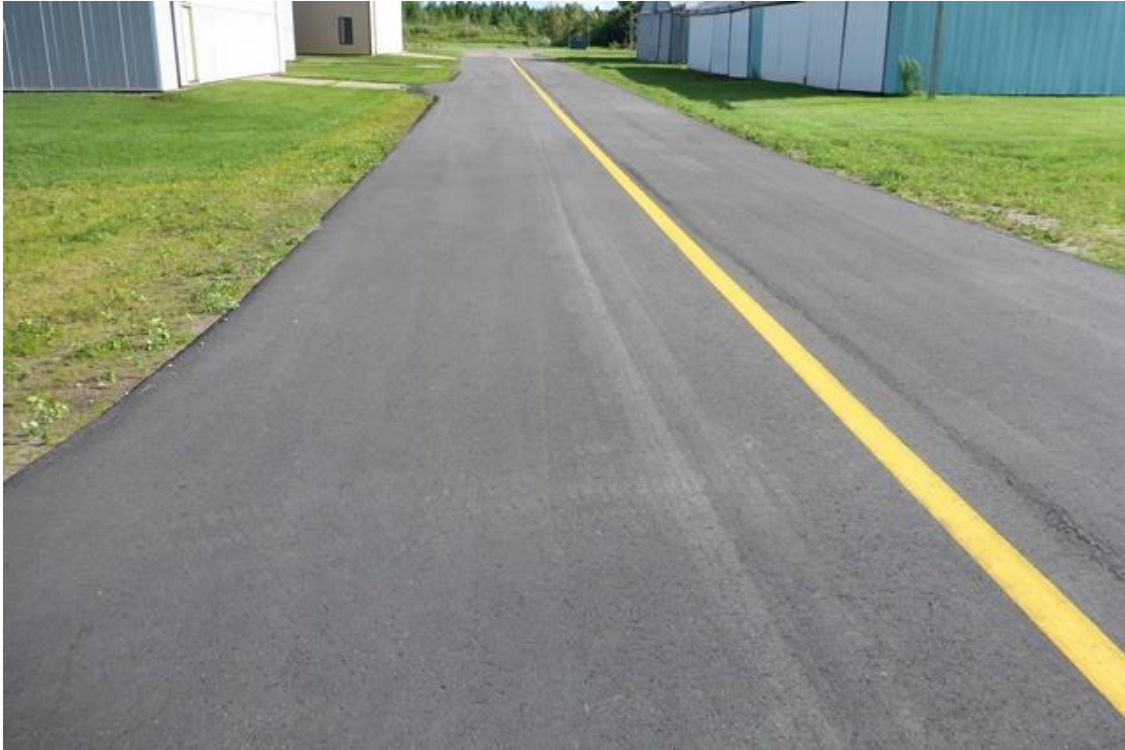
AIT TLC 001 (PCI = 100)

Network:	AIT		Name:	AITKIN					
Branch:	TLC	Name:	TAXILANE C	Use:	TAXILANE	Area:	16,735 SqFt		
Section:	001	of 1	From:	300	To:	305	Last Const.:	10/1/2015	
Surface:	AC	Family:	MN2013 Asphalt Taxilanes	Zone:	E	Category:	3	Rank:	T
Area:	16,735 SqFt	Length:	780 Ft	Width:	20 Ft				
Slabs:		Slab Length:	Ft	Slab Width:	Ft	Joint Length:	Ft		
Shoulder:		Street Type:		Grade:	0	Lanes:	0		
Section Comments:	maint. (R&E) slurry								
Last Insp. Date:	7/12/2016	TotalSamples:	3	Surveyed:	3				
Conditions:	PCI: 100								
Inspection Comments:									
Sample Number:	300	Type:	R	Area:	4380.00 SqFt	PCI:	100		
Sample Comments:	<No Distress>								
Sample Number:	302	Type:	R	Area:	4380.00 SqFt	PCI:	100		
Sample Comments:	<No Distress>								
Sample Number:	304	Type:	R	Area:	4380.00 SqFt	PCI:	100		
Sample Comments:	<No Distress>

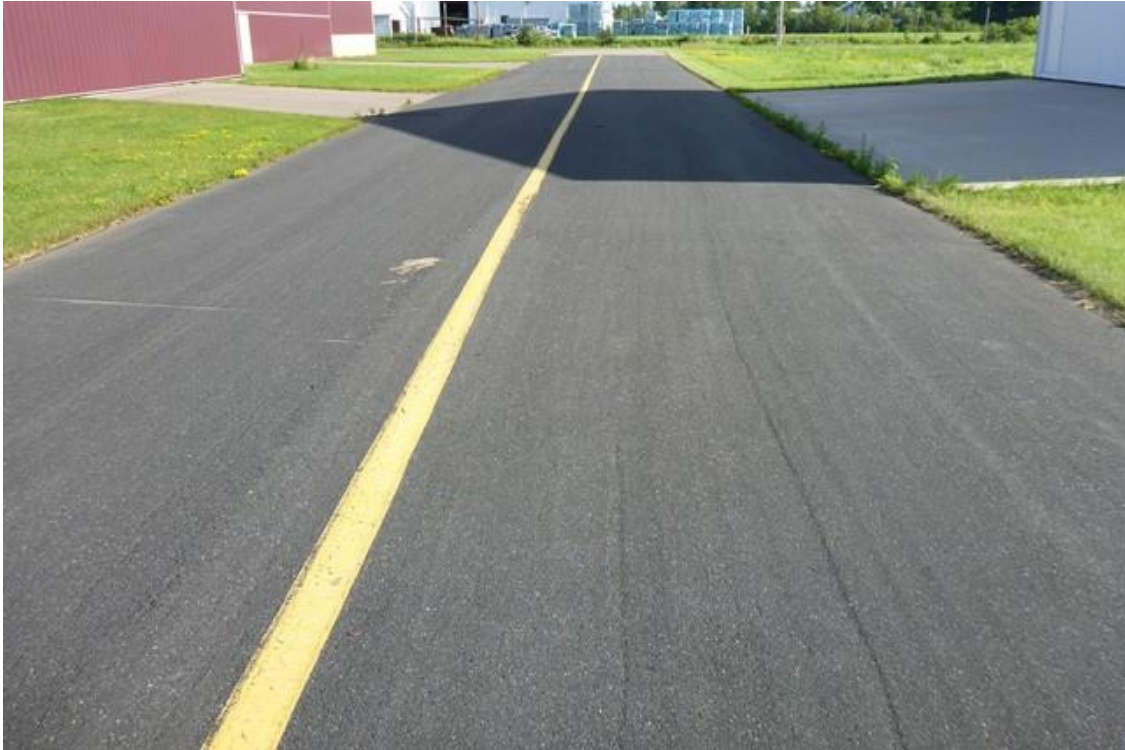
AIT TLE 001 (PCI = 93)

Network:	AIT		Name:	AITKIN						
Branch:	TLE	Name:	TAXILANE E		Use:	TAXILANE	Area:	8,990 SqFt		
Section:	001	of 1	From:	500	To:	503	Last Const.:	8/27/2004		
Surface:	AC	Family:	MN2013 Asphalt Taxilanes		Zone:	E	Category:	3	Rank:	T
Area:	8,990 SqFt		Length:	440 Ft	Width:	20 Ft				
Slabs:	Slab Length:	Ft		Slab Width:	Ft		Joint Length:	Ft		
Shoulder:	Street Type:	Grade:		0	Lanes:		0			
Section Comments:	maint. (R&E) slurry									
Last Insp. Date:	7/12/2016		TotalSamples:	2		Surveyed:	1			
Conditions:	PCI:	93								
Inspection Comments:	Good Crack Seal and Slurry Seal									
Sample Number:	502	Type:	R	Area:	4095.00 SqFt		PCI:	93		
Sample Comments:										
48	L & T CR		L	83.00 Ft
