Pavement Condition Report

Morris Municipal Airport (MOX)

December 2016

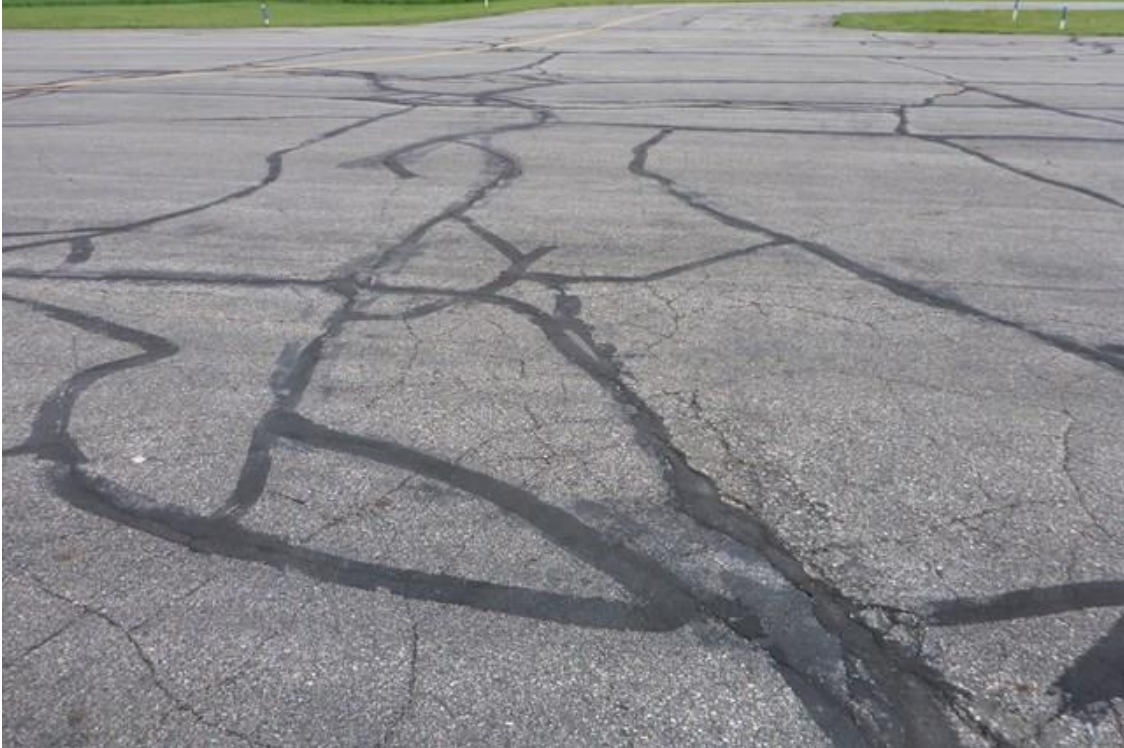
MOX APA 001 (PCI = 30)

Conditions: PCI: 30

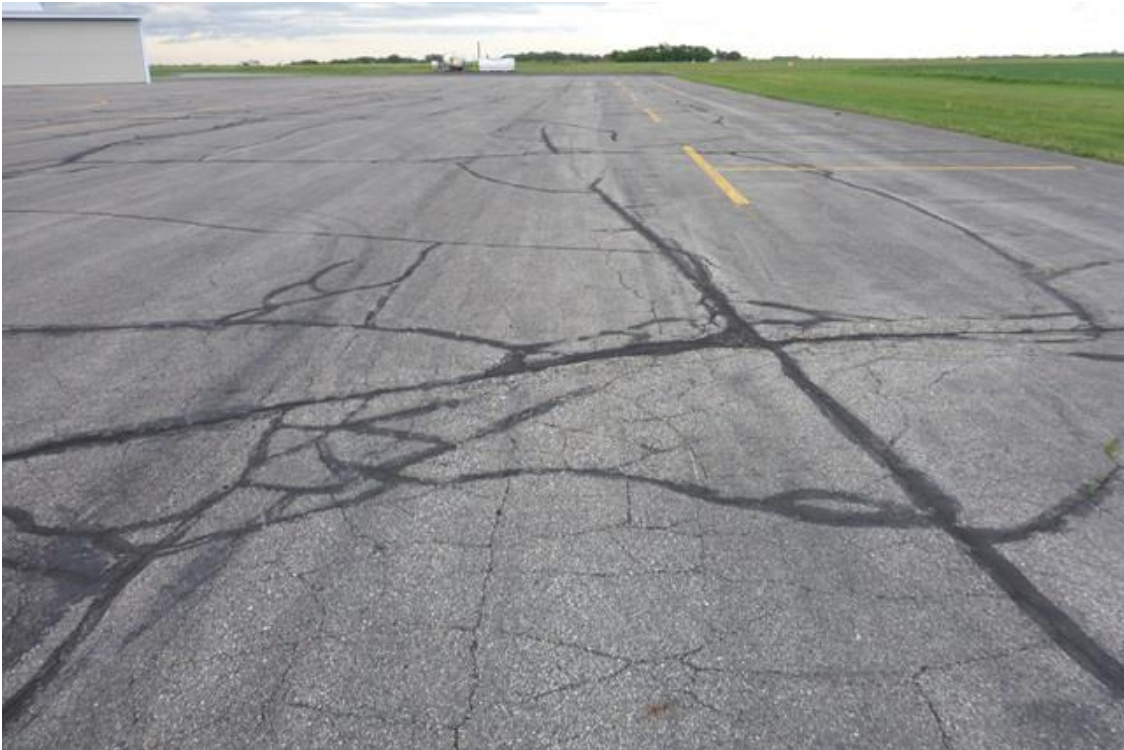
MOX APA 002 (PCI = 13)

Conditions: PCI: 13

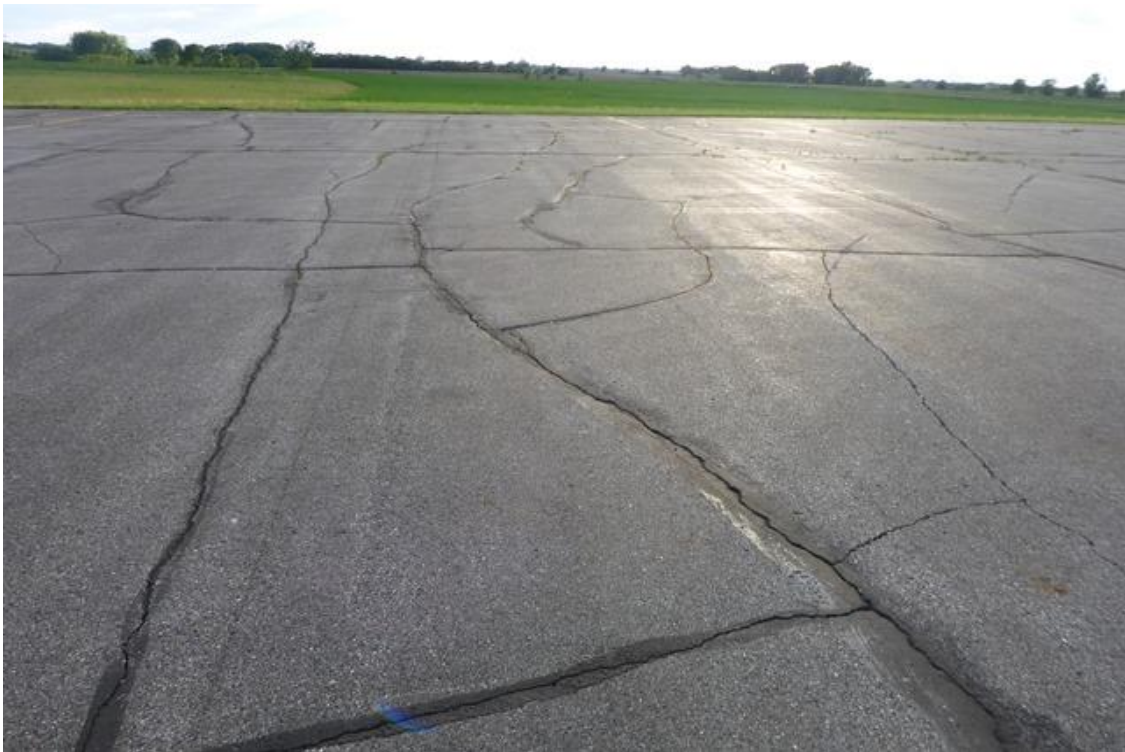
MOX APA 004 (PCI = 48)

Conditions: PCI: 48

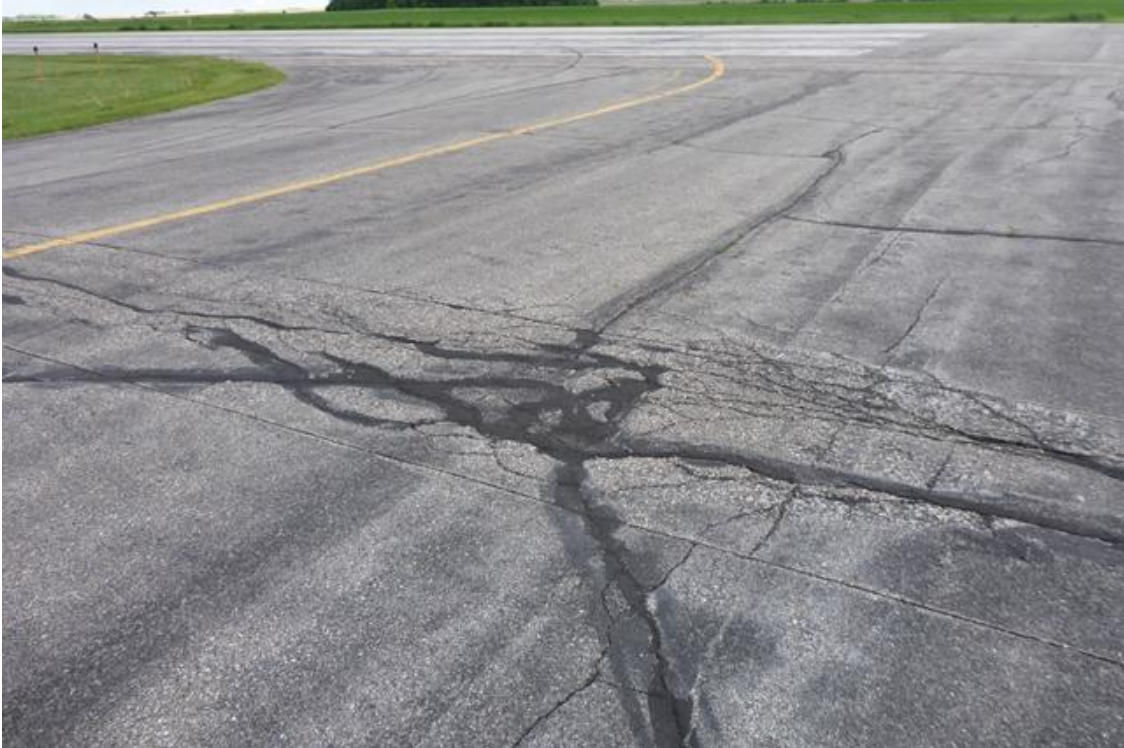
MOX CTA 001 (PCI = 41)

Conditions: PCI: 41

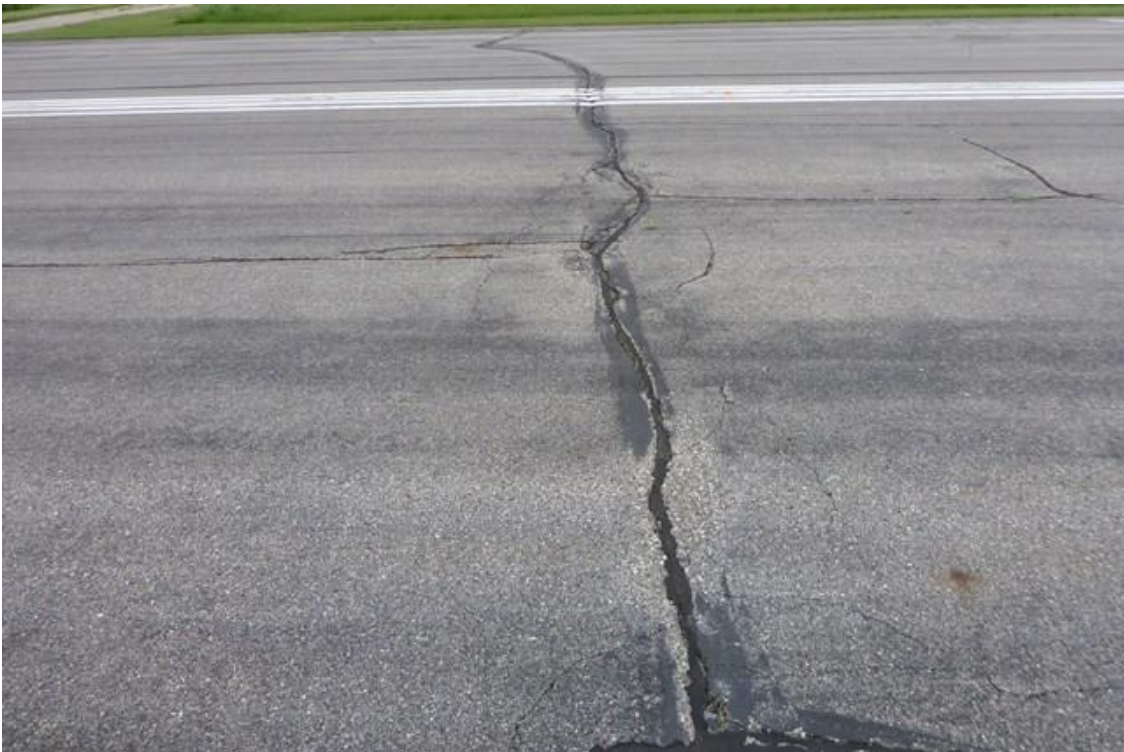
MOX RY1432 001 (PCI = 60)

Network:	MOX	Name:	MORRIS						
Branch:	RY1432	Name:	RUNWAY 14-32	Use:	RUNWAY	Area:	309,935 SqFt		
Section:	001	of 2	From:	100	To:	167	Last Const.:	9/30/1984	
Surface:	AC	Family:	MN2013 Asphalt Runways	Zone:	W	Category:	3	Rank:	P
Area:	255,000 SqFt	Length:	3,400 Ft	Width:	75 Ft				
Slabs:		Slab Length:	Ft	Slab Width:	Ft	Joint Length:	Ft		
Shoulder:		Street Type:		Grade:	0	Lanes:	0		
Section Comments:	maint. (R&E) patching								
Last Insp. Date:	5/31/2016	TotalSamples:	68	Surveyed:	8				
Conditions:	PCI: 60								
Inspection Comments:									
Sample Number:	106	Type:	R	Area:	3750.00 SqFt	PCI:	70		
Sample Comments:									
48	L & T CR	M	115.00	Ft					
48	L & T CR	L	428.00	Ft					
Sample Number:	115	Type:	R	Area:	3750.00 SqFt	PCI:	55		
Sample Comments:									
41	ALLIGATOR CR	M	20.00	SqFt					
48	L & T CR	L	326.00	Ft					
48	L & T CR	M	160.00	Ft					
48	L & T CR	H	18.00	Ft					
Sample Number:	124	Type:	R	Area:	3750.00 SqFt	PCI:	58

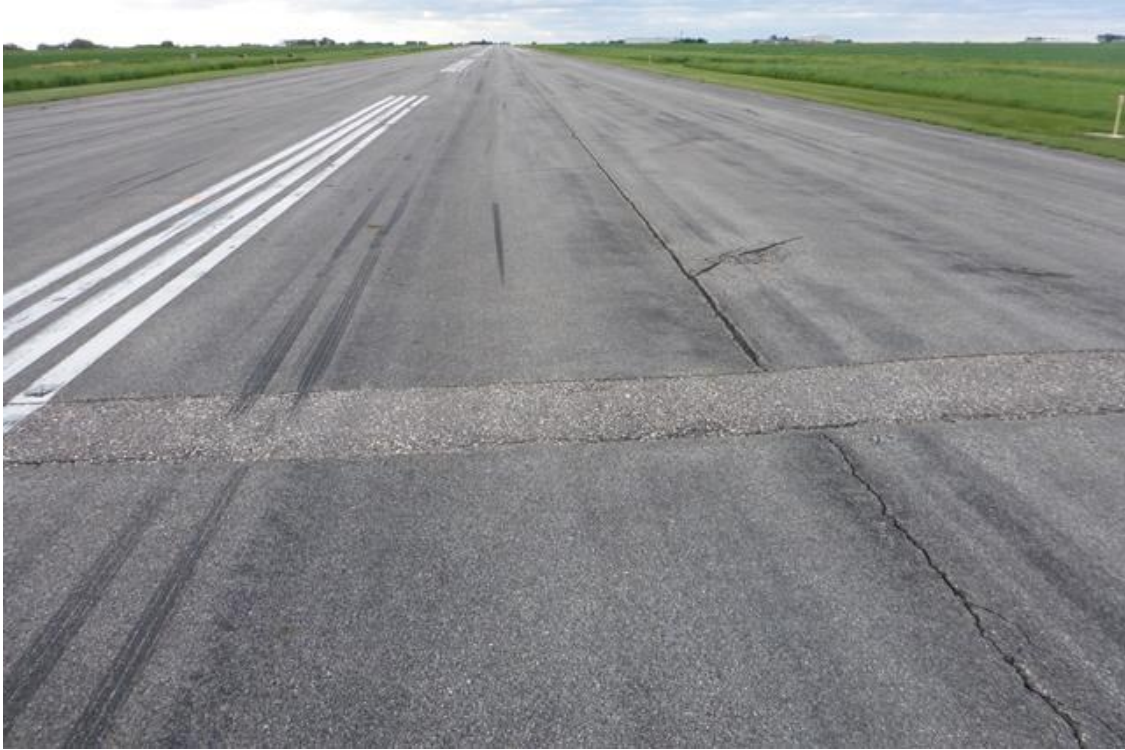
MOX RY1432 002 (PCI = 67)

Network:	MOX	Name:	MORRIS						
Branch:	RY1432	Name:	RUNWAY 14-32	Use:	RUNWAY	Area:	309,935 SqFt		
Section:	002	of 2	From:	168	To:	179	Last Const.:	1/1/2003	
Surface:	AC	Family:	MN2013 Asphalt Runways	Zone:	W	Category:	3	Rank:	P
Area:	54,935 SqFt	Length:	600 Ft	Width:	75 Ft				
Slabs:	Slab Length:	Ft	Slab Width:	Ft	Joint Length:	Ft			
Shoulder:	Street Type:	Grade:	0	Lanes:	0				
Section Comments:	maint. (R&E) patching								
Last Insp. Date:	5/31/2016	TotalSamples:	14	Surveyed:	3				
Conditions:	PCI: 67								
Inspection Comments:									
Sample Number:	170	Type:	R	Area:	3750.00 SqFt	PCI:	76		
Sample Comments:									
48	L & T CR	M	96.00	Ft					
48	L & T CR	L	263.00	Ft					
Sample Number:	173	Type:	R	Area:	3750.00 SqFt	PCI:	51		
Sample Comments:									
50	PATCHING	L	155.00	SqFt					
48	L & T CR	L	243.00	Ft					
48	L & T CR	M	108.00	Ft					
41	ALLIGATOR CR	M	60.00	SqFt					
Sample Number:	178	Type:	R	Area:	3750.00 SqFt	PCI:	75

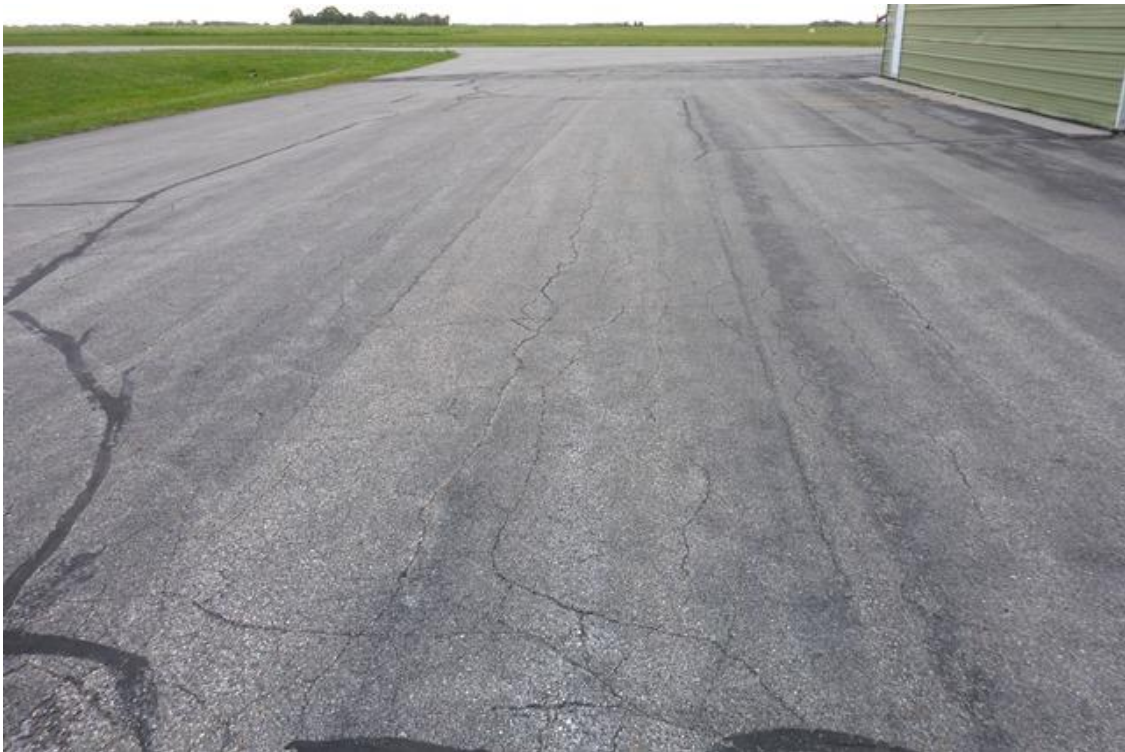
MOX TLA 001 (PCI = 24)

Conditions: PCI: 24

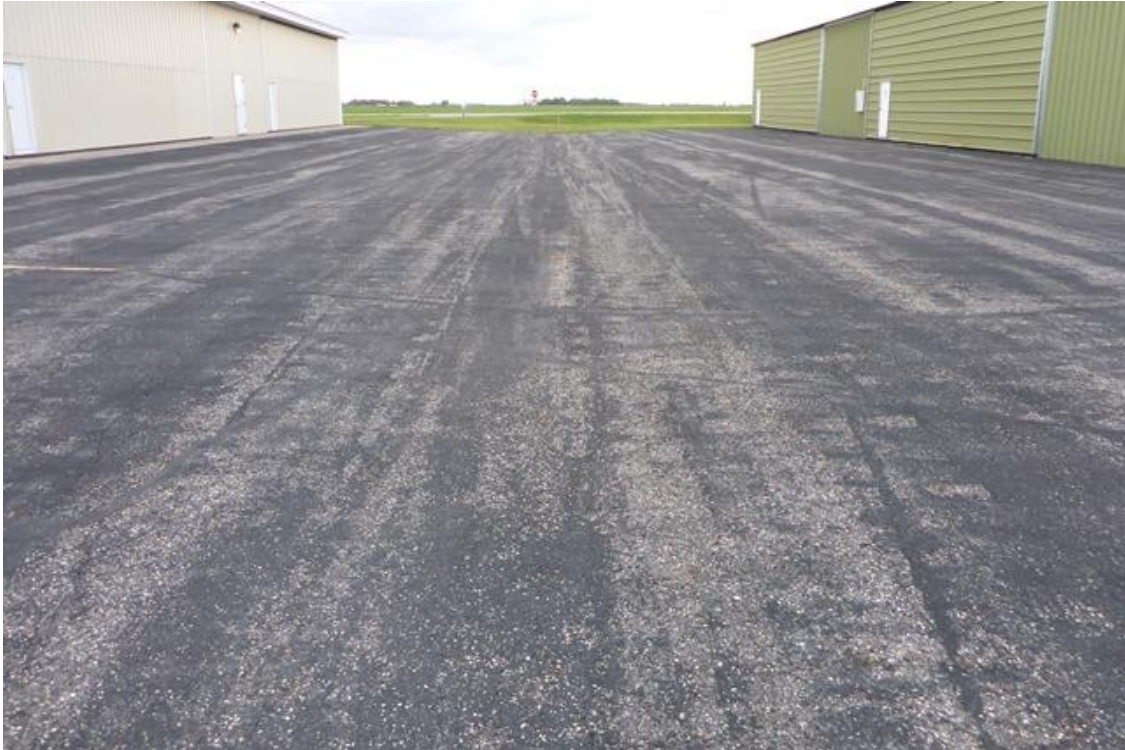
MOX TLA 002 (PCI = 13)

Conditions: PCI: 13

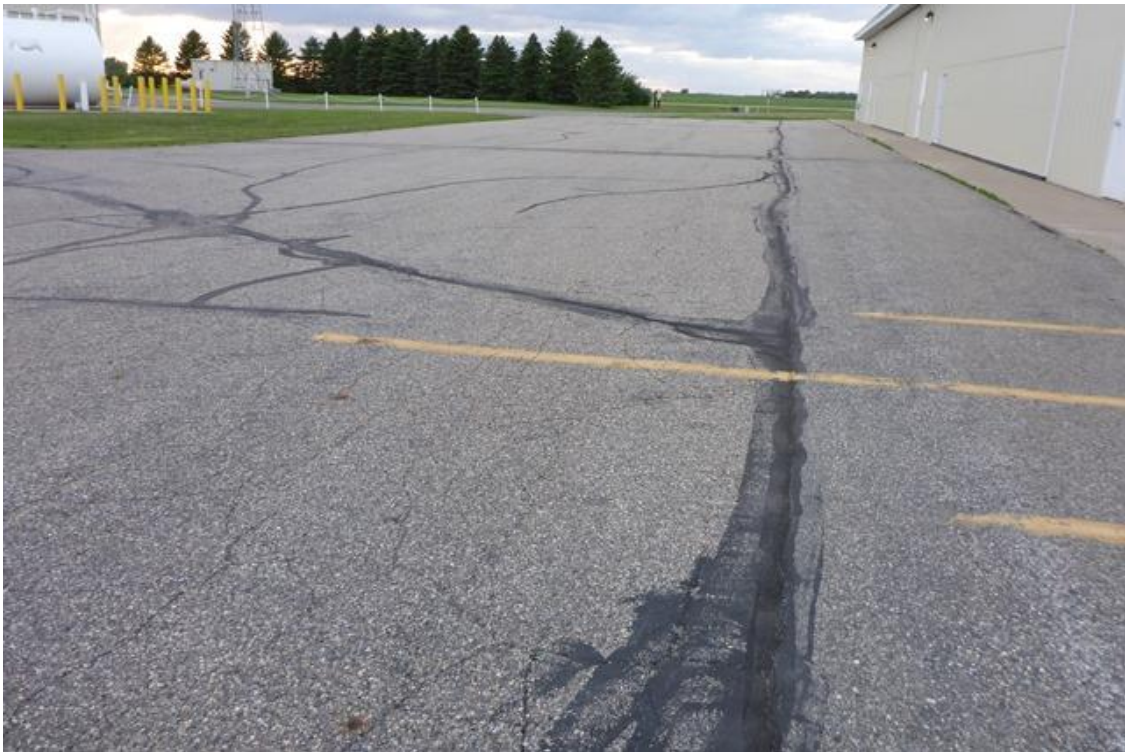
MOX TLA 003 (PCI = 28)

Conditions: PCI: 28

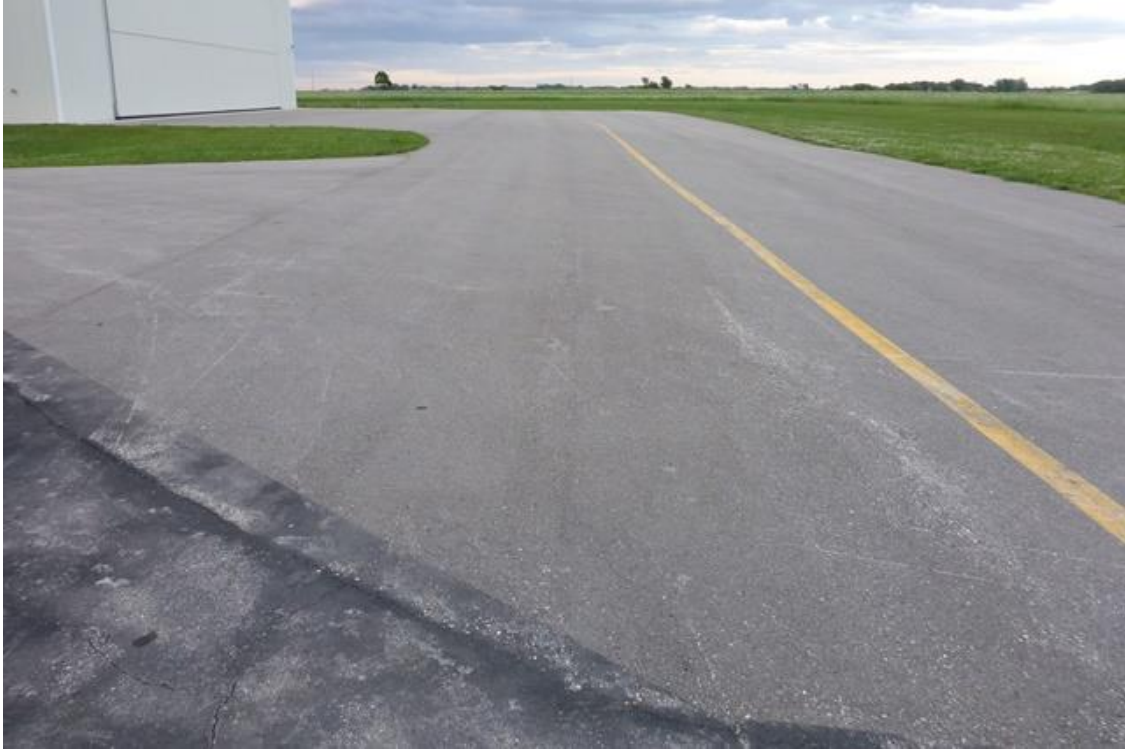
MOX TLA 004 (PCI = 100)

Conditions: PCI: 100
