# Pavement Condition Report

## Hawley Municipal Airport (04Y)

**December 2017**

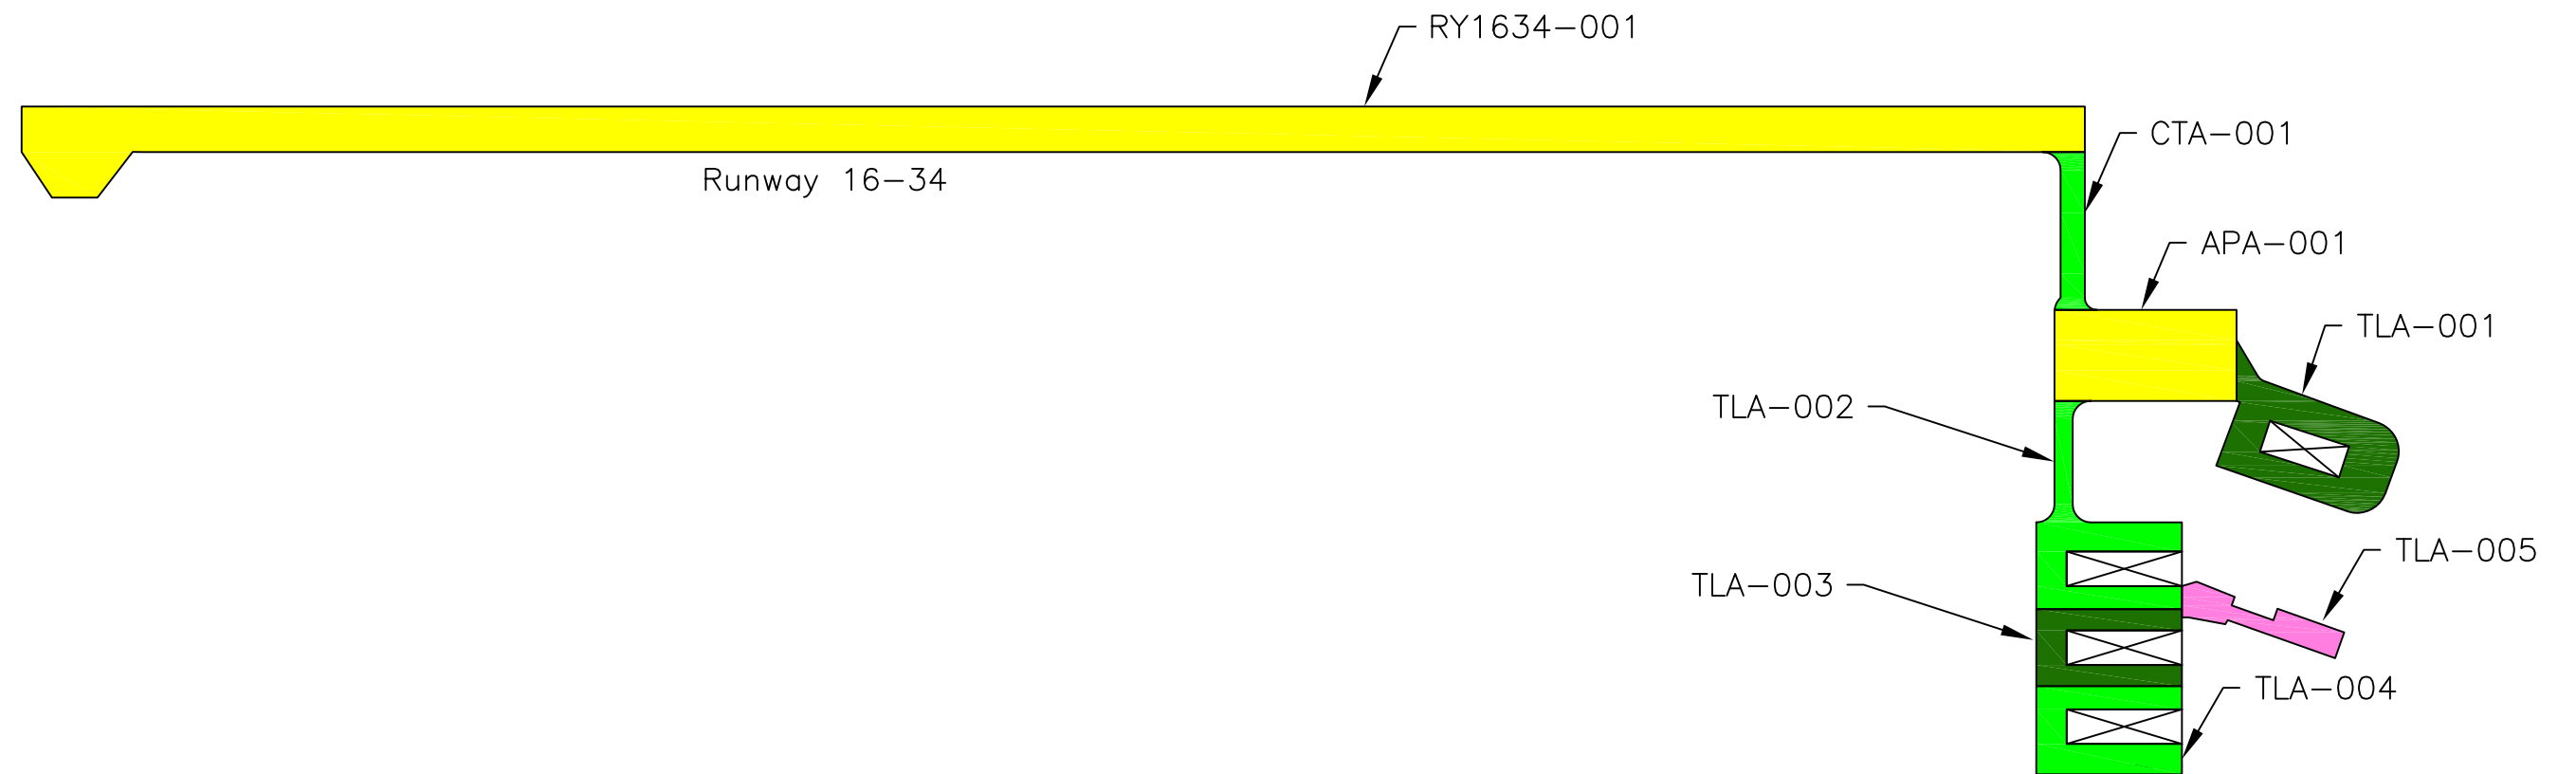
Figure 4. 2017 Pavement Condition Index Rating at Hawley Municipal Airport (04Y).

<sup>6</sup>Higher than expected deterioration rate of 4.6 PCI/year due to the development of low and medium L&T cracking in significant quantities.
