Pavement Condition Report

Herman Municipal Airport (06Y)

December 2017

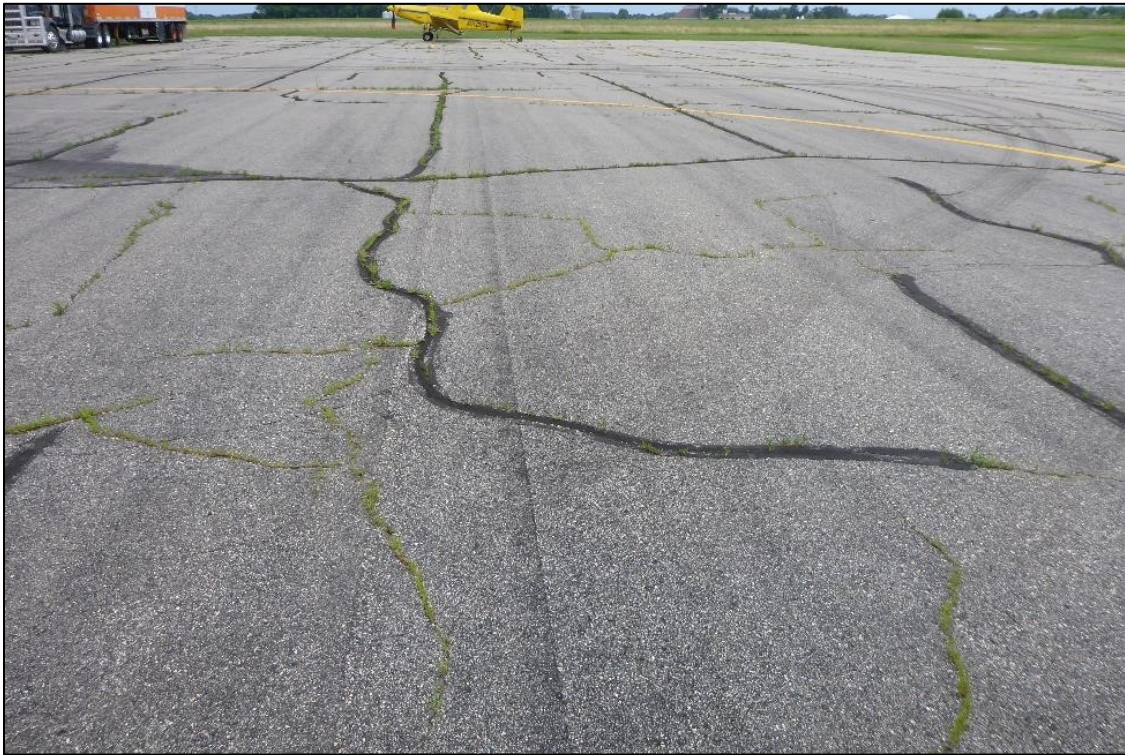
06Y APA 001 (PCI = 64)

Network: 06Y			Name: HERMAN		
Branch: APA	Name: APRON A	Use: APRON	Area: 50,800 SqFt		
Section: 001	of 1	From: 100	To: 302	Last Const.: 10/29/2004	
Surface: AC	Family: MN2013 Asphalt Aprons	Zone: W	Category: 1	Rank: S	
Area: 50,800 SqFt	Length: 360 Ft	Width: 150 Ft			
Slabs:	Slab Length: Ft	Slab Width: Ft	Joint Length: Ft		
Shoulder:	Street Type:	Grade: 0	Lanes: 0		
Last Insp. Date: 6/16/2017	Total Samples: 12	Surveyed: 3			
Conditions: PCI: 64					
Sample Number: 102	Type: R	Area: 5000.00 SqFt	PCI: 66		
48 L & T CR	L	378.00 Ft			
48 L & T CR	M	305.00 Ft			
Sample Number: 201	Type: R	Area: 5000.00 SqFt	PCI: 66		
48 L & T CR	L	752.00 Ft			
48 L & T CR	M	13.00 Ft			
48 L & T CR	H	29.00 Ft			
Sample Number: 300	Type: R	Area: 5000.00 SqFt	PCI: 60		
41 ALLIGATOR CR	M	42.00 SqFt			
48 L & T CR	M	83.00 Ft			
48 L & T CR	L	503.00 Ft

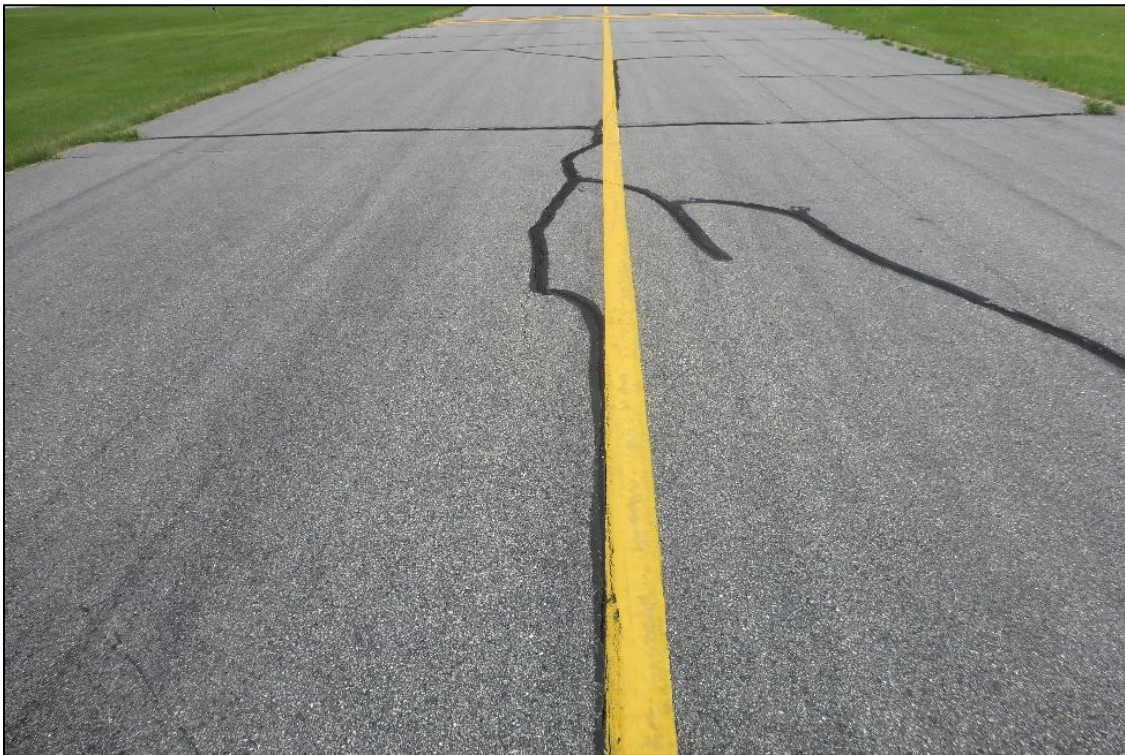
06Y CTA 001 (PCI = 70)

Network:	06Y	Name:	HERMAN						
Branch:	CTA	Name:	CONNECTING TAXIWAY A	Use:	TAXIWAY	Area:	10,800 SqFt		
Section:	001	of	1	From:	100	To:	101	Last Const.:	10/29/2004
Surface:	AC	Family:	MN2013 Asphalt Taxiways	Zone:	W	Category:	1	Rank:	P
Area:	10,800 SqFt	Length:	240 Ft	Width:	40 Ft				
Slabs:		Slab Length:	Ft	Slab Width:	Ft	Joint Length:	Ft		
Shoulder:		Street Type:		Grade:	0	Lanes:	0		
Last Insp. Date:	6/16/2017	Total Samples:	3	Surveyed:	2				
Conditions:	PCI: 70								
Sample Number:	100	Type:	R	Area:	4670.00 SqFt	PCI:	68		
48	L & T CR	L		296.00	Ft				
48	L & T CR	M		169.00	Ft				
56	SWELLING	L		200.00	SqFt				
Sample Number:	101	Type:	R	Area:	4000.00 SqFt	PCI:	72		
48	L & T CR	M		49.00	Ft				
48	L & T CR	L		388.00	Ft

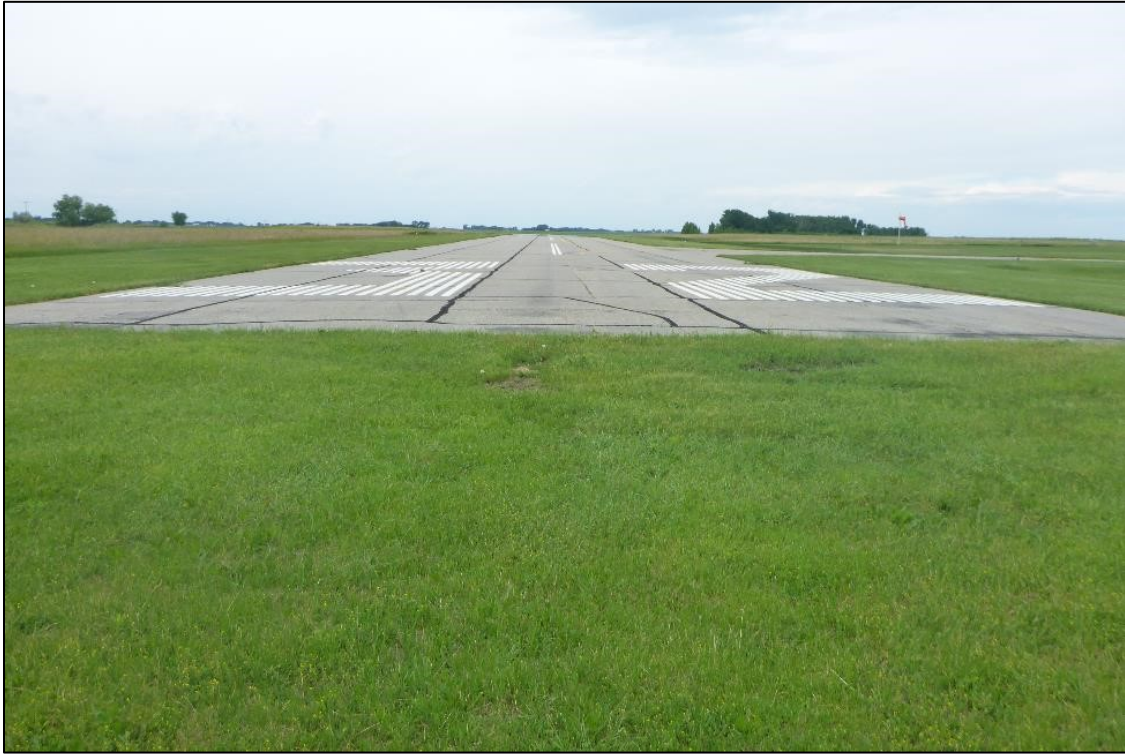
06Y RY1432 001 (PCI = 57)

Network:	06Y	Name:	HERMAN						
Branch:	RY1432	Name:	RUNWAY 14-32	Use:	RUNWAY	Area:	186,100 SqFt		
Section:	001	of	1	From:	100	To:	159	Last Const.:	10/29/2004
Surface:	AC	Family:	MN2013 Asphalt Runways	Zone:	W	Category:	1	Rank:	P
Area:	186,100 SqFt	Length:	2,997 Ft	Width:	60 Ft				
Slabs:		Slab Length:	Ft	Slab Width:	Ft	Joint Length:	Ft		
Shoulder:		Street Type:		Grade:	0	Lanes:	0		
Last Insp. Date:	6/16/2017	Total Samples:	60	Surveyed:	6				
Conditions:	PCI: 57								
Sample Number:	101	Type:	R	Area:	3000.00 SqFt	PCI:	68		
48	L & T CR		L	303.00	Ft				
48	L & T CR		M	147.00	Ft				
Sample Number:	111	Type:	R	Area:	3000.00 SqFt	PCI:	66		
48	L & T CR		L	348.00	Ft				
48	L & T CR		M	159.00	Ft				
Sample Number:	121	Type:	R	Area:	3000.00 SqFt	PCI:	48		
43	BLOCK CR		M	1100.00	SqFt				
52	RAVELING		H	2.00	SqFt				
48	L & T CR		L	261.00	Ft				
48	L & T CR		M	57.00	Ft				
Sample Number:	131	Type:	R	Area:	3000.00 SqFt	PCI:	51

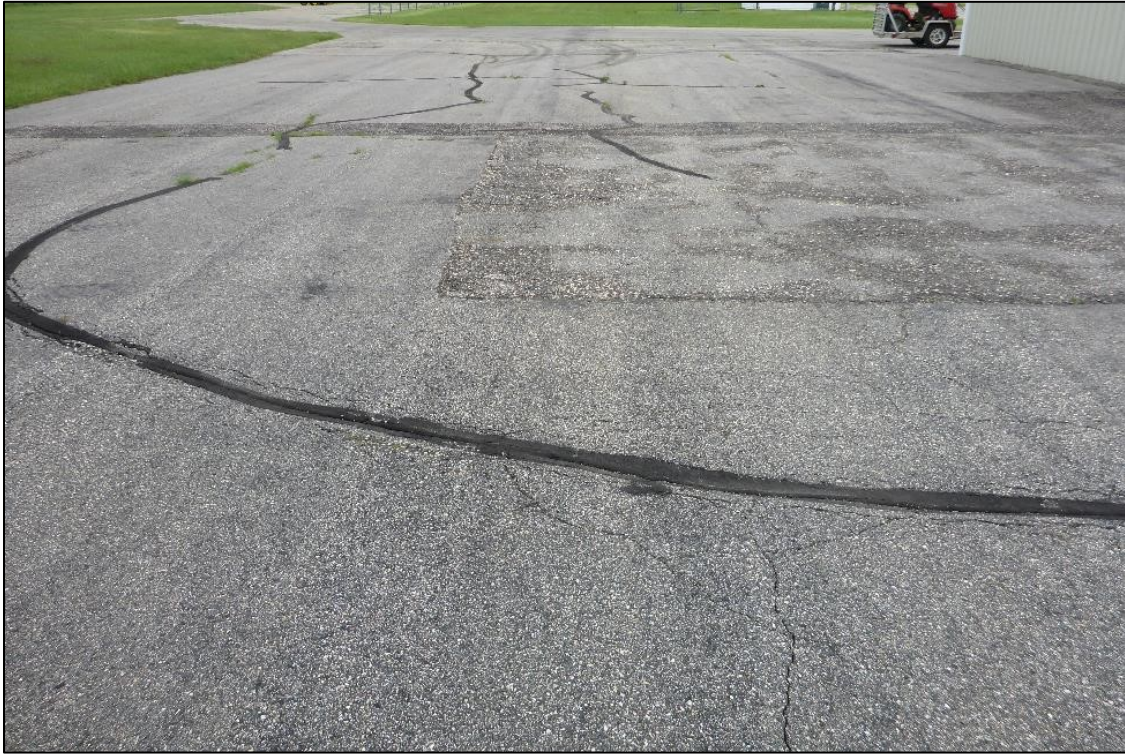
06Y TLA 001 (PCI = 64)

Network:	06Y	Name:	HERMAN						
Branch:	TLA	Name:	Taxilane A	Use:	TAXILANE	Area:	20,250 SqFt		
Section:	001	of	1	From:	100	To:	202	Last Const.:	10/1/2004
Surface:	AC	Family:	MN2013 Asphalt Taxilanes	Zone:	W	Category:	1	Rank:	T
Area:	20,250 SqFt	Length:	185 Ft	Width:	125 Ft				
Slabs:		Slab Length:	Ft	Slab Width:	Ft	Joint Length:	Ft		
Shoulder:		Street Type:		Grade:	0	Lanes:	0		
Last Insp. Date:	6/16/2017	Total Samples:	5	Surveyed:	3				
Conditions:	PCI: 64								
Sample Number:	100	Type:	R	Area:	5000.00 SqFt	PCI:	75		
56	SWELLING	L		400.00	SqFt				
48	L & T CR	M		56.00	Ft				
48	L & T CR	L		201.00	Ft				
Sample Number:	201	Type:	R	Area:	4250.00 SqFt	PCI:	55		
53	RUTTING	M		3.00	SqFt				
53	RUTTING	L		20.00	SqFt				
50	PATCHING	L		175.00	SqFt				
45	DEPRESSION	L		25.00	SqFt				
50	PATCHING	M		138.00	SqFt				
48	L & T CR	L		213.00	Ft				
48	L & T CR	M		51.00	Ft				
Sample Number:	202	Type:	R	Area:	4100.00 SqFt	PCI:	58
