# Pavement Condition Report

## Sky Harbor Airport (DYT)

**December 2017**

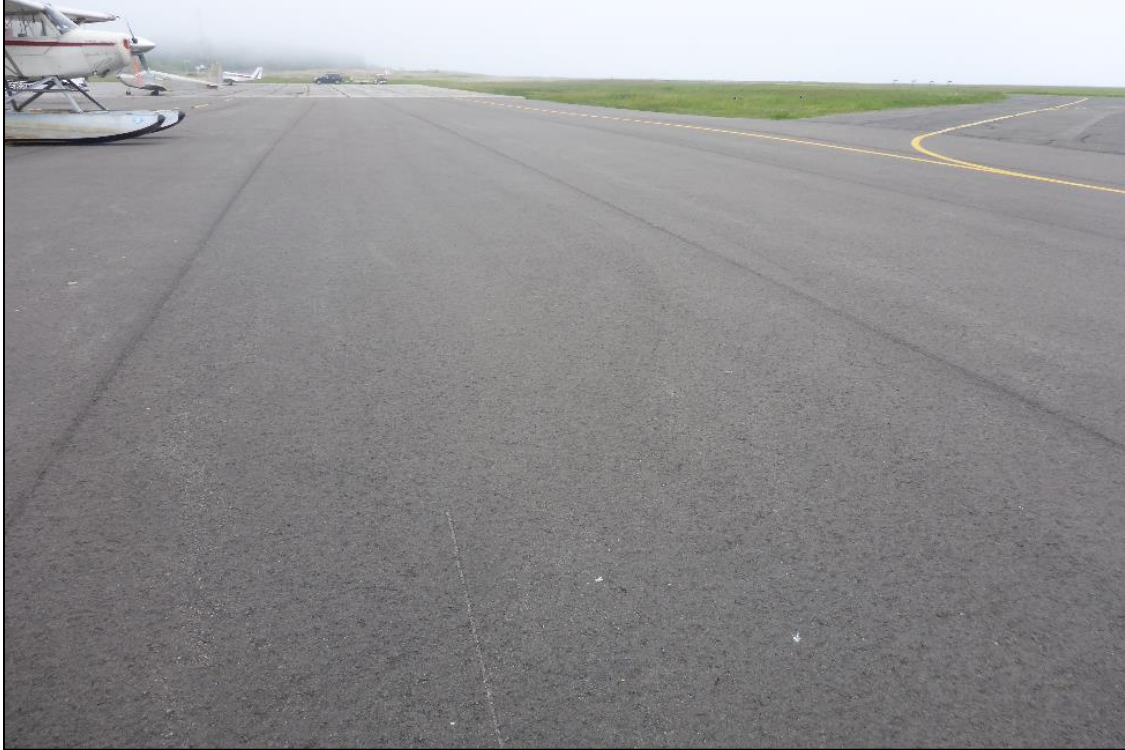
DYT APA 001 (PCI = 100)

| <b>Conditions:</b> | PCI: 100 | | | | |

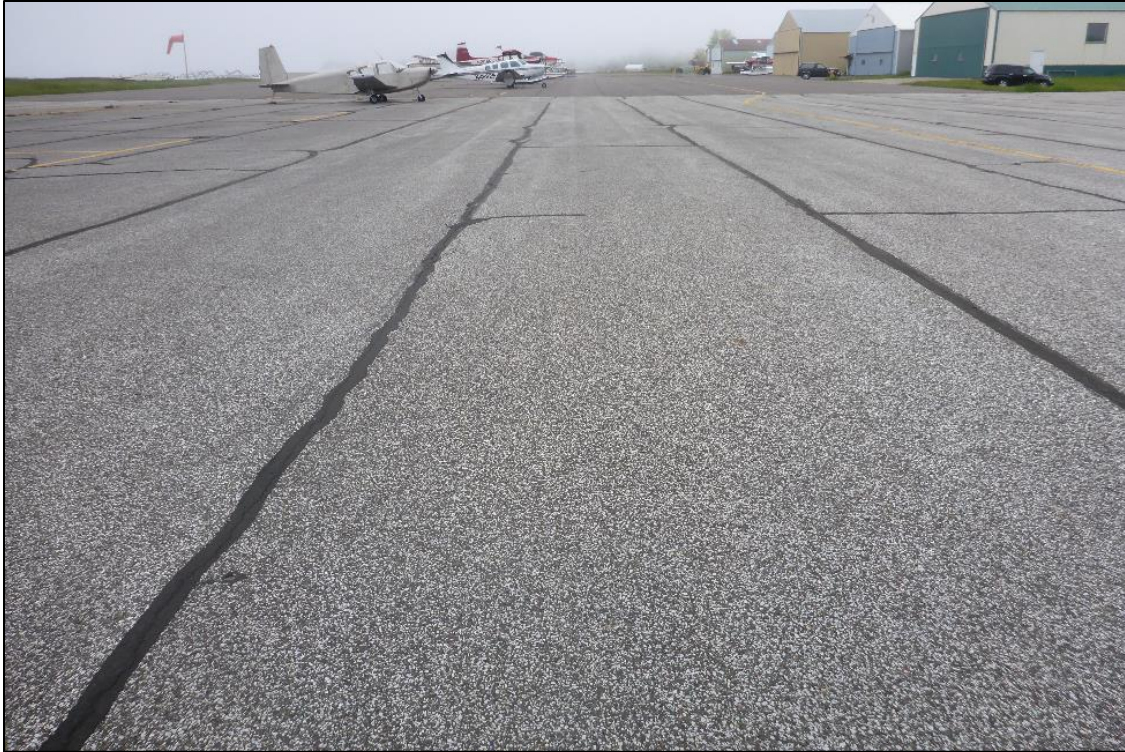
DYT APA 004 (PCI = 66)

| <b>Section Comments:</b> | cracksealed since 08 | | | | | | | | |
| <b>Conditions:</b> | PCI: 66 | | | | | | | | |

| Branch | Section | Treatment | Quantity | Unit | Cost |
|---|---|---|---|---|---|
| APA | 004 | Crack Sealing - AC | 112 | Ft | \$139 |

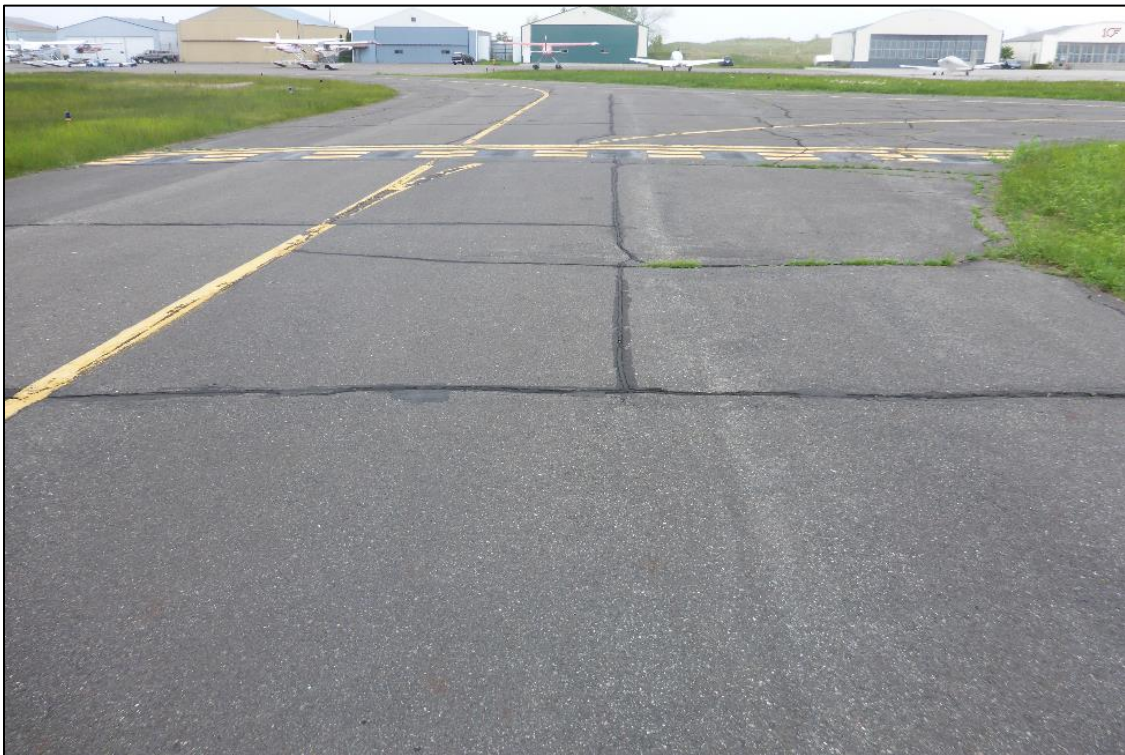
DYT CTA 001 (PCI = 48)

| <b>Section Comments:</b> | cracksealed since 08 | | | | | | |
| <b>Conditions:</b> | PCI: 48 | | | | | | |

| Branch | Section | Treatment | Quantity | Unit | Cost |
|---|---|---|---|---|---|
| CTA | 001 | Crack Sealing - AC | 298 | Ft | \$369 |

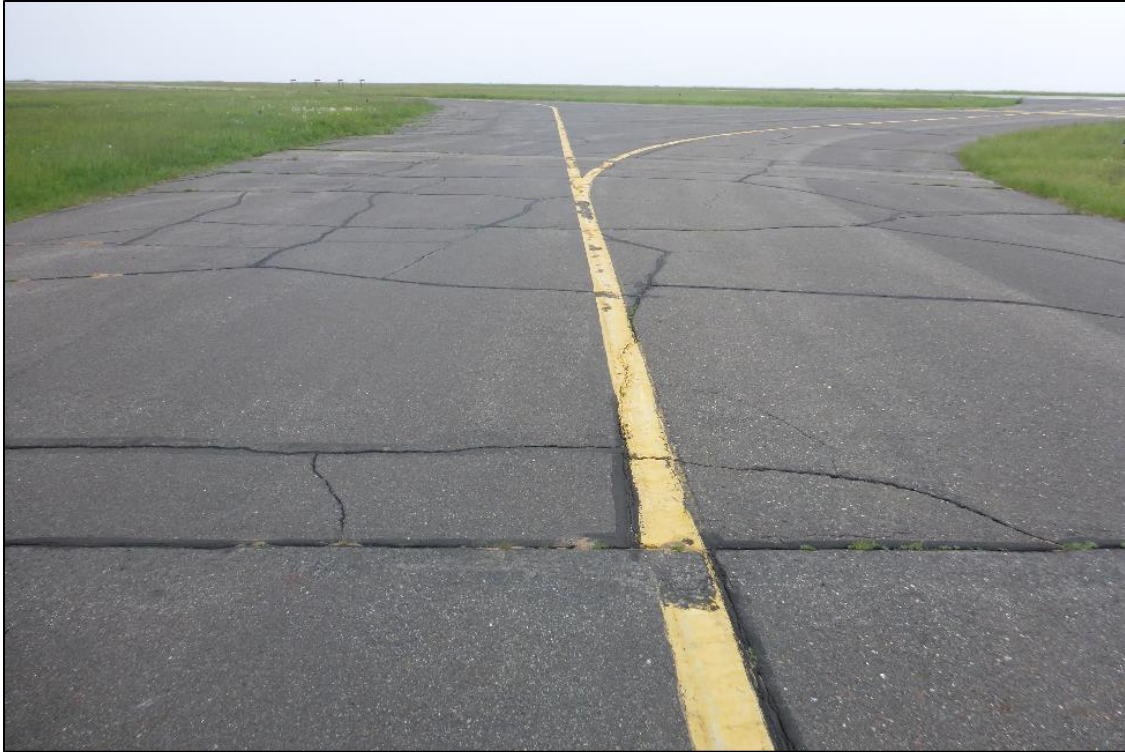
DYT CTA 002 (PCI = 63)

| <b>Section Comments:</b> | cracksealed since 08 | | | | | | | | |

| <b>Conditions:</b> | PCI: 63 | | | | |

| Branch | Section | Treatment | Quantity | Unit | Cost |
|---|---|---|---|---|---|
| CTA | 002 | Crack Sealing - AC | 75 | Ft | \$93 |

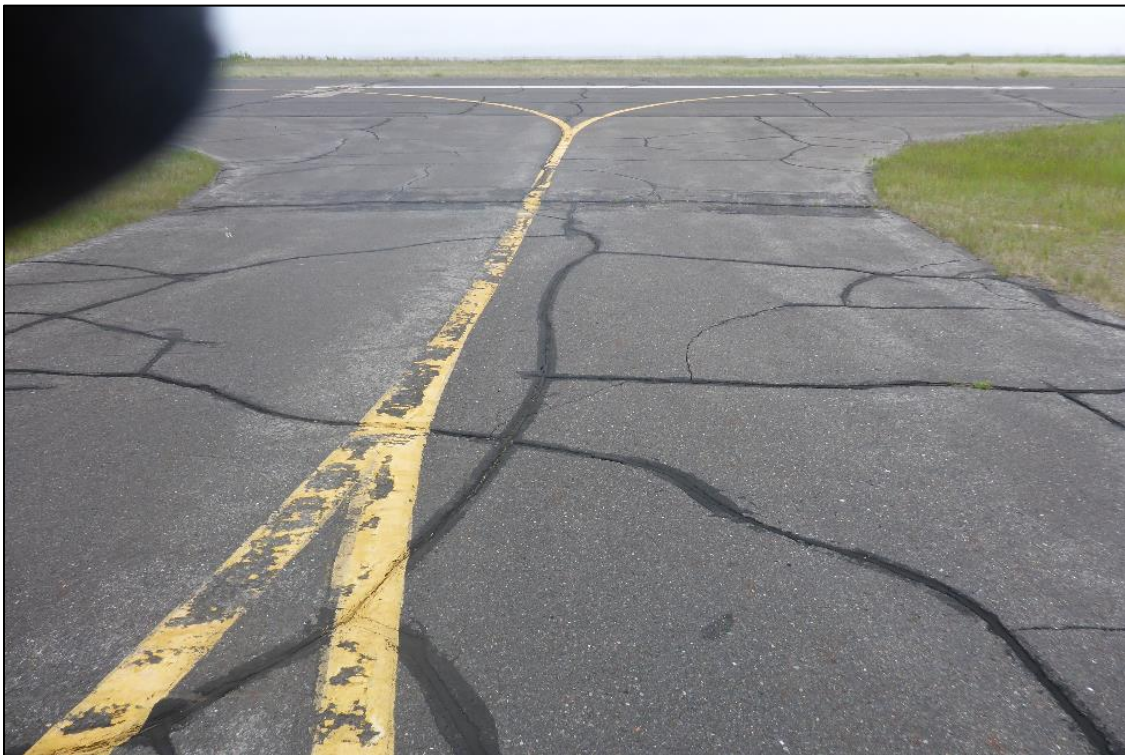
DYT CTB 001 (PCI = 40)

| <b>Section Comments:</b> | cracksealed since 08 | | | | | | | | |

| <b>Conditions:</b> | PCI: 40 | | | | |

| Branch | Section | Treatment | Quantity | Unit | Cost |
|---|---|---|---|---|---|
| CTB | 001 | Crack Sealing - AC | 163 | Ft | \$203 |

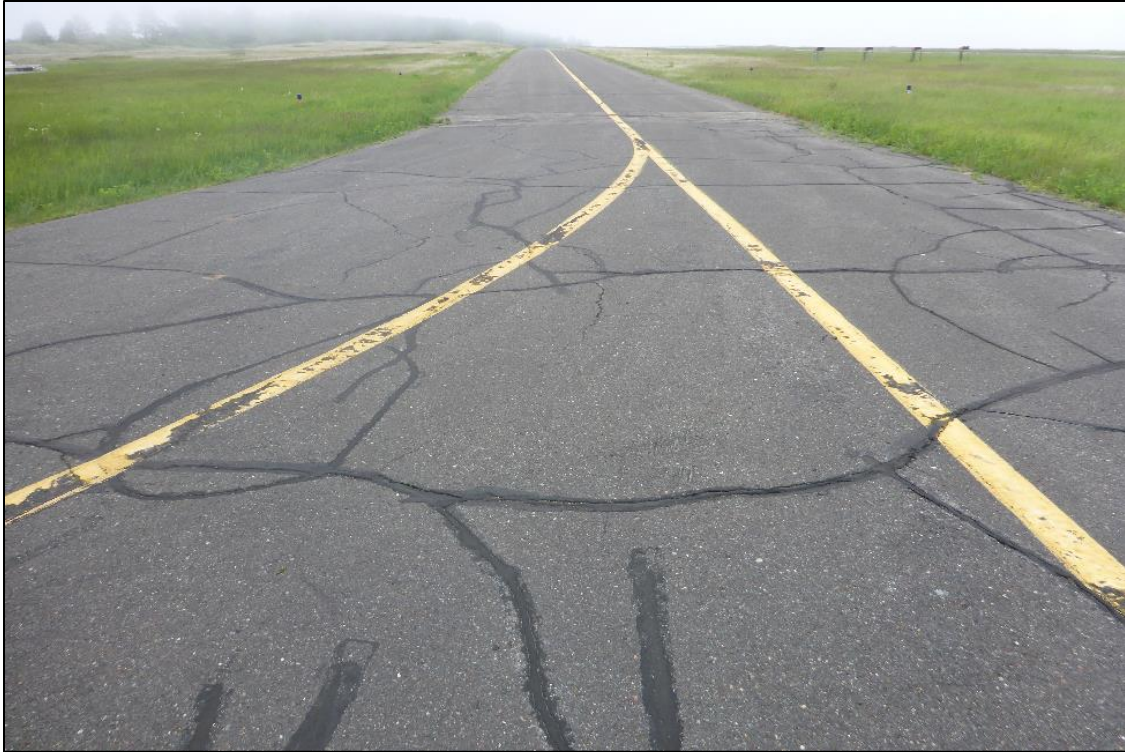
DYT PTA 001 (PCI = 52)

| <b>Section Comments:</b> | cracksealed since 08 | | | | | | | | |
| <b>Conditions:</b> | PCI: 52 | | | | | | | | |

| Branch | Section | Treatment | Quantity | Unit | Cost |
|---|---|---|---|---|---|
| PTA | 001 | Crack Sealing - AC | 2,251 | Ft | \$2,791 |

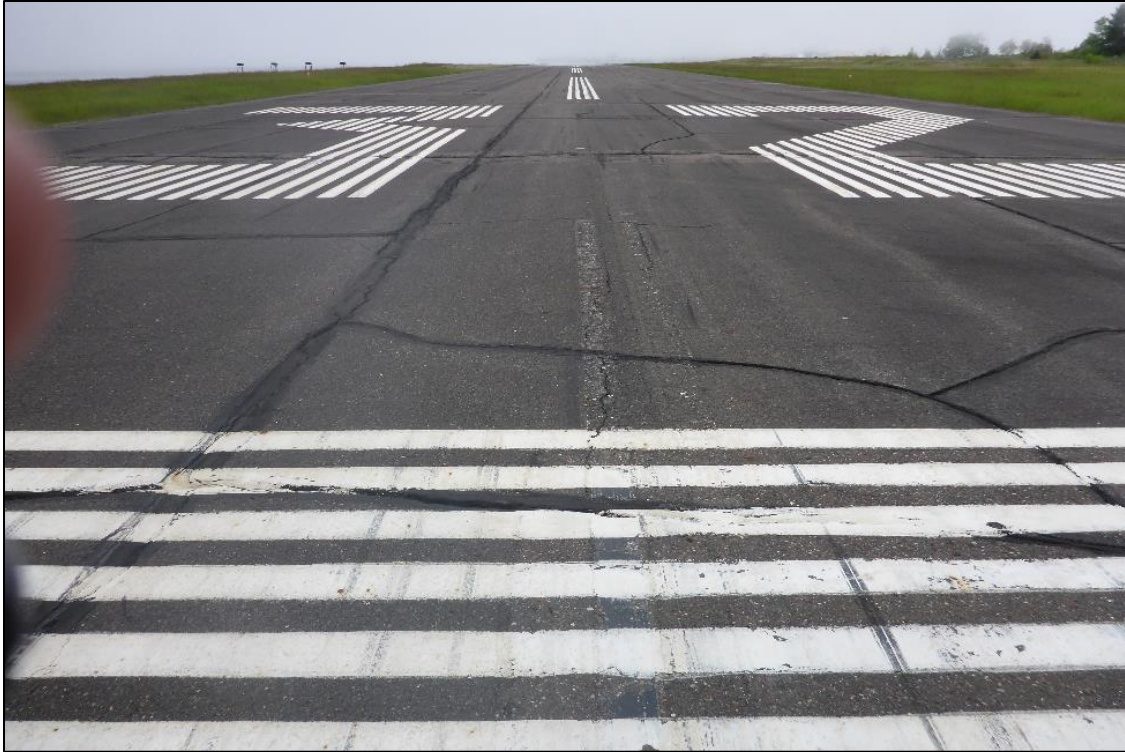
DYT RY1432 001 (PCI = 55)

| <b>Section Comments:</b> | cracksealed since 08 | | | | | | | | |
| <b>Conditions:</b> | PCI: 55 | | | | | | | | |

| Branch | Section | Treatment | Quantity | Unit | Cost |
|---|---|---|---|---|---|
| RY1432 | 001 | Crack Sealing - AC | 7,492 | Ft | \$9,290 |
