Pavement Condition Report

Hector Municipal Airport (1D6)

December 2018

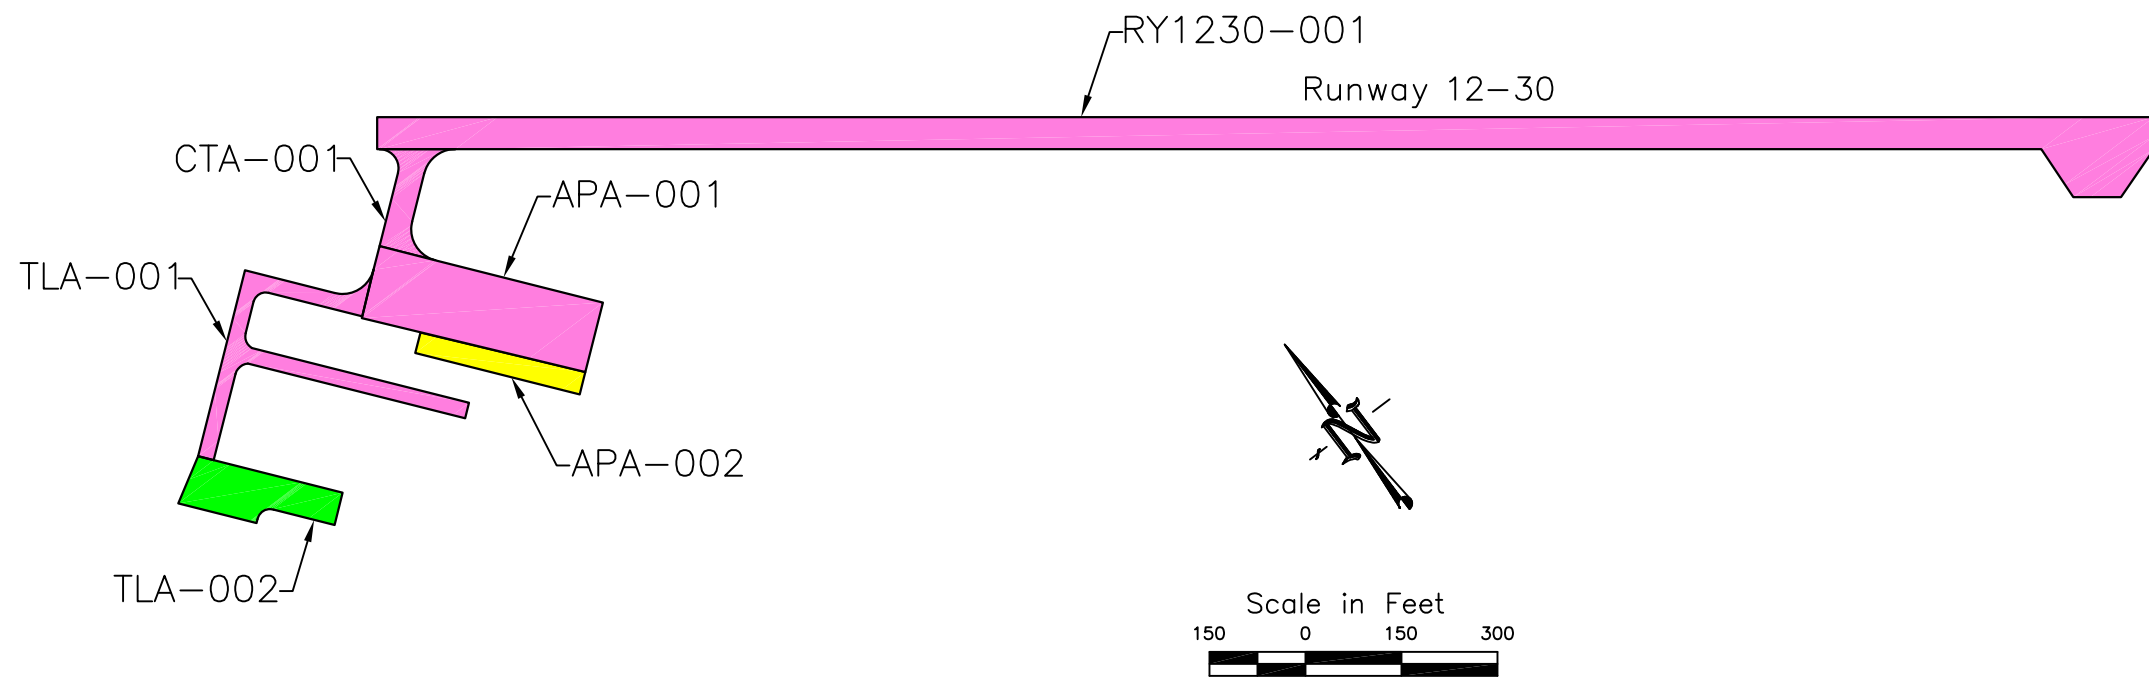
Figure 4. 2018 Pavement Condition Index Rating at Hector Municipal Airport (1D6).

Branch ID	Section ID	Surface type ¹	Section area (SF)	LCD ²	2015 PCI	2018 PCI	Drop in PCI/Yr ³	% Deduct due to		Distress types
								Load ⁴	Climate ⁵	
APA	001	AC	41,000	1985	61	52	1.5	18	82	Alligator cr, L&T cr, Raveling, Weathering
APA	002	AC	9,150	1986	73	61	1.2	-	100	L&T cr, Raveling, Weathering
CTA	001	AC	7,625	1985	56	49	1.5	12	88	Alligator cr, L&T cr, Raveling, Weathering
RY1230	001	AC	148,200	1985	53	47	1.6	13	87	Alligator cracking, Depression, L&T cr, Raveling, Weathering
TLA	001	AC	21,680	1985	51	44	1.7	24	76	Alligator cr, Block cr, L&T cr, Raveling, Weathering
TLA	002	AC	15,750	2005	91	79	1.6	-	99	Depression, L&T cr, Weathering

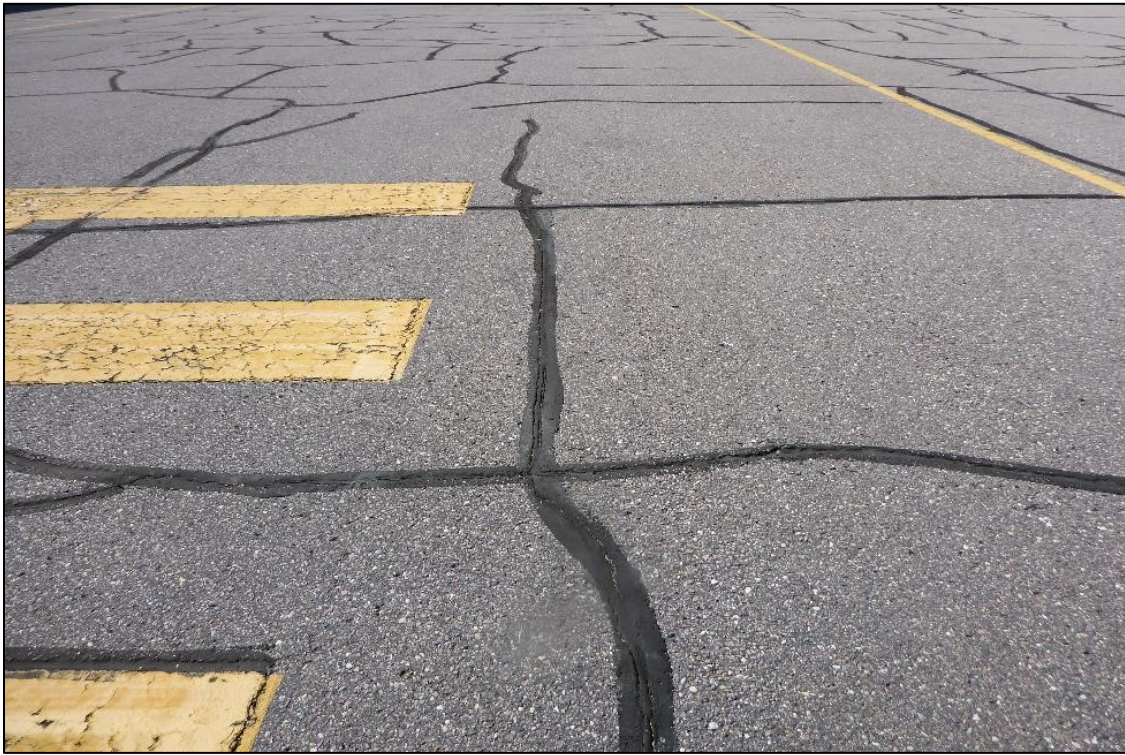
1D6 APA 001 (PCI = 52)

Network: 1D6				Name: HECTOR		
Branch: APA	Name: APRON A	Use: APRON	Area: 50,150 SqFt			
Section: 001	of 2	From: 100	To: 106	Last Const.: 9/30/1985		
Surface: AC	Family: MN2018 Asphalt Aprons	Zone: S	Category: 2	Rank: S		
Area: 41,000 SqFt	Length: 360 Ft	Width: 110 Ft				
Slabs:	Slab Length: Ft	Slab Width: Ft	Joint Length: Ft			
Shoulder:	Street Type:	Grade: 0	Lanes: 0			
Last Insp. Date: 6/3/2018	TotalSamples: 7	Surveyed: 2				
Conditions: PCI: 52						
Sample Number: 100	Type: R	Area: 5000.00 SqFt	PCI: 50			
48 L & T CR	M	31.00 Ft				
41 ALLIGATOR CR	L	40.00 SqFt				
48 L & T CR	L	814.00 Ft				
52 RAVELING	L	1000.00 SqFt				
57 WEATHERING	L	3900.00 SqFt				
Sample Number: 104	Type: R	Area: 5000.00 SqFt	PCI: 55			
48 L & T CR	L	822.00 Ft				
48 L & T CR	M	86.00 Ft				
57 WEATHERING	L	4000.00 SqFt				
52 RAVELING	L	400.00 SqFt

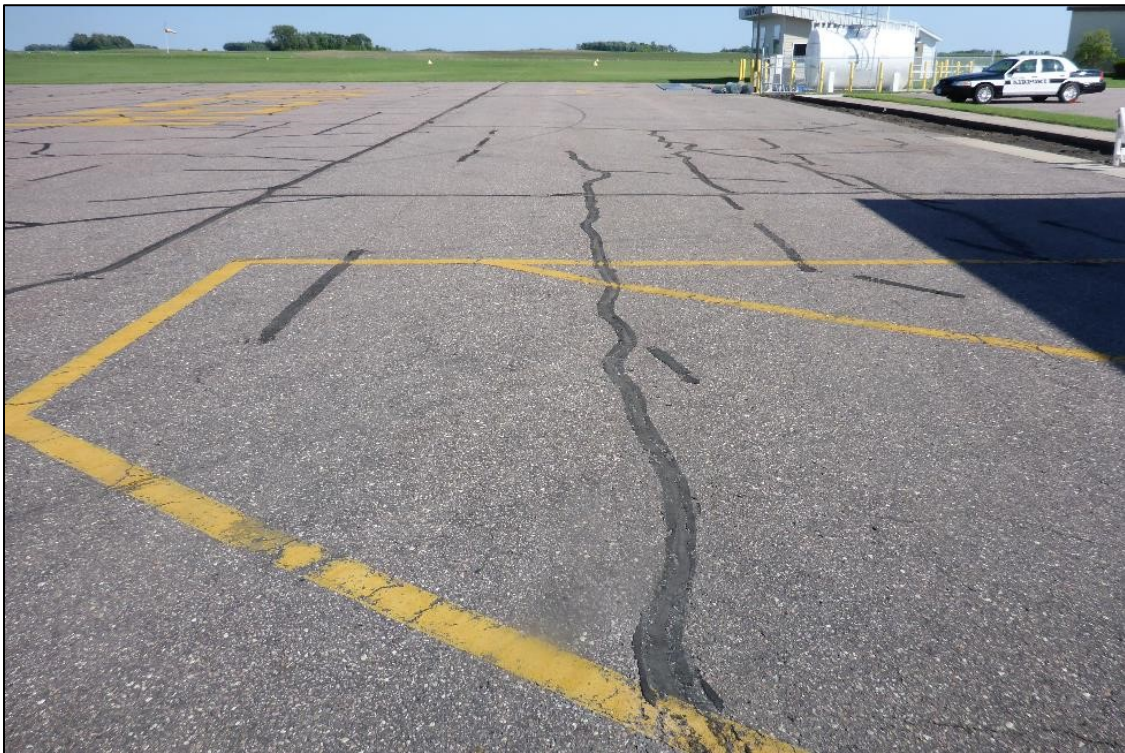
1D6 APA 002 (PCI = 61)

Network:	1D6	Name:	HECTOR						
Branch:	APA	Name:	APRON A	Use:	APRON	Area:	50,150 SqFt		
Section:	002	of 2	From:	200	To:	202	Last Const.: 9/30/1986		
Surface:	AC	Family:	MN2018 Asphalt Aprons	Zone:	S	Category:	2	Rank:	S
Area:	9,150 SqFt	Length:	310 Ft	Width:	40 Ft				
Slabs:	Slab Length:	Ft	Slab Width:	Ft	Joint Length:	Ft			
Shoulder:	Street Type:	Grade:		0	Lanes:	0			
Last Insp. Date:	6/3/2018	TotalSamples:	3	Surveyed:	1				
Conditions:	PCI: 61								
Sample Number:	201	Type:	R	Area:	4000.00 SqFt	PCI:	61		
48	L & T CR	L		447.00	Ft				
48	L & T CR	M		126.00	Ft				
52	RAVELING	L		75.00	SqFt				
57	WEATHERING	L		3500.00	SqFt

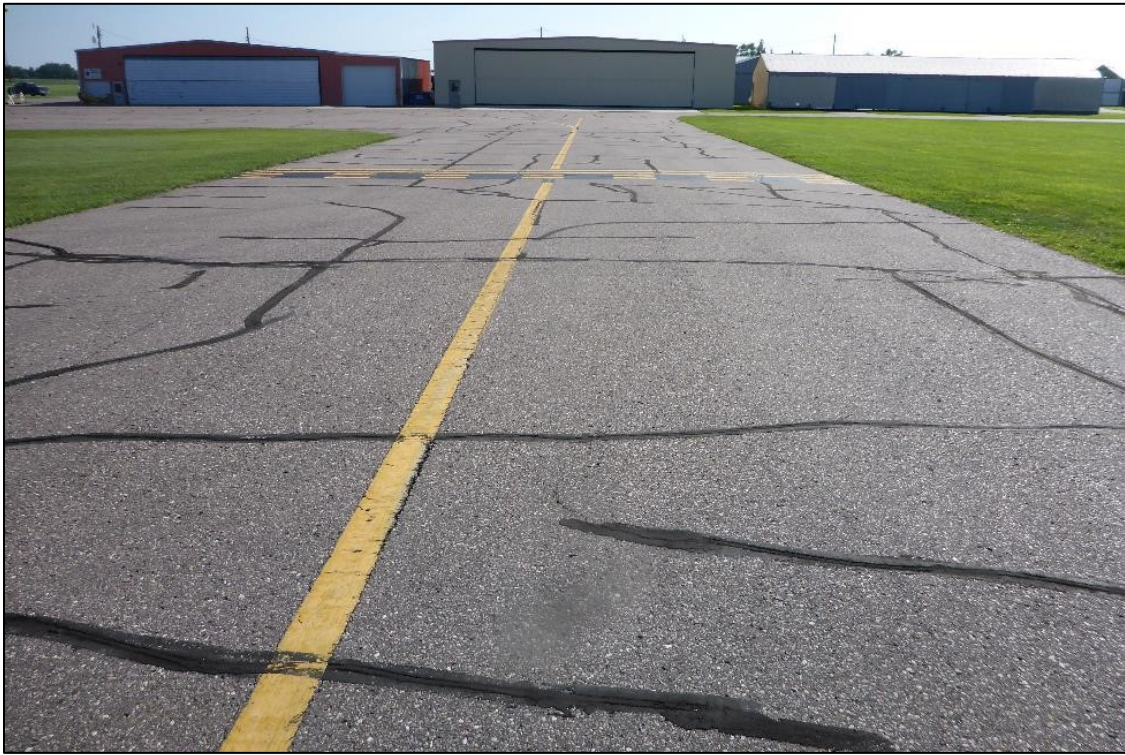
1D6 CTA 001 (PCI = 49)

Network:	1D6	Name:	HECTOR						
Branch:	CTA	Name:	CONNECTING TAXIWAY A	Use:	TAXIWAY	Area:	7,625 SqFt		
Section:	001	of	1	From:	100	To:	101	Last Const.:	9/30/1985
Surface:	AC	Family:	MN2018 Asphalt Runway- Taxiways	Zone:	S	Category:	2	Rank:	P
Area:	7,625 SqFt	Length:	160 Ft	Width:	40 Ft				
Slabs:		Slab Length:	Ft	Slab Width:	Ft	Joint Length:	Ft		
Shoulder:		Street Type:		Grade:	0	Lanes:	0		
Last Insp. Date:	6/3/2018	TotalSamples:	2	Surveyed:	1				
Conditions:	PCI: 49								
Sample Number:	101	Type:	R	Area:	4190.00 SqFt	PCI:	49		
48	L & T CR	L		648.00 Ft					
57	WEATHERING	L		3000.00 SqFt					
48	L & T CR	M		48.00 Ft					
57	WEATHERING	M		50.00 SqFt					
52	RAVELING	L		500.00 SqFt					
41	ALLIGATOR CR	L		8.00 SqFt

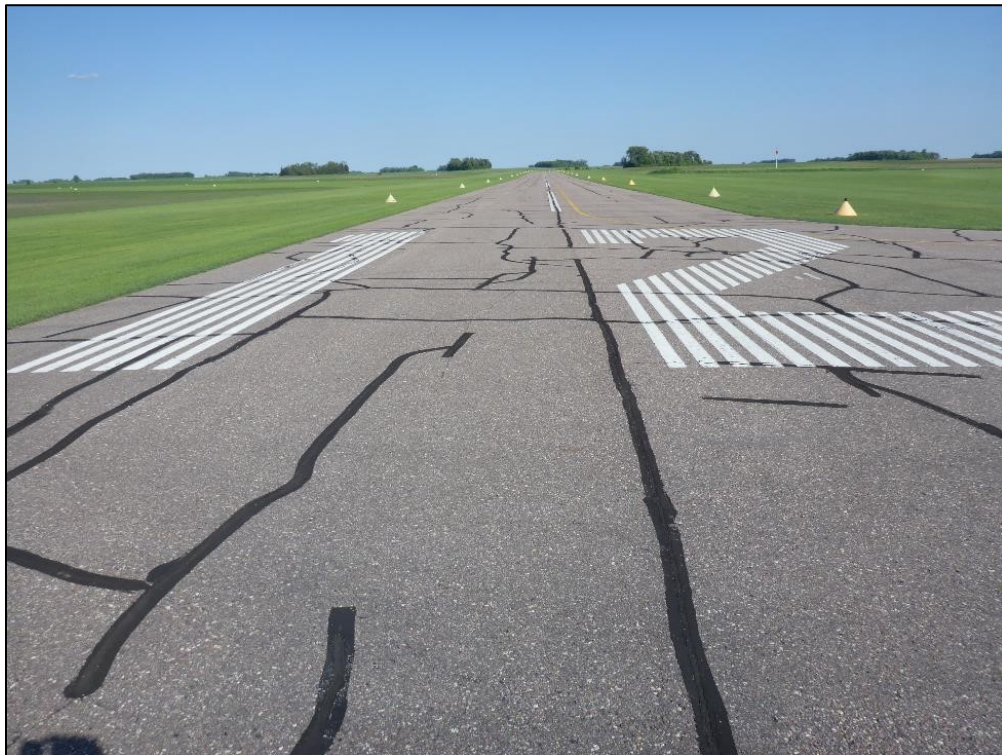
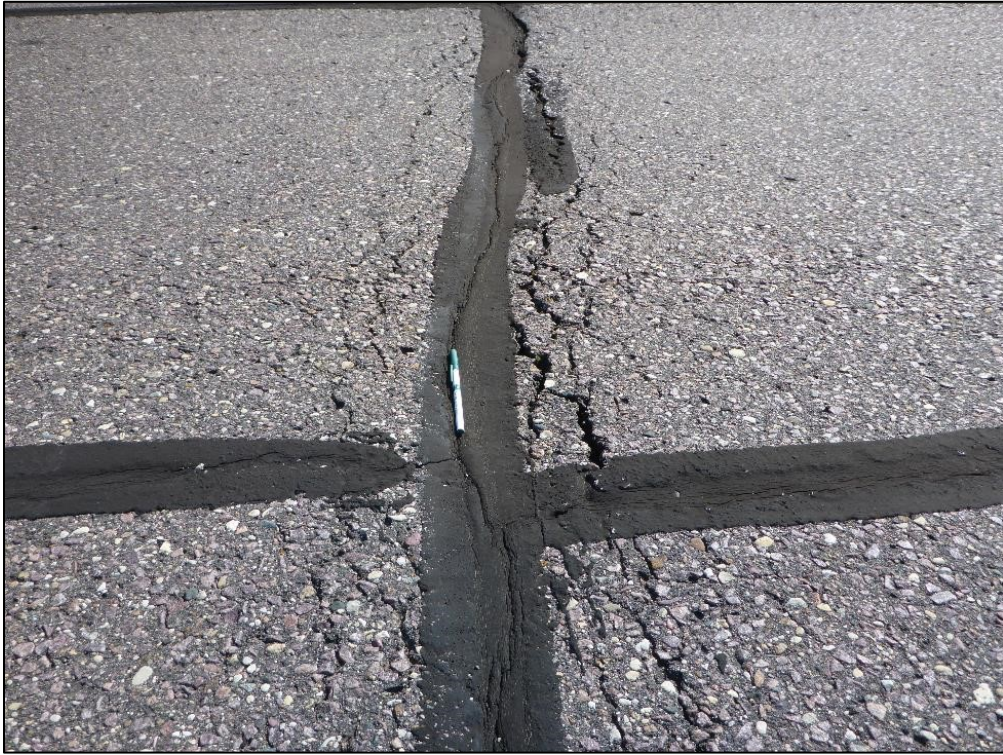
1D6 RY1230 001 (PCI = 47)

Network:	1D6		Name:	HECTOR					
Branch:	RY1230	Name:	RUNWAY 12-30	Use:	RUNWAY	Area:	148,200 SqFt		
Section:	001	of 1	From:	100	To:	127	Last Const.:	9/30/1985	
Surface:	AC	Family:	MN2018 Asphalt Runway- Taxiways	Zone:	S	Category:	2	Rank:	P
Area:	148,200 SqFt	Length:	2,776 Ft	Width:	50 Ft				
Slabs:	Slab Length:	Ft	Slab Width:	Ft	Joint Length:	Ft			
Shoulder:	Street Type:	Grade:	0	Lanes:	0				
Last Insp. Date:	6/3/2018	TotalSamples:	30	Surveyed:	4				
Conditions:	PCI: 47								
Sample Number:	101	Type:	R	Area:	5000.00 SqFt	PCI:	52		
52	RAVELING	L		500.00	SqFt				
57	WEATHERING	M		500.00	SqFt				
48	L & T CR	L		717.00	Ft				
48	L & T CR	M		97.00	Ft				
57	WEATHERING	L		4000.00	SqFt				
Sample Number:	109	Type:	R	Area:	5000.00 SqFt	PCI:	42		
48	L & T CR	H		10.00	Ft				
45	DEPRESSION	L		20.00	SqFt				
41	ALLIGATOR CR	L		30.00	SqFt				
48	L & T CR	M		145.00	Ft				
57	WEATHERING	L		4000.00	SqFt				
57	WEATHERING	M		200.00	SqFt

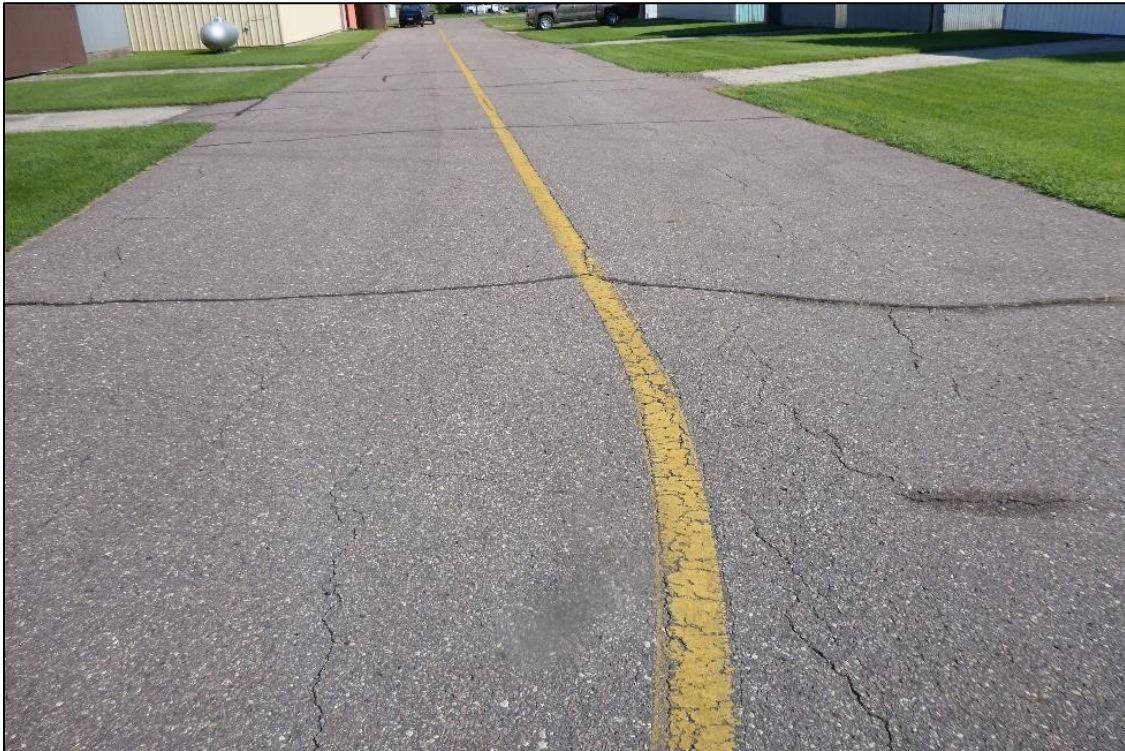
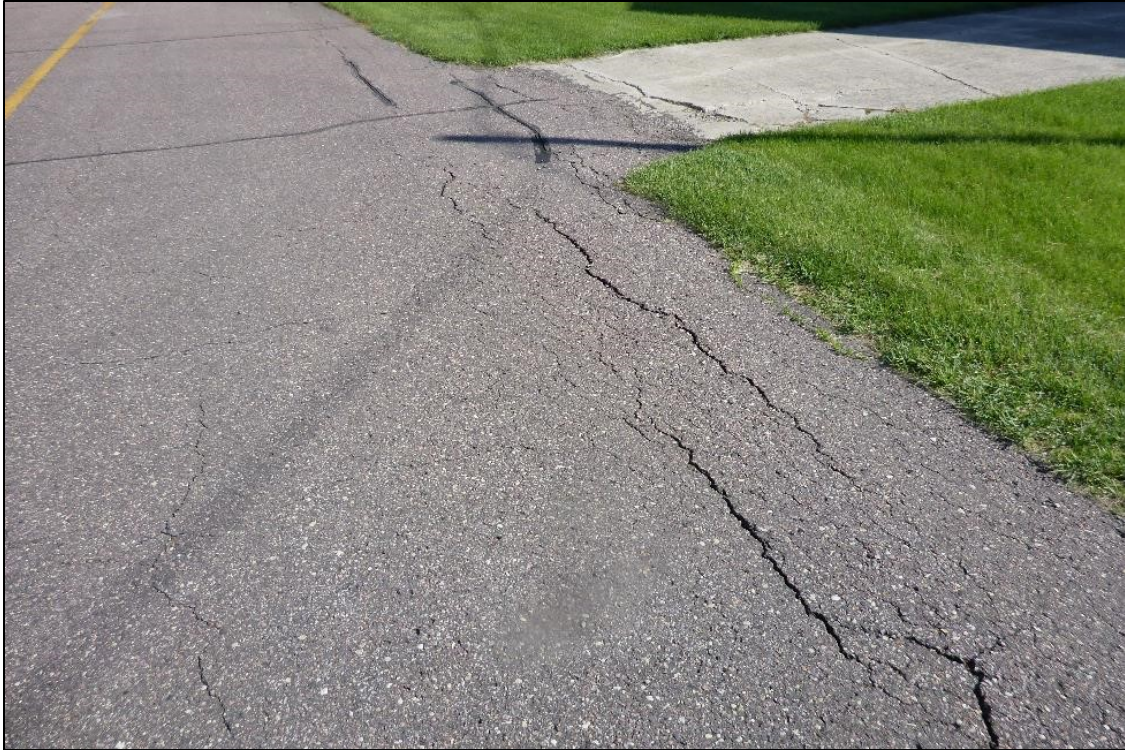
1D6 TLA 001 (PCI = 44)

Network:	1D6	Name:	HECTOR						
Branch:	TLA	Name:	Taxilane A	Use:	TAXILANE	Area:	37,430 SqFt		
Section:	001	of 2	From:	100	To:	103	Last Const.:	9/30/1985	
Surface:	AC	Family:	MN2018 Asphalt Taxilanes	Zone:	S	Category:	2	Rank:	T
Area:	21,680 SqFt	Length:	835 Ft	Width:	25 Ft				
Slabs:	Slab Length:	Ft	Slab Width:	Ft	Joint Length:	Ft			
Shoulder:	Street Type:	Grade:	0	Lanes:	0				
Last Insp. Date:	6/3/2018	TotalSamples:	4	Surveyed:	1				
Conditions:	PCI: 44								
Sample Number:	101	Type:	R	Area:	5000.00 SqFt	PCI:	44		
48	L & T CR	L		410.00 Ft					
48	L & T CR	M		126.00 Ft					
57	WEATHERING	M		3000.00 SqFt					
43	BLOCK CR	L		800.00 SqFt					
41	ALLIGATOR CR	L		85.00 SqFt					
52	RAVELING	L		250.00 SqFt

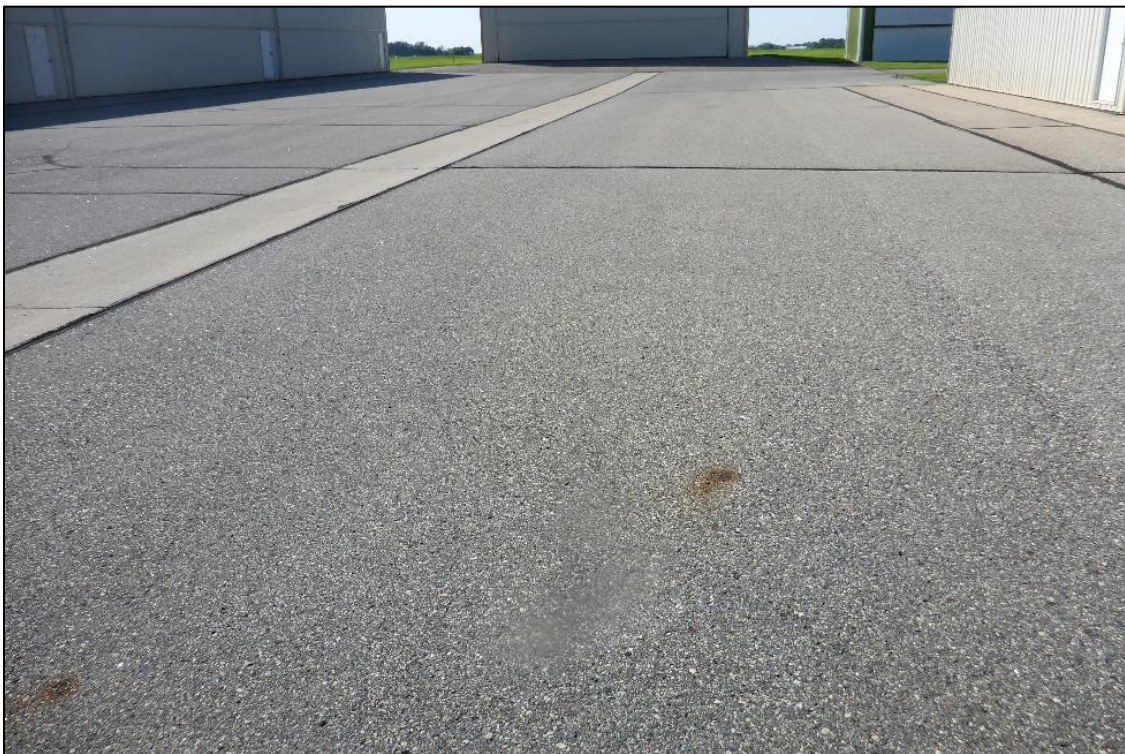
1D6 TLA 002 (PCI = 79)

Network:	1D6	Name:	HECTOR						
Branch:	TLA	Name:	Taxilane A	Use:	TAXILANE	Area:	37,430 SqFt		
Section:	002	of 2	From:	200	To:	202	Last Const.:	9/30/2005	
Surface:	AC	Family:	MN2018 Asphalt Taxilanes	Zone:	S	Category:	2	Rank:	T
Area:	15,750 SqFt	Length:	233 Ft	Width:	75 Ft				
Slabs:	Slab Length:	Ft	Slab Width:	Ft	Joint Length:	Ft			
Shoulder:	Street Type:	Grade:	0	Lanes:	0				
Last Insp. Date:	6/3/2018	TotalSamples:	3	Surveyed:	1				
Conditions:	PCI:	79							
Sample Number:	200	Type:	R	Area:	3750.00 SqFt	PCI:	79		
48	L & T CR	M	4.00	Ft					
57	WEATHERING	L	3000.00	SqFt					
48	L & T CR	L	93.00	Ft					
57	WEATHERING	M	150.00	SqFt					
45	DEPRESSION	L	3.00	SqFt
