Pavement Condition Report

Rushford Municipal Airport (55Y)

December 2018

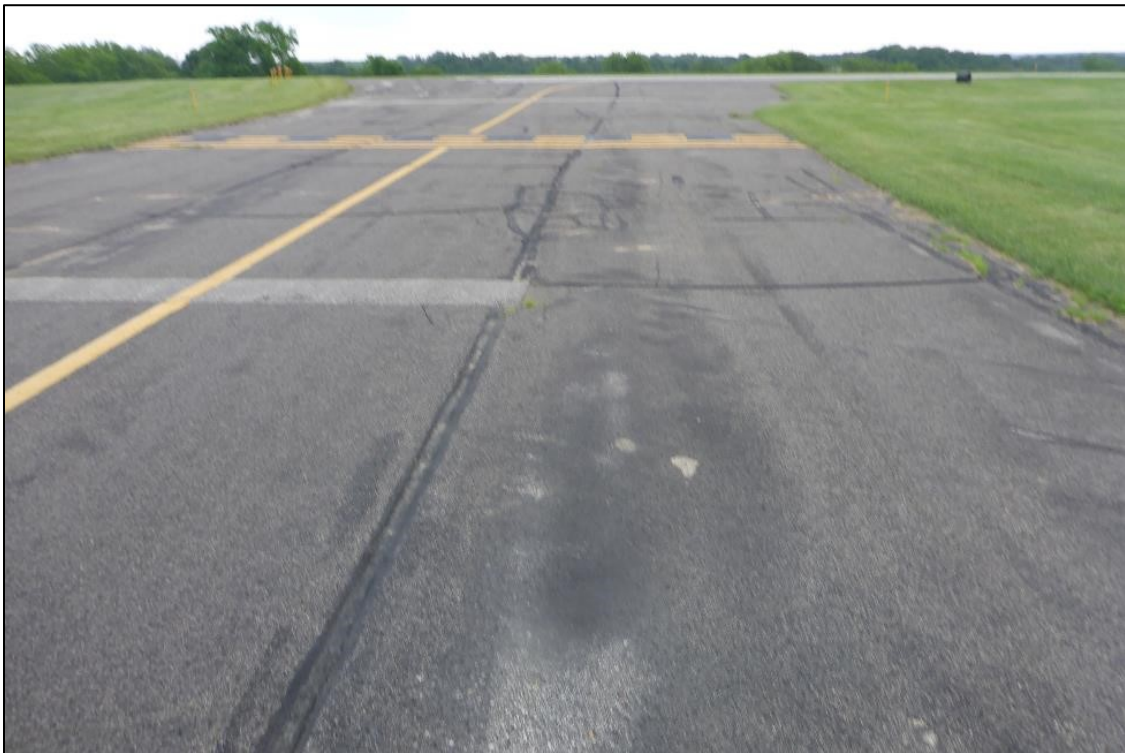
55Y CTA 001 (PCI = 32)

Network:	55Y	Name:	RUSHFORD						
Branch:	CTA	Name:	CONNECTING TAXIWAY A	Use:	TAXIWAY	Area:	26,350 SqFt		
Section:	001	of 2	From:	100	To:	103	Last Const.: 9/1/2005		
Surface:	AC	Family:	MN2018 Asphalt Runway- Taxiways	Zone:	S	Category:	2	Rank:	P
Area:	21,800 SqFt	Length:	360 Ft	Width:	40 Ft				
Slabs:		Slab Length:	Ft	Slab Width:	Ft	Joint Length:	Ft		
Shoulder:		Street Type:		Grade:	0	Lanes:	0		
Last Insp. Date:	6/7/2018	Total Samples:	4	Surveyed:	2				
Conditions:	PCI: 32								
Sample Number:	101	Type:	R	Area:	4000.00 SqFt	PCI:	37		
48	L & T CR	L		250.00 Ft					
48	L & T CR	M		15.00 Ft					
41	ALLIGATOR CR	M		211.00 SqFt					
50	PATCHING	L		160.00 SqFt					
Sample Number:	104	Type:	R	Area:	4000.00 SqFt	PCI:	27		
48	L & T CR	L		240.00 Ft					
50	PATCHING	L		132.00 SqFt					
48	L & T CR	M		120.00 Ft					
41	ALLIGATOR CR	M		445.00 SqFt

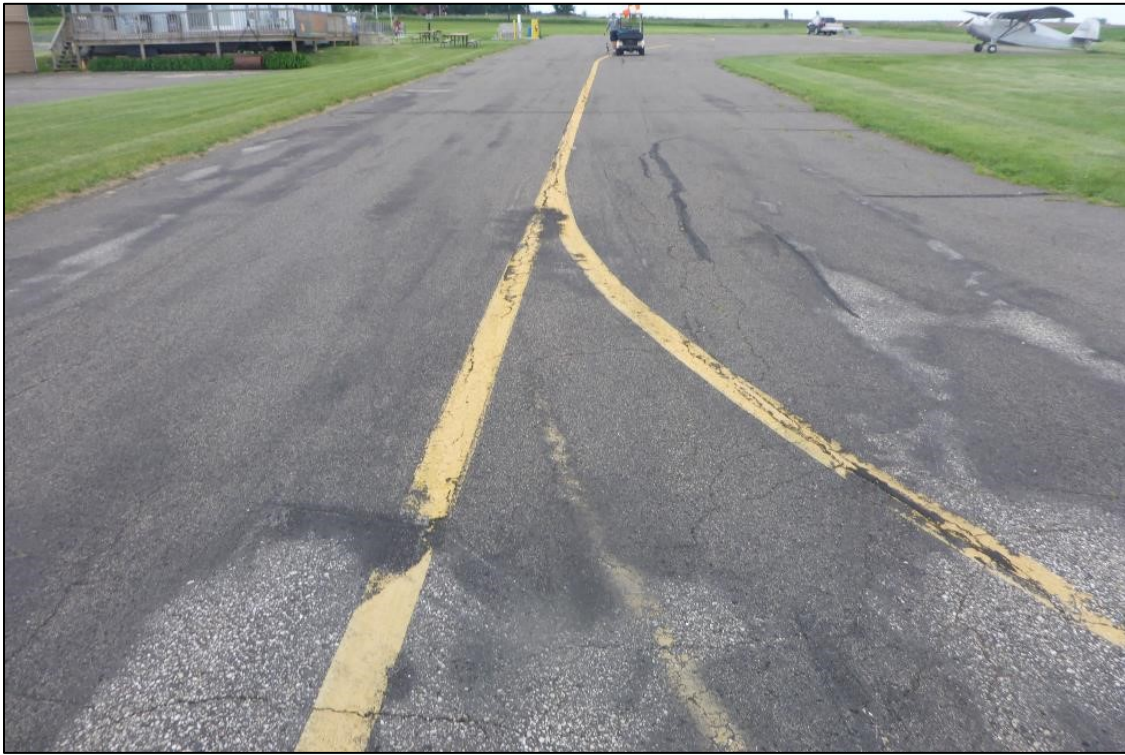
55Y CTA 002 (PCI = 33)

Network:	55Y	Name:	RUSHFORD						
Branch:	CTA	Name:	CONNECTING TAXIWAY A	Use:	TAXIWAY	Area:	26,350 SqFt		
Section:	002	of 2	From:	200	To:	200	Last Const.:	9/1/2005	
Surface:	AC	Family:	MN2018 Asphalt Runway- Taxiways	Zone:	S	Category:	2	Rank:	P
Area:	4,550 SqFt	Length:	200 Ft	Width:	30 Ft				
Slabs:		Slab Length:	Ft	Slab Width:	Ft	Joint Length:	Ft		
Shoulder:		Street Type:		Grade:	0	Lanes:	0		
Last Insp. Date:	6/7/2018	TotalSamples:	2	Surveyed:	1				
Conditions:	PCI: 33								
Sample Number:	201	Type:	R	Area:	4500.00 SqFt	PCI:	33		
48	L & T CR	M		25.00	Ft				
53	RUTTING	L		30.00	SqFt				
41	ALLIGATOR CR	M		225.00	SqFt				
50	PATCHING	L		120.00	SqFt				
48	L & T CR	L		185.00	Ft

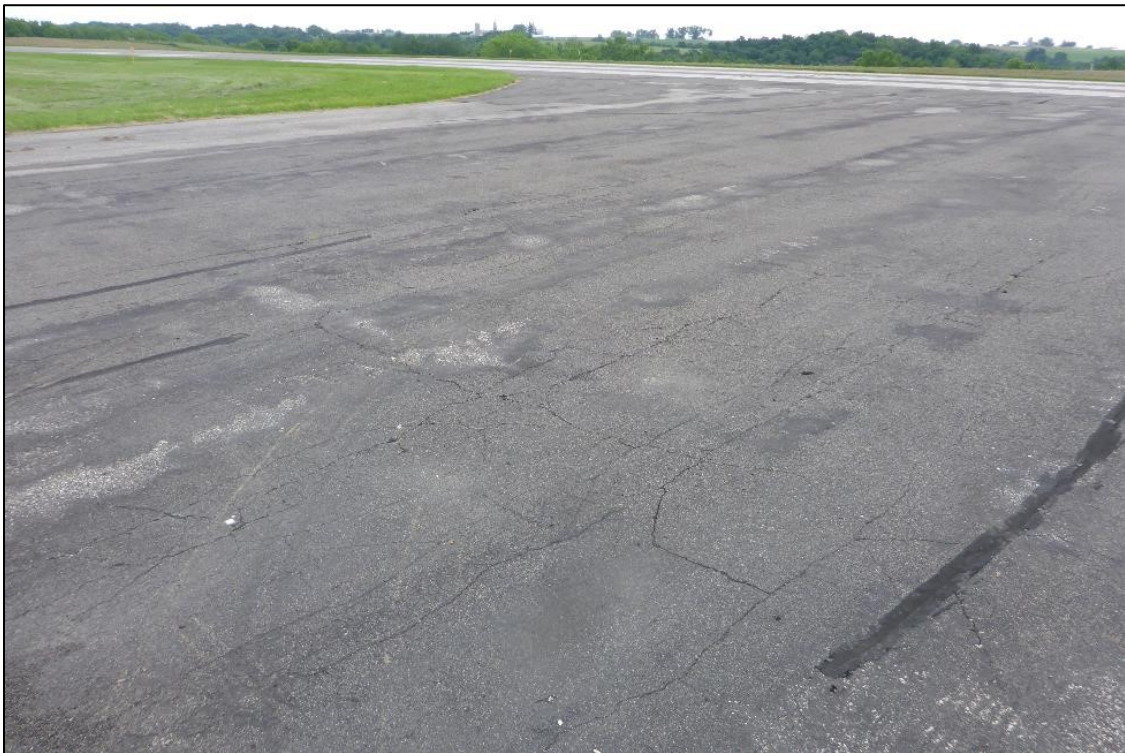
55Y RTA 001 (PCI = 35)

Network:	55Y	Name:	RUSHFORD				
Branch:	RTA	Name:	Runway Turnaround	Use:	TAXIWAY	Area:	6,650 SqFt
Section:	001	of 1	From:	A	To:	B	Last Const.: 9/1/2005
Surface:	AC	Family:	MN2018 Asphalt Runway-Taxiways	Zone:		Category:	Rank: P
Area:	6,650 SqFt	Length:	80 Ft	Width:	80 Ft		
Slabs:		Slab Length:	Ft	Slab Width:	Ft	Joint Length:	Ft
Shoulder:		Street Type:		Grade:	0	Lanes:	0
Last Insp. Date:	6/7/2018	TotalSamples:	2	Surveyed:	1		
Conditions:	PCI: 35						
Sample Number:	263	Type:	R	Area:	4000.00 SqFt	PCI:	35
53	RUTTING	L		45.00	SqFt		
48	L & T CR	M		24.00	Ft		
53	RUTTING	M		35.00	SqFt		
41	ALLIGATOR CR	M		172.00	SqFt		
48	L & T CR	L		248.00	Ft

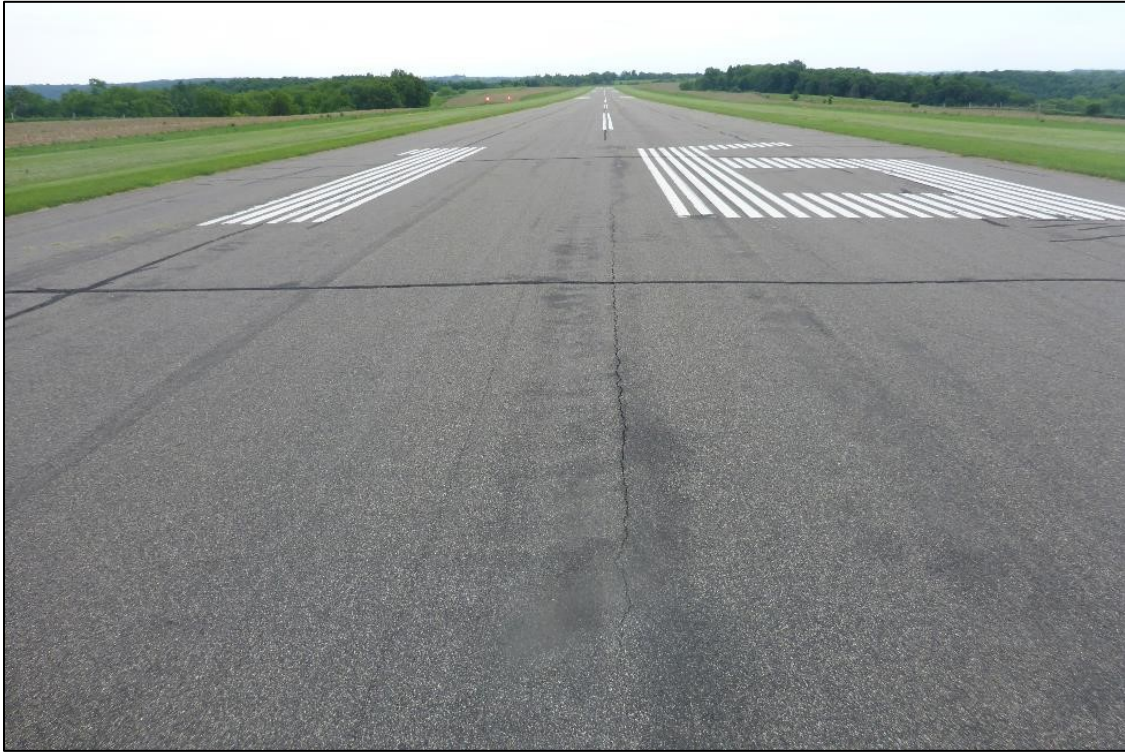
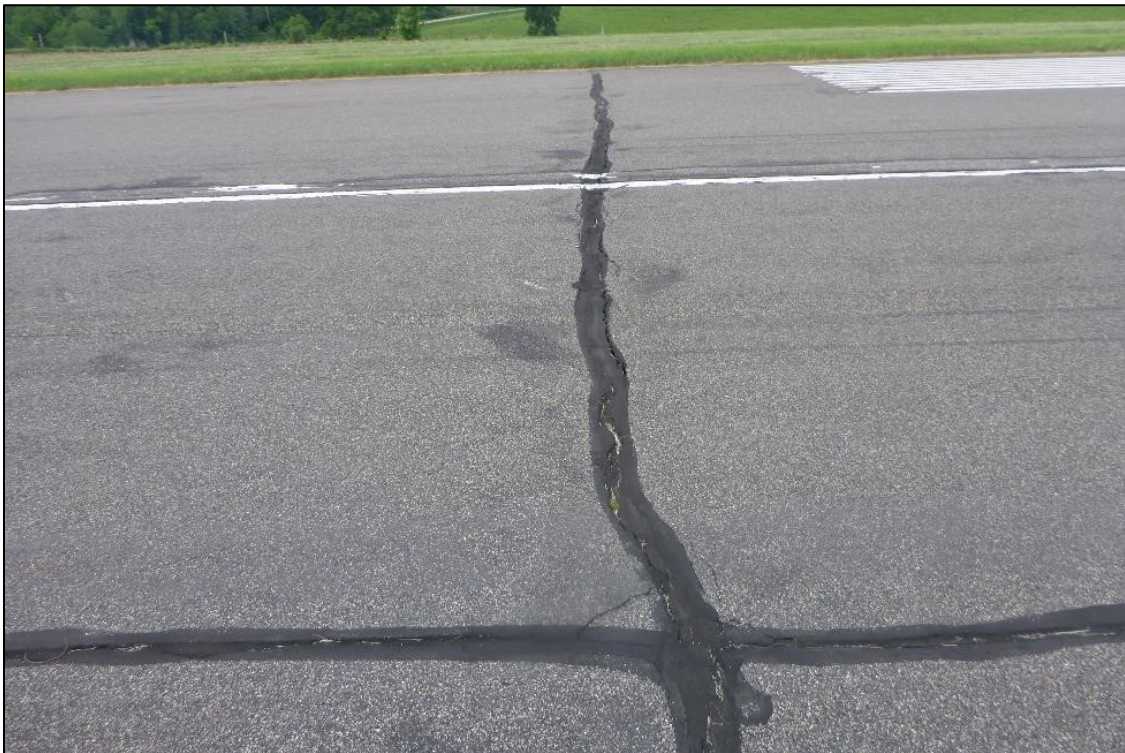
55Y RY1634 001 (PCI = 74)

Network:	55Y	Name:	RUSHFORD						
Branch:	RY1634	Name:	RUNWAY 16-34	Use:	RUNWAY	Area:	192,700 SqFt		
Section:	001	of 1	From:	100	To:	163	Last Const.:	9/1/2005	
Surface:	AC	Family:	MN2018 Asphalt Runway- Taxiways	Zone:	S	Category:	2	Rank:	P
Area:	192,700 SqFt	Length:	3,200 Ft	Width:	60 Ft				
Slabs:		Slab Length:	Ft	Slab Width:	Ft	Joint Length:	Ft		
Shoulder:		Street Type:		Grade:	0	Lanes:	0		
Last Insp. Date:	6/7/2018	Total Samples:	64	Surveyed:	6				
Conditions:	PCI: 74								
Sample Number:	106	Type:	R	Area:	3000.00 SqFt	PCI:	76		
48	L & T CR		M	89.00	Ft				
48	L & T CR		L	215.00	Ft				
Sample Number:	116	Type:	R	Area:	3000.00 SqFt	PCI:	66		
48	L & T CR		M	134.00	Ft				
48	L & T CR		H	3.00	Ft				
48	L & T CR		L	89.00	Ft				
Sample Number:	126	Type:	R	Area:	3000.00 SqFt	PCI:	80		
48	L & T CR		L	153.00	Ft				
48	L & T CR		M	18.00	Ft				
Sample Number:	136	Type:	R	Area:	3000.00 SqFt	PCI:	72		
48	L & T CR		M	61.00	Ft

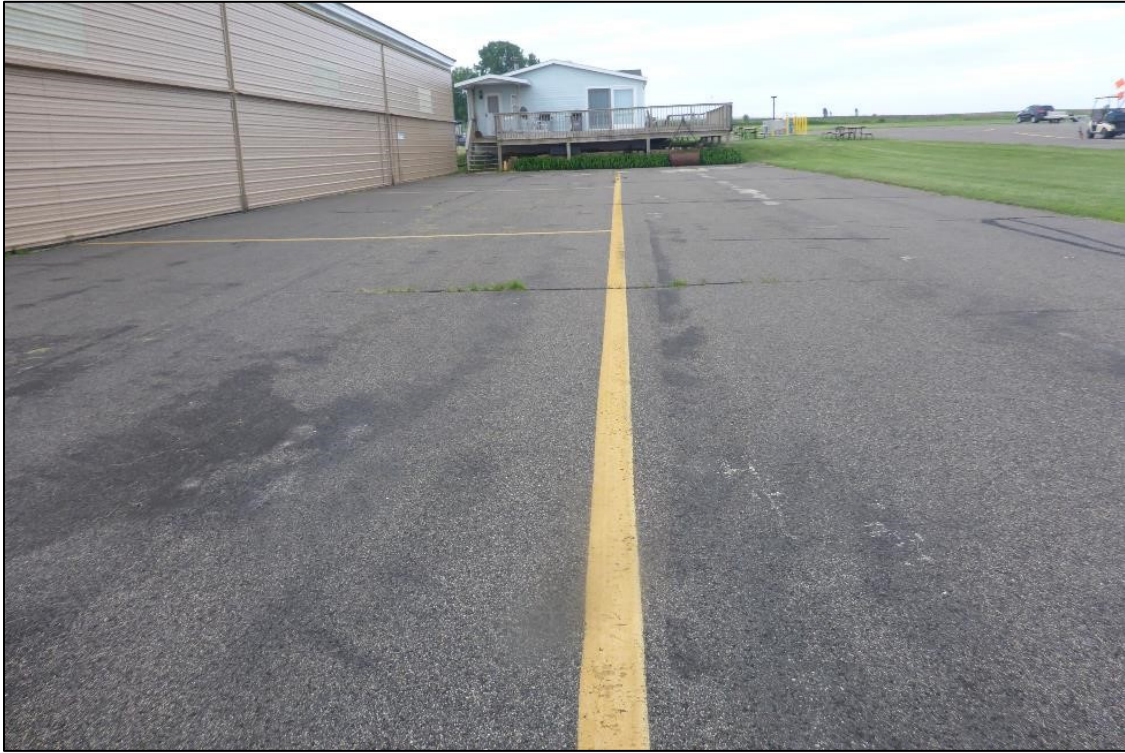
55Y TLA 001 (PCI = 81)

Network:	55Y	Name:	RUSHFORD				
Branch:	TLA	Name:	Taxilane A	Use:	TAXILANE	Area:	29,050 SqFt
Section:	001	of 2	From:	100	To:	300	Last Const.: 9/1/2005
Surface:	AC	Family:	MN2018 Asphalt Taxilanes	Zone:	S	Category:	2
Area:	7,000 SqFt	Length:	280 Ft	Width:	45 Ft	Joint Length:	Ft
Slabs:		Slab Length:	Ft	Slab Width:	Ft	Joint Length:	Ft
Shoulder:		Street Type:		Grade:	0	Lanes:	0
Last Insp. Date:	6/7/2018	TotalSamples:	5	Surveyed:	1		
Conditions:	PCI: 81						
Sample Number:	100	Type:	R	Area:	4400.00 SqFt	PCI:	81
57	WEATHERING		M	120.00	SqFt		
52	RAVELING		M	82.00	SqFt		
48	L & T CR		L	152.00	Ft

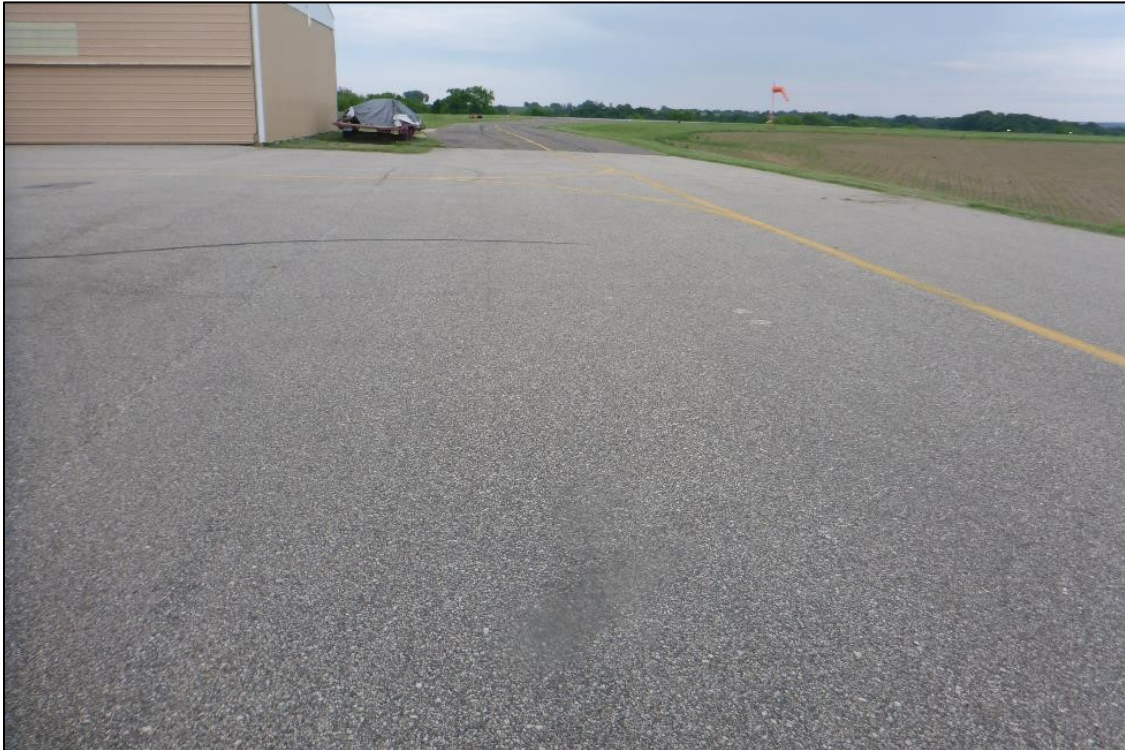
55Y TLA 002 (PCI = 87)

Network:	55Y	Name:	RUSHFORD				
Branch:	TLA	Name:	Taxilane A	Use:	TAXILANE	Area:	29,050 SqFt
Section:	002	of 2	From:	-	To:	-	Last Const.: 9/1/2011
Surface:	AC	Family:	MN2018 Asphalt Taxilanes	Zone:		Category:	Rank: T
Area:	22,050 SqFt	Length:	600 Ft	Width:	50 Ft		
Slabs:		Slab Length:	Ft	Slab Width:	Ft	Joint Length:	Ft
Shoulder:		Street Type:		Grade:	0	Lanes:	0
Last Insp. Date:	6/7/2018	Total Samples:	6	Surveyed:	2		
Conditions:	PCI: 87						
Sample Number:	201	Type:	R	Area:	4000.00 SqFt	PCI:	85
48	L & T CR	M		8.00	Ft		
48	L & T CR	L		31.00	Ft		
57	WEATHERING	L		4000.00	SqFt		
Sample Number:	401	Type:	R	Area:	4300.00 SqFt	PCI:	90
48	L & T CR	L		23.00	Ft		
57	WEATHERING	L		4300.00	SqFt
