Pavement Condition Report

Buffalo Municipal Airport (CFE)

December 2019

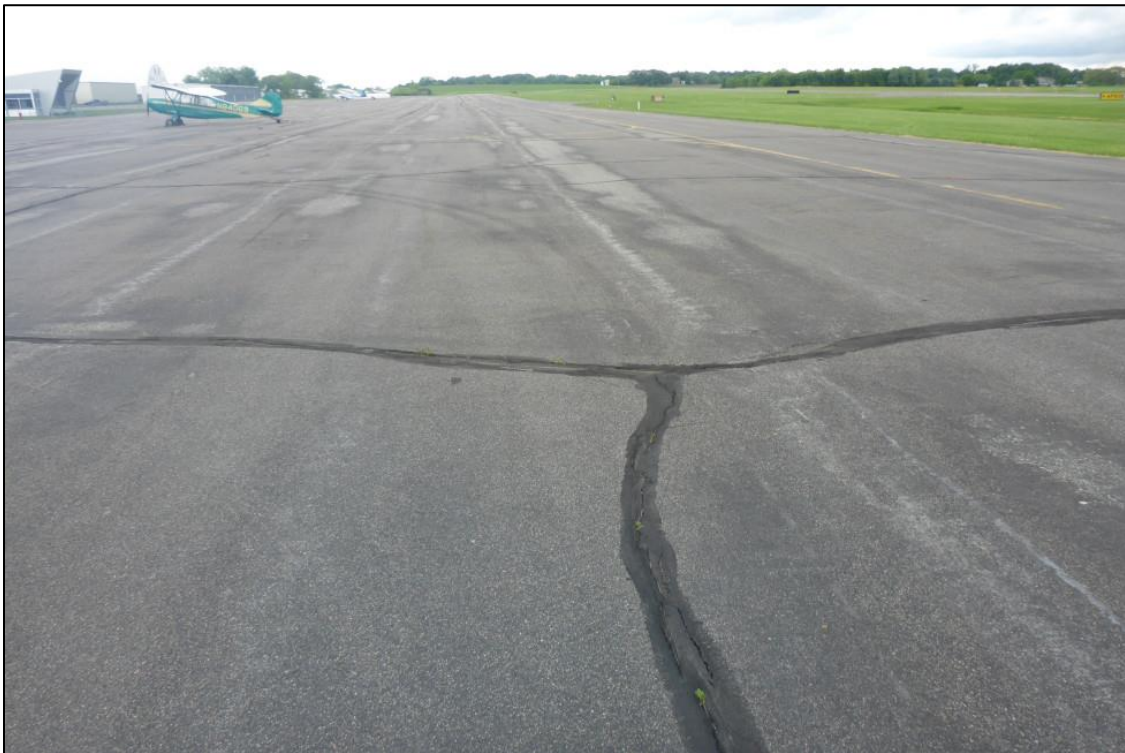
CFE APA 002 (PCI = 75)

Conditions: PCI: 75

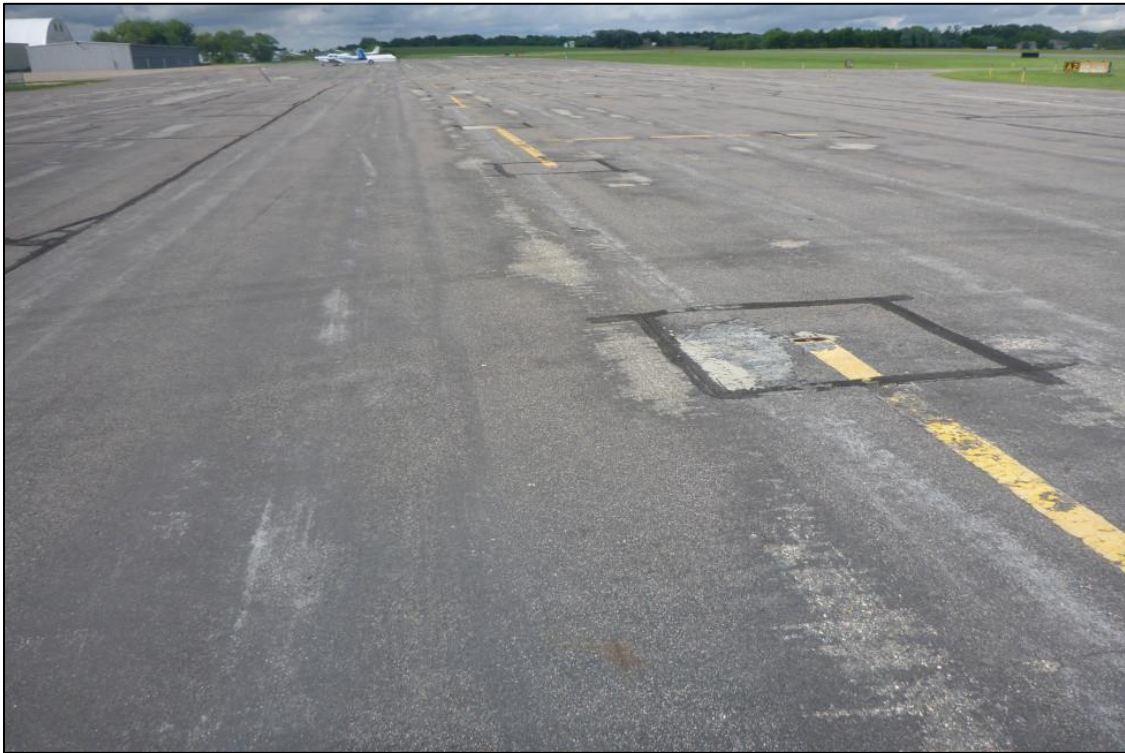
CFE APA 003 (PCI = 77)

Network:	CFE	Name:	BUFFALO						
Branch:	APA	Name:	APRON A	Use:	APRON	Area:	94,650 SqFt		
Section:	003	of 3	From:	210	To:	211	Last Const.:	9/1/2010	
Surface:	AC	Family:	MN2018 Asphalt Aprons	Zone:	E	Category:	3	Rank:	S
Area:	10,650 SqFt	Length:	213 Ft	Width:	50 Ft				
Slabs:	Slab Length:	Ft	Slab Width:	Ft	Joint Length:	Ft			
Shoulder:	Street Type:		Grade:	0	Lanes:	0			
Section Comments:									
Last Insp. Date:	6/11/2019	TotalSamples:	2	Surveyed:	1				
Conditions:	PCI: 77								
Inspection Comments:									
Sample Number:	214	Type:	R	Area:	5000.00 SqFt	PCI:	77		
Sample Comments:	p229 230								
48	L & T CR	L	110.00	Ft					
48	L & T CR	M	108.00	Ft					
57	WEATHERING	M	75.00	SqFt

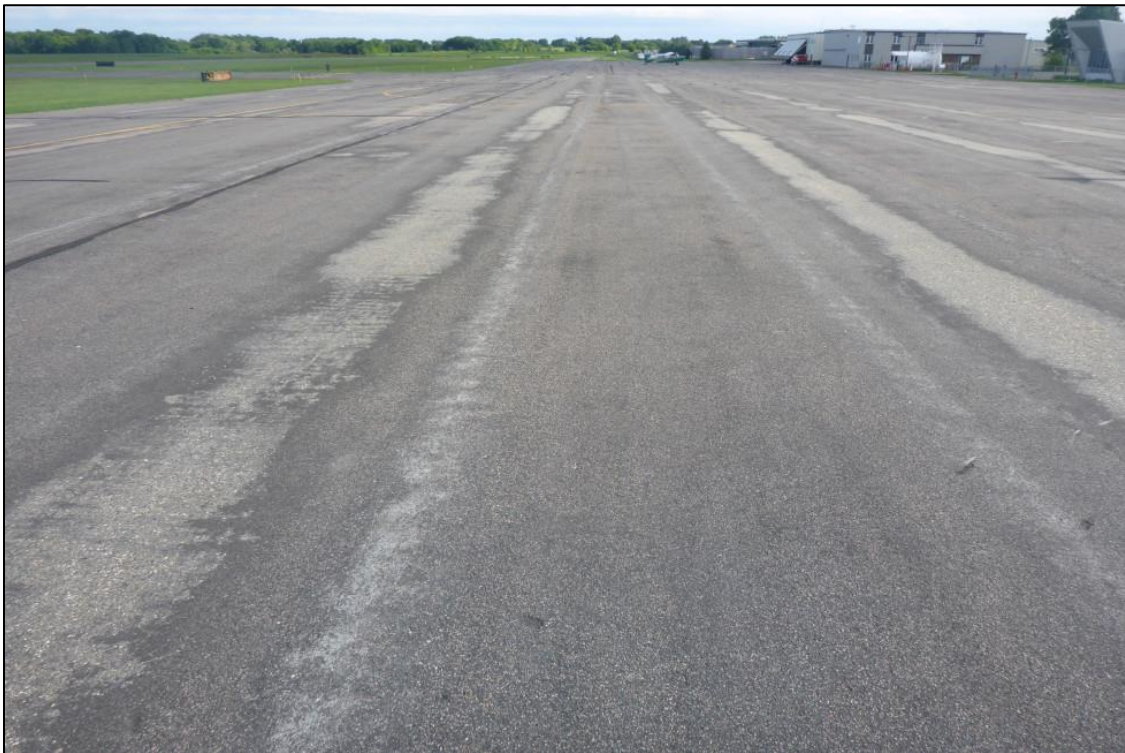
CFE APB 001 (PCI = 86)

Conditions: PCI: 86

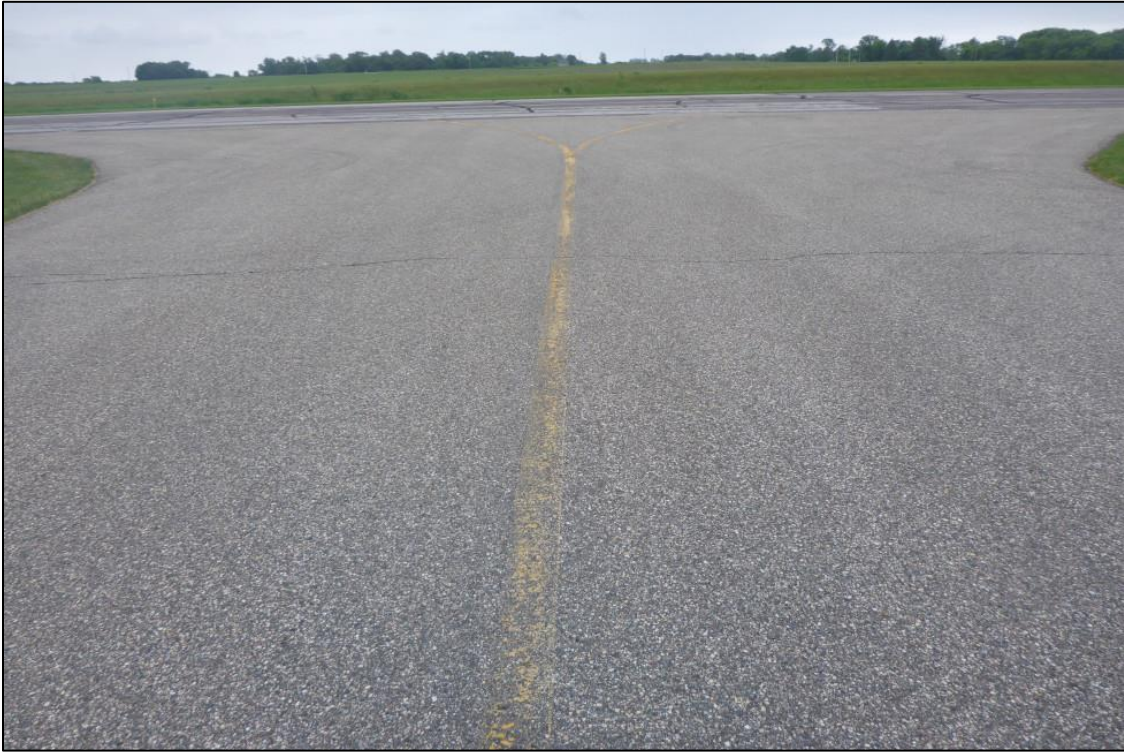
CFE CTA1 001 (PCI = 80)

Conditions: PCI: 80

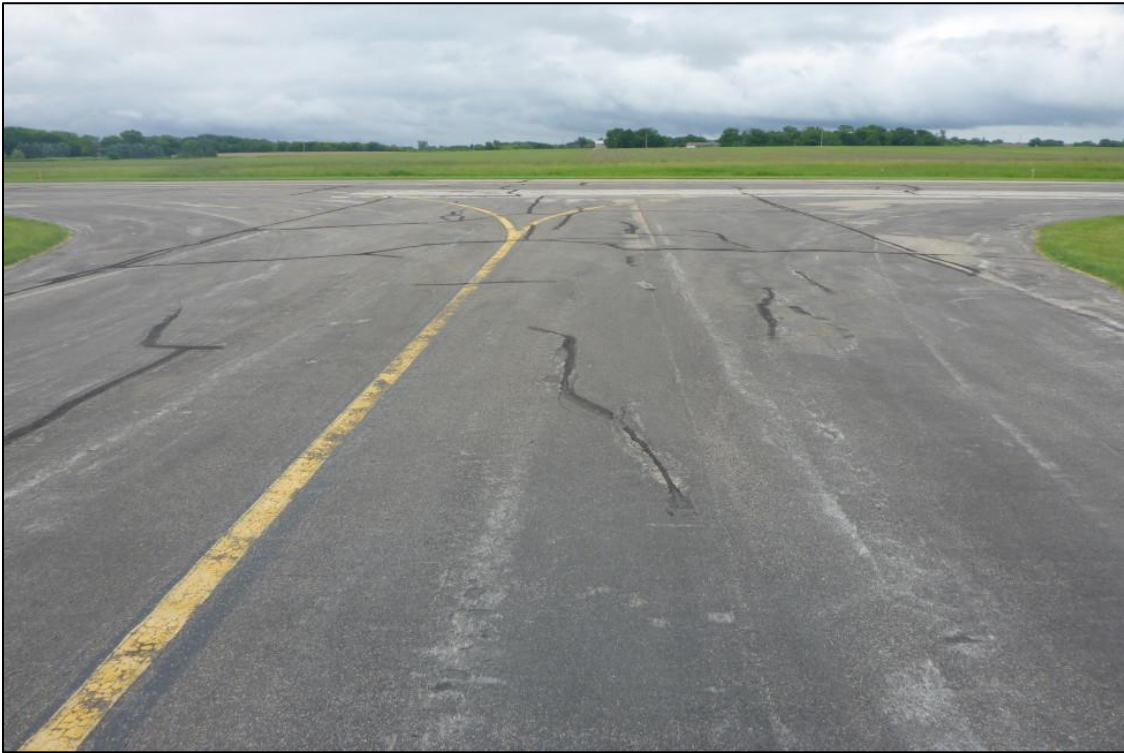
CFE CTA2 001 (PCI = 70)

Network:	CFE	Name:	BUFFALO						
Branch:	CTA2	Name:	CONNECTING TAXIWAY A2	Use:	TAXIWAY	Area:	9,750 SqFt		
Section:	001	of 1	From:	100	To:	101	Last Const.: 8/31/2005		
Surface:	AC	Family:	MN2018 Asphalt Runway- Taxiways	Zone:	E	Category:	3	Rank:	P
Area:	9,750 SqFt	Length:	180 Ft	Width:	40 Ft				
Slabs:		Slab Length:	Ft	Slab Width:	Ft	Joint Length:	Ft		
Shoulder:		Street Type:		Grade:	0	Lanes:	0		
Section Comments:									
Last Insp. Date:	6/11/2019	TotalSamples:	2	Surveyed:	1				
Conditions:	PCI: 70								
Inspection Comments:									
Sample Number:	100	Type:	R	Area:	4000.00 SqFt	PCI:	70		
Sample Comments: p216									
48	L & T CR	L	297.00	Ft					
48	L & T CR	M	150.00	Ft					
57	WEATHERING	M	150.00	SqFt

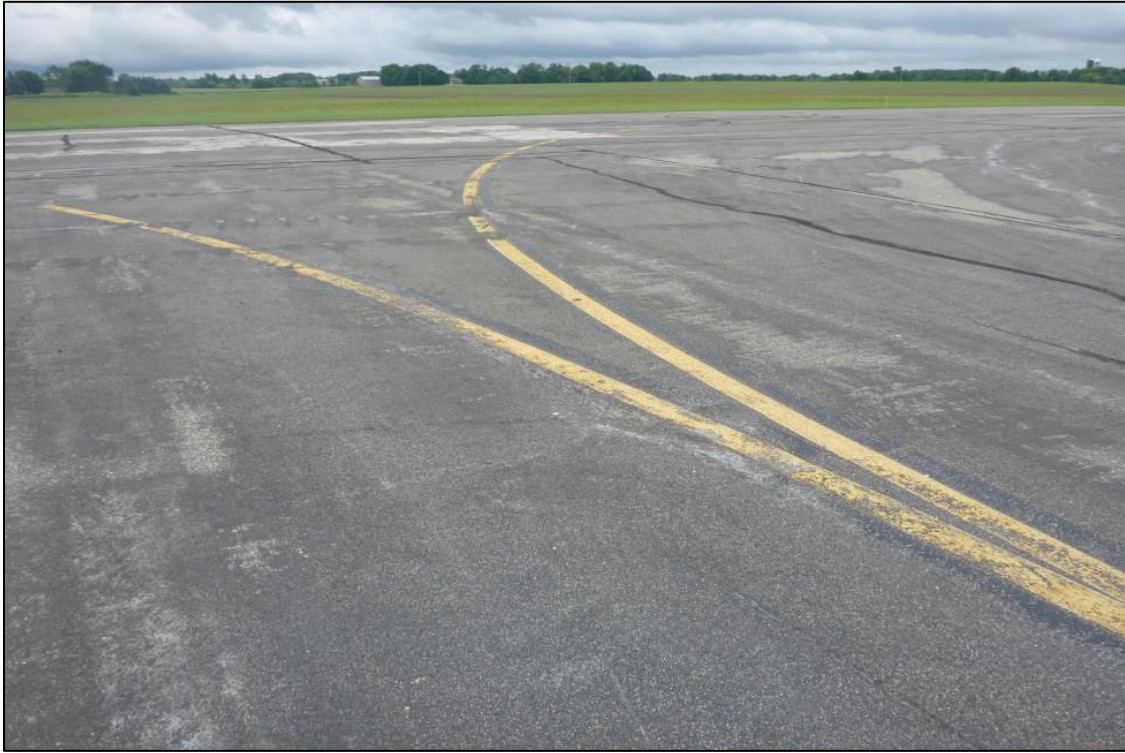
CFE CTA3 001 (PCI = 69)

Conditions: PCI: 69

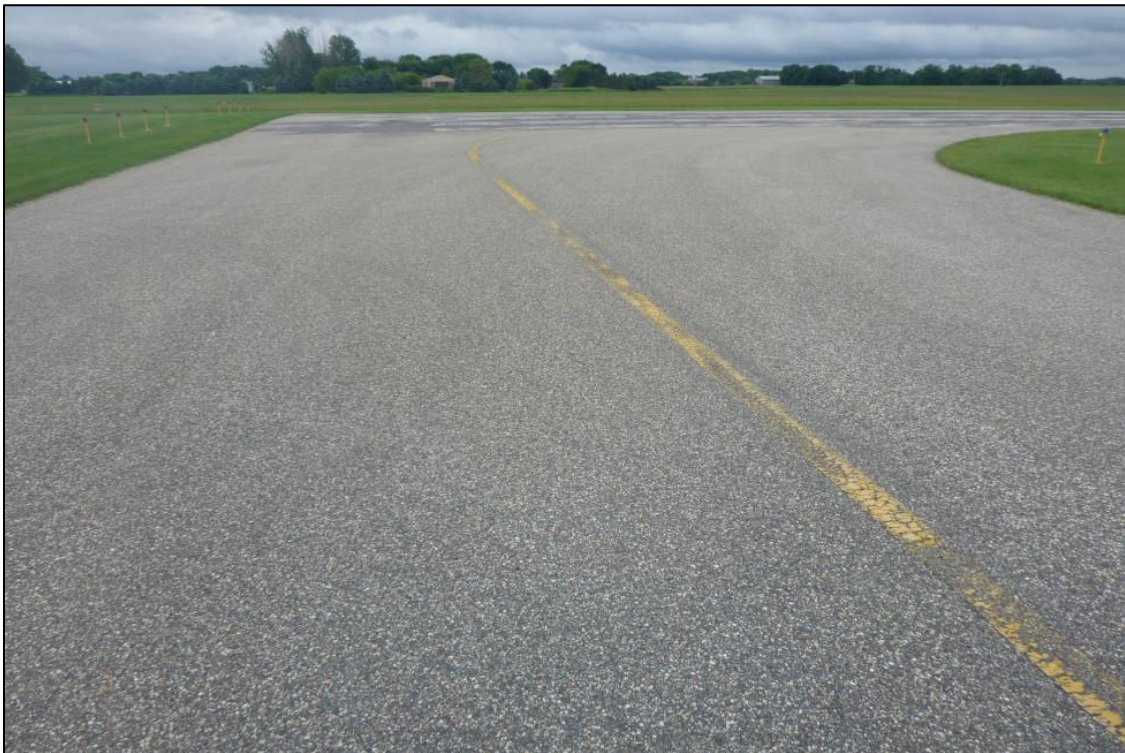
CFE PTA 001 (PCI = 86)

Network:	CFE	Name:	BUFFALO						
Branch:	PTA	Name:	PARALLEL TAXIWAY A	Use:	TAXIWAY	Area:	116,445 SqFt		
Section:	001	of 3	From:	100	To:	104	Last Const.:	9/1/2010	
Surface:	AC	Family:	MN2018 Asphalt Runway- Taxiways	Zone:	E	Category:	3	Rank:	P
Area:	24,095 SqFt	Length:	555 Ft	Width:	40 Ft				
Slabs:		Slab Length:	Ft	Slab Width:	Ft	Joint Length:	Ft		
Shoulder:		Street Type:		Grade:	0	Lanes:	0		
Section Comments:									
Last Insp. Date:	6/11/2019	TotalSamples:	6	Surveyed:	2				
Conditions:	PCI: 86								
Inspection Comments:									
Sample Number:	101	Type:	R	Area:	4000.00 SqFt	PCI:	80		
Sample Comments: p219									
48	L & T CR	L	19.00	Ft					
48	L & T CR	M	25.00	Ft					
57	WEATHERING	L	3850.00	SqFt					
57	WEATHERING	M	150.00	SqFt					
Sample Number:	102	Type:	R	Area:	4000.00 SqFt	PCI:	92		
Sample Comments: p220									
57	WEATHERING	L	3900.00	SqFt					
57	WEATHERING	M	100.00	SqFt

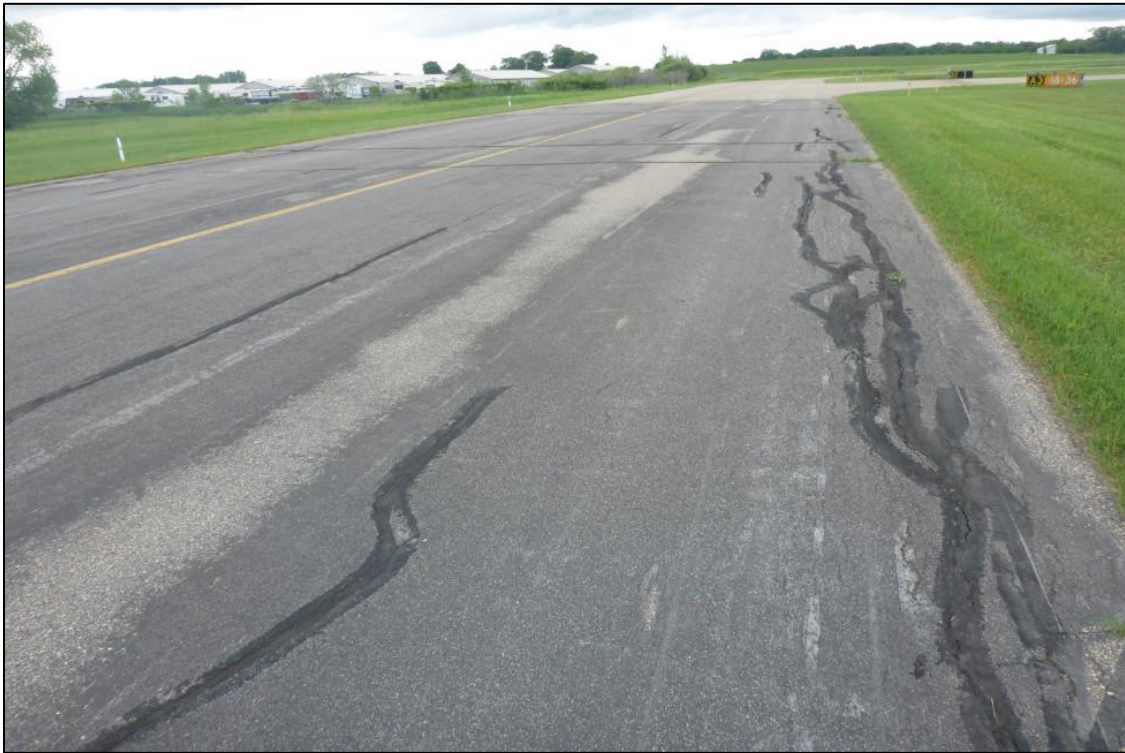
CFE PTA 002 (PCI = 62)

Network:	CFE	Name:	BUFFALO						
Branch:	PTA	Name:	PARALLEL TAXIWAY A	Use:	TAXIWAY	Area:	116,445 SqFt		
Section:	002	of 3	From:	103	To:	109	Last Const.: 8/31/2005		
Surface:	AC	Family:	MN2018 Asphalt Runway- Taxiways	Zone:	E	Category:	3	Rank:	P
Area:	27,600 SqFt	Length:	690 Ft	Width:	40 Ft				
Slabs:		Slab Length:	Ft	Slab Width:	Ft	Joint Length:	Ft		
Shoulder:		Street Type:		Grade:	0	Lanes:	0		
Section Comments:									
Last Insp. Date:	6/11/2019	TotalSamples:	7	Surveyed:	3				
Conditions:	PCI: 62								
Inspection Comments:									
Sample Number:	106	Type:	R	Area:	4000.00 SqFt	PCI:	61		
Sample Comments: p221									
41	ALLIGATOR CR	L	30.00	SqFt					
43	BLOCK CR	M	36.00	SqFt					
48	L & T CR	L	291.00	Ft					
48	L & T CR	M	90.00	Ft					
48	L & T CR	H	8.00	Ft					
Sample Number:	108	Type:	R	Area:	4000.00 SqFt	PCI:	67		
Sample Comments: p222									
41	ALLIGATOR CR	L	12.00	SqFt					
48	L & T CR	L	153.00	Ft

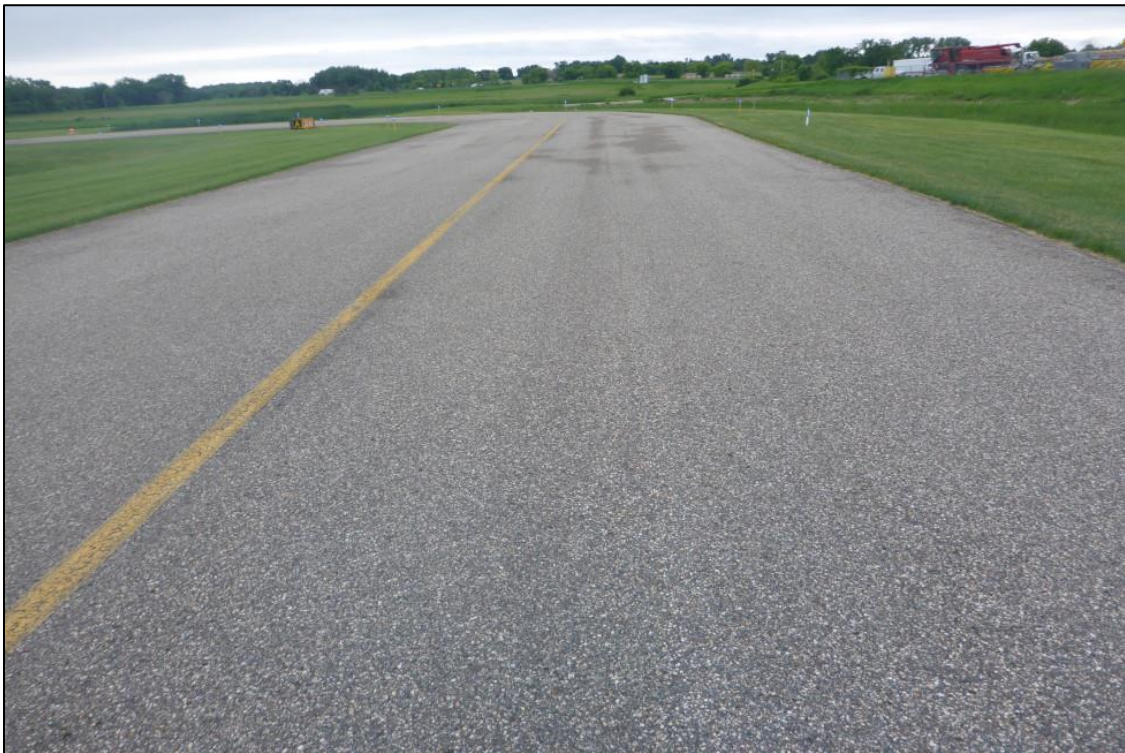
CFE PTA 003 (PCI = 88)

Network:	CFE	Name:	BUFFALO						
Branch:	PTA	Name:	PARALLEL TAXIWAY A	Use:	TAXIWAY	Area:	116,445 SqFt		
Section:	003	of 3	From:	200	To:	217	Last Const.:	9/1/2010	
Surface:	AC	Family:	MN2018 Asphalt Runway- Taxiways	Zone:	E	Category:	3	Rank:	P
Area:	64,750 SqFt	Length:	1,830 Ft	Width:	35 Ft				
Slabs:		Slab Length:	Ft	Slab Width:	Ft	Joint Length:	Ft		
Shoulder:		Street Type:		Grade:	0	Lanes:	0		
Section Comments:									
Last Insp. Date:	6/11/2019	TotalSamples:	18	Surveyed:	4				
Conditions:	PCI: 88								
Inspection Comments:									
Sample Number:	202	Type:	R	Area:	3500.00 SqFt	PCI:	87		
Sample Comments: p212									
48	L & T CR	L	3.00 Ft						
57	WEATHERING	L	3200.00 SqFt						
57	WEATHERING	M	300.00 SqFt						
Sample Number:	206	Type:	R	Area:	3500.00 SqFt	PCI:	90		
Sample Comments:									
57	WEATHERING	L	3300.00 SqFt						
57	WEATHERING	M	200.00 SqFt						
Sample Number:	210	Type:	R	Area:	3500.00 SqFt	PCI:	88

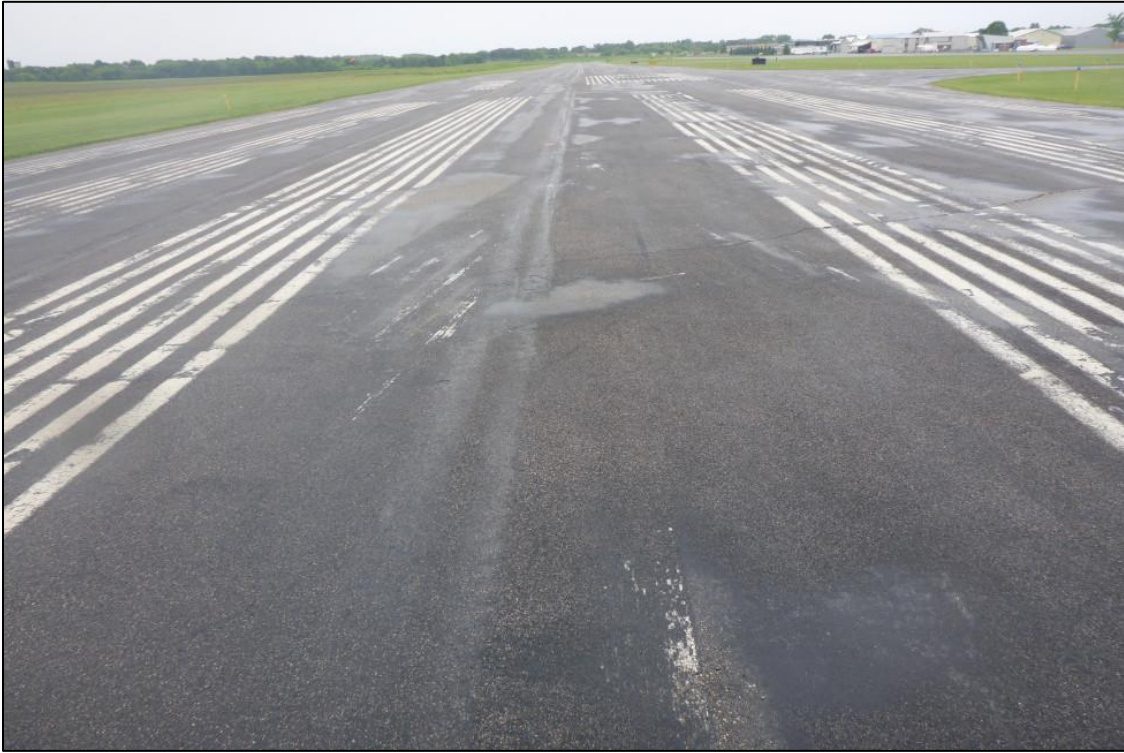
CFE RY1836 001 (PCI = 90)

Network:	CFE	Name:	BUFFALO						
Branch:	RY1836	Name:	RUNWAY 18-36	Use:	RUNWAY	Area:	240,000 SqFt		
Section:	001	of 4	From:	96	To:	99	Last Const.:	9/1/2010	
Surface:	AC	Family:	MN2018 Asphalt Runway- Taxiways	Zone:	E	Category:	3	Rank:	P
Area:	16,500 SqFt	Length:	220 Ft	Width:	75 Ft				
Slabs:		Slab Length:	Ft	Slab Width:	Ft	Joint Length:	Ft		
Shoulder:		Street Type:		Grade:	0	Lanes:	0		
Section Comments:									
Last Insp. Date:	6/11/2019	TotalSamples:	4	Surveyed:	2				
Conditions:	PCI: 90								
Inspection Comments:									
Sample Number:	97	Type:	R	Area:	3750.00 SqFt	PCI:	87		
Sample Comments:	p201 202 old ms								
48	L & T CR	L	73.00 Ft						
48	L & T CR	M	17.00 Ft						
Sample Number:	98	Type:	R	Area:	3750.00 SqFt	PCI:	94		
Sample Comments:									
48	L & T CR	M	11.00 Ft

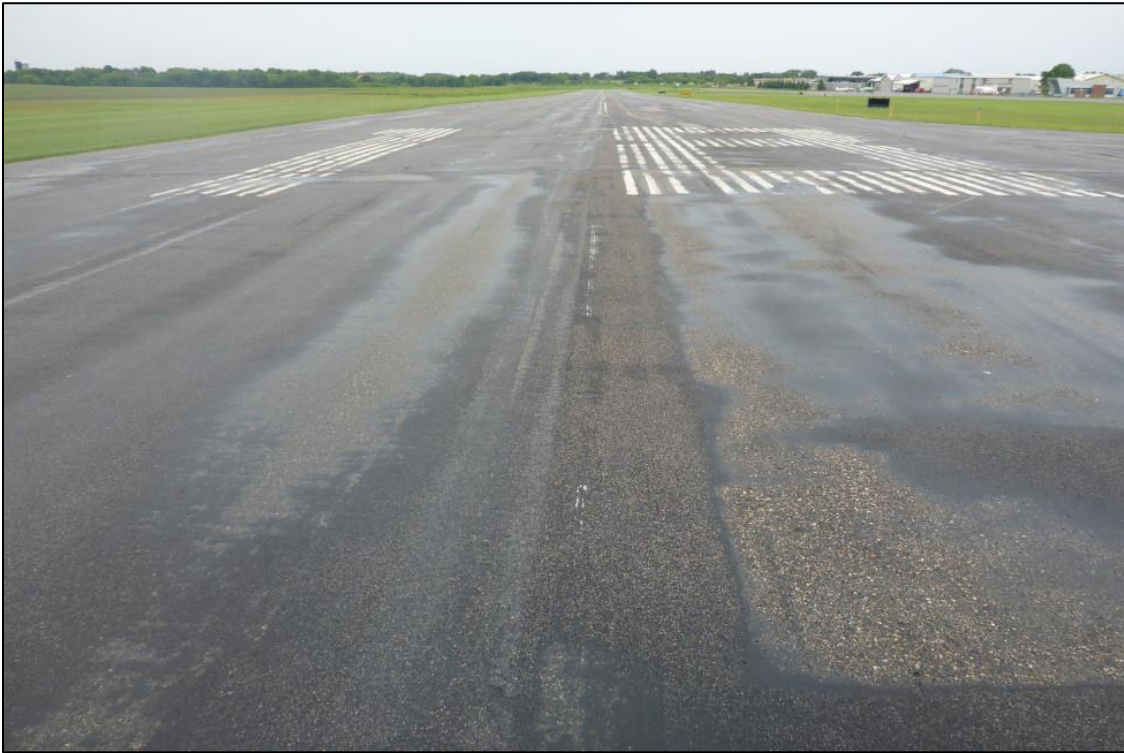
CFE RY1836 002 (PCI = 70)

Network:	CFE	Name:	BUFFALO						
Branch:	RY1836	Name:	RUNWAY 18-36	Use:	RUNWAY	Area:	240,000 SqFt		
Section:	002	of 4	From:	100	To:	151	Last Const.:	8/31/2005	
Surface:	AC	Family:	MN2018 Asphalt Runway- Taxiways	Zone:	E	Category:	3	Rank:	P
Area:	156,000 SqFt	Length:	2,600 Ft	Width:	60 Ft				
Slabs:		Slab Length:	Ft	Slab Width:	Ft	Joint Length:	Ft		
Shoulder:		Street Type:		Grade:	0	Lanes:	0		
Section Comments:									
Last Insp. Date:	6/11/2019	TotalSamples:	52	Surveyed:	6				
Conditions:	PCI: 70								
Inspection Comments:									
Sample Number:	106	Type:	R	Area:	3000.00 SqFt	PCI:	77		
Sample Comments:	p203 nbrs								
48	L & T CR	L	205.00	Ft					
48	L & T CR	M	52.00	Ft					
Sample Number:	114	Type:	R	Area:	3000.00 SqFt	PCI:	67		
Sample Comments:									
48	L & T CR	L	144.00	Ft					
48	L & T CR	M	116.00	Ft					
48	L & T CR	H	4.00	Ft					
57	WEATHERING	L	150.00	SqFt					
Sample Number:	122	Type:	R	Area:	3000.00 SqFt	PCI:	68

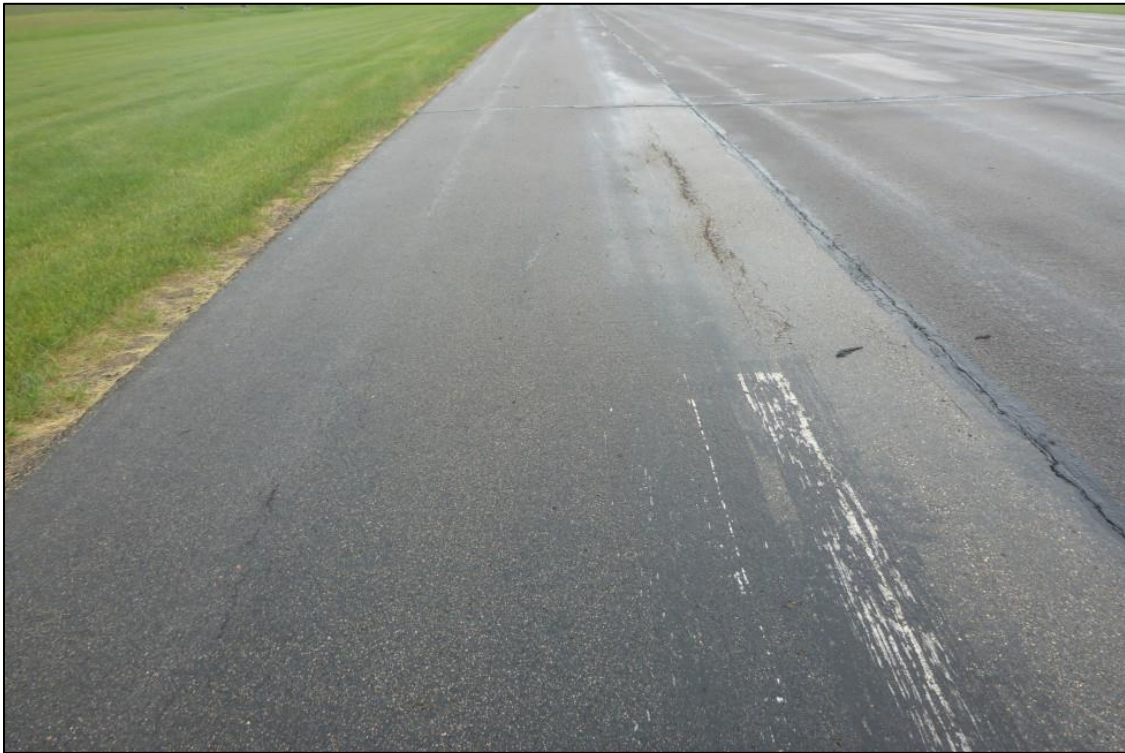
CFE RY1836 003 (PCI = 76)

Network:	CFE	Name:	BUFFALO						
Branch:	RY1836	Name:	RUNWAY 18-36	Use:	RUNWAY	Area:	240,000 SqFt		
Section:	003	of 4	From:	-	To:	-	Last Const.: 9/1/2010		
Surface:	AC	Family:	MN2018 Asphalt Runway- Taxiways	Zone:	E	Category:	3	Rank:	P
Area:	39,000 SqFt	Length:	2,600 Ft	Width:	15 Ft				
Slabs:		Slab Length:	Ft	Slab Width:	Ft	Joint Length:	Ft		
Shoulder:		Street Type:		Grade:	0	Lanes:	0		
Section Comments:									
Last Insp. Date:	6/11/2019	TotalSamples:	9	Surveyed:	3				
Conditions:	PCI: 76								
Inspection Comments:									
Sample Number:	201	Type:	R	Area:	4500.00 SqFt	PCI:	79		
Sample Comments: p204									
48	L & T CR	L	211.00	Ft					
48	L & T CR	M	22.00	Ft					
57	WEATHERING	L	400.00	SqFt					
Sample Number:	204	Type:	R	Area:	4500.00 SqFt	PCI:	74		
Sample Comments: p206									
48	L & T CR	L	227.00	Ft					
48	L & T CR	M	94.00	Ft					
56	SWELLING	L	48.00	SqFt					
57	WEATHERING	L	400.00	SqFt					
Sample Number:	207	Type:	R	Area:	4500.00 SqFt	PCI:	75

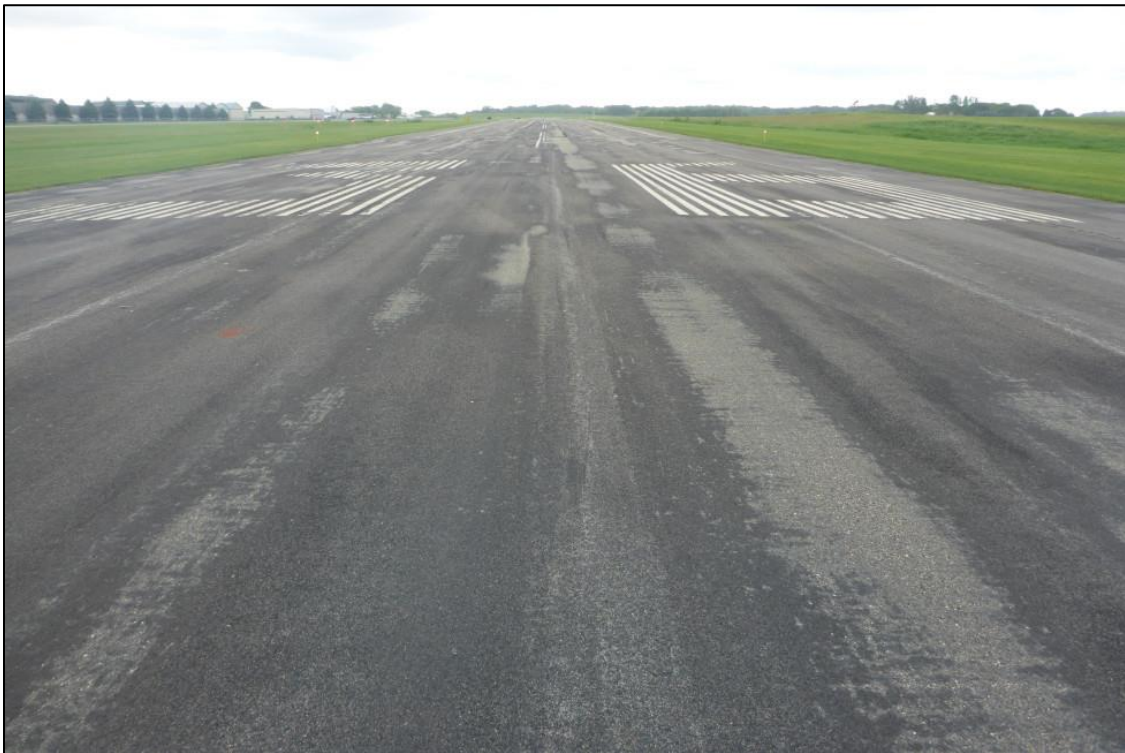
CFE RY1836 004 (PCI = 93)

Network:	CFE	Name:	BUFFALO						
Branch:	RY1836	Name:	RUNWAY 18-36	Use:	RUNWAY	Area:	240,000 SqFt		
Section:	004	of 4	From:	152	To:	159	Last Const.:	9/1/2010	
Surface:	AC	Family:	MN2018 Asphalt Runway- Taxiways	Zone:	E	Category:	3	Rank:	P
Area:	28,500 SqFt	Length:	380 Ft	Width:	75 Ft				
Slabs:		Slab Length:	Ft	Slab Width:	Ft	Joint Length:	Ft		
Shoulder:		Street Type:		Grade:	0	Lanes:	0		
Section Comments:									
Last Insp. Date:	6/11/2019	TotalSamples:	8	Surveyed:	3				
Conditions:	PCI: 93								
Inspection Comments:									
Sample Number:	153	Type:	R	Area:	3750.00 SqFt	PCI:	98		
Sample Comments:									
52	RAVELING	L	5.00	SqFt					
57	WEATHERING	L	250.00	SqFt					
Sample Number:	155	Type:	R	Area:	3750.00 SqFt	PCI:	97		
Sample Comments:									
48	L & T CR	L	10.00	Ft					
Sample Number:	157	Type:	R	Area:	3750.00 SqFt	PCI:	84		
Sample Comments: p208 p209 number									
48	L & T CR	M	75.00	Ft					
57	WEATHERING	L	50.00	SqFt

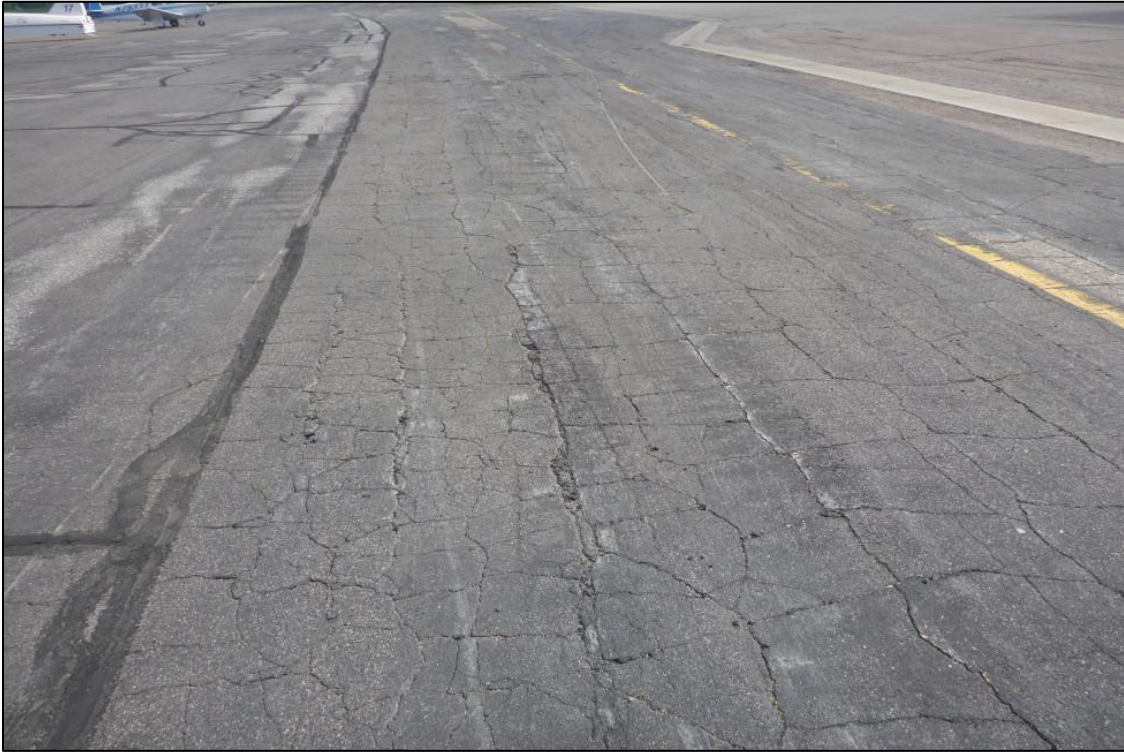
CFE TLA 001 (PCI = 16)

⁶Higher than expected deterioration rate for TLA-001, TLA-002, and TLB-002 are due to the development of severe Alligator cracking in significant quantities.

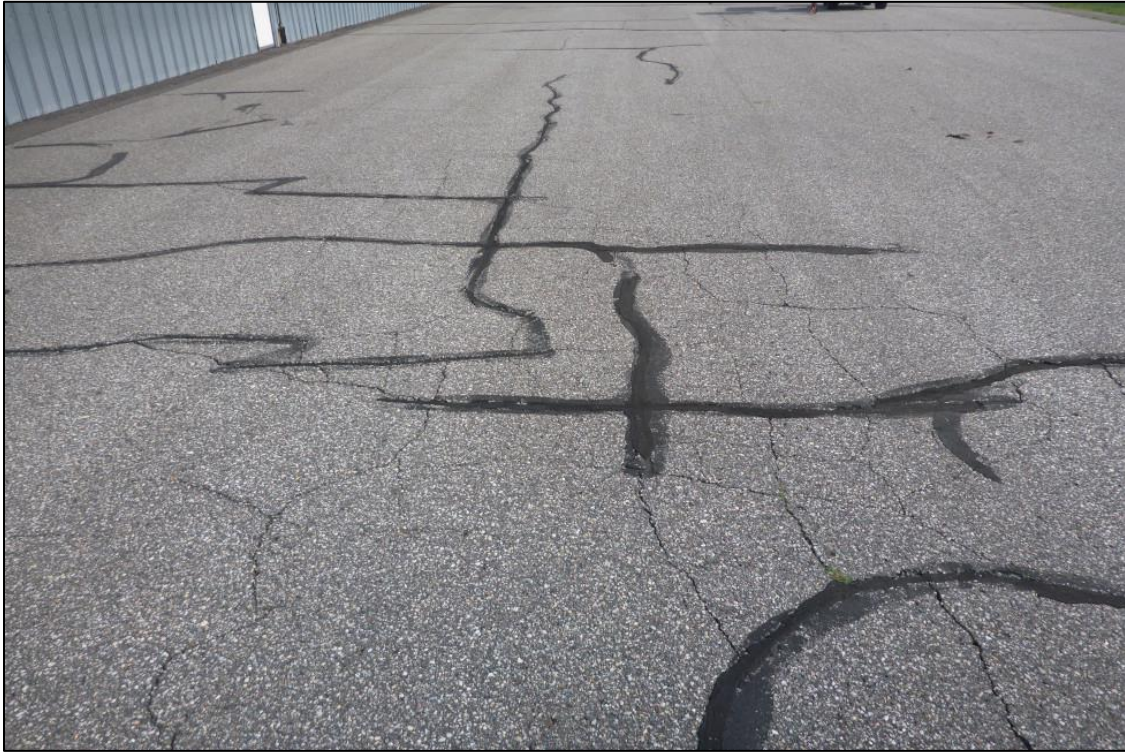
CFE TLA 003 (PCI = 57)

Conditions: PCI: 57
