Pavement Condition Report

Jackson Municipal Airport (MJQ)

December 2019

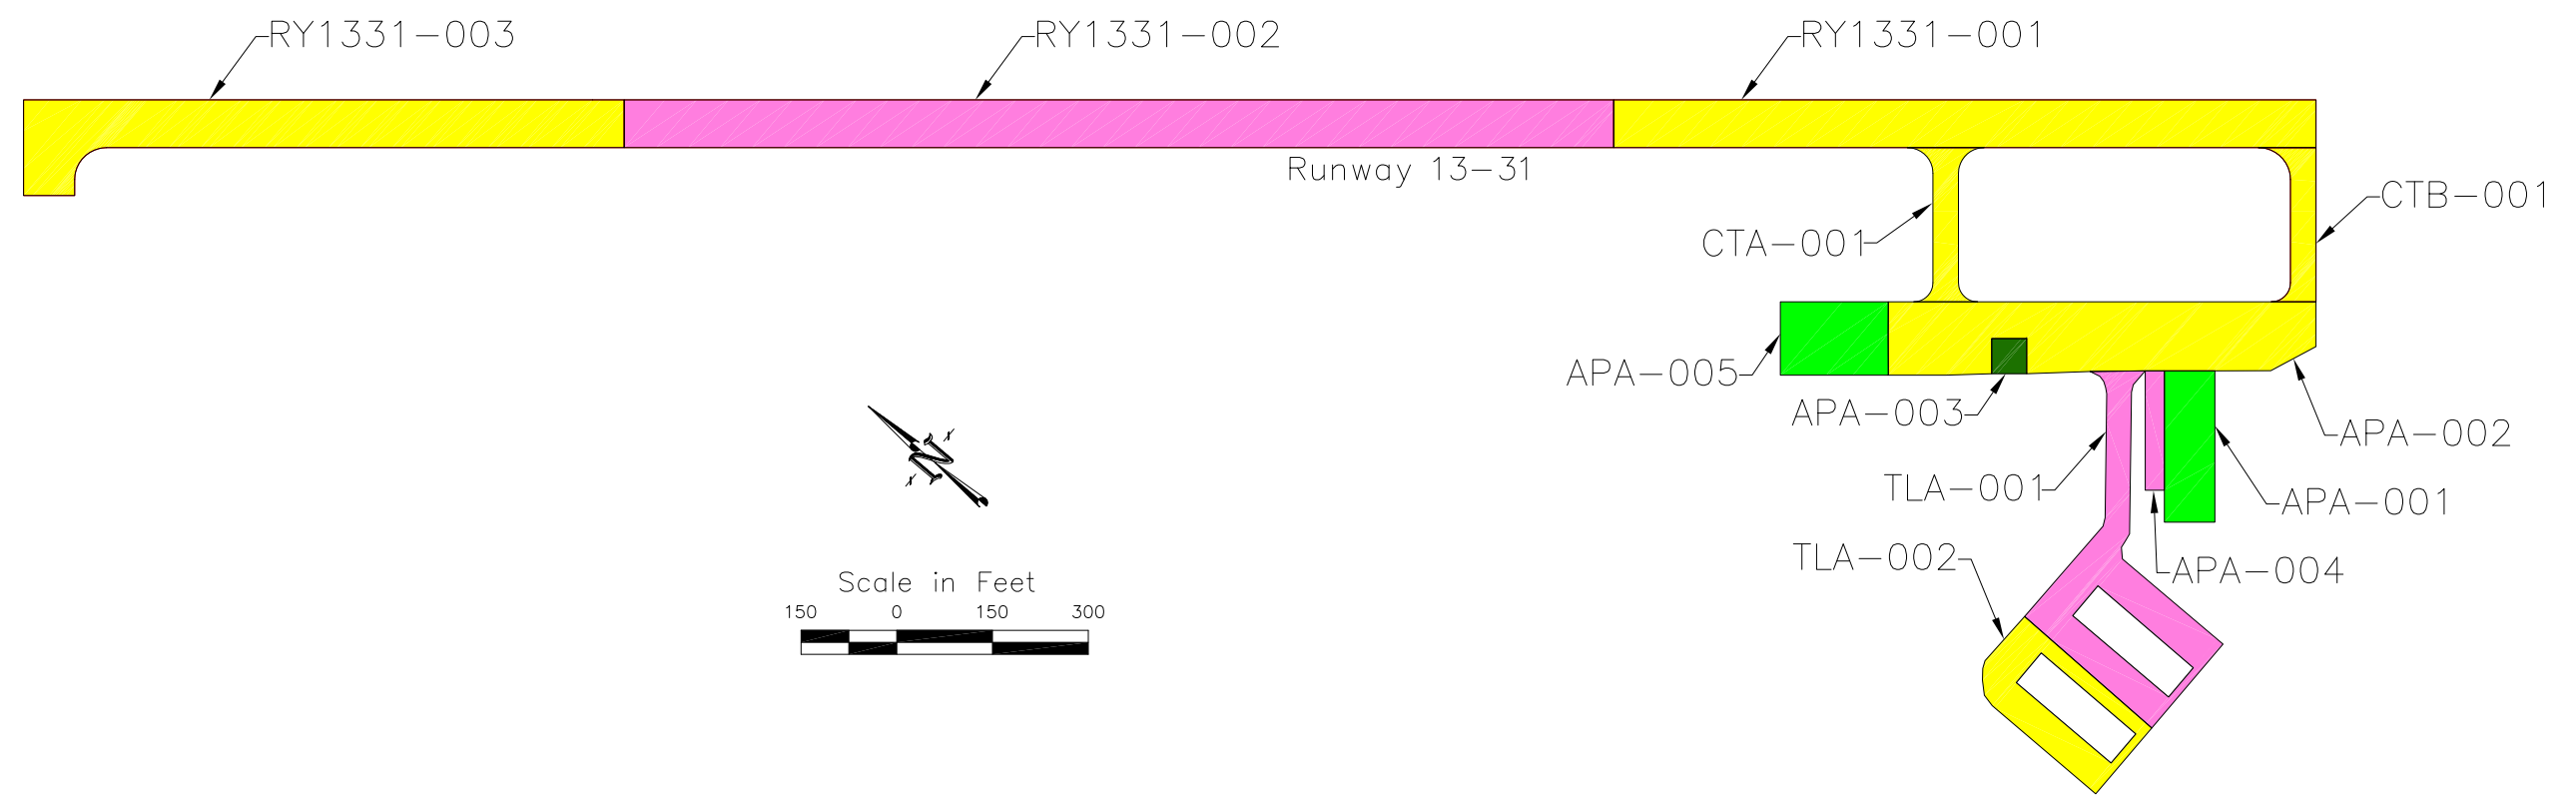
Figure 4. 2019 Pavement Condition Index Rating at Jackson Municipal Airport (MJQ).

Branch ID	Section ID	Surface type ¹	Section area (SF)	LCD ²	2016 PCI	2019 PCI	Drop in PCI/Yr ³	% Deduct due to		Distress types
								Load ⁴	Climate ⁵	
APA	001	AC	18,468	2001	72	72	1.6	-	100	L&T cr, Weathering
APA	002	AC	70,847	1995	67	68	1.3	-	100	L&T cr, Weathering
APA	003	PCC	3,025	1995	98	93	0.3	-	100	Joint seal damage
APA	004	AC	5,400	2001	64	46	3.0	53	44	Alligator cr, L&T cr, swell, Weathering
APA	005	AC	18,928	2011	93	81	2.4	-	100	L&T cr, Weathering
CTA	001	AC	10,550	1995	66	65	1.5	-	100	L&T cr, Weathering
CTB	001	AC	9,872	1995	61	56	1.8	-	100	L&T cr, Weathering
RY1331	001	AC	82,500	1995	61	58	1.8	29	71	Alligator cr, L&T cr, Weathering
RY1331	002	AC	116,250	1995	61	55	1.9	49	51	Alligator cr, L&T cr
RY1331	003	AC	76,835	1995	64	58	1.8	29	71	Alligator cr, L&T cr
TLA	001	AC	44,450	2000	62	55	2.4	38	60	Alligator cr, L&T cr, swell, Weathering
TLA	002	AC	24,010	2001	75	62	2.1	-	100	L&T cr

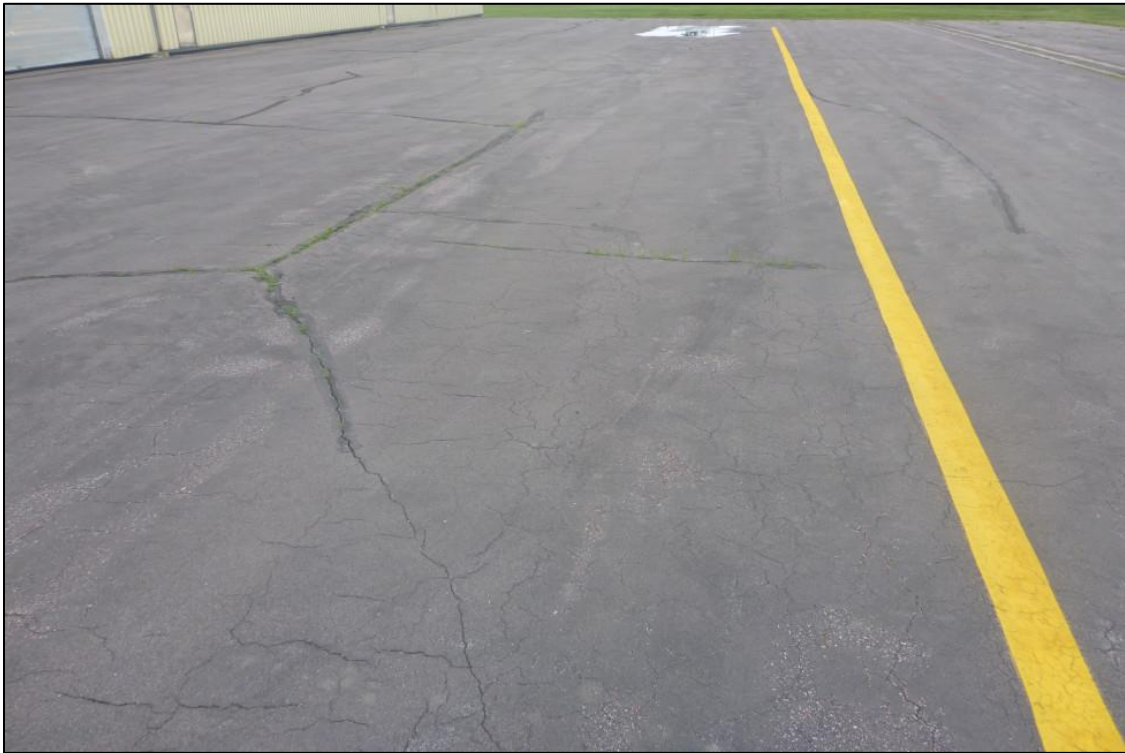
MJQ APA 001 (PCI = 72)

Conditions: PCI: 72

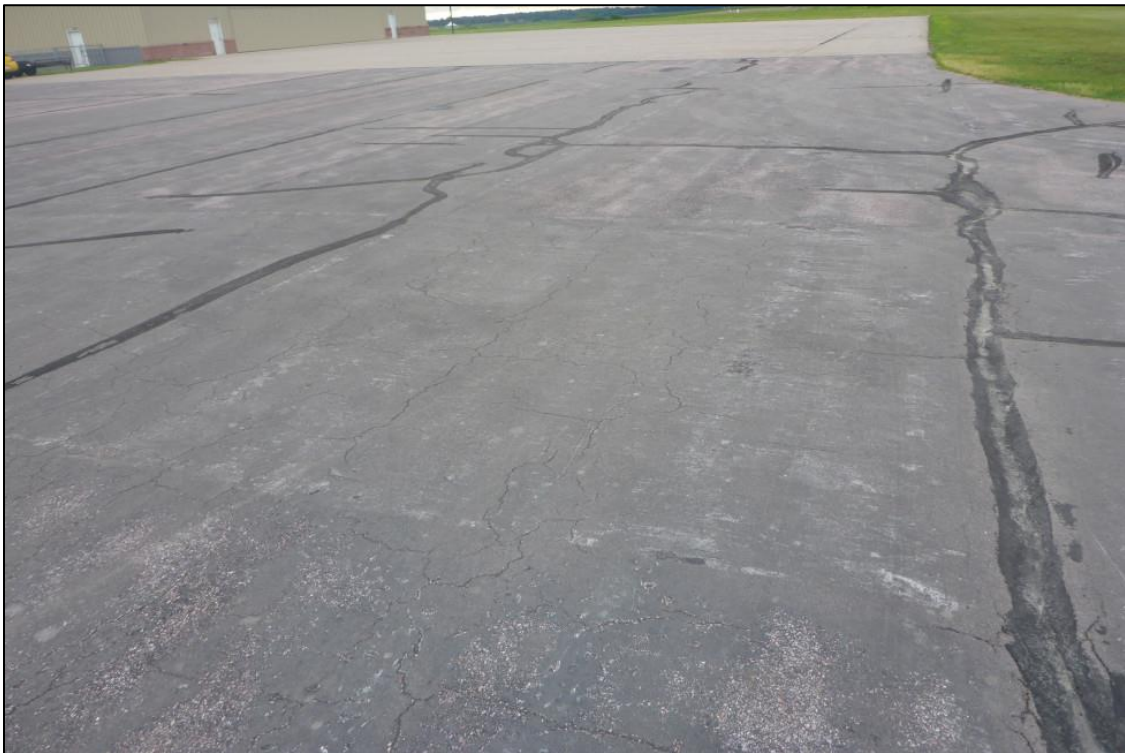
MJQ APA 002 (PCI = 68)

Network:	MIQ		Name:	JACKSON					
Branch:	APA	Name:	APRON A	Use:	APRON	Area:	116,668 SqFt		
Section:	002	of 5	From:	200	To:	306	Last Const.:	9/30/1995	
Surface:	AC	Family:	MN2018 Asphalt Aprons	Zone:	S	Category:	3	Rank:	S
Area:	70,847 SqFt	Length:	684 Ft	Width:	108 Ft				
Slabs:	Slab Length:	Ft	Slab Width:	Ft	Joint Length:	Ft			
Shoulder:	Street Type:	Grade:	0	Lanes:	0				
Section Comments:									
Last Insp. Date:	6/11/2019	TotalSamples:	14	Surveyed:	4				
Conditions:	PCI: 68								
Inspection Comments:									
Sample Number:	203	Type:	R	Area:	5800.00 SqFt	PCI:	68		
Sample Comments:									
48	L & T CR	L	545.00	Ft					
48	L & T CR	M	13.00	Ft					
57	WEATHERING	L	5800.00	SqFt					
Sample Number:	300	Type:	R	Area:	5000.00 SqFt	PCI:	72		
Sample Comments: p 392 nww cs									
48	L & T CR	L	332.00	Ft					
48	L & T CR	M	32.00	Ft					
57	WEATHERING	L	5000.00	SqFt					
Sample Number:	301	Type:	R	Area:	5000.00 SqFt	PCI:	69

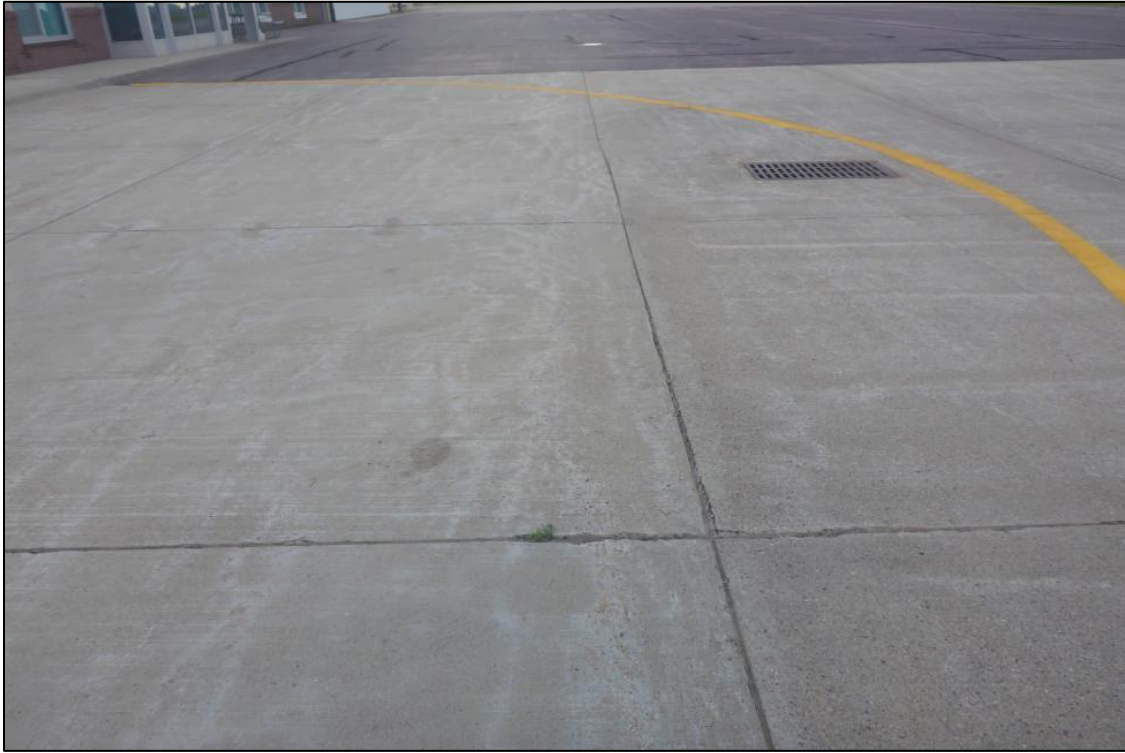
MJQ APA 003 (PCI = 93)

Network:	MJQ	Name:	JACKSON						
Branch:	APA	Name:	APRON A	Use:	APRON	Area:	116,668 SqFt		
Section:	003	of 5	From:	400	To:	400	Last Const.:	9/30/1995	
Surface:	PCC	Family:	MN2018 PCC	Zone:	S	Category:	3	Rank:	S
Area:	3,025 SqFt	Length:	55 Ft	Width:	55 Ft				
Slabs:	25	Slab Length:	11 Ft	Slab Width:	11 Ft	Joint Length:	440 Ft		
Shoulder:		Street Type:		Grade:	0	Lanes:	0		
Section Comments:									
Last Insp. Date:	6/11/2019	TotalSamples:	1	Surveyed:	1				
Conditions:	PCI: 93								
Inspection Comments:									
Sample Number:	400	Type:	R	Area:	25.00 Slabs	PCI:	93		
Sample Comments:	p 395								
65	JT SEAL DMG	M	25.00	Slabs

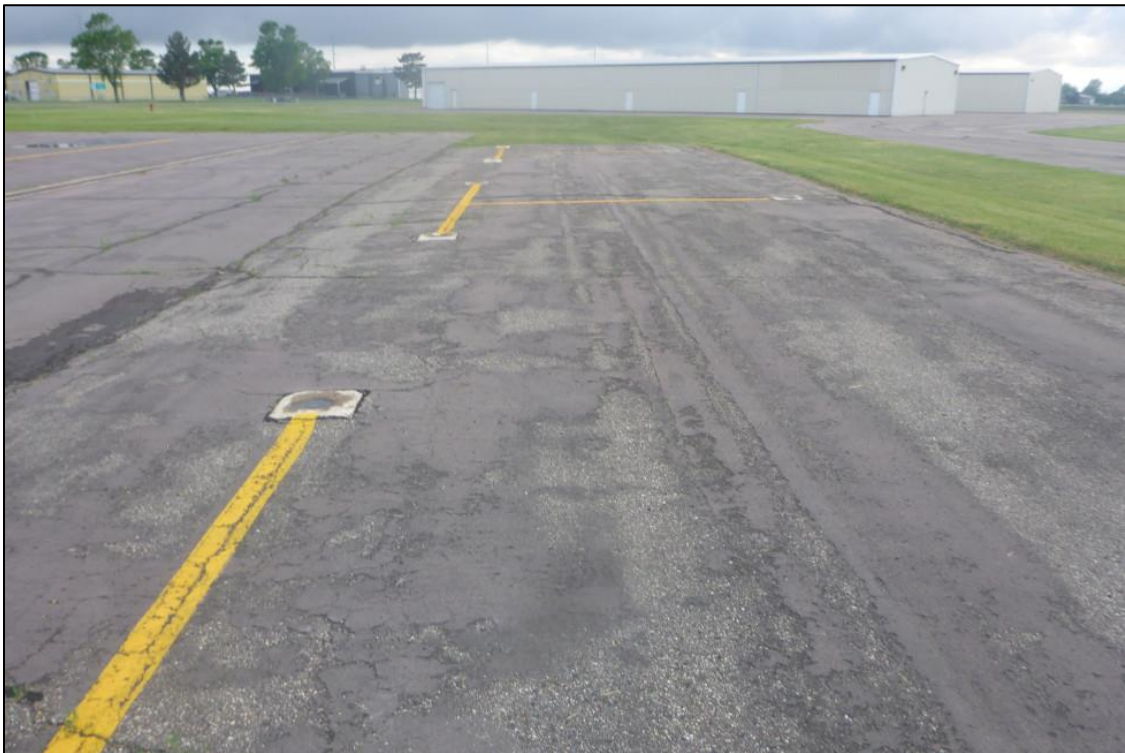
MJQ APA 004 (PCI = 46)

Conditions: PCI: 46

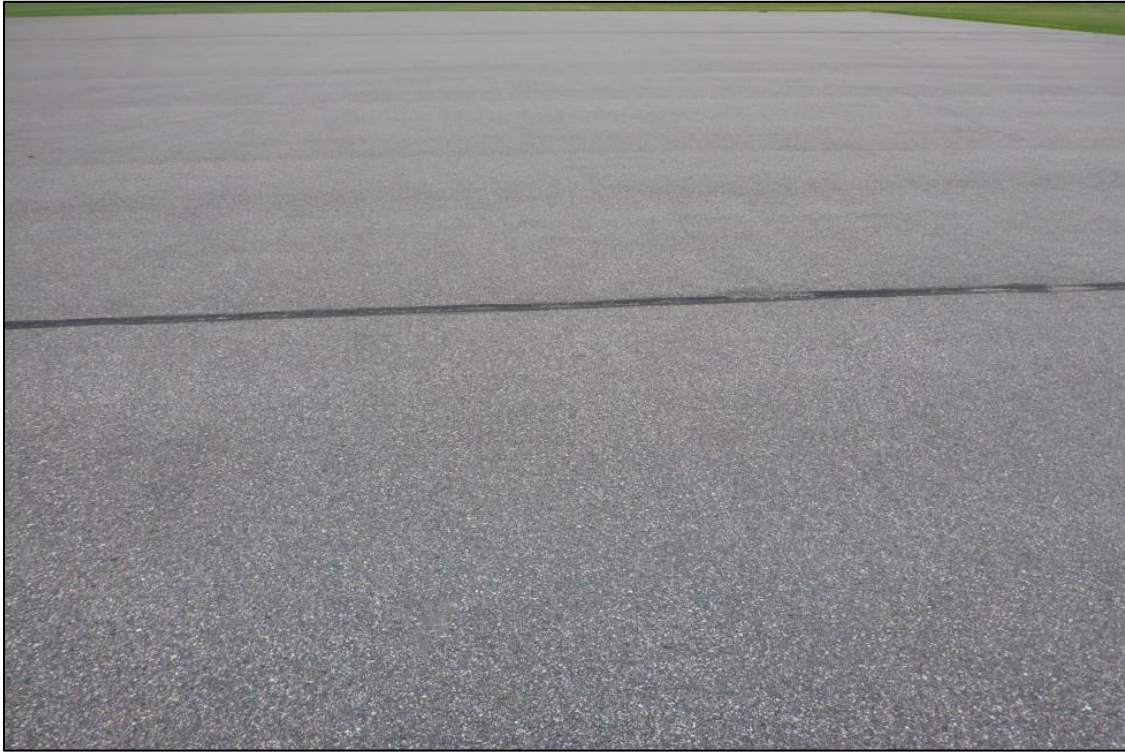
MJQ APA 005 (PCI = 81)

Network:	MJQ	Name:	JACKSON				
Branch:	APA	Name:	APRON A	Use:	APRON	Area:	116,668 SqFt
Section:	005	of 5	From:	-	To:	-	Last Const.: 6/1/2011
Surface:	AC	Family:	MN2018 Asphalt Aprons	Zone:		Category:	Rank: S
Area:	18,928 SqFt	Length:	169 Ft	Width:	112 Ft		
Slabs:		Slab Length:	Ft	Slab Width:	Ft	Joint Length:	Ft
Shoulder:		Street Type:		Grade:	0	Lanes:	0
Section Comments:							
Last Insp. Date:	6/11/2019	TotalSamples:	4	Surveyed:	1		
Conditions:	PCI: 81						
Inspection Comments:							
Sample Number:	500	Type:	R	Area:	5000.00 SqFt	PCI:	81
Sample Comments: p 391							
48	L & T CR	L	258.00	Ft			
57	WEATHERING	L	2000.00	SqFt

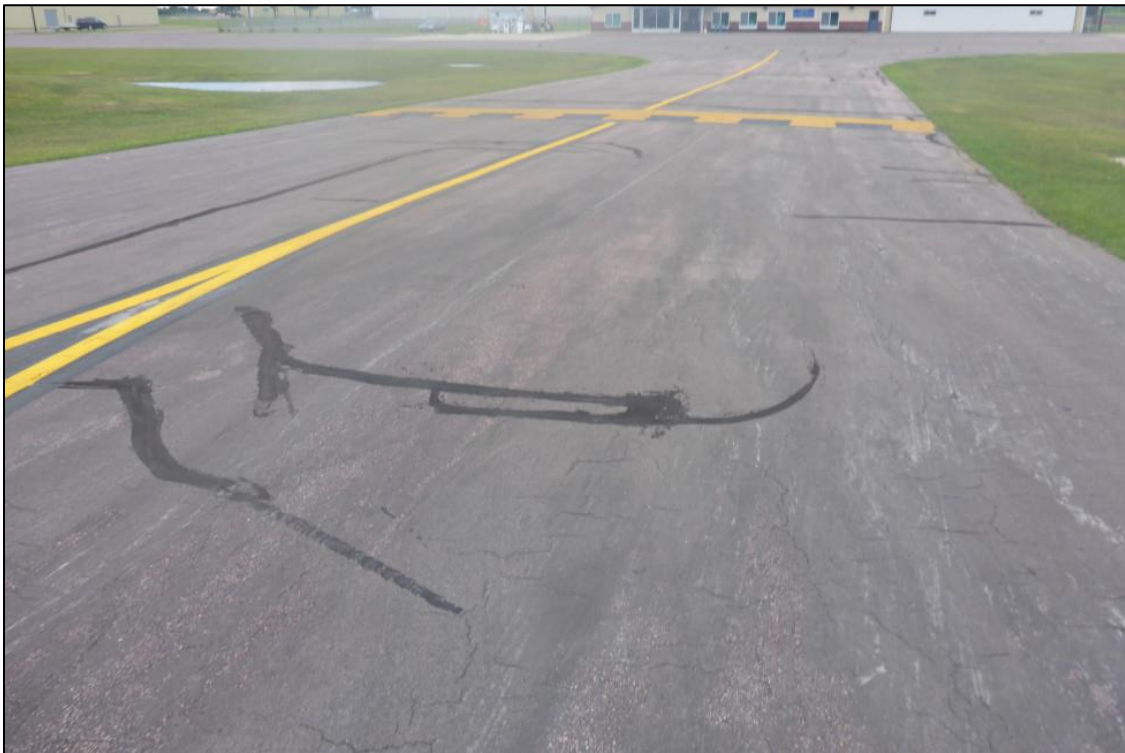
MJQ CTA 001 (PCI = 65)

Conditions: PCI: 65

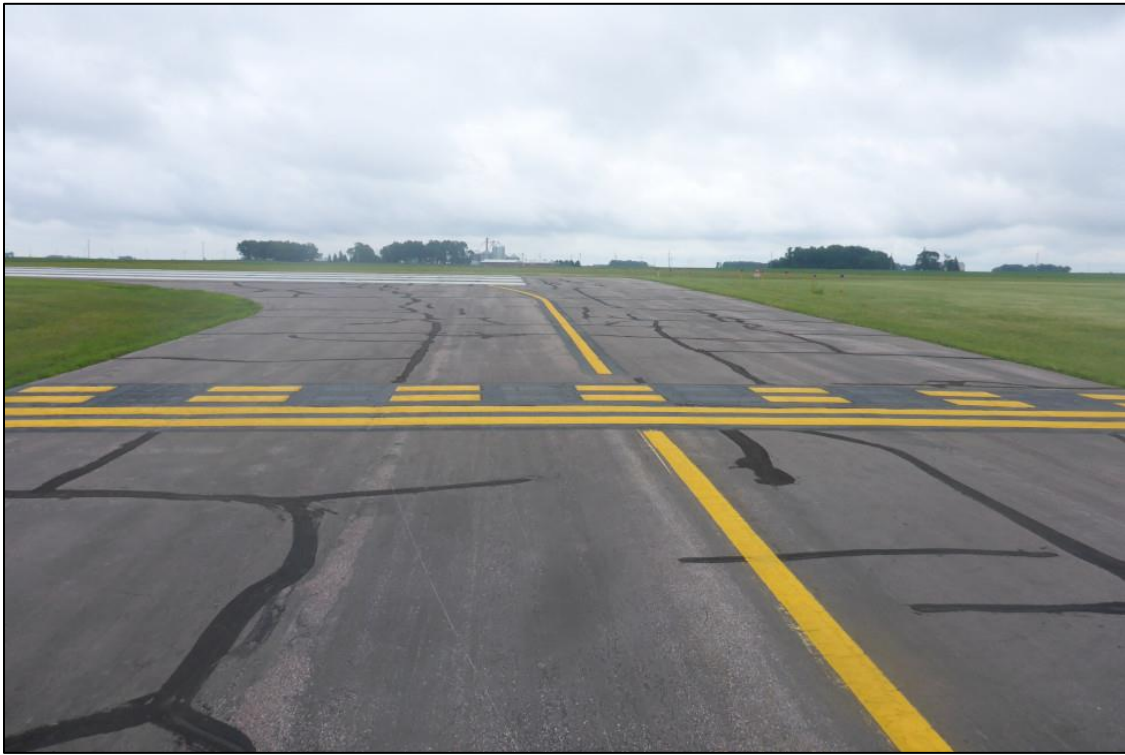
MJQ CTB 001 (PCI = 56)

Conditions: PCI: 56

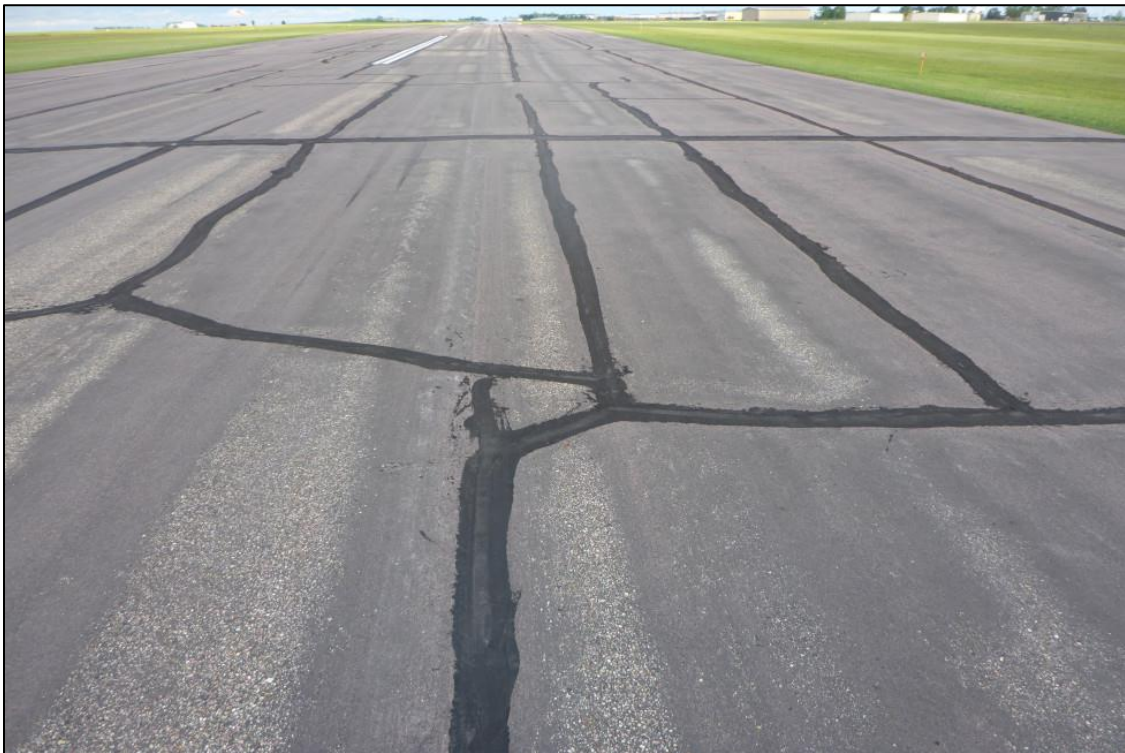
MJQ RY1331 001 (PCI = 58)

Conditions: PCI: 58

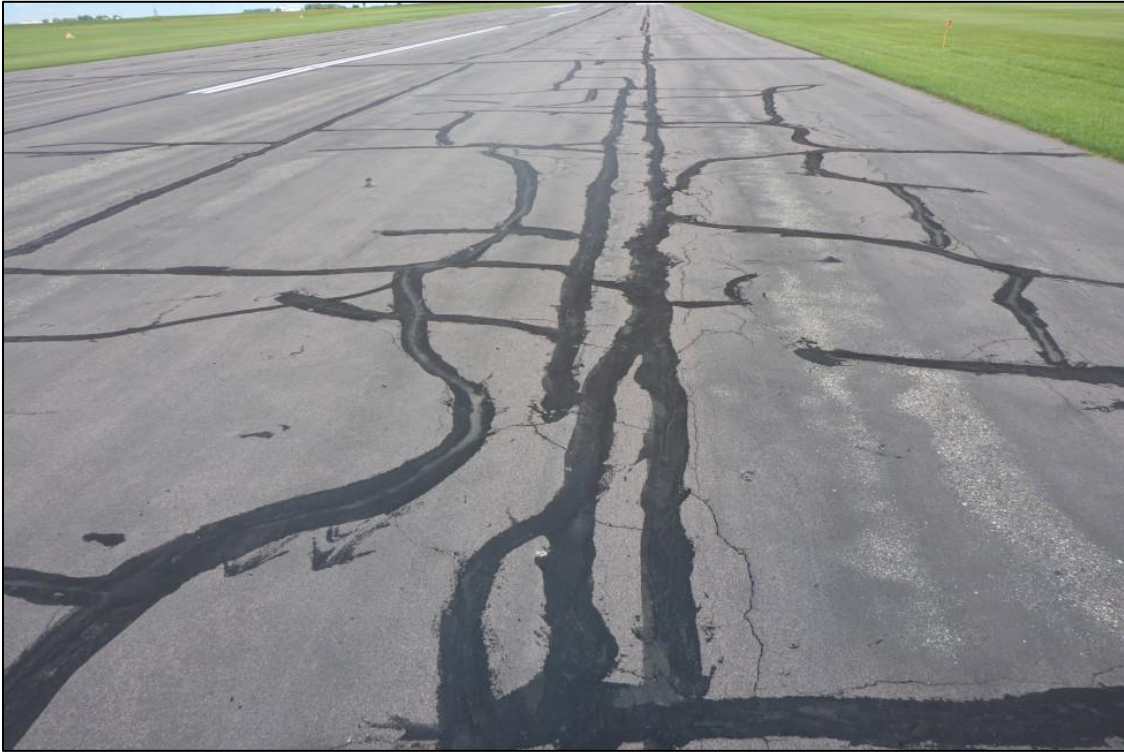
MJQ RY1331 002 (PCI = 55)

Conditions: PCI: 55

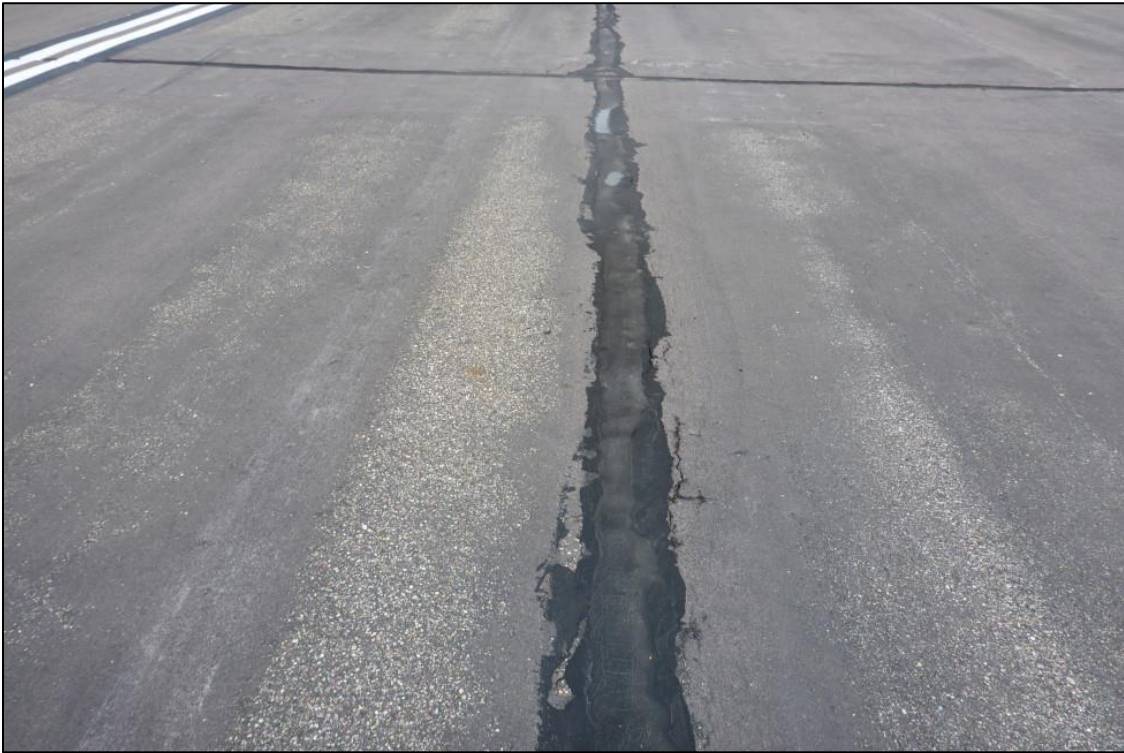
MJQ RY1331 003 (PCI = 58)

Conditions: PCI: 58

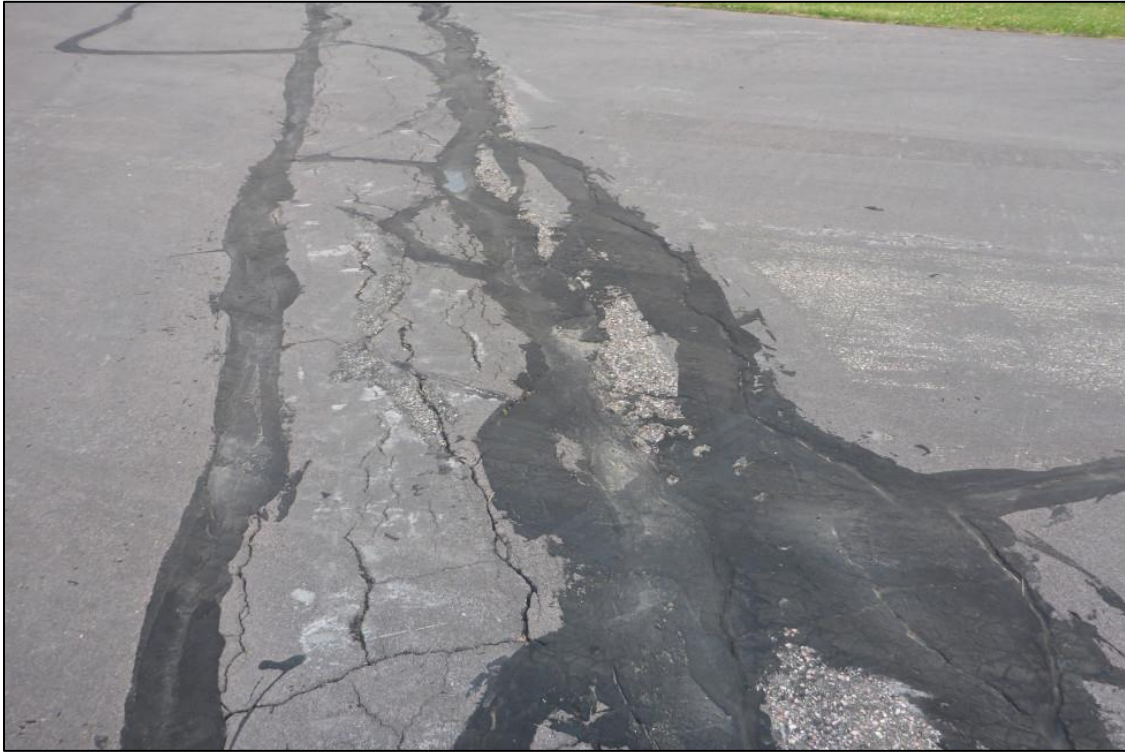
MJQ TLA 001 (PCI = 55)

Conditions: PCI: 55

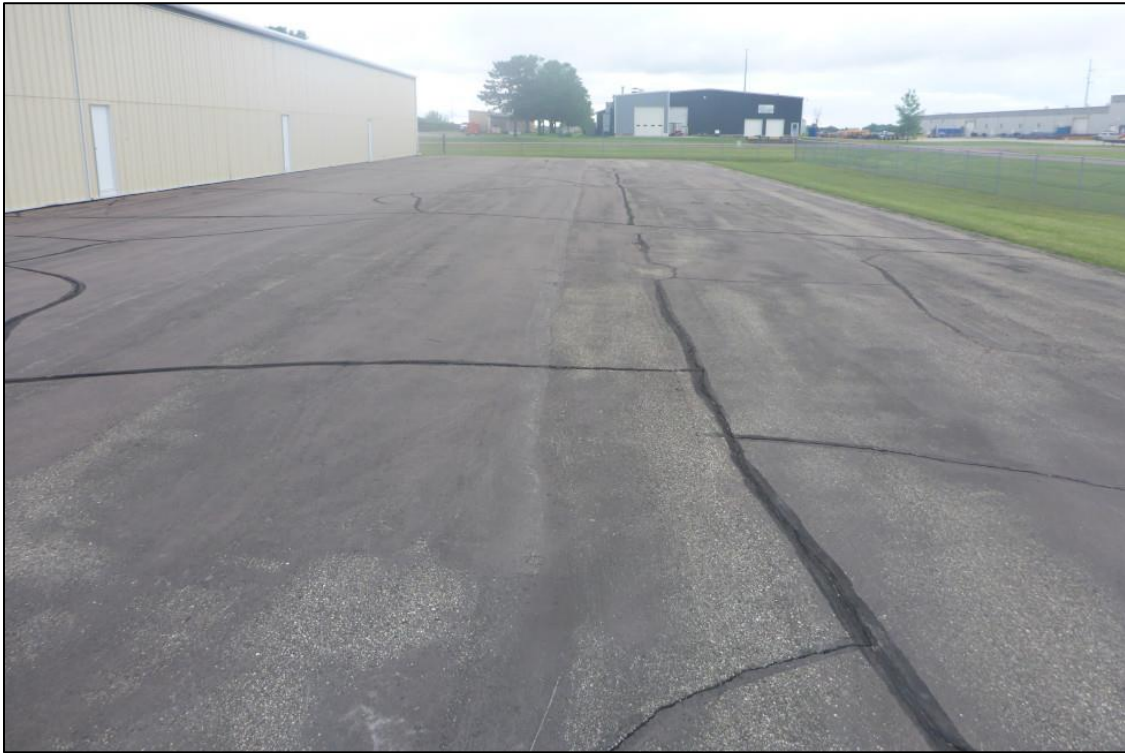
MJQ TLA 002 (PCI = 62)

Network:	MJQ	Name:	JACKSON						
Branch:	TLA	Name:	TAXILANE A	Use:	TAXILANE	Area:	68,460 SqFt		
Section:	002	of 2	From:	200	To:	202	Last Const.:	9/30/2001	
Surface:	AC	Family:	MN2018 Asphalt Taxilanes	Zone:	S	Category:	3	Rank:	T
Area:	24,010 SqFt	Length:	310 Ft	Width:	40 Ft				
Slabs:	Slab Length:	Ft	Slab Width:	Ft	Joint Length:	Ft			
Shoulder:	Street Type:	Grade:	0	Lanes:	0				
Section Comments:									
Last Insp. Date:	6/11/2019	TotalSamples:	4	Surveyed:	1				
Conditions:	PCI: 62								
Inspection Comments:									
Sample Number:	201	Type:	R	Area:	5000.00 SqFt	PCI:	62		
Sample Comments:	crack seal failing in most of su p939,940								
48	L & T CR	L	248.00	Ft					
48	L & T CR	M	405.00	Ft
