# Minnesota Airport System Pavement Evaluation 2010 Update

Tower Municipal Airport (12D)

Tower, Minnesota

December 2010

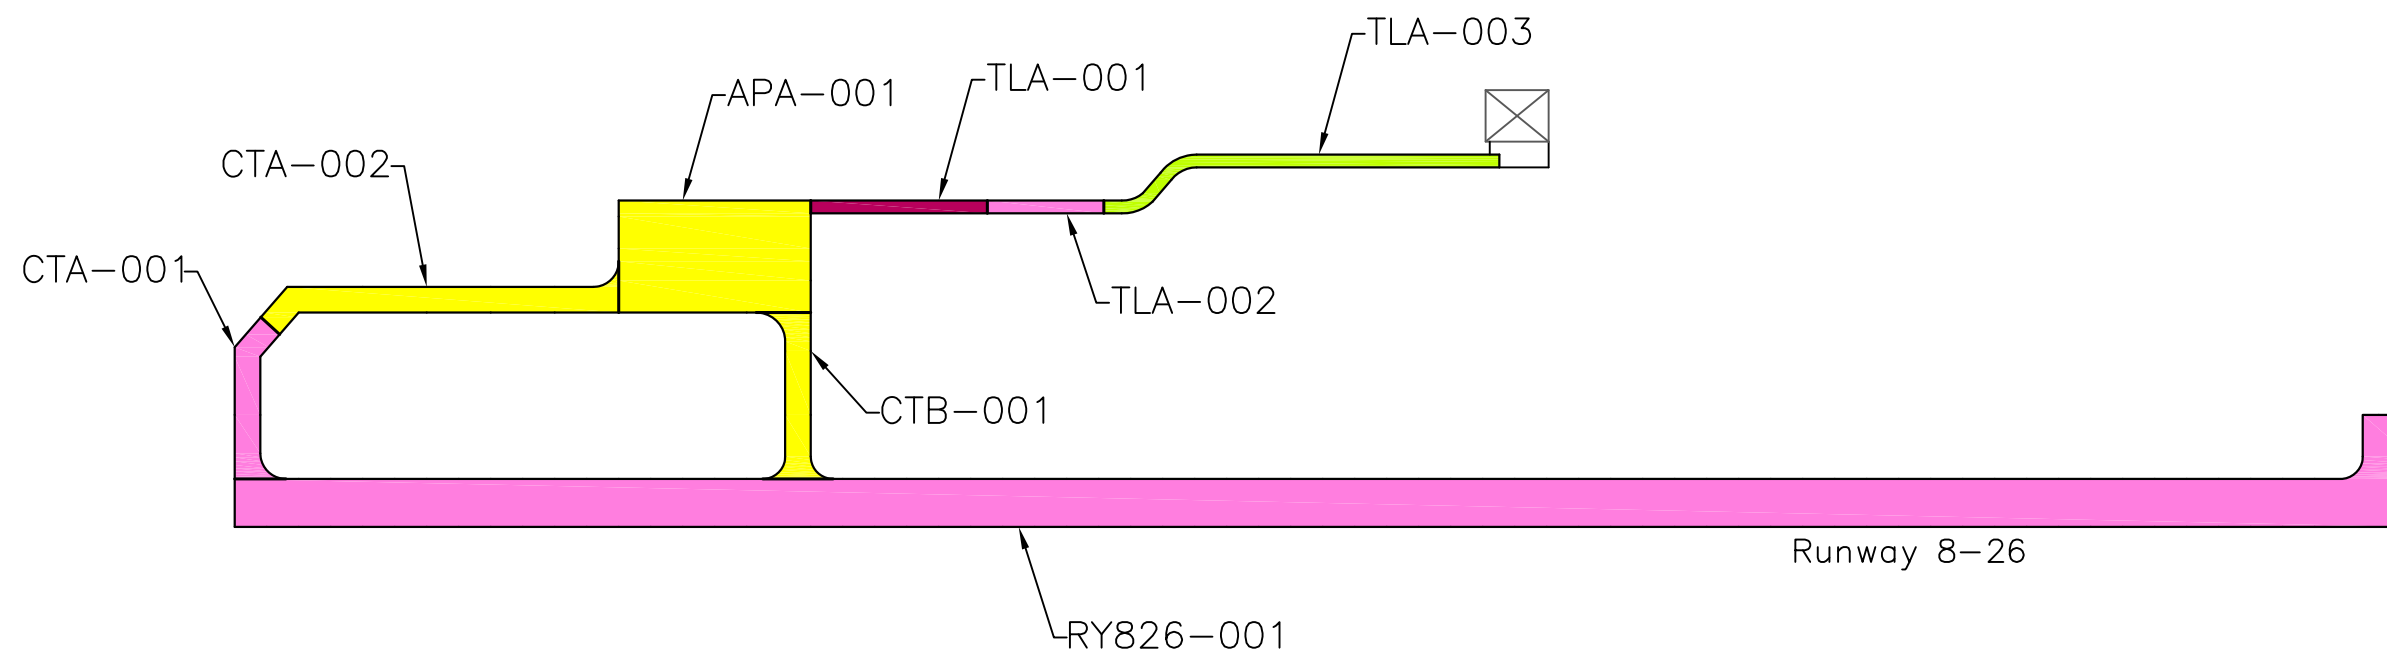
Figure 4. 2010 Pavement Condition Index Rating at Tower Municipal Airport & Seaplane Base (12D).

The results of the 2010 PCI inspection are presented in figure 4. The overall area-weighted PCI for 12D is 56. When summarizing PCI values, an area-weighted calculation is used instead of a straight mathematical average because the area-weighted calculations eliminate the skewing of the PCI due to the disparity of the section sizes.

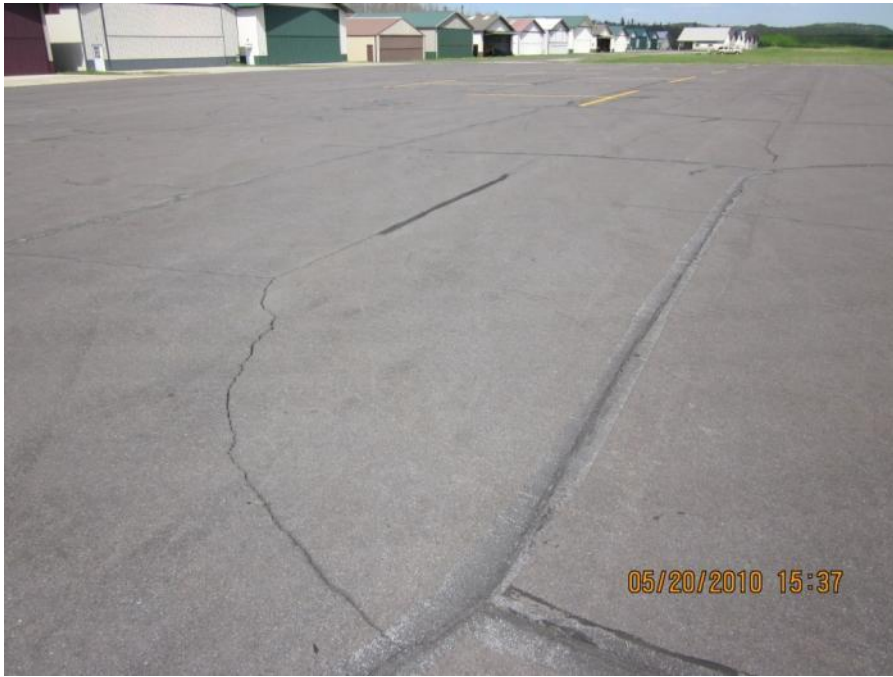
12D APA 001 (PCI = 60)

Conditions: PCI: 60.00 |

48 LONGITUDINAL/TRANSVERSE CRACKING L 764.00 Ft

48 LONGITUDINAL/TRANSVERSE CRACKING M 116.00 Ft

48 LONGITUDINAL/TRANSVERSE CRACKING L 735.00 Ft

48 LONGITUDINAL/TRANSVERSE CRACKING M 95.00 Ft

48 LONGITUDINAL/TRANSVERSE CRACKING M 122.00 Ft

41 ALLIGATOR CRACKING L 213.00 SqFt

48 LONGITUDINAL/TRANSVERSE CRACKING L 617.00 Ft

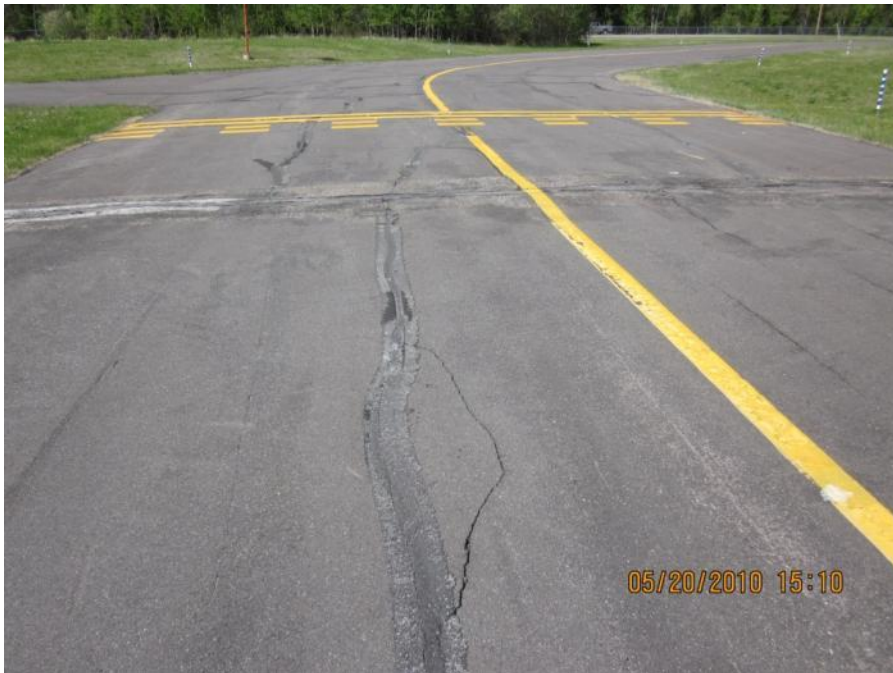
12D CTA 001 (PCI = 41)

Conditions: PCI:41.00 |

41 ALLIGATOR CRACKING	M	125.00	SqFt
41 ALLIGATOR CRACKING	L	42.00	SqFt
48 LONGITUDINAL/TRANSVERSE CRACKING	L	457.00	Ft
48 LONGITUDINAL/TRANSVERSE CRACKING	M	56.00	Ft
48 LONGITUDINAL/TRANSVERSE CRACKING	H	30.00	Ft
53 RUTTING	L	4.00	SqFt
53 RUTTING	M	2.00	SqFt
56 SWELLING	L	240.00	SqFt

41 ALLIGATOR CRACKING	L	123.00	SqFt
48 LONGITUDINAL/TRANSVERSE CRACKING	H	15.00	Ft
48 LONGITUDINAL/TRANSVERSE CRACKING	L	411.00	Ft
48 LONGITUDINAL/TRANSVERSE CRACKING	M	66.00	Ft
56 SWELLING	L	201.00	SqFt

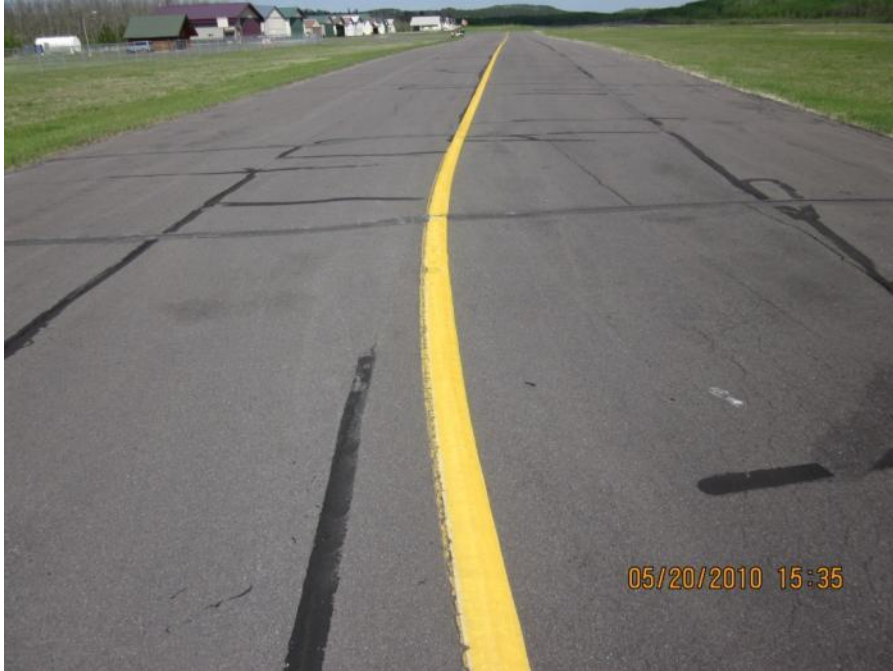
12D CTA 002 (PCI = 67)

Conditions: PCI:67.00 |

48 LONGITUDINAL/TRANSVERSE CRACKING L 535.00 Ft

48 LONGITUDINAL/TRANSVERSE CRACKING M 30.00 Ft

48 LONGITUDINAL/TRANSVERSE CRACKING H 8.00 Ft

48 LONGITUDINAL/TRANSVERSE CRACKING M 102.00 Ft

48 LONGITUDINAL/TRANSVERSE CRACKING L 431.00 Ft

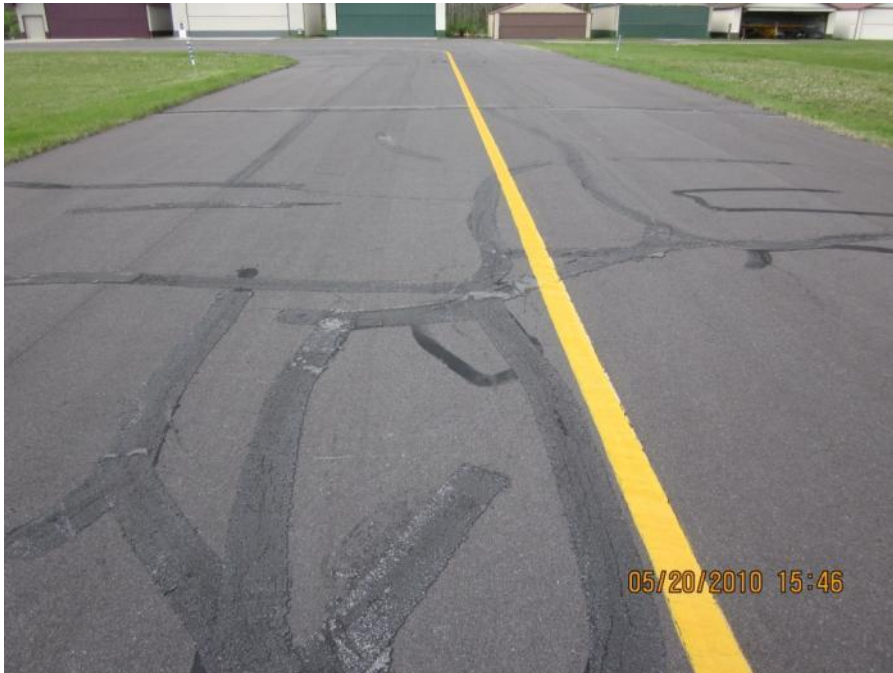
12D CTB 001 (PCI = 67)

Conditions: PCI:67.00 |

48 LONGITUDINAL/TRANSVERSE CRACKING L 646.00 Ft

48 LONGITUDINAL/TRANSVERSE CRACKING M 46.00 Ft

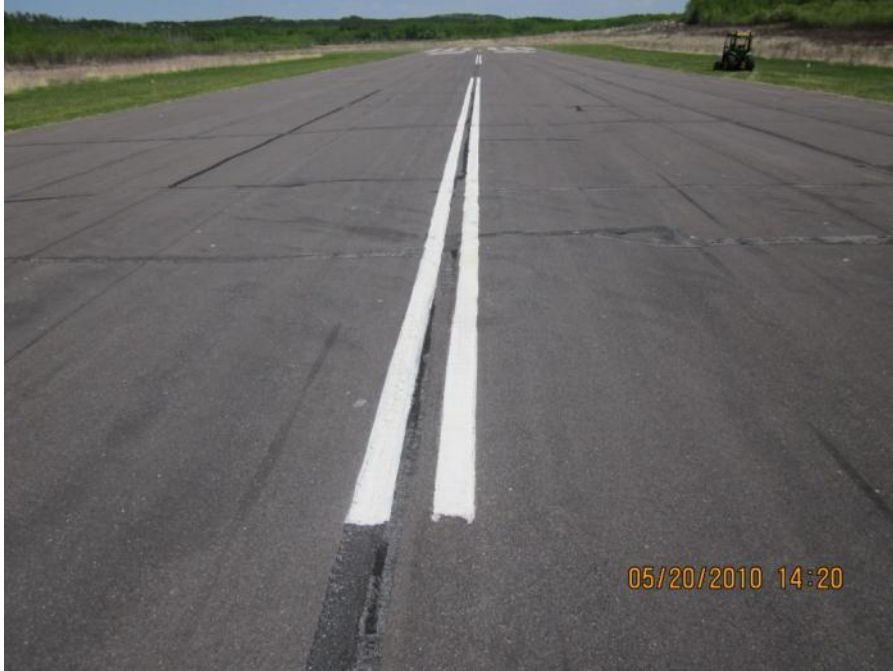
12D RY826 001 (PCI = 54)

Conditions: PCI:54.00 |

41 ALLIGATOR CRACKING	L	266.00	SqFt
41 ALLIGATOR CRACKING	M	174.00	SqFt
48 LONGITUDINAL/TRANSVERSE CRACKING	L	420.00	Ft
48 LONGITUDINAL/TRANSVERSE CRACKING	M	94.00	Ft
56 SWELLING	L	172.00	SqFt
53 RUTTING	L	75.00	SqFt
53 RUTTING	H	15.00	SqFt

48 LONGITUDINAL/TRANSVERSE CRACKING	L	546.00	Ft
48 LONGITUDINAL/TRANSVERSE CRACKING	M	39.00	Ft
41 ALLIGATOR CRACKING	L	28.00	SqFt
56 SWELLING	L	20.00	SqFt

41 ALLIGATOR CRACKING	L	238.00	SqFt
48 LONGITUDINAL/TRANSVERSE CRACKING	H	5.00	Ft
48 LONGITUDINAL/TRANSVERSE CRACKING	L	563.00	Ft
48 LONGITUDINAL/TRANSVERSE CRACKING	M	94.00	Ft
56 SWELLING	L	130.00	SqFt

48 LONGITUDINAL/TRANSVERSE CRACKING	L	456.00	Ft
48 LONGITUDINAL/TRANSVERSE CRACKING	M	58.00	Ft
48 LONGITUDINAL/TRANSVERSE CRACKING	H	40.00	Ft
41 ALLIGATOR CRACKING	L	11.00	SqFt

48 LONGITUDINAL/TRANSVERSE CRACKING	L	449.00	Ft
48 LONGITUDINAL/TRANSVERSE CRACKING	M	49.00	Ft
41 ALLIGATOR CRACKING	L	68.00	SqFt
41 ALLIGATOR CRACKING	M	50.00	SqFt
56 SWELLING	L	69.00	SqFt

48 LONGITUDINAL/TRANSVERSE CRACKING	L	464.00	Ft
48 LONGITUDINAL/TRANSVERSE CRACKING	M	88.00	Ft
41 ALLIGATOR CRACKING	L	5.00	SqFt

48 LONGITUDINAL/TRANSVERSE CRACKING	L	307.00	Ft
48 LONGITUDINAL/TRANSVERSE CRACKING	M	34.00	Ft
48 LONGITUDINAL/TRANSVERSE CRACKING	H	75.00	Ft

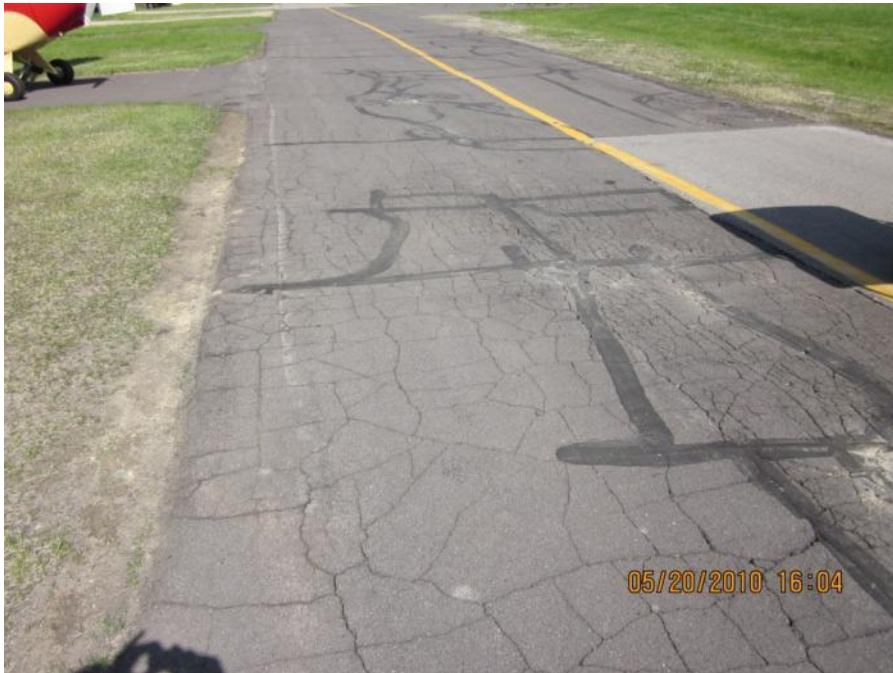
12D TLA 001 (PCI = 11)

Conditions: PCI:11.00 |

50	PATCHING	L	950.00	SqFt
48	LONGITUDINAL/TRANSVERSE CRACKING	H	15.00	Ft
41	ALLIGATOR CRACKING	L	125.00	SqFt
41	ALLIGATOR CRACKING	M	2,270.00	SqFt
41	ALLIGATOR CRACKING	H	70.00	SqFt
53	RUTTING	L	200.00	SqFt
53	RUTTING	M	25.00	SqFt

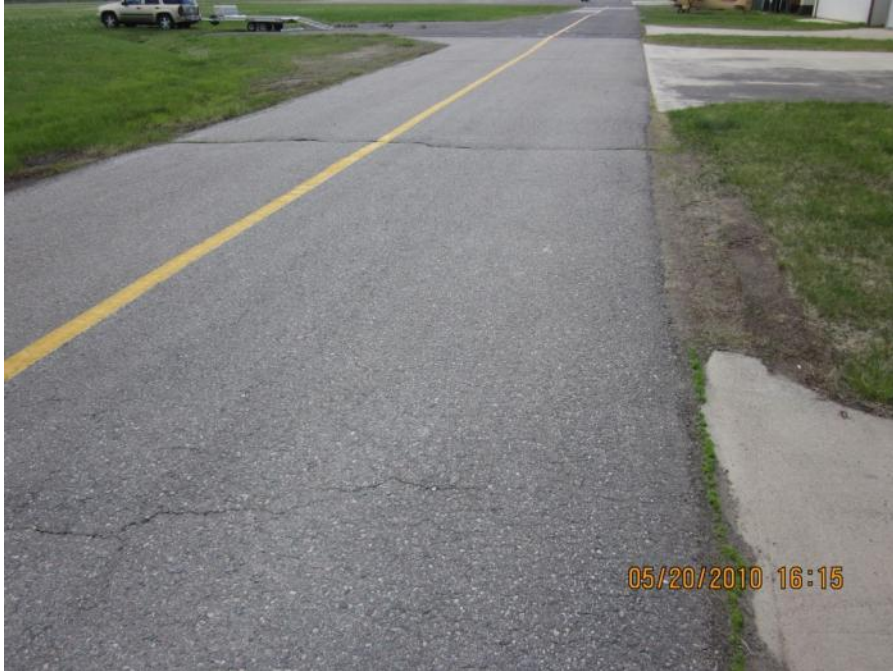
12D TLA 002 (PCI = 49)

Conditions: PCI:49.00 |

41 ALLIGATOR CRACKING	H	10.00 SqFt
41 ALLIGATOR CRACKING	L	30.00 SqFt
48 LONGITUDINAL/TRANSVERSE CRACKING	H	20.00 Ft
48 LONGITUDINAL/TRANSVERSE CRACKING	L	110.00 Ft
53 RUTTING	L	30.00 SqFt

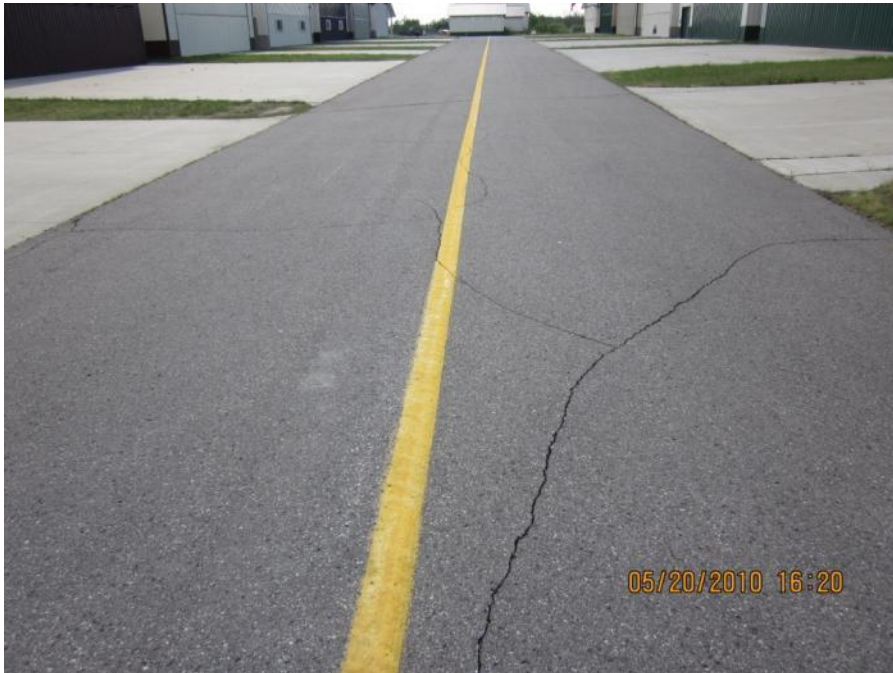
12D TLA 003 (PCI = 79)

Conditions: PCI:79.00 I

48 LONGITUDINAL/TRANSVERSE CRACKING L 230.00 Ft

48 LONGITUDINAL/TRANSVERSE CRACKING M 27.00 Ft
