# Minnesota Airport System Pavement Evaluation 2010 Update

Long Prairie Municipal Airport  
(14Y)

Long Prairie, Minnesota

December 2010

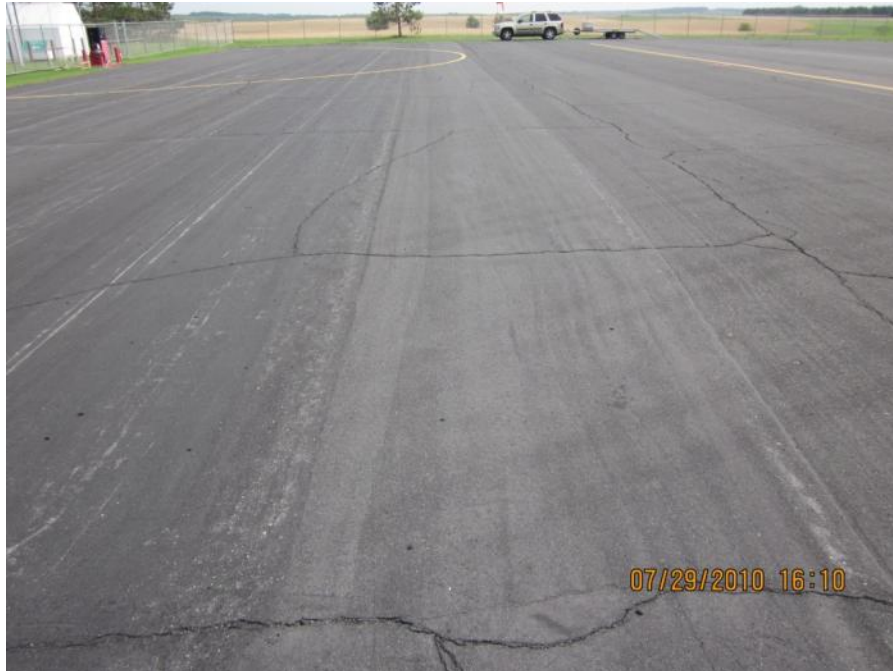
14Y APA 001 (PCI = 66)

| Branch ID | Section ID | Surface type <sup>1</sup> | Section Area (SF) | LCD <sup>2</sup> | 2010 PCI | % Deduct due to | | Distress types |
|---|---|---|---|---|---|---|---|---|
| APA | 1 | AC | 61,250 | 1987 | 66 | 26 | 74 | Alligator cracking, Longitudinal & transverse (L&T) cracking |

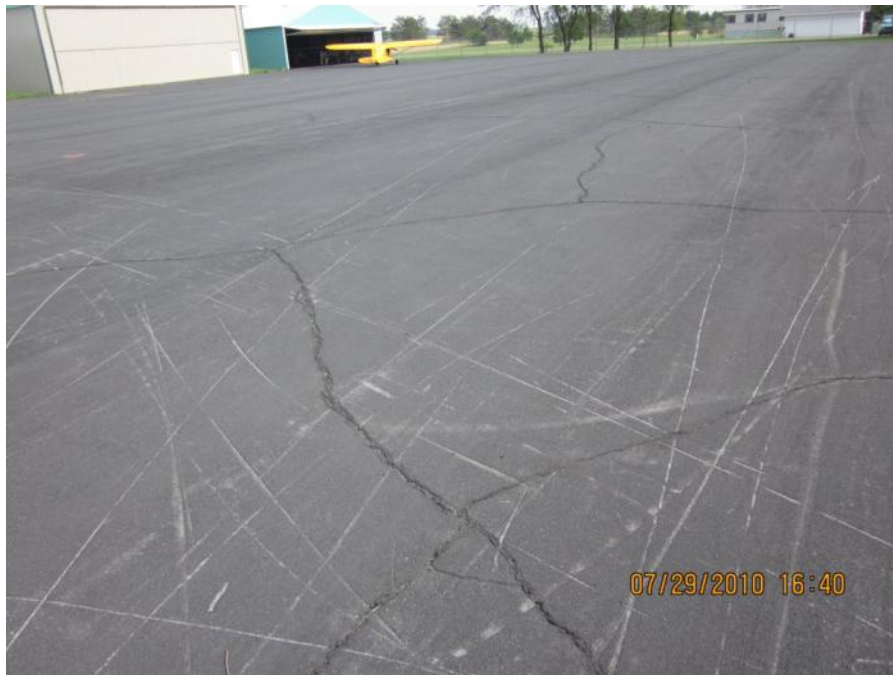
14Y APA 002 (PCI = 72)

| Branch ID | Section ID | Surface type <sup>1</sup> | Section Area (SF) | LCD <sup>2</sup> | 2010 PCI | % Deduct due to | | Distress types |
|---|---|---|---|---|---|---|---|---|
| APA | 2 | AC | 55,235 | 1995 <sup>5</sup> | 72 | 20 | 80 | Alligator cracking, L&T cracking |

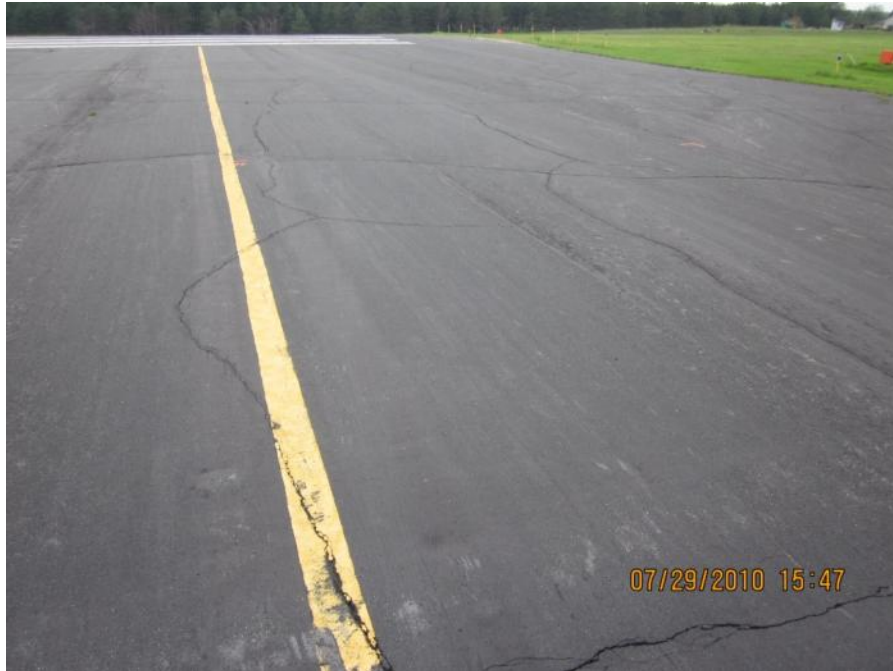
14Y CTA 001 (PCI = 53)

| Branch ID | Section ID | Surface type <sup>1</sup> | Section Area (SF) | LCD <sup>2</sup> | 2010 PCI | % Deduct due to | | Distress types |
|---|---|---|---|---|---|---|---|---|
| CTA | 1 | AC | 16,675 | 1987 | 53 | 45 | 52 | Alligator cracking, L&T cracking, Rutting, Swelling |

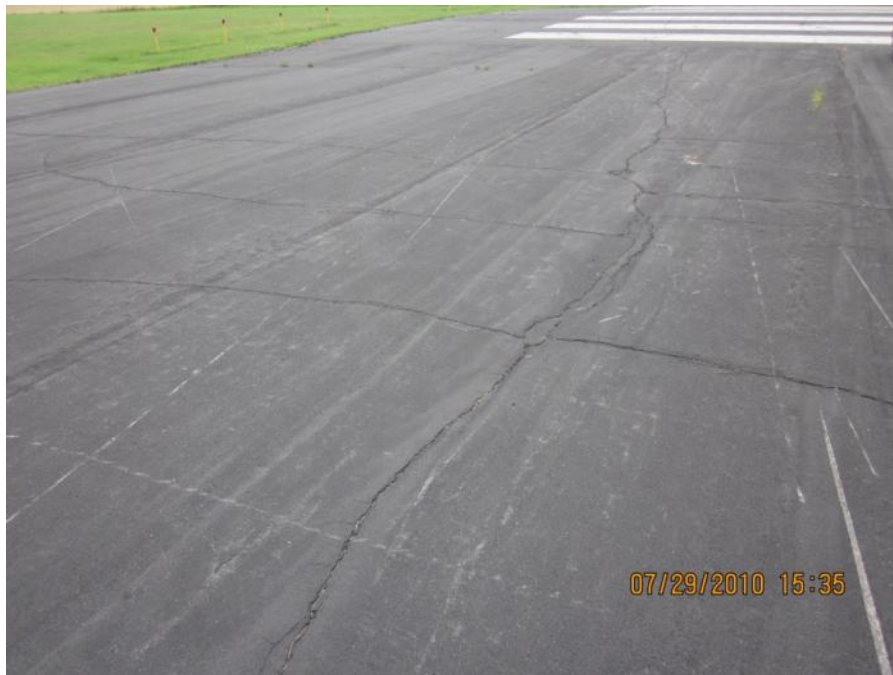
14Y RTA 001 (PCI = 61)

| Branch ID | Section ID | Surface type <sup>1</sup> | Section Area (SF) | LCD <sup>2</sup> | 2010 PCI | % Deduct due to | | Distress types |
|---|---|---|---|---|---|---|---|---|
| RTA | 1 | AC | 6,400 | 1987 | 61 | 14 | 86 | Alligator cracking, L&T cracking |

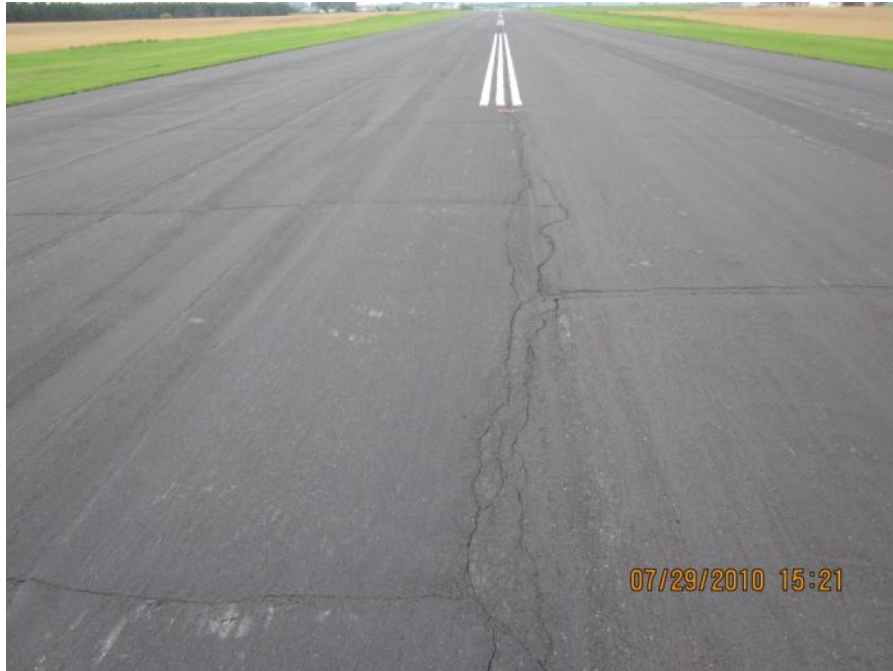
14Y RY1634 001 (PCI = 62)

| Branch ID | Section ID | Surface type <sup>1</sup> | Section Area (SF) | LCD <sup>2</sup> | 2010 PCI | % Deduct due to | | Distress types |
|---|---|---|---|---|---|---|---|---|
| RY1634 | 1 | AC | 225,000 | 1987 | 62 | 10 | 90 | Alligator cracking, Block cracking, L&T cracking |

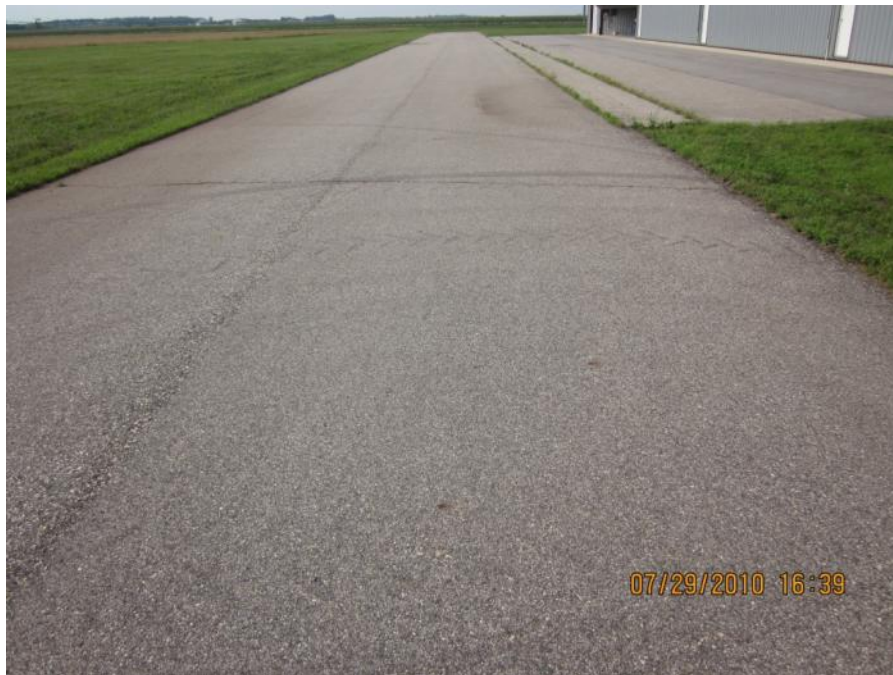
14Y TLA 001 (PCI = 95)

| Branch ID | Section ID | Surface type <sup>1</sup> | Section Area (SF) | LCD <sup>2</sup> | 2010 PCI | % Deduct due to | | Distress types |
|---|---|---|---|---|---|---|---|---|
| TLA | 1 | AC | 9,100 | 2008 <sup>5</sup> | 95 | 0 | 100 | L&T cracking |

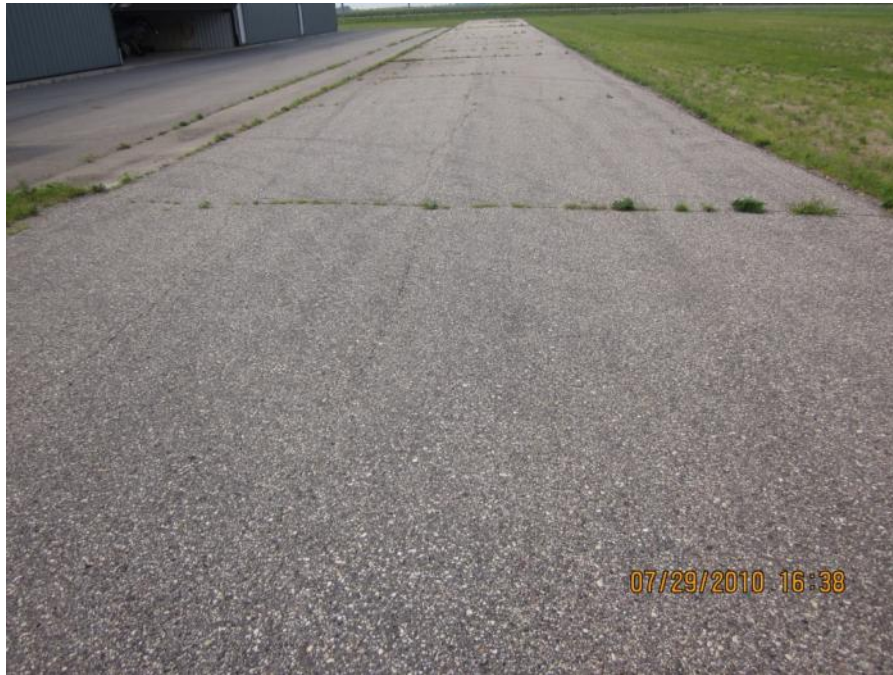
14Y TLA 002 (PCI = 48)

| Branch ID | Section ID | Surface type <sup>1</sup> | Section Area (SF) | LCD <sup>2</sup> | 2010 PCI | % Deduct due to | | Distress types |
|---|---|---|---|---|---|---|---|---|
| TLA | 2 | AC | 8,500 | 2000 <sup>5</sup> | 48 | 0 | 100 | L&T cracking, Weathering/raveling |
