Minnesota Airport System Pavement Evaluation 2010 Update

Piney – Pinecreek Border
Airport (48Y)

Pinecreek, Minnesota

December 2010

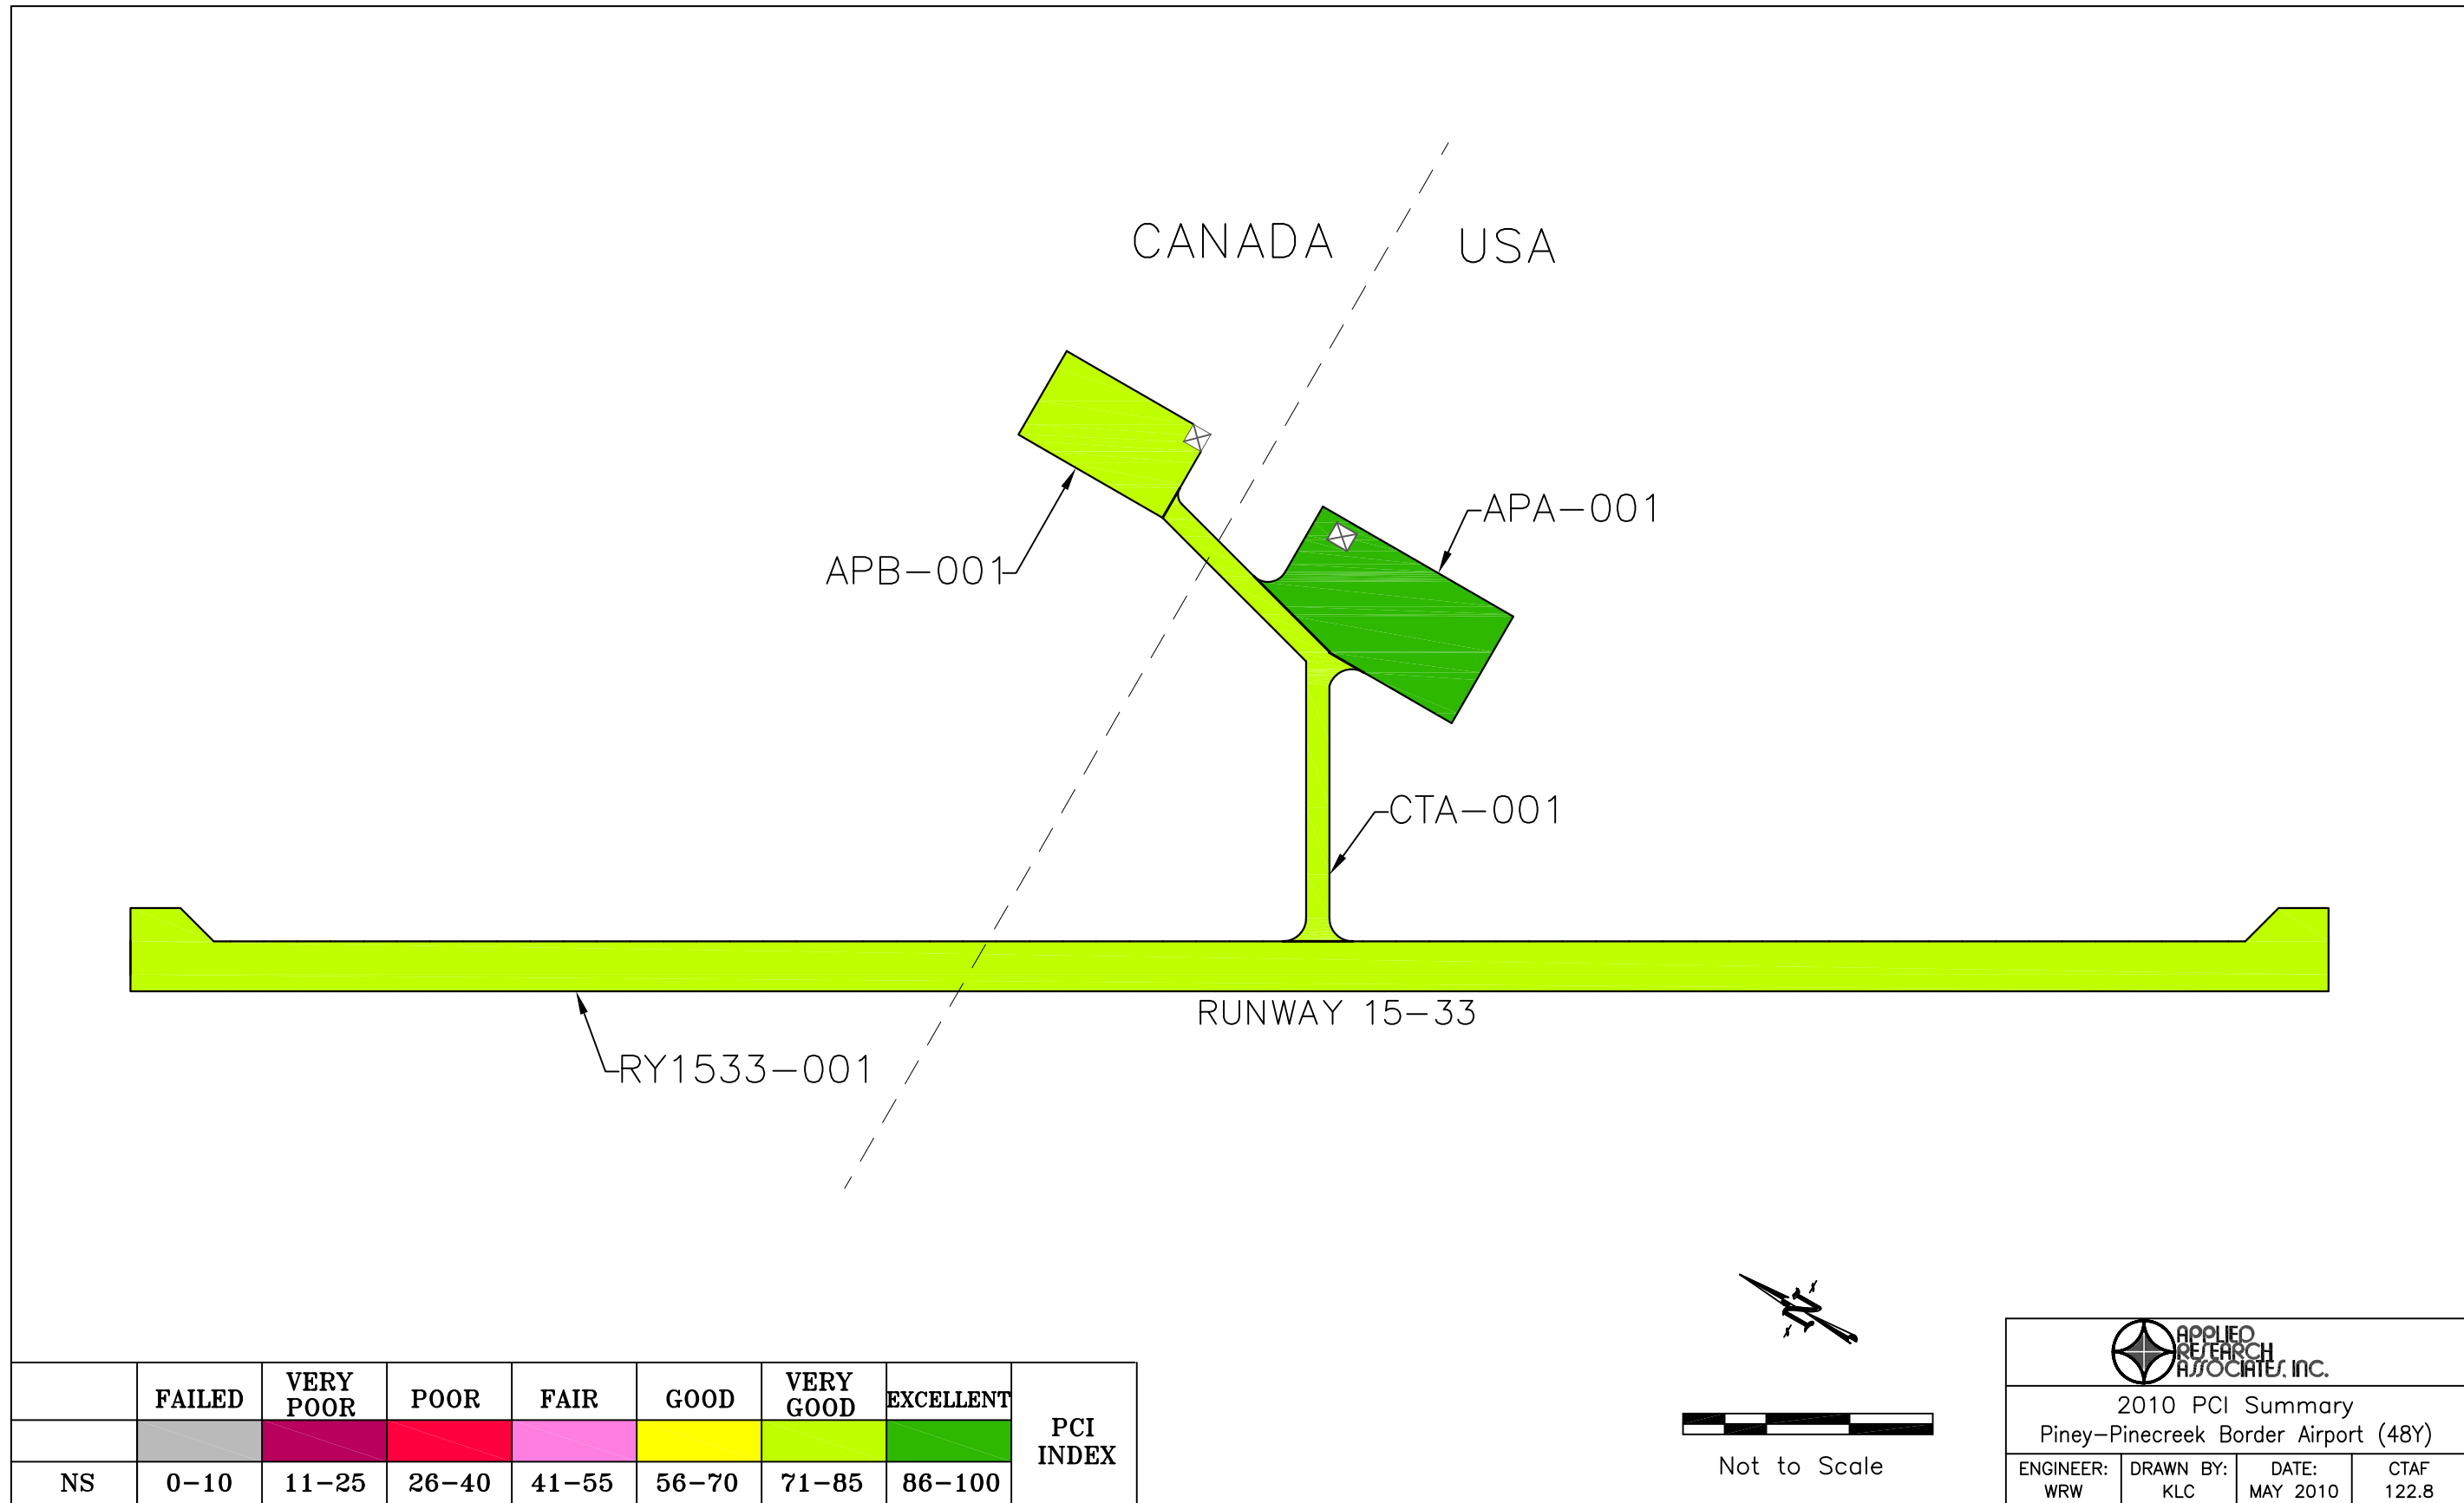
Figure 4. 2010 Pavement Condition Index Rating at Piney-Pinecreek Border Airport (48Y).

The results of the 2010 PCI inspection are presented in figure 4. The overall area-weighted PCI for 48Y is 79. When summarizing PCI values, an area-weighted calculation is used instead of a straight mathematical average because the area-weighted calculations eliminate the skewing of the PCI due to the disparity of the section sizes.

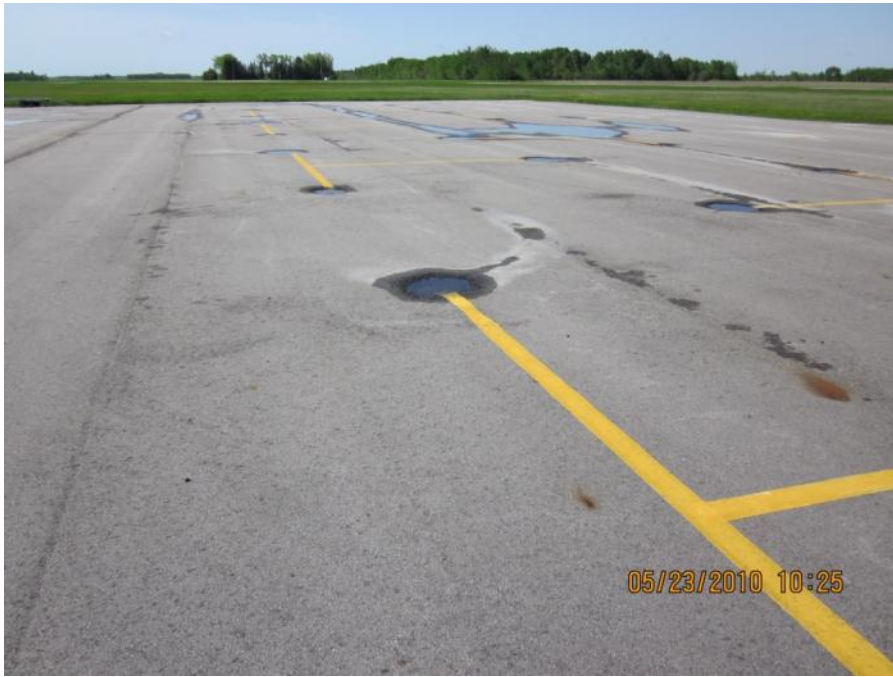
48Y APA 001 (PCI = 88)

Section Comments: 2009 - thin overlay on pavement in poor condition

Conditions: PCI:88.00 I

Sample Number: 200 Type: R Area: 5,000.00SqFt PCI = 93
48 LONGITUDINAL/TRANSVERSE CRACKING L 88.00 Ft

Sample Number: 202 Type: R Area: 5,000.00SqFt PCI = 87
48 LONGITUDINAL/TRANSVERSE CRACKING L 170.00 Ft
45 DEPRESSION L 18.00 SqFt

Sample Number: 301 Type: R Area: 5,000.00SqFt PCI = 83
48 LONGITUDINAL/TRANSVERSE CRACKING L 159.00 Ft
45 DEPRESSION L 110.00 SqFt

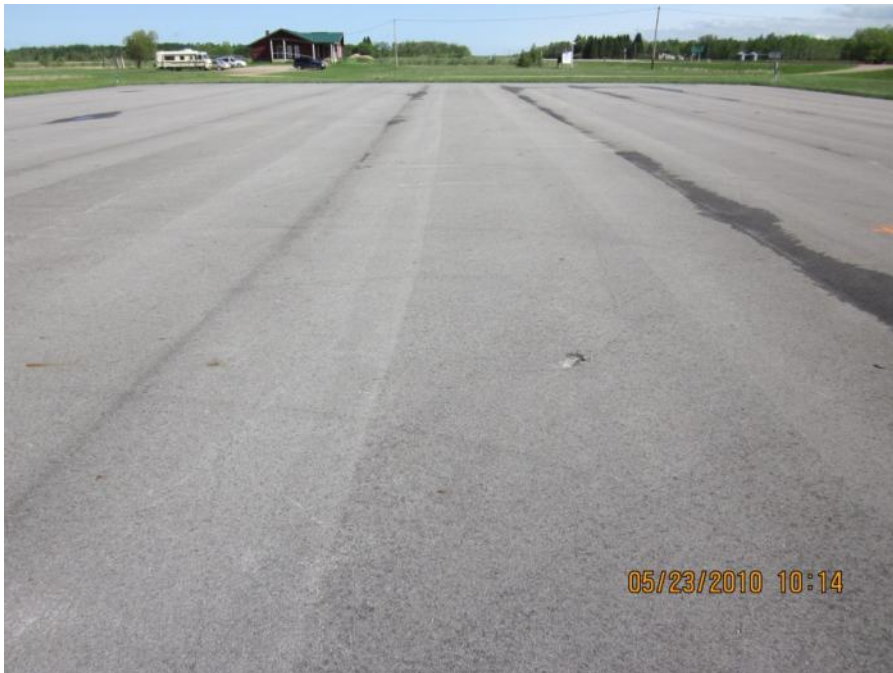
48Y APB 001 (PCI = 84)

Section Comments: 2009 - thin overlay on pavement in poor condition

Conditions: PCI:84.00 |

Sample Number: 101 Type: R Area: 5,000.00SqFt PCI = 86
48 LONGITUDINAL/TRANSVERSE CRACKING L 225.00 Ft

Sample Number: 200 Type: R Area: 5,000.00SqFt PCI = 82
48 LONGITUDINAL/TRANSVERSE CRACKING L 304.00 Ft
56 SWELLING L 1.00 SqFt

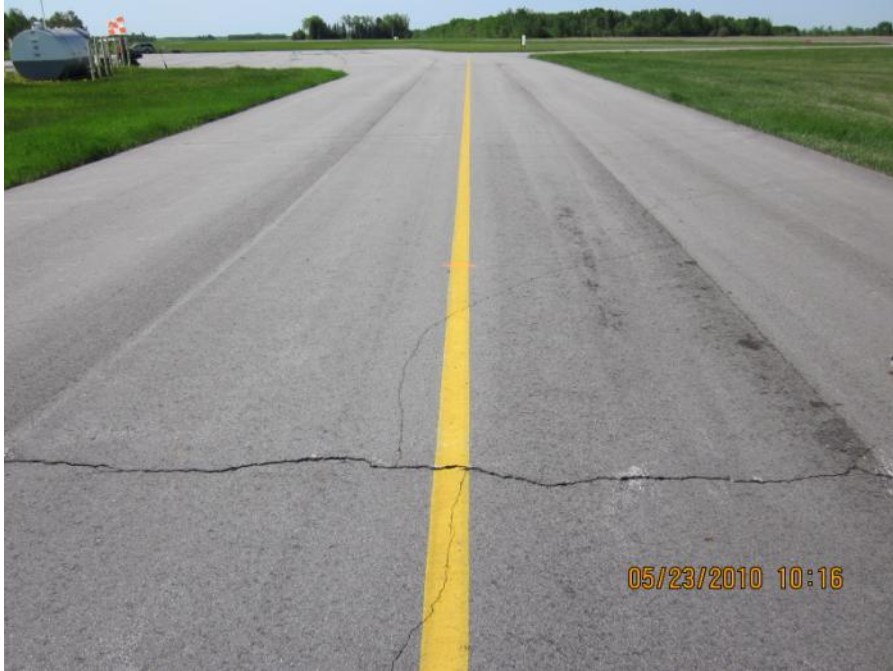
48Y CTA 001 (PCI = 76)

Section Comments: 2009 - thin overlay on pavement in poor condition

Conditions: PCI:76.00 |

48 LONGITUDINAL/TRANSVERSE CRACKING L 392.00 Ft

48 LONGITUDINAL/TRANSVERSE CRACKING L 362.00 Ft

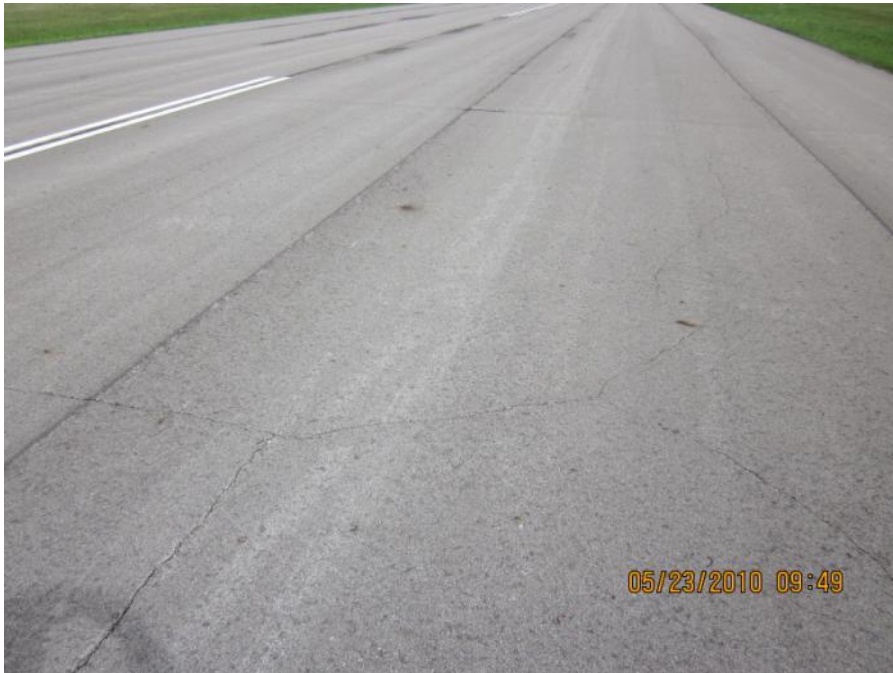
48Y RY1533 001 (PCI = 77)

Section Comments: 2009 - thin overlay on pavement in poor condition

Conditions: PCI:77.00 |

Sample Number: 106 Type: R Area: 3,750.00SqFt PCI = 78
48 LONGITUDINAL/TRANSVERSE CRACKING L 331.00 Ft

Sample Number: 115 Type: R Area: 3,750.00SqFt PCI = 80
48 LONGITUDINAL/TRANSVERSE CRACKING L 287.00 Ft

Sample Number: 124 Type: R Area: 3,750.00SqFt PCI = 78
48 LONGITUDINAL/TRANSVERSE CRACKING L 344.00 Ft

Sample Number: 133 Type: R Area: 3,750.00SqFt PCI = 77
48 LONGITUDINAL/TRANSVERSE CRACKING L 263.00 Ft
48 LONGITUDINAL/TRANSVERSE CRACKING M 5.00 Ft

Sample Number: 142 Type: R Area: 3,750.00SqFt PCI = 73
48 LONGITUDINAL/TRANSVERSE CRACKING L 353.00 Ft
48 LONGITUDINAL/TRANSVERSE CRACKING M 5.00 Ft

Sample Number: 151 Type: R Area: 3,750.00SqFt PCI = 75
48 LONGITUDINAL/TRANSVERSE CRACKING L 285.00 Ft
48 LONGITUDINAL/TRANSVERSE CRACKING M 7.00 Ft

Sample Number: 160 Type: R Area: 3,750.00SqFt PCI = 74
48 LONGITUDINAL/TRANSVERSE CRACKING L 337.00 Ft
48 LONGITUDINAL/TRANSVERSE CRACKING M 3.00 Ft

Branch ID	Section ID	Distress Type	Severity	Treatment	Estimated Quantity	Unit	Cost
RY1533	1	L & T CR	M	Crack Sealing - AC	196	Ft	\$200
Airport Total							\$200
