Minnesota Airport System Pavement Evaluation 2010 Update

Bagley Municipal Airport (7Y4)

Bagley, Minnesota

December 2010

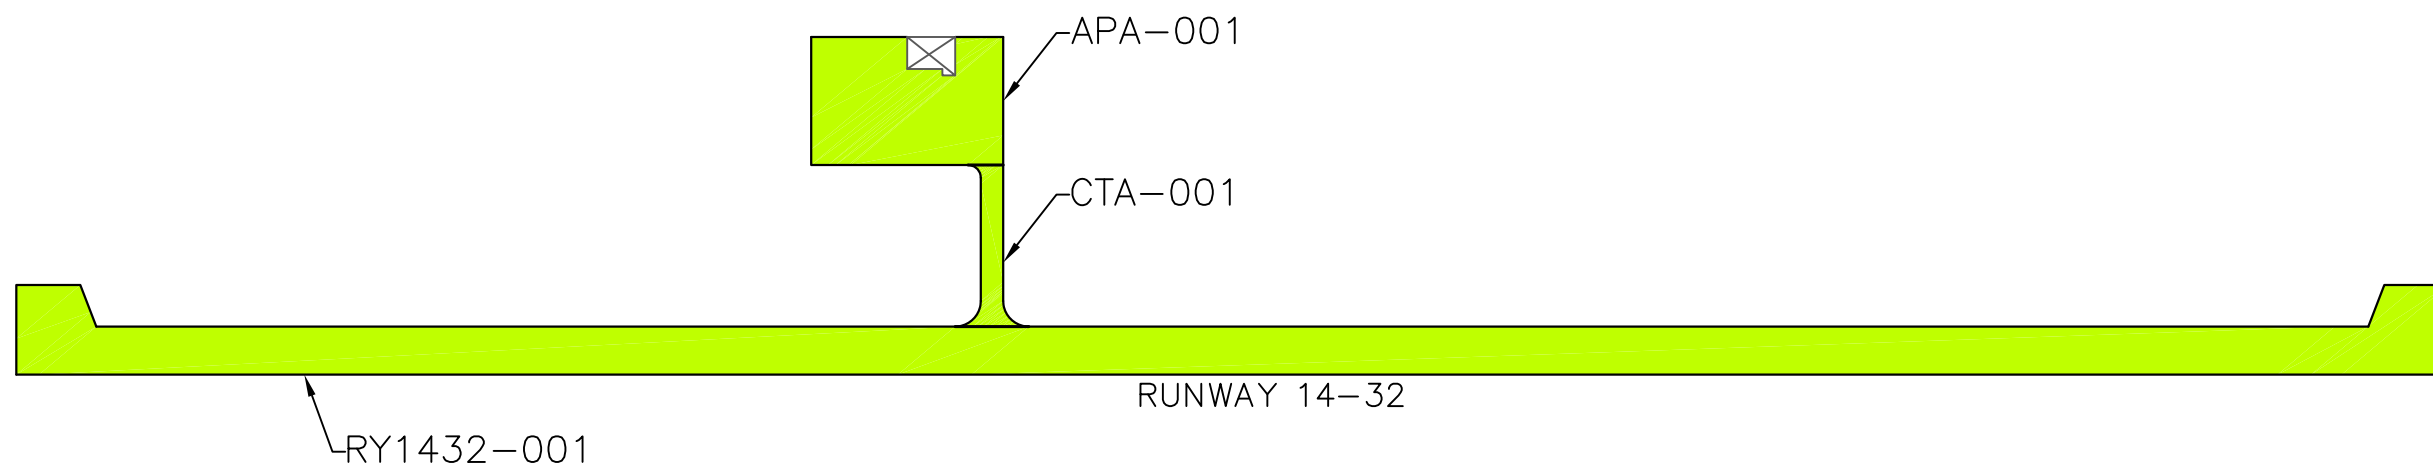
Figure 4. 2010 Pavement Condition Index Rating at Bagley Municipal Airport (7Y4).

The results of the 2010 PCI inspection are presented in figure 4. The overall area-weighted PCI for 7Y4 is 77. When summarizing PCI values, an area-weighted calculation is used instead of a straight mathematical average because the area-weighted calculations eliminate the skewing of the PCI due to the disparity of the section sizes.

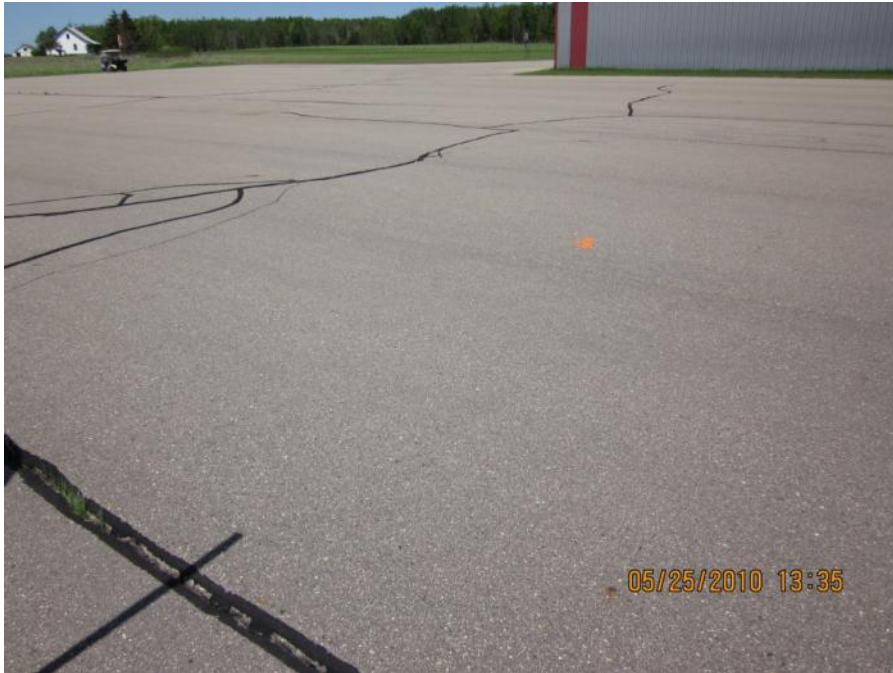
7Y4 APA 001 (PCI = 76)

Conditions: PCI: 76.00 |

48 LONGITUDINAL/TRANSVERSE CRACKING L 97.00 Ft

48 LONGITUDINAL/TRANSVERSE CRACKING M 133.00 Ft

48 LONGITUDINAL/TRANSVERSE CRACKING L 171.00 Ft

48 LONGITUDINAL/TRANSVERSE CRACKING M 164.00 Ft

48 LONGITUDINAL/TRANSVERSE CRACKING L 304.00 Ft

48 LONGITUDINAL/TRANSVERSE CRACKING M 67.00 Ft

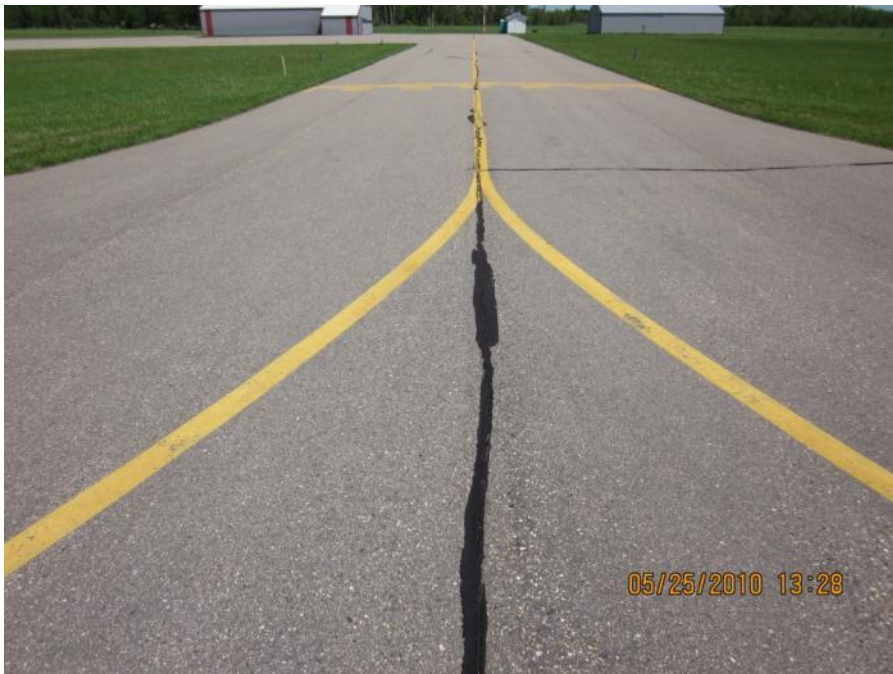
7Y4 CTA 001 (PCI = 80)

Conditions: PCI:80.00 |

48 LONGITUDINAL/TRANSVERSE CRACKING L 176.00 Ft

48 LONGITUDINAL/TRANSVERSE CRACKING M 34.00 Ft

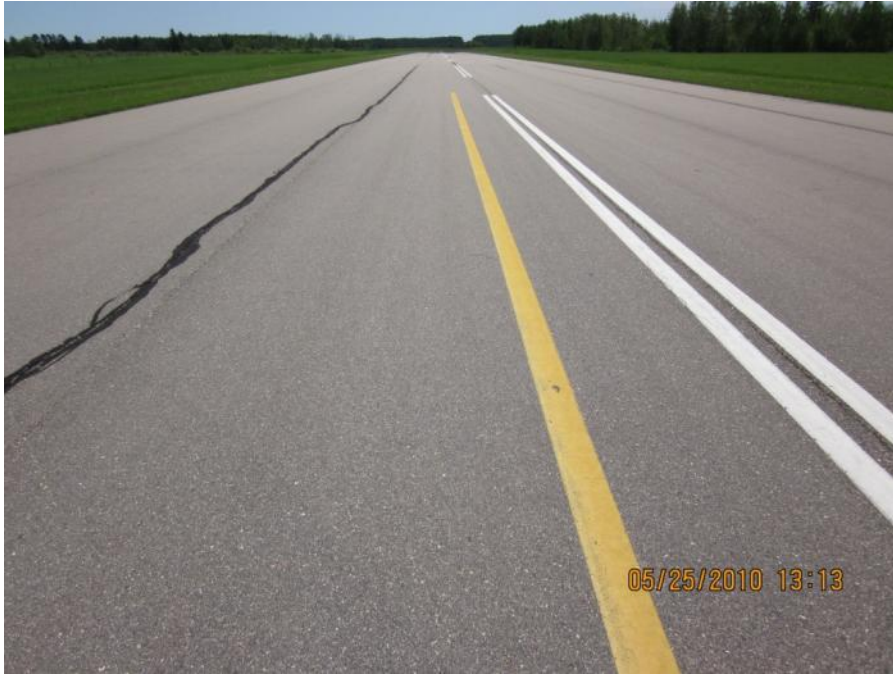
7Y4 RY1432 001 (PCI = 77)

Conditions: PCI: 77.00 |

48 LONGITUDINAL/TRANSVERSE CRACKING L 223.00 Ft

48 LONGITUDINAL/TRANSVERSE CRACKING M 48.00 Ft

48 LONGITUDINAL/TRANSVERSE CRACKING H 6.00 Ft
