Minnesota Airport System Pavement Evaluation 2010 Update

Albert Lea Municipal Airport
(AEL)

Albert Lea, Minnesota

December 2010

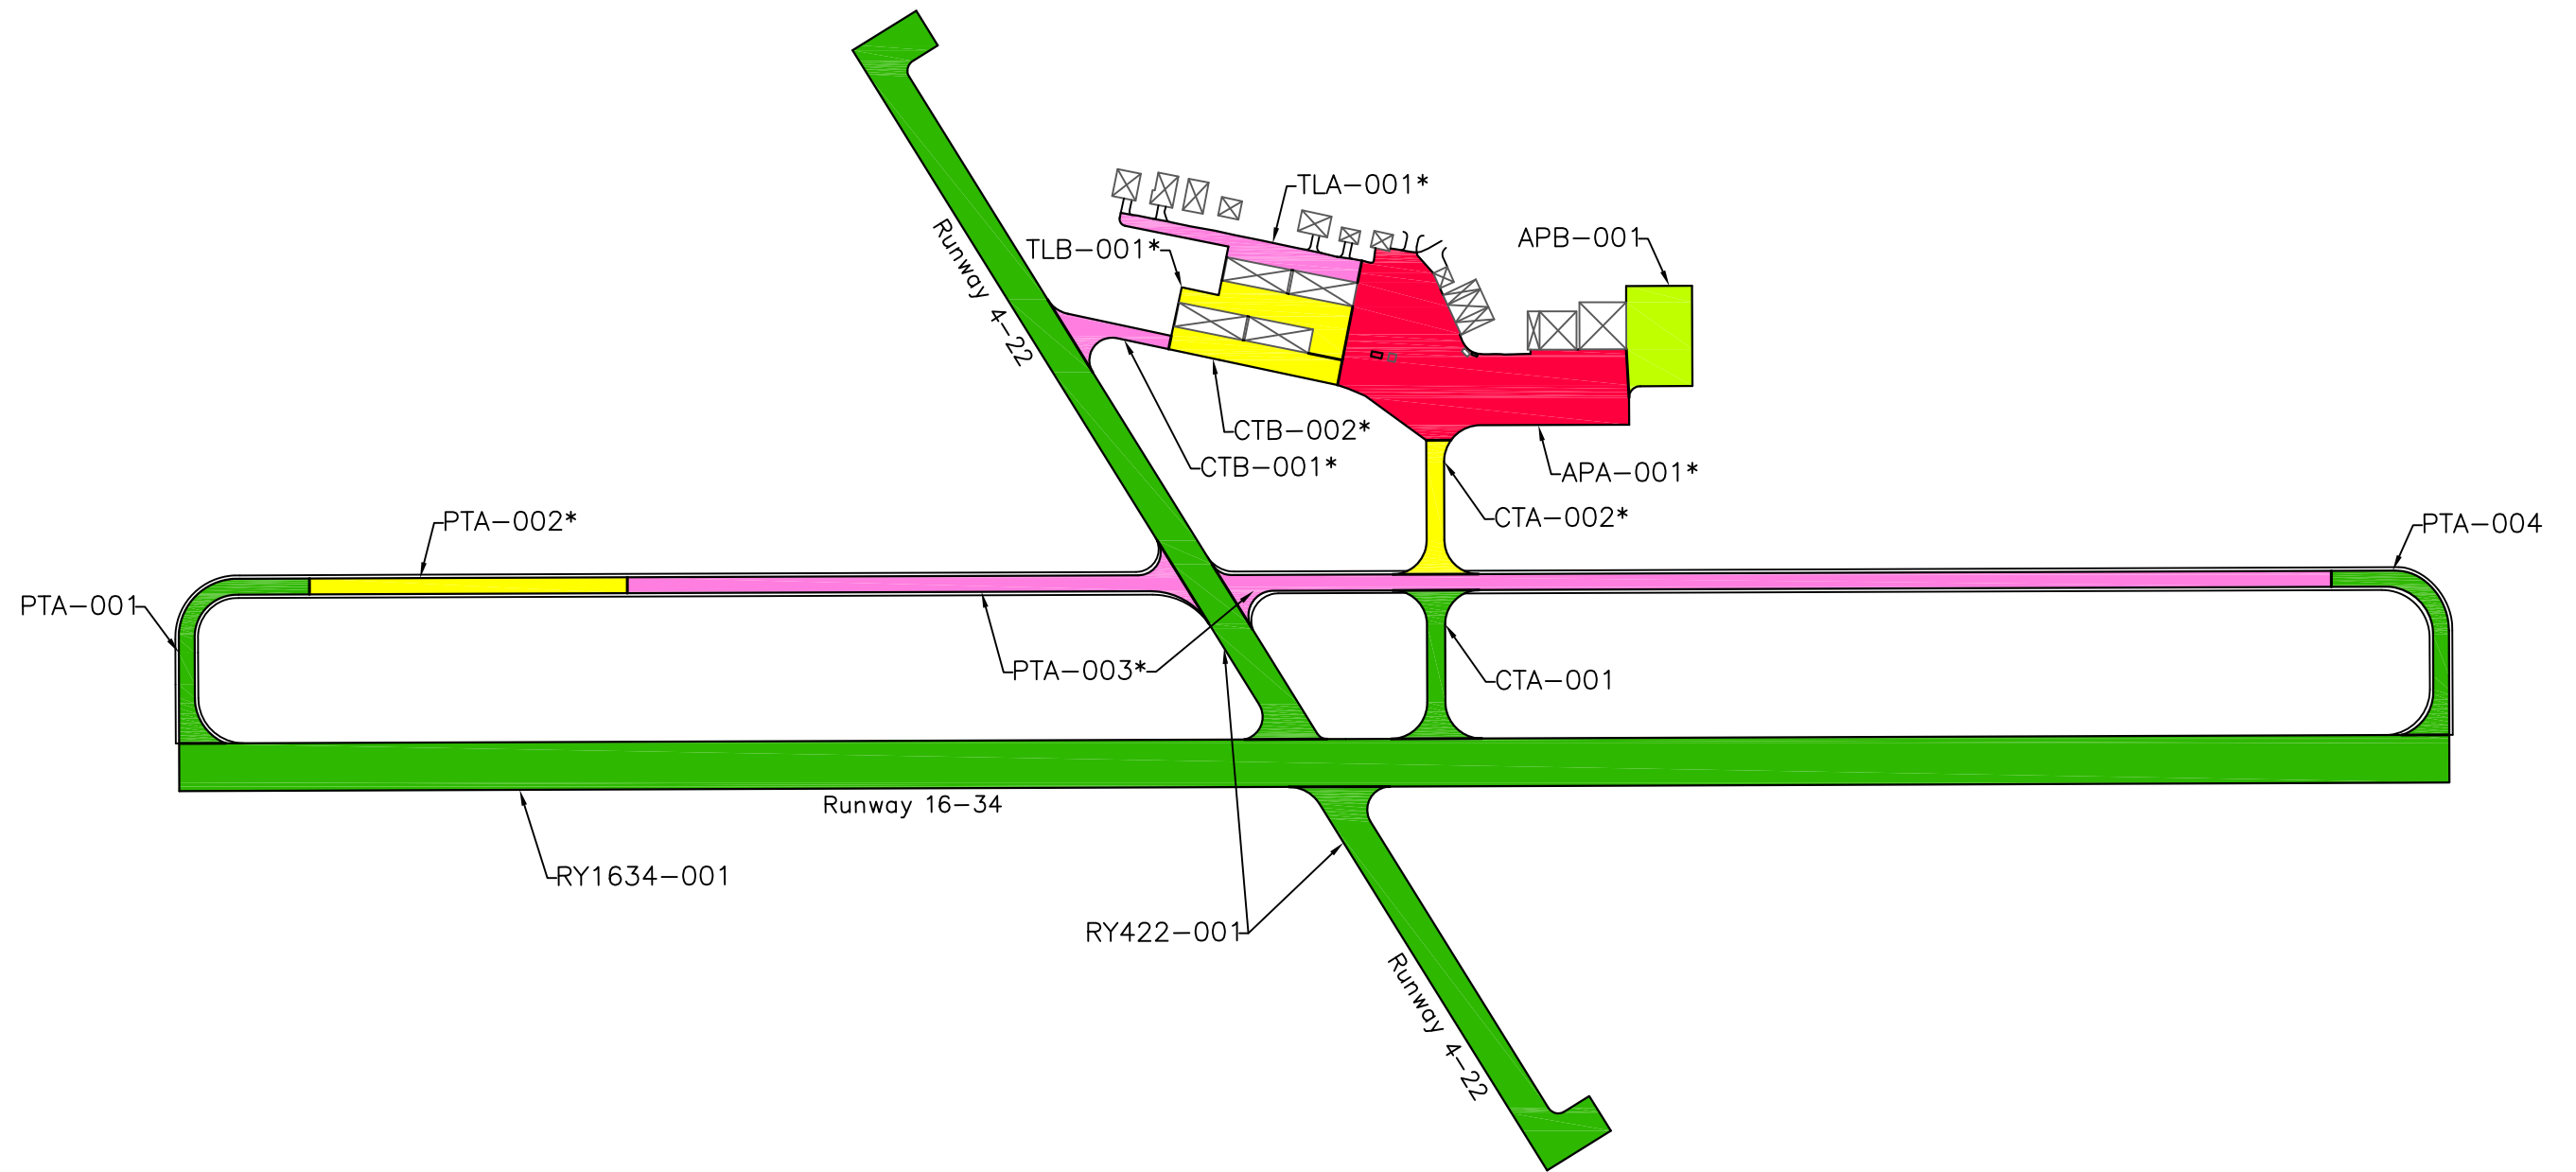
Figure 4. 2010 Pavement Condition Index Rating at Albert Lea Municipal Airport (AEL).

The results of the 2010 PCI inspection are presented in figure 4. The overall area-weighted PCI for AEL is 83. This report assumes the following pavement sections will be completed during the 2010 construction at AEL and are distress-free (i.e. PCI = 100), CTA-001, PTA-001, PTA-004, RY1634-001, and RY422-001. Also, the condition of the pavement sections scheduled to be constructed during 2011 are reported as inspected in July 2010. These sections include APA-001, CTA-002, CTB-001, CTB-002, PTA-002, PTA-003, TLA-001, and TLB-001.

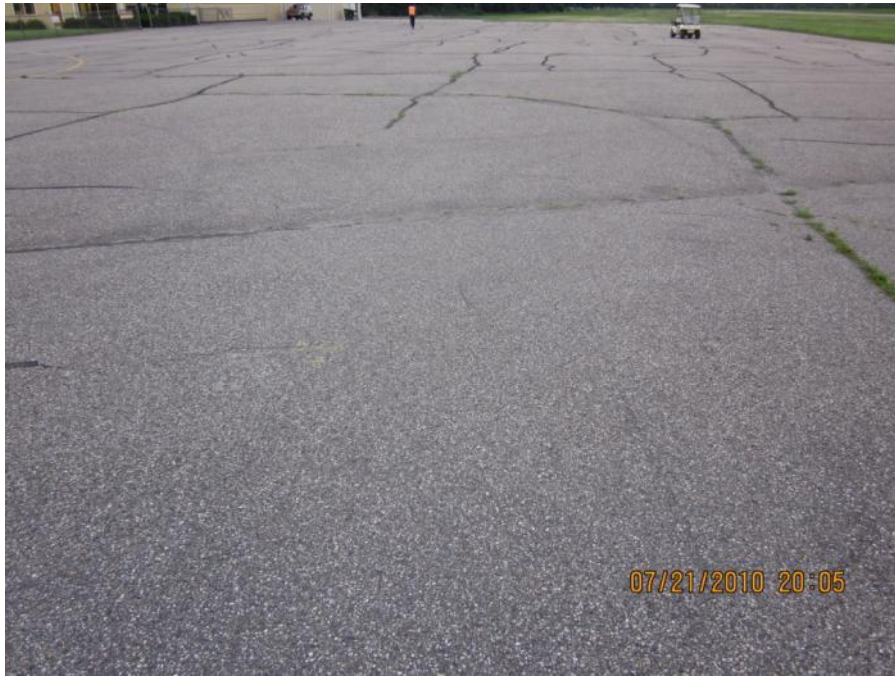
AEL APA 001 (PCI = 35 prior to 2011 construction)

48	LONGITUDINAL/TRANSVERSE CRACKING	L	625.00	Ft
48	LONGITUDINAL/TRANSVERSE CRACKING	M	72.00	Ft
41	ALLIGATOR CRACKING	L	45.00	SqFt
50	PATCHING	L	90.00	SqFt
50	PATCHING	M	60.00	SqFt
43	BLOCK CRACKING	L	600.00	SqFt
52	WEATHERING/RAVELING	M	5,000.00	SqFt

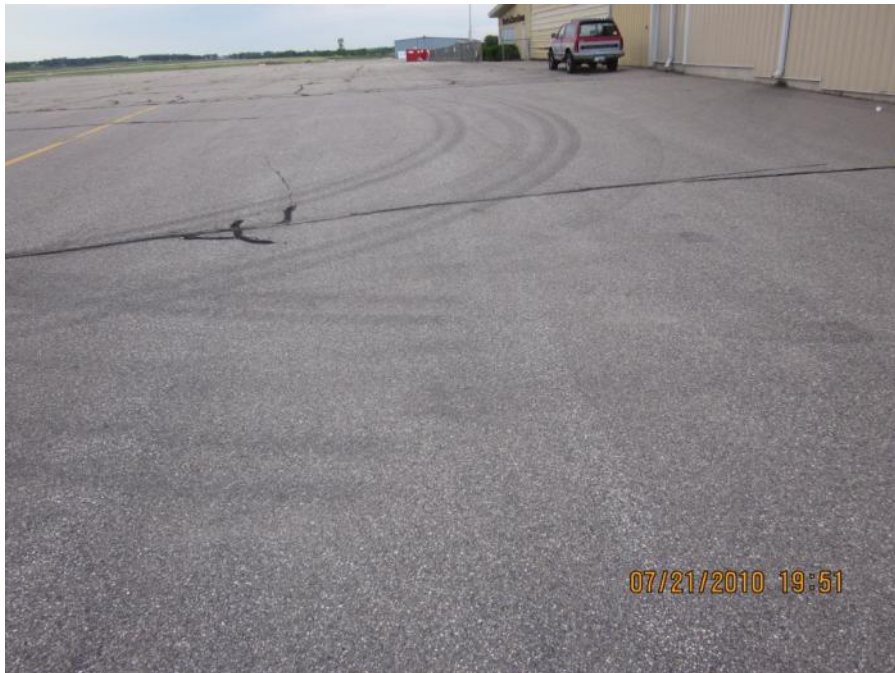
AEL APB 001 (PCI = 78)

48 LONGITUDINAL/TRANSVERSE CRACKING L 210.00 Ft

48 LONGITUDINAL/TRANSVERSE CRACKING M 3.00 Ft

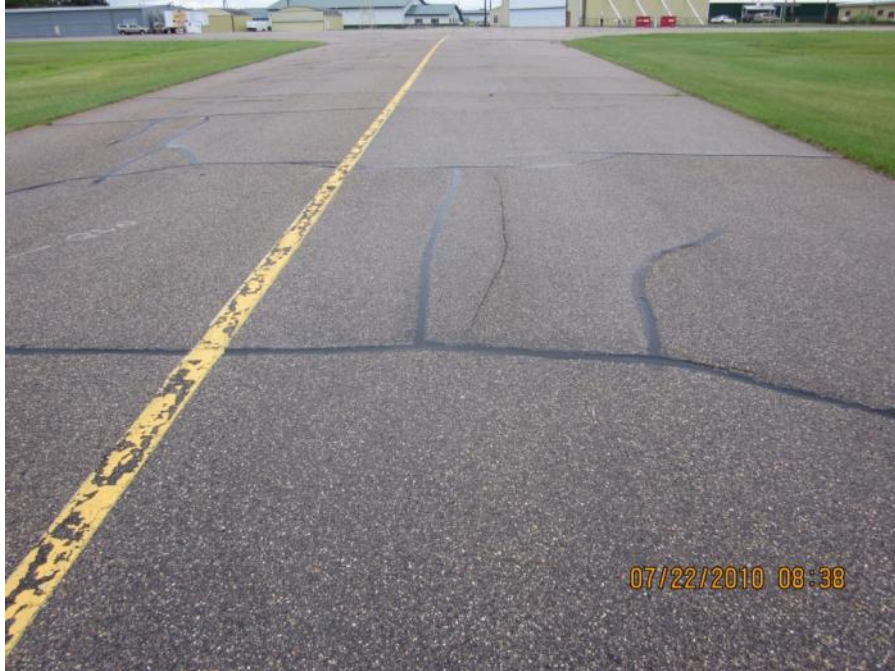
AEL CTA 002 (PCI = 69 prior to 2011 construction)

48 LONGITUDINAL/TRANSVERSE CRACKING L 477.00 Ft

48 LONGITUDINAL/TRANSVERSE CRACKING M 65.00 Ft

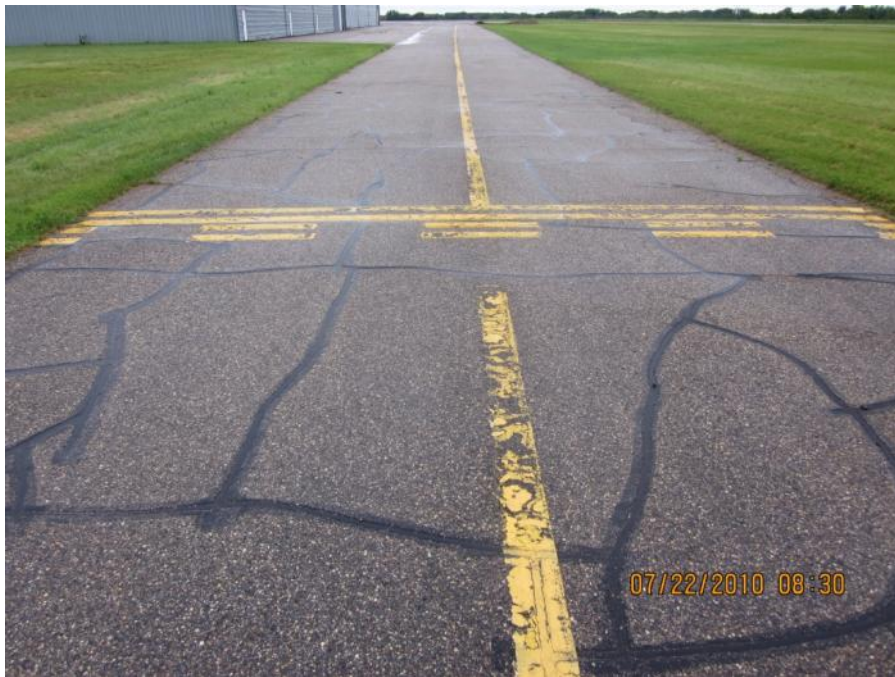
AEL CTB 001 (PCI = 44 prior to 2011 construction)

43 BLOCK CRACKING L 4,000.00 SqFt

43 BLOCK CRACKING M 1,000.00 SqFt

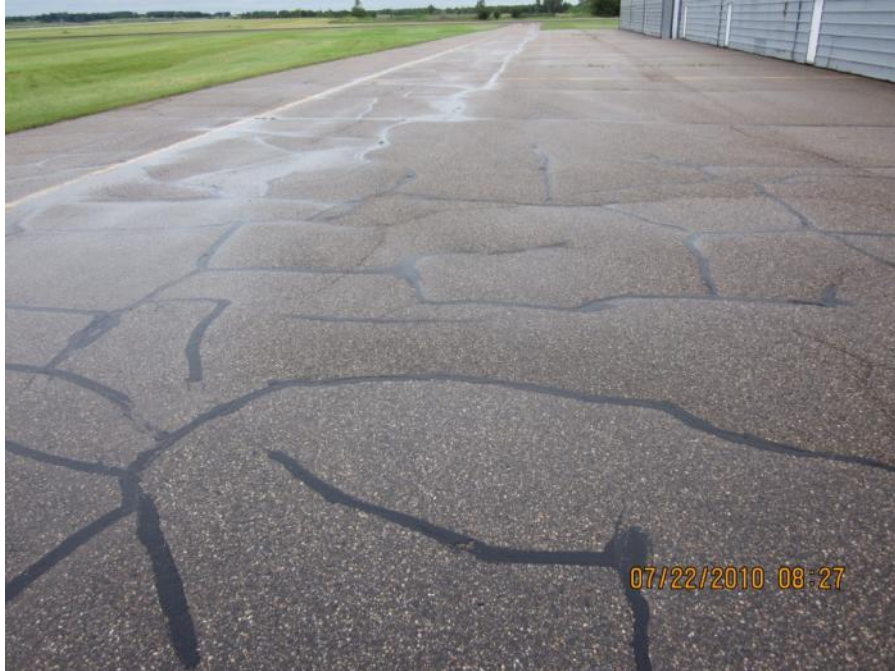
AEL CTB 002 (PCI = 56 prior to 2011 construction)

48 LONGITUDINAL/TRANSVERSE CRACKING L 105.00 Ft

48 LONGITUDINAL/TRANSVERSE CRACKING M 4.00 Ft

43 BLOCK CRACKING L 3,400.00 SqFt

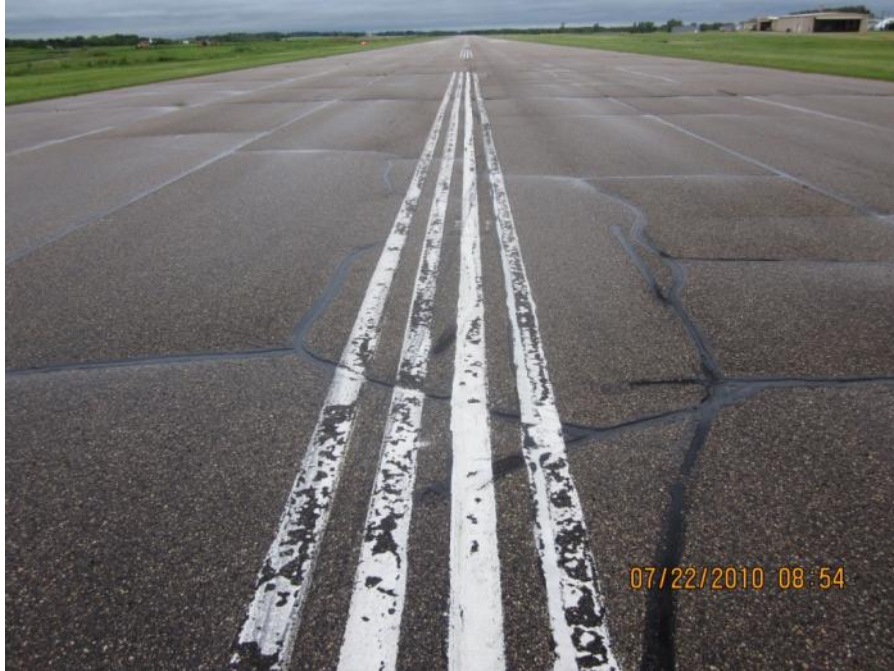
AEL PTA 002 (formerly RY1634 001) (PCI = 59)

Sample Number: 179 Type: R Area: 5,000.00SqFt PCI = 60
48 LONGITUDINAL/TRANSVERSE CRACKING L 542.00 Ft
48 LONGITUDINAL/TRANSVERSE CRACKING M 88.00 Ft
52 WEATHERING/RAVELING L 5,000.00 SqFt

Sample Number: 183 Type: R Area: 5,000.00SqFt PCI = 58
48 LONGITUDINAL/TRANSVERSE CRACKING L 418.00 Ft
48 LONGITUDINAL/TRANSVERSE CRACKING M 116.00 Ft
52 WEATHERING/RAVELING L 5,000.00 SqFt
41 ALLIGATOR CRACKING L 5.00 SqFt

Sample Number: 187 Type: R Area: 5,000.00SqFt PCI = 59
48 LONGITUDINAL/TRANSVERSE CRACKING L 537.00 Ft
48 LONGITUDINAL/TRANSVERSE CRACKING M 41.00 Ft
52 WEATHERING/RAVELING L 5,000.00 SqFt
41 ALLIGATOR CRACKING L 9.00 SqFt

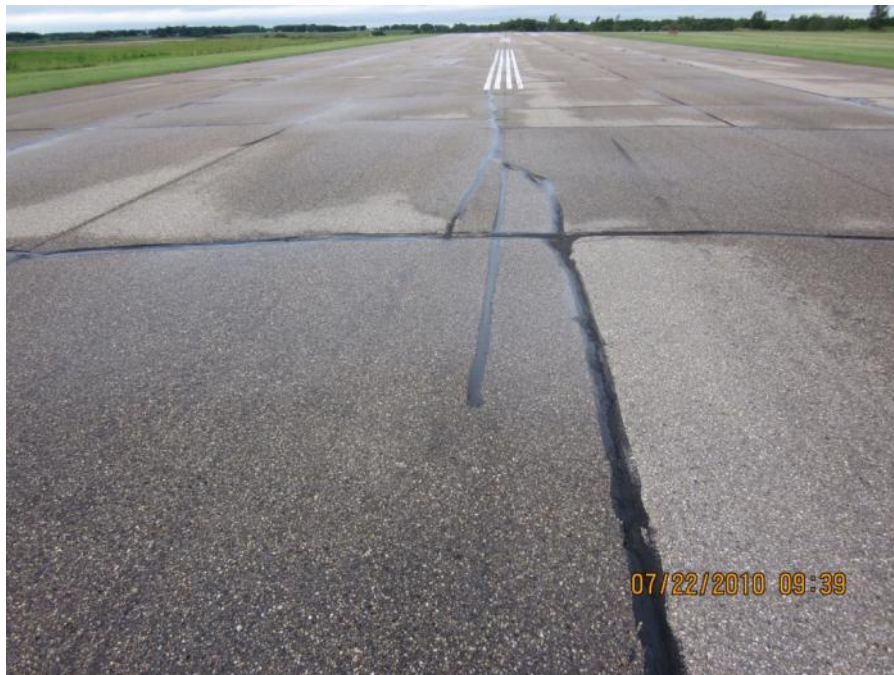
AEL PTA 003 (formerly RY1634 002) (PCI = 54)

48	LONGITUDINAL/TRANSVERSE CRACKING	L	553.00	Ft
48	LONGITUDINAL/TRANSVERSE CRACKING	M	25.00	Ft
41	ALLIGATOR CRACKING	L	12.00	SqFt
52	WEATHERING/RAVELING	L	5,000.00	SqFt

48	LONGITUDINAL/TRANSVERSE CRACKING	L	433.00	Ft
48	LONGITUDINAL/TRANSVERSE CRACKING	M	101.00	Ft
41	ALLIGATOR CRACKING	L	64.00	SqFt
48	LONGITUDINAL/TRANSVERSE CRACKING	H	6.00	Ft
52	WEATHERING/RAVELING	L	5,000.00	SqFt
