Minnesota Airport System Pavement Evaluation 2010 Update

Madison – Lac Qui Parle County
Airport (DXX)

Madison, Minnesota

December 2010

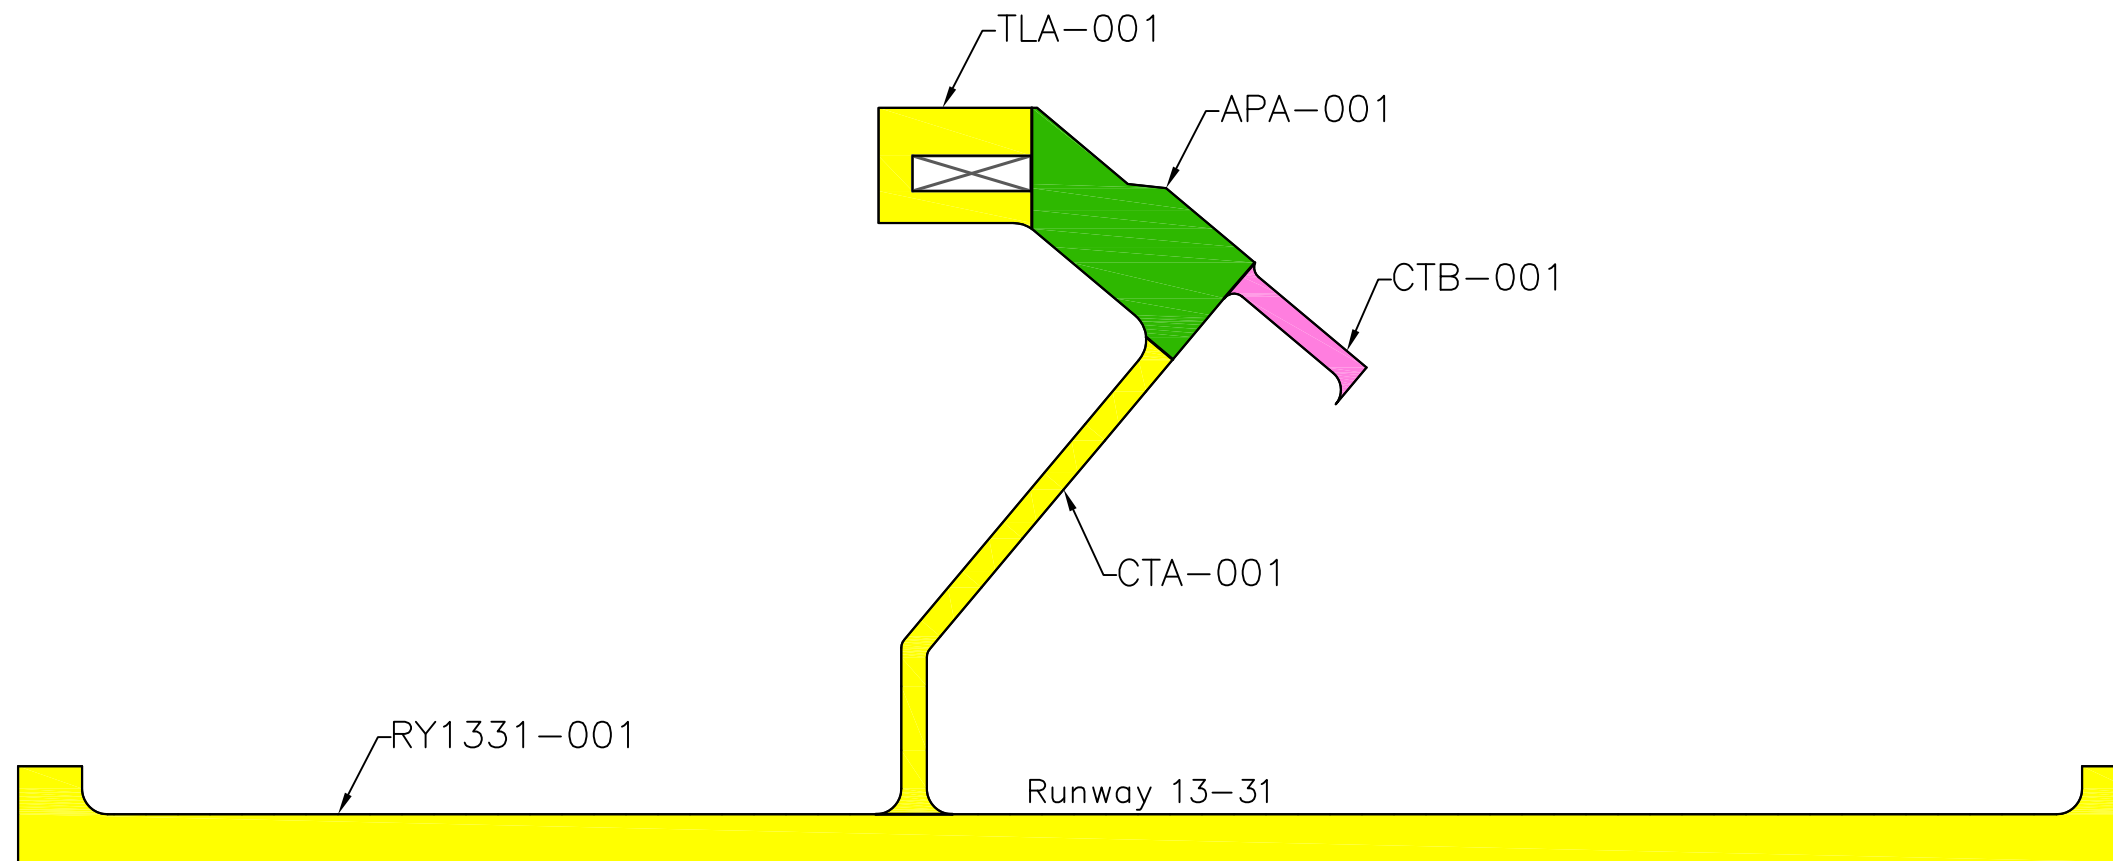
Figure 4. 2010 Pavement Condition Index Rating at Lac Qui Parle County Airport (Madison) (DXX).

The results of the 2010 PCI inspection are presented in figure 4. The overall area-weighted PCI for DXX is 69. When summarizing PCI values, an area-weighted calculation is used instead of a straight mathematical average because the area-weighted calculations eliminate the skewing of the PCI due to the disparity of the section sizes.

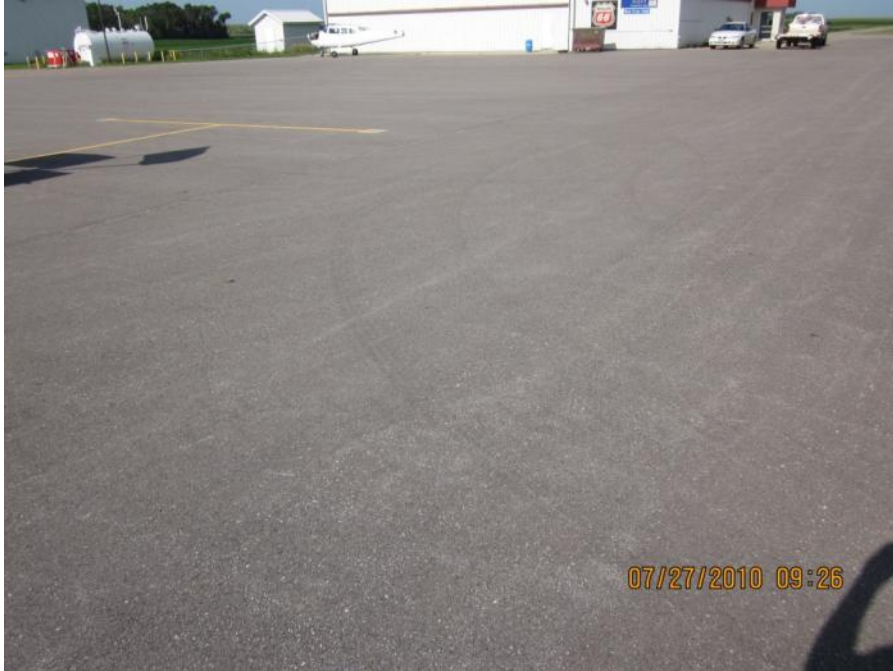
DXX APA 001 (PCI = 100)

Conditions: PCI:100.00 |

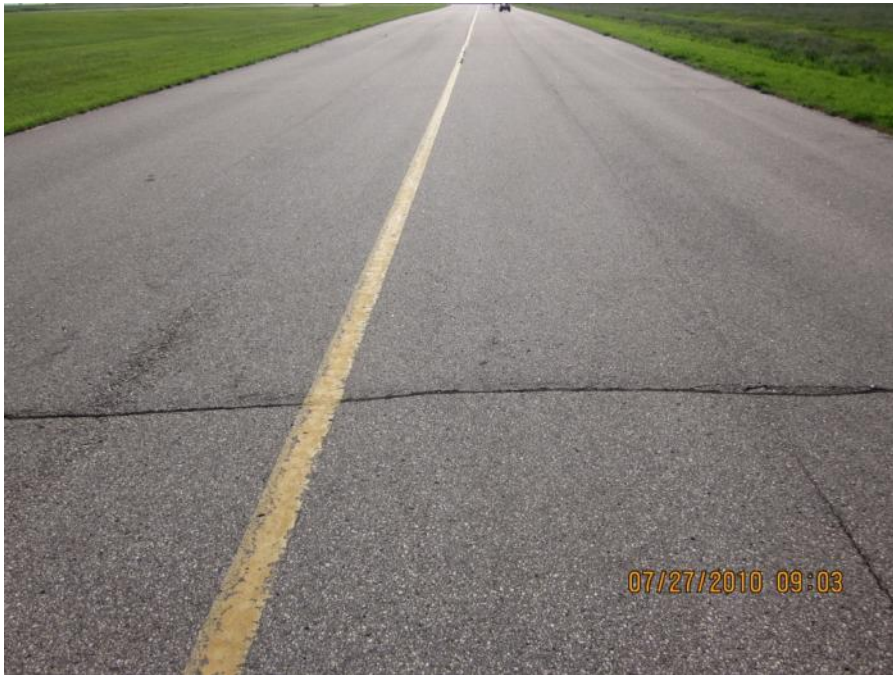
DXX CTA 001 (PCI = 64)

Conditions: PCI:64.00 |

48 LONGITUDINAL/TRANSVERSE CRACKING L 237.00 Ft

48 LONGITUDINAL/TRANSVERSE CRACKING M 62.00 Ft

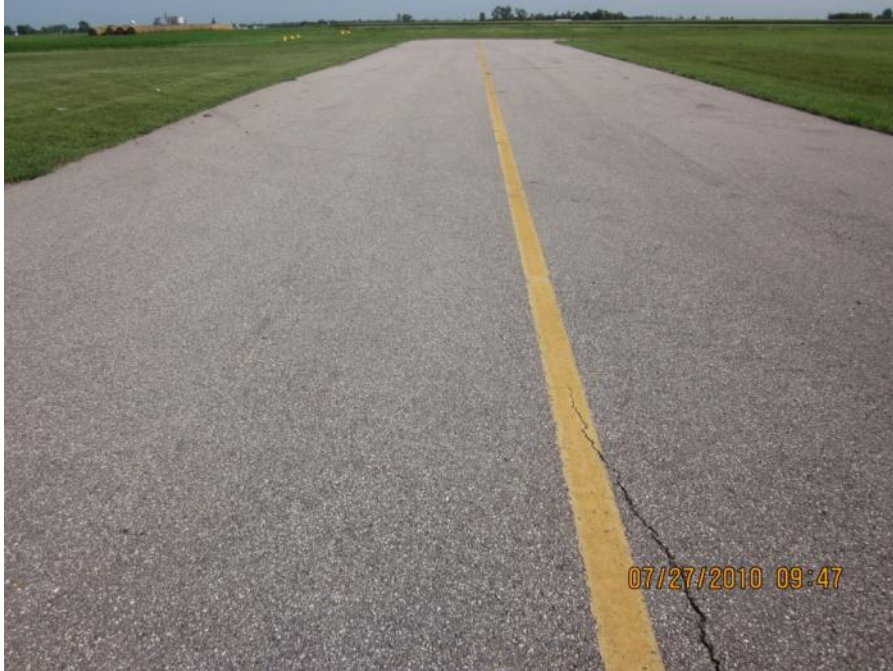
DXX CTB 001 (PCI = 54)

Conditions: PCI:54.00 |

48	LONGITUDINAL/TRANSVERSE CRACKING	L	161.00	Ft
48	LONGITUDINAL/TRANSVERSE CRACKING	M	11.00	Ft
52	WEATHERING/RAVELING	M	20.00	SqFt
52	WEATHERING/RAVELING	H	5.00	SqFt
52	WEATHERING/RAVELING	L	3,975.00	SqFt

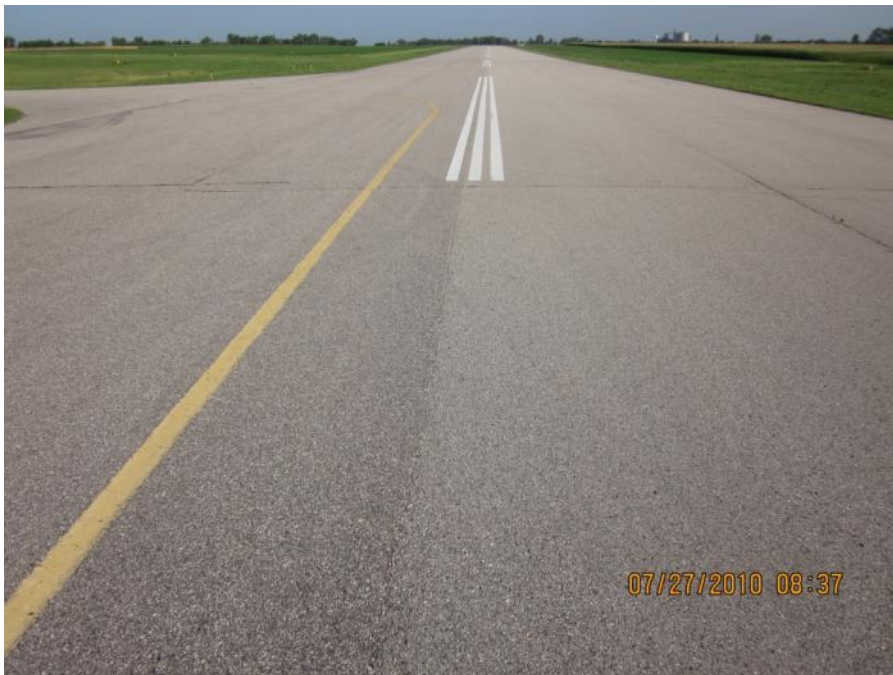
DXX RY1331 001 (PCI = 64)

Conditions: PCI:64.00 |

Sample Number: 106 Type: R Area: 3,750.00SqFt PCI = 64
48 LONGITUDINAL/TRANSVERSE CRACKING L 167.00 Ft
48 LONGITUDINAL/TRANSVERSE CRACKING M 55.00 Ft
52 WEATHERING/RAVELING L 3,750.00 SqFt

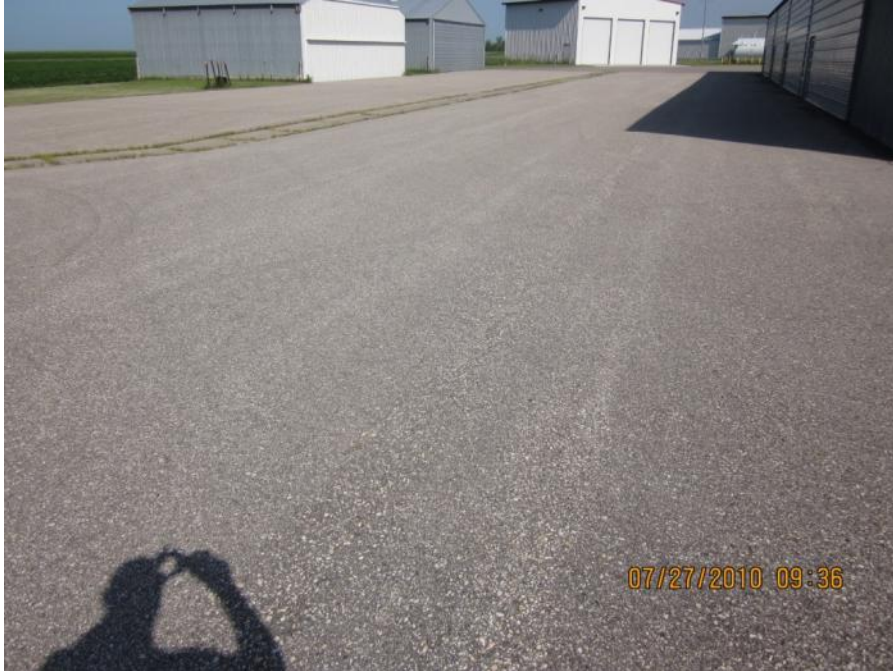
DXX TLA 001 (PCI = 62)

Conditions: PCI:62.00 |

48	LONGITUDINAL/TRANSVERSE CRACKING	L	163.00	Ft
52	WEATHERING/RAVELING	L	4,800.00	SqFt
41	ALLIGATOR CRACKING	L	95.00	SqFt
53	RUTTING	L	20.00	SqFt
53	RUTTING	M	5.00	SqFt
