Minnesota Airport System Pavement Evaluation 2010 Update

Granite Falls Municipal Airport
(GDB)

Granite Falls, Minnesota

December 2010

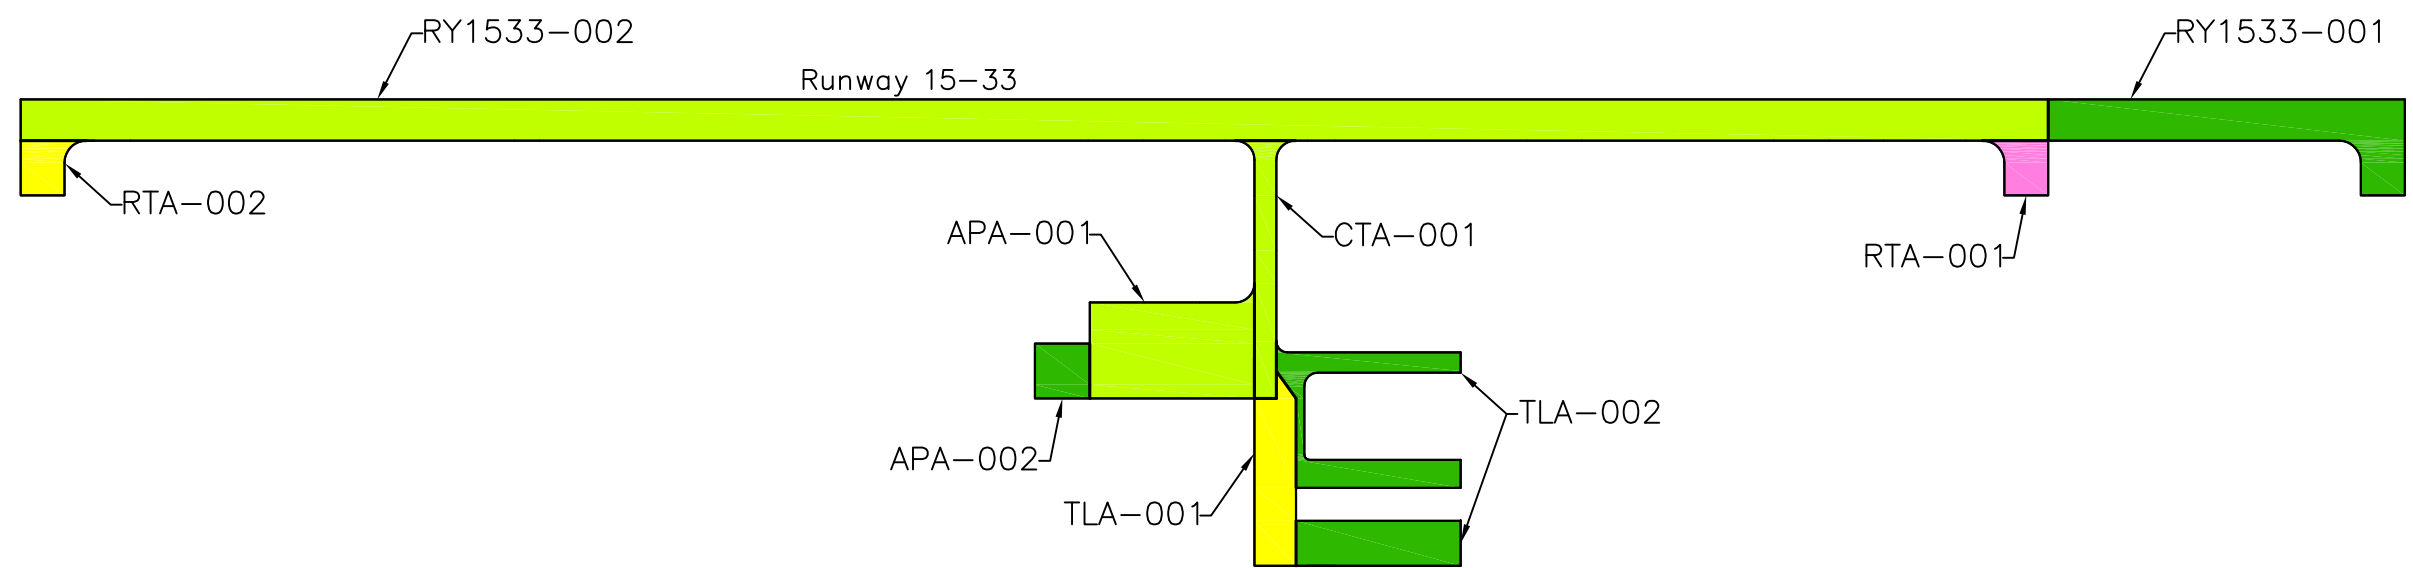
Figure 4. 2010 Pavement Condition Index Rating at Granite Falls Municipal Airport (GDB).

The results of the 2010 PCI inspection are presented in figure 4. The overall area-weighted PCI for GDB is 79. When summarizing PCI values, an area-weighted calculation is used instead of a straight mathematical average because the area-weighted calculations eliminate the skewing of the PCI due to the disparity of the section sizes.

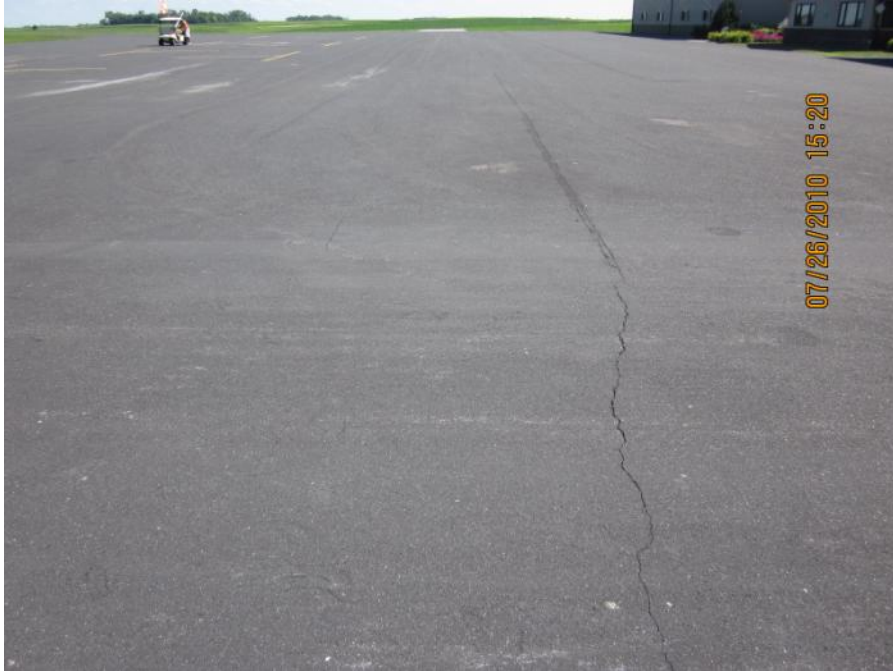
GDB APA 001 (PCI = 72)

48	LONGITUDINAL/TRANSVERSE CRACKING	L	307.00	Ft
48	LONGITUDINAL/TRANSVERSE CRACKING	M	10.00	Ft
41	ALLIGATOR CRACKING	L	4.00	SqFt

48	LONGITUDINAL/TRANSVERSE CRACKING	L	410.00	Ft
41	ALLIGATOR CRACKING	L	84.00	SqFt
53	RUTTING	L	172.00	SqFt

48	LONGITUDINAL/TRANSVERSE CRACKING	L	141.00	Ft
48	LONGITUDINAL/TRANSVERSE CRACKING	M	36.00	Ft

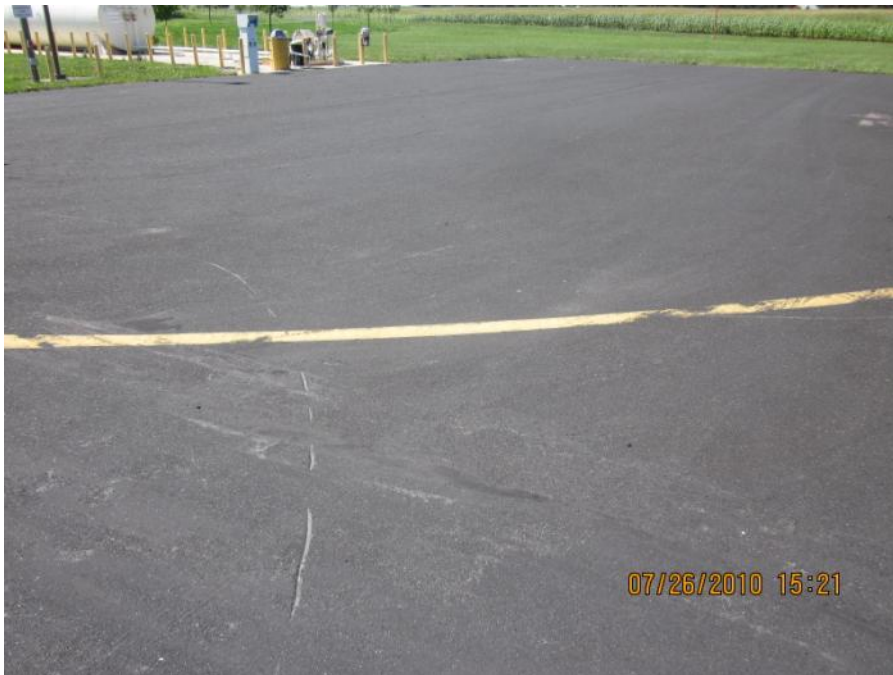
GDB APA 002 (PCI = 98)

Conditions: PCI:98.00 I

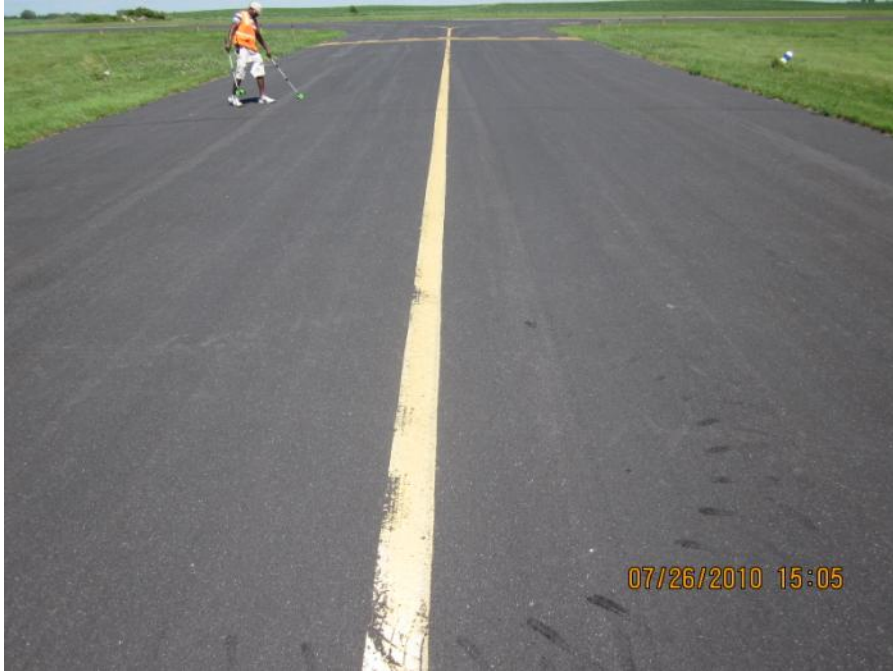
GDB CTA 001 (PCI = 76)

48 LONGITUDINAL/TRANSVERSE CRACKING L 95.00 Ft

48 LONGITUDINAL/TRANSVERSE CRACKING M 42.00 Ft

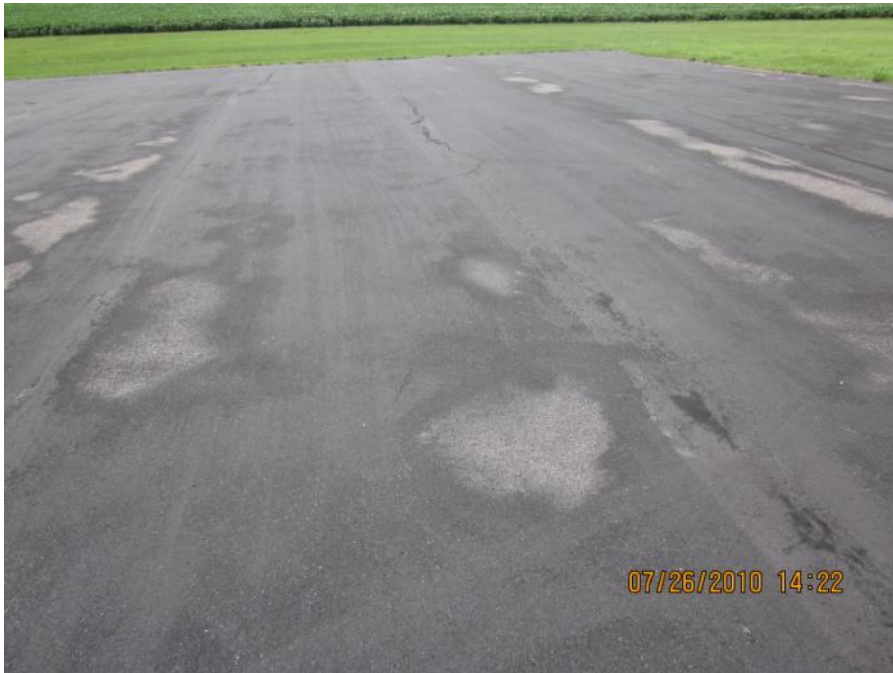
GDB RTA 001 (PCI = 45)

48	LONGITUDINAL/TRANSVERSE CRACKING	L	123.00	Ft
48	LONGITUDINAL/TRANSVERSE CRACKING	M	10.00	Ft
41	ALLIGATOR CRACKING	M	55.00	SqFt
41	ALLIGATOR CRACKING	L	26.00	SqFt
53	RUTTING	L	144.00	SqFt

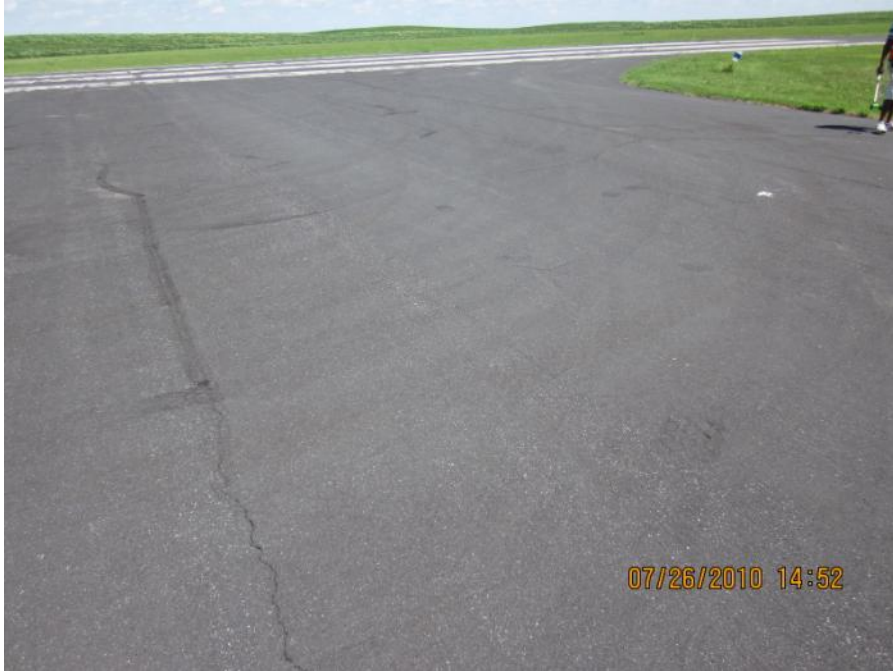
GDB RTA 002 (PCI = 60)

41 ALLIGATOR CRACKING L 24.00 SqFt

48 LONGITUDINAL/TRANSVERSE CRACKING L 455.00 Ft

48 LONGITUDINAL/TRANSVERSE CRACKING M 17.00 Ft

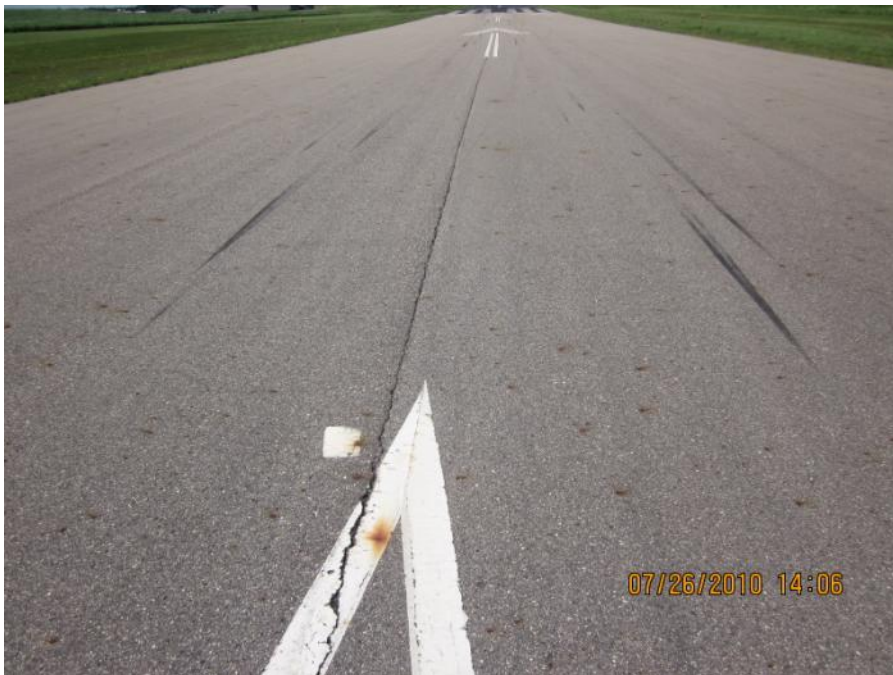
GDB RY1533 001 (PCI = 91)

48 LONGITUDINAL/TRANSVERSE CRACKING L 118.00 Ft

48 LONGITUDINAL/TRANSVERSE CRACKING M 2.00 Ft

48 LONGITUDINAL/TRANSVERSE CRACKING L 68.00 Ft

48 LONGITUDINAL/TRANSVERSE CRACKING L 23.00 Ft

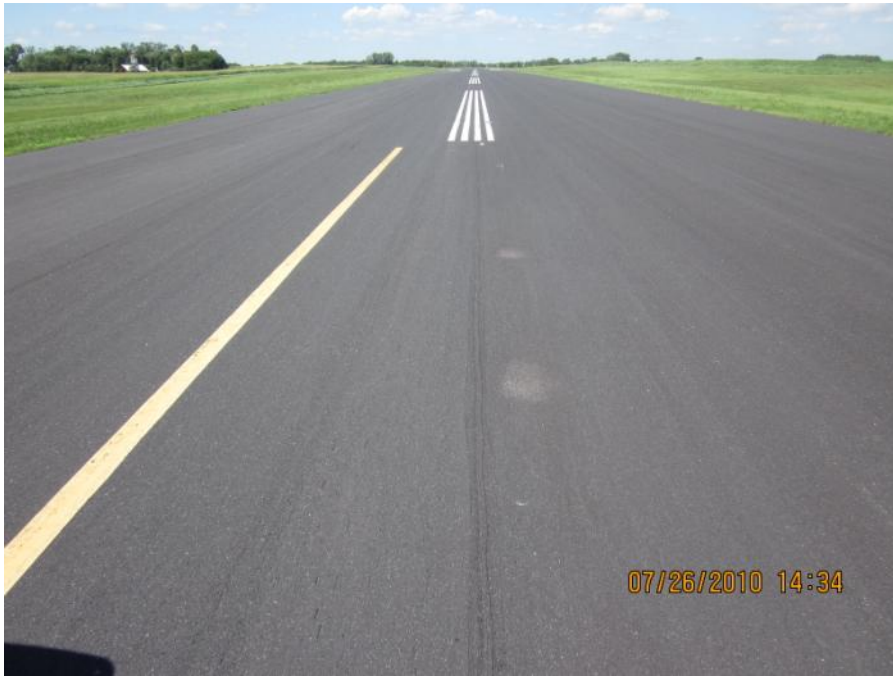
GDB RY1533 002 (PCI = 76)

48 LONGITUDINAL/TRANSVERSE CRACKING L 298.00 Ft

48 LONGITUDINAL/TRANSVERSE CRACKING M 12.00 Ft

48 LONGITUDINAL/TRANSVERSE CRACKING L 246.00 Ft

48 LONGITUDINAL/TRANSVERSE CRACKING M 13.00 Ft

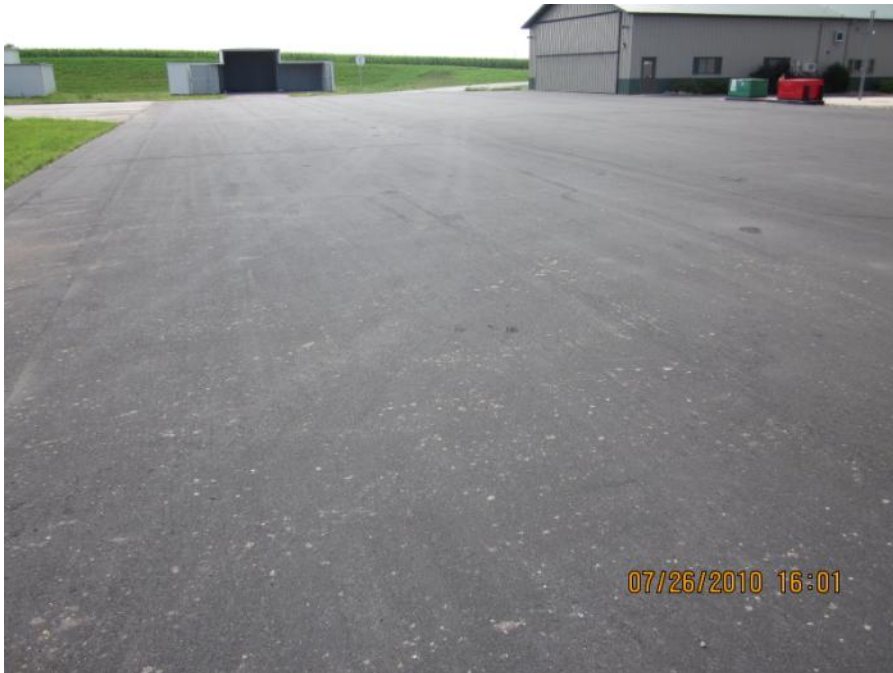
GDB TLA 001 (PCI = 67)

48	LONGITUDINAL/TRANSVERSE CRACKING	L	342.00	Ft
48	LONGITUDINAL/TRANSVERSE CRACKING	M	31.00	Ft
41	ALLIGATOR CRACKING	L	17.00	SqFt
53	RUTTING	L	15.00	SqFt

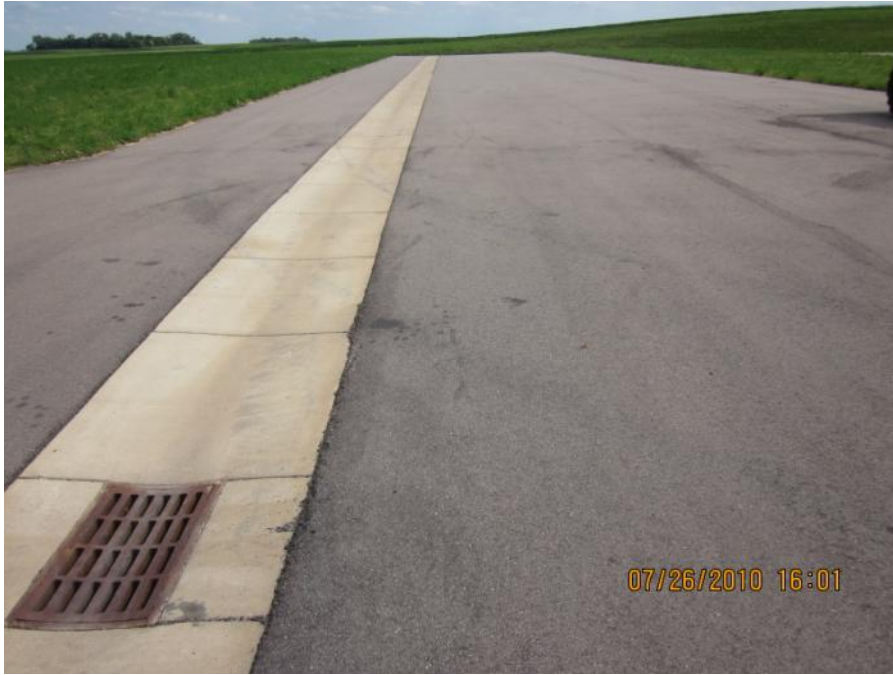
GDB TLA 002 (PCI = 97)

Sample Number: 202 Type: R Area: 4,056.00SqFt PCI = 97
48 LONGITUDINAL/TRANSVERSE CRACKING L 11.00 Ft

Sample Number: 301 Type: R Area: 4,100.00SqFt PCI = 97
48 LONGITUDINAL/TRANSVERSE CRACKING L 7.00 Ft

Sample Number: 303 Type: R Area: 4,100.00SqFt PCI = 96
48 LONGITUDINAL/TRANSVERSE CRACKING L 25.00 Ft
