Minnesota Airport System Pavement Evaluation 2010 Update

Hutchinson Municipal Airport
(HCD)

Hutchinson, Minnesota

December 2010

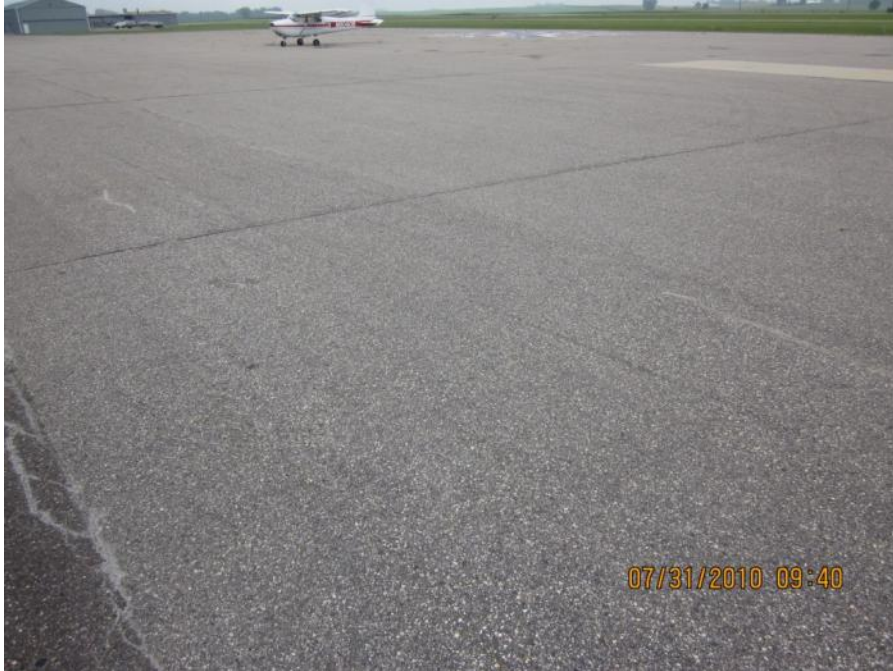
HCD APB 001 (PCI = 76)

Branch ID	Section ID	Surface type ¹	Section Area (SF)	LCD ²	2010 PCI	% Deduct due to		Distress types
						Load ³	Climate ⁴	
APB	1	AC	123,875	2000	76	42	58	Alligator cracking, Longitudinal & transverse (L&T) cracking, Rutting
APB	2	PCC	4,000	2000	91	0	79	Joint seal damage, Corner spall
CTB	1	AC	10,950	1994	64	22	78	Alligator cracking, L&T cracking, Weathering/raveling
CTC	1	AC	10,950	1994	55	13	87	Alligator cracking, L&T cracking, Weathering/raveling
CTCX	1	AC	16,200	2000	61	19	81	L&T cracking, Rutting
CTD	1	AC	10,950	1994	70	0	100	L&T cracking
PTA	1	AC	7,615	1994	63	25	75	Alligator cracking, L&T cracking
PTA	2	AC	42,100	2000	80	0	100	L&T cracking
PTA	3	AC	130,275	1994	58	22	75	Alligator cracking, L&T cracking, Swelling
RY1533	1	AC	300,000	1994	57	31	69	Alligator cracking, L&T cracking, Weathering/raveling, Rutting
TLA	1	AC	43,150	2000 ⁵	71	42	53	Alligator cracking, L&T cracking, Swelling
TLA	2	AC	20,600	2002 ⁵	67	0	100	L&T cracking, Weathering/raveling

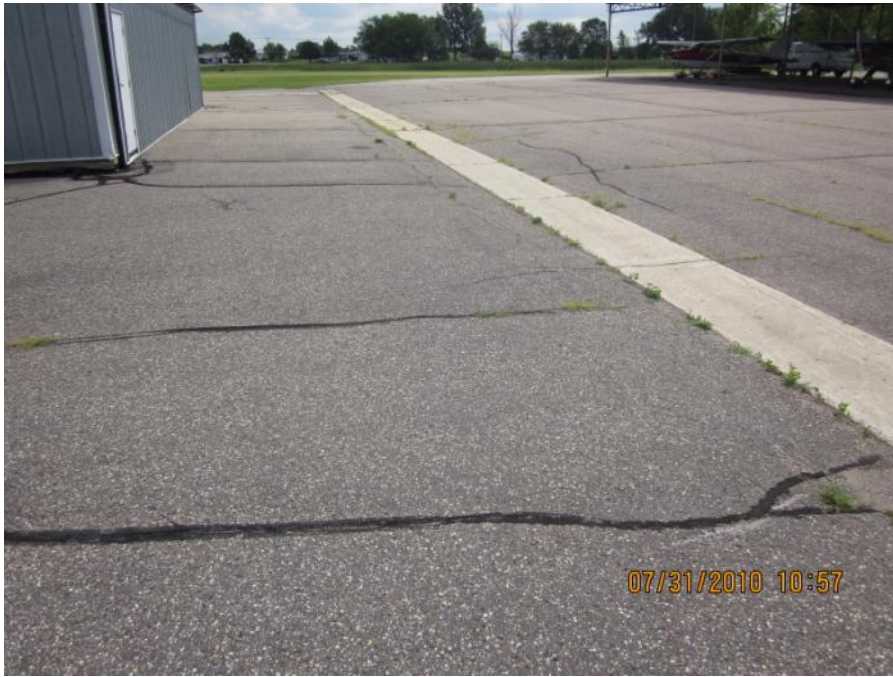
HCD TLA 003 (PCI = 52)

TLA	3	AC	47,700	1990 ⁵	52	31	69	Alligator cracking, L&T cracking, Weathering/raveling
TLA	4	PCC	6,400	1990 ⁵	40	73	11	Corner break, Linear cracking, Joint seal damage, Small patch, Faulting, Shatter slab, Shrinkage crack, Joint spall, Corner spall
TLA	5	AC	8,250	2000 ⁵	79	0	100	L&T cracking
TLB	1	AC	51,100	2000	79	0	100	L&T cracking, Patching
