# Minnesota Airport System Pavement Evaluation 2010 Update

St. James Municipal Airport  
(JYG)

December 2010

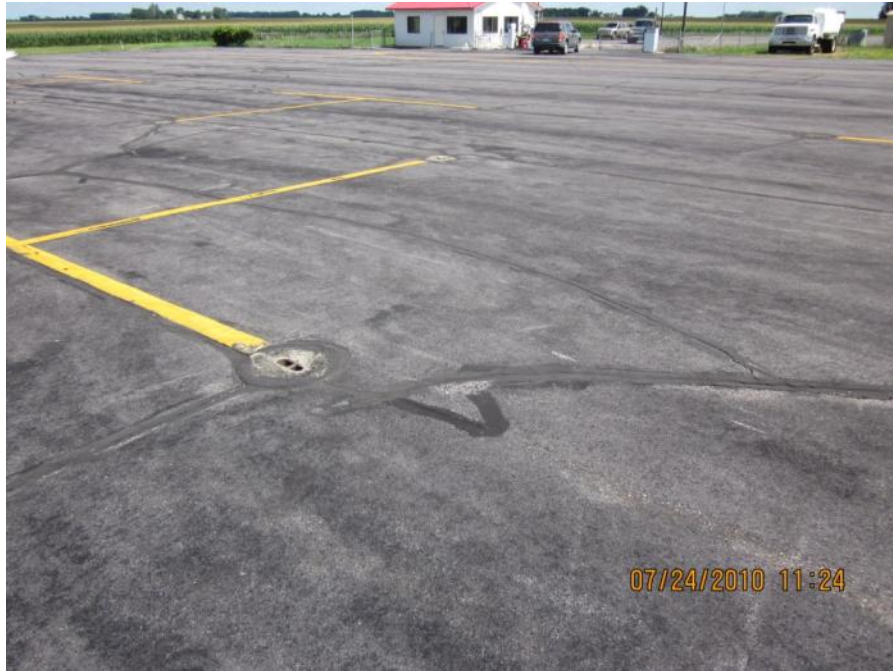
JYG APA 001 (PCI = 78)

| Branch ID | Section ID | Surface type <sup>1</sup> | Section Area (SF) | LCD <sup>2</sup> | 2010 PCI | % Deduct due to | | Distress types |
|---|---|---|---|---|---|---|---|---|
| APA | 1 | AC | 46,800 | 2001 <sup>5</sup> | 78 | 0 | 100 | Longitudinal & transverse (L&T) cracking |

Last Insp. Date: 7/24/2010      Total Samples: 9      Surveyed: 2  
Conditions: PCI: 78.00 |

| 48 LONGITUDINAL/TRANSVERSE CRACKING | L | 235.00 Ft | |
| 48 LONGITUDINAL/TRANSVERSE CRACKING | M | 85.00 Ft | |

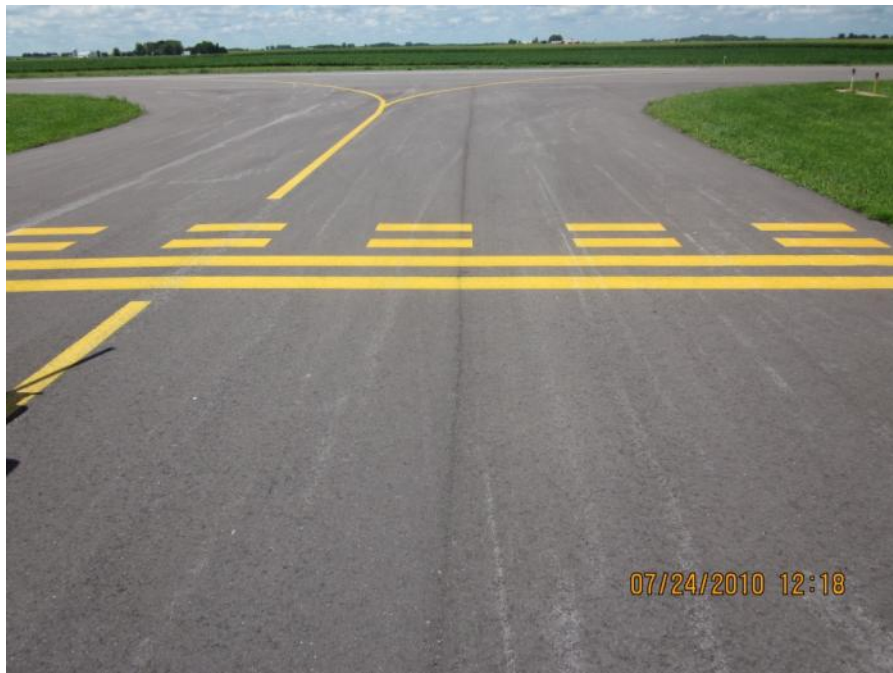
JYG CTA 001 (PCI = 100)

Conditions: PCI:100.00 |

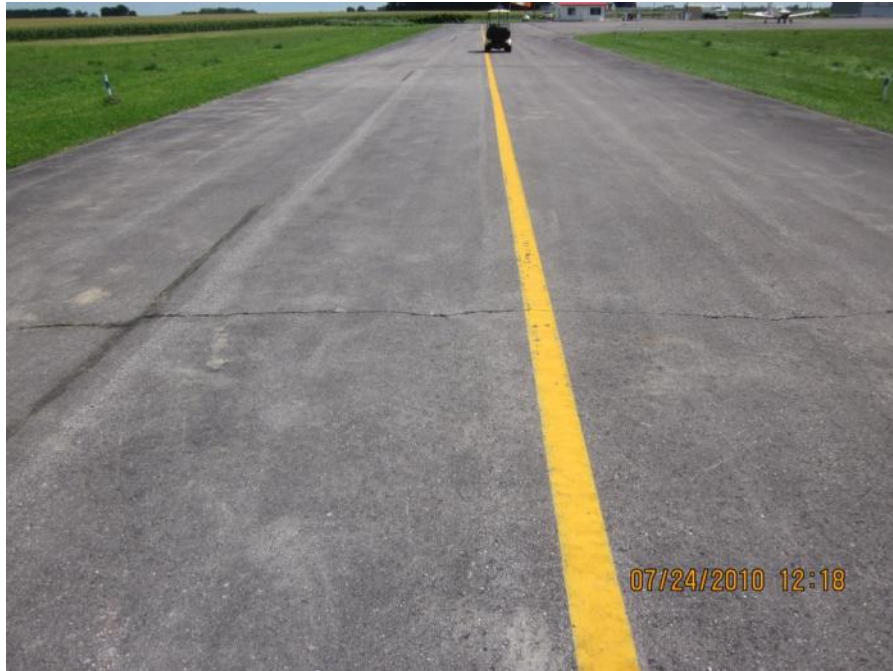
JYG CTA 002 (PCI = 65)

| Branch ID | Section ID | Surface type <sup>1</sup> | Section Area (SF) | LCD <sup>2</sup> | 2010 PCI | % Deduct due to | | Distress types |
|---|---|---|---|---|---|---|---|---|
| CTA | 2 | AC | 9,450 | 2001 <sup>5</sup> | 65 | 26 | 74 | Alligator cracking, L&T cracking, Weathering/raveling |

Last Insp. Date: 7/24/2010 Total Samples: 3 Surveyed: 1  
Conditions: PCI: 65.00

| 48 | LONGITUDINAL/TRANSVERSE CRACKING | L | | 135.00 | Ft | |
| 48 | LONGITUDINAL/TRANSVERSE CRACKING | M | | 4.00 | Ft | |
| 48 | LONGITUDINAL/TRANSVERSE CRACKING | H | | 40.00 | Ft | |
| 41 | ALLIGATOR CRACKING | L | | 15.00 | SqFt | |

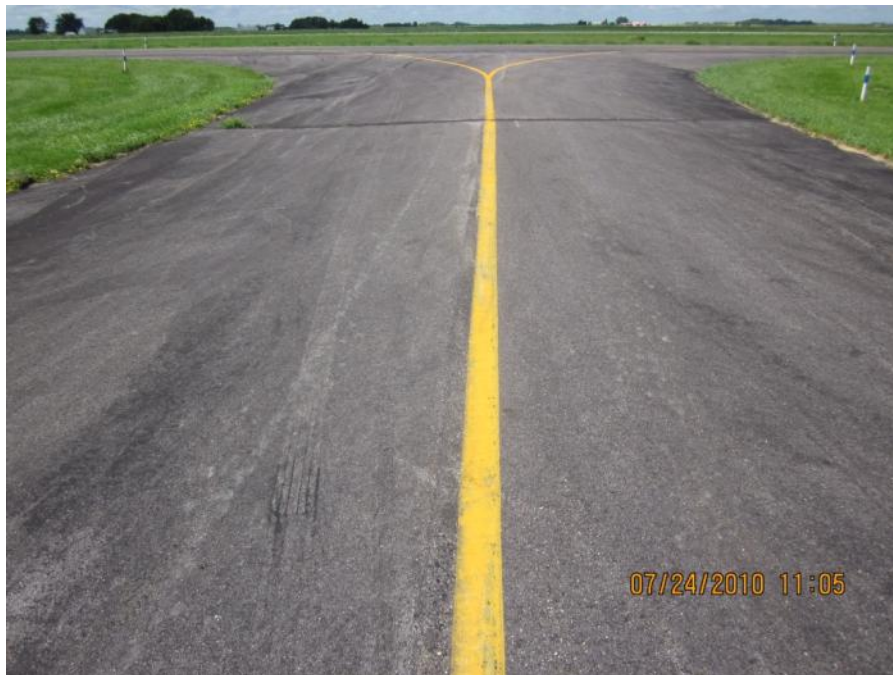
JYG CTB 001 (PCI = 79)

| Branch ID | Section ID | Surface type <sup>1</sup> | Section Area (SF) | LCD <sup>2</sup> | 2010 PCI | % Deduct due to | | Distress types |
|---|---|---|---|---|---|---|---|---|
| CTB | 1 | AC | 4,950 | 2001 <sup>5</sup> | 79 | 0 | 100 | L&T cracking, Weathering/raveling |

Last Insp. Date: 7/24/2010      Total Samples: 1      Surveyed: 1  
Conditions: PCI: 79.00 |

| 48 LONGITUDINAL/TRANSVERSE CRACKING | L | 75.00 Ft | |
| 48 LONGITUDINAL/TRANSVERSE CRACKING | M | 31.00 Ft | |

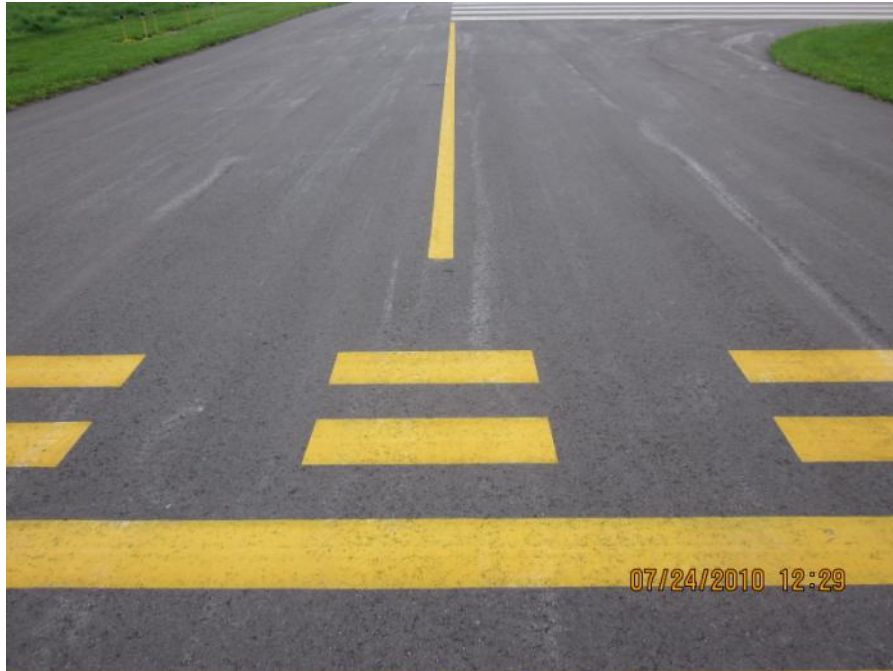
JYG PPTA 001 (PCI = 100)

Conditions: PCI:100.00 |

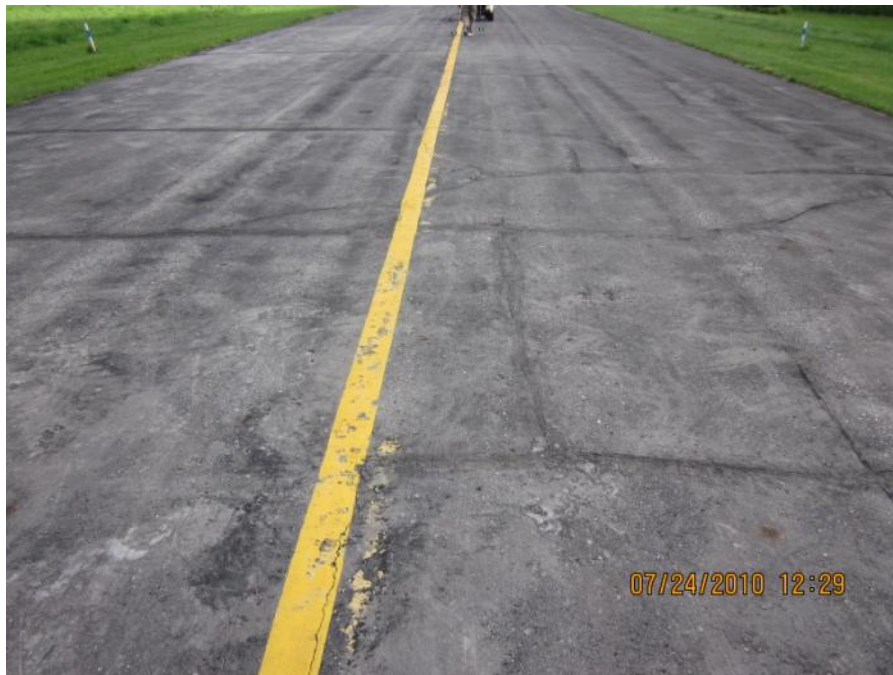
JYG PPTA 002 (PCI = 59)

| Branch ID | Section ID | Surface type <sup>1</sup> | Section Area (SF) | LCD <sup>2</sup> | 2010 PCI | % Deduct due to | | Distress types |
|---|---|---|---|---|---|---|---|---|
| PPTA | 2 | AAC | 6,000 | 1999 | 59 | 15 | 85 | Alligator cracking, L&T cracking, Weathering/raveling |

Last Insp. Date: 7/24/2010 Total Samples: 2 Surveyed: 1  
Conditions: PCI: 59.00 I

| 48 | LONGITUDINAL/TRANSVERSE CRACKING | L | | 358.00 | Ft | |
| 48 | LONGITUDINAL/TRANSVERSE CRACKING | M | | 39.00 | Ft | |
| 48 | LONGITUDINAL/TRANSVERSE CRACKING | H | | 3.00 | Ft | |
| 41 | ALLIGATOR CRACKING | L | | 6.00 | SqFt | |

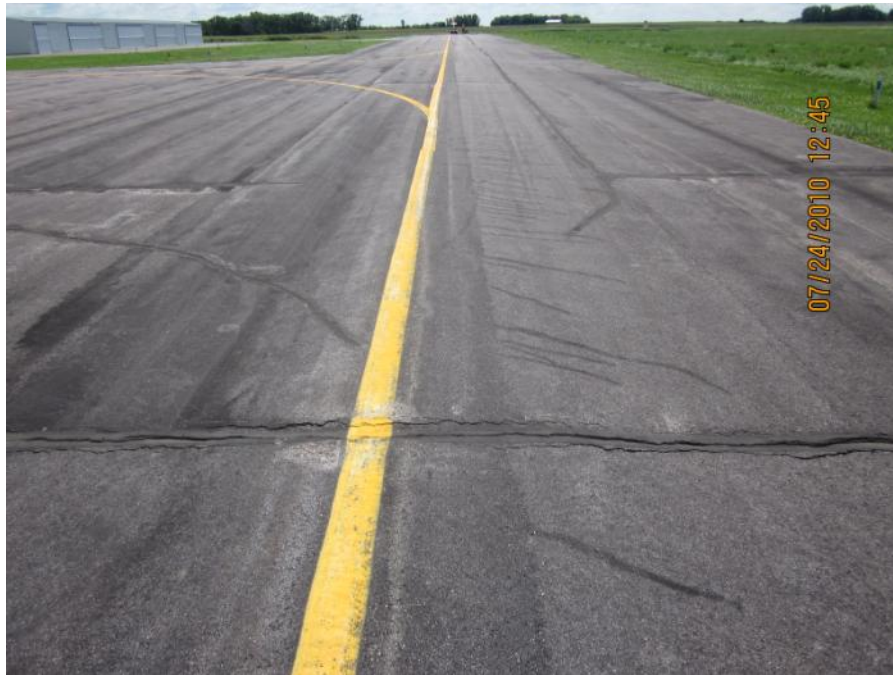
JYG PPTA 003 (PCI = 74)

| Branch ID | Section ID | Surface type <sup>1</sup> | Section Area (SF) | LCD <sup>2</sup> | 2010 PCI | % Deduct due to | | Distress types |
|---|---|---|---|---|---|---|---|---|
| PPTA | 3 | AC | 59,080 | 2001 | 74 | 0 | 100 | L&T cracking, Weathering/raveling |

Last Insp. Date: 7/24/2010 Total Samples: 14 Surveyed: 3  
Conditions: PCI: 74.00

Sample Number: 106 Type: R Area: 4,000.00SqFt PCI = 73  
48 LONGITUDINAL/TRANSVERSE CRACKING L 176.00 Ft  
48 LONGITUDINAL/TRANSVERSE CRACKING M 66.00 Ft  
48 LONGITUDINAL/TRANSVERSE CRACKING H 28.00 Ft

Sample Number: 110 Type: R Area: 4,000.00SqFt PCI = 78  
48 LONGITUDINAL/TRANSVERSE CRACKING L 234.00 Ft  
48 LONGITUDINAL/TRANSVERSE CRACKING M 55.00 Ft

Sample Number: 115 Type: R Area: 4,000.00SqFt PCI = 69  
48 LONGITUDINAL/TRANSVERSE CRACKING L 140.00 Ft  
48 LONGITUDINAL/TRANSVERSE CRACKING M 32.00 Ft  
48 LONGITUDINAL/TRANSVERSE CRACKING H 25.00 Ft  
52 WEATHERING/RAVELING M 15.00 SqFt

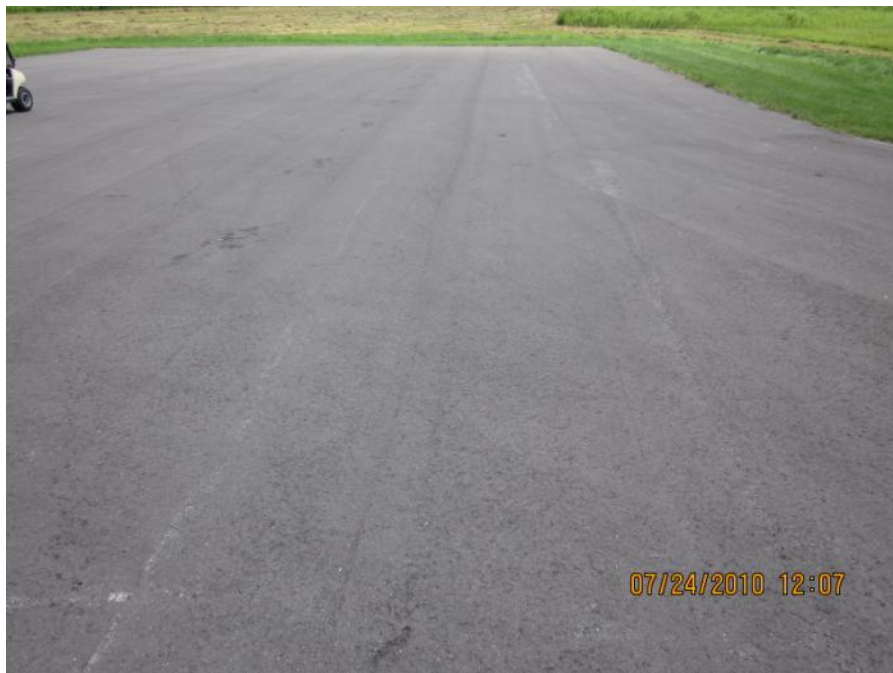
JYG RTA 001 (PCI = 91)

| Branch ID | Section ID | Surface type <sup>1</sup> | Section Area (SF) | LCD <sup>2</sup> | 2010 PCI | % Deduct due to | | Distress types |
|---|---|---|---|---|---|---|---|---|
| RTA | 1 | AC | 9,625 | 2008 | 91 | 0 | 100 | L&T cracking |

Last Insp. Date: 7/24/2010 Total Samples: 3 Surveyed: 1  
Conditions: PCI: 91.00

Sample Number: 280 Type: R Area: 3,750.00SqFt PCI = 91  
48 LONGITUDINAL/TRANSVERSE CRACKING L 96.00 Ft

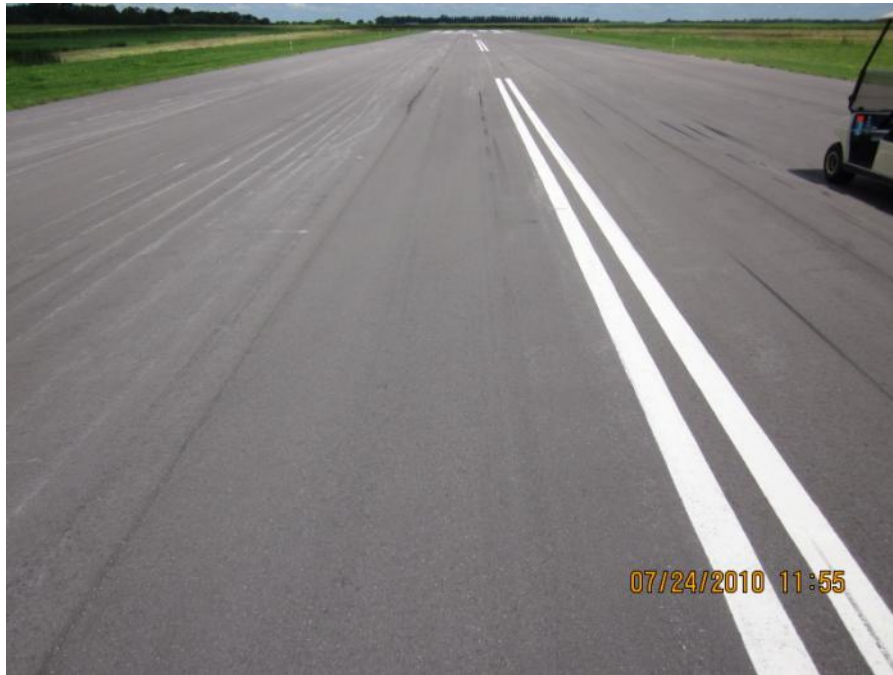
JYG RY1533 001 (PCI = 100)

Last Insp. Date: 7/24/2010 Total Samples: 68 Surveyed: 7  
Conditions: PCI: 100.00

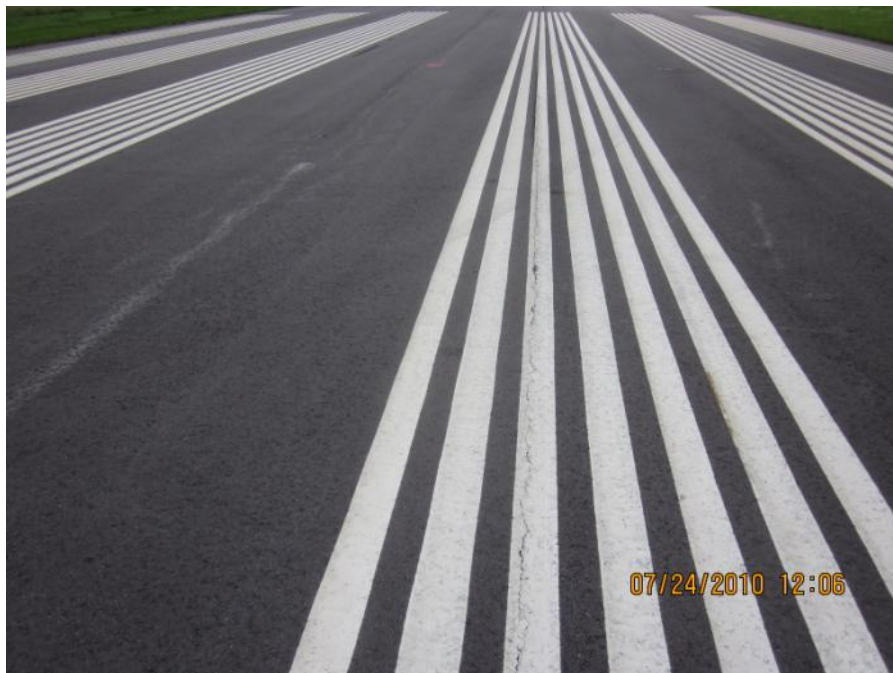
JYG RY1533 002 (PCI = 91)

| Branch ID | Section ID | Surface type <sup>1</sup> | Section Area (SF) | LCD <sup>2</sup> | 2010 PCI | % Deduct due to | | Distress types |
|---|---|---|---|---|---|---|---|---|
| RY1533 | 2 | AAC | 45,000 | 2008 | 91 | 0 | 100 | L&T cracking |

Last Insp. Date: 7/24/2010 Total Samples: 12 Surveyed: 3  
Conditions: PCI: 91.00 I

Sample Number: 170 Type: R Area: 3,750.00SqFt PCI = 94  
48 LONGITUDINAL/TRANSVERSE CRACKING L 50.00 Ft

Sample Number: 174 Type: R Area: 3,750.00SqFt PCI = 90  
48 LONGITUDINAL/TRANSVERSE CRACKING L 106.00 Ft

Sample Number: 178 Type: R Area: 3,750.00SqFt PCI = 88  
48 LONGITUDINAL/TRANSVERSE CRACKING L 140.00 Ft

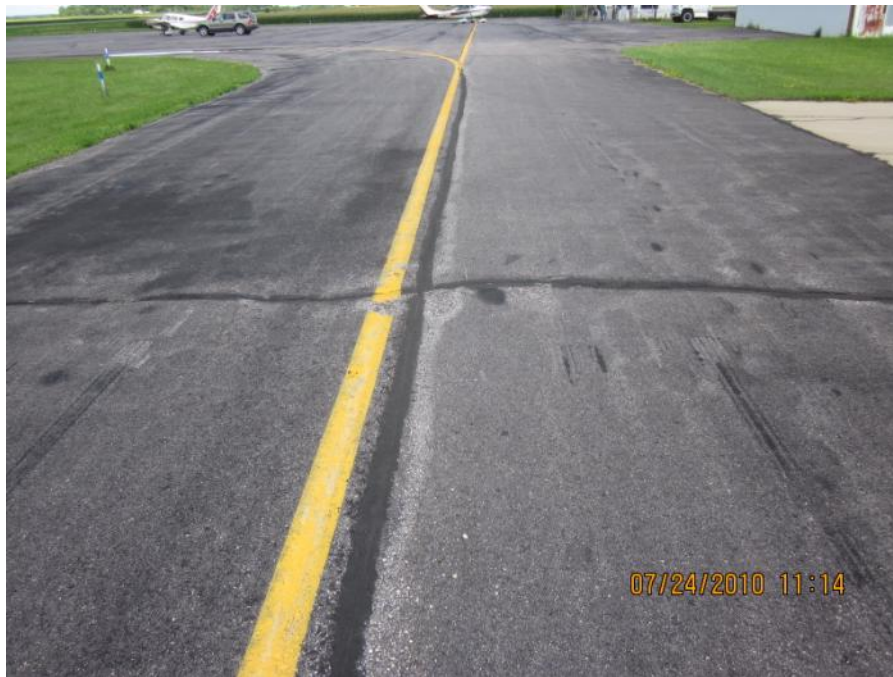
JYG TLA 001 (PCI = 77)

| Branch ID | Section ID | Surface type <sup>1</sup> | Section Area (SF) | LCD <sup>2</sup> | 2010 PCI | % Deduct due to | | Distress types |
|---|---|---|---|---|---|---|---|---|
| TLA | 1 | AC | 6,250 | 2001 <sup>5</sup> | 77 | 0 | 100 | L&T cracking, Weathering/raveling |

Last Insp. Date: 7/24/2010 Total Samples: 2 Surveyed: 1  
Conditions: PCI: 77.00 I

| 48 | LONGITUDINAL/TRANSVERSE CRACKING | | L | | 137.00 Ft | | |
| 48 | LONGITUDINAL/TRANSVERSE CRACKING | | M | | 30.00 Ft | | |

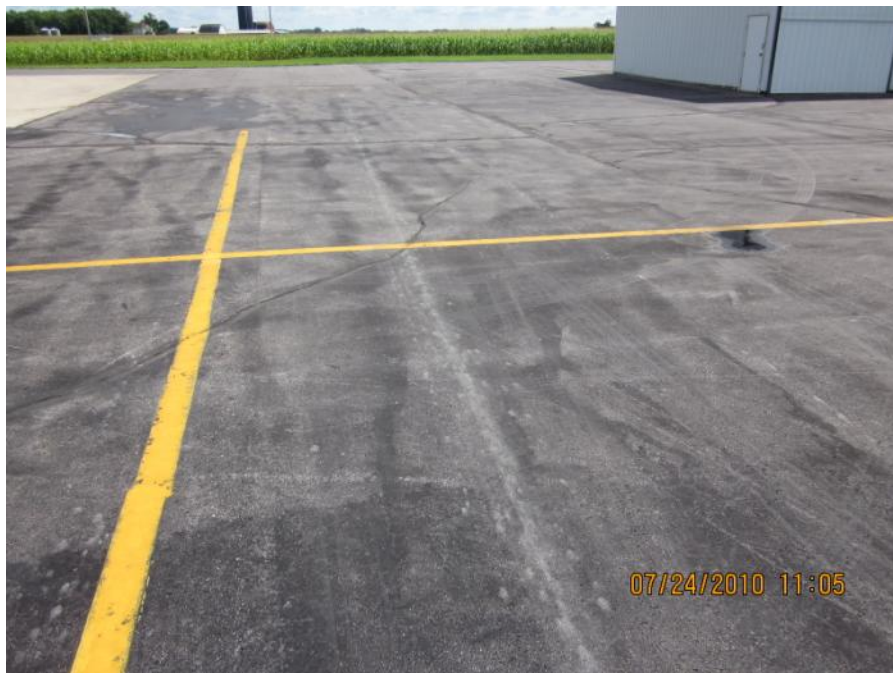
JYG TLA 002 (PCI = 72)

| Branch ID | Section ID | Surface type <sup>1</sup> | Section Area (SF) | LCD <sup>2</sup> | 2010 PCI | % Deduct due to | | Distress types |
|---|---|---|---|---|---|---|---|---|
| TLA | 2 | AC | 38,150 | 2001 <sup>5</sup> | 72 | 17 | 82 | Alligator cracking, Depression, L&T cracking, Weathering/raveling |

Last Insp. Date: 7/24/2010 Total Samples: 8 Surveyed: 2  
Conditions: PCI: 72.00

| 48 LONGITUDINAL/TRANSVERSE CRACKING | L | 141.00 Ft | |
| 48 LONGITUDINAL/TRANSVERSE CRACKING | M | 109.00 Ft | |
| 48 LONGITUDINAL/TRANSVERSE CRACKING | H | 20.00 Ft | |
