Minnesota Airport System Pavement Evaluation 2010 Update

Litchfield Municipal Airport (LJF)

Litchfield, Minnesota

December 2010

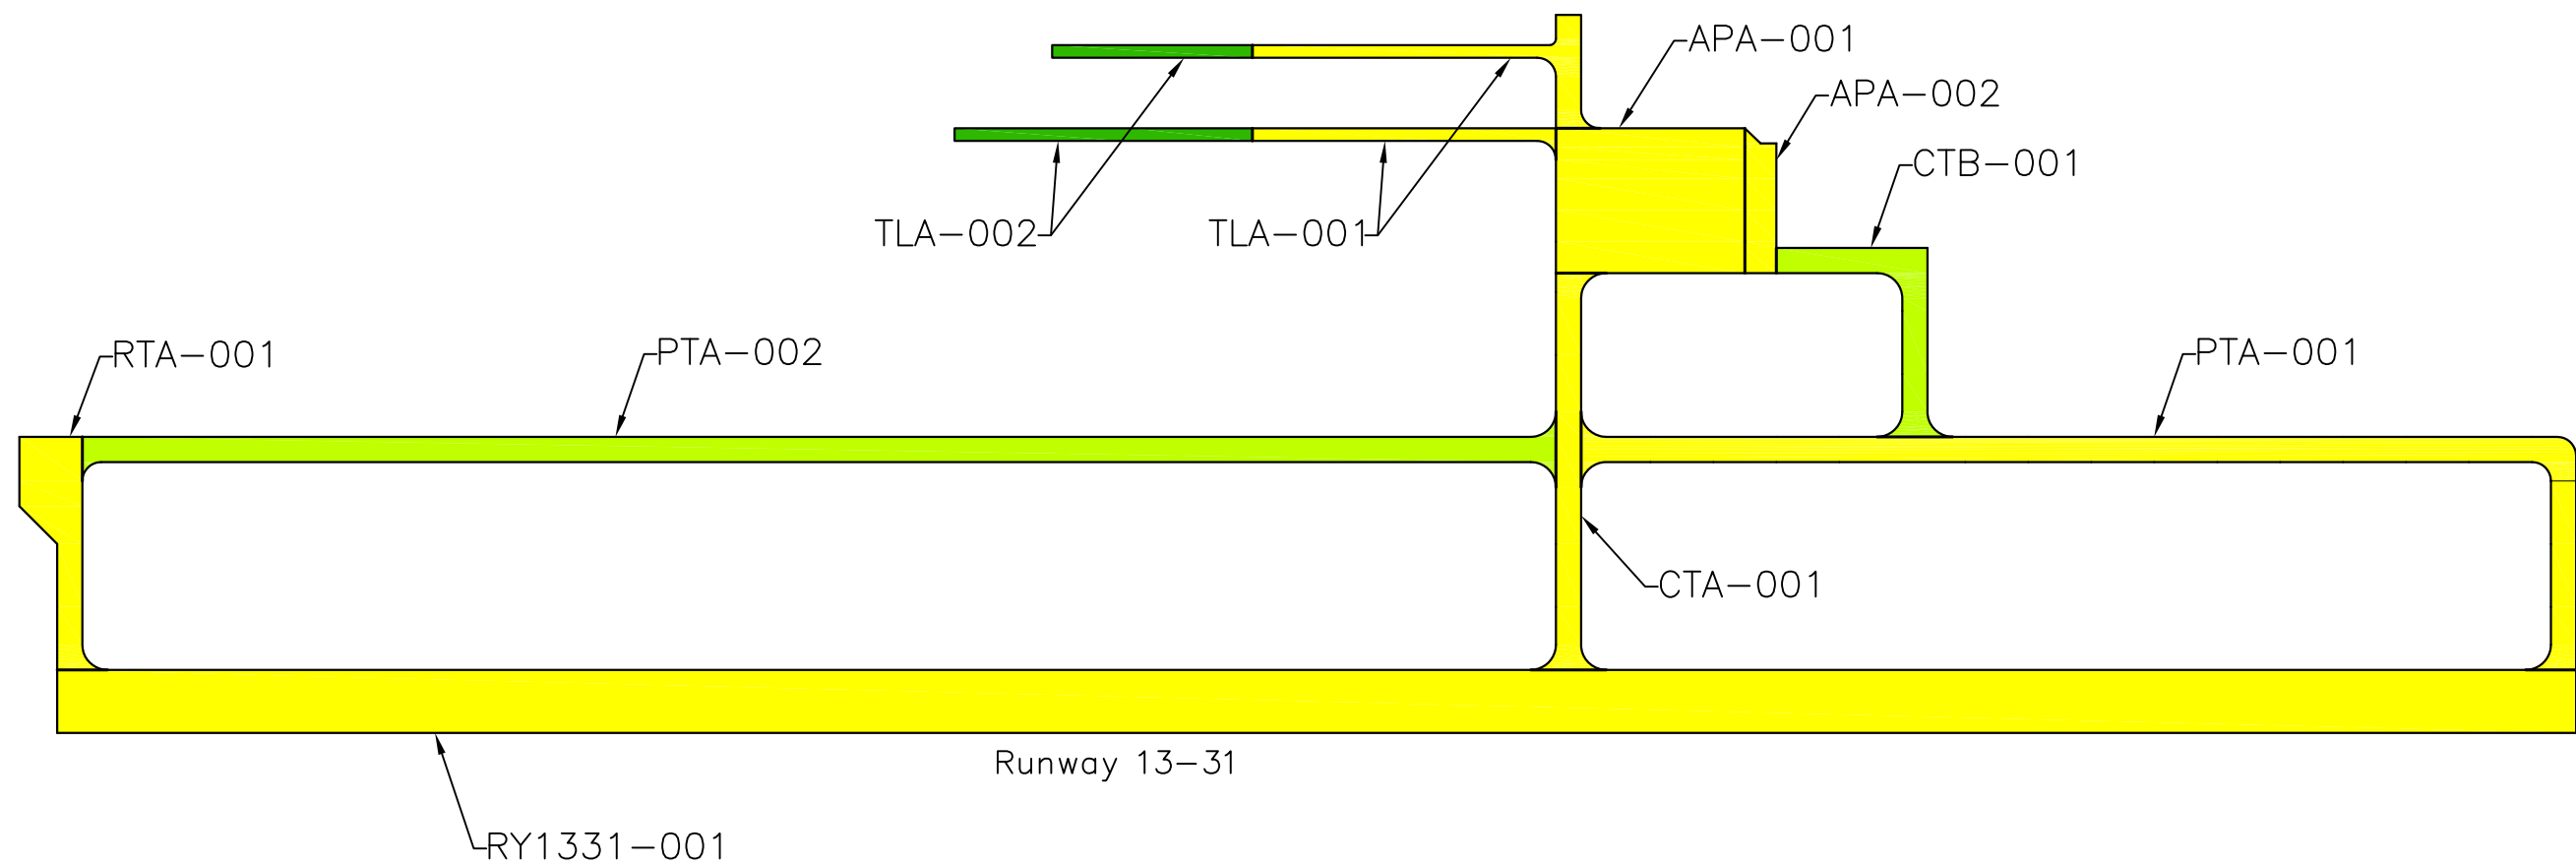
Figure 4. 2010 Pavement Condition Index Rating at Litchfield Municipal Airport (LJF).

The results of the 2010 PCI inspection are presented in figure 4. The overall area-weighted PCI for LJF is 71. When summarizing PCI values, an area-weighted calculation is used instead of a straight mathematical average because the area-weighted calculations eliminate the skewing of the PCI due to the disparity of the section sizes.

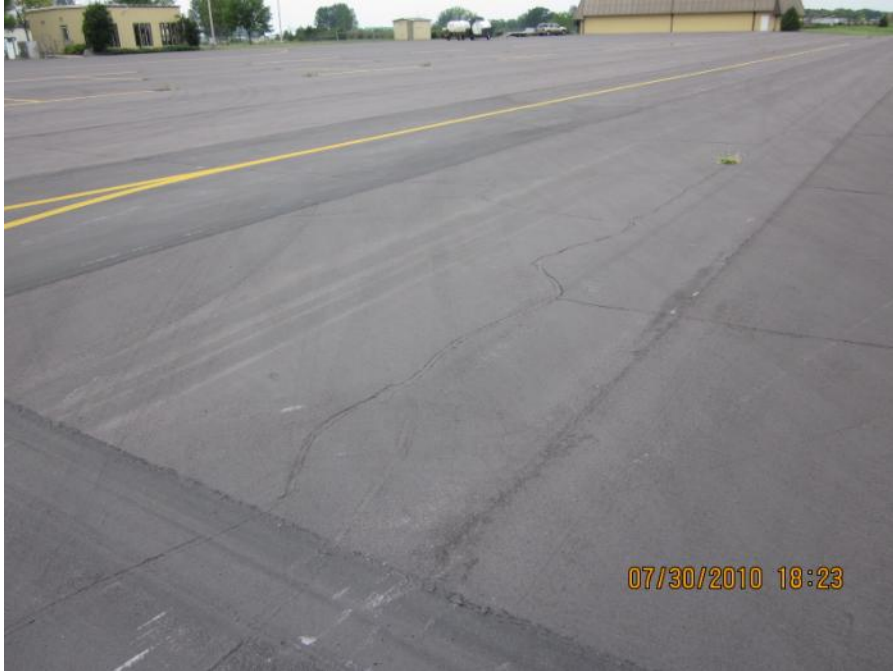
LJF APA 001 (PCI = 67)

Sample Number: 101 Type: R Area: 5,000.00SqFt PCI = 68
48 LONGITUDINAL/TRANSVERSE CRACKING L 666.00 Ft
48 LONGITUDINAL/TRANSVERSE CRACKING M 34.00 Ft

Sample Number: 200 Type: R Area: 5,000.00SqFt PCI = 67
48 LONGITUDINAL/TRANSVERSE CRACKING L 694.00 Ft
48 LONGITUDINAL/TRANSVERSE CRACKING M 20.00 Ft

Sample Number: 401 Type: R Area: 5,000.00SqFt PCI = 67
48 LONGITUDINAL/TRANSVERSE CRACKING L 682.00 Ft
48 LONGITUDINAL/TRANSVERSE CRACKING M 91.00 Ft

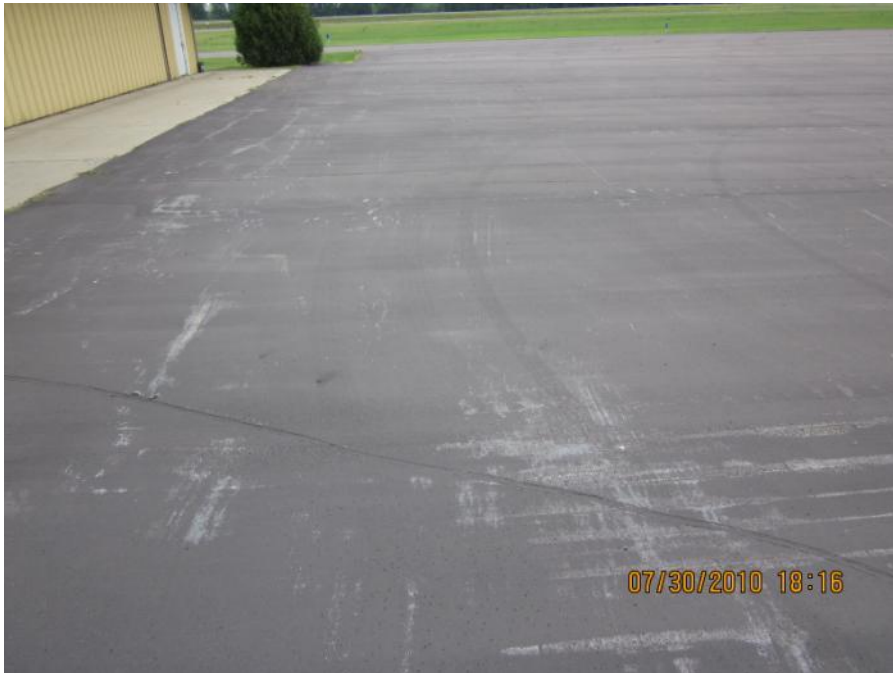
LJF APA 002 (PCI = 70)

48 LONGITUDINAL/TRANSVERSE CRACKING L 717.00 Ft

48 LONGITUDINAL/TRANSVERSE CRACKING M 18.00 Ft

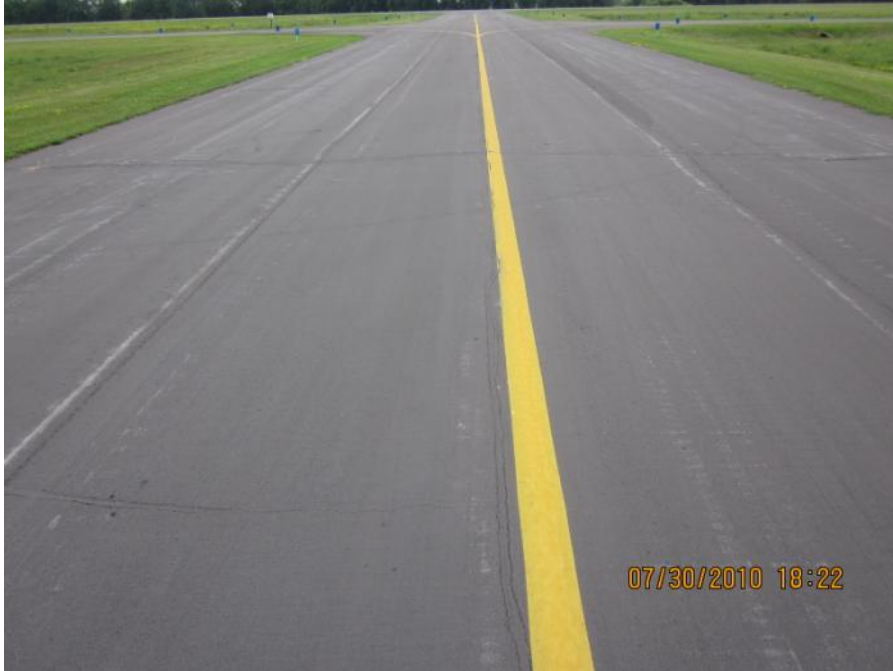
LJF CTA 001 (PCI = 69)

48 LONGITUDINAL/TRANSVERSE CRACKING L 432.00 Ft

48 LONGITUDINAL/TRANSVERSE CRACKING M 86.00 Ft

48 LONGITUDINAL/TRANSVERSE CRACKING L 530.00 Ft

48 LONGITUDINAL/TRANSVERSE CRACKING M 40.00 Ft

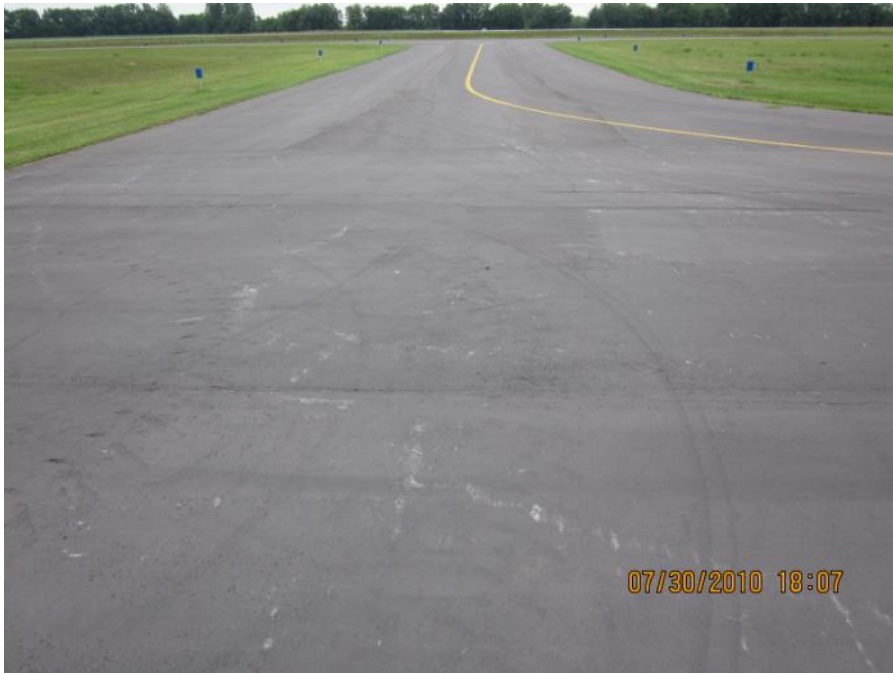
LJF CTB 001 (PCI = 73)

48 LONGITUDINAL/TRANSVERSE CRACKING L 389.00 Ft

48 LONGITUDINAL/TRANSVERSE CRACKING M 2.00 Ft

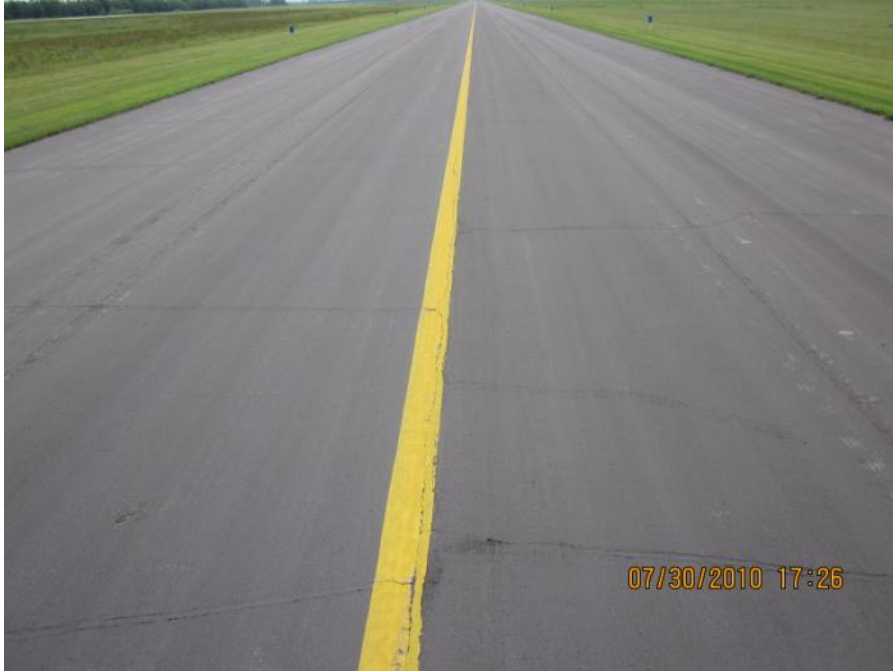
LJF PTA 001 (PCI = 70)

48 LONGITUDINAL/TRANSVERSE CRACKING L 374.00 Ft

48 LONGITUDINAL/TRANSVERSE CRACKING M 43.00 Ft

48 LONGITUDINAL/TRANSVERSE CRACKING L 575.00 Ft

48 LONGITUDINAL/TRANSVERSE CRACKING M 30.00 Ft

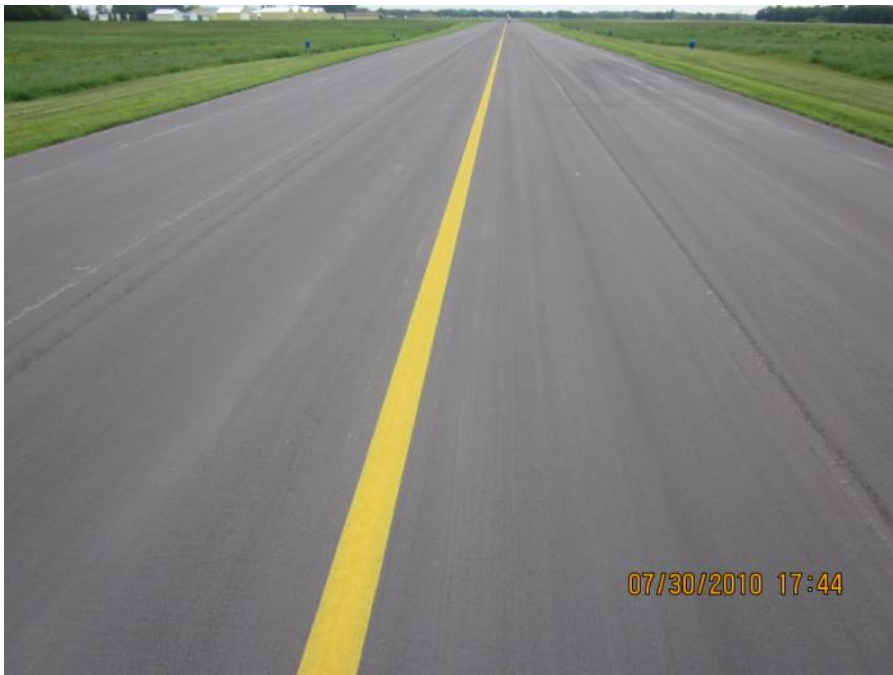
LJF PTA 002 (PCI = 79)

48 LONGITUDINAL/TRANSVERSE CRACKING L 260.00 Ft

48 LONGITUDINAL/TRANSVERSE CRACKING M 10.00 Ft

48 LONGITUDINAL/TRANSVERSE CRACKING L 226.00 Ft

48 LONGITUDINAL/TRANSVERSE CRACKING L 243.00 Ft

48 LONGITUDINAL/TRANSVERSE CRACKING M 9.00 Ft

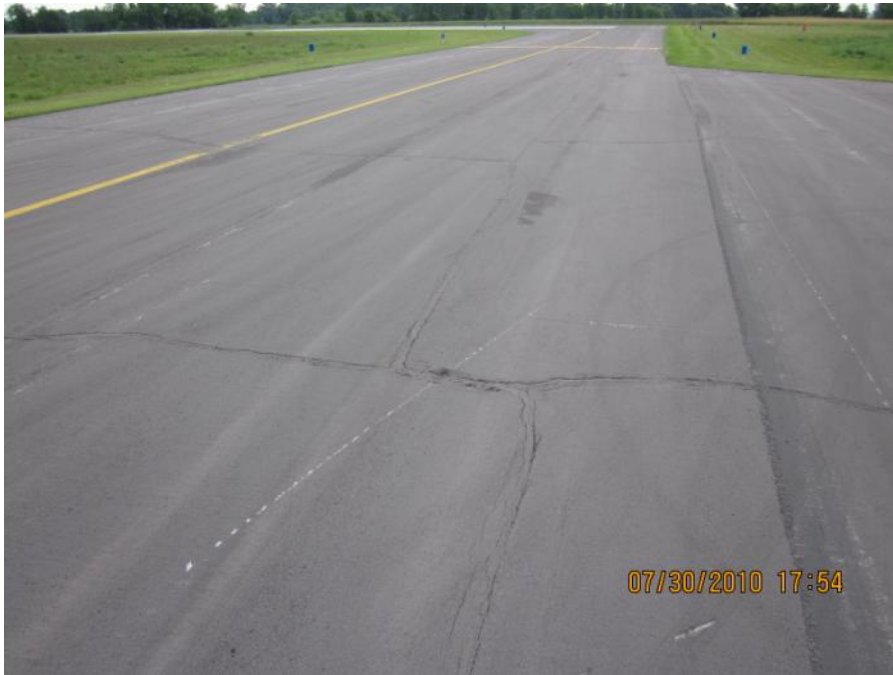
LJF RTA 001 (PCI = 70)

48 LONGITUDINAL/TRANSVERSE CRACKING L 476.00 Ft

48 LONGITUDINAL/TRANSVERSE CRACKING M 5.00 Ft

48 LONGITUDINAL/TRANSVERSE CRACKING L 438.00 Ft

48 LONGITUDINAL/TRANSVERSE CRACKING M 56.00 Ft

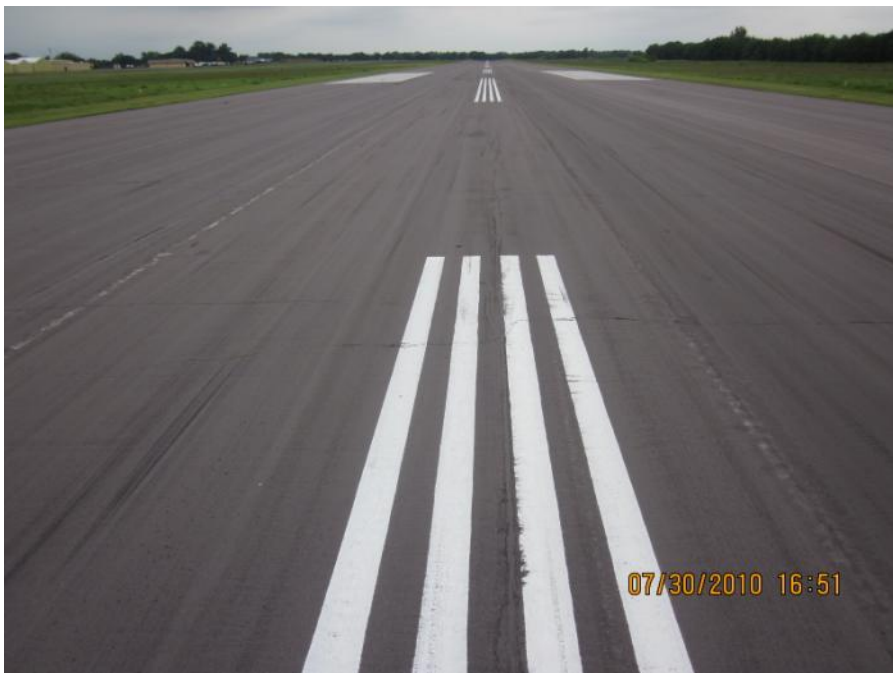
LJF RY1331 001 (PCI = 69)

48 LONGITUDINAL/TRANSVERSE CRACKING L 568.00 Ft

48 LONGITUDINAL/TRANSVERSE CRACKING M 44.00 Ft

48 LONGITUDINAL/TRANSVERSE CRACKING L 739.00 Ft

48 LONGITUDINAL/TRANSVERSE CRACKING M 58.00 Ft

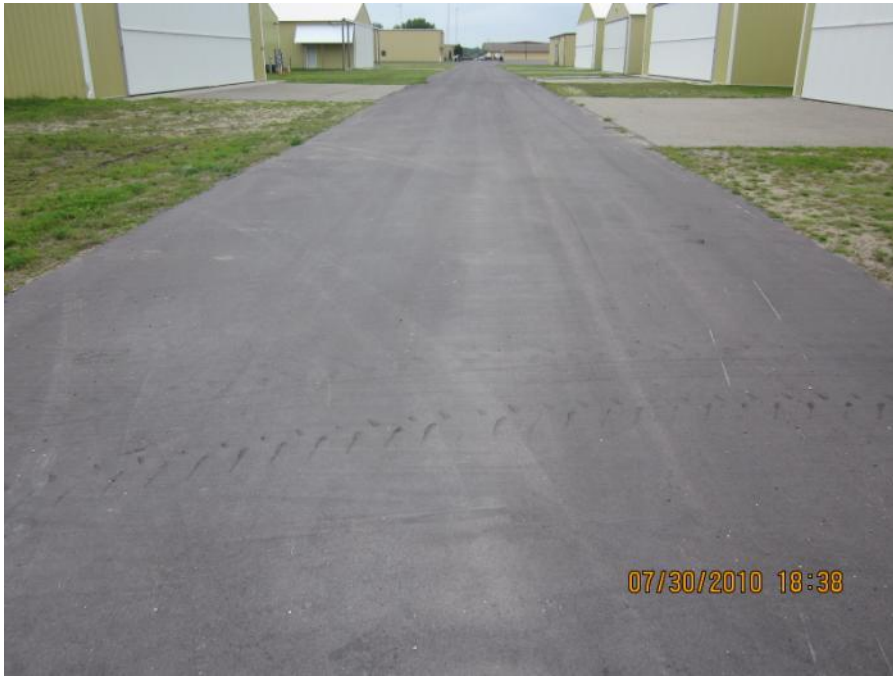
LJF TLA 001 (PCI = 61)

48 LONGITUDINAL/TRANSVERSE CRACKING L 542.00 Ft

48 LONGITUDINAL/TRANSVERSE CRACKING M 48.00 Ft

48 LONGITUDINAL/TRANSVERSE CRACKING L 465.00 Ft

48 LONGITUDINAL/TRANSVERSE CRACKING M 5.00 Ft

41 ALLIGATOR CRACKING L 35.00 SqFt

48 LONGITUDINAL/TRANSVERSE CRACKING L 550.00 Ft

48 LONGITUDINAL/TRANSVERSE CRACKING M 13.00 Ft

41 ALLIGATOR CRACKING L 40.00 SqFt
