Minnesota Airport System Pavement Evaluation 2010 Update

Little Falls – Morrison County
Airport (LXL)

Little Falls, Minnesota

December 2010

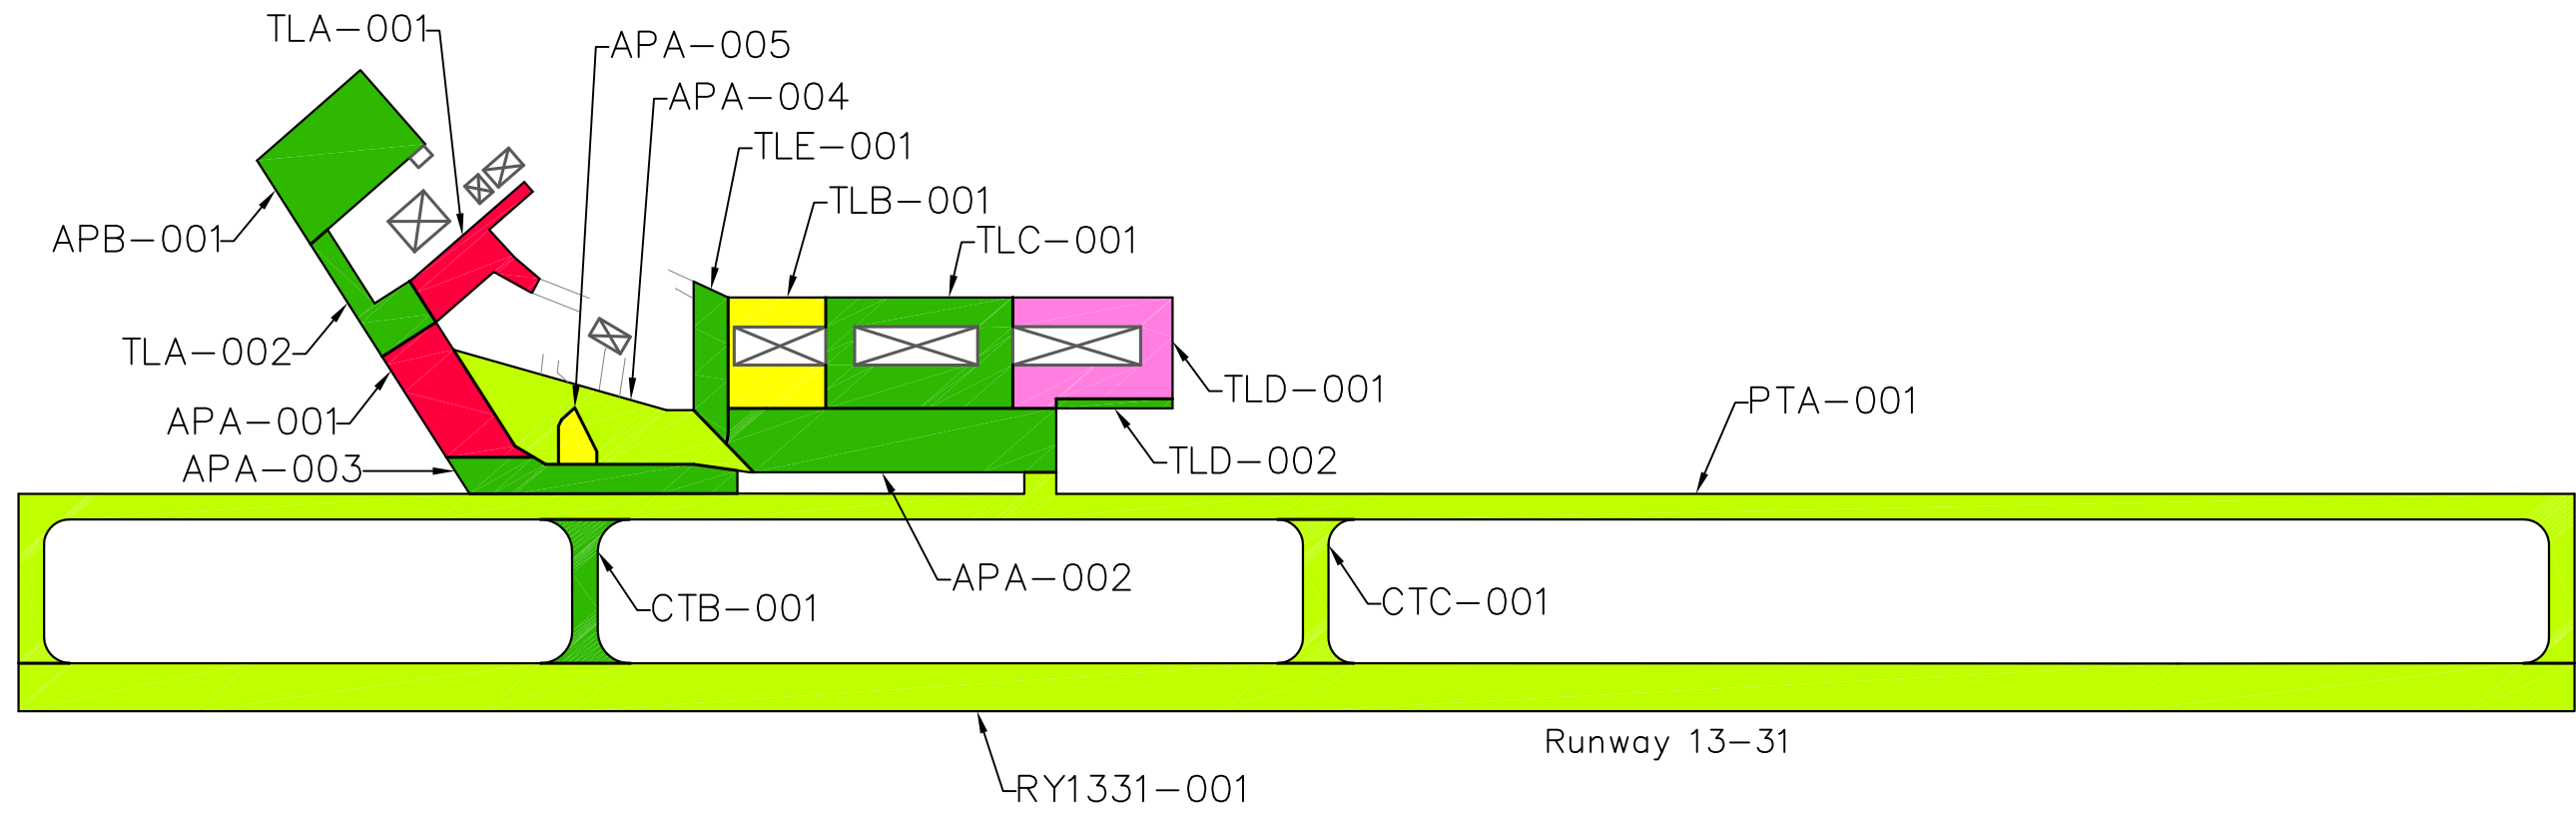
Figure 4. 2010 Pavement Condition Index Rating at Little Falls-Morrison County Airport (LXL).

The results of the 2010 PCI inspection are presented in figure 4. The overall area-weighted PCI for LXL is 77. When summarizing PCI values, an area-weighted calculation is used instead of a straight mathematical average because the area-weighted calculations eliminate the skewing of the PCI due to the disparity of the section sizes.

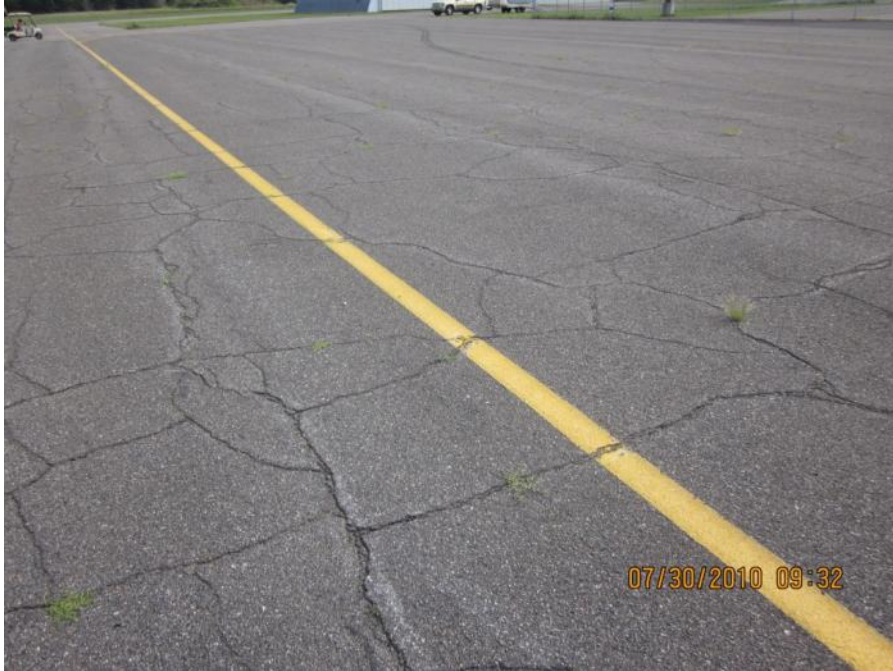
LXL APA 001 (PCI = 27)

Conditions: PCI:27.00 |

43 BLOCK CRACKING H 500.00 SqFt

43 BLOCK CRACKING M 3,500.00 SqFt

43 BLOCK CRACKING L 1,000.00 SqFt

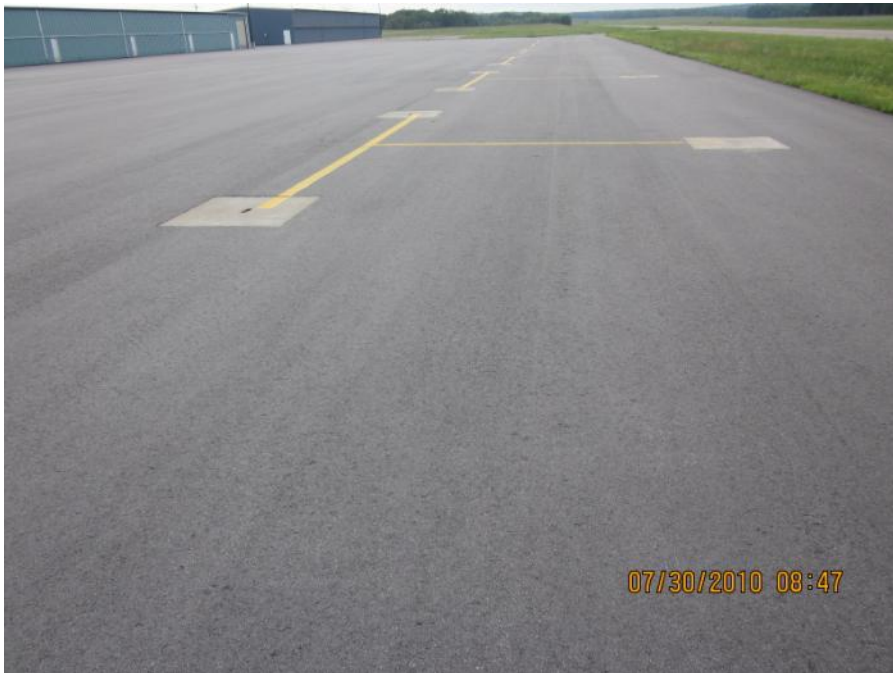
LXL APA 002 (PCI = 100)

Conditions: PCI:100.00 |

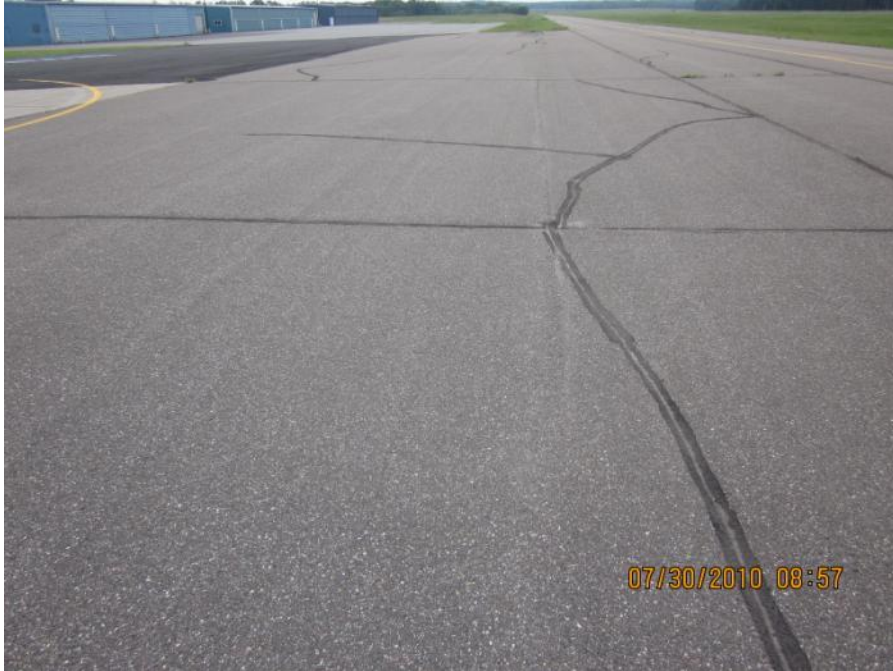
LXL APA 003 (PCI = 90)

Conditions: PCI:90.00 |

48 LONGITUDINAL/TRANSVERSE CRACKING L 137.00 Ft

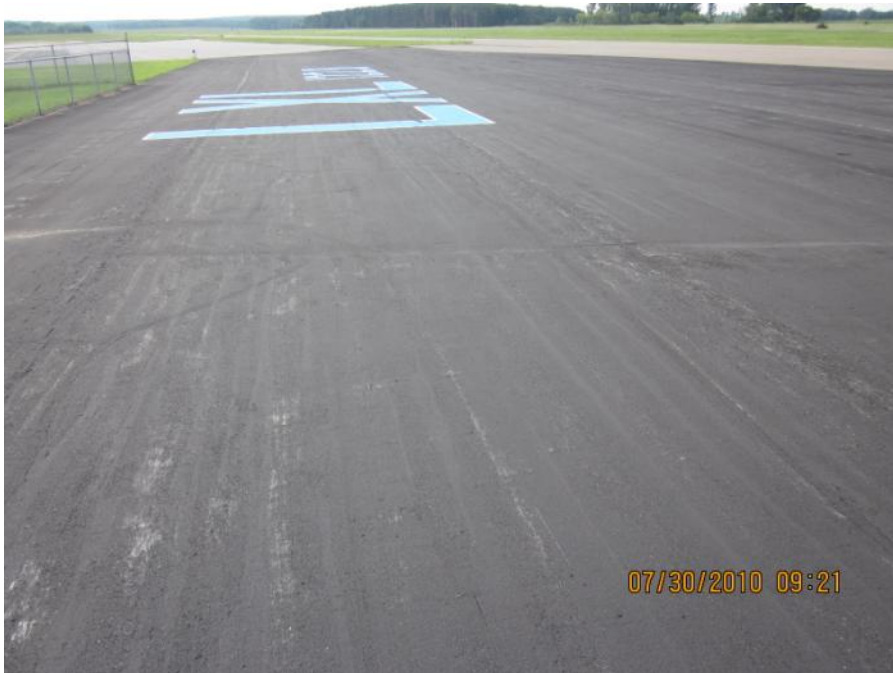
LXL APA 004 (PCI = 73)

Conditions: PCI: 73.00 |

48 LONGITUDINAL/TRANSVERSE CRACKING L 450.00 Ft

48 LONGITUDINAL/TRANSVERSE CRACKING M 40.00 Ft

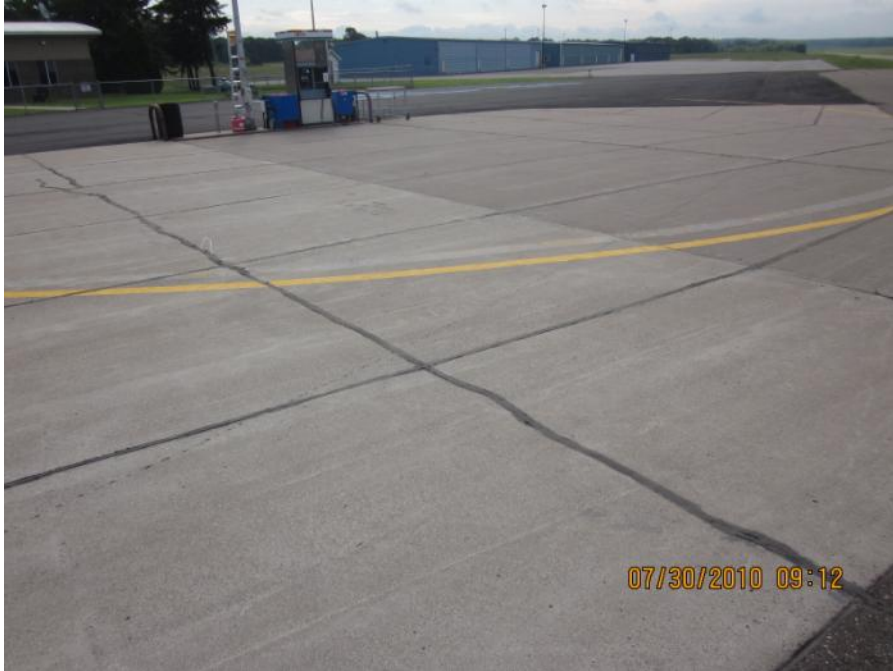
LXL APA 005 (PCI = 66)

Conditions: PCI:66.00 |

63 LINEAR CRACKING L 11.00 Slabs

73 SHRINKAGE CRACKING N 1.00 Slabs

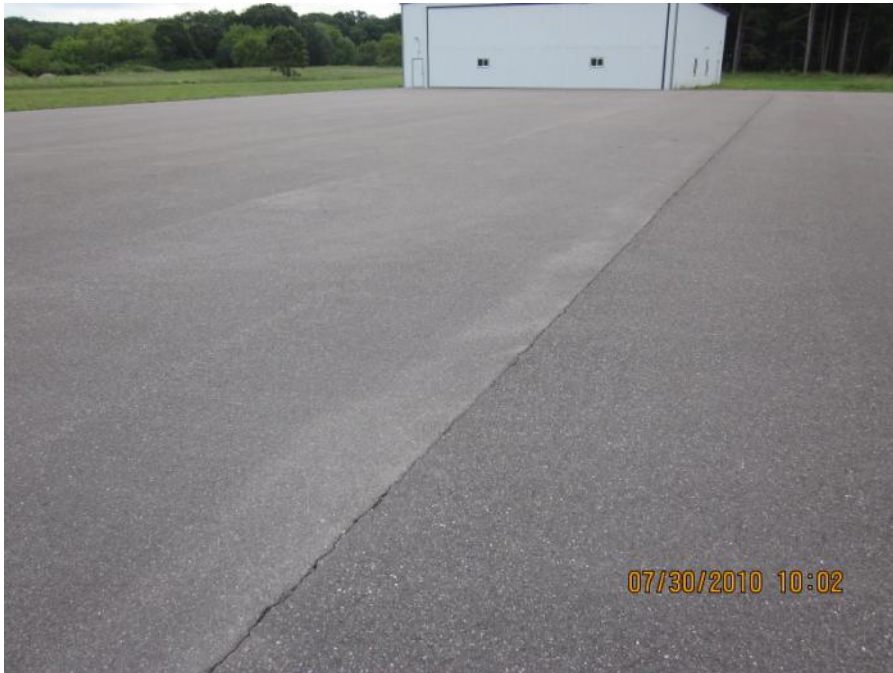
LXL APB 001 (PCI = 90)

Conditions: PCI:90.00 |

48 LONGITUDINAL/TRANSVERSE CRACKING L 44.00 Ft

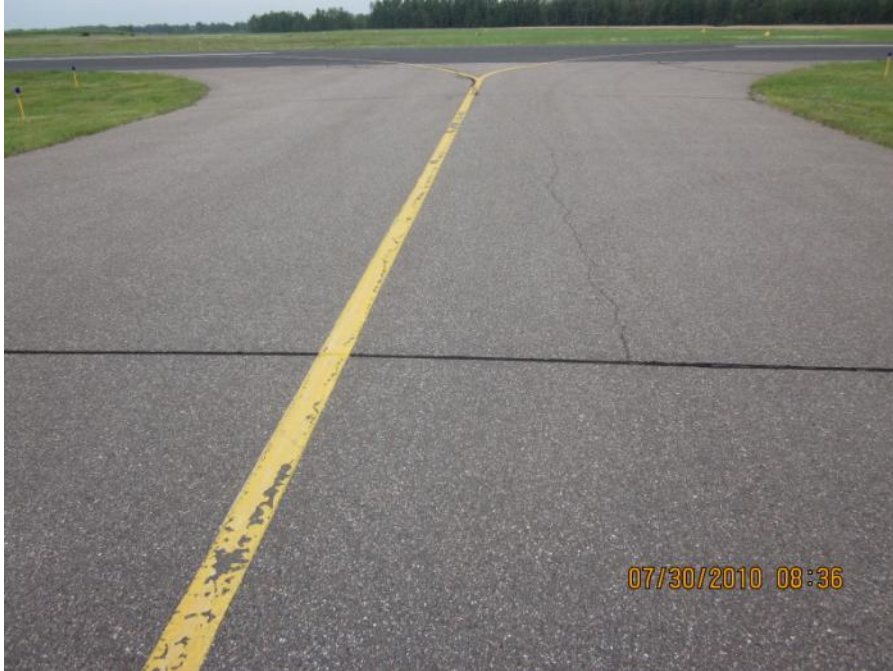
LXL CTB 001 (PCI = 88)

Conditions: PCI:88.00 |

48 LONGITUDINAL/TRANSVERSE CRACKING L 182.00 Ft

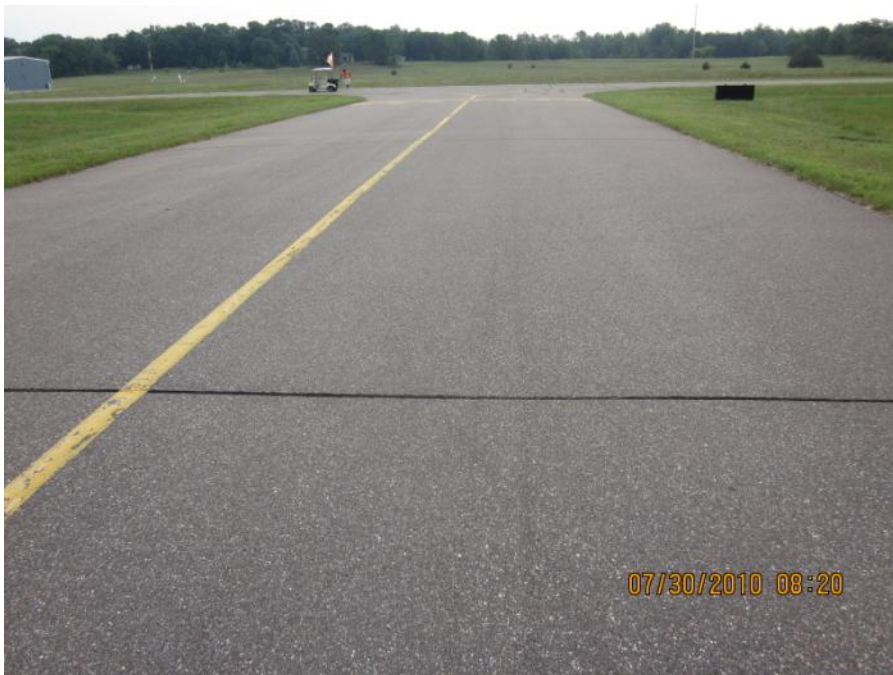
LXL CTC 001 (PCI = 81)

Conditions: PCI:81.00 |

48 LONGITUDINAL/TRANSVERSE CRACKING L 73.00 Ft

48 LONGITUDINAL/TRANSVERSE CRACKING M 4.00 Ft

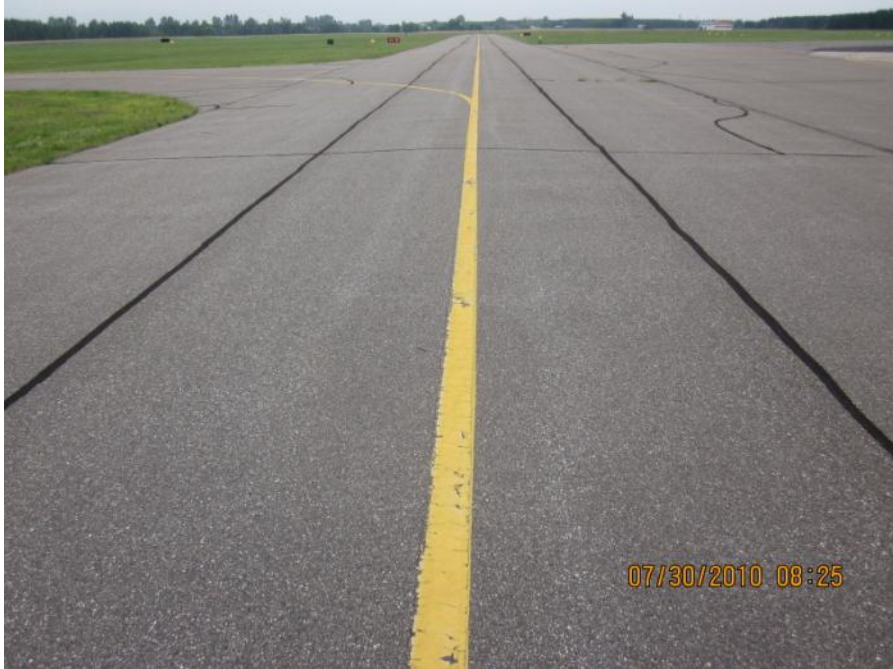
LXL PTA 001 (PCI = 80)

Conditions: PCI:80.00 |

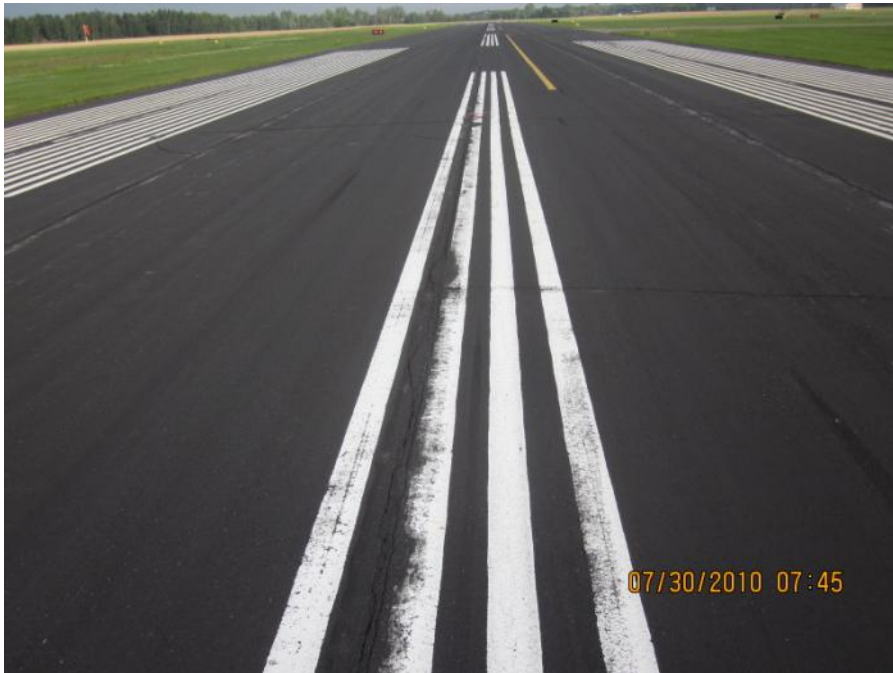
LXL RY1331 001 (PCI = 73)

Conditions: PCI:73.00 |

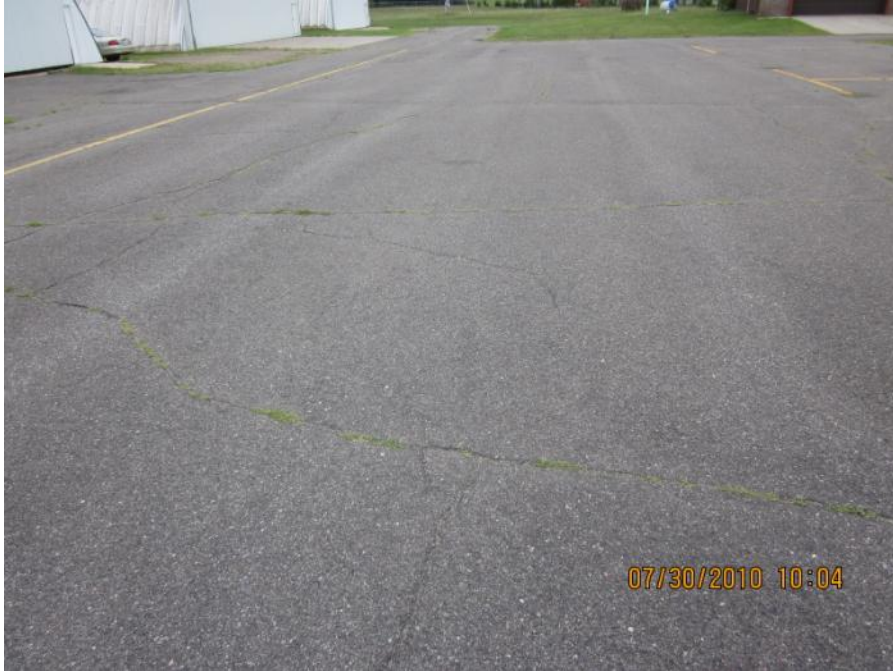
LXL TLA 001 (PCI = 36)

Conditions: PCI:36.00 |

48	LONGITUDINAL/TRANSVERSE CRACKING	L	151.00	Ft
48	LONGITUDINAL/TRANSVERSE CRACKING	M	440.00	Ft
48	LONGITUDINAL/TRANSVERSE CRACKING	H	50.00	Ft
53	RUTTING	M	40.00	SqFt
52	WEATHERING/RAVELING	L	375.00	SqFt
52	WEATHERING/RAVELING	M	30.00	SqFt

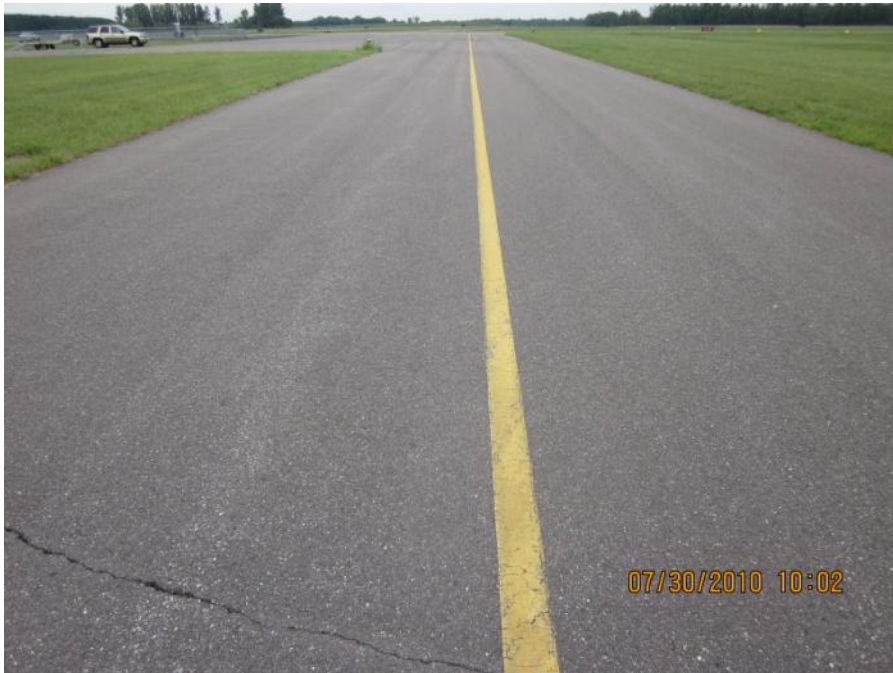
LXL TLA 002 (PCI = 94)

Conditions: PCI:94.00 I

48 LONGITUDINAL/TRANSVERSE CRACKING L 53.00 Ft

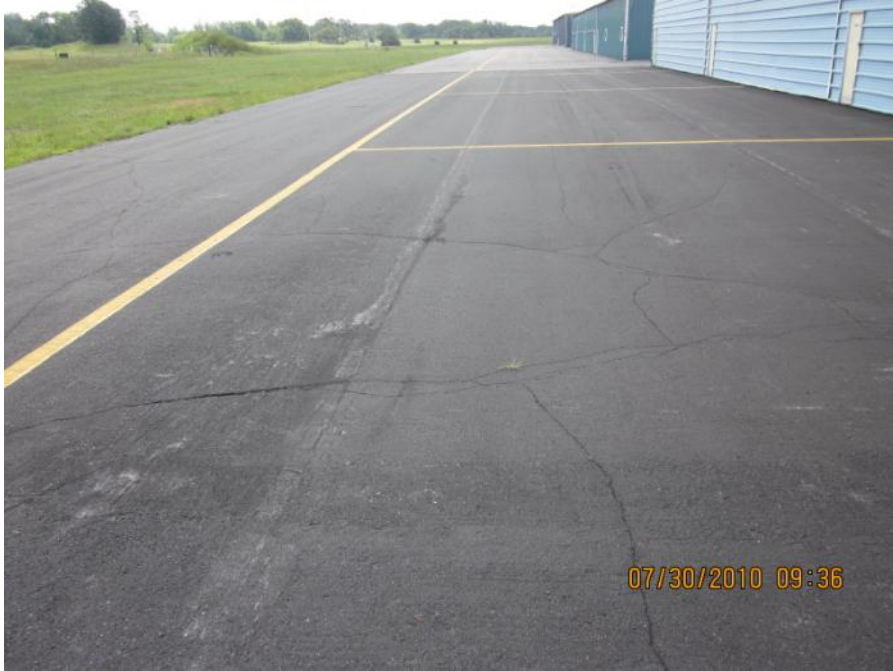
LXL TLB 001 (PCI = 63)

Conditions: PCI:63.00 |

48 LONGITUDINAL/TRANSVERSE CRACKING L 825.00 Ft

48 LONGITUDINAL/TRANSVERSE CRACKING M 111.00 Ft

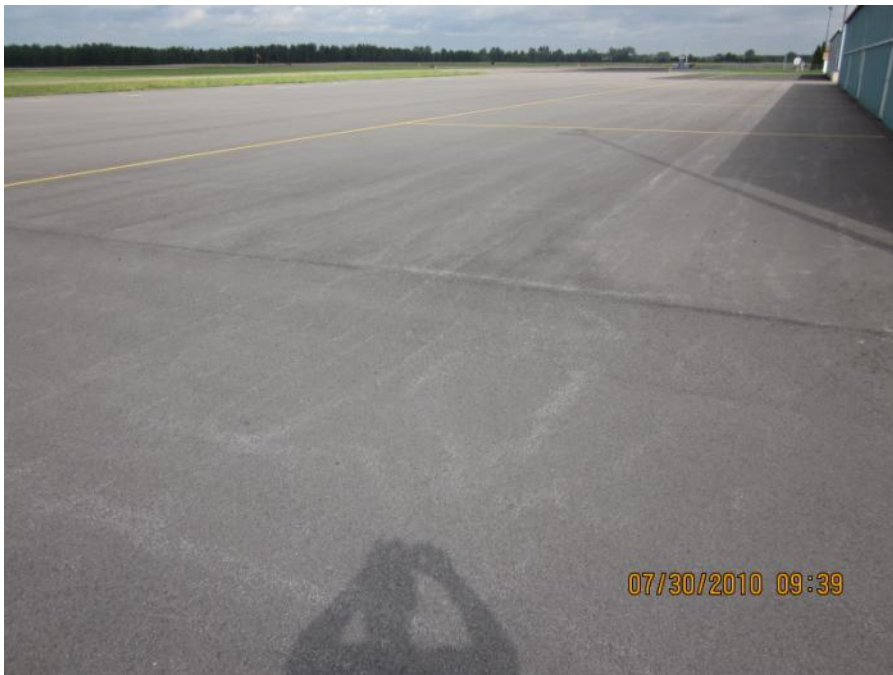
LXL TLC 001 (PCI = 100)

Conditions: PCI:100.00 |

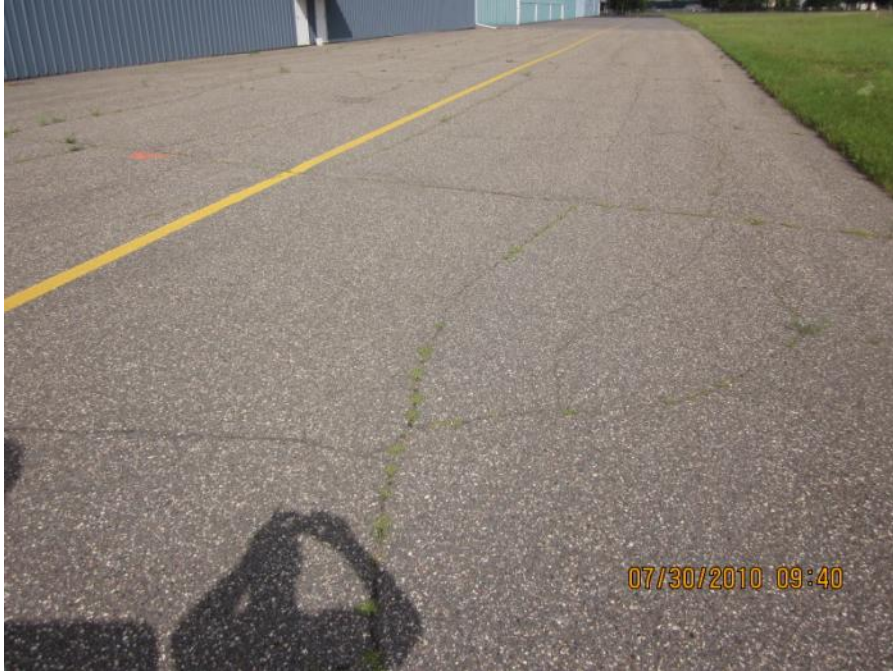
LXL TLD 001 (PCI = 51)

Conditions: PCI:51.00 I

43 BLOCK CRACKING L 4,000.00 SqFt

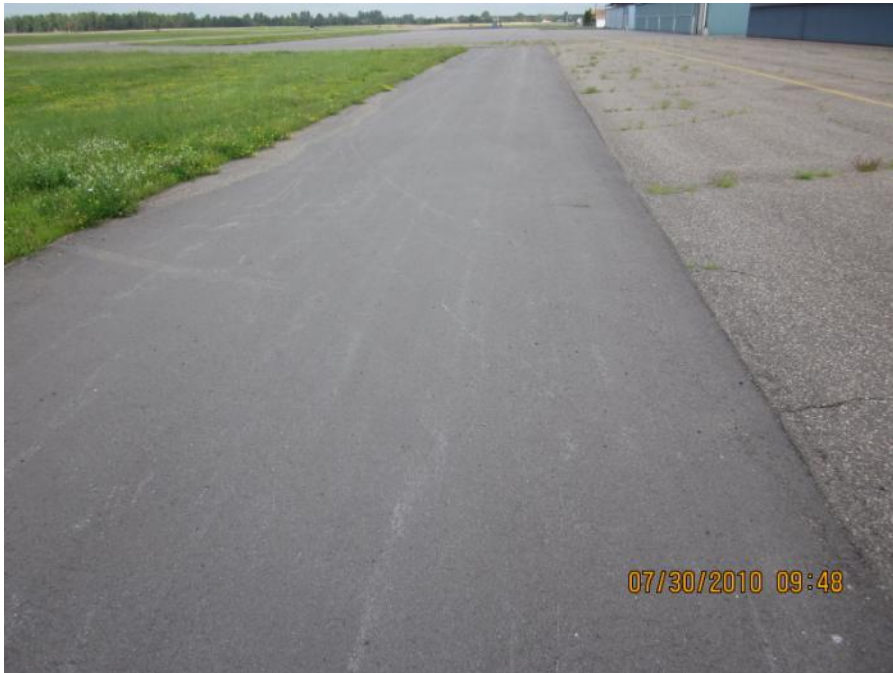
LXL TLD 002 (PCI = 100)

Conditions: PCI:100.00 |

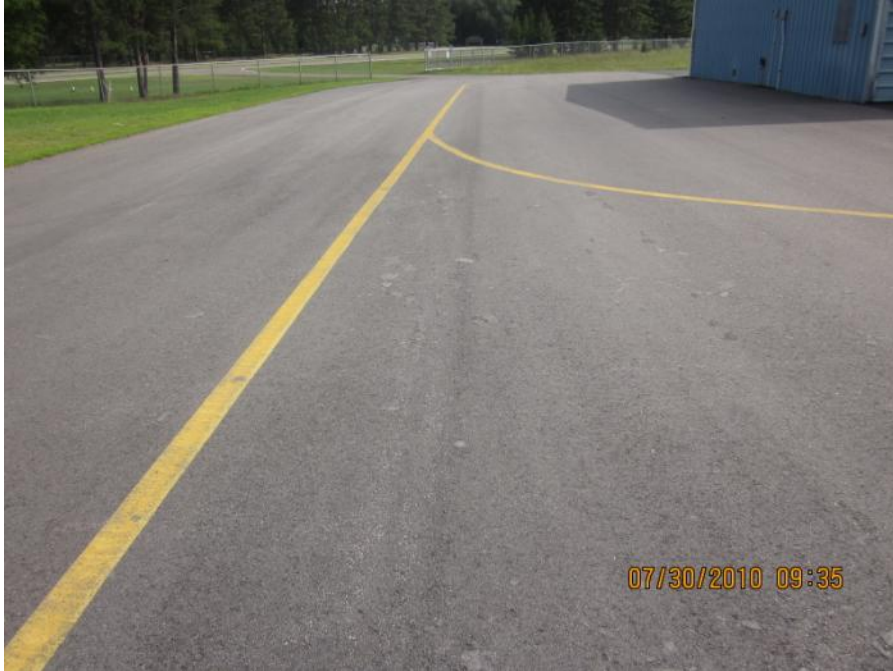
LXL TLE 001 (PCI = 100)

Conditions: PCI:100.00 |
