Minnesota Airport System Pavement Evaluation 2010 Update

Southwest Minnesota Regional
Airport - Marshall (MML)

Marshall, Minnesota

December 2010

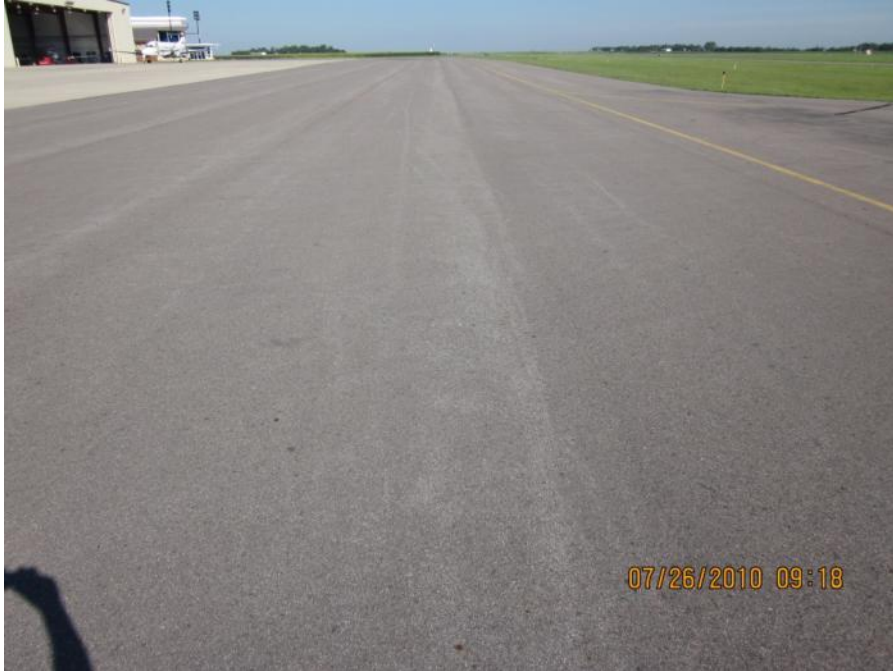
MML APA 001 (PCI = 100)

Conditions: PCI:100.00 |

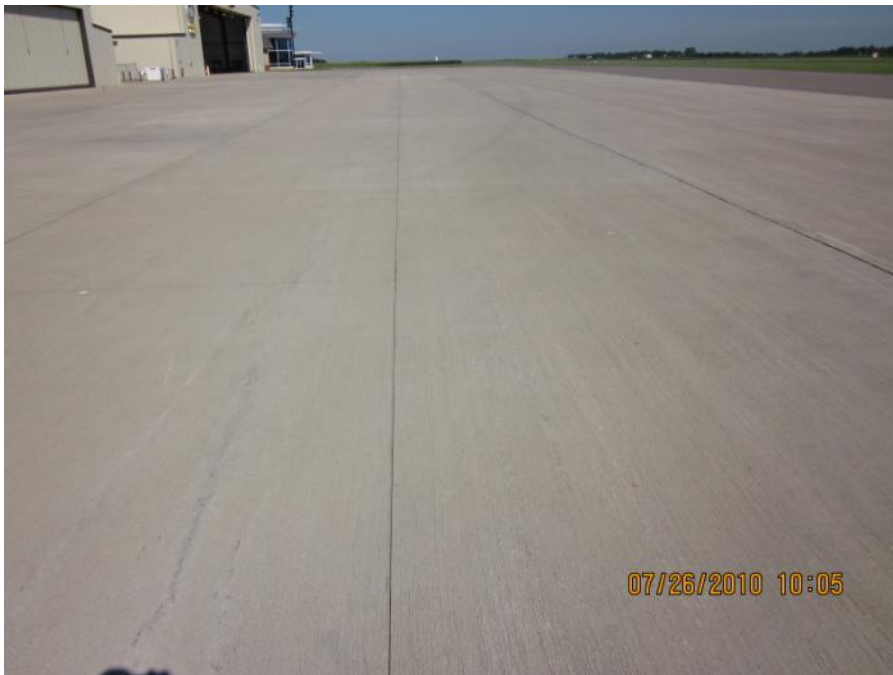
MML APA 002 (PCI = 100)

Conditions: PCI:100.00 |

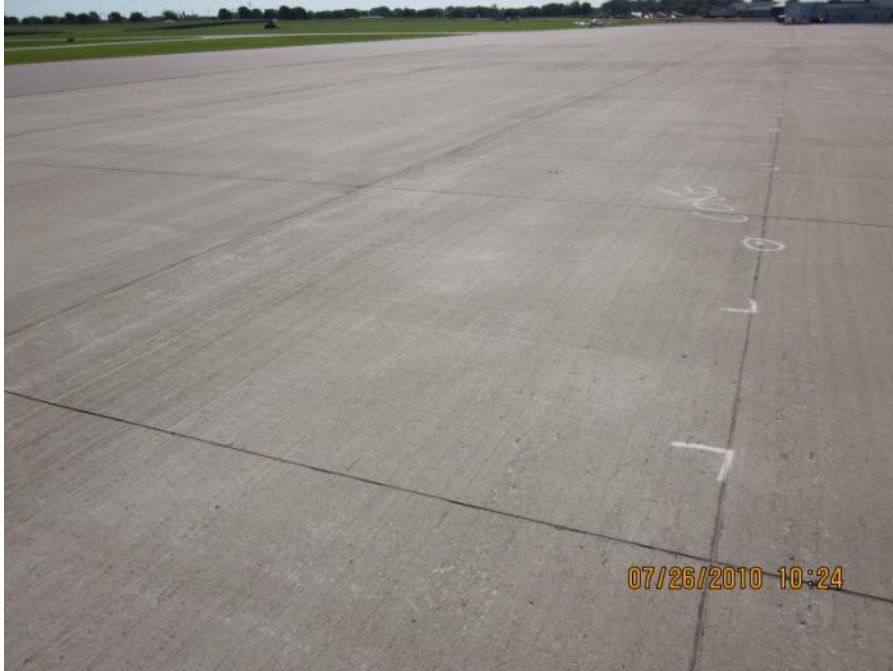
MML APA 003 (PCI = 90)

Conditions: PCI:90.00 I

63 LINEAR CRACKING M 1.00 Slabs

74 JOINT SPALLING L 1.00 Slabs

75 CORNER SPALLING L 1.00 Slabs

75 CORNER SPALLING H 1.00 Slabs

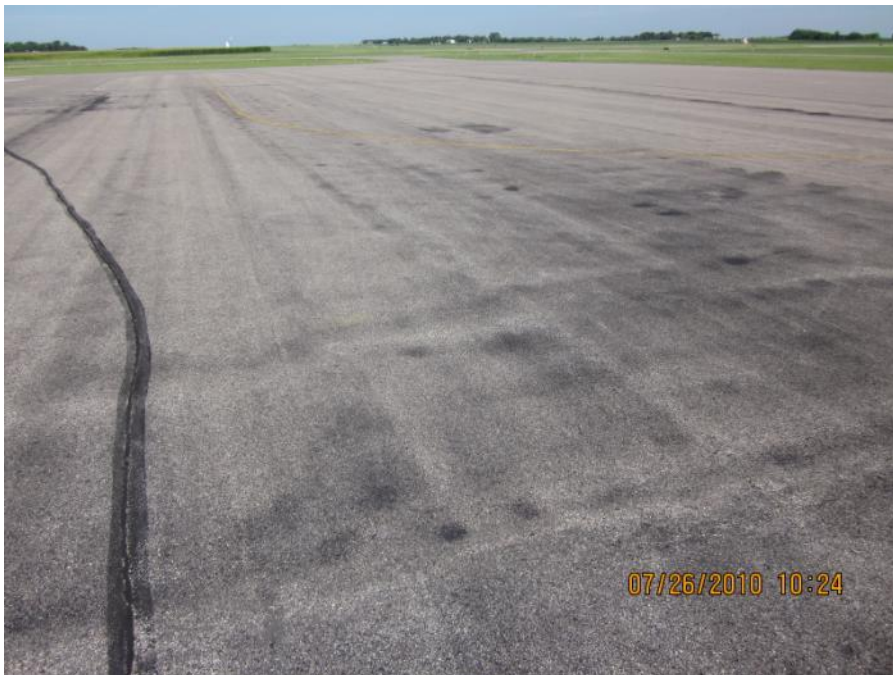
MML APA 004 (PCI = 84)

Conditions: PCI:84.00 I

48 LONGITUDINAL/TRANSVERSE CRACKING H 50.00 Ft
52 WEATHERING/RAVELING L 10.00 SqFt

48 LONGITUDINAL/TRANSVERSE CRACKING L 91.00 Ft
48 LONGITUDINAL/TRANSVERSE CRACKING M 11.00 Ft

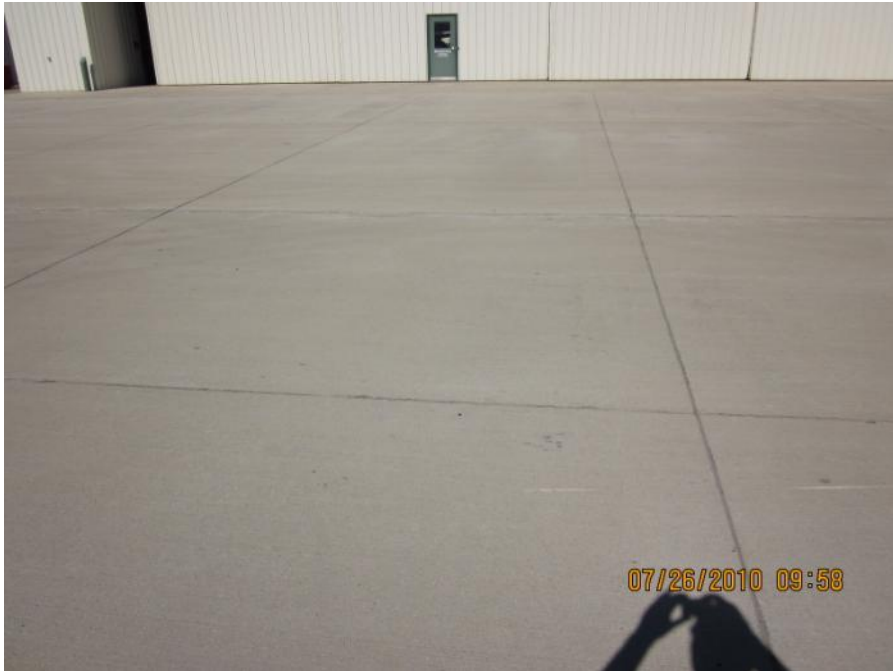
MML APA 005 (PCI = 97)

Conditions: PCI:97.00 I

75 CORNER SPALLING M 1.00 Slabs

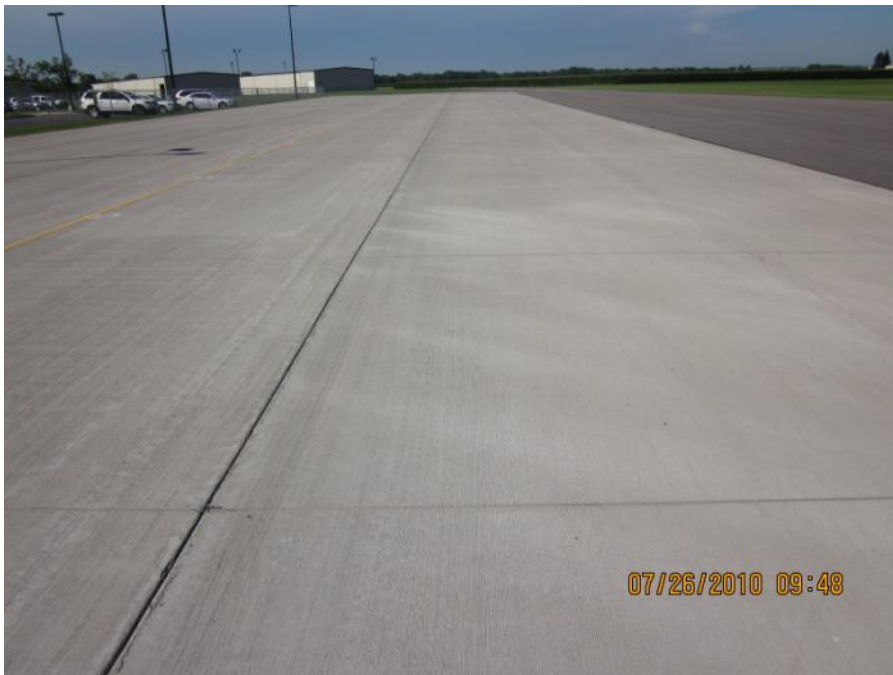
MML APA 006 (PCI = 99)

Conditions: PCI:99.00 I

Sample Number: 517 Type: R Area: 15.00Slabs PCI = 98
75 CORNER SPALLING L 1.00 Slabs

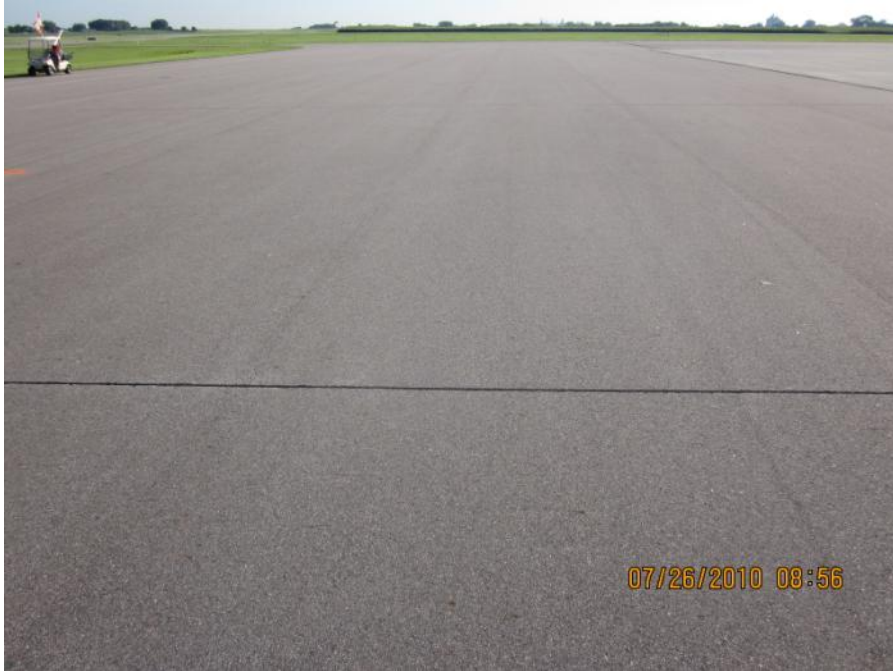
MML APA 007 (PCI = 98)

Conditions: PCI:98.00 I

Sample Number: 200 Type: R Area: 5,000.00SqFt PCI = 97
48 LONGITUDINAL/TRANSVERSE CRACKING L 8.00 Ft

Sample Number: 203 Type: R Area: 5,000.00SqFt PCI = 95
48 LONGITUDINAL/TRANSVERSE CRACKING M 6.00 Ft
52 WEATHERING/RAVELING L 1.00 SqFt

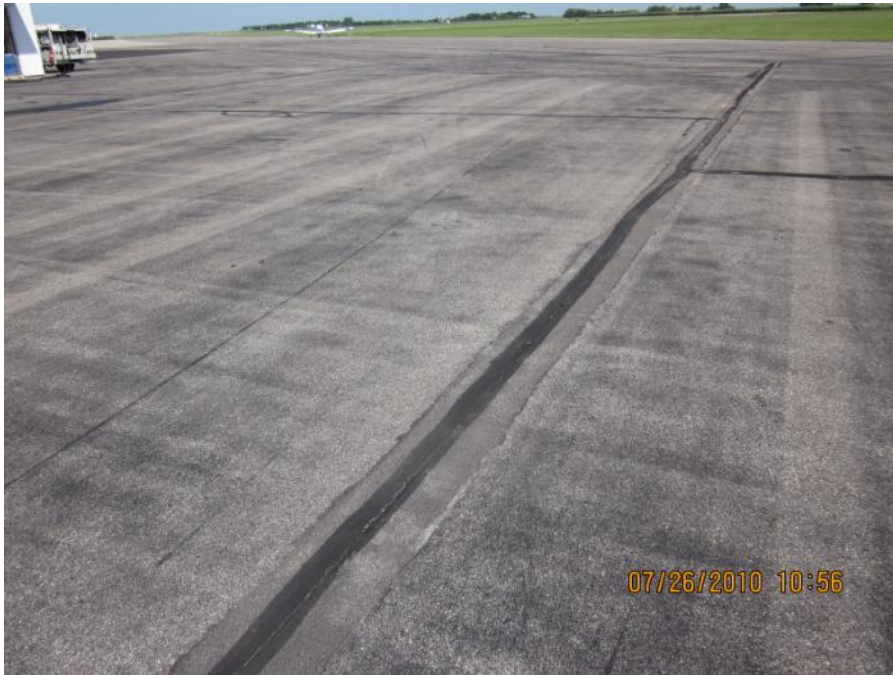
MML APA 008 (PCI = 70)

Conditions: PCI:70.00 |

48	LONGITUDINAL/TRANSVERSE CRACKING	L	246.00	Ft
48	LONGITUDINAL/TRANSVERSE CRACKING	M	39.00	Ft
52	WEATHERING/RAVELING	L	3.00	SqFt
41	ALLIGATOR CRACKING	L	8.00	SqFt
48	LONGITUDINAL/TRANSVERSE CRACKING	H	15.00	Ft

48	LONGITUDINAL/TRANSVERSE CRACKING	L	230.00	Ft
48	LONGITUDINAL/TRANSVERSE CRACKING	M	27.00	Ft
48	LONGITUDINAL/TRANSVERSE CRACKING	H	5.00	Ft
50	PATCHING	L	42.00	SqFt
50	PATCHING	M	10.00	SqFt

48	LONGITUDINAL/TRANSVERSE CRACKING	L	226.00	Ft
56	SWELLING	L	10.00	SqFt
50	PATCHING	L	58.00	SqFt
50	PATCHING	M	44.00	SqFt

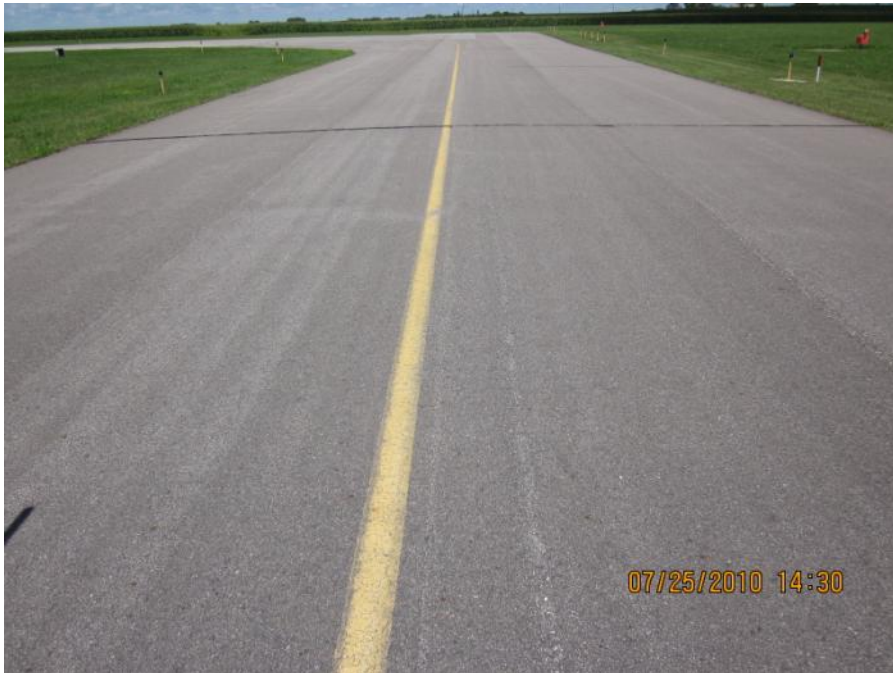
MML CTA 001 (PCI = 86)

Conditions: PCI:86.00 |

48 LONGITUDINAL/TRANSVERSE CRACKING L 72.00 Ft

48 LONGITUDINAL/TRANSVERSE CRACKING M 24.00 Ft

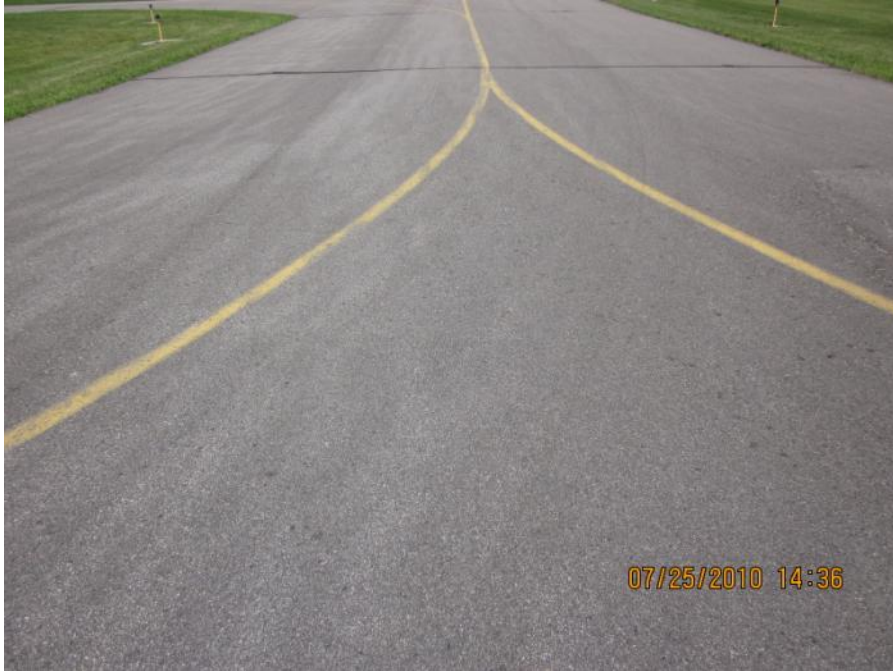
MML CTA 002 (PCI = 86)

Conditions: PCI:86.00 |

48 LONGITUDINAL/TRANSVERSE CRACKING L 80.00 Ft

48 LONGITUDINAL/TRANSVERSE CRACKING M 3.00 Ft

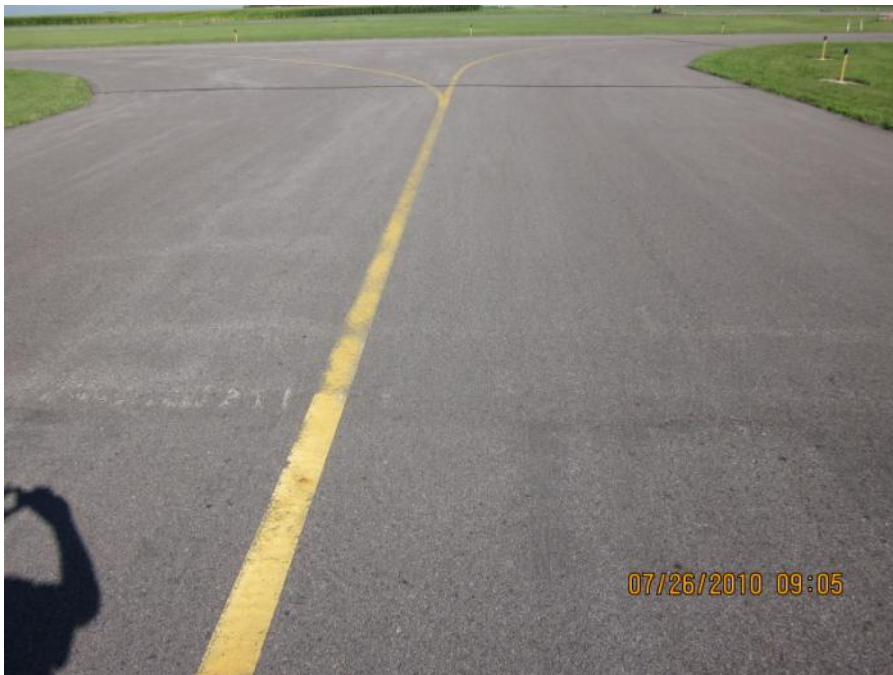
MML CTC 001 (PCI = 87)

Conditions: PCI:87.00 |

48 LONGITUDINAL/TRANSVERSE CRACKING L 40.00 Ft

48 LONGITUDINAL/TRANSVERSE CRACKING M 15.00 Ft

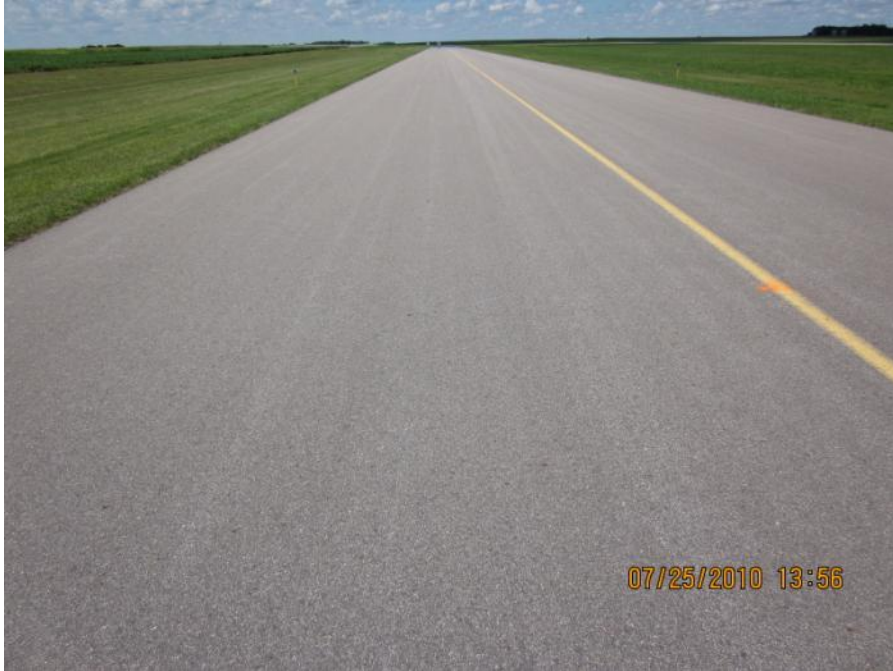
MML PTA 001 (PCI = 99)

Conditions: PCI:99.00 I

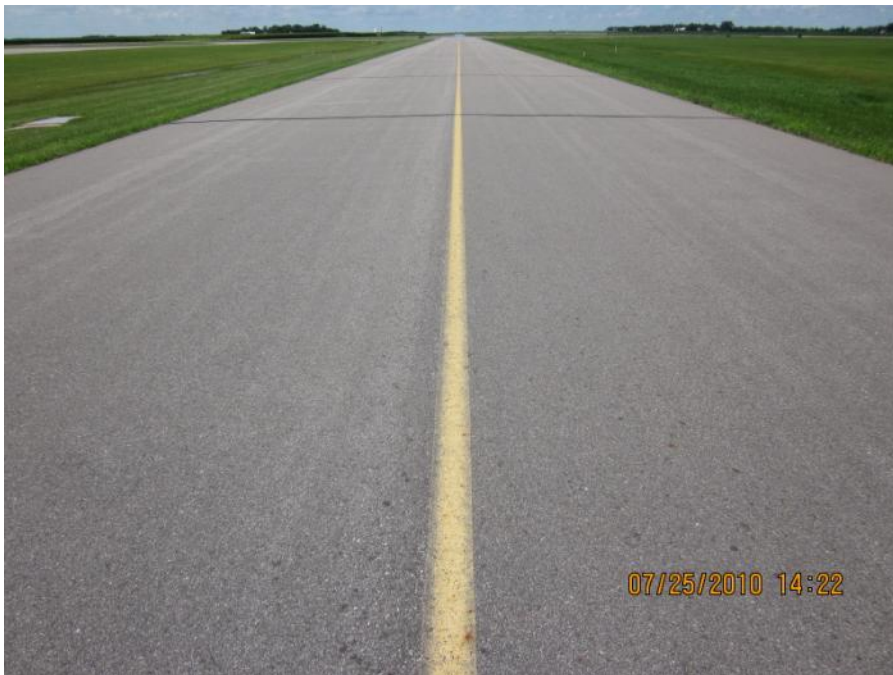
MML PTA 002 (PCI = 93)

Conditions: PCI:93.00 |

Sample Number: 104 Type: R Area: 4,000.00SqFt PCI = 93
48 LONGITUDINAL/TRANSVERSE CRACKING L 76.00 Ft

Sample Number: 113 Type: R Area: 4,000.00SqFt PCI = 93
48 LONGITUDINAL/TRANSVERSE CRACKING L 80.00 Ft

Sample Number: 122 Type: R Area: 4,000.00SqFt PCI = 95
48 LONGITUDINAL/TRANSVERSE CRACKING L 38.00 Ft

Sample Number: 131 Type: R Area: 4,000.00SqFt PCI = 93
48 LONGITUDINAL/TRANSVERSE CRACKING L 80.00 Ft

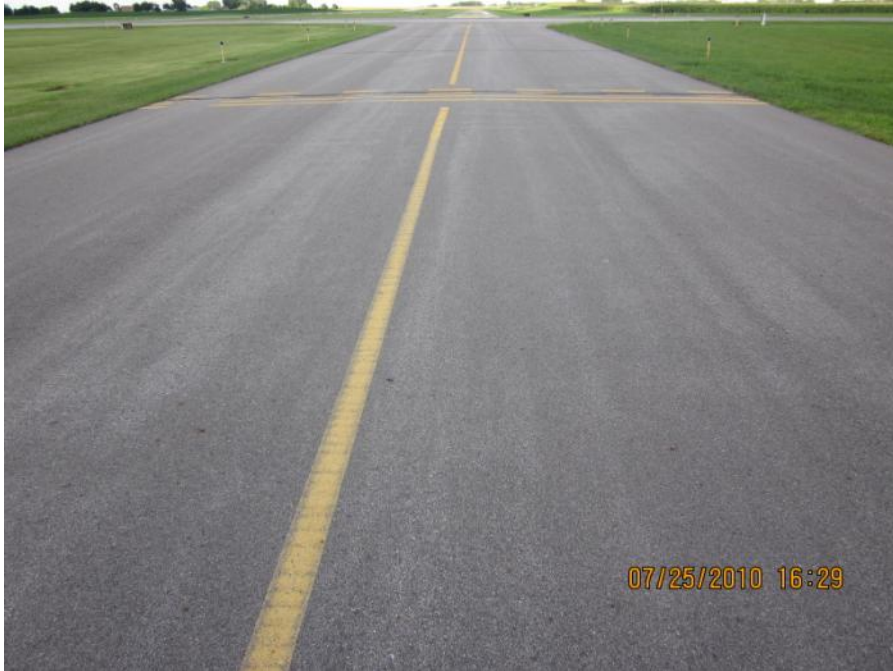
MML PTB 001 (PCI = 92)

Conditions: PCI:92.00 |

48 LONGITUDINAL/TRANSVERSE CRACKING L 79.00 Ft

48 LONGITUDINAL/TRANSVERSE CRACKING M 3.00 Ft

48 LONGITUDINAL/TRANSVERSE CRACKING L 40.00 Ft

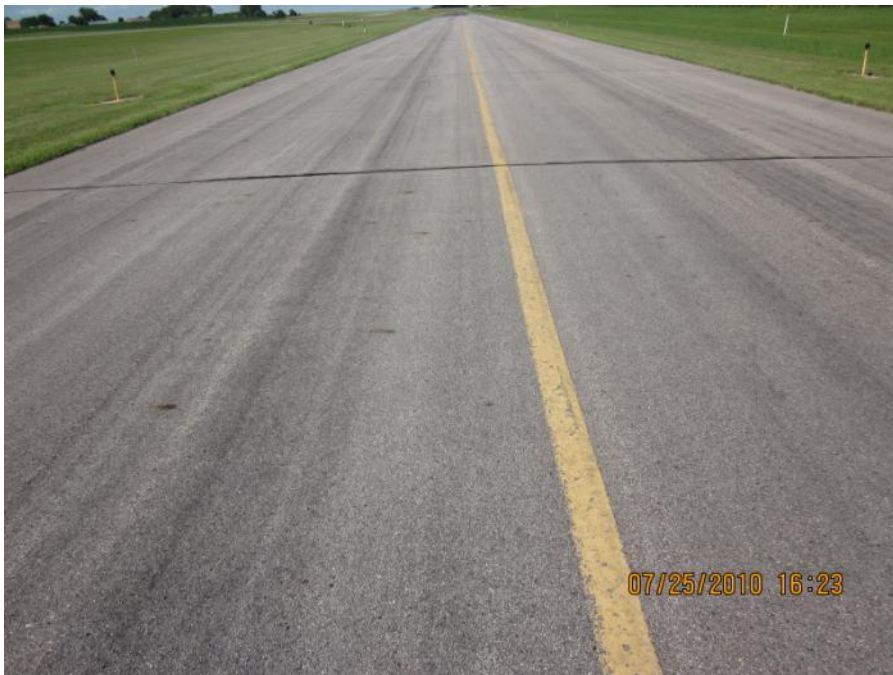
MML PTB 002 (PCI = 91)

Conditions: PCI:91.00 |

48 LONGITUDINAL/TRANSVERSE CRACKING L 6.00 Ft

48 LONGITUDINAL/TRANSVERSE CRACKING M 44.00 Ft

41 ALLIGATOR CRACKING L 5.00 SqFt

48 LONGITUDINAL/TRANSVERSE CRACKING L 89.00 Ft

48 LONGITUDINAL/TRANSVERSE CRACKING M 12.00 Ft

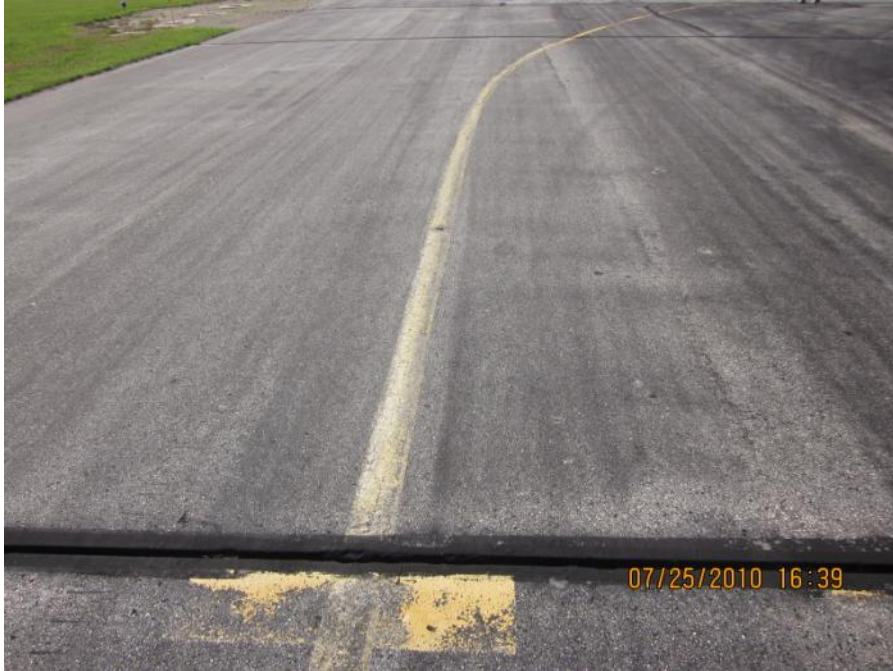
MML PTB 003 (PCI = 74)

Conditions: PCI:74.00 |

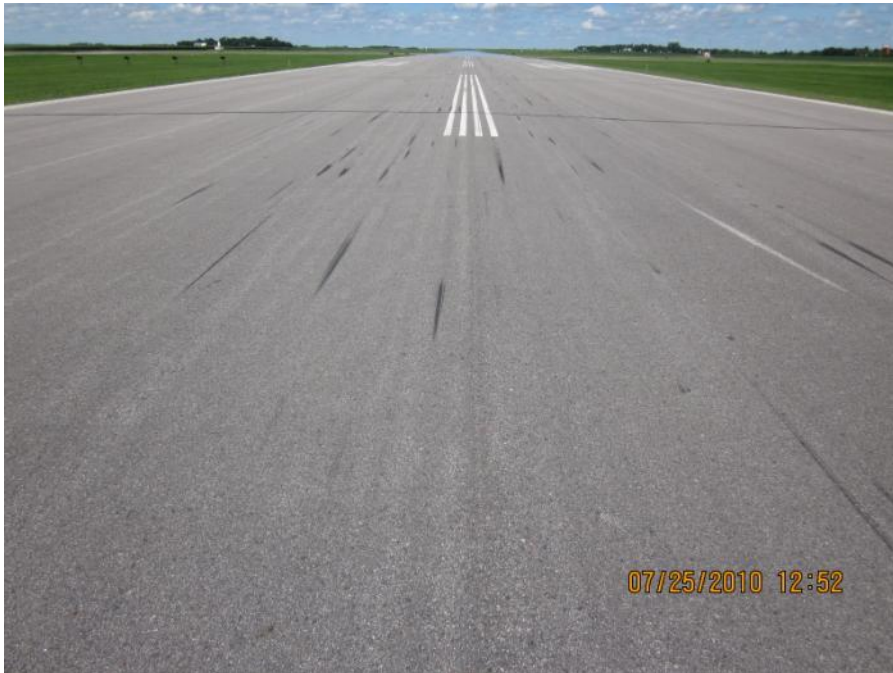
MML RY1230 001 (PCI = 94)

Conditions: PCI:94.00 |

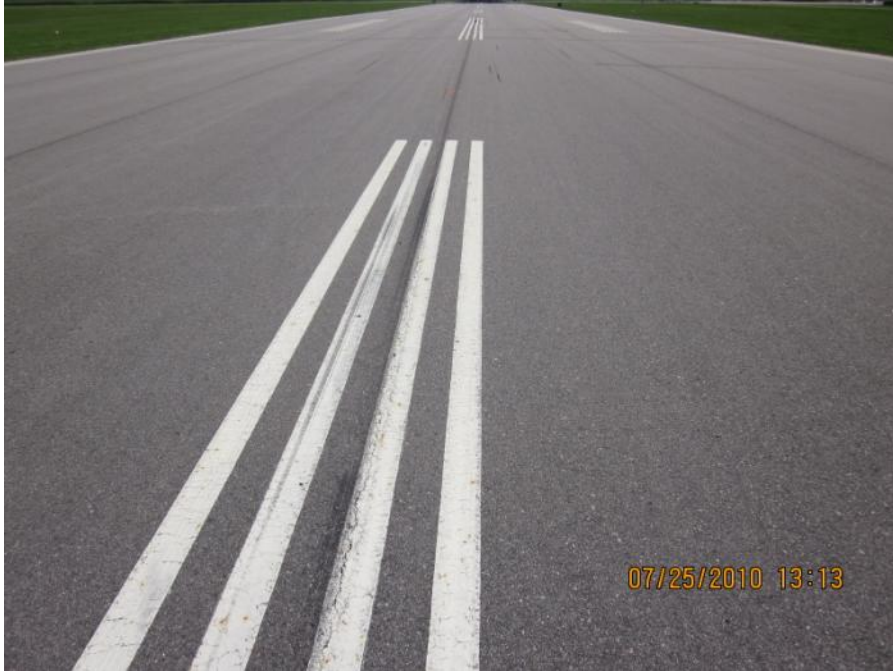
MML RY1230 002 (PCI = 94)

Conditions: PCI:94.00 |

48 LONGITUDINAL/TRANSVERSE CRACKING L 55.00 Ft
