Minnesota Airport System Pavement Evaluation 2010 Update

Orr Regional Airport (ORB)

Orr, Minnesota

December 2010

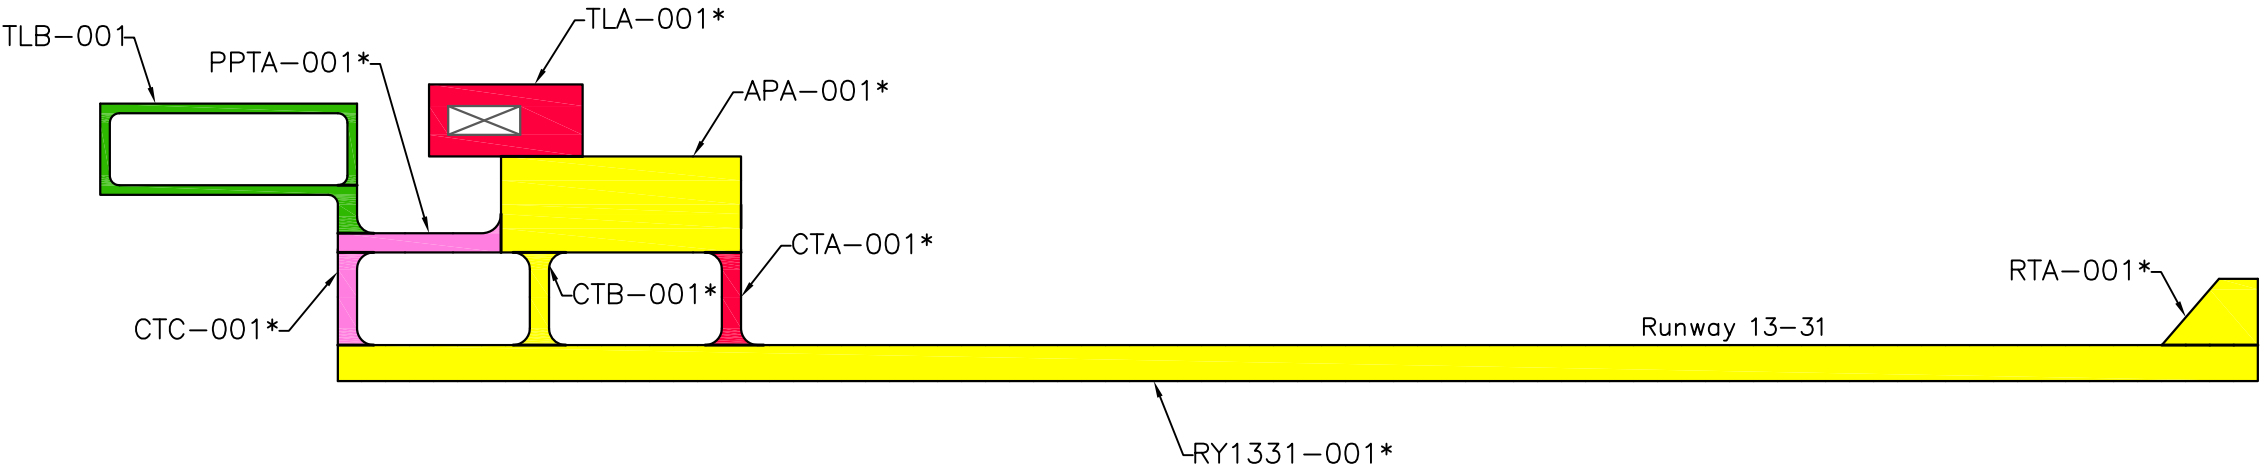
Figure 4. 2010 Pavement Condition Index Rating at Orr Regional Airport (ORB).

The results of the 2010 PCI inspection are presented in figure 4. The overall area-weighted PCI for ORB is 61. The condition of the pavement sections scheduled to be repaved during 2011 are reported as inspected in May 2010. These sections include APA-001, CTA-001, CTB-001, CTC-001, PPTA-001, RTA-001, RY1331-001, and TLA-001.

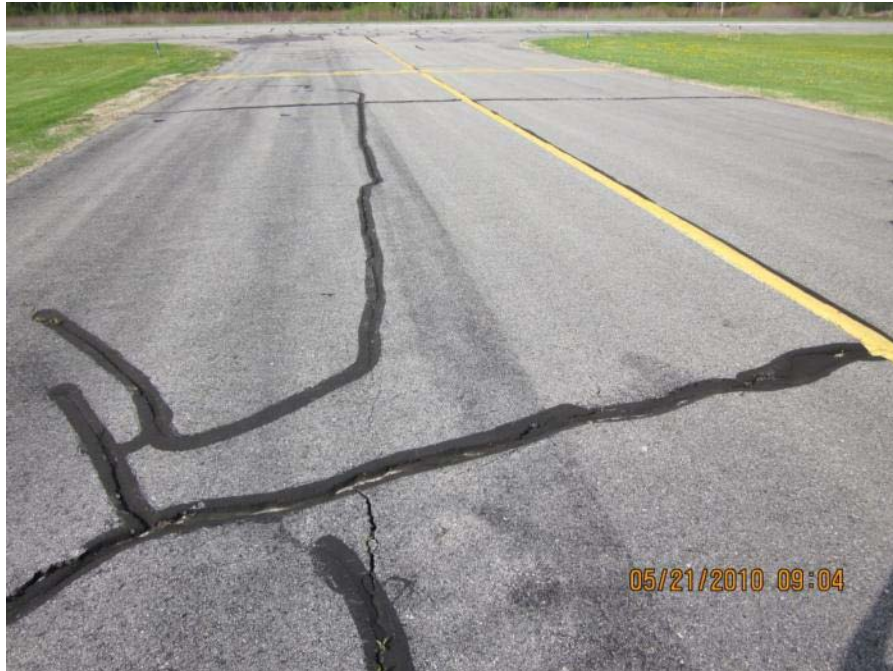
ORB CTA (A3) 001 (PCI = 38)

Conditions: PCI: 38.00 I

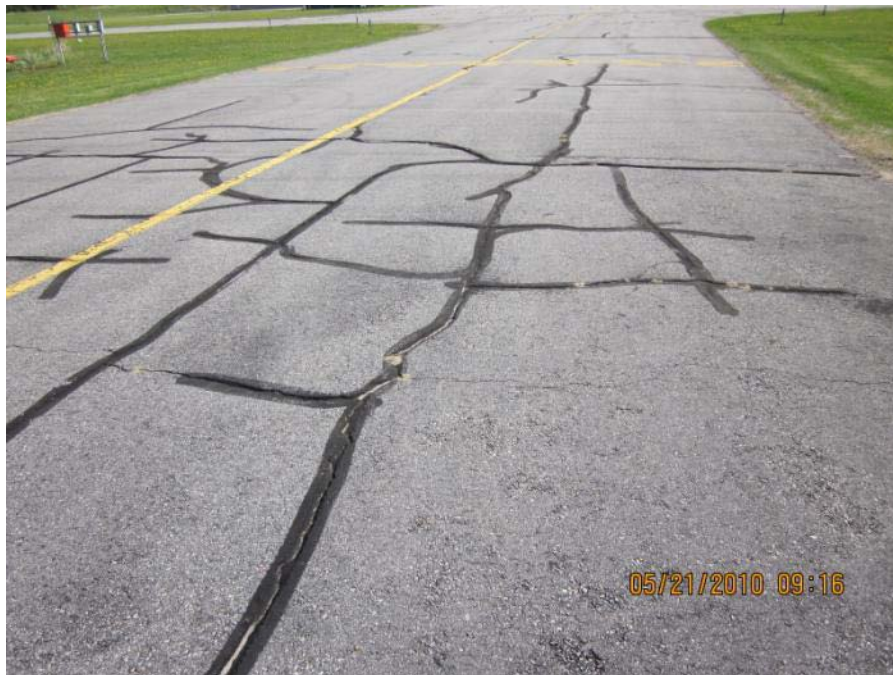
ORB CTB (A2) 001 (PCI = 61)

Conditions: PCI: 61.00 I

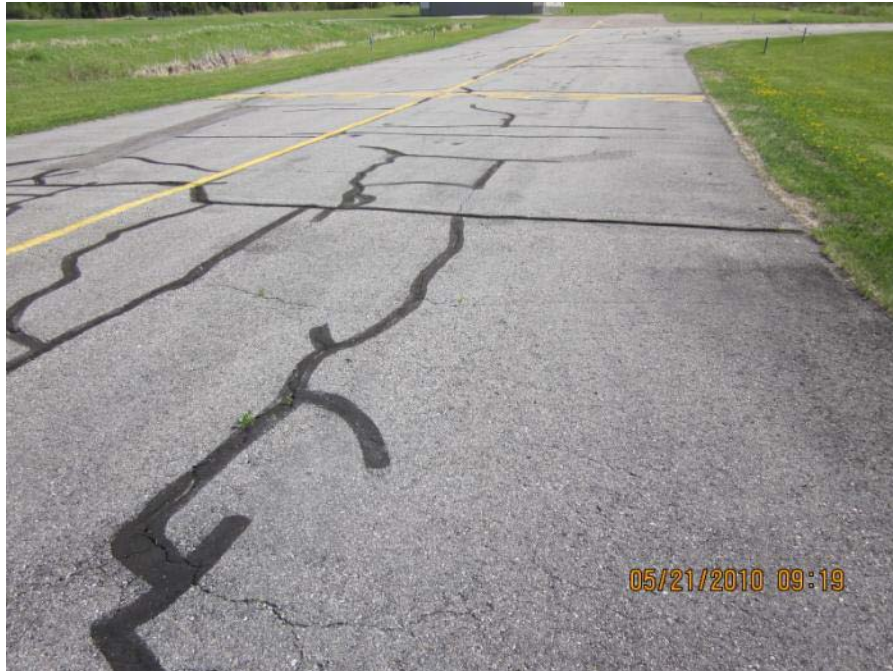
ORB CTC (A1) 001 (PCI = 52)

Conditions: PCI: 52.00 I

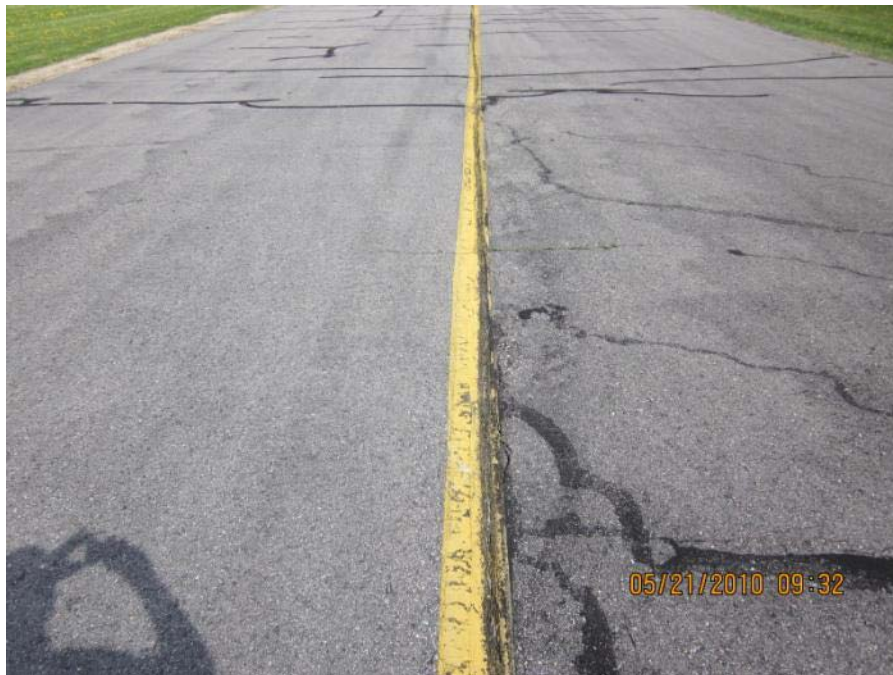
ORB PPTA 001 (PCI = 41)

Conditions: PCI: 41.00 I

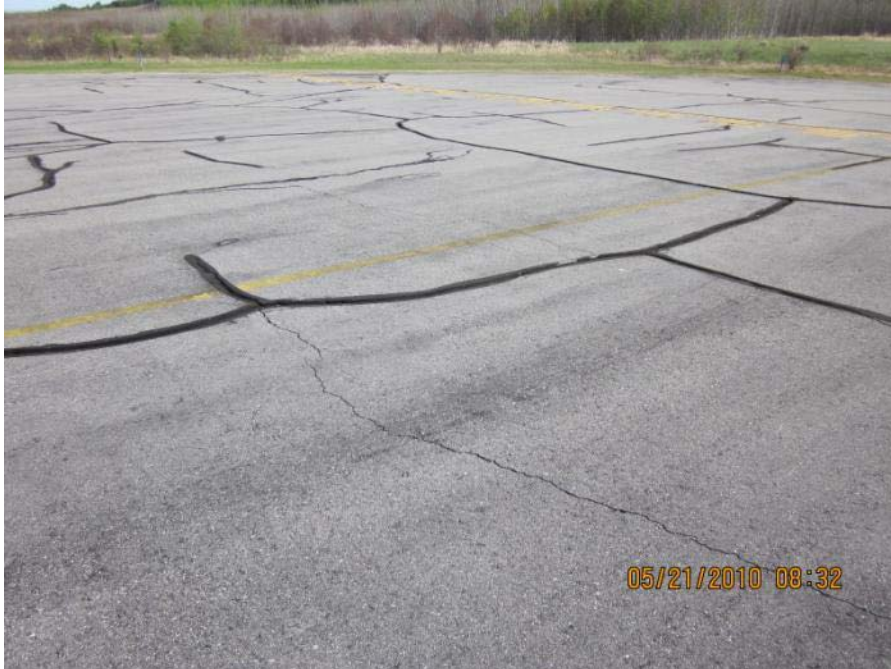
ORB RTA 001 (PCI = 63)

Conditions: PCI: 63.00 I

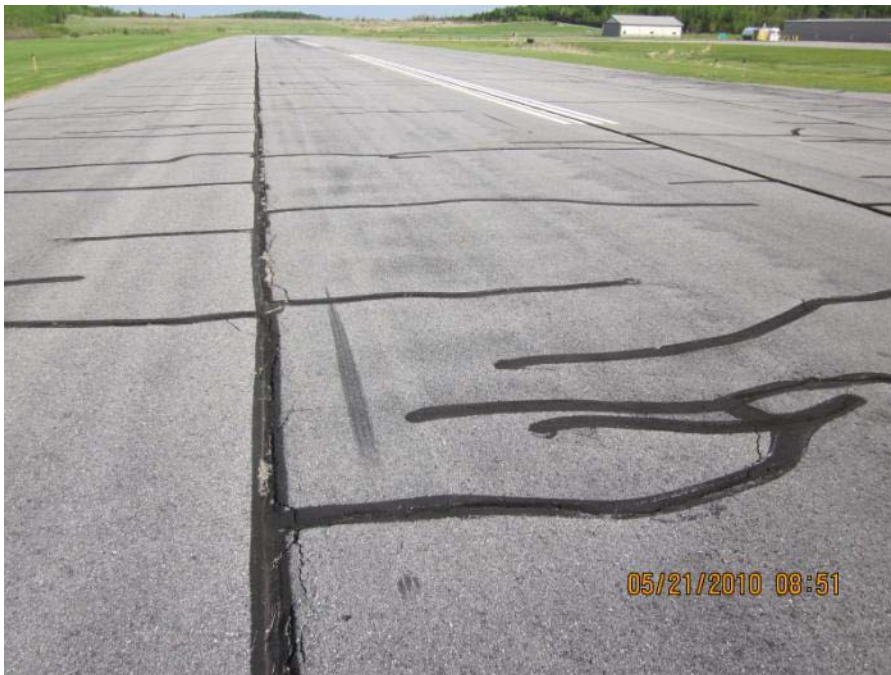
ORB RY1331 001 (PCI = 63)

Conditions: PCI: 63.00

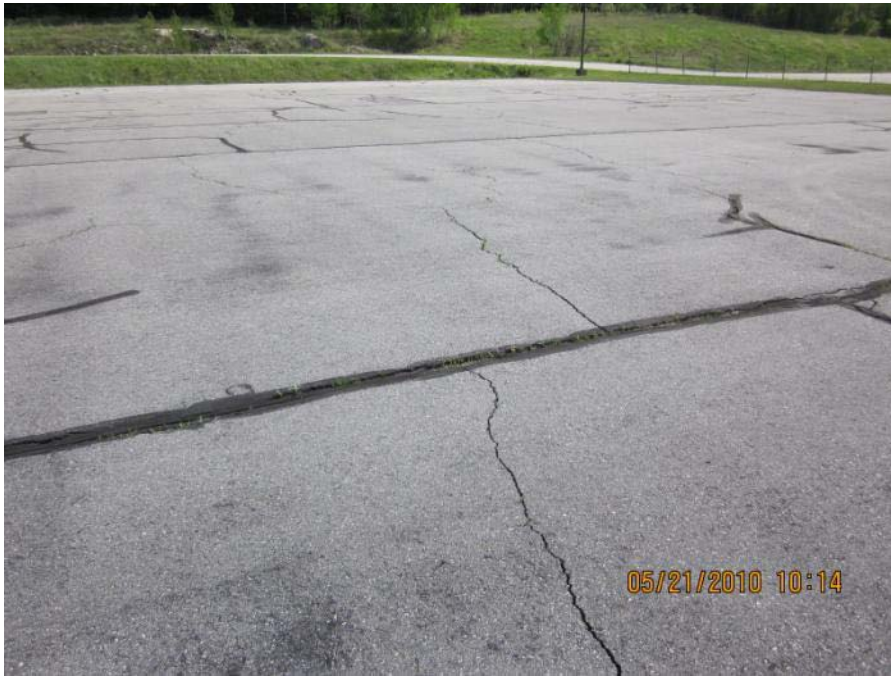
ORB TLA 001 (PCI = 35)

Conditions: PCI: 35.00

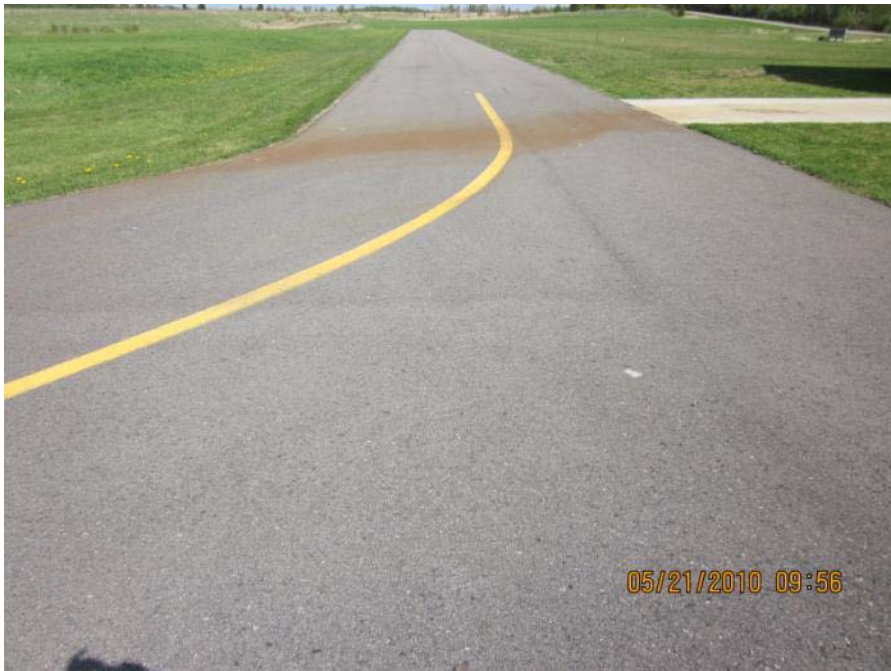
ORB TLB 001 (PCI = 97)

Conditions: PCI: 97.00
