# Minnesota Airport System Pavement Evaluation 2010 Update

Park Rapids Municipal Airport  
(PKD)

Park Rapids, Minnesota

December 2010

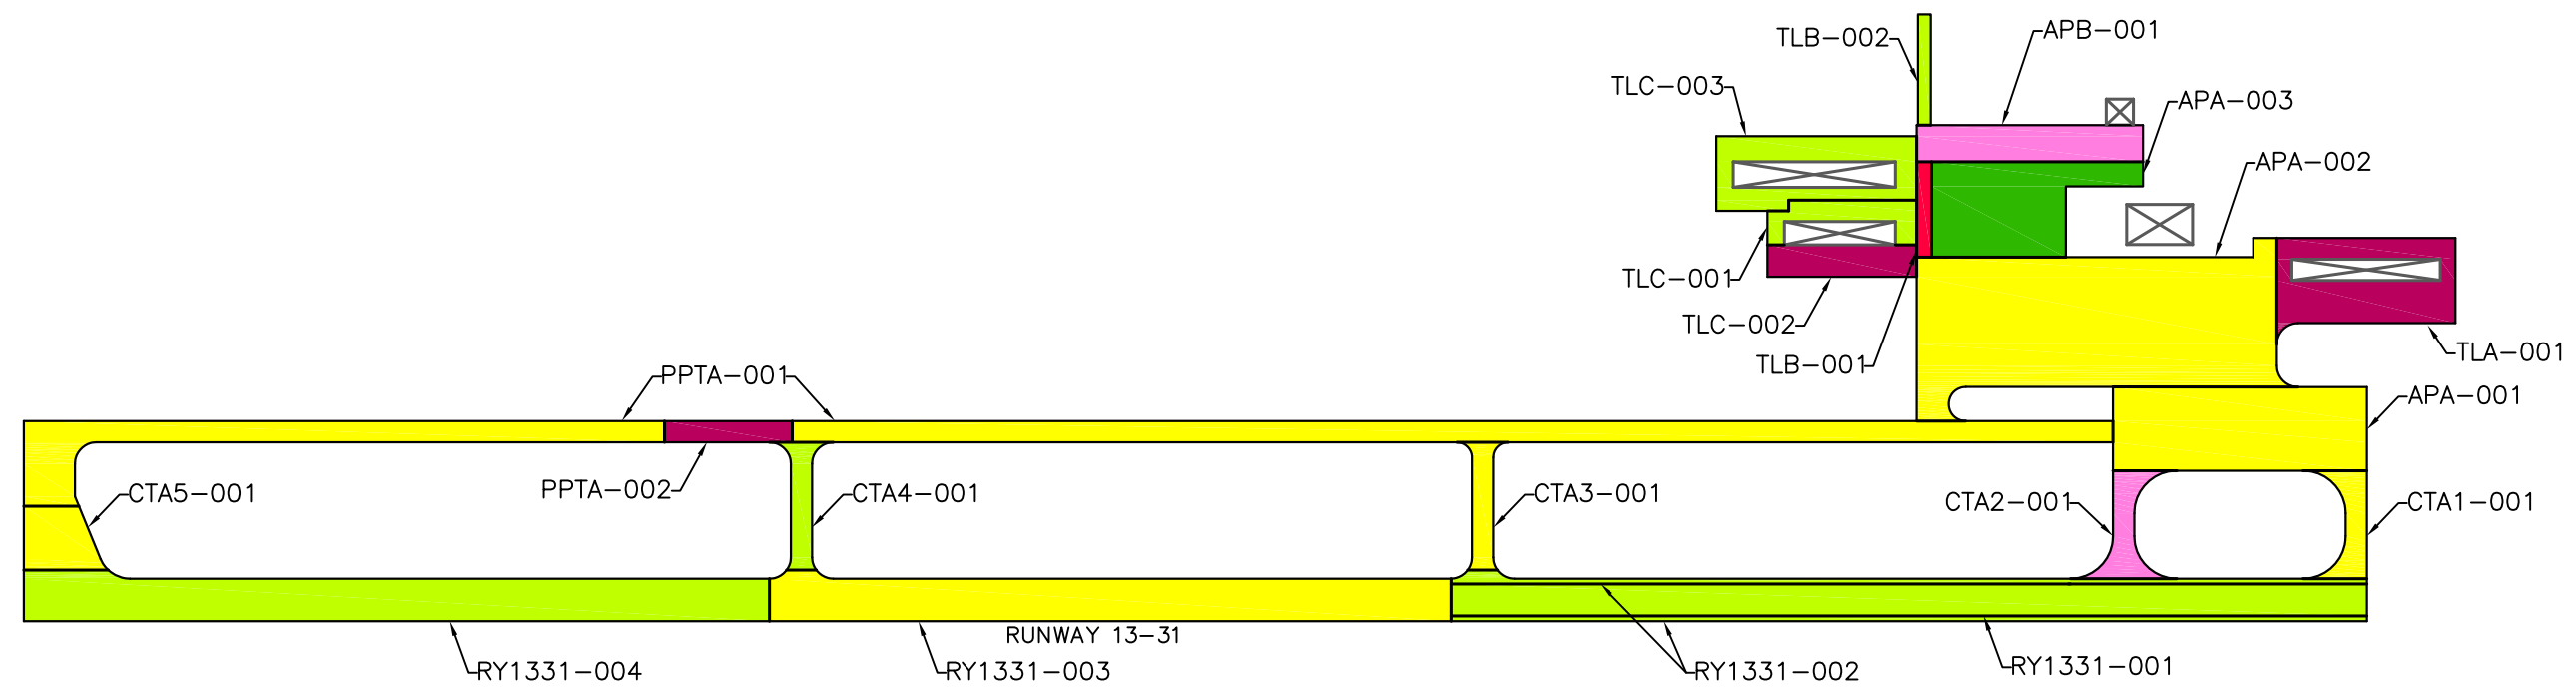
Figure 4. 2010 Pavement Condition Index Rating at Park Rapids Municipal Airport (PKD).

The results of the 2010 PCI inspection are presented in figure 4. The overall area-weighted PCI for PKD is 66. When summarizing PCI values, an area-weighted calculation is used instead of a straight mathematical average because the area-weighted calculations eliminate the skewing of the PCI due to the disparity of the section sizes.

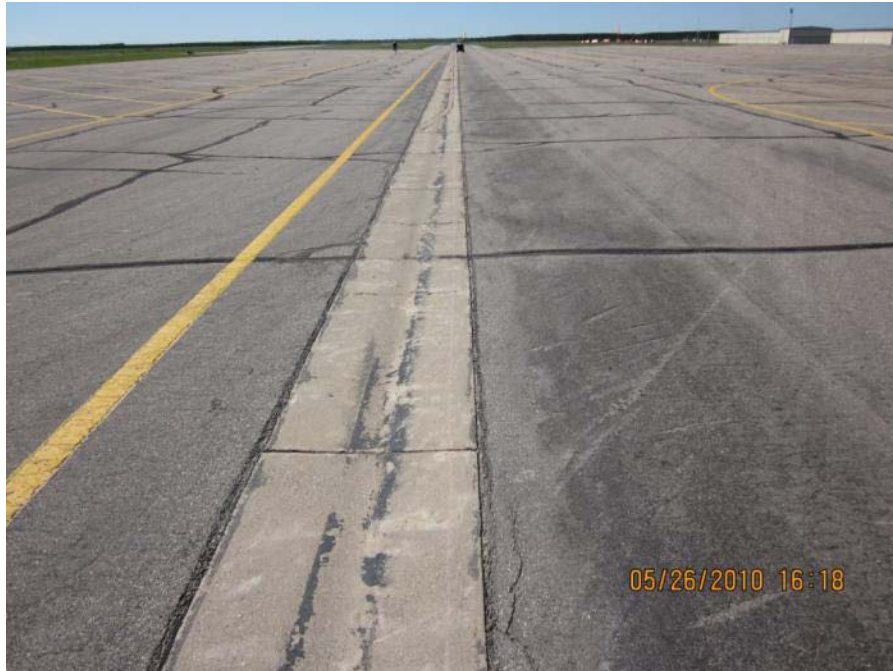
PKD APA 001 (PCI = 61)

| Branch ID | Section ID | Surface type <sup>1</sup> | Section Area (SF) | LCD <sup>2</sup> | 2010 PCI | % Deduct due to | | Distress types |
|---|---|---|---|---|---|---|---|---|
| APA | 1 | AC | 120,000 | 1998 | 61 | 15 | 85 | Alligator cracking, Longitudinal & transverse (L&T) cracking |

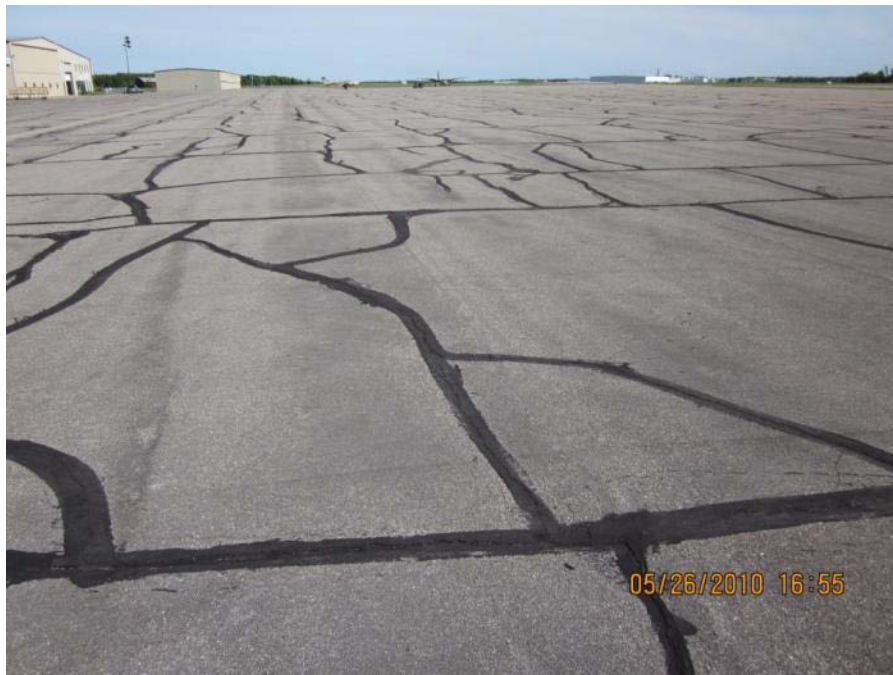
PKD APA 002 (PCI = 64)

| Branch ID | Section ID | Surface type <sup>1</sup> | Section Area (SF) | LCD <sup>2</sup> | 2010 PCI | % Deduct due to | | Distress types |
|---|---|---|---|---|---|---|---|---|
| APA | 2 | AC | 255,000 | 1998 | 64 | 12 | 88 | Alligator cracking, L&T cracking |

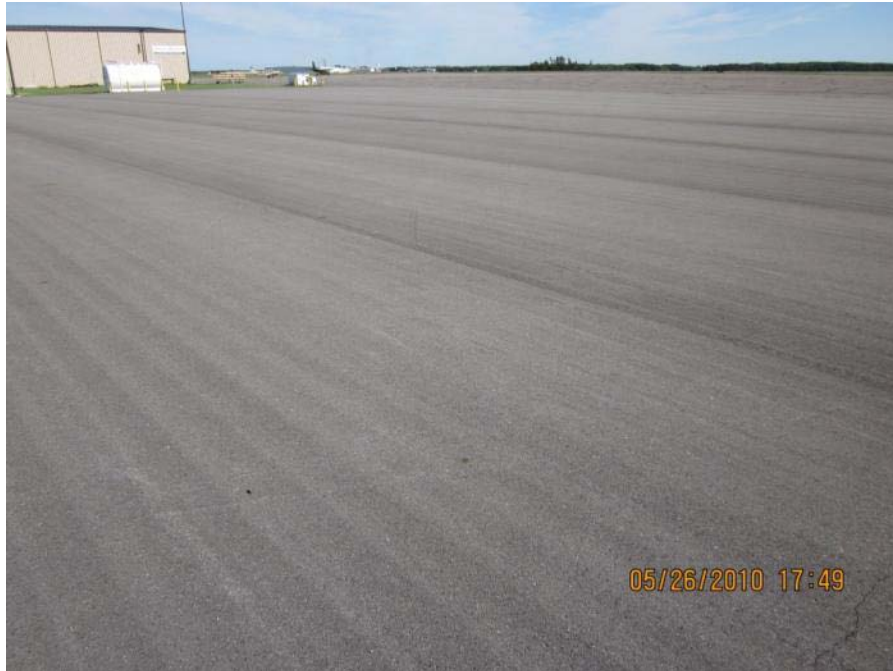
PKD APA 003 (PCI = 94)

| Branch ID | Section ID | Surface type <sup>1</sup> | Section Area (SF) | LCD <sup>2</sup> | 2010 PCI | % Deduct due to | | Distress types |
|---|---|---|---|---|---|---|---|---|
| APA | 3 | AC | 82,645 | 2007 | 94 | 0 | 100 | L&T cracking |

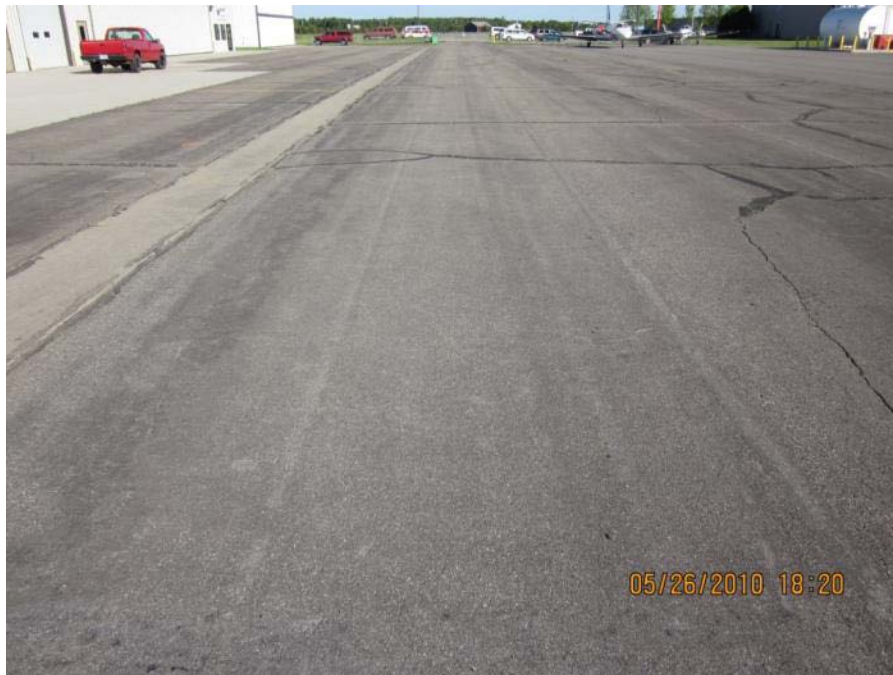
PKD APB 001 (PCI = 47)

| Branch ID | Section ID | Surface type <sup>1</sup> | Section Area (SF) | LCD <sup>2</sup> | 2010 PCI | % Deduct due to | | Distress types |
|---|---|---|---|---|---|---|---|---|
| APB | 1 | AC | 45,666 | 1998 | 47 | 39 | 61 | Alligator cracking, L&T cracking, Rutting |

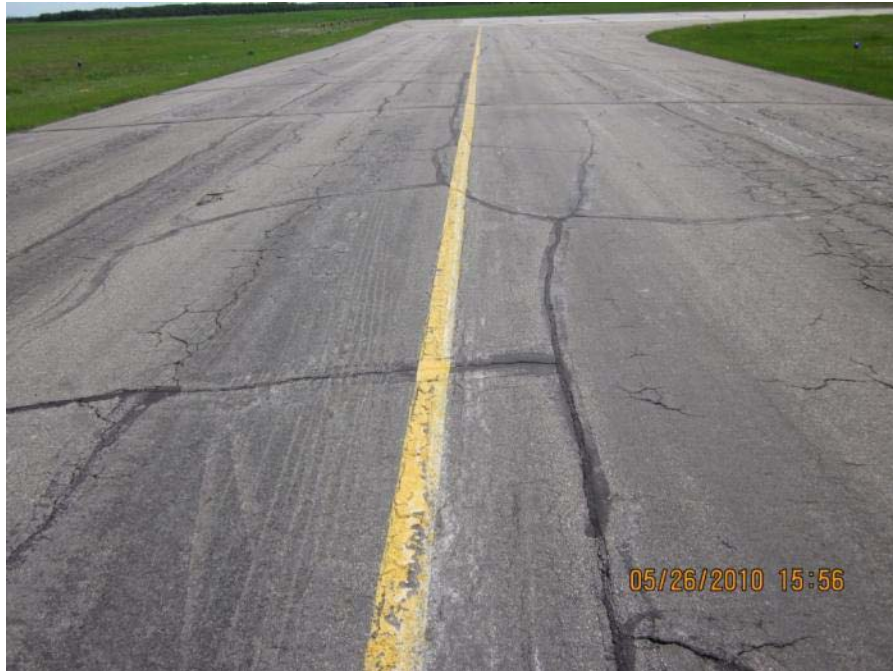
PKD CTA1 001 (PCI = 62)

| Branch ID | Section ID | Surface type <sup>1</sup> | Section Area (SF) | LCD <sup>2</sup> | 2010 PCI | % Deduct due to | | Distress types |
|---|---|---|---|---|---|---|---|---|
| CTA1 | 1 | AC | 14,860 | 1998 | 62 | 15 | 85 | Alligator cracking, L&T cracking, Weathering/raveling |

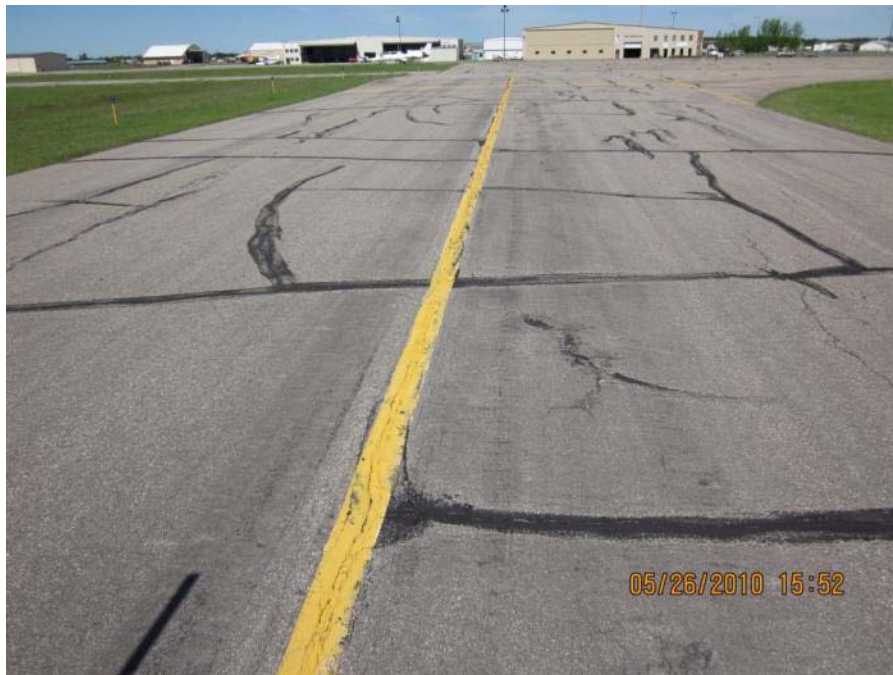
PKD CTA2 001 (PCI = 50)

| Branch ID | Section ID | Surface type <sup>1</sup> | Section Area (SF) | LCD <sup>2</sup> | 2010 PCI | % Deduct due to | | Distress types |
|---|---|---|---|---|---|---|---|---|
| CTA2 | 1 | AC | 16,050 | 1998 | 50 | 49 | 51 | Alligator cracking, L&T cracking |

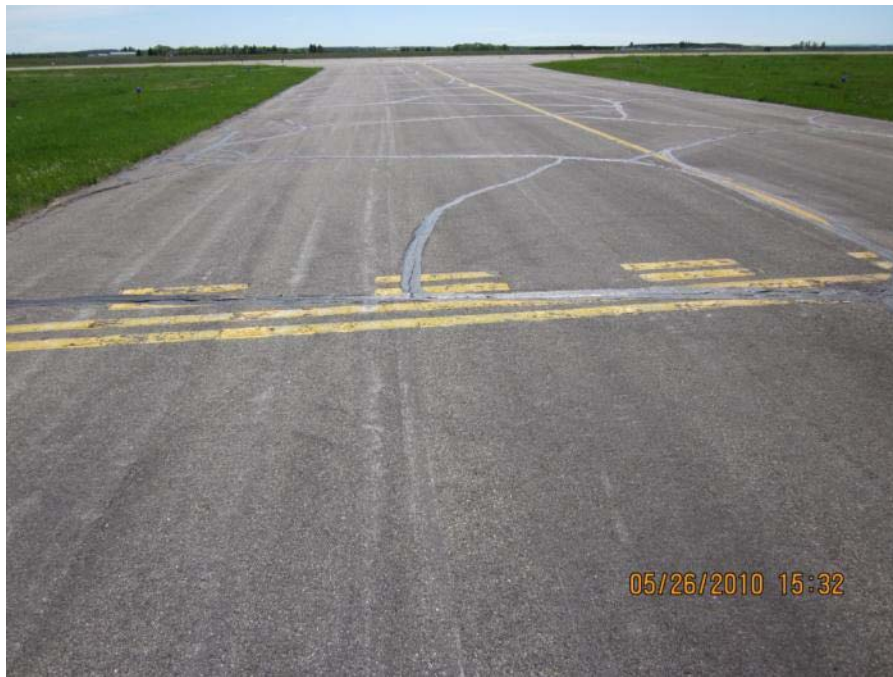
PKD CTA3 001 (PCI = 70)

| Branch ID | Section ID | Surface type <sup>1</sup> | Section Area (SF) | LCD <sup>2</sup> | 2010 PCI | % Deduct due to | | Distress types |
|---|---|---|---|---|---|---|---|---|
| CTA3 | 1 | AC | 15,500 | 1998 | 70 | 0 | 100 | L&T cracking |

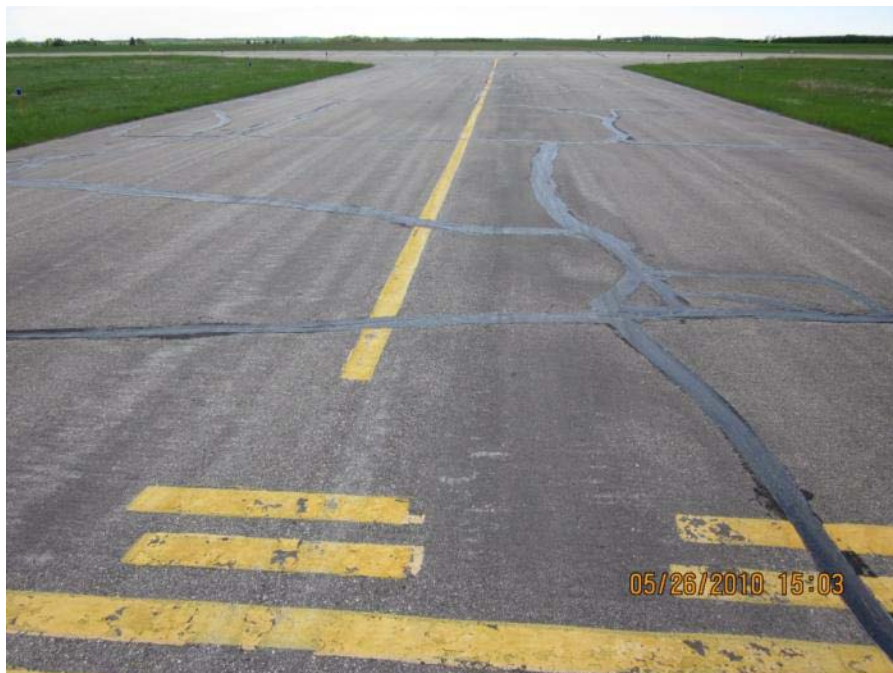
PKD CTA4 001 (PCI = 73)

| Branch ID | Section ID | Surface type <sup>1</sup> | Section Area (SF) | LCD <sup>2</sup> | 2010 PCI | % Deduct due to | | Distress types |
|---|---|---|---|---|---|---|---|---|
| CTA4 | 1 | AC | 15,500 | 1998 | 73 | 0 | 100 | L&T cracking |

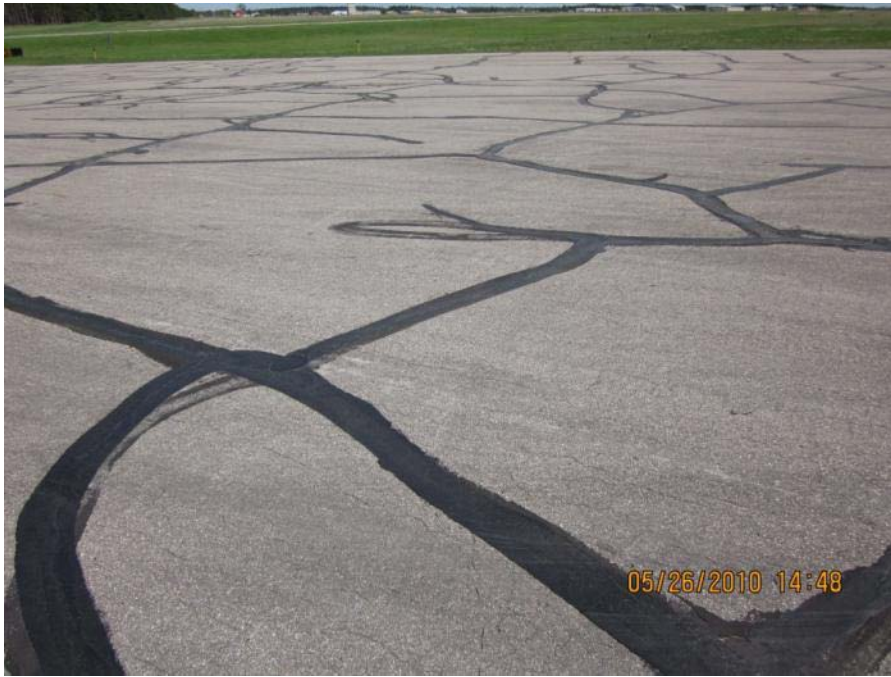
PKD CTA5 001 (PCI = 68)

| Branch ID | Section ID | Surface type <sup>1</sup> | Section Area (SF) | LCD <sup>2</sup> | 2010 PCI | % Deduct due to | | Distress types |
|---|---|---|---|---|---|---|---|---|
| CTA5 | 1 | AC | 28,050 | 1998 | 68 | 0 | 100 | L&T cracking |

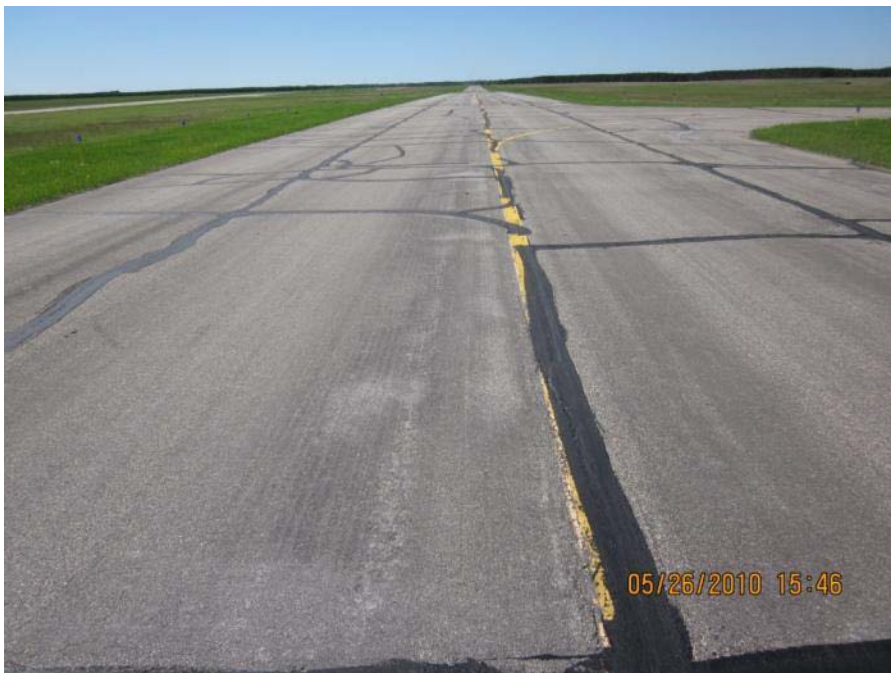
PKD PPTA 001 (PCI = 68)

| Branch ID | Section ID | Surface type <sup>1</sup> | Section Area (SF) | LCD <sup>2</sup> | 2010 PCI | % Deduct due to | | Distress types |
|---|---|---|---|---|---|---|---|---|
| PPTA | 1 | AC | 242,500 | 1998 | 68 | 12 | 88 | Alligator cracking, Block cracking, L&T cracking |

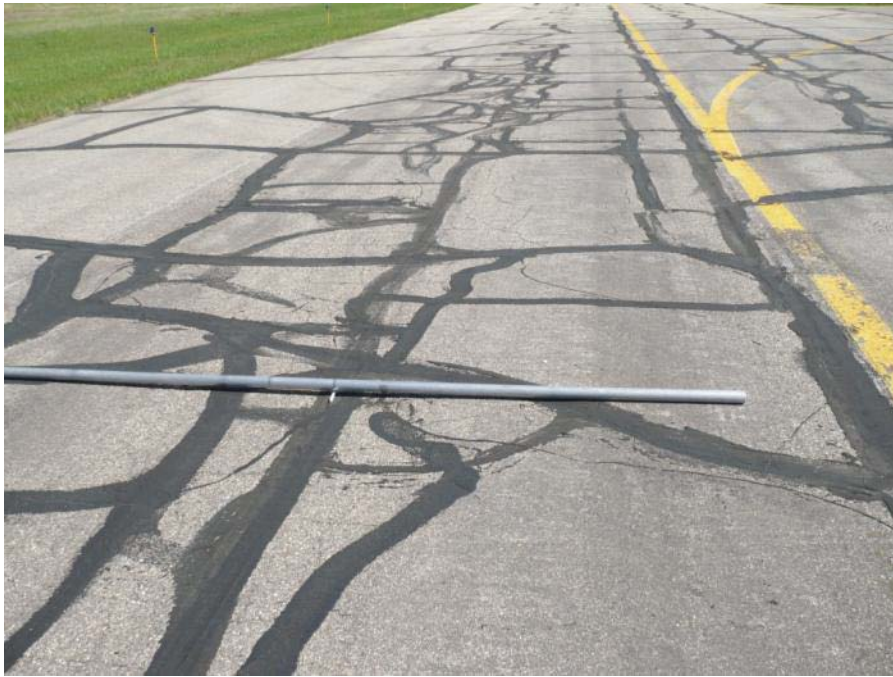
PKD PPTA 002 (PCI = 22)

| Branch ID | Section ID | Surface type <sup>1</sup> | Section Area (SF) | LCD <sup>2</sup> | 2010 PCI | % Deduct due to | | Distress types |
|---|---|---|---|---|---|---|---|---|
| PPTA | 2 | AC | 15,000 | 1998 | 22 | 75 | 25 | Alligator cracking, Block cracking, L&T cracking, Rutting |

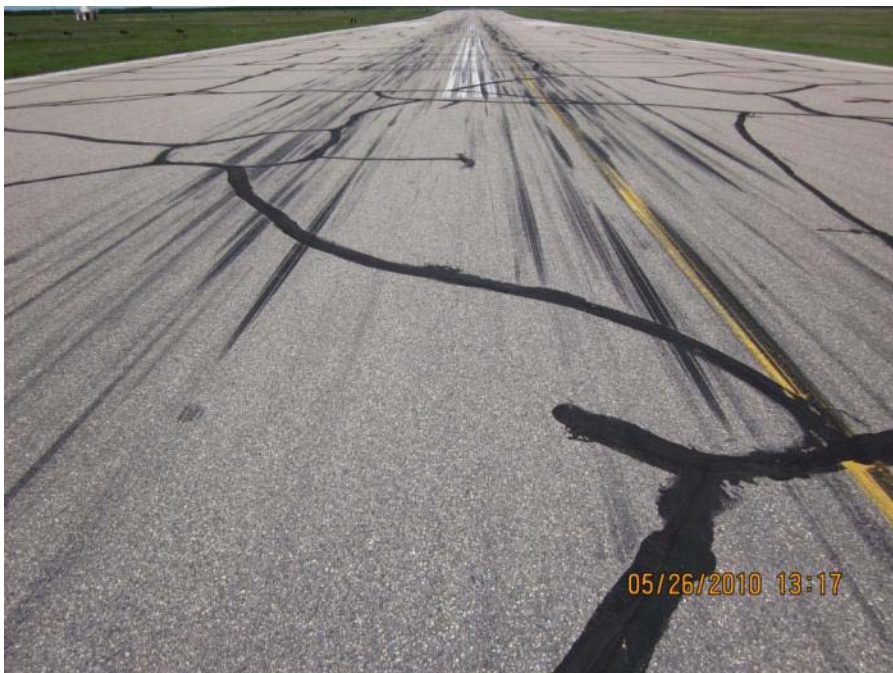
PKD RY1331 001 (PCI = 73)

| Branch ID | Section ID | Surface type <sup>1</sup> | Section Area (SF) | LCD <sup>2</sup> | 2010 PCI | % Deduct due to | | Distress types |
|---|---|---|---|---|---|---|---|---|
| RY1331 | 1 | AAC | 161,250 | 1998 | 73 | 0 | 100 | L&T cracking, Weathering/raveling |

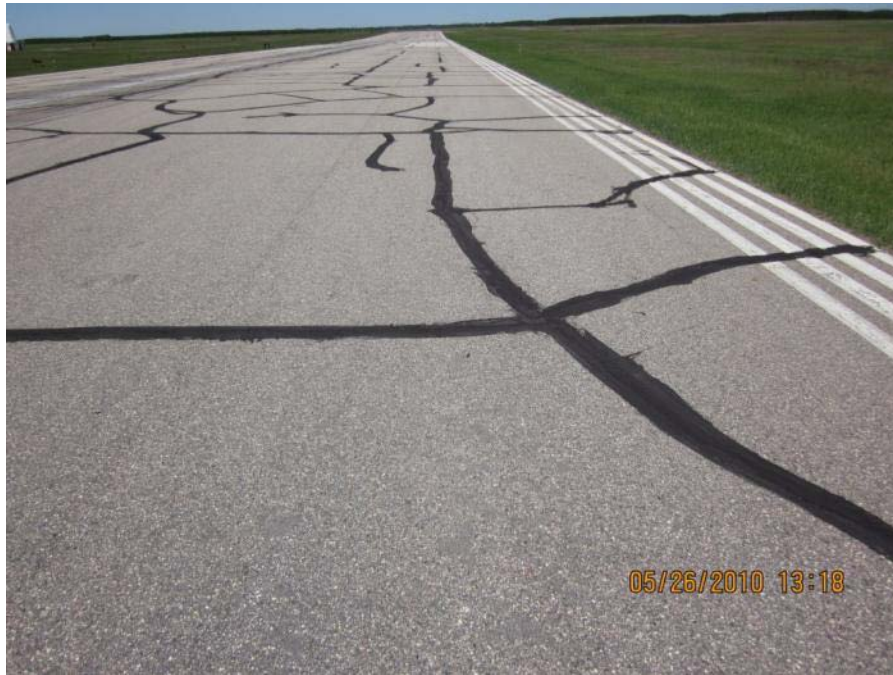
PKD RY1331 002 (PCI = 73)

| Branch ID | Section ID | Surface type <sup>1</sup> | Section Area (SF) | LCD <sup>2</sup> | 2010 PCI | % Deduct due to | | Distress types |
|---|---|---|---|---|---|---|---|---|
| RY1331 | 2 | AAC | 53,750 | 1998 | 73 | 0 | 100 | L&T cracking |

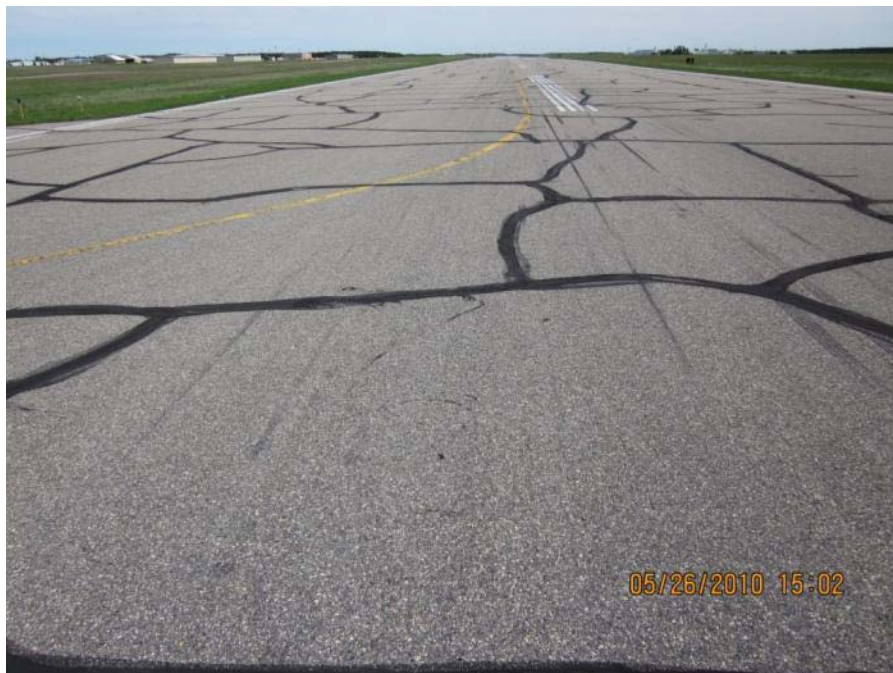
PKD RY1331 003 (PCI = 70)

| Branch ID | Section ID | Surface type <sup>1</sup> | Section Area (SF) | LCD <sup>2</sup> | 2010 PCI | % Deduct due to | | Distress types |
|---|---|---|---|---|---|---|---|---|
| RY1331 | 3 | AAC | 160,000 | 1998 | 70 | 0 | 100 | L&T cracking |

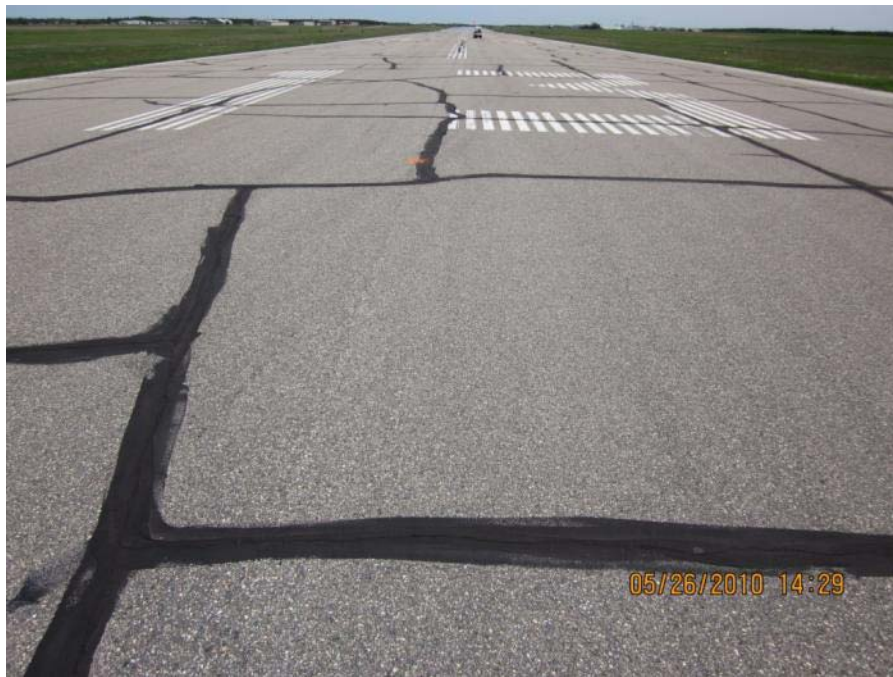
PKD RY1331 004 (PCI = 72)

| Branch ID | Section ID | Surface type <sup>1</sup> | Section Area (SF) | LCD <sup>2</sup> | 2010 PCI | % Deduct due to | | Distress types |
|---|---|---|---|---|---|---|---|---|
| RY1331 | 4 | AAC | 175,000 | 1998 | 72 | 0 | 100 | L&T cracking, Weathering/raveling |

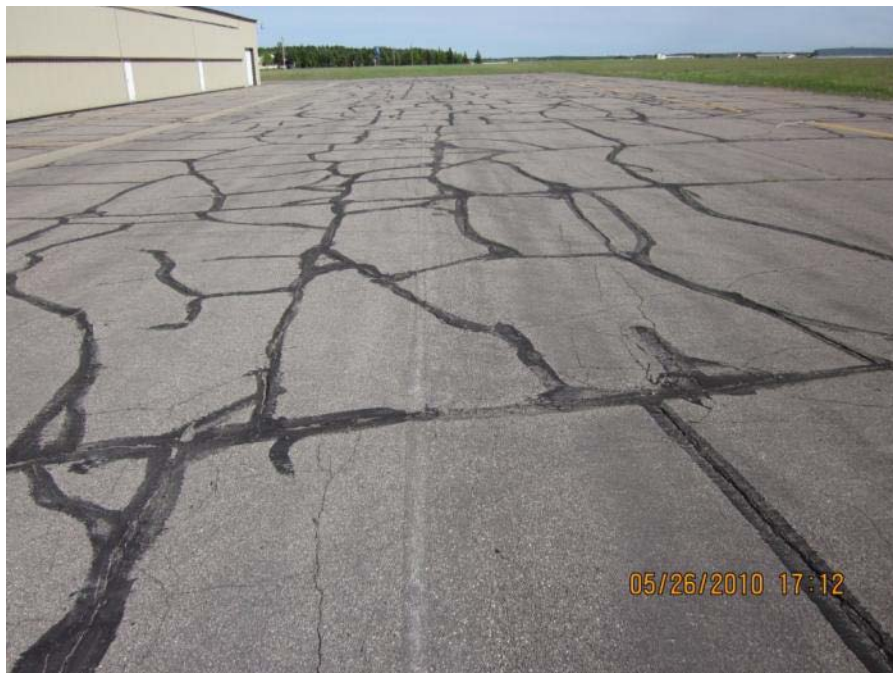
PKD TLA 001 (PCI = 25)

| Branch ID | Section ID | Surface type <sup>1</sup> | Section Area (SF) | LCD <sup>2</sup> | 2010 PCI | % Deduct due to | | Distress types |
|---|---|---|---|---|---|---|---|---|
| TLA | 1 | AC | 66,460 | 1998 | 25 | 79 | 21 | Alligator cracking, Block cracking, Rutting |

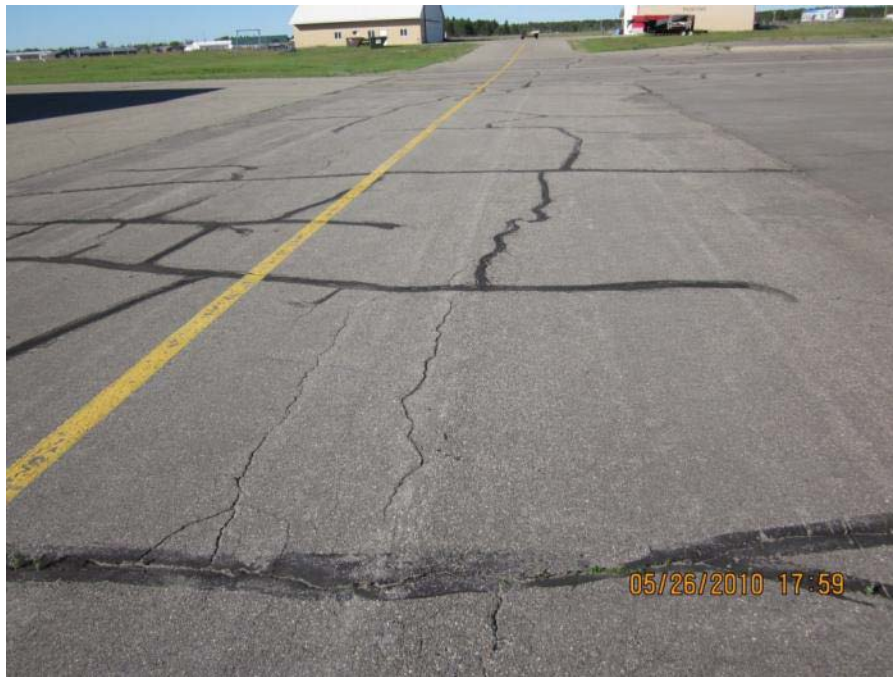
PKD TLB 001 (PCI = 40)

| Branch ID | Section ID | Surface type <sup>1</sup> | Section Area (SF) | LCD <sup>2</sup> | 2010 PCI | % Deduct due to | | Distress types |
|---|---|---|---|---|---|---|---|---|
| TLB | 1 | AC | 7,805 | 1998 | 40 | 53 | 47 | Alligator cracking, Block cracking, L&T cracking |

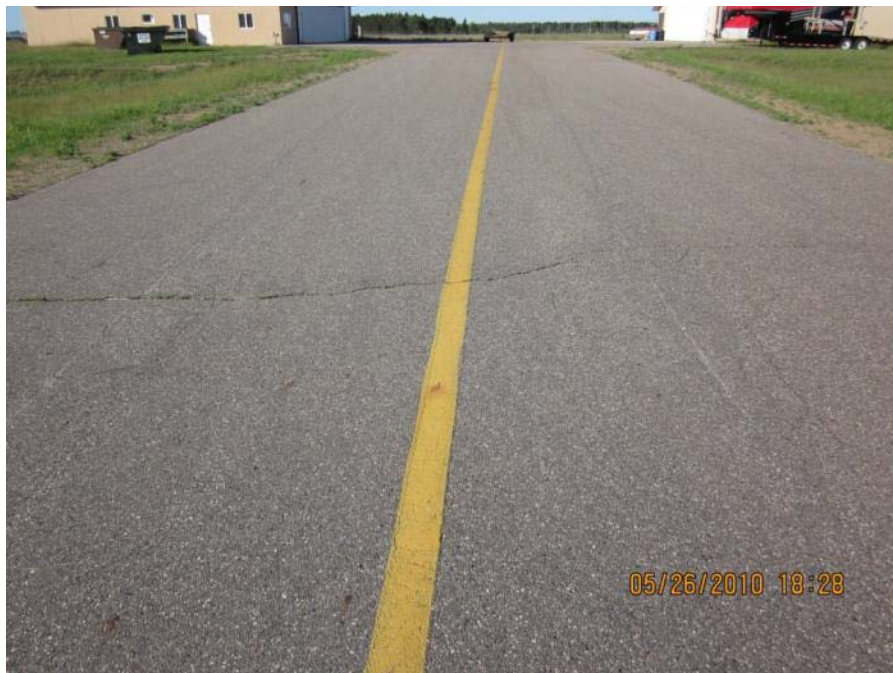
PKD TLB 002 (PCI = 81)

| Branch ID | Section ID | Surface type <sup>1</sup> | Section Area (SF) | LCD <sup>2</sup> | 2010 PCI | % Deduct due to | | Distress types |
|---|---|---|---|---|---|---|---|---|
| TLB | 2 | AC | 7,800 | 2004 <sup>5</sup> | 81 | 0 | 100 | L&T cracking |

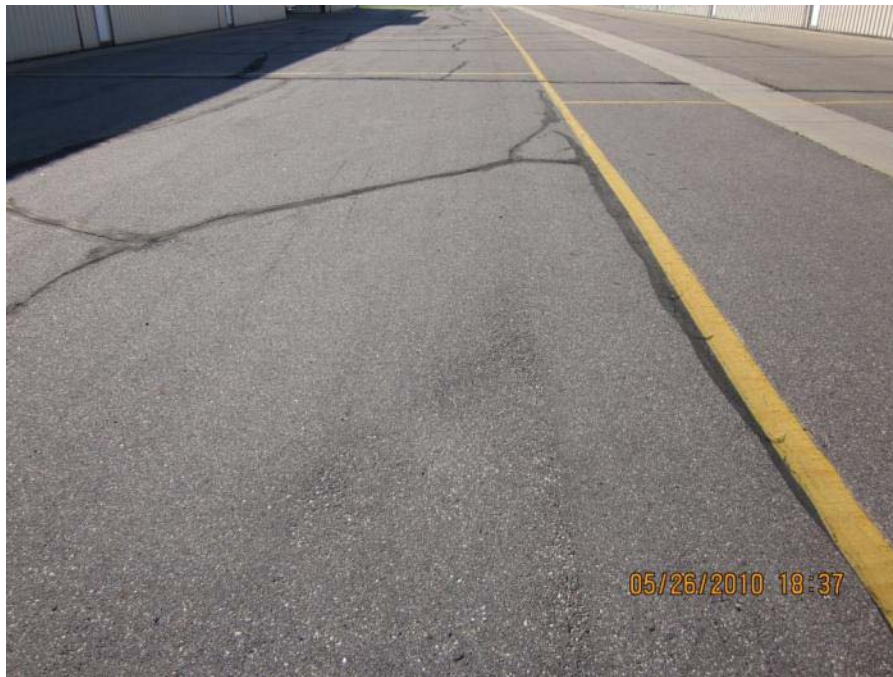
PKD TLC 001 (PCI = 73)

| Branch ID | Section ID | Surface type <sup>1</sup> | Section Area (SF) | LCD <sup>2</sup> | 2010 PCI | % Deduct due to | | Distress types |
|---|---|---|---|---|---|---|---|---|
| TLC | 1 | AC | 20,250 | 1996 | 73 | 0 | 100 | L&T cracking |

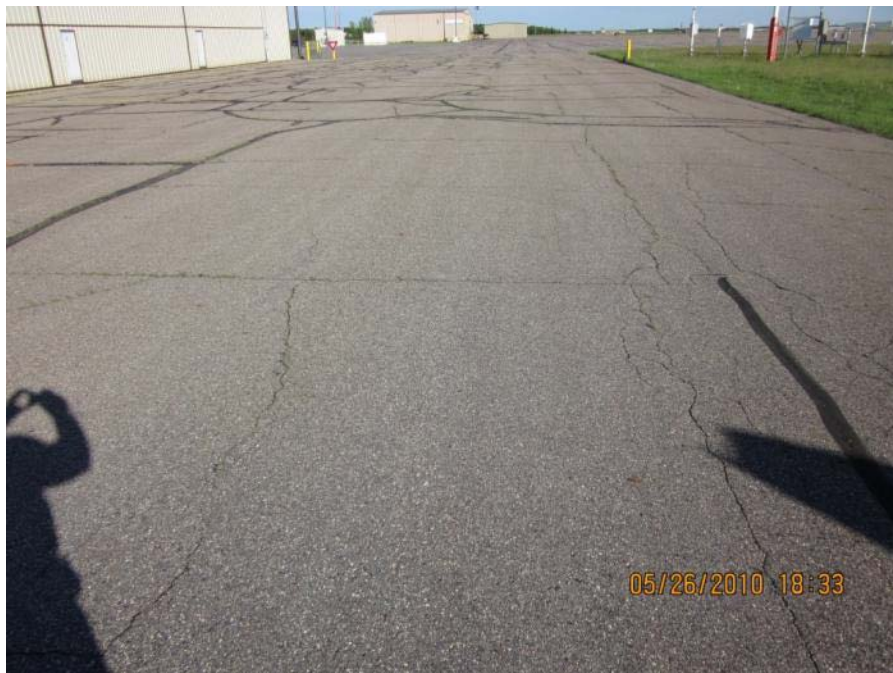
PKD TLC 002 (PCI = 23)

| Branch ID | Section ID | Surface type <sup>1</sup> | Section Area (SF) | LCD <sup>2</sup> | 2010 PCI | % Deduct due to | | Distress types |
|---|---|---|---|---|---|---|---|---|
| TLC | 2 | AC | 26,250 | 1996 | 23 | 61 | 39 | Alligator cracking, Block cracking, L&T cracking, Rutting |

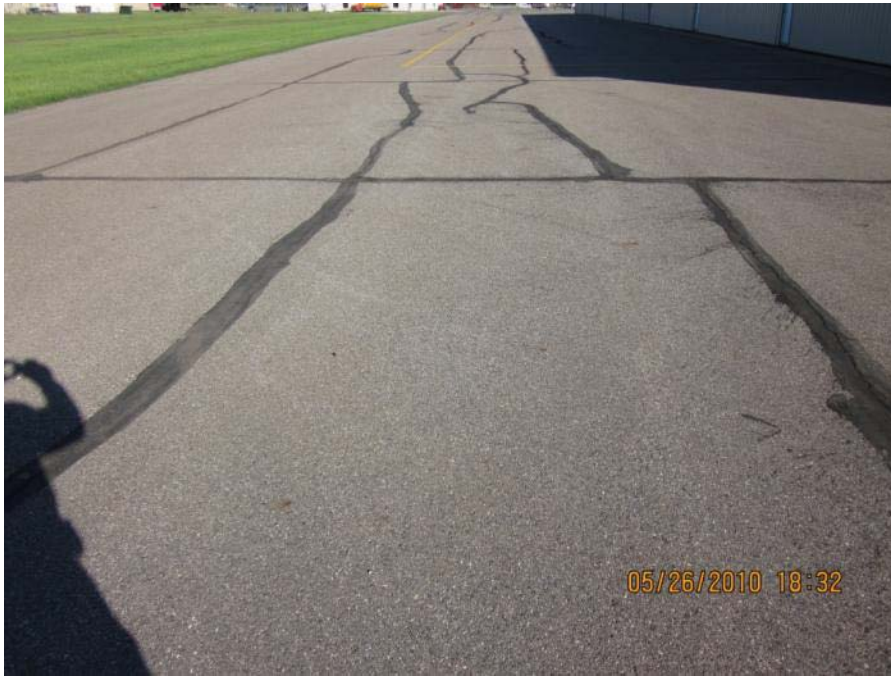
PKD TLC 003 (PCI = 82)

| Branch ID | Section ID | Surface type <sup>1</sup> | Section Area (SF) | LCD <sup>2</sup> | 2010 PCI | % Deduct due to | | Distress types |
|---|---|---|---|---|---|---|---|---|
| TLC | 3 | AC | 46,200 | 2001 | 82 | 0 | 100 | L&T cracking |
