# Minnesota Airport System Pavement Evaluation 2010 Update

Pine River Regional Airport  
(PWC)

Pine River, Minnesota

December 2010

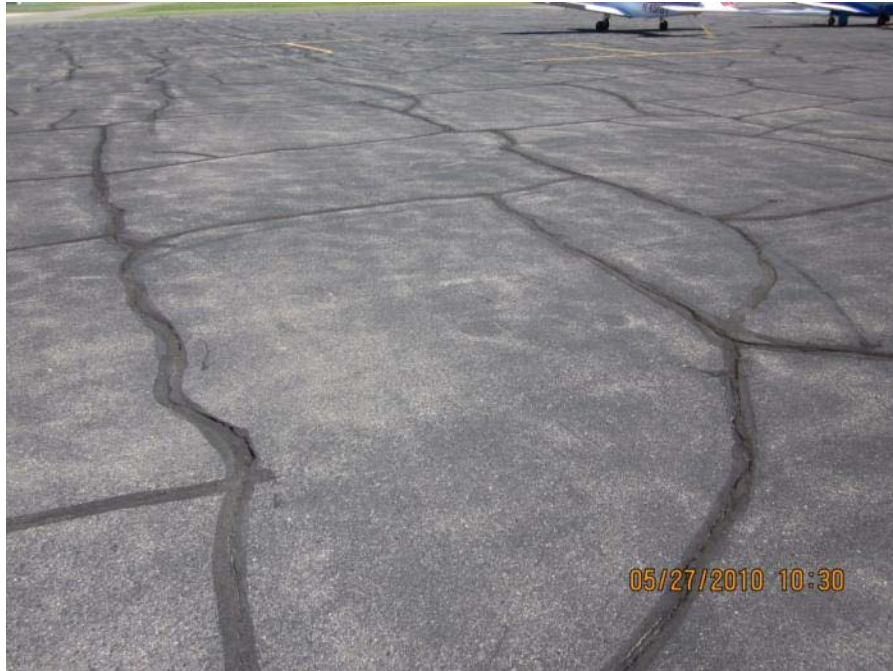
PWC APA 001 (PCI = 48)

| Branch ID | Section ID | Surface type <sup>1</sup> | Section Area (SF) | LCD <sup>2</sup> | 2010 PCI | % Deduct due to | | Distress types |
|---|---|---|---|---|---|---|---|---|
| APA | 1 | AC | 75,000 | 1993 | 48 | 16 | 84 | Alligator cracking, Block cracking, Longitudinal & transverse (L&T) cracking |

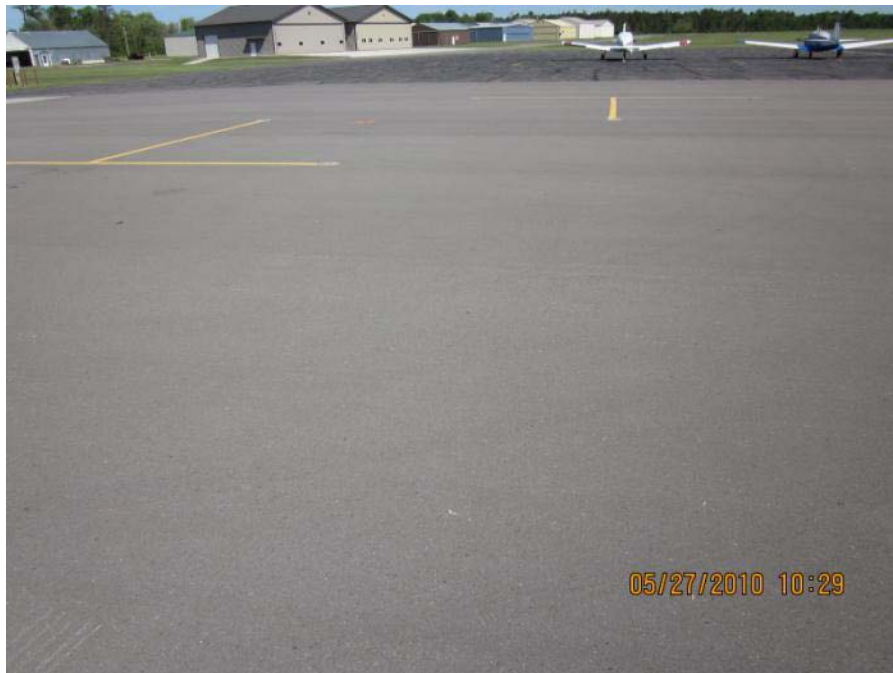
PWC APA 002 (PCI = 97)

| Branch ID | Section ID | Surface type <sup>1</sup> | Section Area (SF) | LCD <sup>2</sup> | 2010 PCI | % Deduct due to | | Distress types |
|---|---|---|---|---|---|---|---|---|
| APA | 2 | AC | 38,800 | 2008 <sup>5</sup> | 97 | 0 | 100 | L&T cracking, Weathering/raveling |

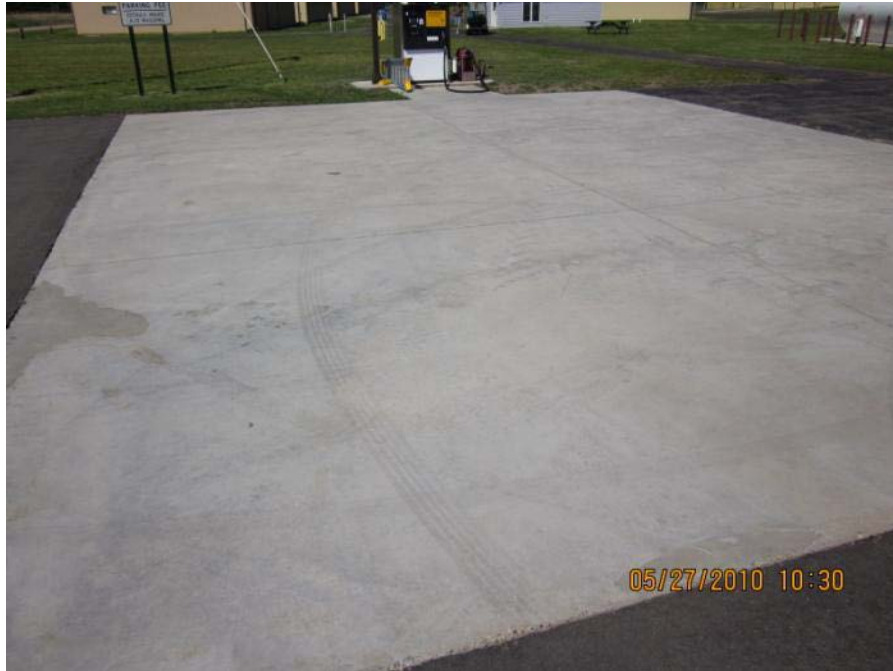
PWC APA 003 (PCI = 80)

| Branch ID | Section ID | Surface type <sup>1</sup> | Section Area (SF) | LCD <sup>2</sup> | 2010 PCI | % Deduct due to | | Distress types |
|---|---|---|---|---|---|---|---|---|
| APA | 3 | PCC | 1,200 | 2008 <sup>5</sup> | 80 | 57 | 32 | Linear cracking, Joint seal damage, Shrinkage cracking |

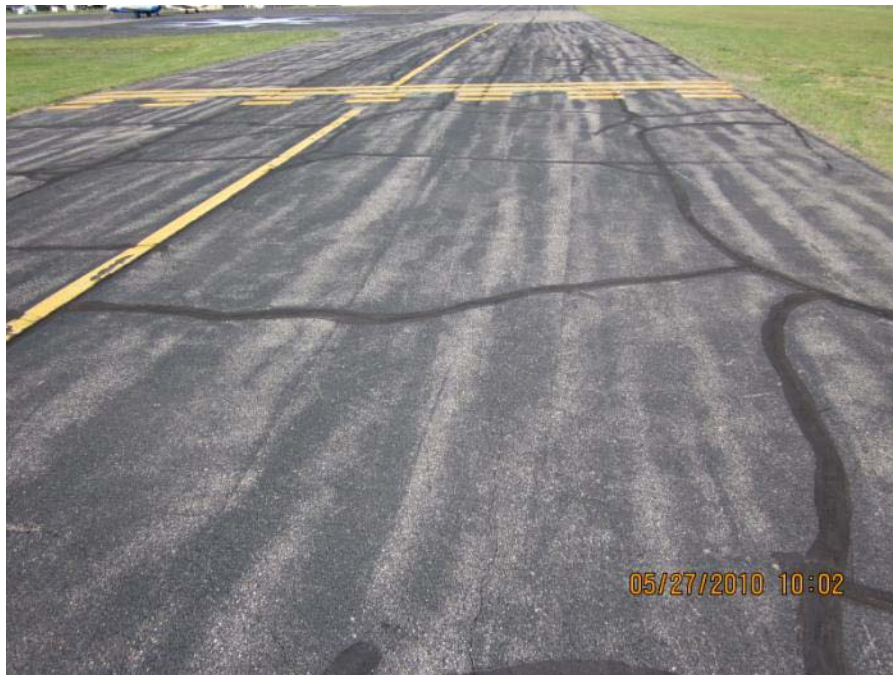
PWC CTA 001 (PCI = 48)

| Branch ID | Section ID | Surface type <sup>1</sup> | Section Area (SF) | LCD <sup>2</sup> | 2010 PCI | % Deduct due to | | Distress types |
|---|---|---|---|---|---|---|---|---|
| CTA | 1 | AC | 8,675 | 1993 | 48 | 16 | 84 | Alligator cracking, Block cracking, L&T cracking, Patching |

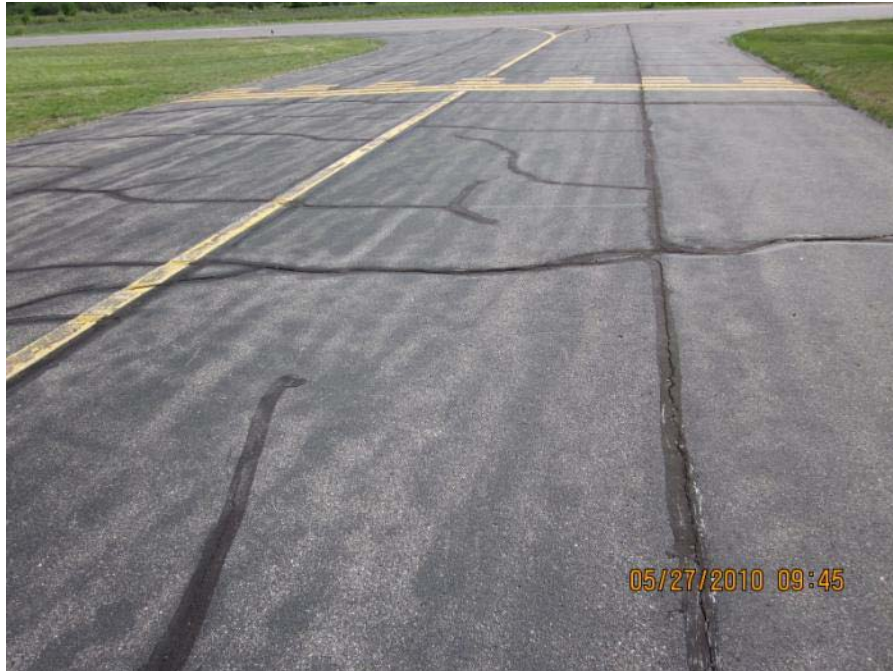
PWC CTB 001 (PCI = 56)

| Branch ID | Section ID | Surface type <sup>1</sup> | Section Area (SF) | LCD <sup>2</sup> | 2010 PCI | % Deduct due to | | Distress types |
|---|---|---|---|---|---|---|---|---|
| CTB | 1 | AC | 6,475 | 1993 | 56 | 0 | 100 | L&T cracking |

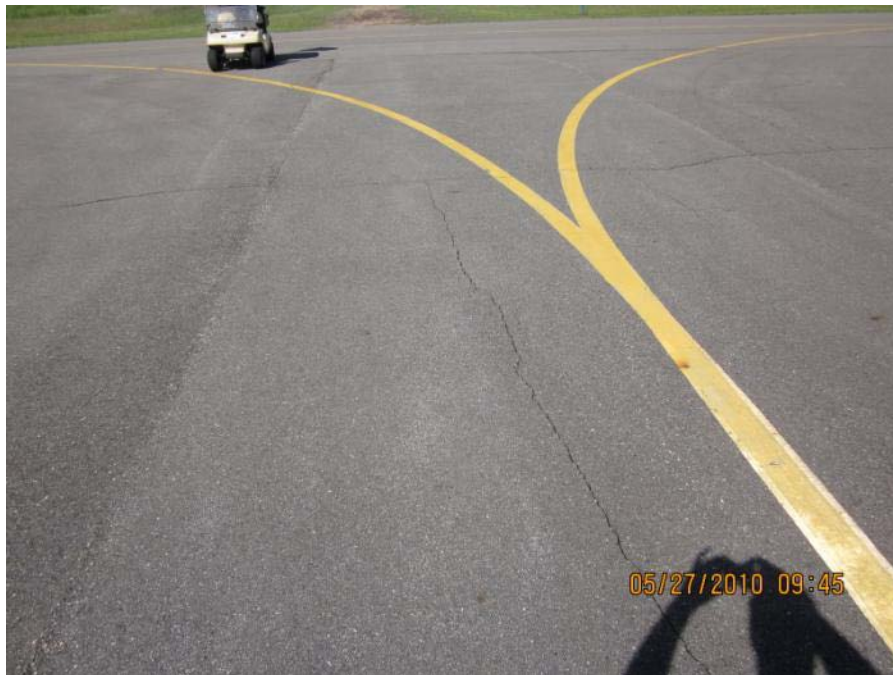
PWC CTB 002 (PCI = 78)

| Branch ID | Section ID | Surface type <sup>1</sup> | Section Area (SF) | LCD <sup>2</sup> | 2010 PCI | % Deduct due to | | Distress types |
|---|---|---|---|---|---|---|---|---|
| CTB | 2 | AAC | 2,955 | 2005 | 78 | 0 | 100 | L&T cracking |

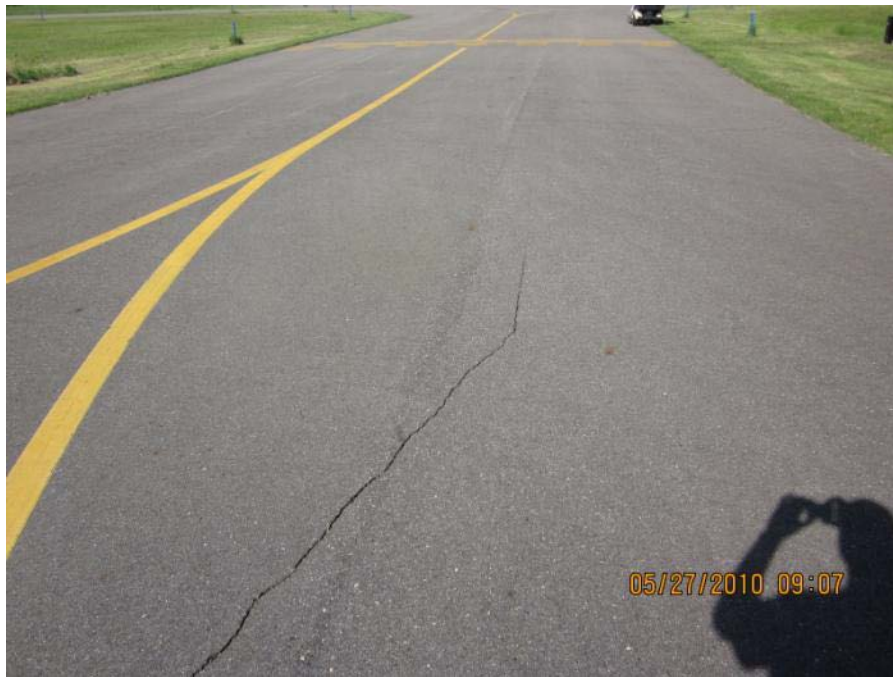
PWC CTC 001 (PCI = 89)

| Branch ID | Section ID | Surface type <sup>1</sup> | Section Area (SF) | LCD <sup>2</sup> | 2010 PCI | % Deduct due to | | Distress types |
|---|---|---|---|---|---|---|---|---|
| CTC | 1 | AC | 9,350 | 2005 | 89 | 0 | 100 | L&T cracking |

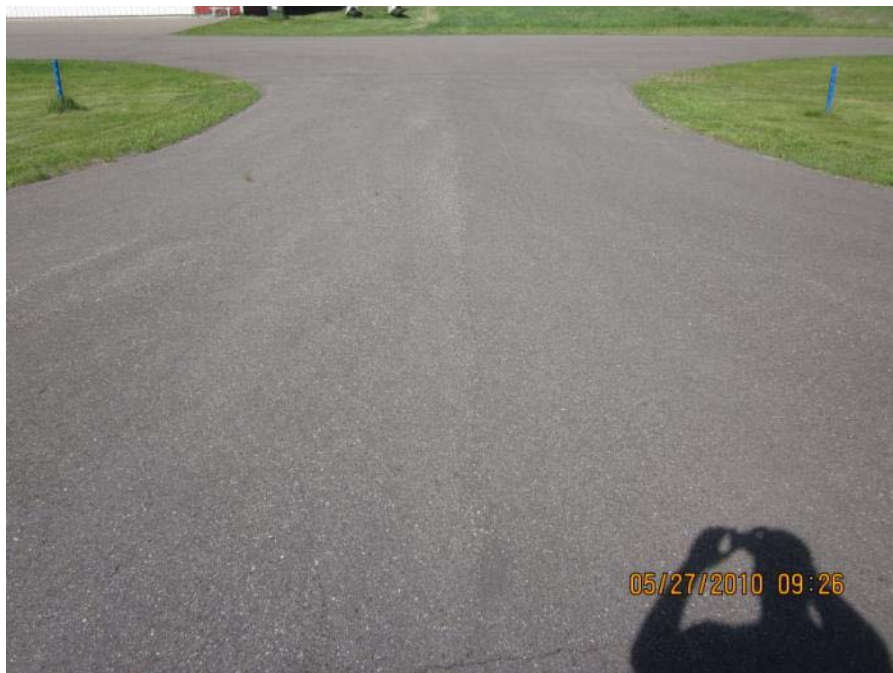
PWC CTCX 001 (PCI = 86)

| Branch ID | Section ID | Surface type <sup>1</sup> | Section Area (SF) | LCD <sup>2</sup> | 2010 PCI | % Deduct due to | | Distress types |
|---|---|---|---|---|---|---|---|---|
| CTCX | 1 | AC | 2,260 | 2005 | 86 | 0 | 100 | L&T cracking |

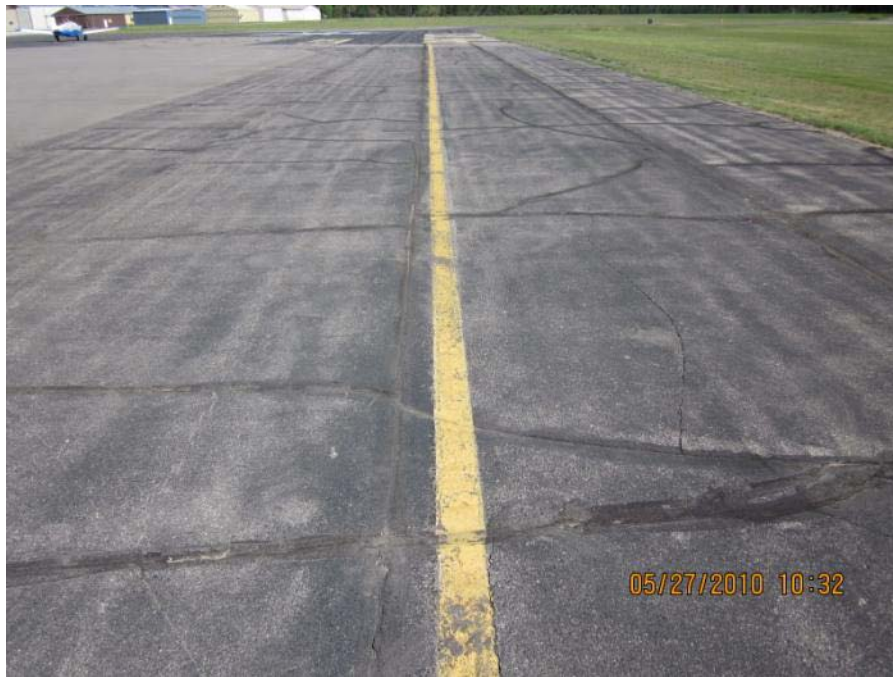
PWC PTA 001 (PCI = 66)

| Branch ID | Section ID | Surface type <sup>1</sup> | Section Area (SF) | LCD <sup>2</sup> | 2010 PCI | % Deduct due to | | Distress types |
|---|---|---|---|---|---|---|---|---|
| PTA | 1 | AC | 12,400 | 1993 | 66 | 0 | 100 | Block cracking |

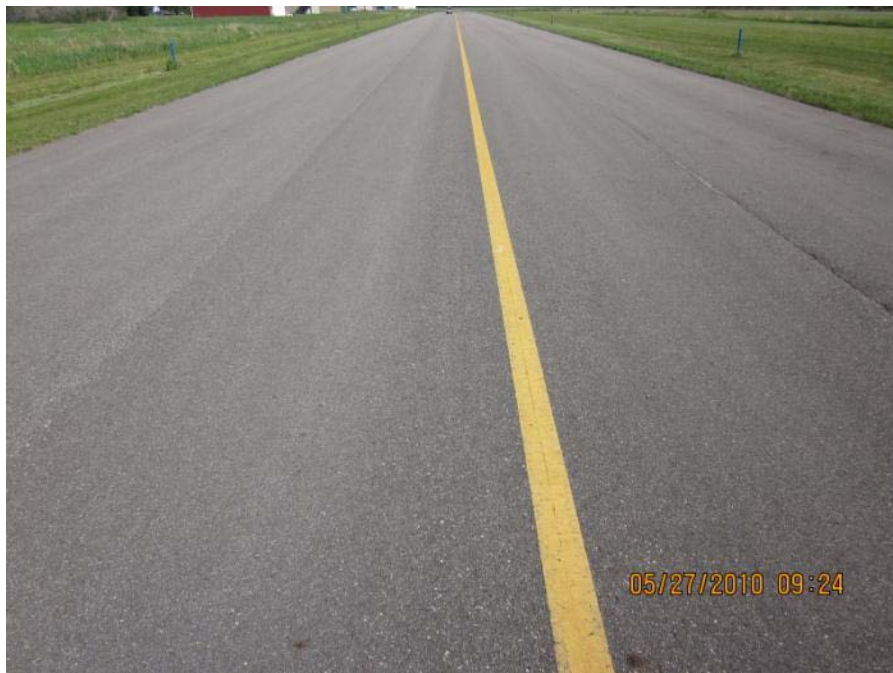
PWC PTA 001 (PCI = 91)

| Branch ID | Section ID | Surface type <sup>1</sup> | Section Area (SF) | LCD <sup>2</sup> | 2010 PCI | % Deduct due to | | Distress types |
|---|---|---|---|---|---|---|---|---|
| PTA | 2 | AC | 100,120 | 2005 | 91 | 0 | 100 | L&T cracking |

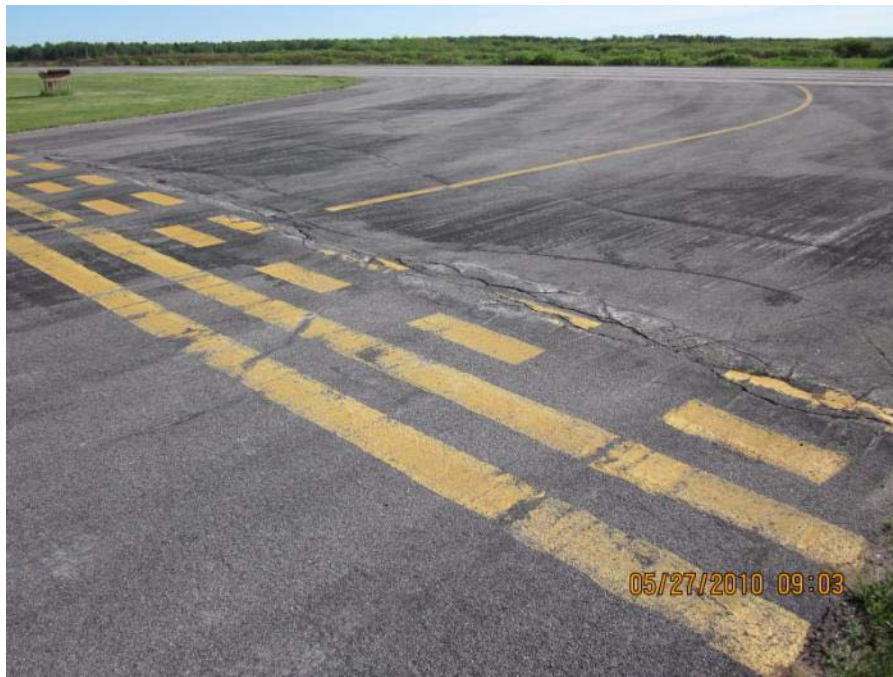
PWC PTA 003 (PCI = 26)

| Branch ID | Section ID | Surface type <sup>1</sup> | Section Area (SF) | LCD <sup>2</sup> | 2010 PCI | % Deduct due to | | Distress types |
|---|---|---|---|---|---|---|---|---|
| PTA | 3 | AC | 7,975 | 1993 | 26 | 63 | 30 | Alligator cracking, Block cracking, L&T cracking, Rutting, Swelling |

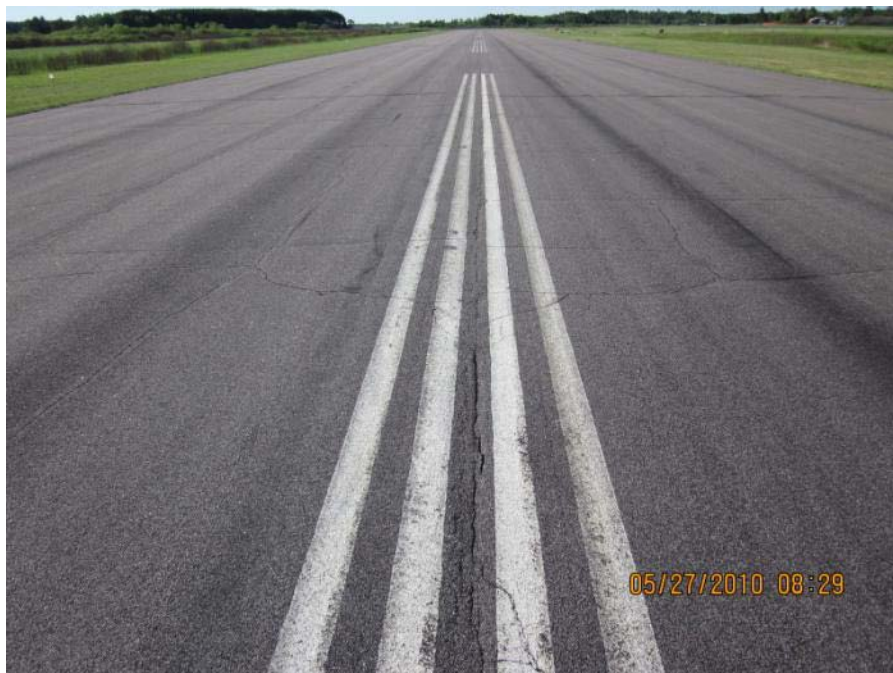
PWC RY1634 001 (PCI = 52)

| Branch ID | Section ID | Surface type <sup>1</sup> | Section Area (SF) | LCD <sup>2</sup> | 2010 PCI | % Deduct due to | | Distress types |
|---|---|---|---|---|---|---|---|---|
| RY1634 | 1 | AC | 225,000 | 1993 | 52 | 45 | 55 | Alligator cracking, Block cracking, L&T cracking, Patching, Rutting |

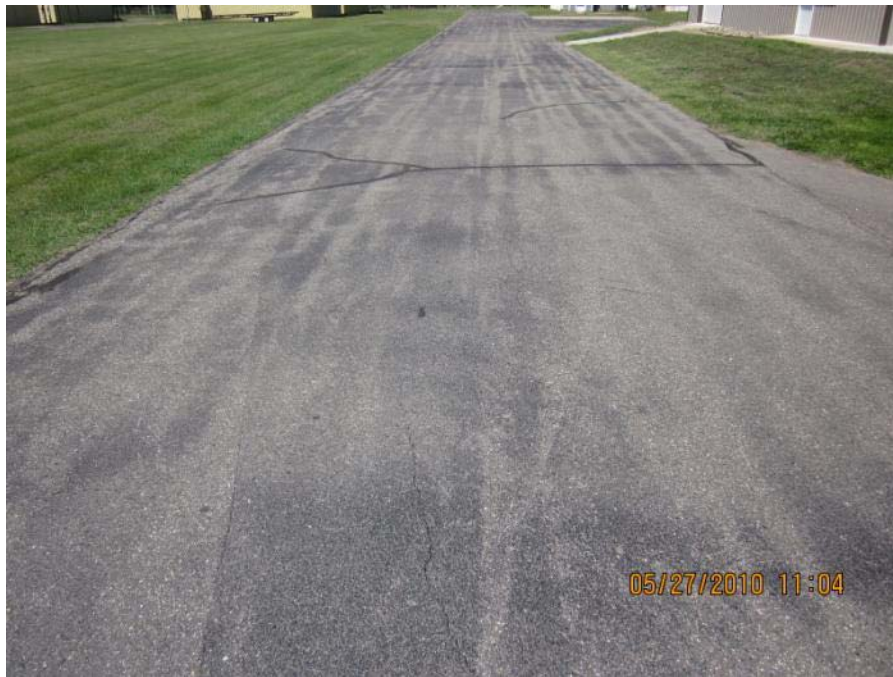
PWC TLA 001 (PCI = 60)

| Branch ID | Section ID | Surface type <sup>1</sup> | Section Area (SF) | LCD <sup>2</sup> | 2010 PCI | % Deduct due to | | Distress types |
|---|---|---|---|---|---|---|---|---|
| TLA | 1 | AC | 23,200 | 1993 | 60 | 33 | 67 | Alligator cracking, L&T cracking |

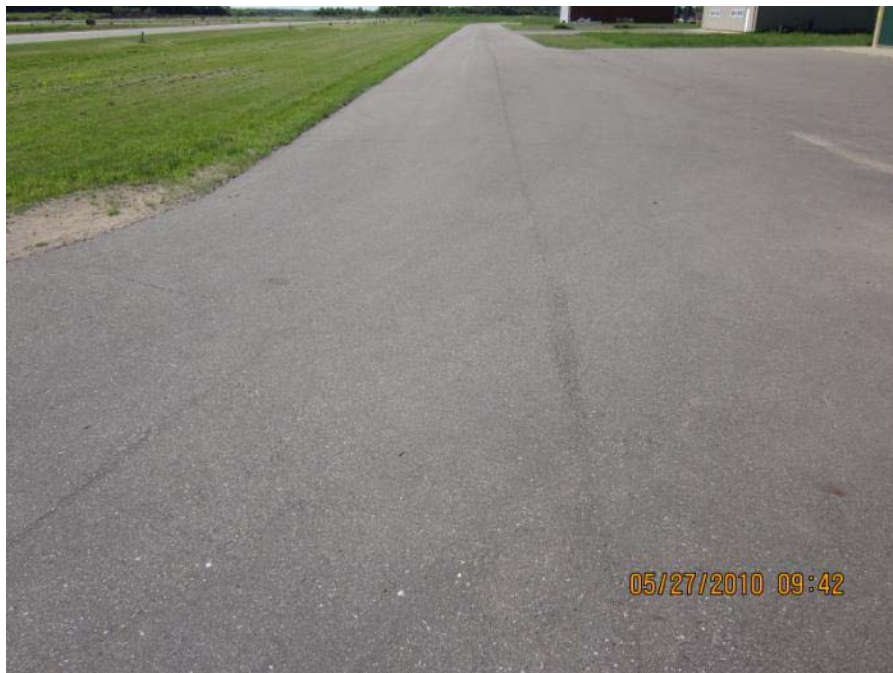
PWC TLB 001 (PCI = 82)

| Branch ID | Section ID | Surface type <sup>1</sup> | Section Area (SF) | LCD <sup>2</sup> | 2010 PCI | % Deduct due to | | Distress types |
|---|---|---|---|---|---|---|---|---|
| TLB | 1 | AC | 12,800 | 2005 | 82 | 0 | 100 | L&T cracking |

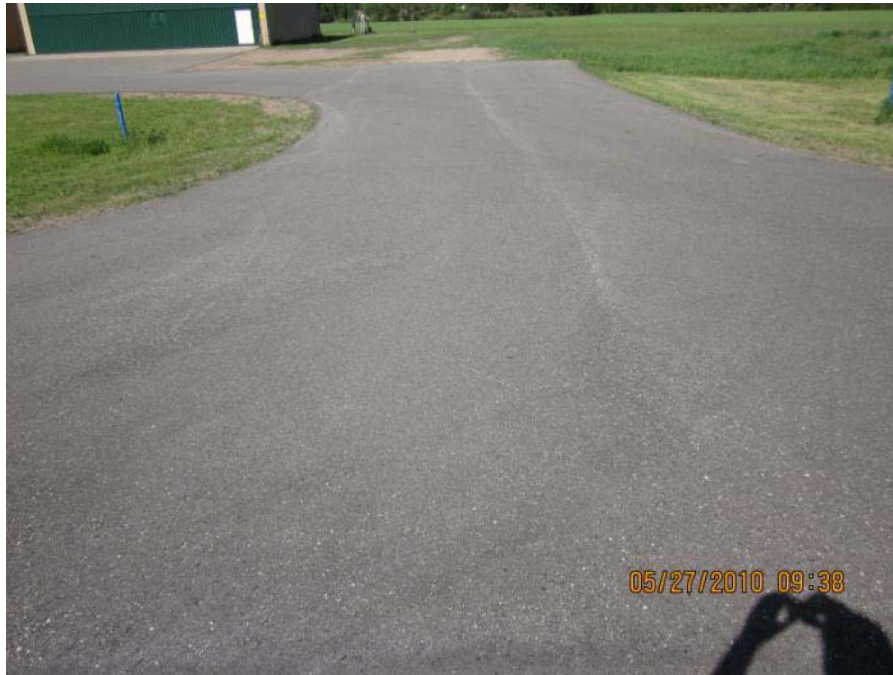
PWC TLB1 001 (PCI = 97)

| Branch ID | Section ID | Surface type <sup>1</sup> | Section Area (SF) | LCD <sup>2</sup> | 2010 PCI | % Deduct due to | | Distress types |
|---|---|---|---|---|---|---|---|---|
| TLB1 | 1 | AC | 1,880 | 2005 | 97 | 0 | 100 | L&T cracking |

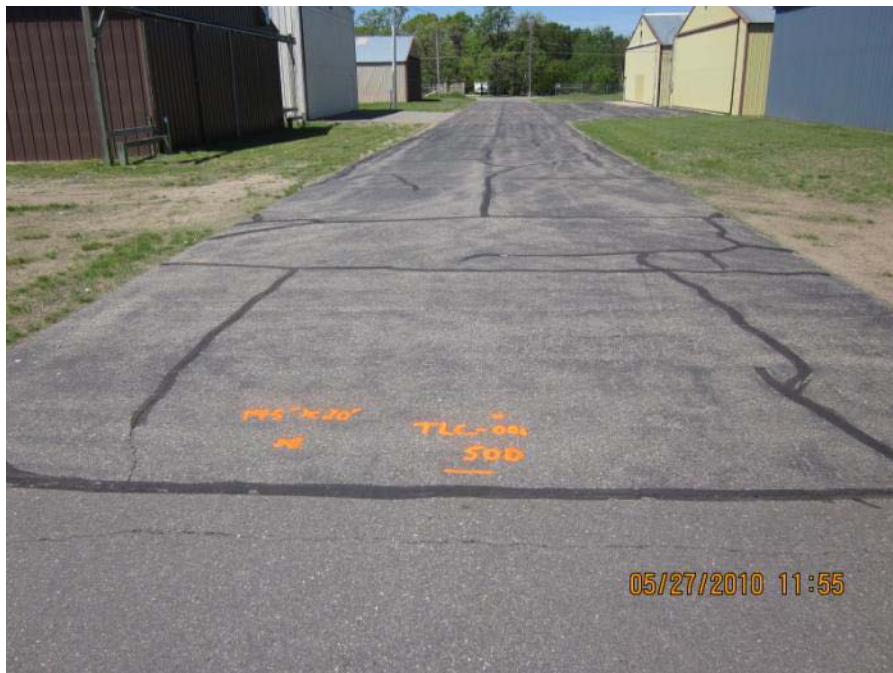
PWC TLC 001 (PCI = 59)

| Branch ID | Section ID | Surface type <sup>1</sup> | Section Area (SF) | LCD <sup>2</sup> | 2010 PCI | % Deduct due to | | Distress types |
|---|---|---|---|---|---|---|---|---|
| TLC | 1 | AC | 14,420 | 1993 | 59 | 0 | 100 | L&T cracking |

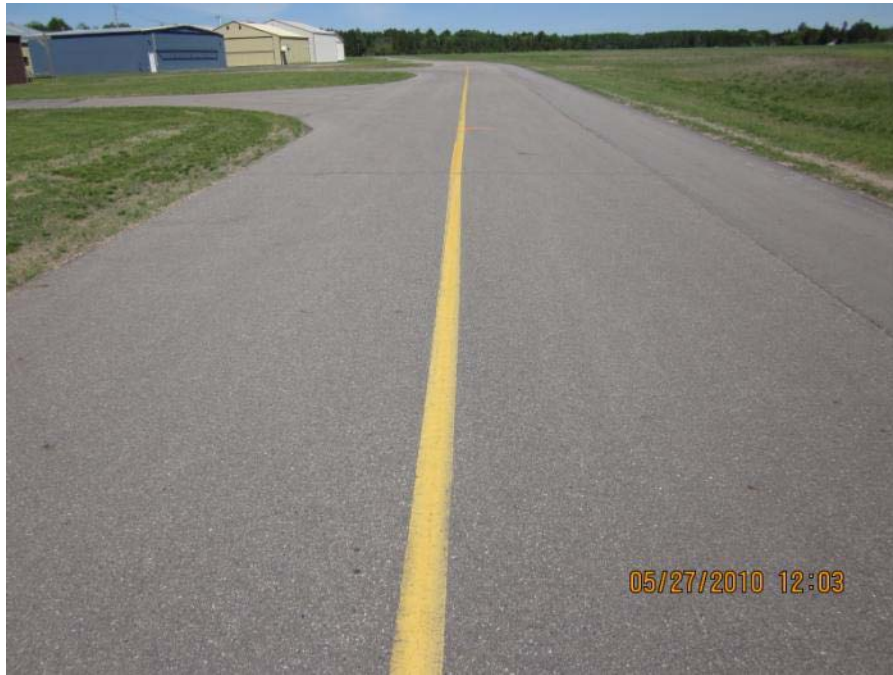
PWC TLD 001 (PCI = 85)

| Branch ID | Section ID | Surface type <sup>1</sup> | Section Area (SF) | LCD <sup>2</sup> | 2010 PCI | % Deduct due to | | Distress types |
|---|---|---|---|---|---|---|---|---|
| TLD | 1 | AC | 37,980 | 2005 | 85 | 0 | 100 | L&T cracking |
