Minnesota Airport System Pavement Evaluation 2010 Update

Staples Municipal Airport (SAZ)

Staples, Minnesota

December 2010

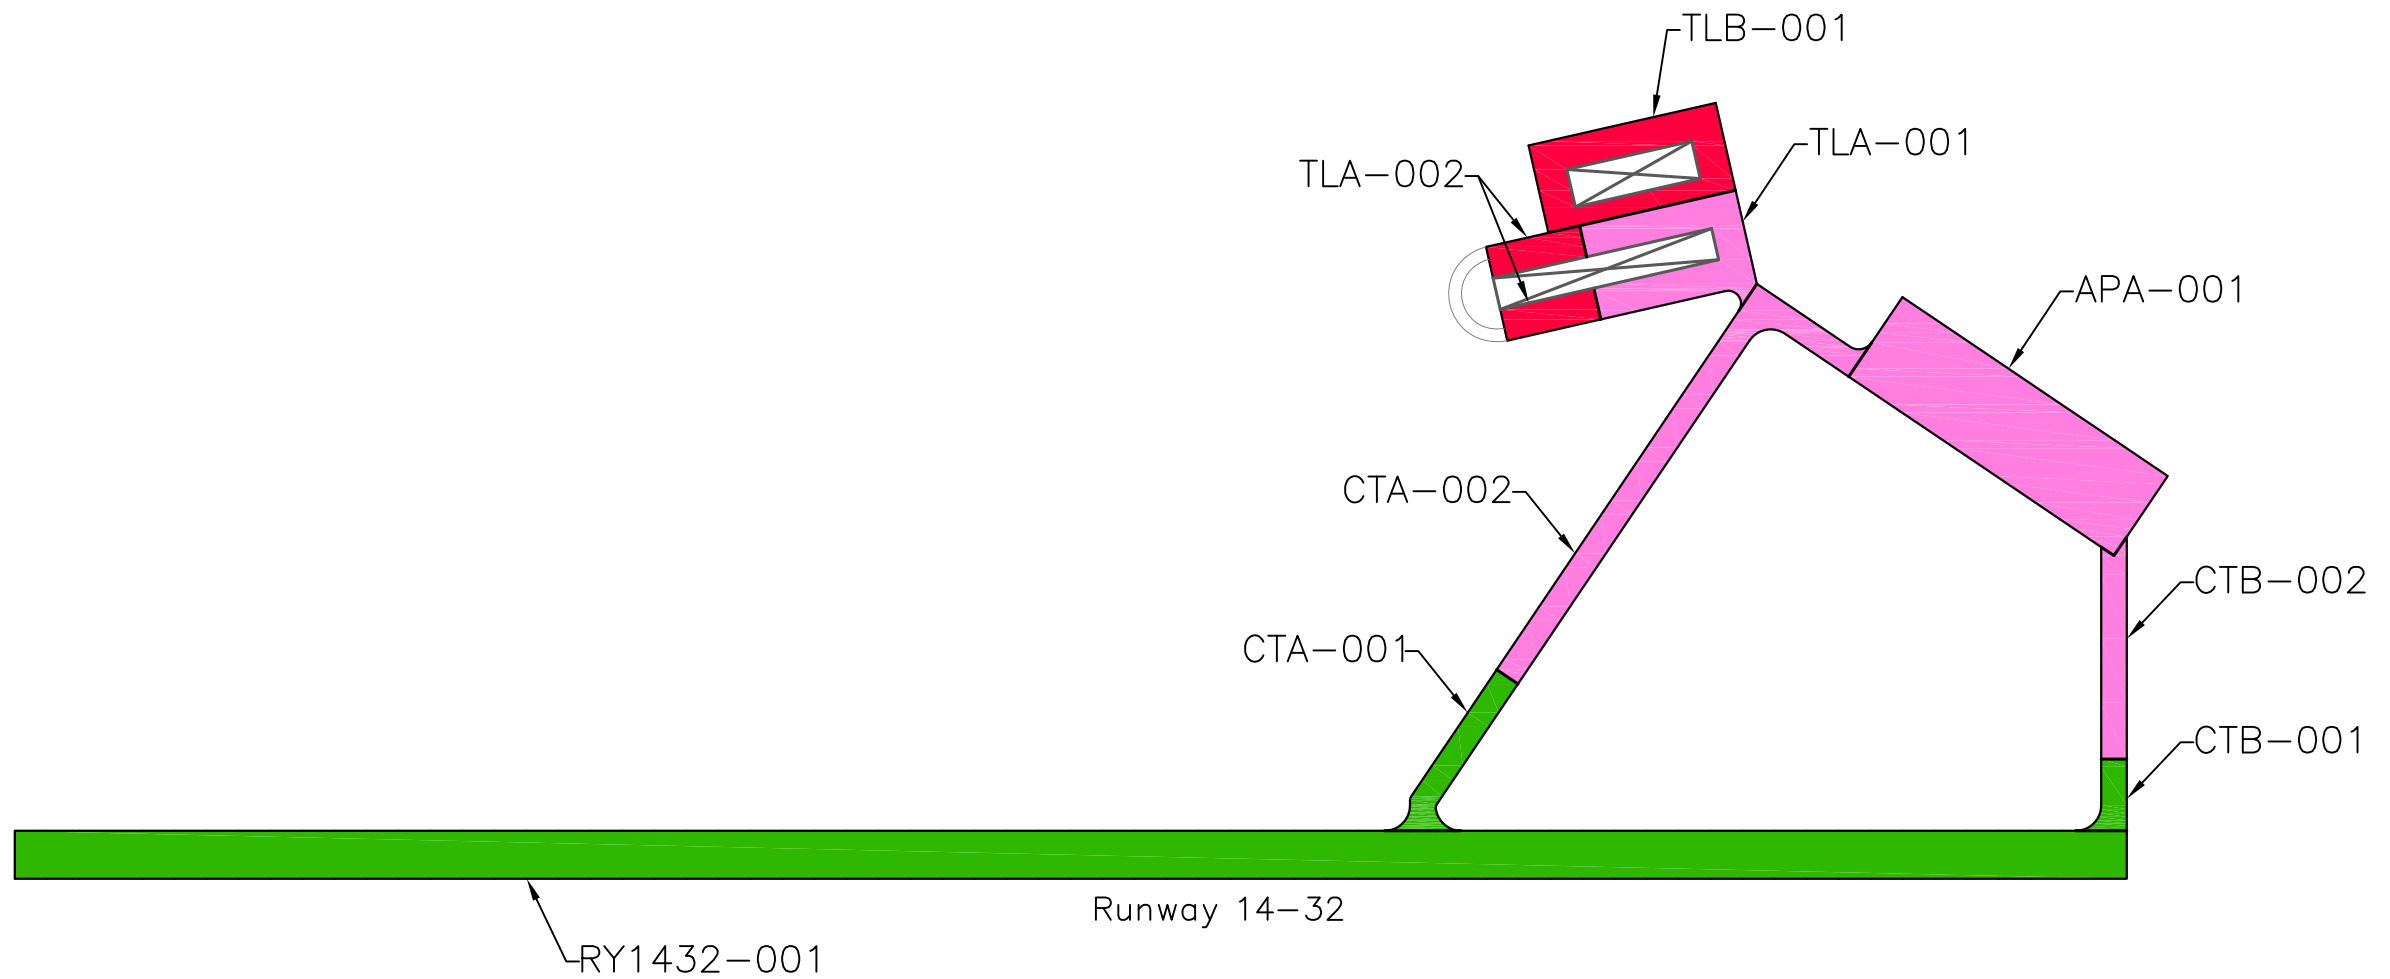
Figure 4. 2010 Pavement Condition Index Rating at Staples Municipal Airport (SAZ).

The results of the 2010 PCI inspection are presented in figure 4. The overall area-weighted PCI for SAZ is 69. When summarizing PCI values, an area-weighted calculation is used instead of a straight mathematical average because the area-weighted calculations eliminate the skewing of the PCI due to the disparity of the section sizes.

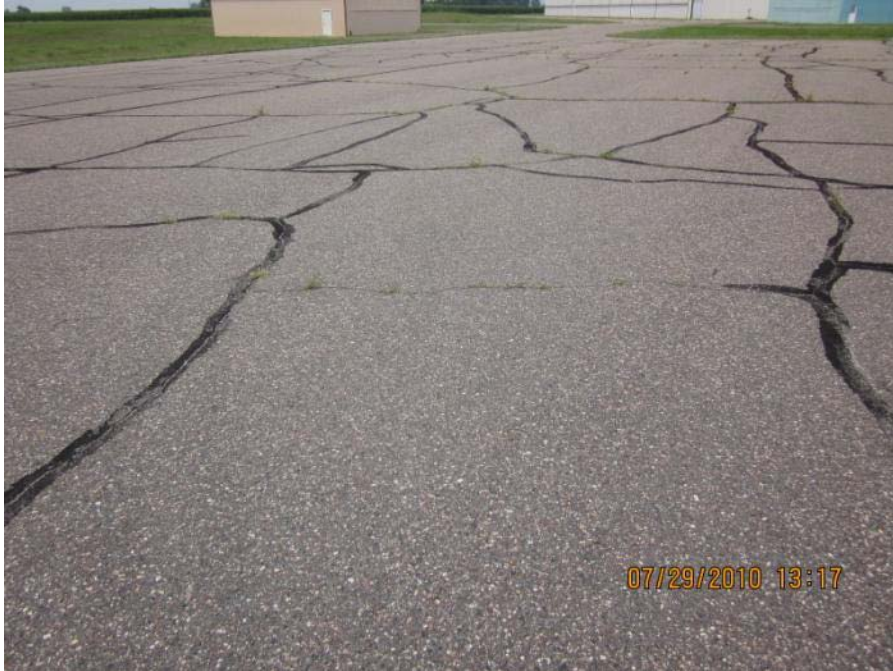
SAZ APA 001 (PCI = 49)

| Branch ID | Section ID | Surface type ¹ | Section Area (SF) | LCD ² | 2010 PCI | % Deduct due to | | Distress types |
|---|---|---|---|---|---|---|---|--|
| APA | 1 | AC | 75,000 | 1990 | 49 | 34 | 66 | Alligator cracking, Block cracking, Weathering/raveling, Rutting |

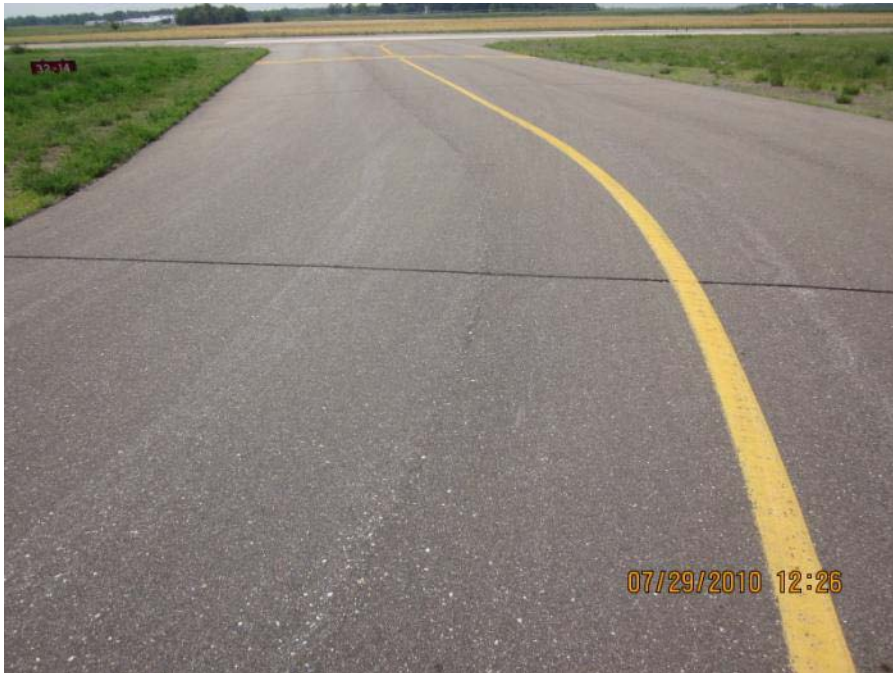
SAZ CTA 001 (PCI = 97)

| Branch ID | Section ID | Surface type ¹ | Section Area (SF) | LCD ² | 2010 PCI | % Deduct due to | | Distress types |
|---|---|---|---|---|---|---|---|--|
| CTA | 1 | AC | 11,915 | 2006 | 97 | 0 | 100 | Longitudinal & transverse (L&T) cracking |

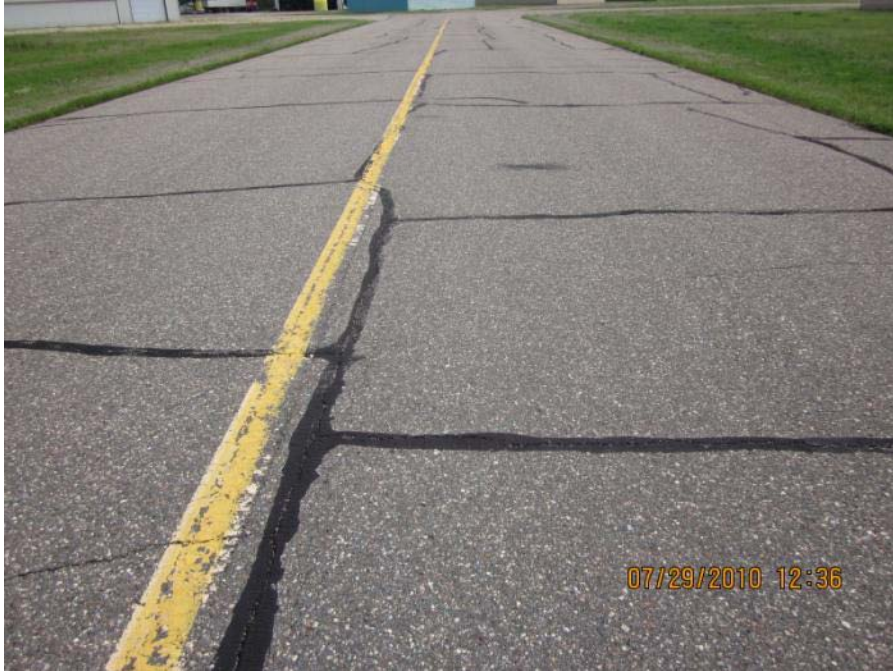
SAZ CTA 002 (PCI = 43)

| Branch ID | Section ID | Surface type ¹ | Section Area (SF) | LCD ² | 2010 PCI | % Deduct due to | | Distress types |
|---|---|---|---|---|---|---|---|--|
| CTA | 2 | AC | 36,760 | 1990 | 43 | 51 | 49 | Alligator cracking, L&T cracking, Patching, Weathering/raveling, Rutting |

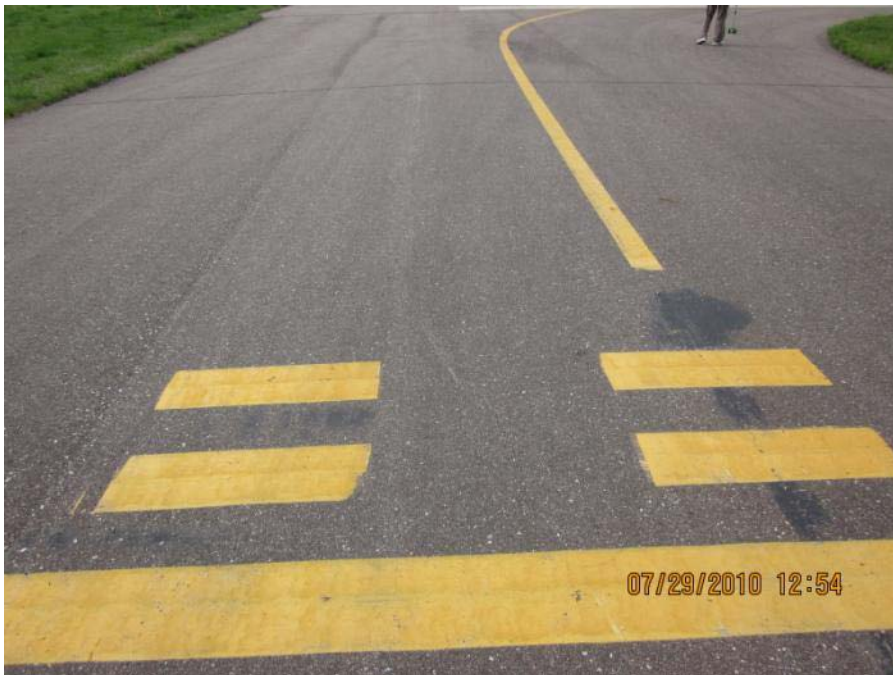
SAZ CTB 001 (PCI = 89)

| Branch ID | Section ID | Surface type ¹ | Section Area (SF) | LCD ² | 2010 PCI | % Deduct due to | | Distress types |
|---|---|---|---|---|---|---|---|--|
| CTB | 1 | AC | 4,815 | 2006 | 89 | 0 | 100 | L&T cracking, Weathering/raveling |

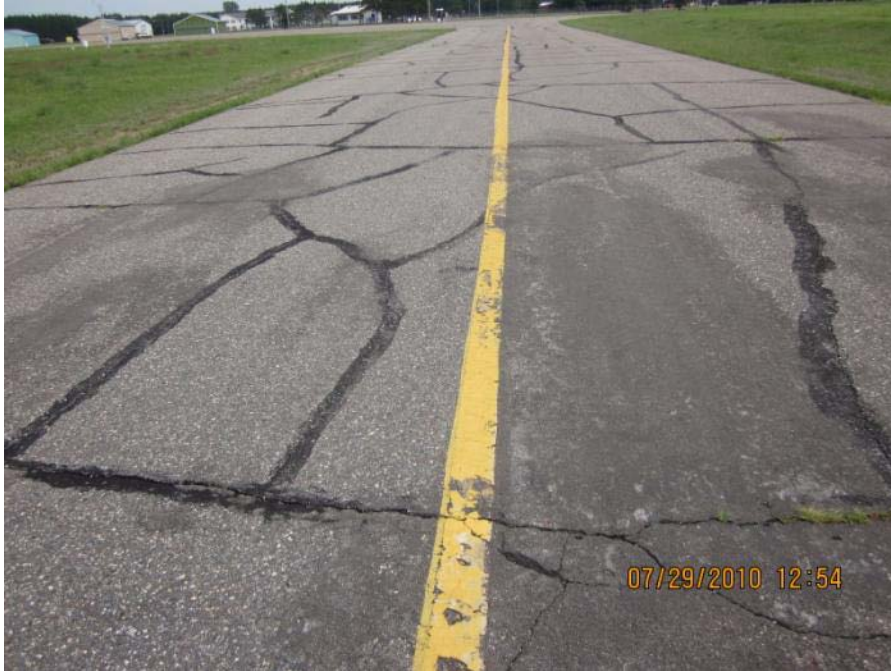
SAZ CTB 002 (PCI = 46)

| Branch ID | Section ID | Surface type ¹ | Section Area (SF) | LCD ² | 2010 PCI | % Deduct due to | | Distress types |
|---|---|---|---|---|---|---|---|--|
| CTB | 2 | AC | 12,200 | 1990 | 46 | 31 | 69 | Alligator cracking, L&T cracking, Weathering/raveling, Rutting |

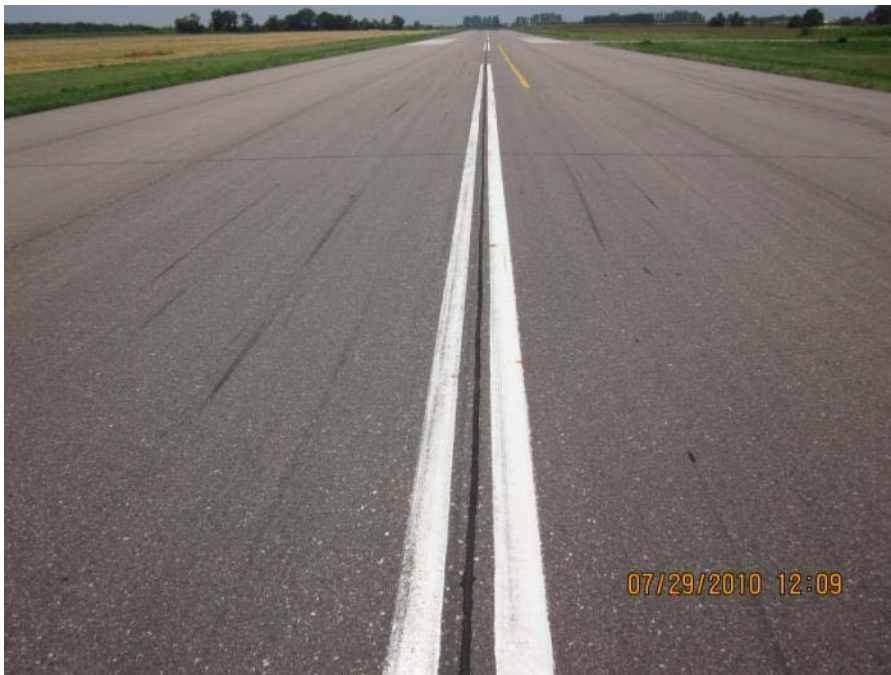
SAZ RY1432 001 (PCI = 89)

| Branch ID | Section ID | Surface type ¹ | Section Area (SF) | LCD ² | 2010 PCI | % Deduct due to | | Distress types |
|---|---|---|---|---|---|---|---|--|
| RY1432 | 1 | AC | 247,800 | 2006 | 89 | 0 | 100 | L&T cracking |

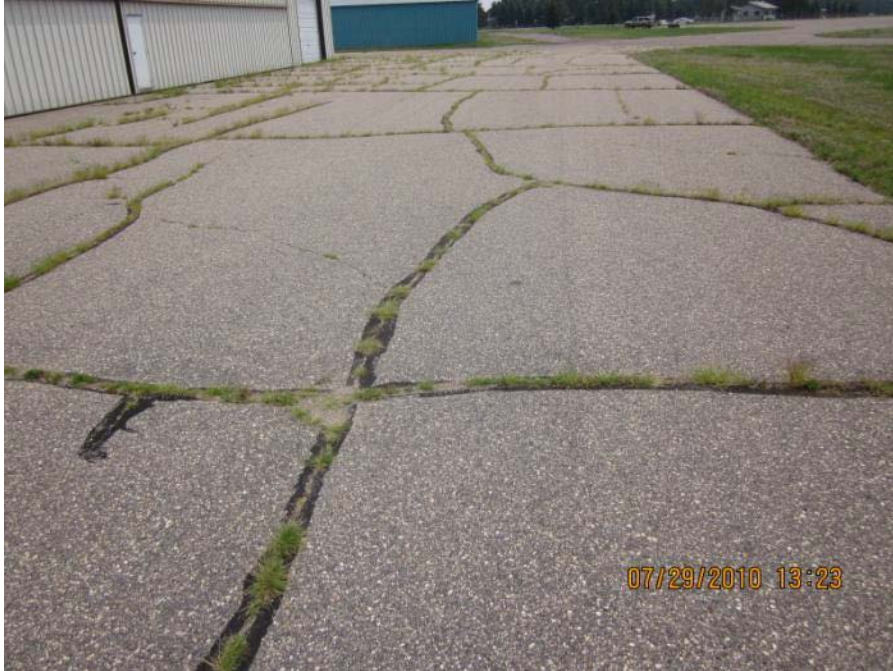
SAZ TLA 001 (PCI = 42)

| Branch ID | Section ID | Surface type ¹ | Section Area (SF) | LCD ² | 2010 PCI | % Deduct due to | | Distress types |
|---|---|---|---|---|---|---|---|--|
| TLA | 1 | AC | 30,000 | 1988 | 42 | 0 | 100 | Block cracking, Weathering/raveling |

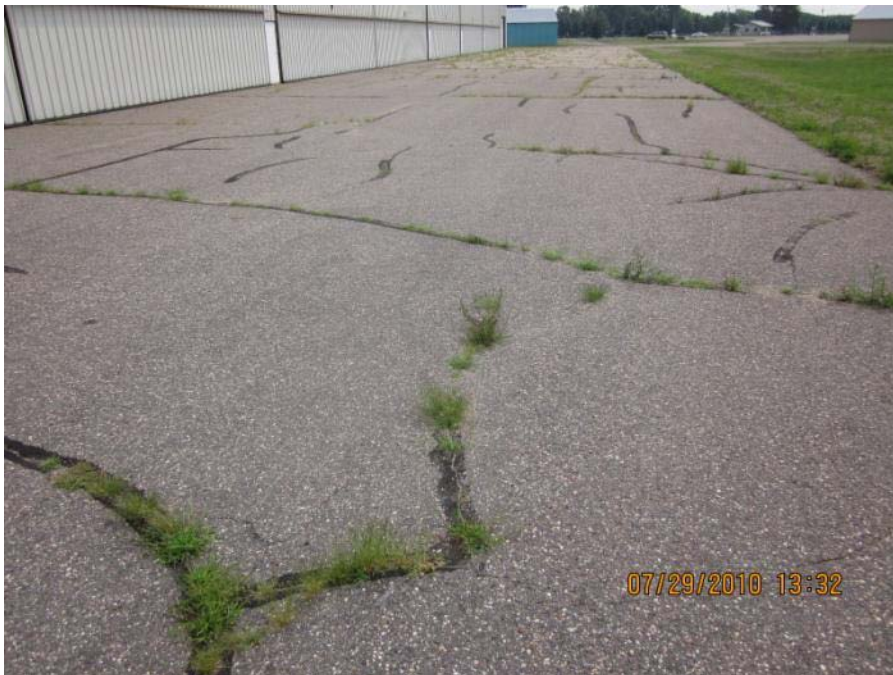
SAZ TLA 002 (PCI = 30)

| Branch ID | Section ID | Surface type ¹ | Section Area (SF) | LCD ² | 2010 PCI | % Deduct due to | | Distress types |
|---|---|---|---|---|---|---|---|--|
| TLA | 2 | AC | 15,000 | 1990 | 30 | 35 | 65 | Alligator cracking, L&T cracking, Weathering/raveling, Rutting |

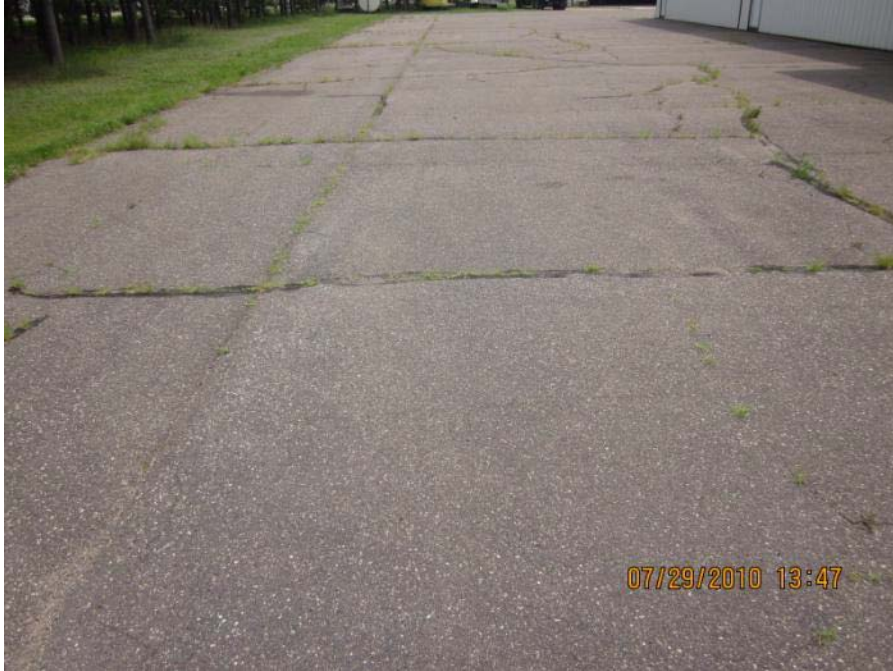
SAZ TLB 001 (PCI = 30)

| Branch ID | Section ID | Surface type ¹ | Section Area (SF) | LCD ² | 2010 PCI | % Deduct due to | | Distress types |
|---|---|---|---|---|---|---|---|--|
| TLB | 1 | AC | 30,000 | 1995 | 30 | 39 | 61 | Alligator cracking, Block cracking, L&T cracking, Patching, Weathering/raveling, Rutting |
