Minnesota Airport System Pavement Evaluation 2010 Update

Thief River Falls Regional
Airport (TVF)

Thief River Falls, Minnesota

December 2010

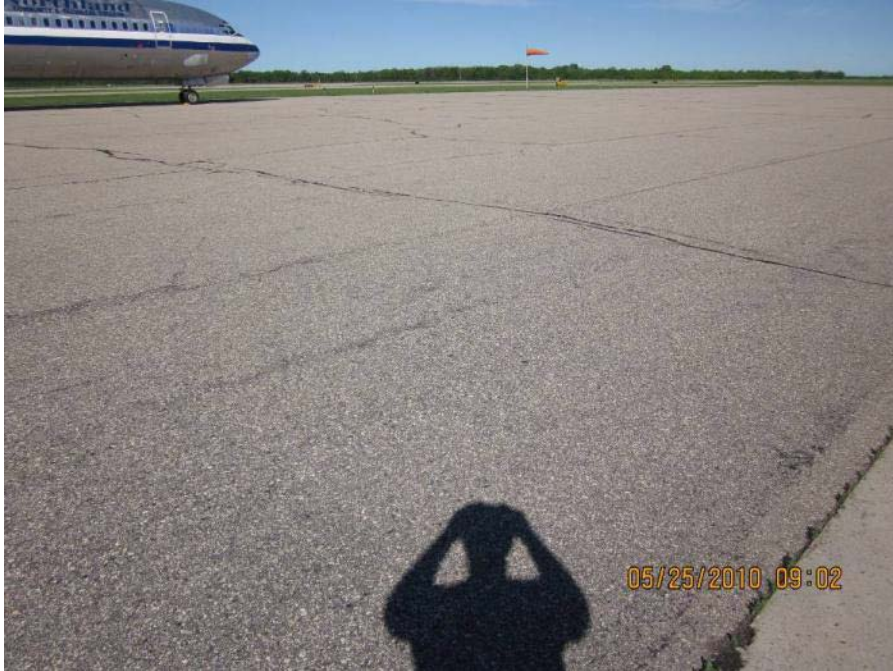
TVF APA 001 (PCI = 53)

Conditions: PCI:53.00 |

41 ALLIGATOR CRACKING	L	50.00	SqFt
48 LONGITUDINAL/TRANSVERSE CRACKING	L	283.00	Ft
48 LONGITUDINAL/TRANSVERSE CRACKING	M	135.00	Ft
48 LONGITUDINAL/TRANSVERSE CRACKING	H	15.00	Ft
53 RUTTING	L	12.00	SqFt
52 WEATHERING/RAVELING	M	25.00	SqFt

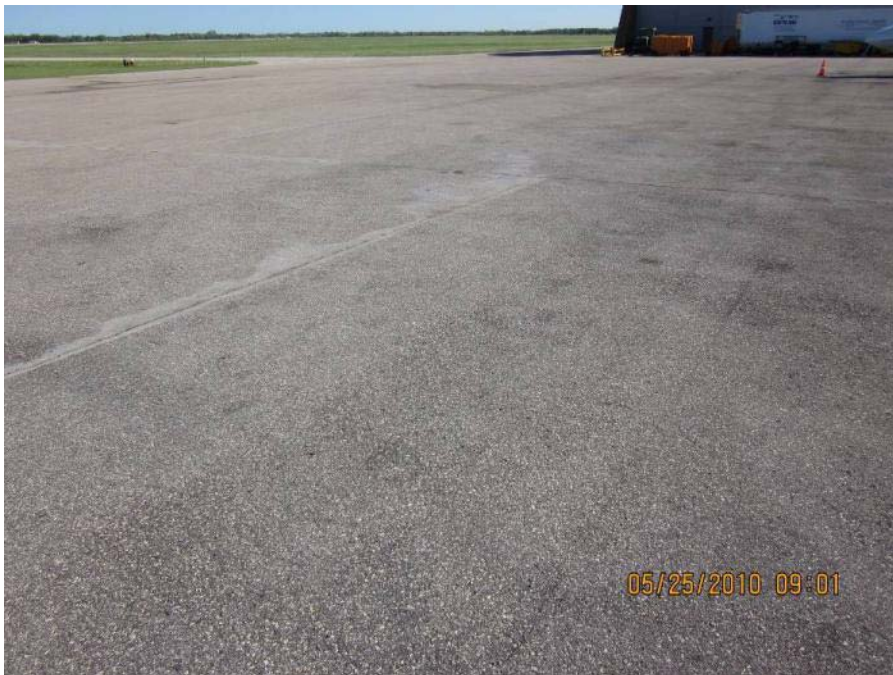
TVF APA 002 (PCI = 85)

Conditions: PCI:85.00 |

48 LONGITUDINAL/TRANSVERSE CRACKING L 189.00 Ft
56 SWELLING L 18.00 SqFt

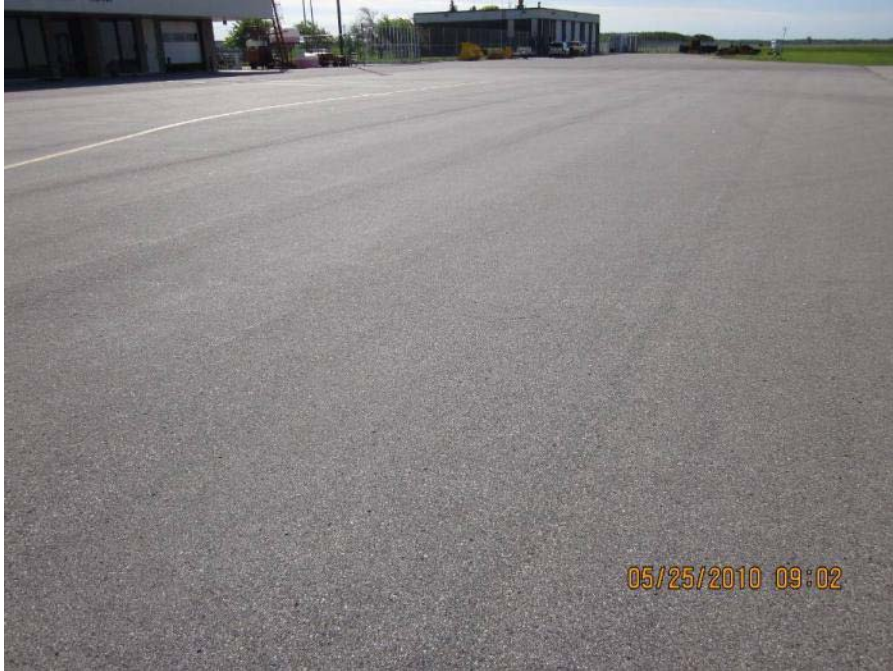
TVF APA 003 (PCI = 60)

Conditions: PCI:60.00 |

48 LONGITUDINAL/TRANSVERSE CRACKING L 671.00 Ft

48 LONGITUDINAL/TRANSVERSE CRACKING M 40.00 Ft

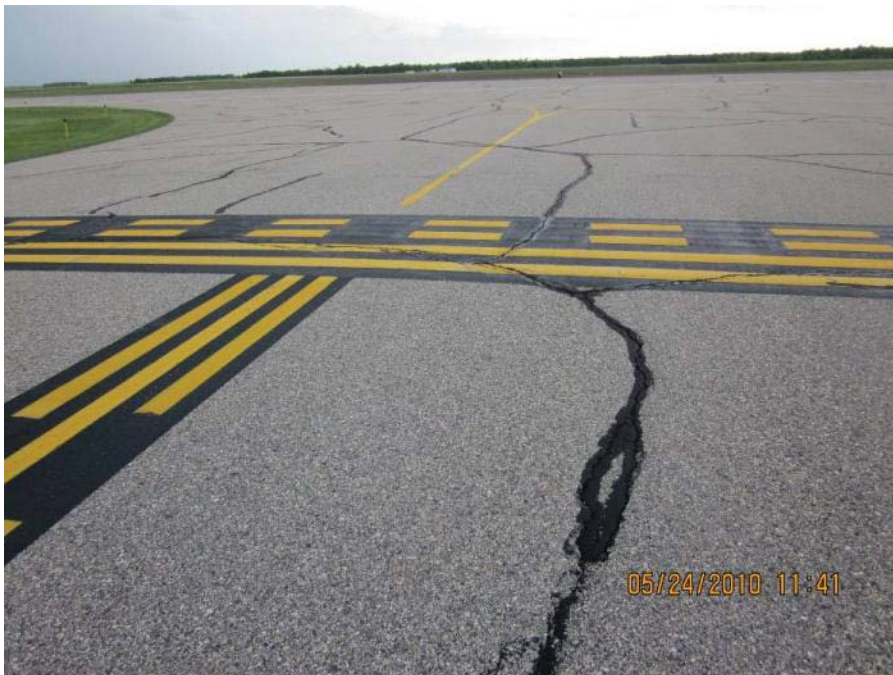
TVF CTA2 001 (PCI = 64)

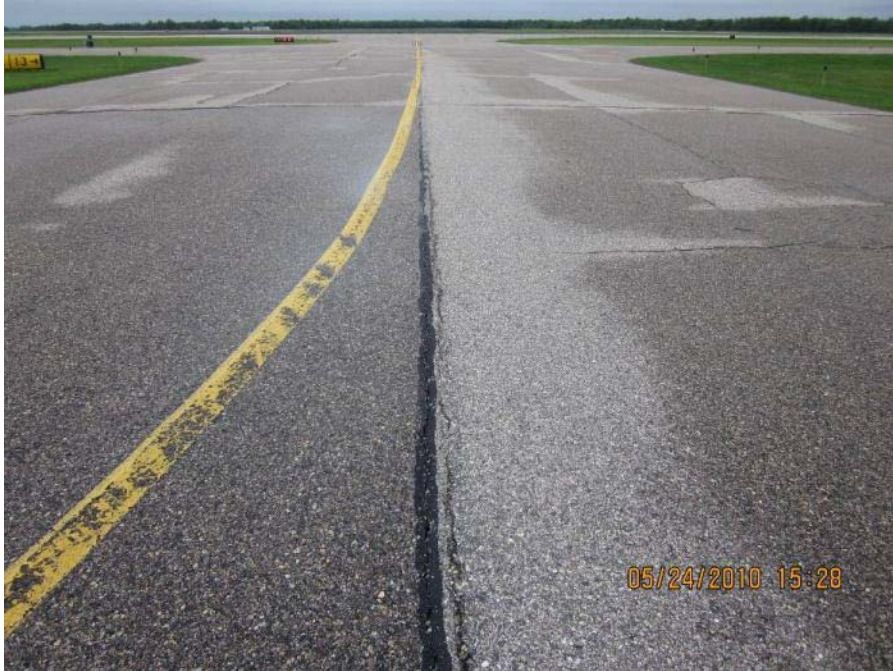
TVF CTA2X 001 (PCI = 60)

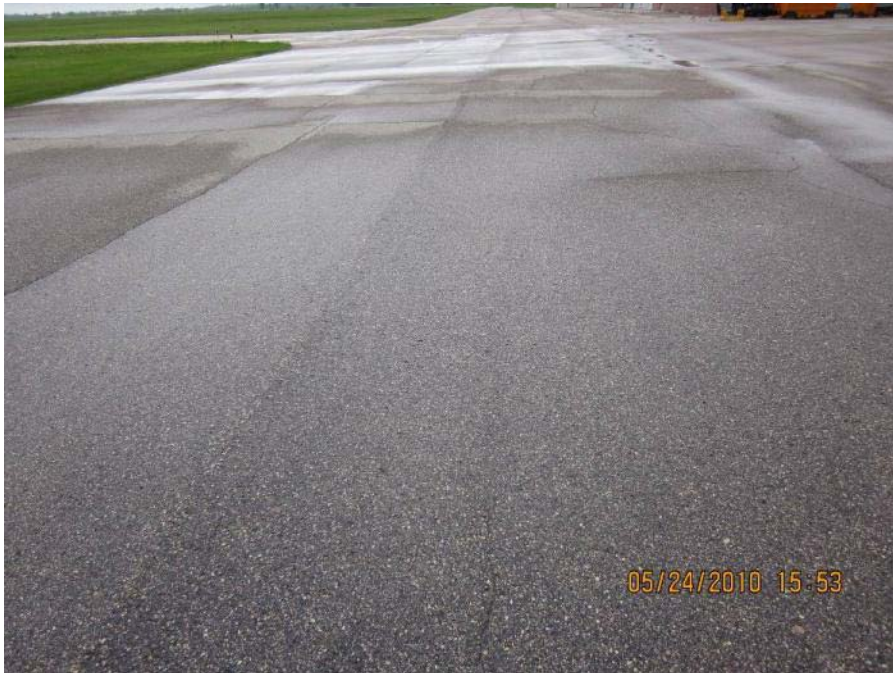
TVF CTA2X 002 (PCI = 66)

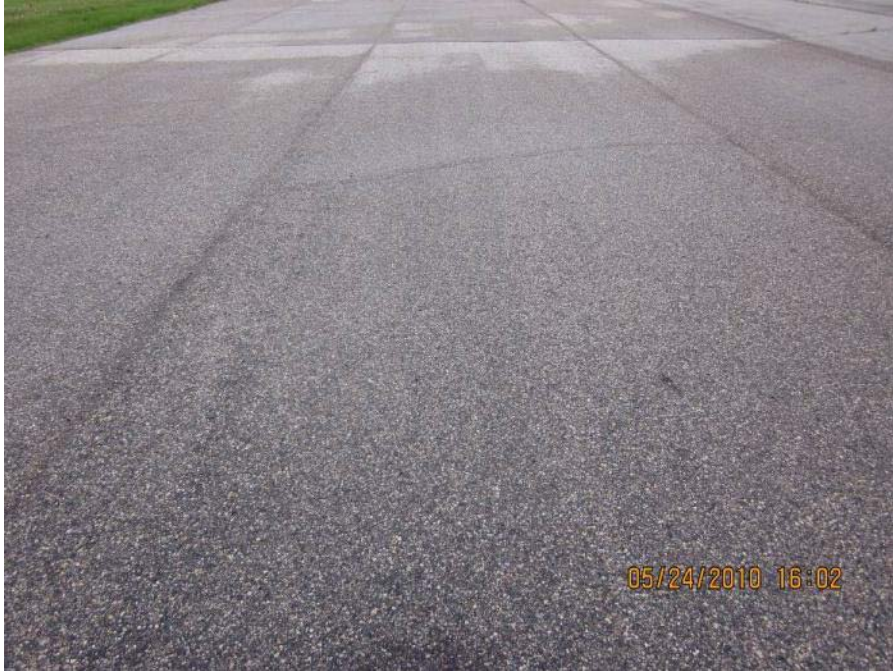
TVF CTA2X 003 (PCI = 69)

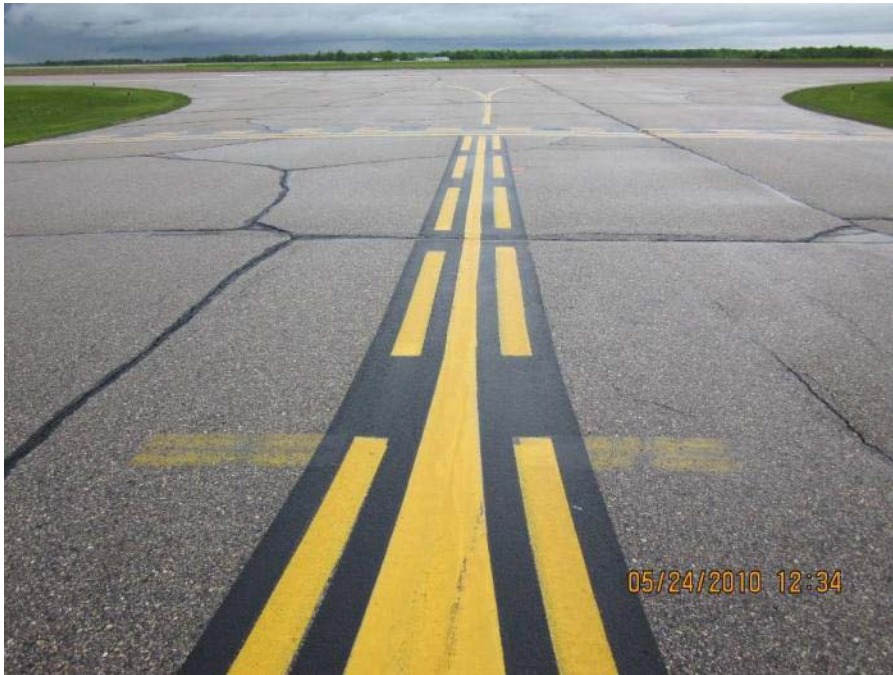
TVF CTA3 001 (PCI = 60)

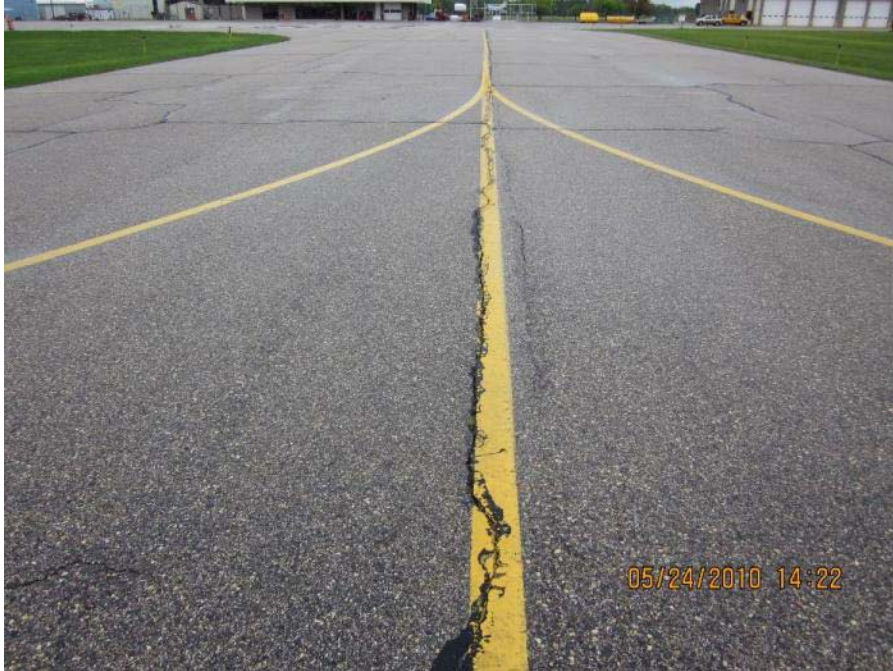
TVF CTA3X 001 (PCI = 38)

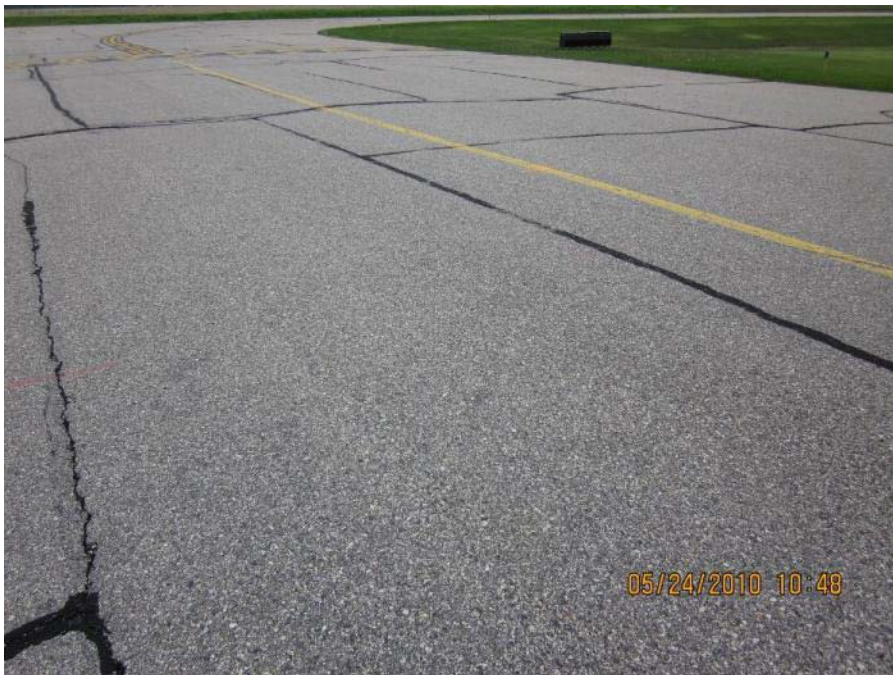
TVF CTA 001 (PCI = 70)

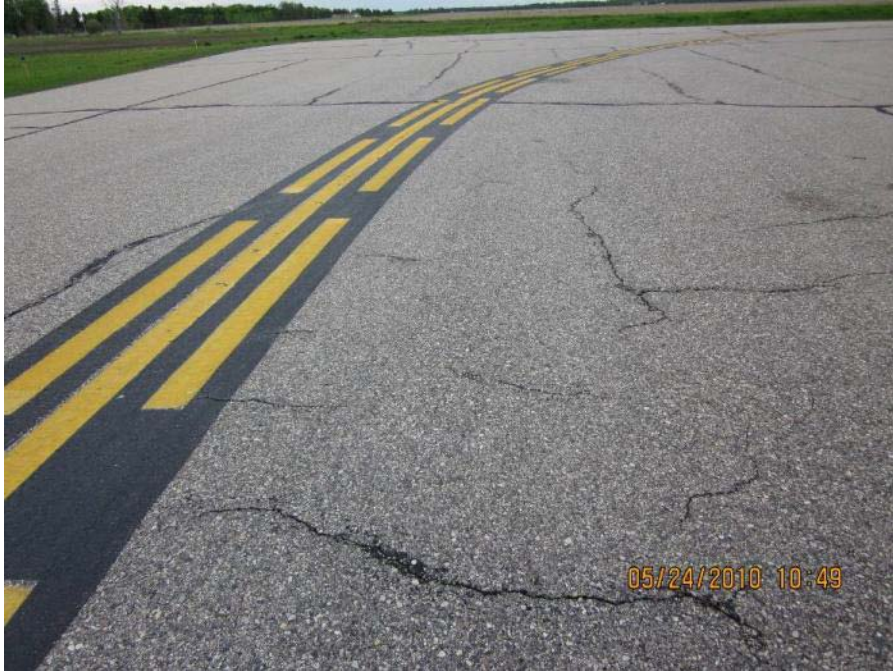
TVF CTA 002 (PCI = 71)

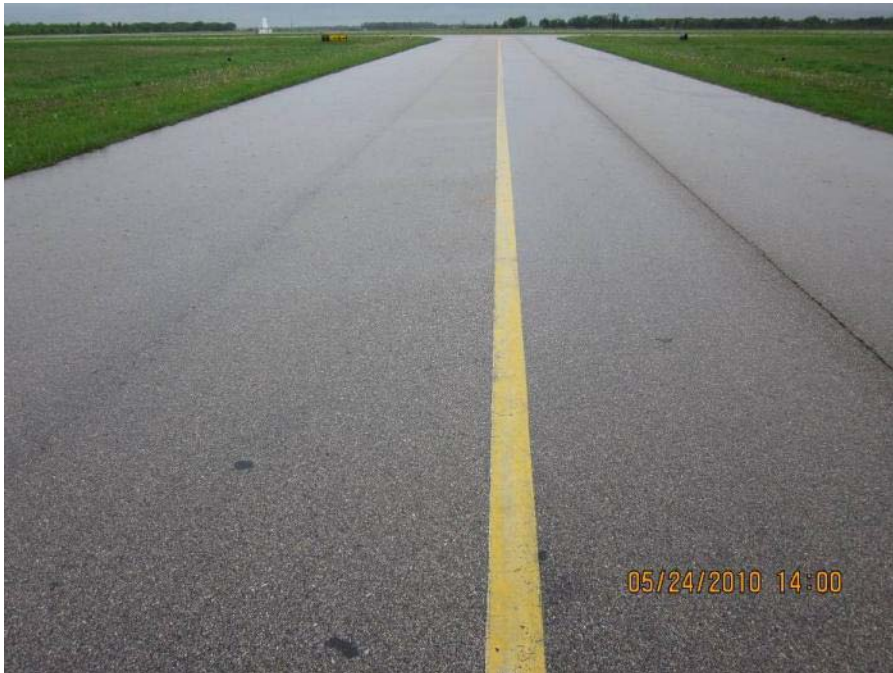
TVF CTC 001 (PCI = 85)

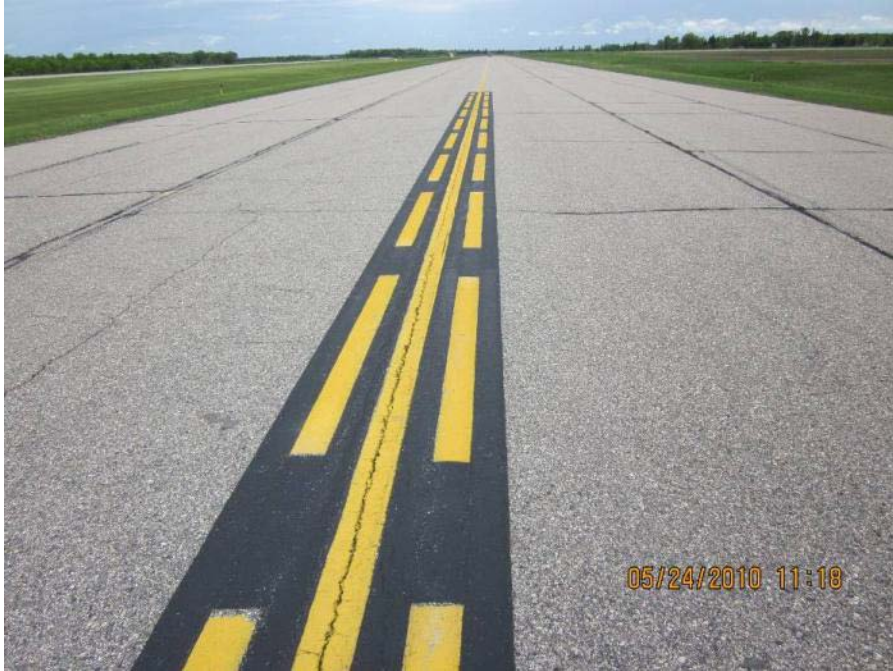
PTA	1	AC	150,225	1994	43	49	51	Alligator cracking, block cracking, L&T cracking, rutting
PTA	2	AC	97,500	1994	58	0	99	L&T cracking, swelling, weathering/raveling
PTA	3	AC	25,045	1994	57	27	73	Alligator cracking, L&T cracking, rutting, weathering/raveling
PTA	4	AC	67,500	2003	72	34	66	Alligator cracking, L&T cracking
PTA	5	AC	168,750	1994	45	41	58	Alligator cracking, block cracking, L&T cracking, rutting, swelling, weathering/raveling
PTB	1	AC	227,120	2003	91	0	100	L&T cracking
RY1331	1	AC	540,000	1993	53	40	60	Alligator cracking, L&T cracking, rutting
RY1331	2	AC	173,250	2003 ⁵	82	0	100	L&T cracking
RY1331	3	AC	262,200	1993	55	27	73	Alligator cracking, L&T cracking, rutting, weathering/raveling
RY321	1	AAC	357,975	2003	92	0	100	L&T cracking
TLA	1	AC	12,000	1993	25	0	100	Block cracking, weathering/raveling

TVF PTA 001 (PCI = 43)

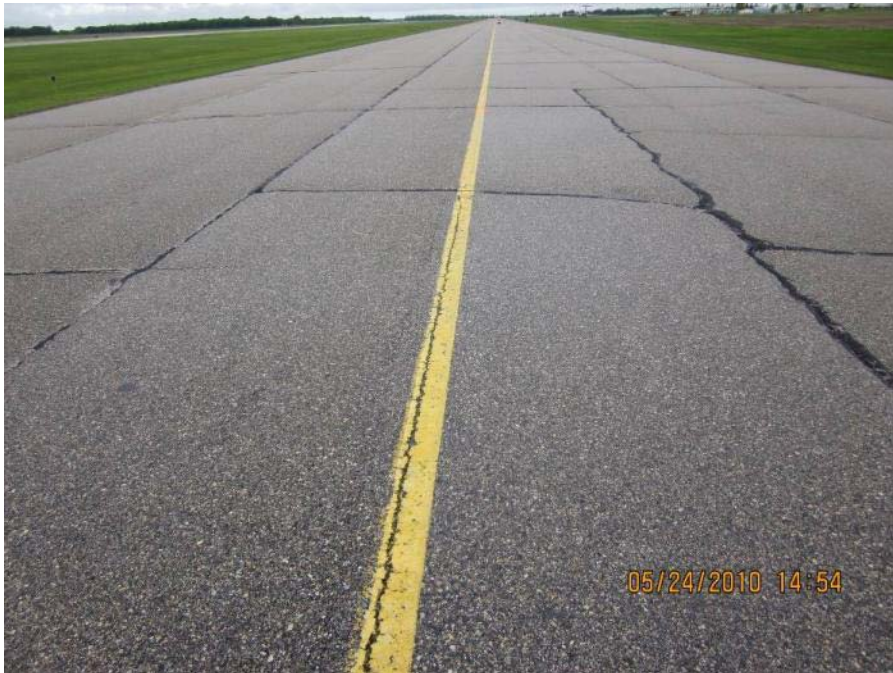
TVF PTA 002 (PCI = 58)

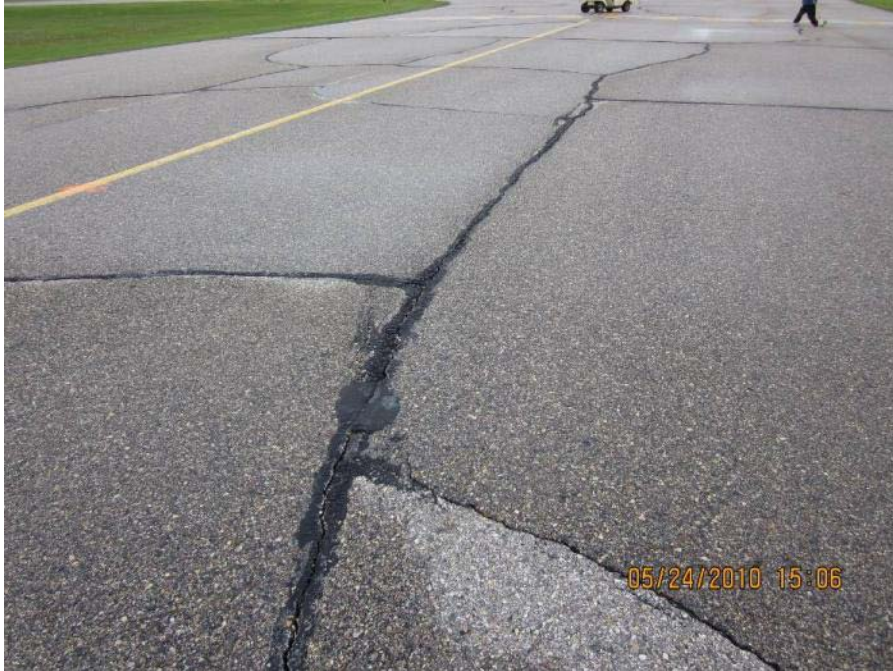
TVF PTA 003 (PCI = 57)

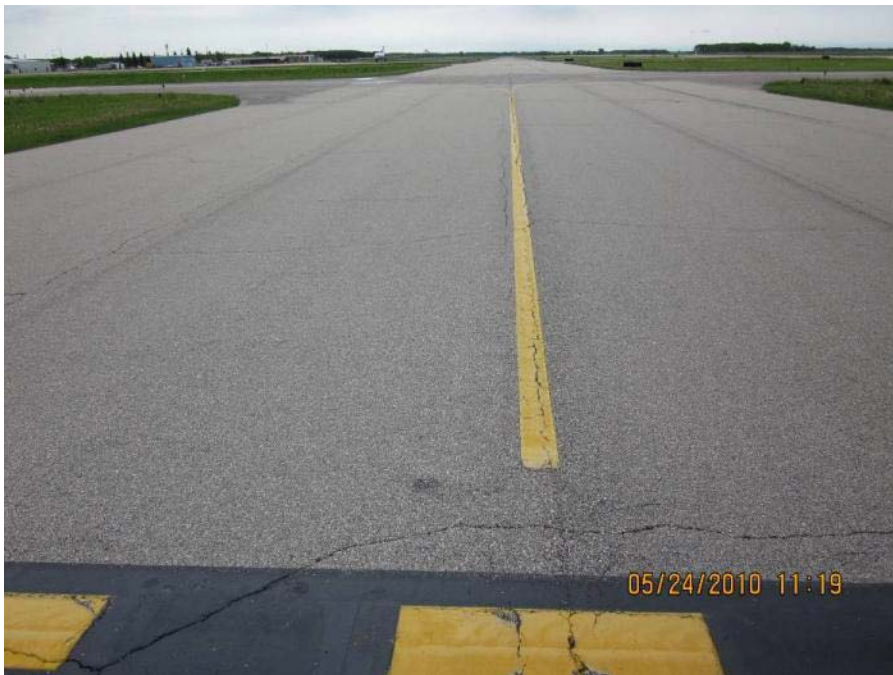
TVF PTA 004 (PCI = 72)

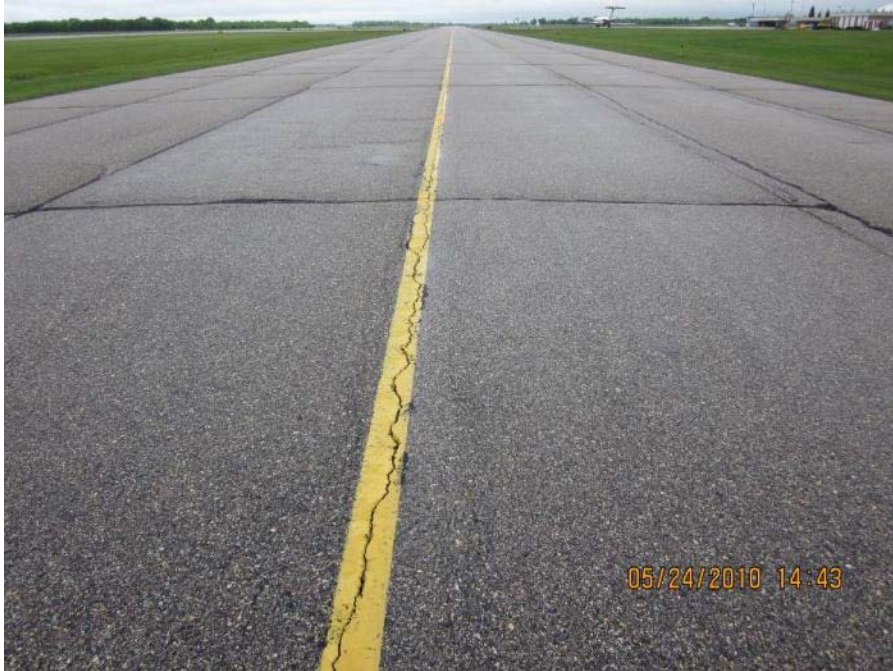
TVF PTA 005 (PCI = 45)

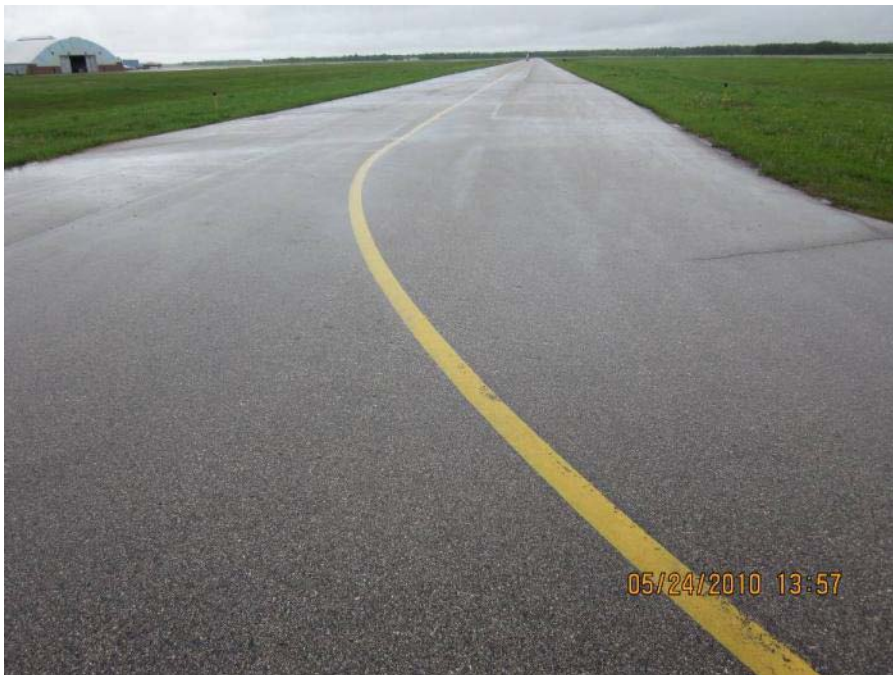
TVF PTB 001 (PCI = 91)

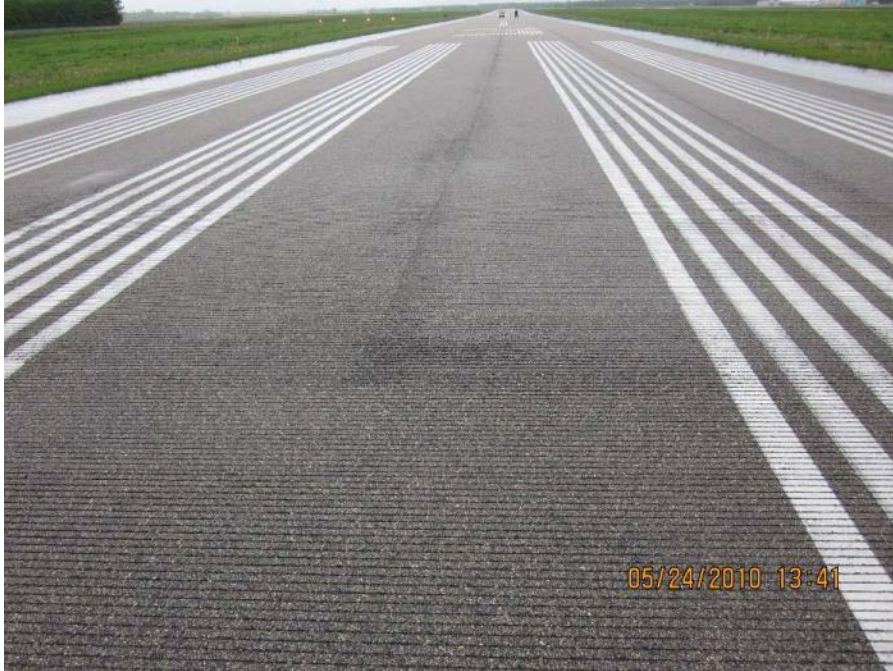
TVF RY321 001 (PCI = 92)

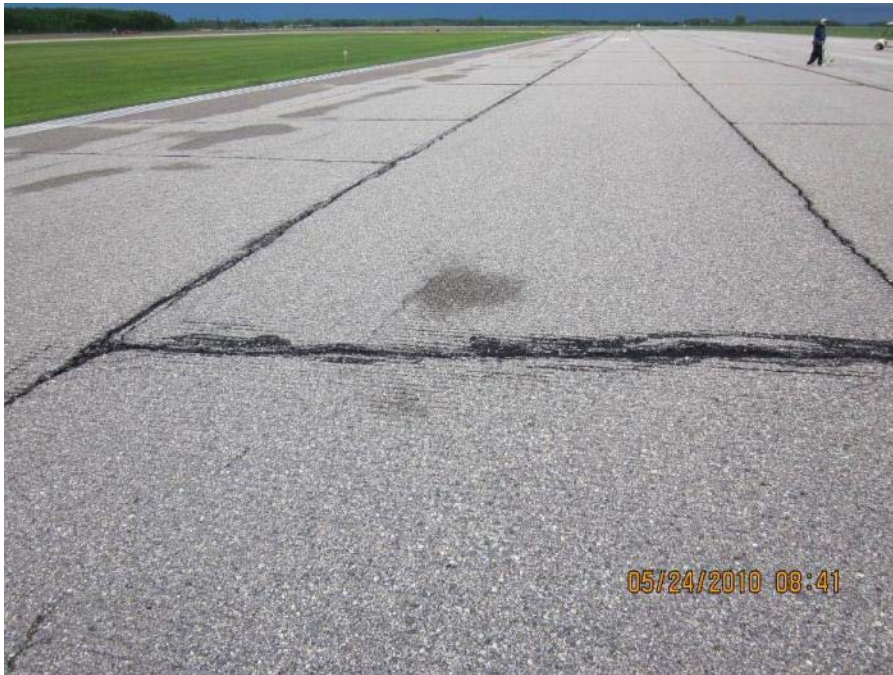
TVF RY1331 001 (PCI = 53)

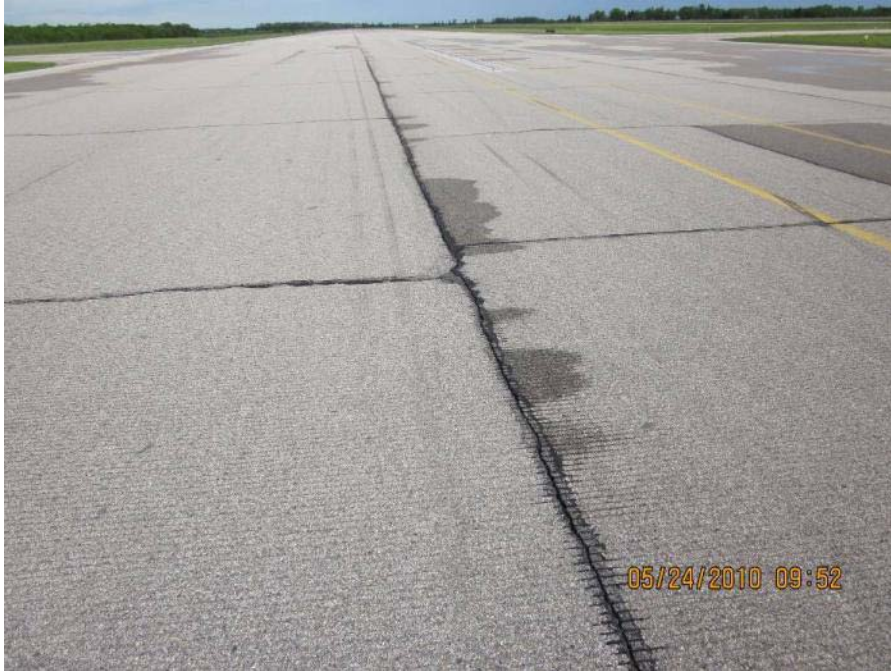
TVF RY1331 002 (PCI = 82)

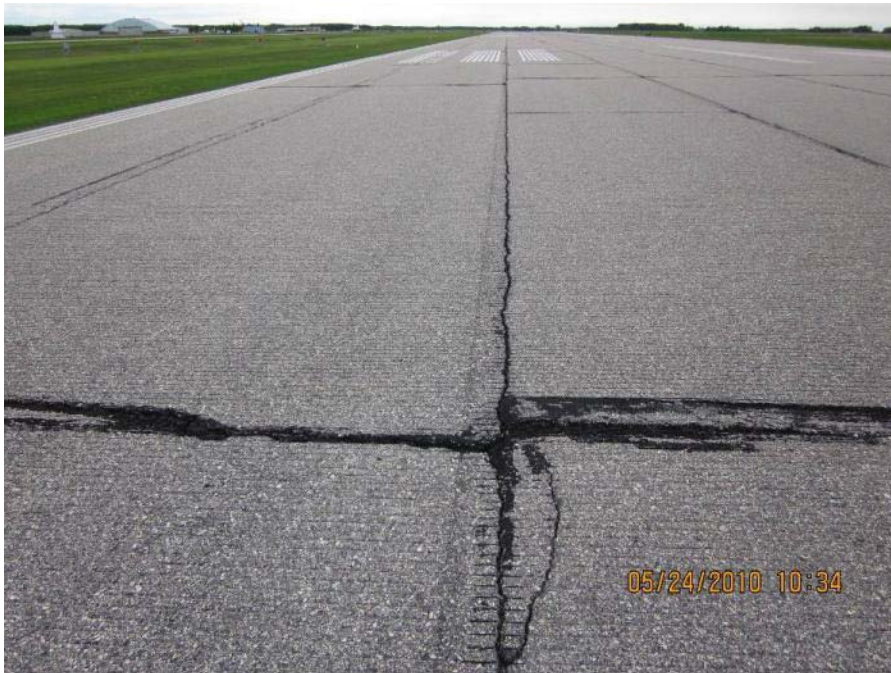
TVF RY1331 003 (PCI = 55)

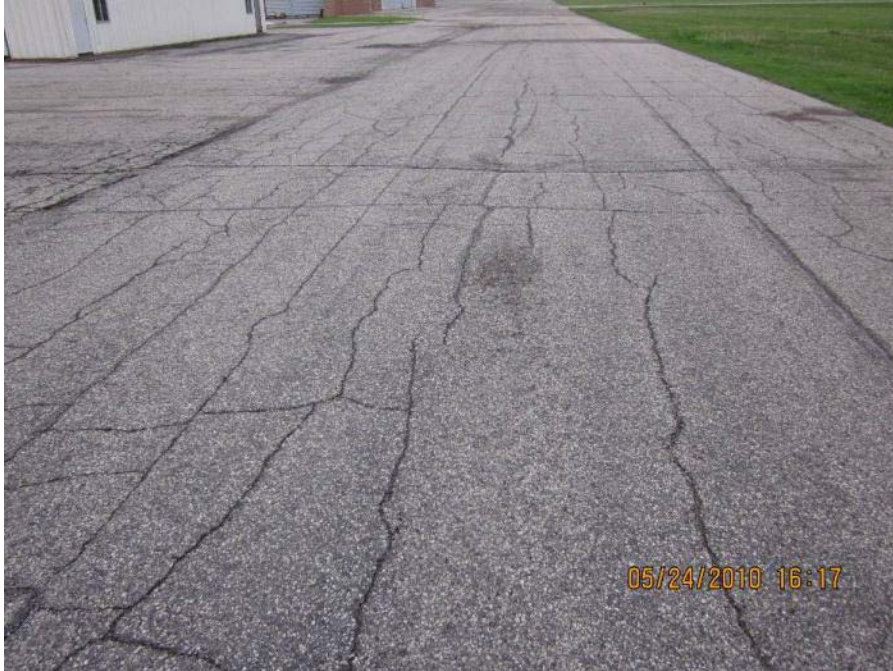
TVF TLA 001 (PCI = 25)

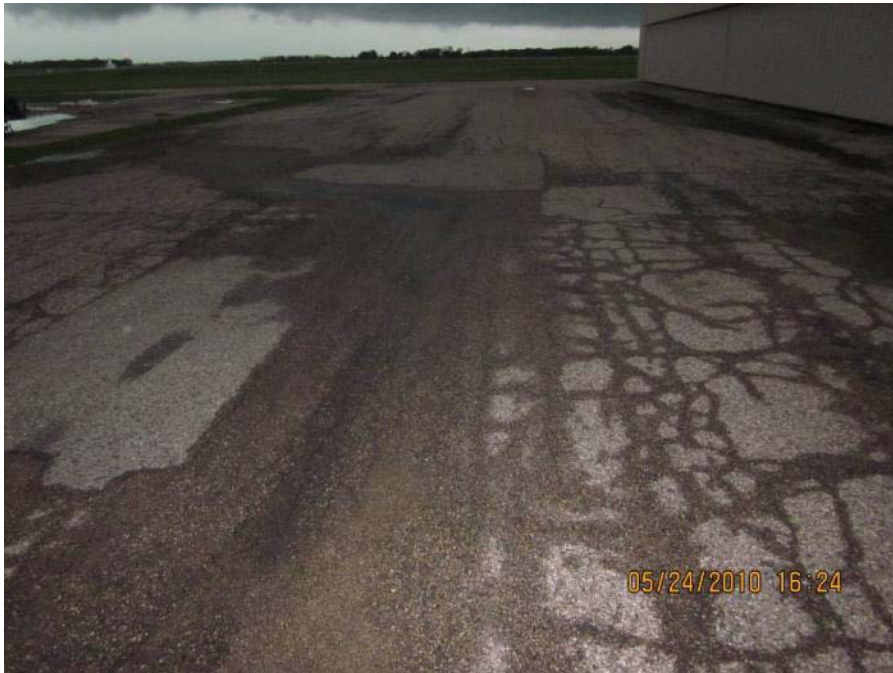
Branch ID	Section ID	Surface type ¹	Section area (SF)	LCD ²	2010 PCI	% Deduct due to		Distress types
						Load ³	Climate ⁴	
TLB	1	AC	20,000	1983 ⁵	4	29	71	Alligator cracking, block cracking, patching, weathering/raveling
TLC	1	AC	20,100	1983 ⁵	9	61	39	Alligator cracking, patching, weathering/raveling
TLD	1	AC	26,800	1983	33	53	23	Alligator cracking, depression, L&T cracking, weathering/raveling

TVF TLB 001 (PCI = 4)

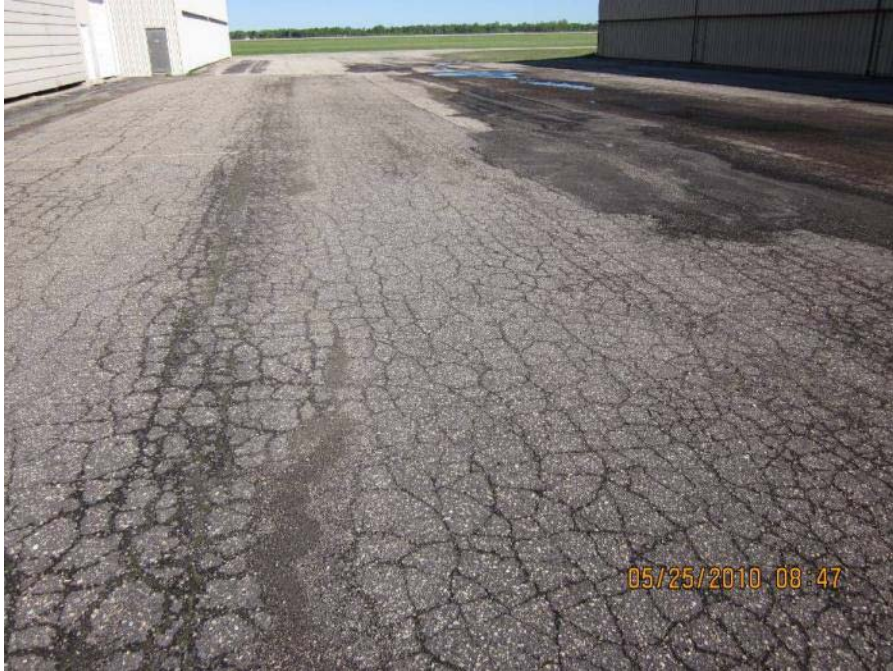
TVF TLC 001 (PCI = 9)

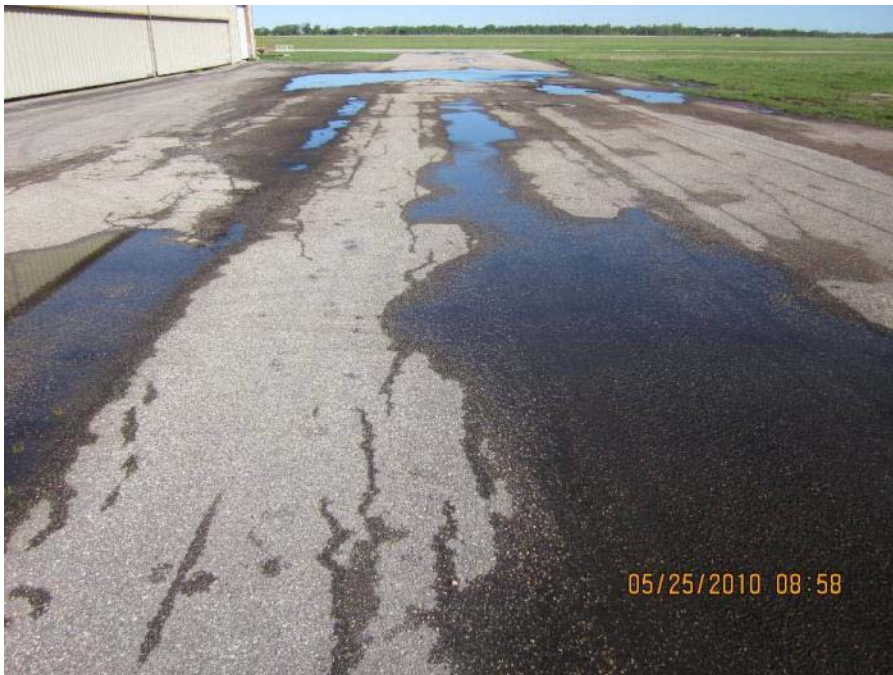
TVF TLD 001 (PCI = 33)
