# Minnesota Airport System Pavement Evaluation 2010 Update

New Ulm Municipal Airport  
(ULM)

New Ulm, Minnesota

December 2010

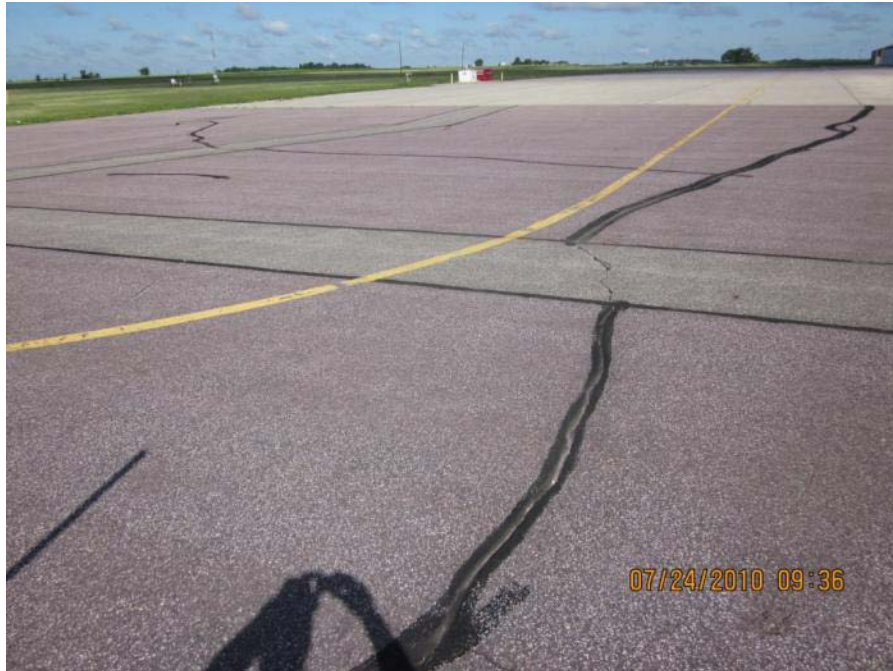
ULM APA 001 (PCI = 64)

| Branch ID | Section ID | Surface type <sup>1</sup> | Section Area (SF) | LCD <sup>2</sup> | 2010 PCI | % Deduct due to | | Distress types |
|---|---|---|---|---|---|---|---|---|
| APA | 1 | AC | 29,500 | 1991 | 64 | 0 | 100 | Longitudinal & transverse (L&T) cracking, Patching, Weathering/raveling |

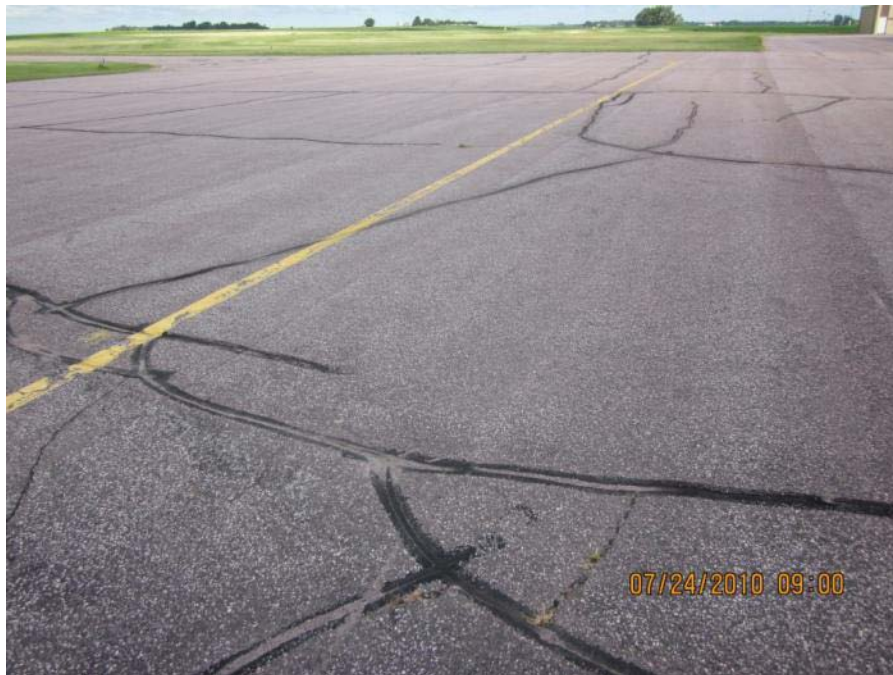
ULM APA 002 (PCI = 64)

| Branch ID | Section ID | Surface type <sup>1</sup> | Section Area (SF) | LCD <sup>2</sup> | 2010 PCI | % Deduct due to | | Distress types |
|---|---|---|---|---|---|---|---|---|
| APA | 2 | AC | 39,000 | 1991 | 64 | 0 | 100 | L&T cracking, Weathering/raveling |

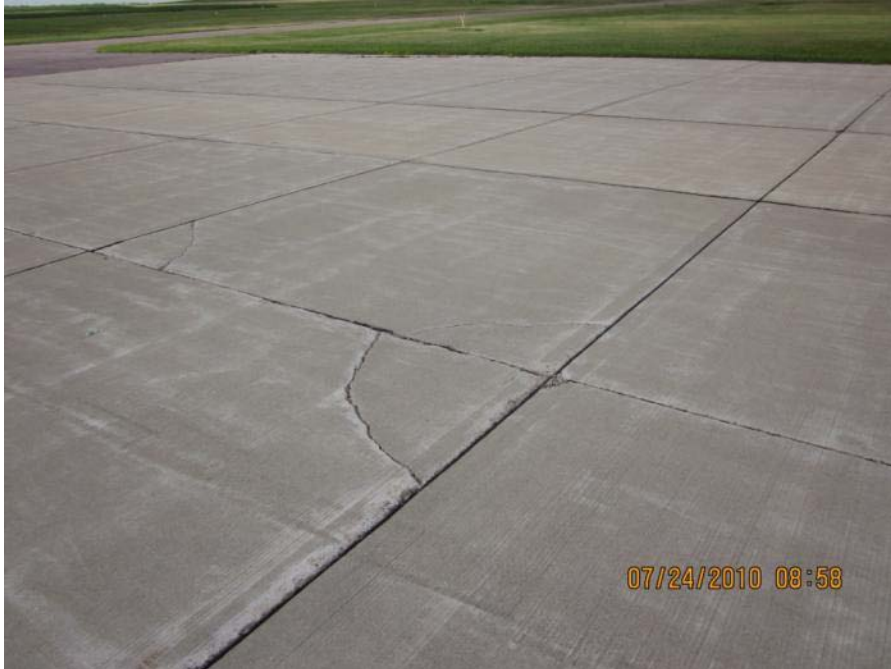
ULM APA 003 (PCI = 89)

| Branch ID | Section ID | Surface type <sup>1</sup> | Section Area (SF) | LCD <sup>2</sup> | 2010 PCI | % Deduct due to | | Distress types |
|---|---|---|---|---|---|---|---|---|
| APA | 3 | PCC | 35,496 | 1991 | 89 | 33 | 53 | Corner break, Linear cracking, Joint seal damage, Faulting |

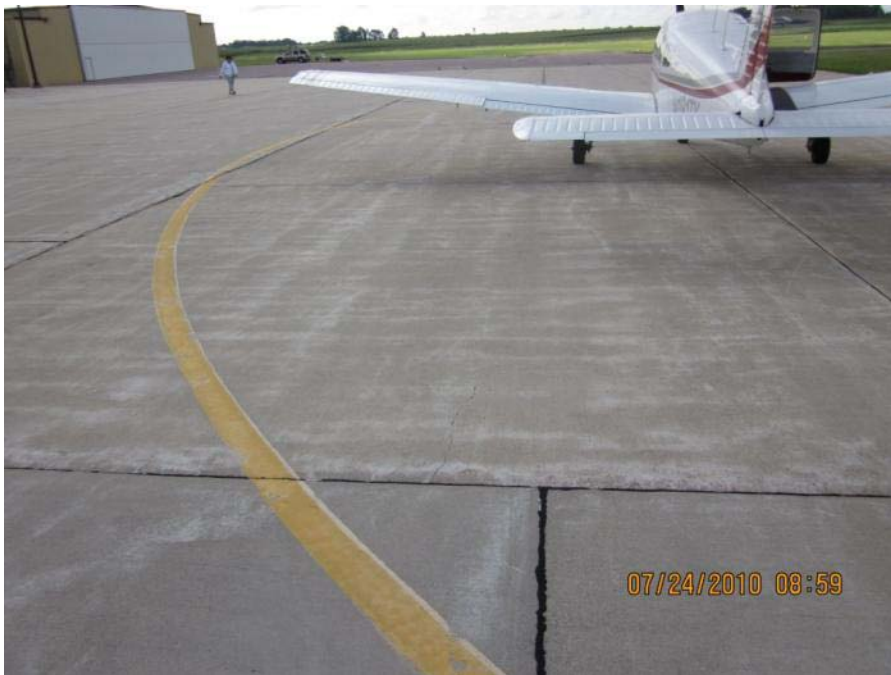
ULM APA 004 (PCI = 43)

| Branch ID | Section ID | Surface type <sup>1</sup> | Section Area (SF) | LCD <sup>2</sup> | 2010 PCI | % Deduct due to | | Distress types |
|---|---|---|---|---|---|---|---|---|
| APA | 4 | PCC | 2,904 | 1991 | 43 | 39 | 0 | Corner break, Linear cracking, Faulting, Shrinkage cracking, Corner spall |

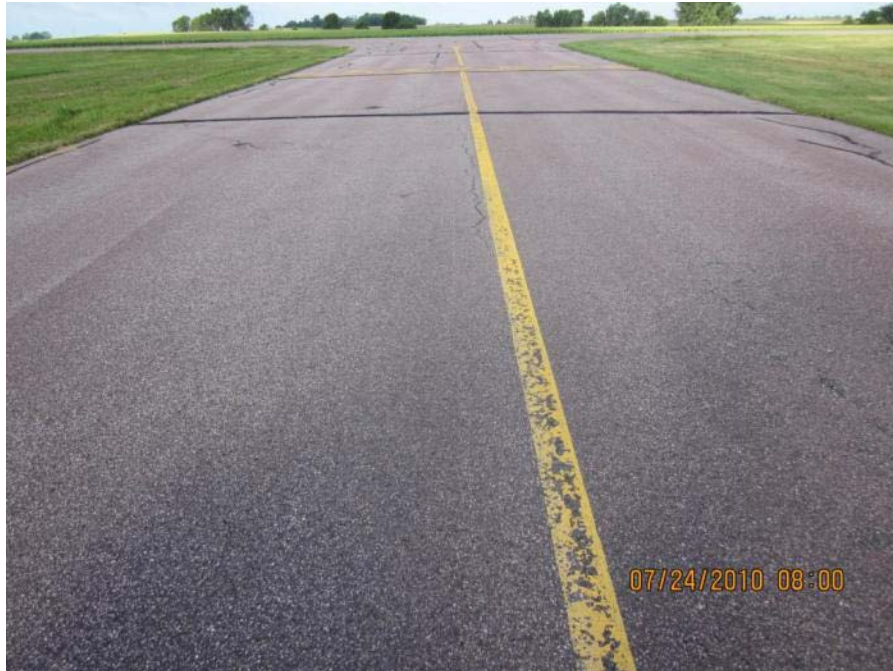
ULM CTA 001 (PCI = 52)

| Branch ID | Section ID | Surface type <sup>1</sup> | Section Area (SF) | LCD <sup>2</sup> | 2010 PCI | % Deduct due to | | Distress types |
|---|---|---|---|---|---|---|---|---|
| CTA | 1 | AC | 15,630 | 1985 | 52 | 41 | 59 | Alligator cracking, L&T cracking, Patching, Weathering/raveling, Rutting |

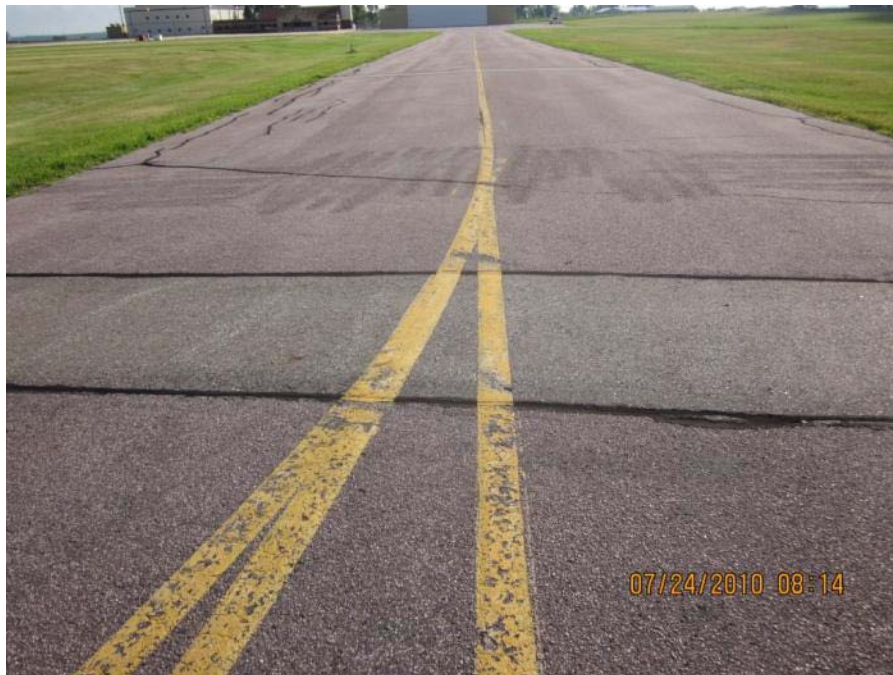
ULM CTAX 001 (PCI = 64)

| Branch ID | Section ID | Surface type <sup>1</sup> | Section Area (SF) | LCD <sup>2</sup> | 2010 PCI | % Deduct due to | | Distress types |
|---|---|---|---|---|---|---|---|---|
| CTAX | 1 | AC | 25,030 | 1985 | 64 | 0 | 100 | L&T cracking, Patching, Weathering/raveling |

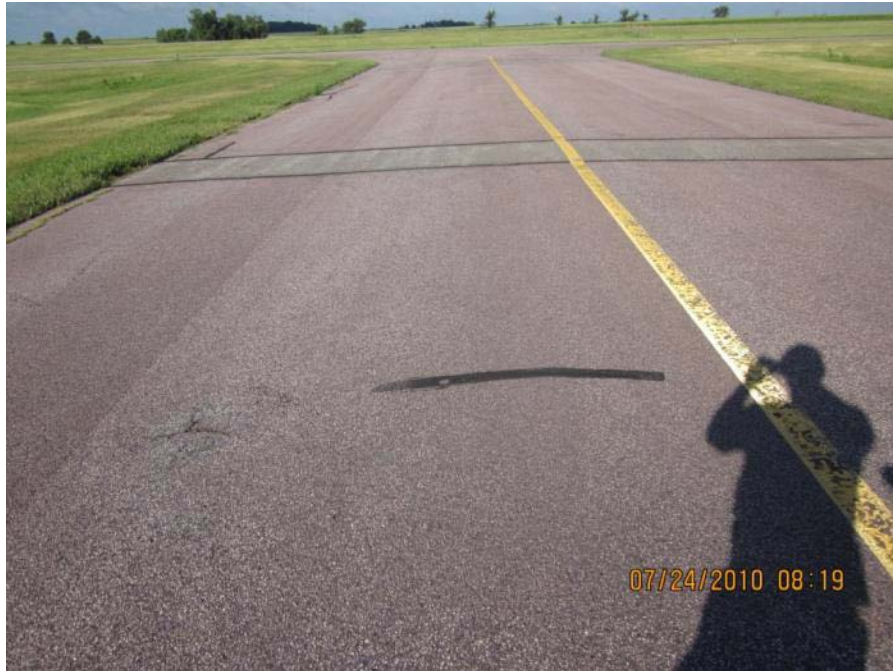
ULM CTB 001 (PCI = 59)

| Branch ID | Section ID | Surface type <sup>1</sup> | Section Area (SF) | LCD <sup>2</sup> | 2010 PCI | % Deduct due to | | Distress types |
|---|---|---|---|---|---|---|---|---|
| CTB | 1 | AC | 17,010 | 1985 | 59 | 0 | 100 | L&T cracking, Patching, Weathering/raveling |

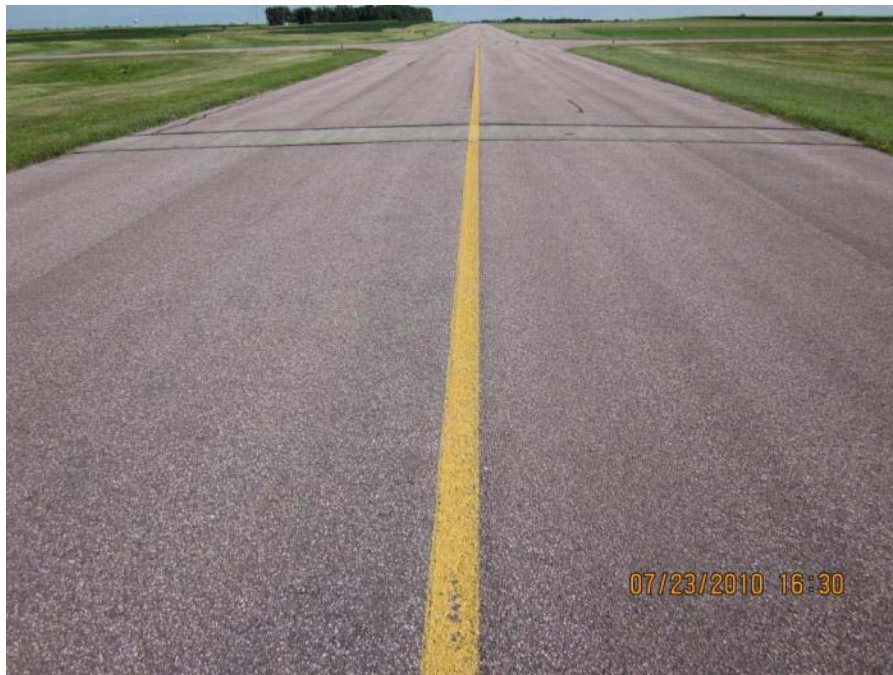
ULM PTA 001 (PCI = 61)

| Branch ID | Section ID | Surface type <sup>1</sup> | Section Area (SF) | LCD <sup>2</sup> | 2010 PCI | % Deduct due to | | Distress types |
|---|---|---|---|---|---|---|---|---|
| PTA | 1 | AC | 196,000 | 1985 | 61 | 11 | 89 | Alligator cracking, L&T cracking, Patching, Weathering/raveling |

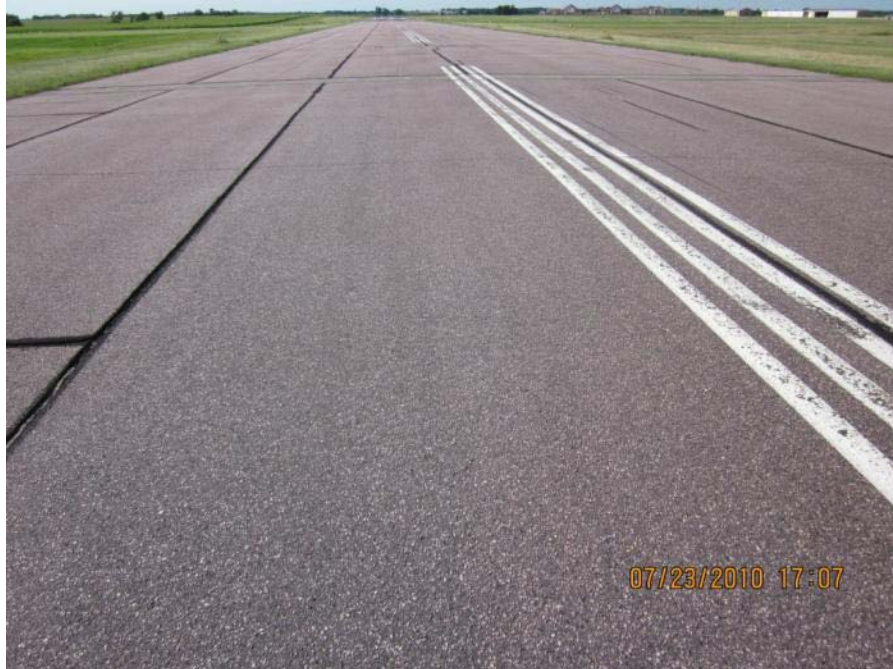
ULM RY1533 001 (PCI = 59)

| Branch ID | Section ID | Surface type <sup>1</sup> | Section Area (SF) | LCD <sup>2</sup> | 2010 PCI | % Deduct due to | | Distress types |
|---|---|---|---|---|---|---|---|---|
| RY1533 | 1 | AC | 330,000 | 1985 | 59 | 8 | 92 | Alligator cracking, L&T cracking, Patching, Weathering/raveling |

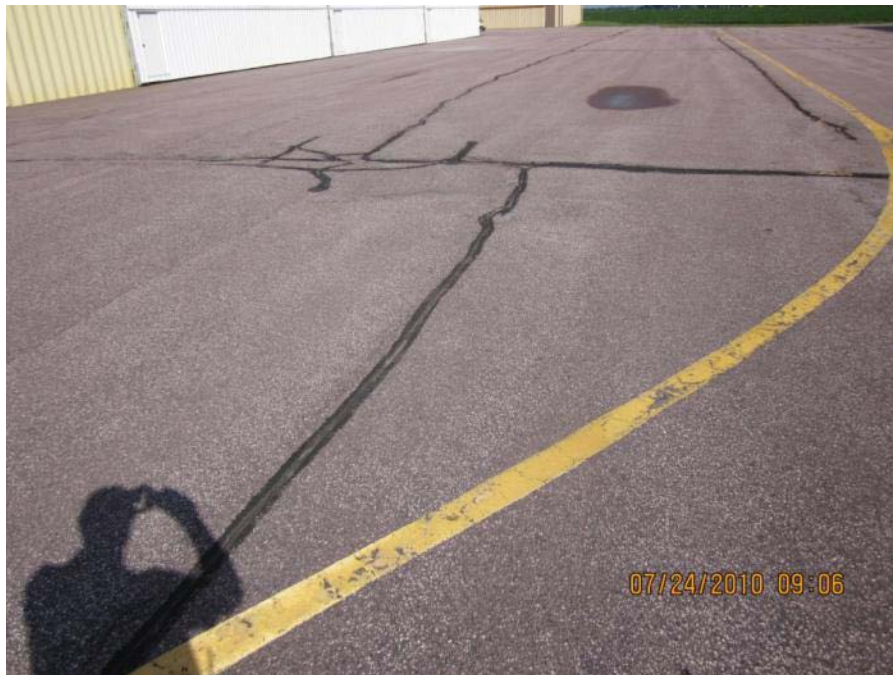
ULM TLA 001 (PCI = 53)

| Branch ID | Section ID | Surface type <sup>1</sup> | Section Area (SF) | LCD <sup>2</sup> | 2010 PCI | % Deduct due to | | Distress types |
|---|---|---|---|---|---|---|---|---|
| TLA | 1 | AC | 22,606 | 1980 | 53 | 39 | 61 | Alligator cracking, L&T cracking, Weathering/raveling |

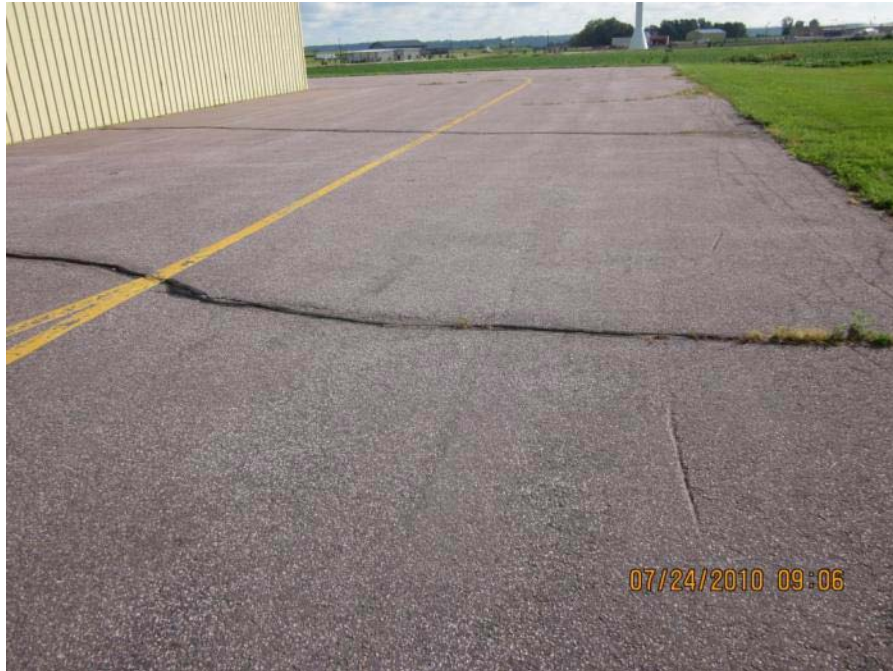
ULM TLB 001 (PCI = 56)

| Branch ID | Section ID | Surface type <sup>1</sup> | Section Area (SF) | LCD <sup>2</sup> | 2010 PCI | % Deduct due to | | Distress types |
|---|---|---|---|---|---|---|---|---|
| TLB | 1 | AC | 39,390 | 1980 | 56 | 22 | 78 | Alligator cracking, L&T cracking, Weathering/raveling |

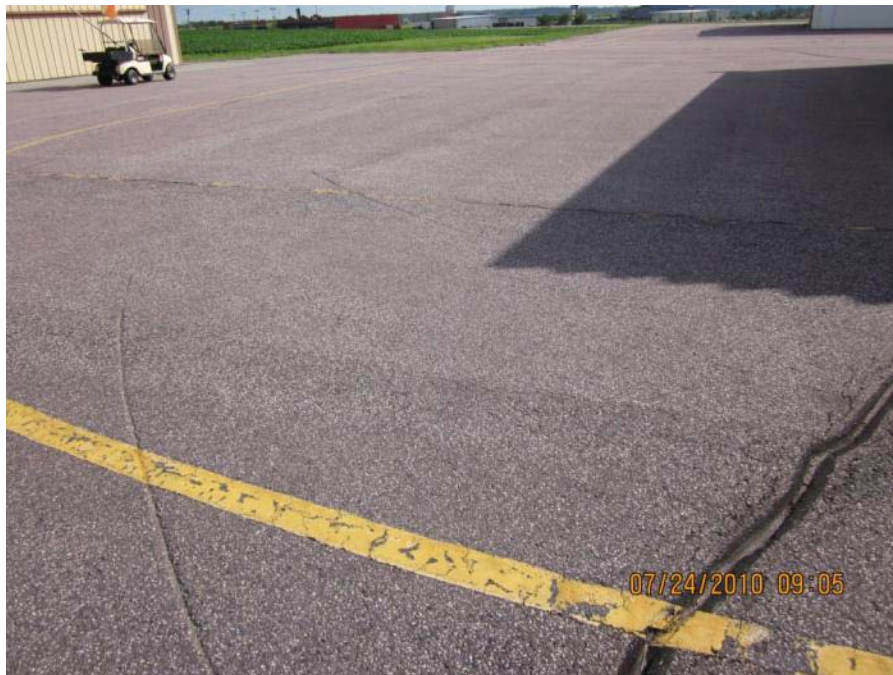
ULM TLC 001 (PCI = 58)

| Branch ID | Section ID | Surface type <sup>1</sup> | Section Area (SF) | LCD <sup>2</sup> | 2010 PCI | % Deduct due to | | Distress types |
|---|---|---|---|---|---|---|---|---|
| TLC | 1 | AC | 11,700 | 1978 | 58 | 0 | 99 | Depression, L&T cracking, Weathering/raveling |
