Minnesota Airport System Pavement Evaluation 2010 Update

Longville Municipal Airport
(XVG)

Longville, Minnesota

December 2010

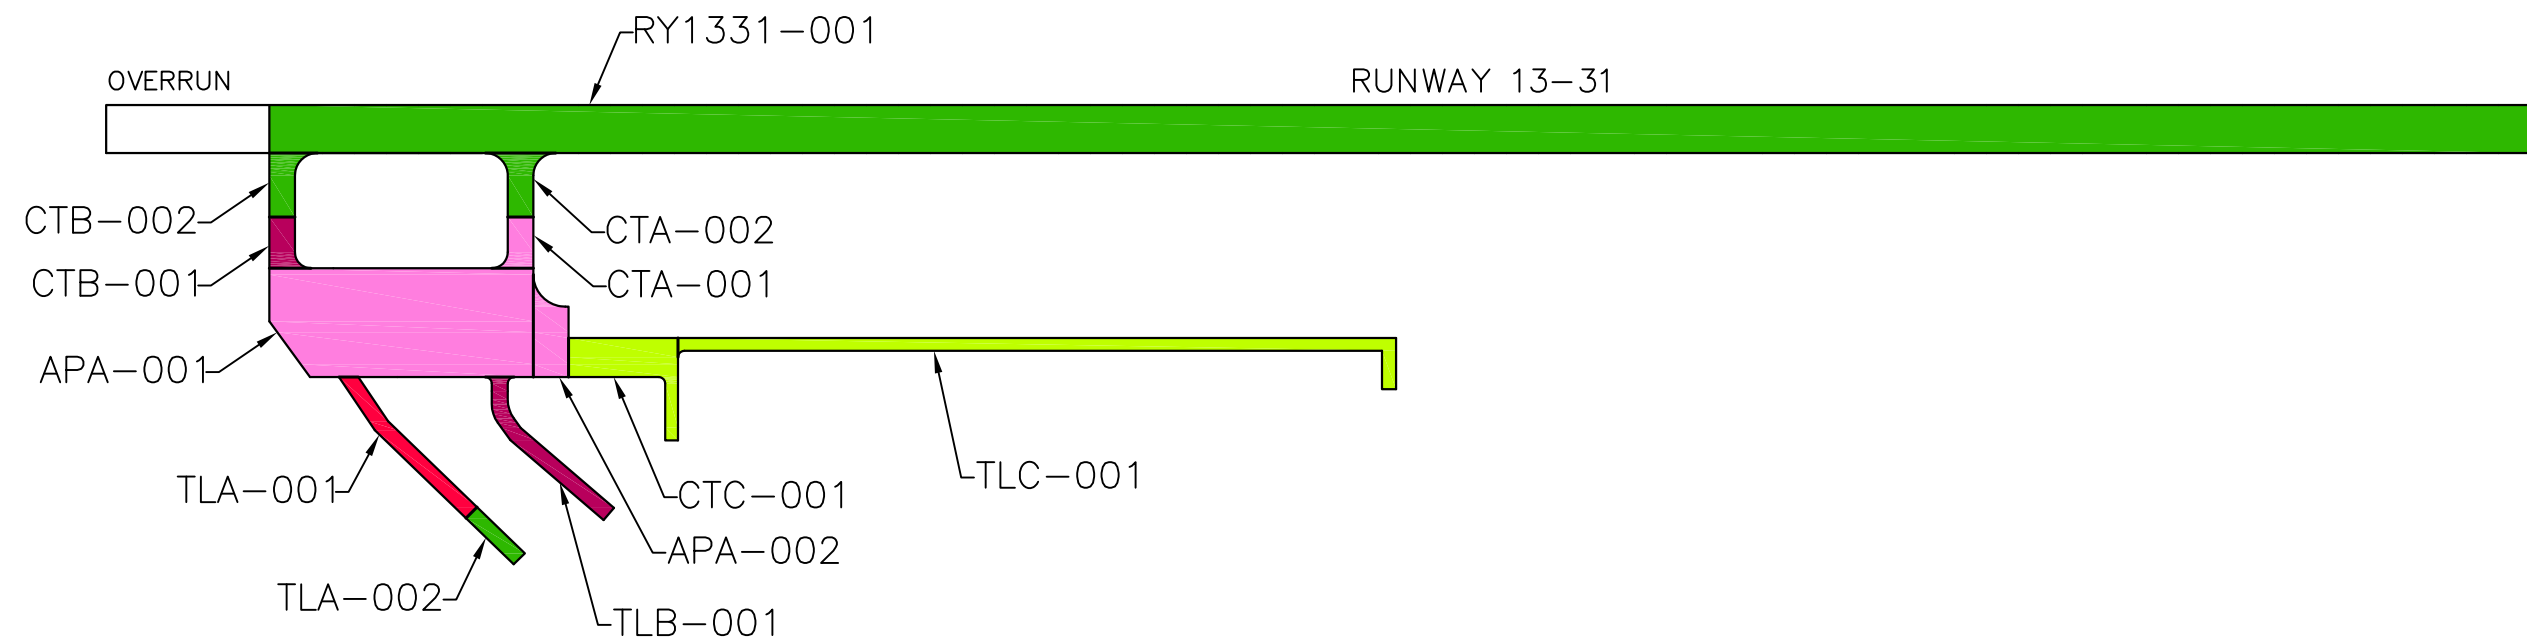
Figure 4. 2010 Pavement Condition Index Rating at Longville Municipal Airport (XVG).

The results of the 2010 PCI inspection are presented in figure 4. The overall area-weighted PCI for XVG is 85. When summarizing PCI values, an area-weighted calculation is used instead of a straight mathematical average because the area-weighted calculations eliminate the skewing of the PCI due to the disparity of the section sizes.

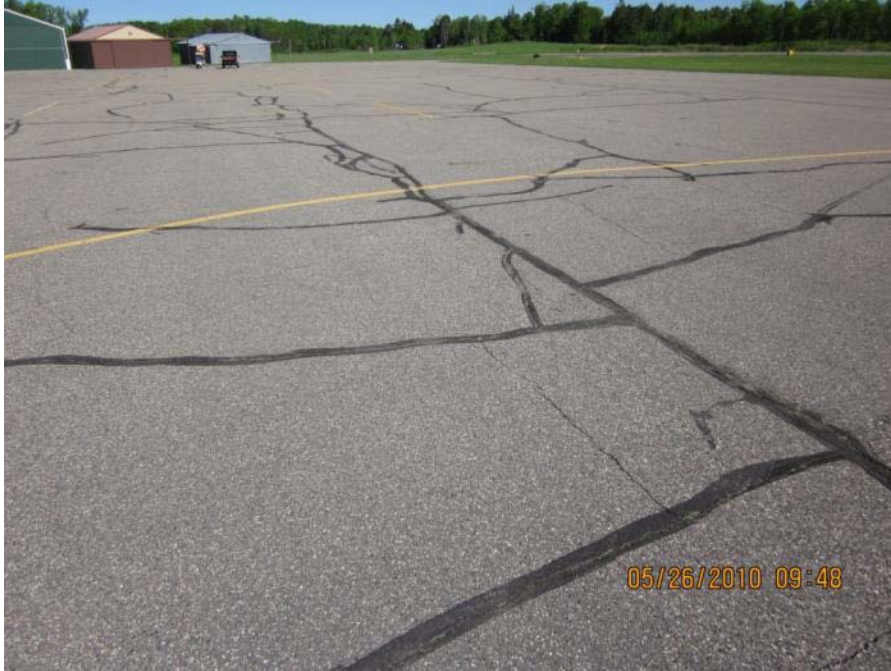
XVG APA 001 (PCI = 46)

48	LONGITUDINAL/TRANSVERSE CRACKING	L	899.00	Ft
48	LONGITUDINAL/TRANSVERSE CRACKING	M	47.00	Ft
43	BLOCK CRACKING	L	300.00	SqFt
41	ALLIGATOR CRACKING	M	4.00	SqFt
52	WEATHERING/RAVELING	L	1,000.00	SqFt

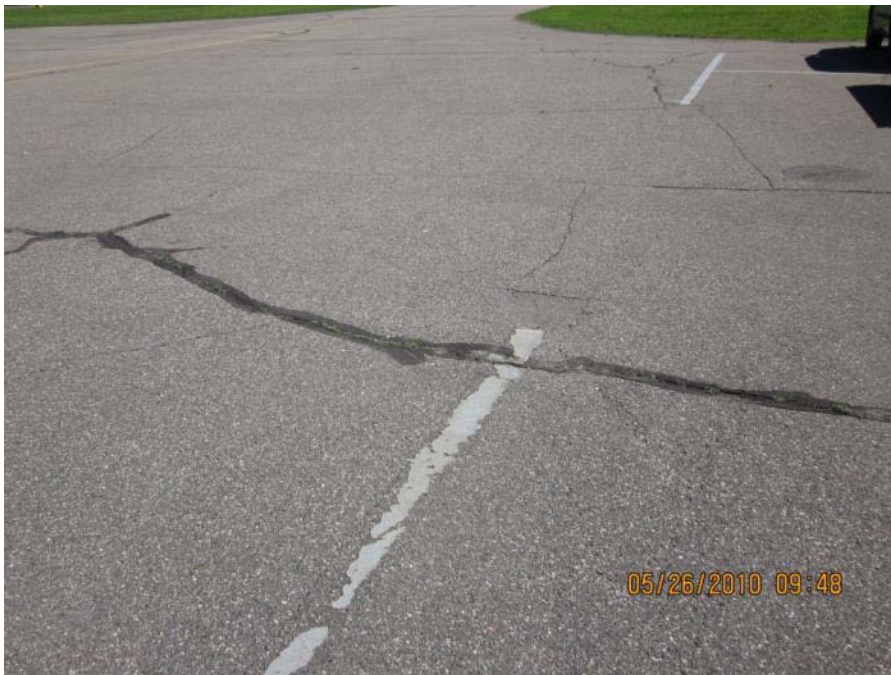
XVG APA 002 (PCI = 46)

48	LONGITUDINAL/TRANSVERSE CRACKING	L	825.00	Ft
48	LONGITUDINAL/TRANSVERSE CRACKING	M	231.00	Ft
48	LONGITUDINAL/TRANSVERSE CRACKING	H	47.00	Ft
52	WEATHERING/RAVELING	L	800.00	SqFt

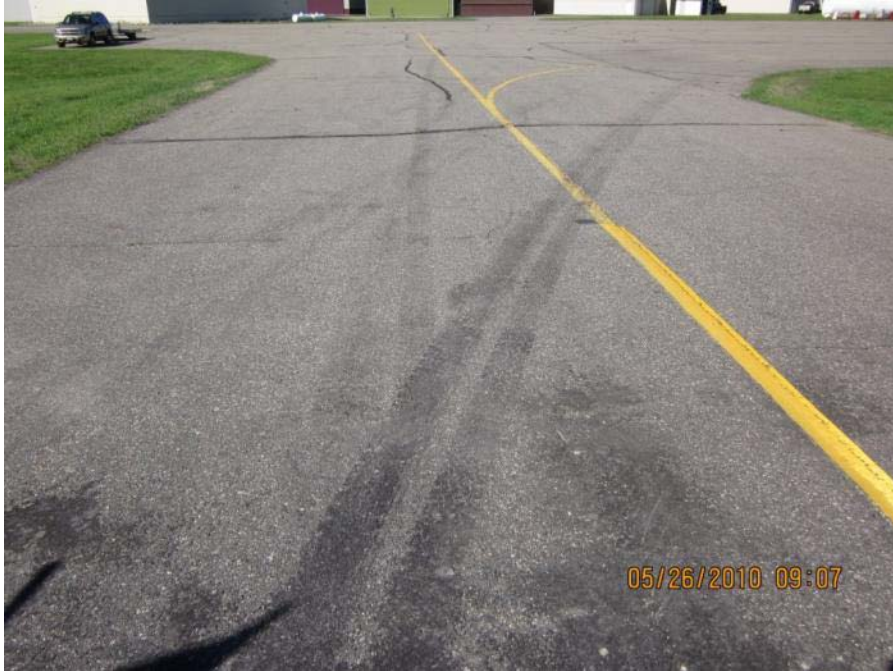
XVG CTA 001 (PCI = 54)

48	LONGITUDINAL/TRANSVERSE CRACKING	L	326.00	Ft
48	LONGITUDINAL/TRANSVERSE CRACKING	M	150.00	Ft
48	LONGITUDINAL/TRANSVERSE CRACKING	H	4.00	Ft
52	WEATHERING/RAVELING	L	2,268.00	SqFt

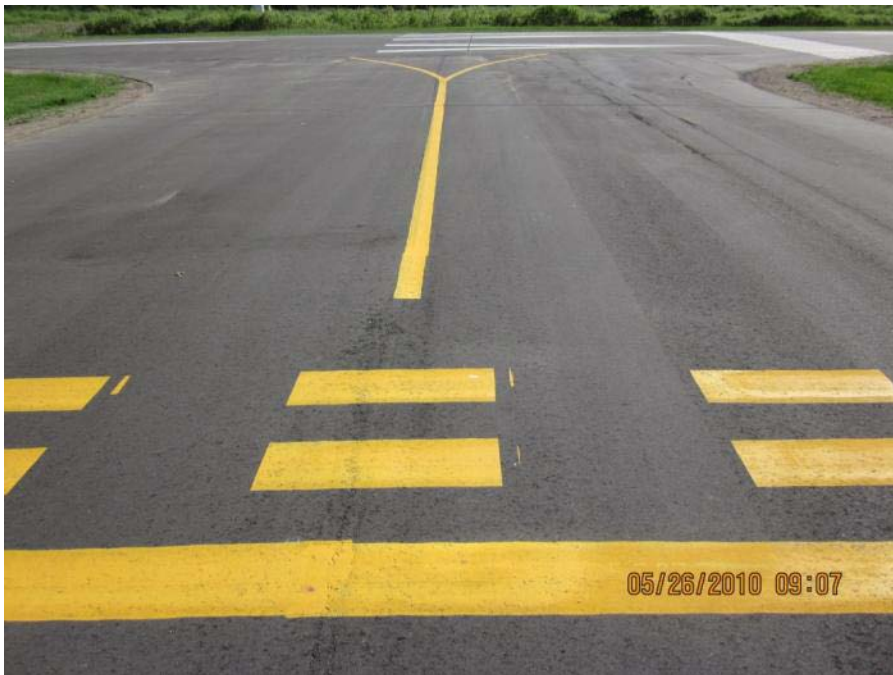
XVG CTA 002 (PCI = 100)

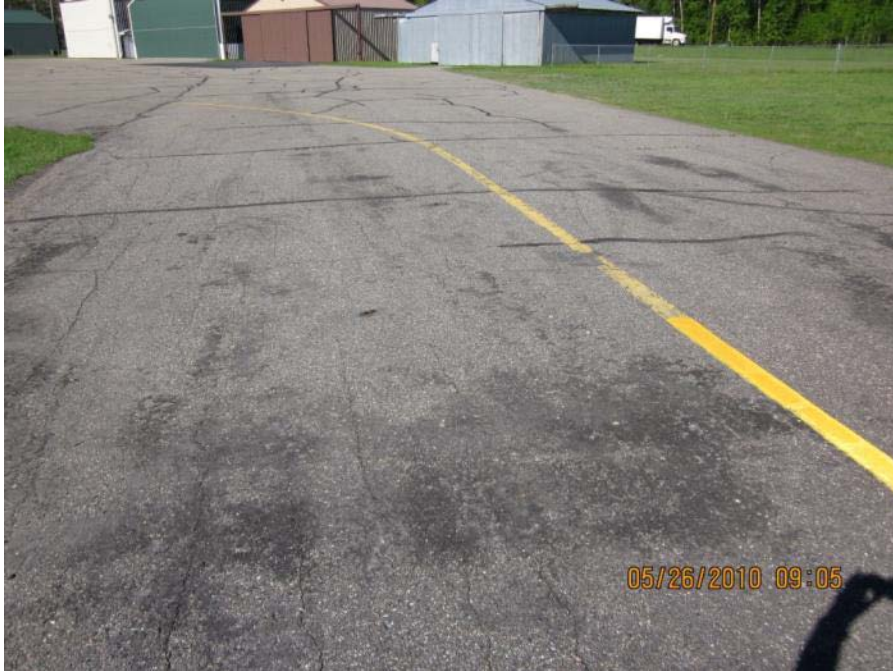
XVG CTB 001 (PCI = 24)

48	LONGITUDINAL/TRANSVERSE CRACKING	L	652.00	Ft
48	LONGITUDINAL/TRANSVERSE CRACKING	M	41.00	Ft
41	ALLIGATOR CRACKING	M	293.00	SqFt
41	ALLIGATOR CRACKING	H	7.00	SqFt
56	SWELLING	L	36.00	SqFt
52	WEATHERING/RAVELING	L	960.00	SqFt
53	RUTTING	L	120.00	SqFt

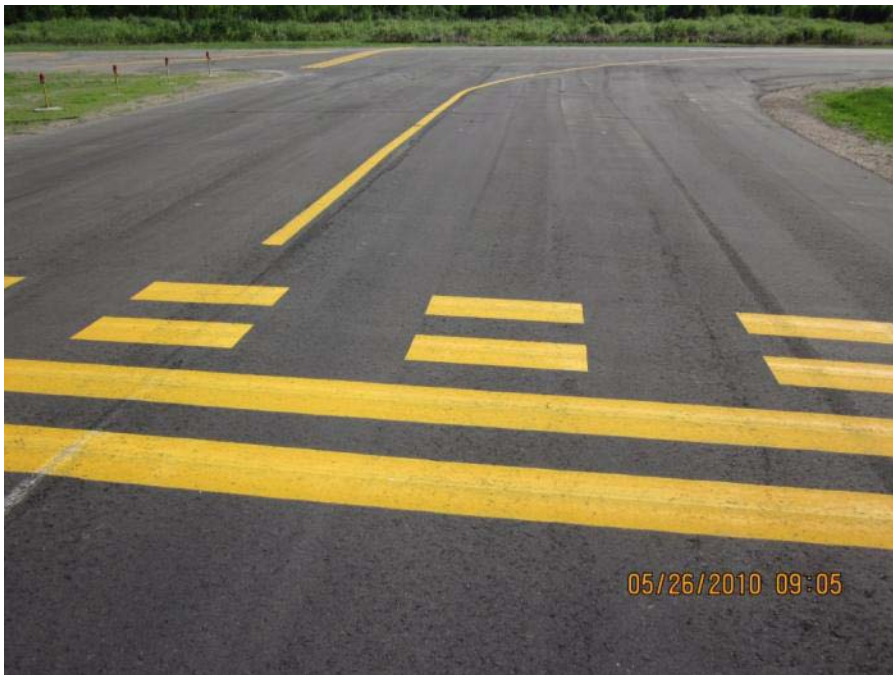
XVG CTB 002 (PCI = 100)

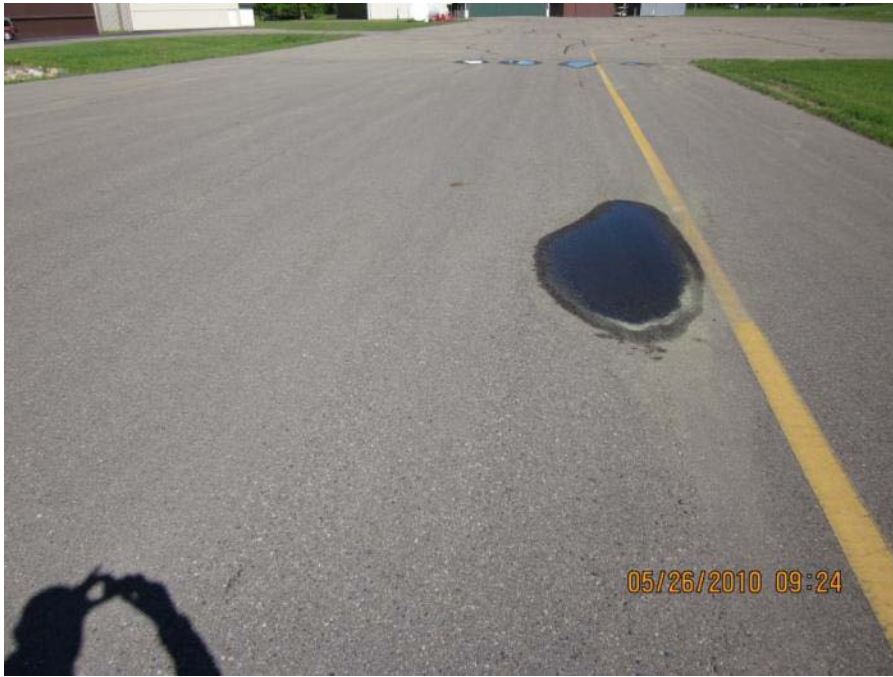
XVG CTC 001 (PCI = 73)

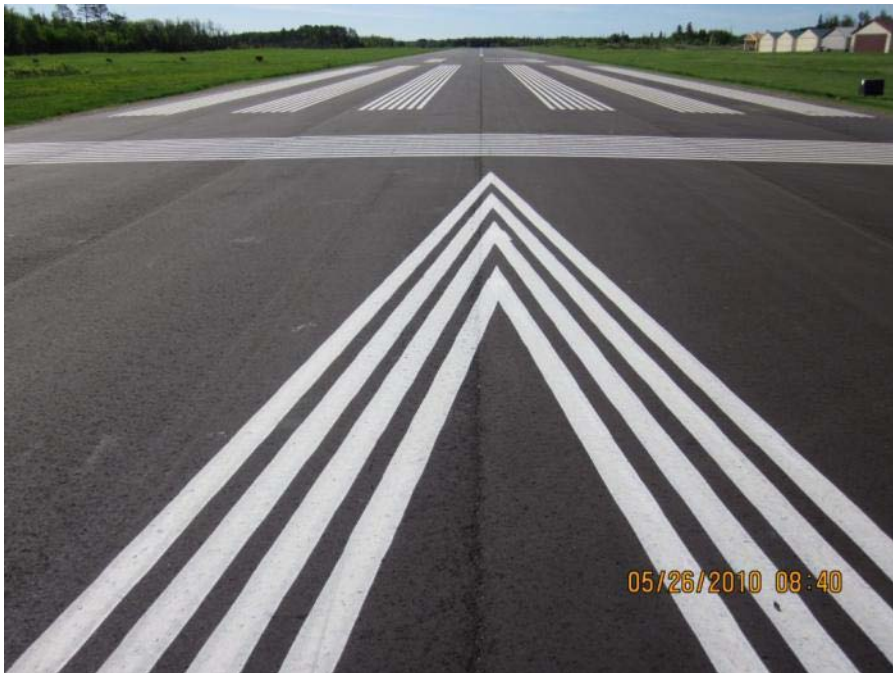
XVG RY1331 001 (PCI = 100)

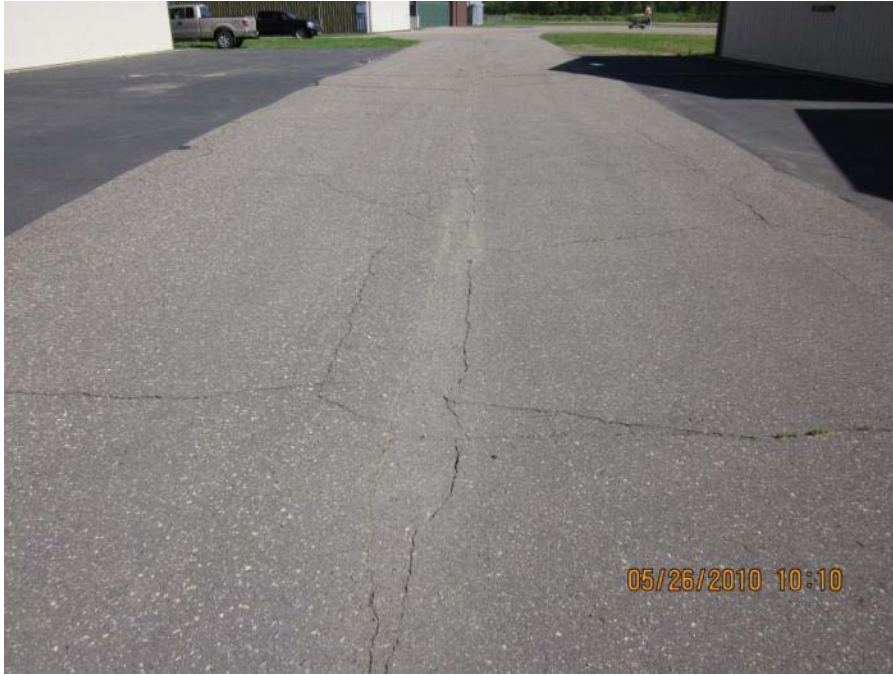
XVG TLA 001 (PCI = 32)

41	ALLIGATOR CRACKING	L	20.00	SqFt
41	ALLIGATOR CRACKING	M	33.00	SqFt
43	BLOCK CRACKING	L	2,500.00	SqFt
52	WEATHERING/RAVELING	L	2,500.00	SqFt
56	SWELLING	L	25.00	SqFt
53	RUTTING	L	80.00	SqFt

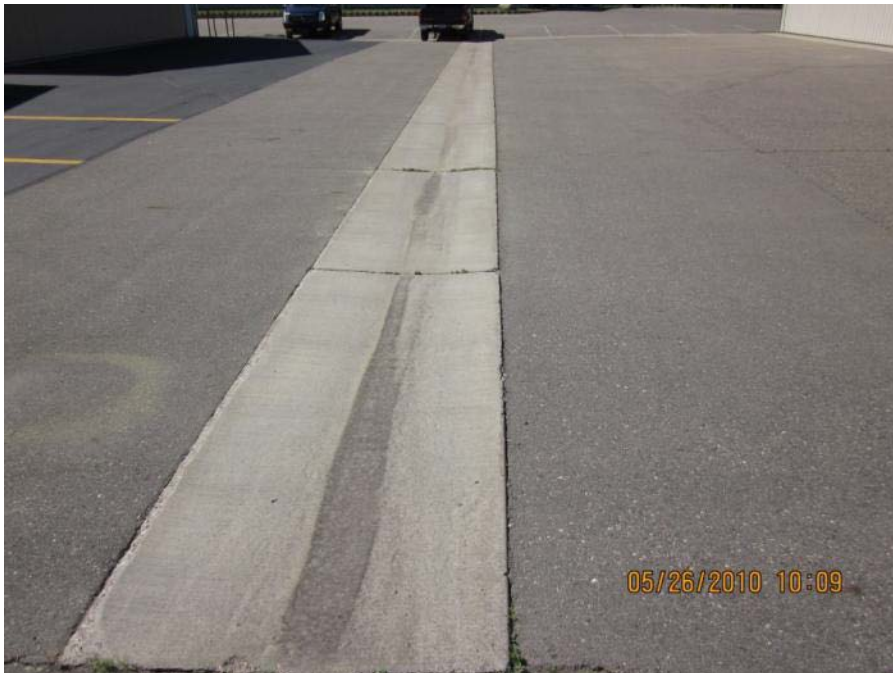
XVG TLA 002 (PCI = 96)

48 LONGITUDINAL/TRANSVERSE CRACKING L 15.00 Ft

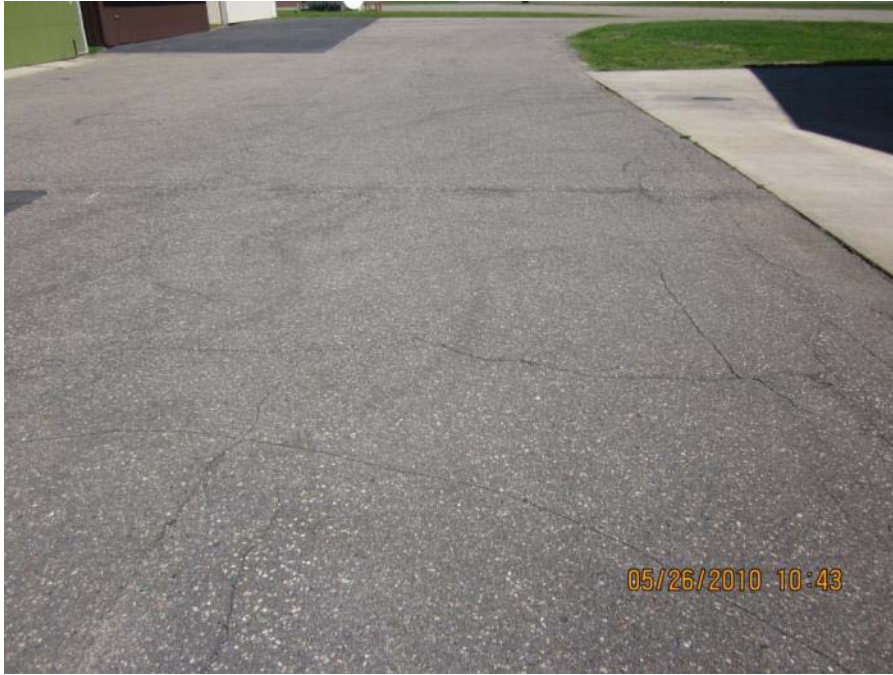
XVG TLB 001 (PCI = 25)

41	ALLIGATOR CRACKING	L	171.00	SqFt
41	ALLIGATOR CRACKING	M	49.00	SqFt
43	BLOCK CRACKING	L	2,500.00	SqFt
52	WEATHERING/RAVELING	L	500.00	SqFt
53	RUTTING	L	96.00	SqFt
56	SWELLING	L	25.00	SqFt

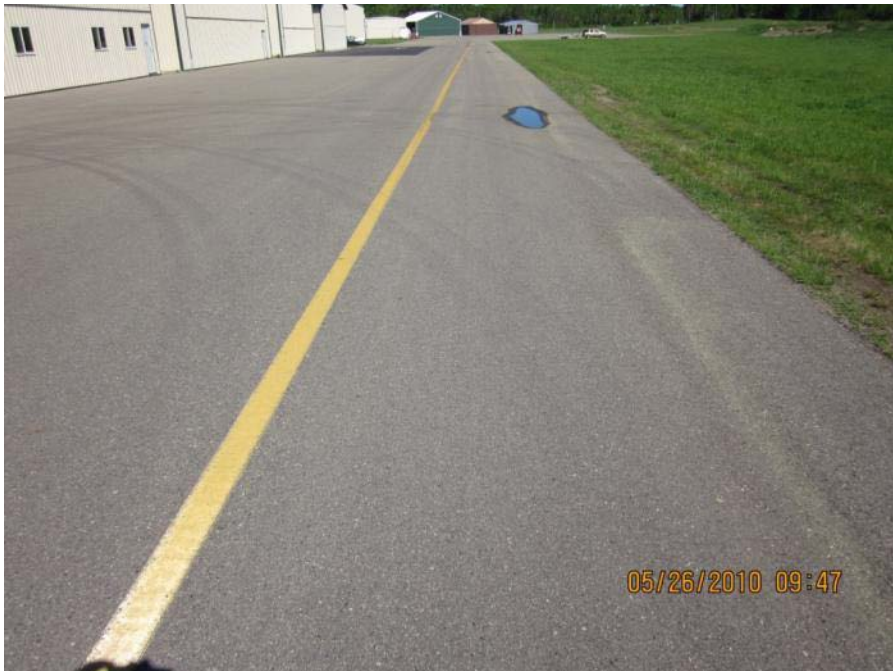
TLC	1	AC	22,540	2005	79	80	20	L&T cracking, Rutting

XVG TLC 001 (PCI = 79)
