# Minnesota Airport System Pavement Evaluation 2011 Update

Hawley Municipal Airport (04Y)

Hawley, Minnesota

January 2012

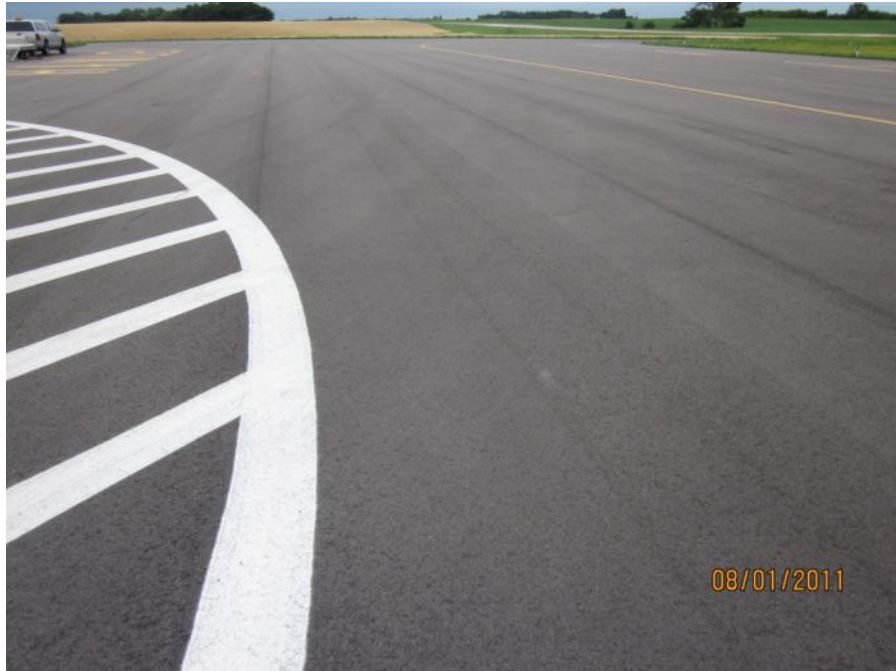
04Y APA 001 (PCI = 93)

| Branch ID | Section ID | Surface type <sup>1</sup> | Section area (SF) | LCD <sup>2</sup> | 2008 PCI | 2011 PCI | Drop in PCI/Yr <sup>3</sup> | % Deduct due to | | Distress types |
|---|---|---|---|---|---|---|---|---|---|---|
| APA | 1 | AAC | 45,000 | 2010 | 64 | 93 | 7.0 | 0 | 100 | Longitudinal & transverse (L&T) cracking |

Conditions: PCI : 93

48 LONGITUDINAL/TRANSVERSE CRACKING L 116.00 Ft Comments:

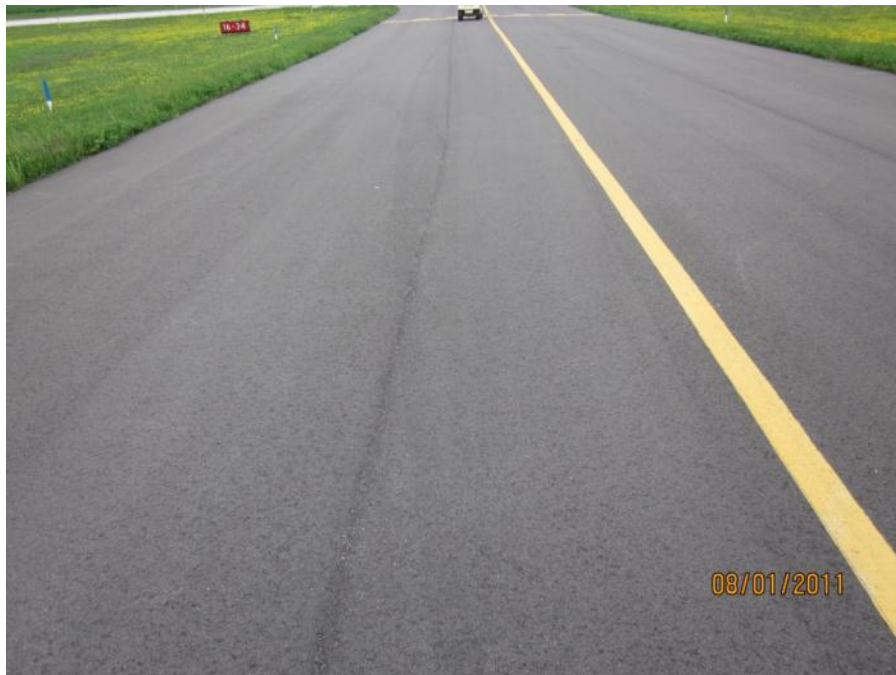
04Y CTA 001 (PCI = 96)

| Branch ID | Section ID | Surface type <sup>1</sup> | Section area (SF) | LCD <sup>2</sup> | 2008 PCI | 2011 PCI | Drop in PCI/Yr <sup>3</sup> | % Deduct due to | | Distress types |
|---|---|---|---|---|---|---|---|---|---|---|
| CTA | 1 | AAC | 10,750 | 2010 | 40 | 96 | 4.0 | 0 | 100 | L&T cracking |

Conditions: PCI : 96

48 LONGITUDINAL/TRANSVERSE CRACKING L 16.00 Ft Comments:

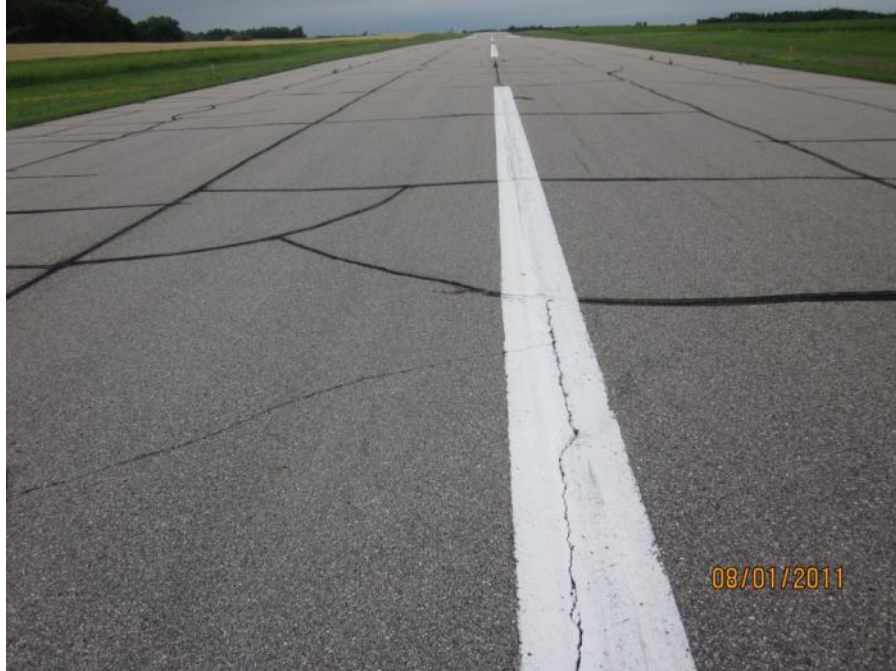
04Y RY1634 001 (PCI = 70)

| Branch ID | Section ID | Surface type <sup>1</sup> | Section area (SF) | LCD <sup>2</sup> | 2008 PCI | 2011 PCI | Drop in PCI/Yr <sup>3</sup> | % Deduct due to | | Distress types |
|---|---|---|---|---|---|---|---|---|---|---|
| RY1634 | 1 | AAC | 264,375 | 2004 | 71 | 70 | 4.3 | 0 | 100 | L&T cracking |

Conditions: PCI : 70

48 LONGITUDINAL/TRANSVERSE CRACKING L 461.00 Ft Comments:  
48 LONGITUDINAL/TRANSVERSE CRACKING M 76.00 Ft Comments:

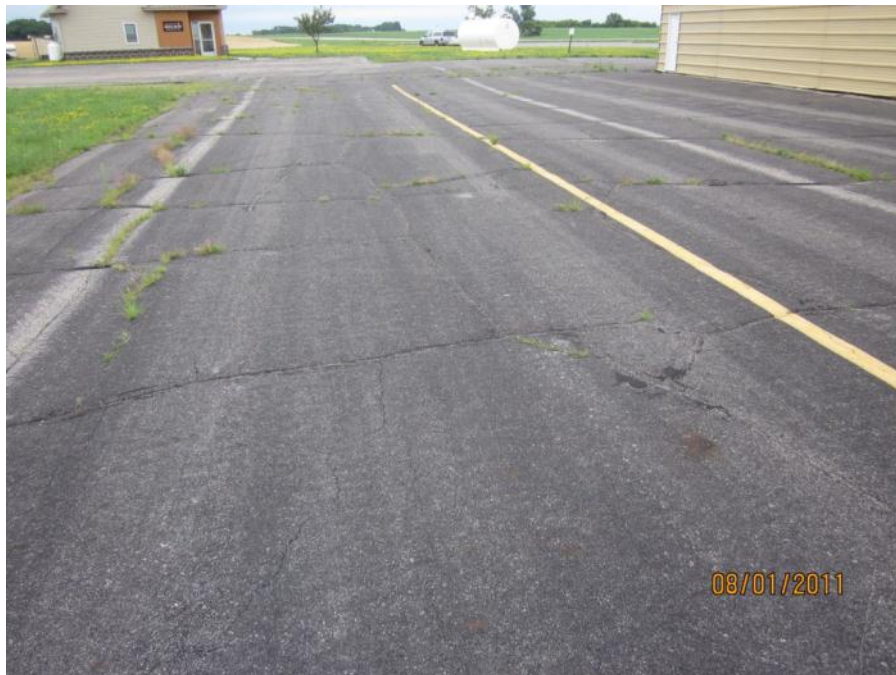
04Y TLA 001 (PCI = 45)

| Branch ID | Section ID | Surface type <sup>1</sup> | Section area (SF) | LCD <sup>2</sup> | 2008 PCI | 2011 PCI | Drop in PCI/Yr <sup>3</sup> | % Deduct due to | | Distress types |
|---|---|---|---|---|---|---|---|---|---|---|
| TLA | 1 | AC | 30,500 | 1973 | 43 | 45 | 1.4 | 49 | 51 | Alligator cracking, Block cracking, Weathering |

Conditions: PCI : 45

| 41 ALLIGATOR CRACKING | M | 24.00 SqFt | Comments: |
| 43 BLOCK CRACKING | L | 5,000.00 SqFt | Comments: |

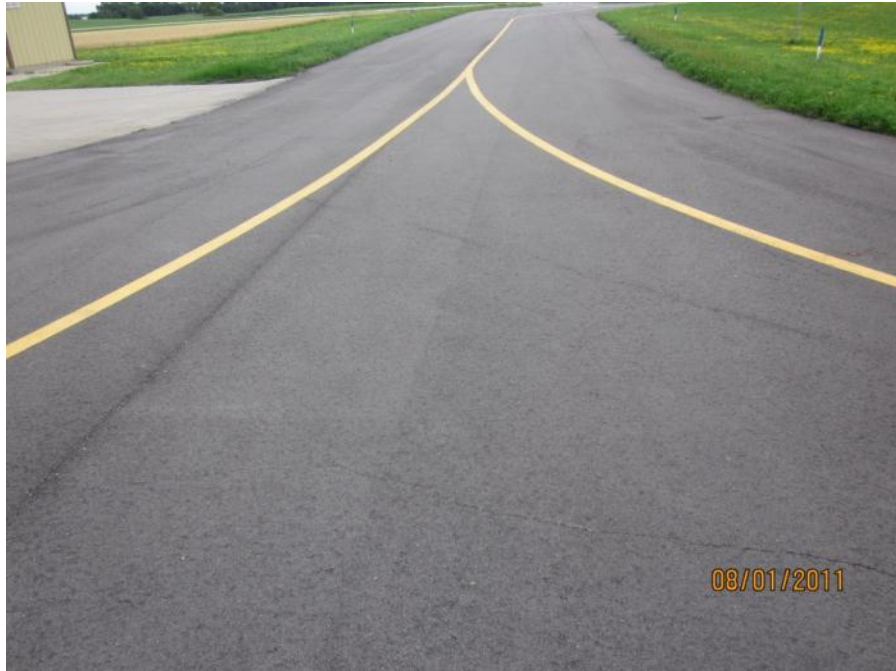
04Y TLA 002 (PCI = 96)

| Branch ID | Section ID | Surface type <sup>1</sup> | Section area (SF) | LCD <sup>2</sup> | 2008 PCI | 2011 PCI | Drop in PCI/Yr <sup>3</sup> | % Deduct due to | | Distress types |
|---|---|---|---|---|---|---|---|---|---|---|
| TLA | 2 | AC | 29,720 | 2010 | 32 | 96 | 4.0 | 0 | 100 | L&T cracking, Weathering |

Conditions: PCI : 96

Sample Number: 101 Type: R Area: 3,378.00SqFt PCI = 88  
Sample Comments:  
48 LONGITUDINAL/TRANSVERSE CRACKING L 126.00 Ft Comments:

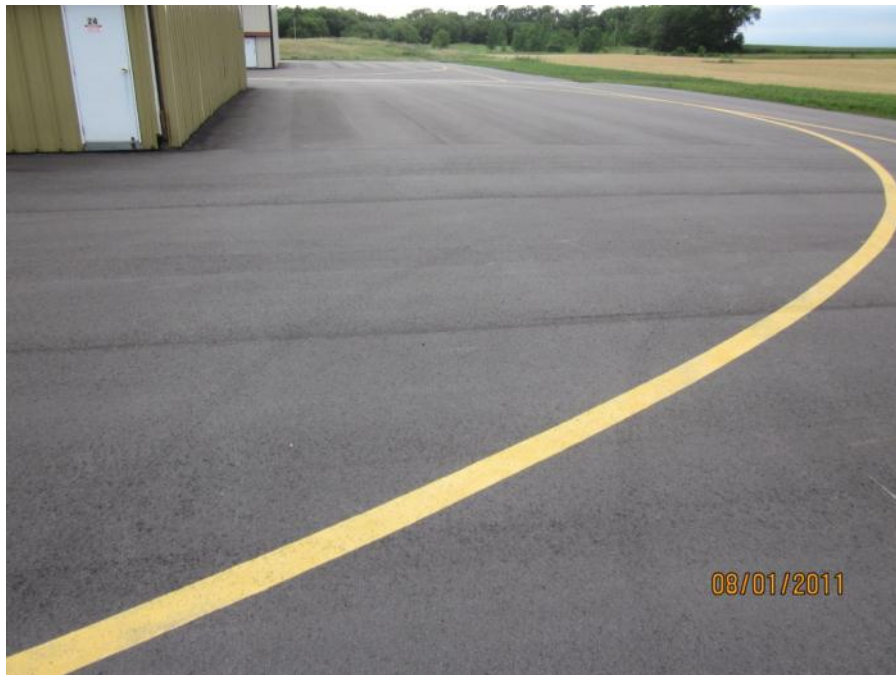
04Y TLA 003 (PCI = 100)

Conditions: PCI : 100

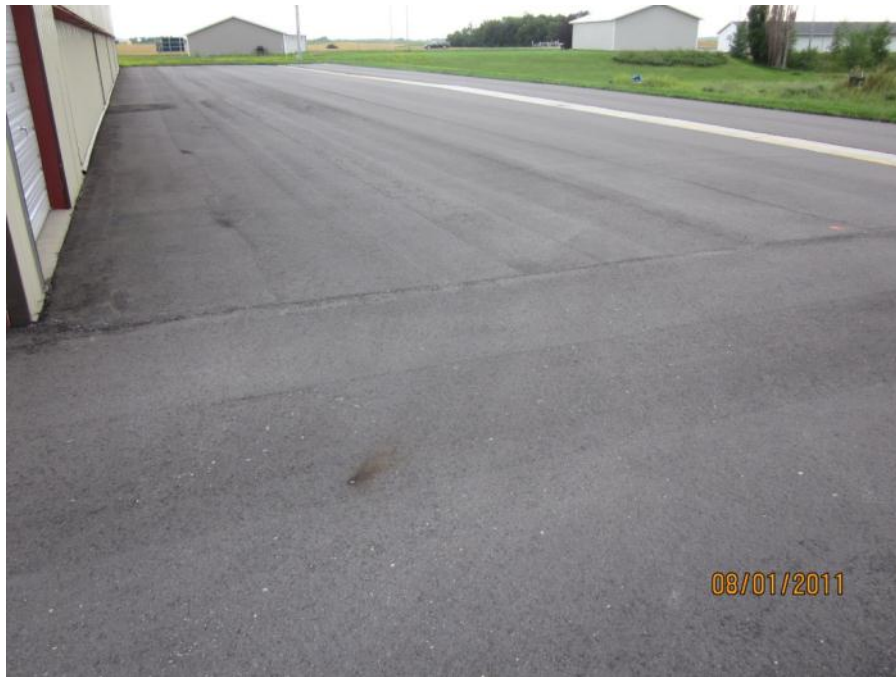
04Y TLA 004 (PCI = 100)

Conditions: PCI : 100
