# Minnesota Airport System Pavement Evaluation 2011 Update

Le Sueur Municipal Airport (12Y)

Le Sueur, Minnesota

January 2012

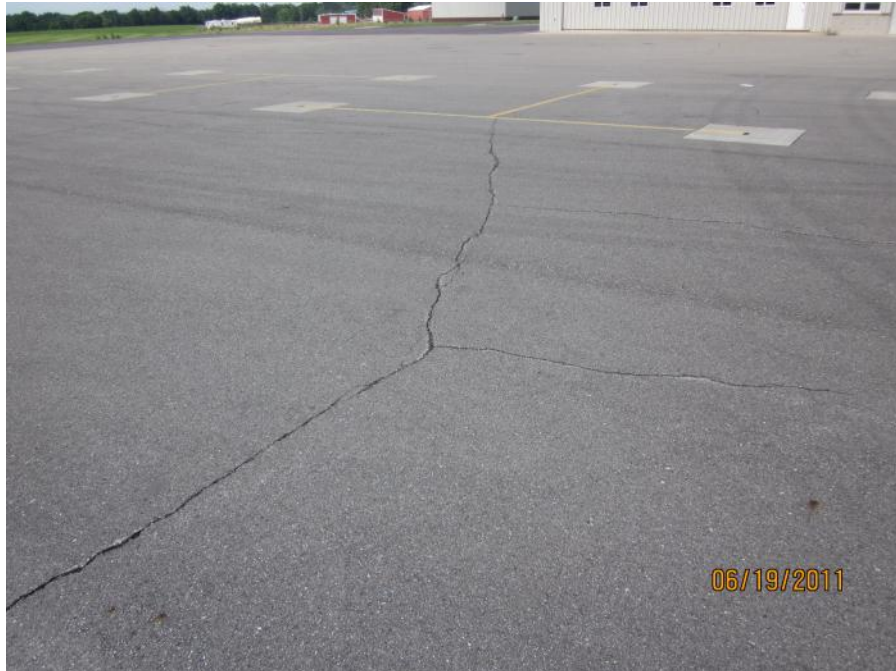
12Y APA 001 (PCI = 78)

| Branch ID | Section ID | Surface type <sup>1</sup> | Section area (SF) | LCD <sup>2</sup> | 2008 PCI | 2011 PCI | Drop in PCI/Yr <sup>3</sup> | % Deduct due to | | Distress types |
|---|---|---|---|---|---|---|---|---|---|---|
| APA | 1 | AC | 45,000 | 2008 | 100 | 78 | 7.3 | 0 | 100 | Longitudinal & transverse (L&T) cracking |

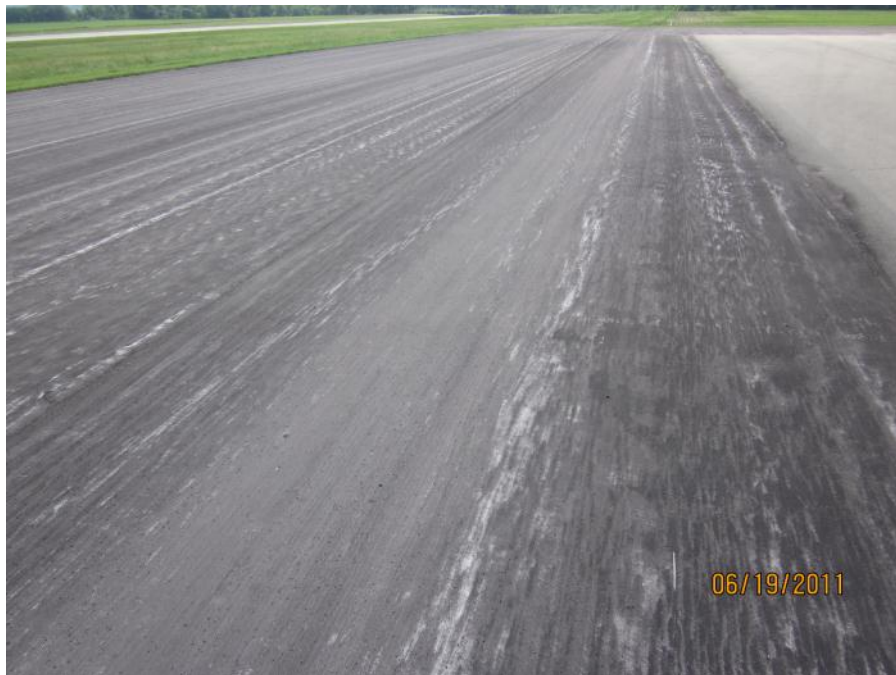
12Y APA 002 (PCI = 95)

| Branch ID | Section ID | Surface type <sup>1</sup> | Section area (SF) | LCD <sup>2</sup> | 2008 PCI | 2011 PCI | Drop in PCI/Yr <sup>3</sup> | % Deduct due to | | Distress types |
|---|---|---|---|---|---|---|---|---|---|---|
| APA | 2 | AAC | 71,882 | 2003 | 95 | 95 | 0.6 | 0 | 100 | L&T cracking |

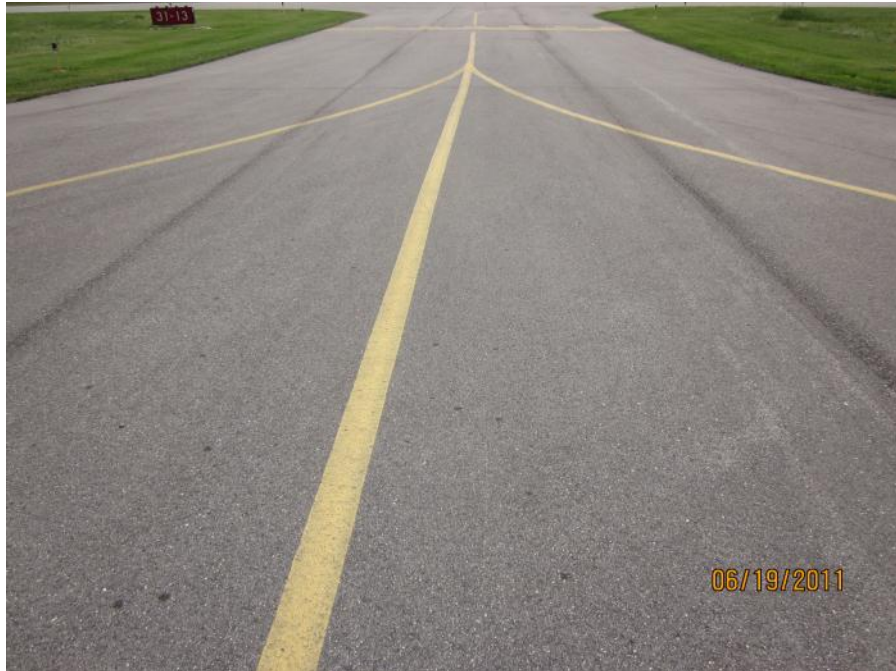
12Y CTA 001 (PCI = 96)

| Branch ID | Section ID | Surface type <sup>1</sup> | Section area (SF) | LCD <sup>2</sup> | 2008 PCI | 2011 PCI | Drop in PCI/Yr <sup>3</sup> | % Deduct due to | | Distress types |
|---|---|---|---|---|---|---|---|---|---|---|
| CTA | 1 | AC | 10,120 | 2008 | 91 | 96 | 1.3 | 0 | 100 | L&T cracking |

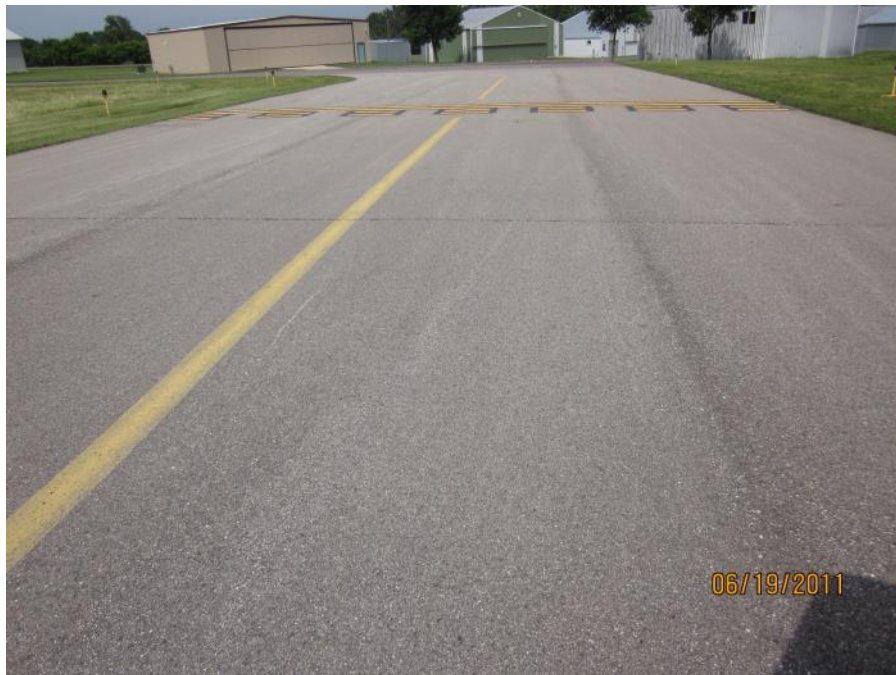
12Y CTB 001 (PCI = 91)

| Branch ID | Section ID | Surface type <sup>1</sup> | Section area (SF) | LCD <sup>2</sup> | 2008 PCI | 2011 PCI | Drop in PCI/Yr <sup>3</sup> | % Deduct due to | | Distress types |
|---|---|---|---|---|---|---|---|---|---|---|
| CTB | 1 | AC | 7,500 | 2008 | 100 | 91 | 3.0 | 0 | 100 | L&T cracking |

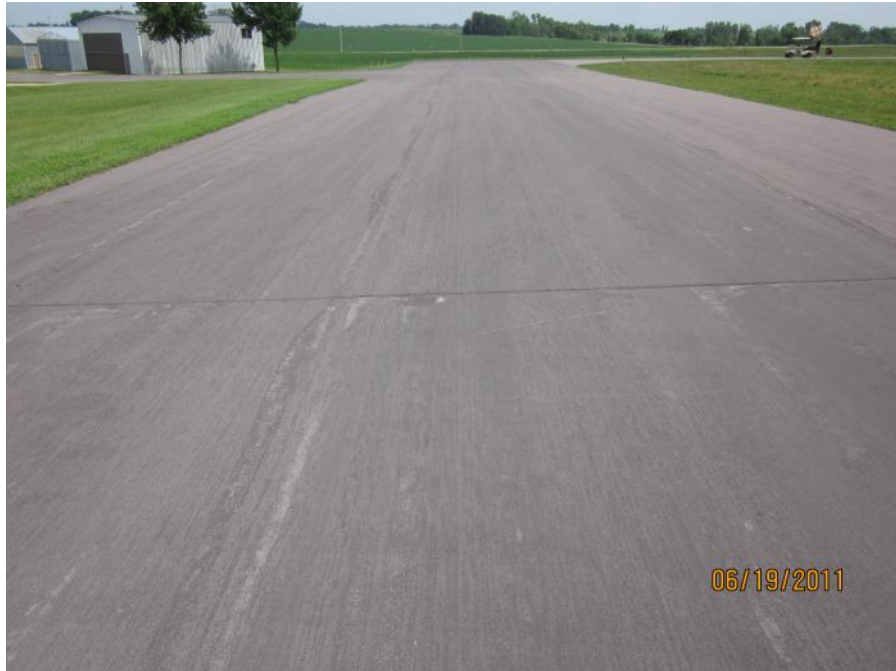
12Y PPTA 001 (PCI = 92)

| Branch ID | Section ID | Surface type <sup>1</sup> | Section area (SF) | LCD <sup>2</sup> | 2008 PCI | 2011 PCI | Drop in PCI/Yr <sup>3</sup> | % Deduct due to | | Distress types |
|---|---|---|---|---|---|---|---|---|---|---|
| PPTA | 1 | AC | 25,600 | 2004 | 100 | 92 | 1.1 | 0 | 100 | L&T cracking |

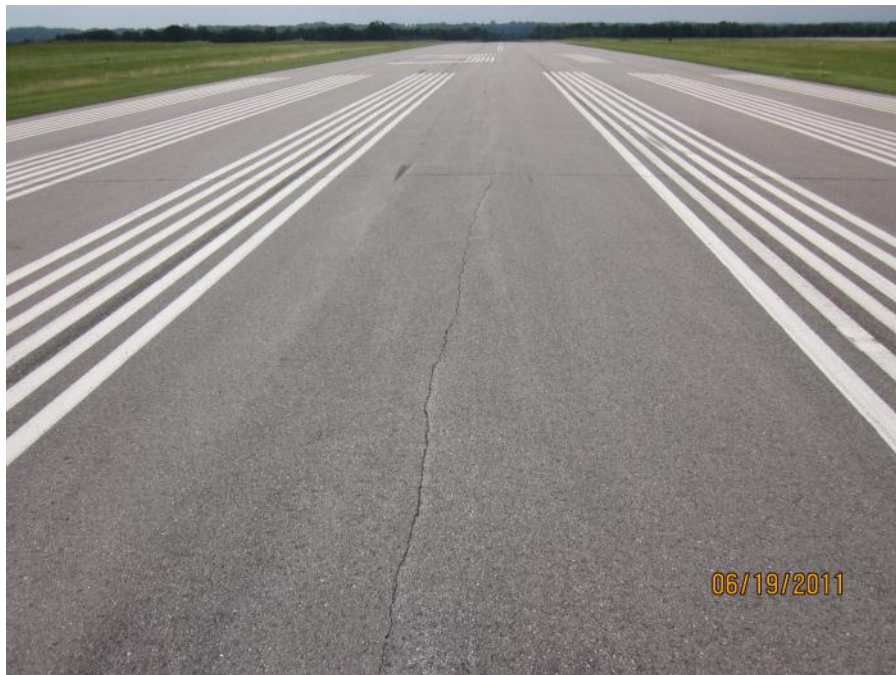
12Y RY1331 001 (PCI = 95)

| Branch ID | Section ID | Surface type <sup>1</sup> | Section area (SF) | LCD <sup>2</sup> | 2008 PCI | 2011 PCI | Drop in PCI/Yr <sup>3</sup> | % Deduct due to | | Distress types |
|---|---|---|---|---|---|---|---|---|---|---|
| RY1331 | 1 | AC | 150,000 | 2008 | 100 | 95 | 1.7 | 0 | 97 | Depression, L&T cracking |

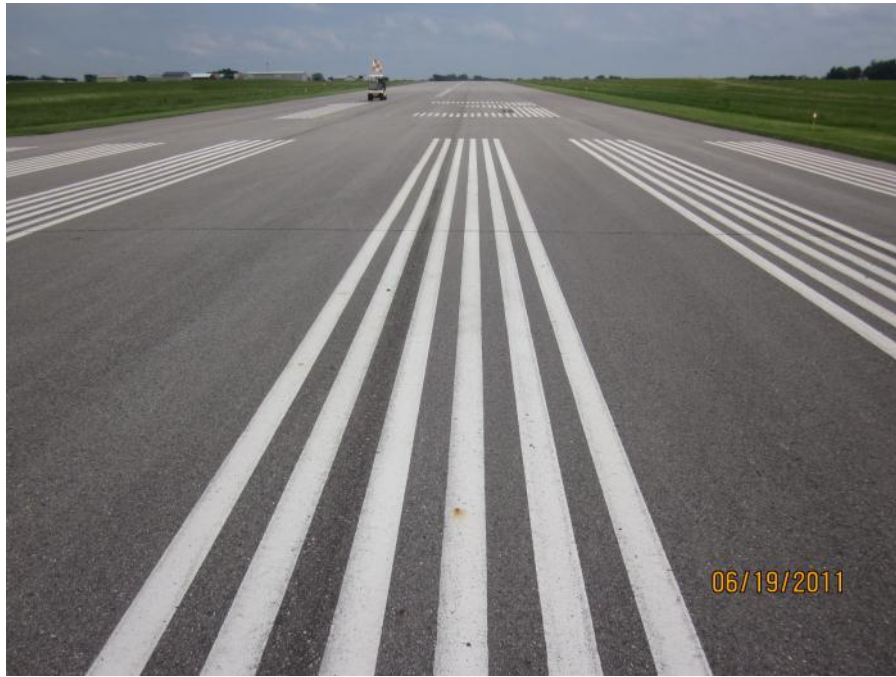
12Y RY1331 002 (PCI = 96)

| Branch ID | Section ID | Surface type <sup>1</sup> | Section area (SF) | LCD <sup>2</sup> | 2008 PCI | 2011 PCI | Drop in PCI/Yr <sup>3</sup> | % Deduct due to | | Distress types |
|---|---|---|---|---|---|---|---|---|---|---|
| RY1331 | 2 | AC | 81,575 | 2008 | 100 | 96 | 1.3 | 0 | 100 | L&T cracking |

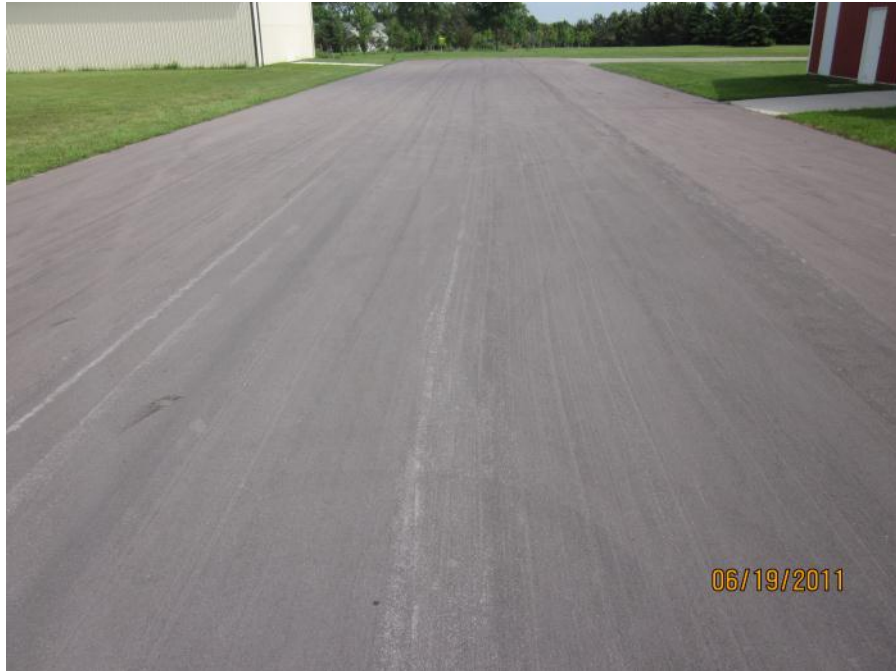
12Y TLB 001 (PCI = 95)

| Branch ID | Section ID | Surface type <sup>1</sup> | Section area (SF) | LCD <sup>2</sup> | 2008 PCI | 2011 PCI | Drop in PCI/Yr <sup>3</sup> | % Deduct due to | | Distress types |
|---|---|---|---|---|---|---|---|---|---|---|
| TLB | 1 | AC | 20,280 | 2004 | 100 | 95 | 0.7 | 0 | 100 | L&T cracking |

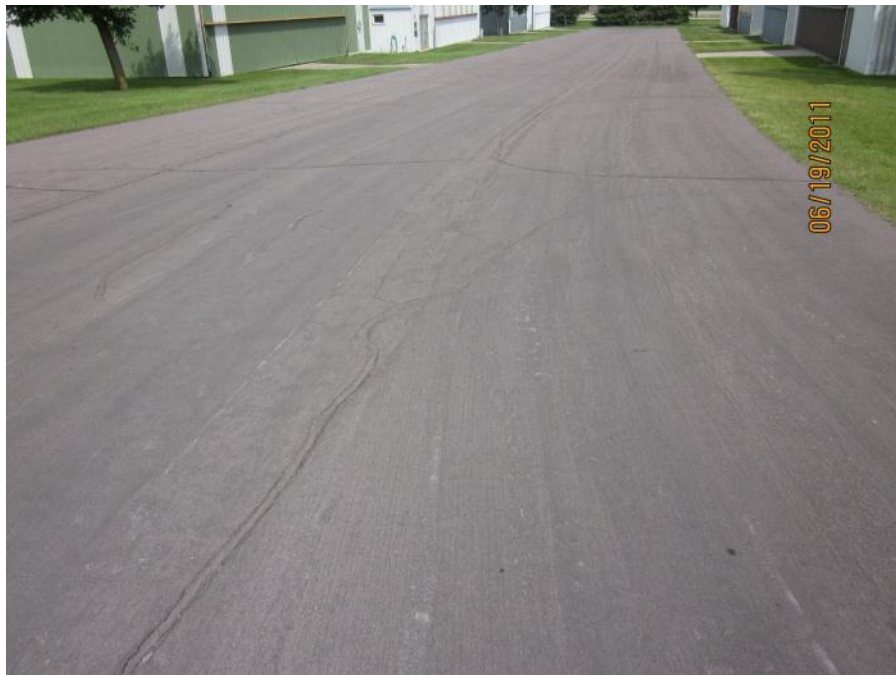
12Y TLC 001 (PCI = 66)

| Branch ID | Section ID | Surface type <sup>1</sup> | Section area (SF) | LCD <sup>2</sup> | 2008 PCI | 2011 PCI | Drop in PCI/Yr <sup>3</sup> | % Deduct due to | | Distress types |
|---|---|---|---|---|---|---|---|---|---|---|
| TLC | 1 | AC | 18,640 | 1971 | 72 | 66 | 0.9 | 0 | 100 | L&T cracking |

48 LONGITUDINAL/TRANSVERSE CRACKING L 781.00 Ft Comments:  
48 LONGITUDINAL/TRANSVERSE CRACKING M 8.00 Ft Comments:

48 LONGITUDINAL/TRANSVERSE CRACKING L 656.00 Ft Comments:

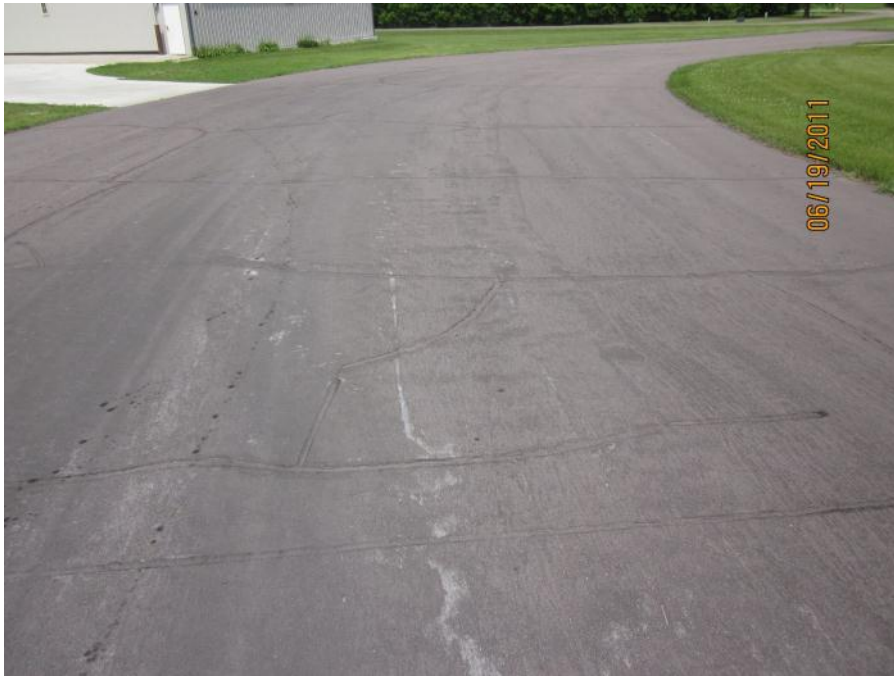
12Y TLD 001 (PCI = 65)

| Branch ID | Section ID | Surface type <sup>1</sup> | Section area (SF) | LCD <sup>2</sup> | 2008 PCI | 2011 PCI | Drop in PCI/Yr <sup>3</sup> | % Deduct due to | | Distress types |
|---|---|---|---|---|---|---|---|---|---|---|
| TLD | 1 | AC | 13,640 | 1971 | 74 | 65 | 0.9 | 0 | 100 | L&T cracking |

48 LONGITUDINAL/TRANSVERSE CRACKING L 655.00 Ft Comments:

48 LONGITUDINAL/TRANSVERSE CRACKING M 13.00 Ft Comments:
