# Minnesota Airport System Pavement Evaluation 2011 Update

Austin Municipal Airport (AUM)

Austin, Minnesota

January 2012

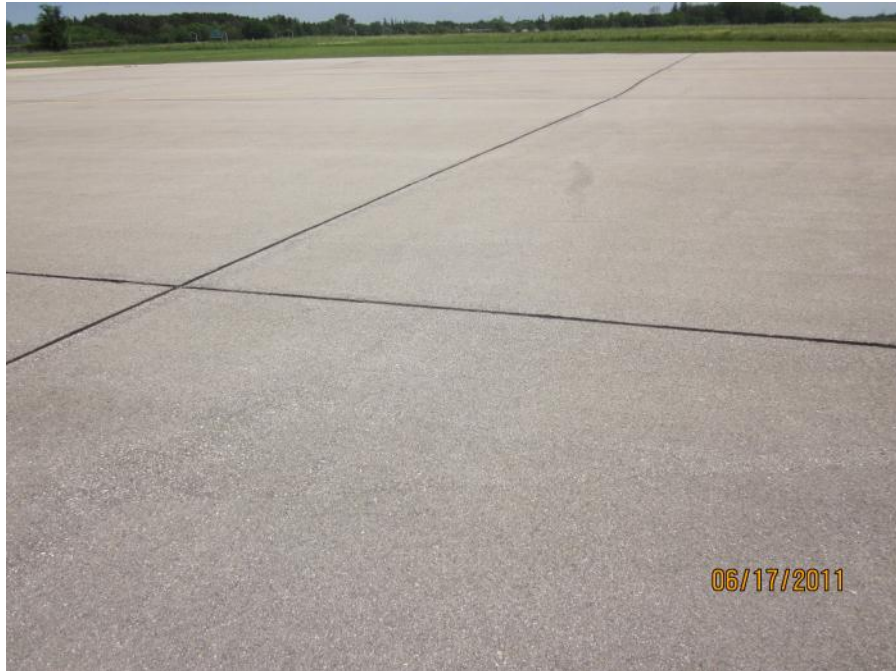
AUM APA 001 (PCI = 86)

| Branch ID | Section ID | Surface type <sup>1</sup> | Section area (SF) | LCD <sup>2</sup> | 2008 PCI | 2011 PCI | Drop in PCI/Yr <sup>3</sup> | % Deduct due to | | Distress types |
|---|---|---|---|---|---|---|---|---|---|---|
| APA | 1 | AC | 126,000 | 2007 | 100 | 86 | 3.5 | 33 | 53 | Alligator cracking, Depression, Longitudinal & transverse (L&T) cracking, Swelling |

48 LONGITUDINAL/TRANSVERSE CRACKING L 90.00 Ft Comments:  
48 LONGITUDINAL/TRANSVERSE CRACKING M 10.00 Ft Comments:  
56 SWELLING L 30.00 SqFt Comments:  
45 DEPRESSION L 25.00 SqFt Comments:

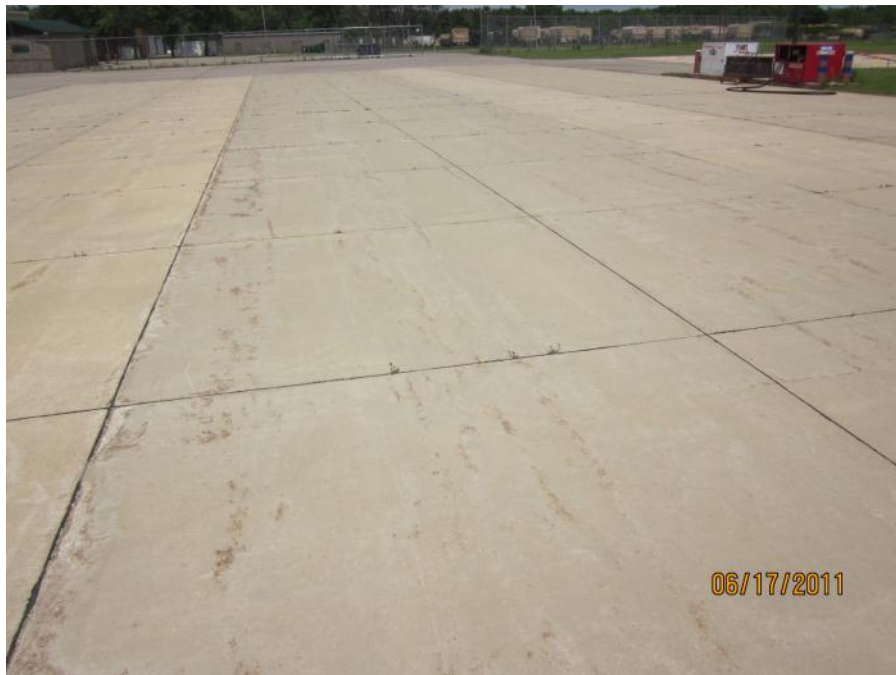
AUM APA 002 (PCI = 95)

| Branch ID | Section ID | Surface type <sup>1</sup> | Section area (SF) | LCD <sup>2</sup> | 2008 PCI | 2011 PCI | Drop in PCI/Yr <sup>3</sup> | % Deduct due to | | Distress types |
|---|---|---|---|---|---|---|---|---|---|---|
| APA | 2 | PCC | 11,200 | 2007 | 100 | 95 | 1.3 | 0 | 100 | Joint seal damage |

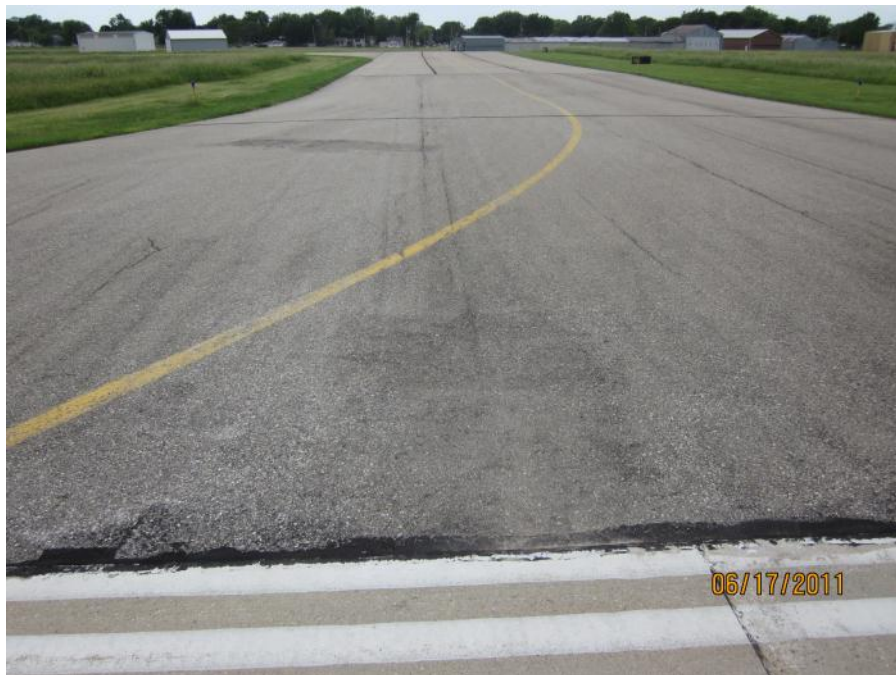
AUM CTA1 001 (PCI = 71)

| Branch ID | Section ID | Surface type <sup>1</sup> | Section area (SF) | LCD <sup>2</sup> | 2008 PCI | 2011 PCI | Drop in PCI/Yr <sup>3</sup> | % Deduct due to | | Distress types |
|---|---|---|---|---|---|---|---|---|---|---|
| CTA1 | 1 | AC | 7,025 | 2005 | 100 | 71 | 4.8 | 31 | 69 | L&T cracking, Raveling, Rutting |

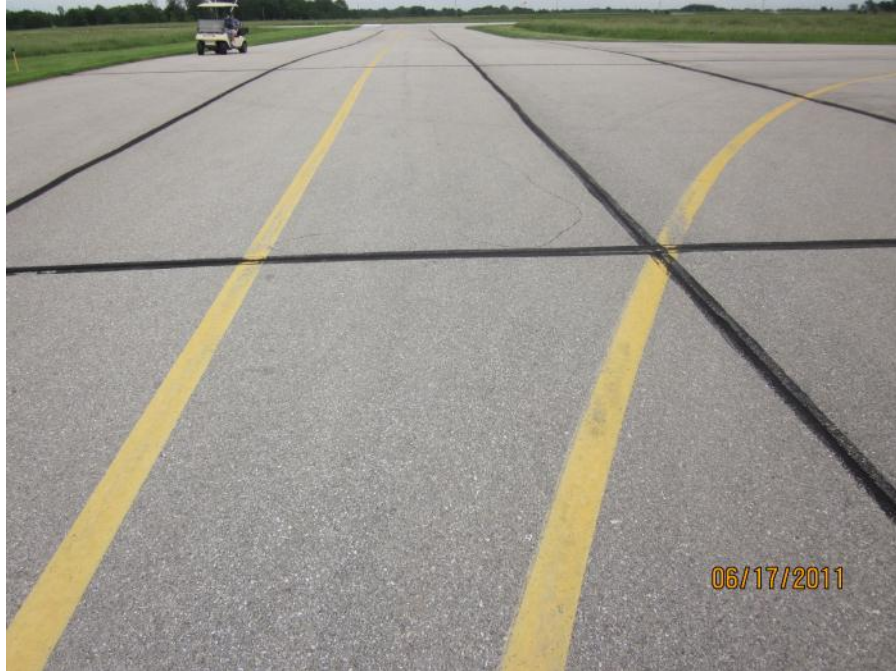
AUM CTA1 002 (PCI = 96)

| Branch ID | Section ID | Surface type <sup>1</sup> | Section area (SF) | LCD <sup>2</sup> | 2008 PCI | 2011 PCI | Drop in PCI/Yr <sup>3</sup> | % Deduct due to | | Distress types |
|---|---|---|---|---|---|---|---|---|---|---|
| CTA1 | 2 | AC | 19,250 | 2004 | 100 | 96 | 0.6 | 0 | 100 | L&T cracking |

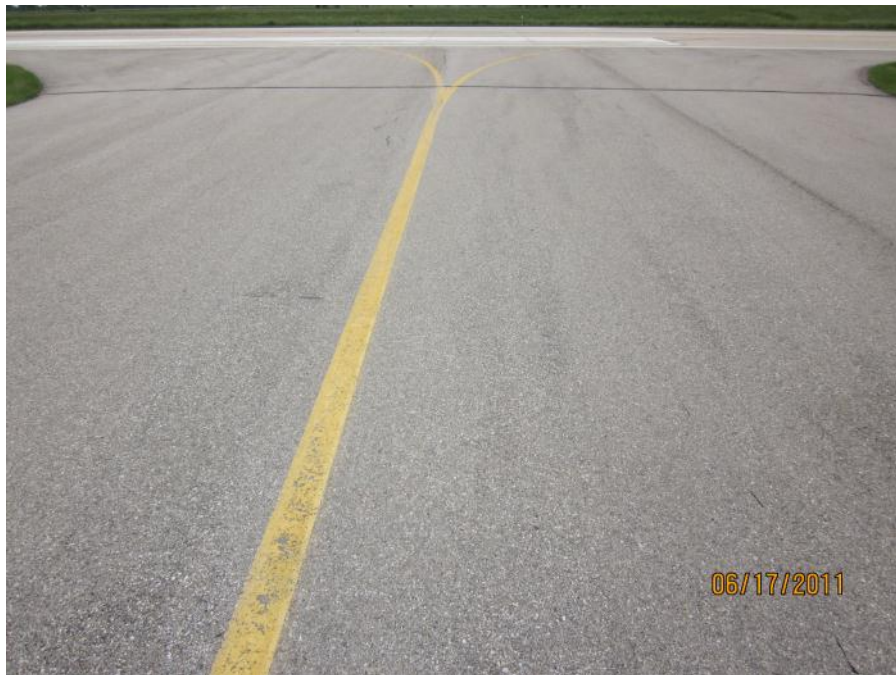
AUM CTA2 001 (PCI = 82)

| Branch ID | Section ID | Surface type <sup>1</sup> | Section area (SF) | LCD <sup>2</sup> | 2008 PCI | 2011 PCI | Drop in PCI/Yr <sup>3</sup> | % Deduct due to | | Distress types |
|---|---|---|---|---|---|---|---|---|---|---|
| CTA2 | 1 | AAC | 7,200 | 2005 | 100 | 82 | 3.0 | 0 | 100 | L&T cracking, Raveling |

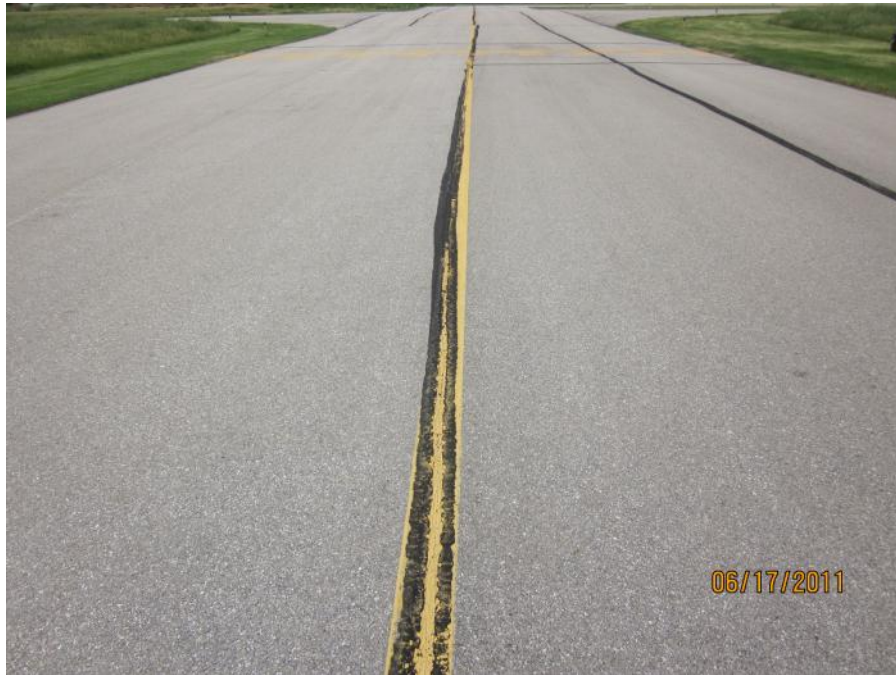
AUM CTA2 002 (PCI = 82)

| Branch ID | Section ID | Surface type <sup>1</sup> | Section area (SF) | LCD <sup>2</sup> | 2008 PCI | 2011 PCI | Drop in PCI/Yr <sup>3</sup> | % Deduct due to | | Distress types |
|---|---|---|---|---|---|---|---|---|---|---|
| CTA2 | 2 | AC | 12,050 | 2004 | 100 | 82 | 2.6 | 0 | 100 | L&T cracking, Raveling |

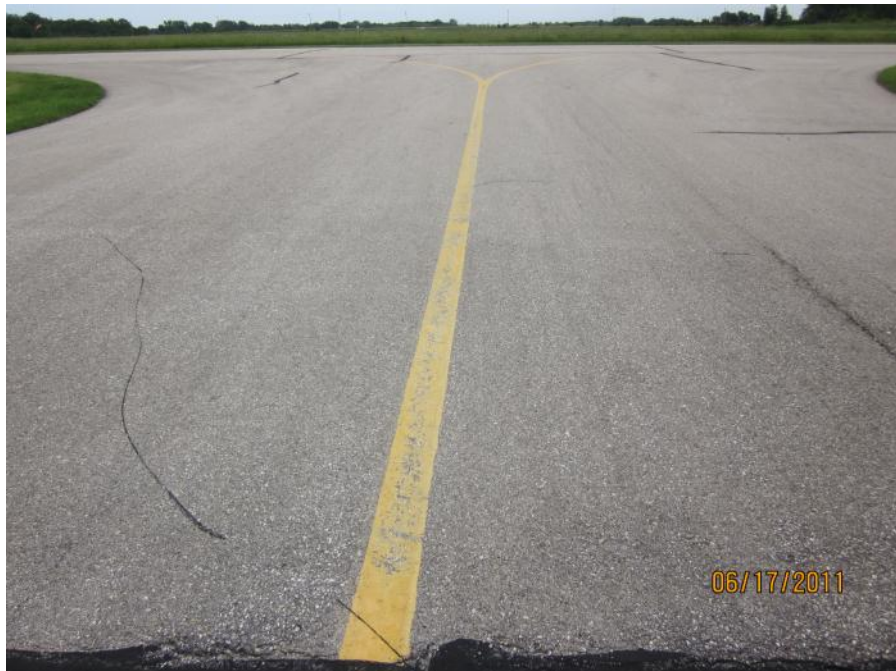
AUM CTA2X 001 (PCI = 80)

| Branch ID | Section ID | Surface type <sup>1</sup> | Section area (SF) | LCD <sup>2</sup> | 2008 PCI | 2011 PCI | Drop in PCI/Yr <sup>3</sup> | % Deduct due to | | Distress types |
|---|---|---|---|---|---|---|---|---|---|---|
| CTA2X | 1 | AC | 20,350 | 2004 | 96 | 80 | 2.9 | 26 | 74 | Alligator cracking, L&T cracking, Raveling |

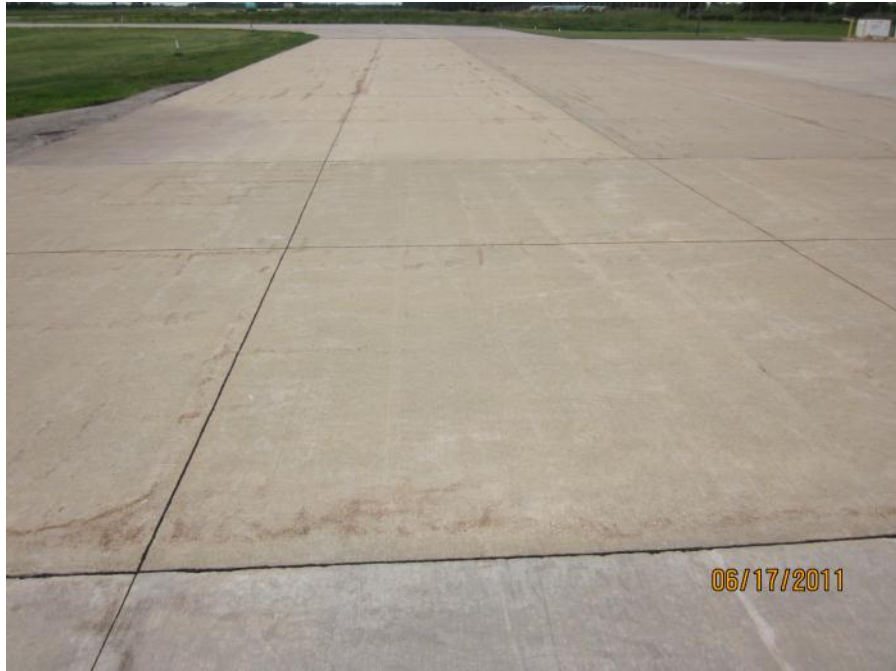
AUM CTA2X 002 (PCI = 98)

| Branch ID | Section ID | Surface type <sup>1</sup> | Section area (SF) | LCD <sup>2</sup> | 2008 PCI | 2011 PCI | Drop in PCI/Yr <sup>3</sup> | % Deduct due to | | Distress types |
|---|---|---|---|---|---|---|---|---|---|---|
| CTA2X | 2 | PCC | 11,650 | 2004 | 99 | 98 | 0.3 | 63 | 0 | Corner break, Shrinkage cracking |

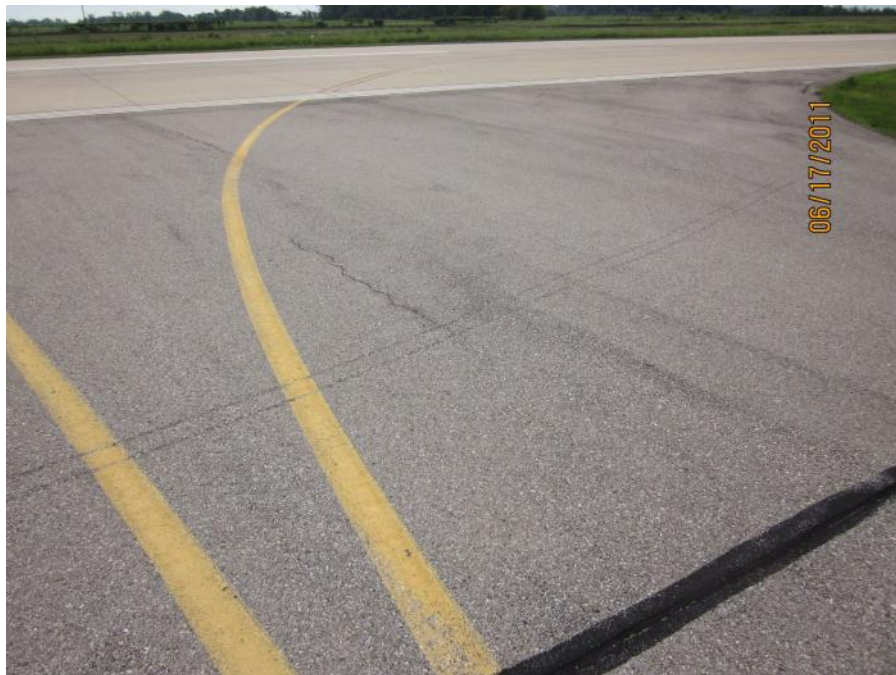
AUM CTA3 001 (PCI = 81)

| Branch ID | Section ID | Surface type <sup>1</sup> | Section area (SF) | LCD <sup>2</sup> | 2008 PCI | 2011 PCI | Drop in PCI/Yr <sup>3</sup> | % Deduct due to | | Distress types |
|---|---|---|---|---|---|---|---|---|---|---|
| CTA3 | 1 | AAC | 7,750 | 2005 | 100 | 81 | 3.2 | 0 | 100 | L&T cracking, Raveling, Weathering |

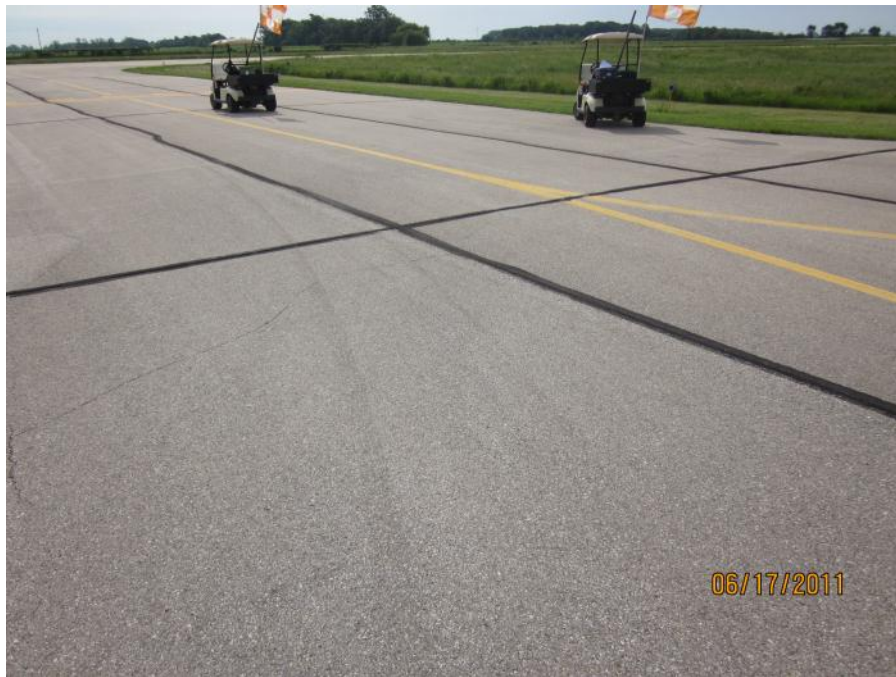
AUM CTA3 002 (PCI = 90)

| Branch ID | Section ID | Surface type <sup>1</sup> | Section area (SF) | LCD <sup>2</sup> | 2008 PCI | 2011 PCI | Drop in PCI/Yr <sup>3</sup> | % Deduct due to | | Distress types |
|---|---|---|---|---|---|---|---|---|---|---|
| CTA3 | 2 | AC | 11,500 | 2004 | 100 | 90 | 1.4 | 0 | 100 | L&T cracking, Raveling, Weathering |

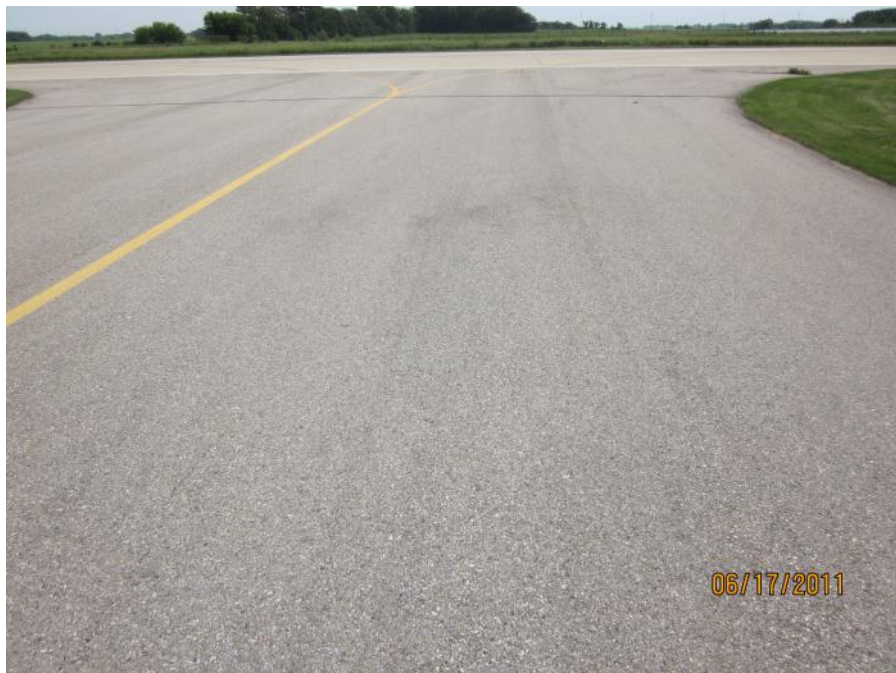
AUM CTA4 001 (PCI = 83)

| Branch ID | Section ID | Surface type <sup>1</sup> | Section area (SF) | LCD <sup>2</sup> | 2008 PCI | 2011 PCI | Drop in PCI/Yr <sup>3</sup> | % Deduct due to | | Distress types |
|---|---|---|---|---|---|---|---|---|---|---|
| CTA4 | 1 | AAC | 7,750 | 2005 | 92 | 83 | 2.8 | 0 | 100 | L&T cracking, Raveling |

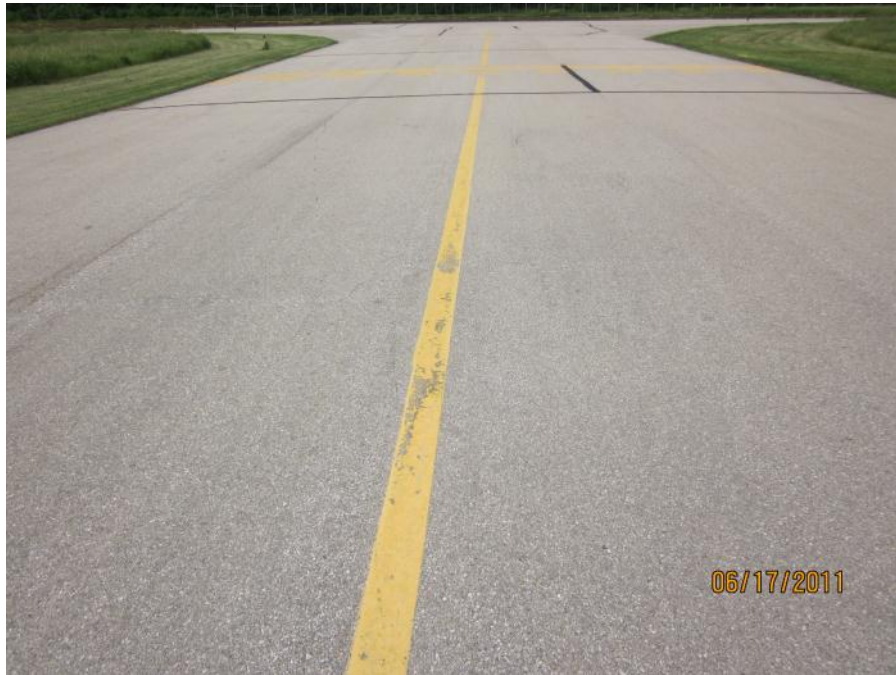
AUM CTA4 002 (PCI = 89)

| Branch ID | Section ID | Surface type <sup>1</sup> | Section area (SF) | LCD <sup>2</sup> | 2008 PCI | 2011 PCI | Drop in PCI/Yr <sup>3</sup> | % Deduct due to | | Distress types |
|---|---|---|---|---|---|---|---|---|---|---|
| CTA4 | 2 | AAC | 11,500 | 2004 | 95 | 89 | 1.6 | 0 | 100 | L&T cracking, Raveling |

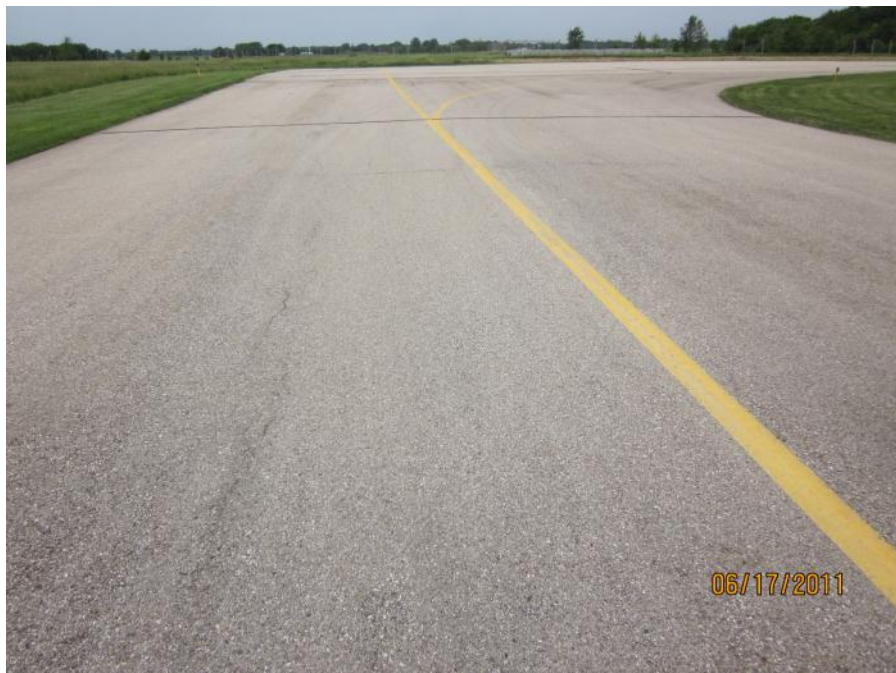
AUM CTA5 001 (PCI = 92)

| Branch ID | Section ID | Surface type <sup>1</sup> | Section area (SF) | LCD <sup>2</sup> | 2008 PCI | 2011 PCI | Drop in PCI/Yr <sup>3</sup> | % Deduct due to | | Distress types |
|---|---|---|---|---|---|---|---|---|---|---|
| CTA5 | 1 | AC | 17,750 | 2005 | 100 | 92 | 1.3 | 0 | 100 | L&T cracking, Raveling |

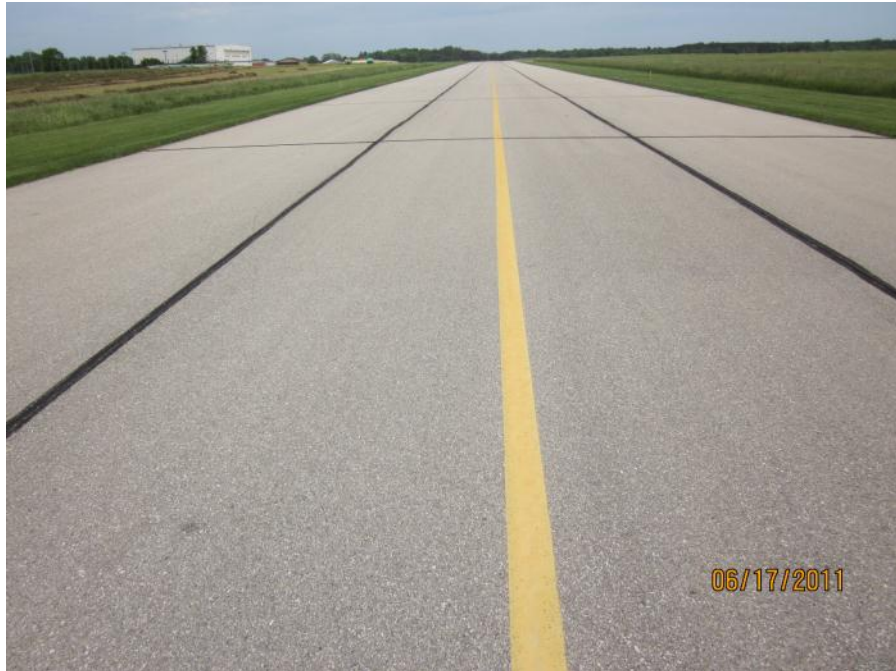
AUM PTA 001 (PCI = 98)

| Branch ID | Section ID | Surface type <sup>1</sup> | Section area (SF) | LCD <sup>2</sup> | 2008 PCI | 2011 PCI | Drop in PCI/Yr <sup>3</sup> | % Deduct due to | | Distress types |
|---|---|---|---|---|---|---|---|---|---|---|
| PTA | 1 | AAC | 287,500 | 2004 | 87 | 98 | 0.3 | 0 | 100 | L&T cracking |

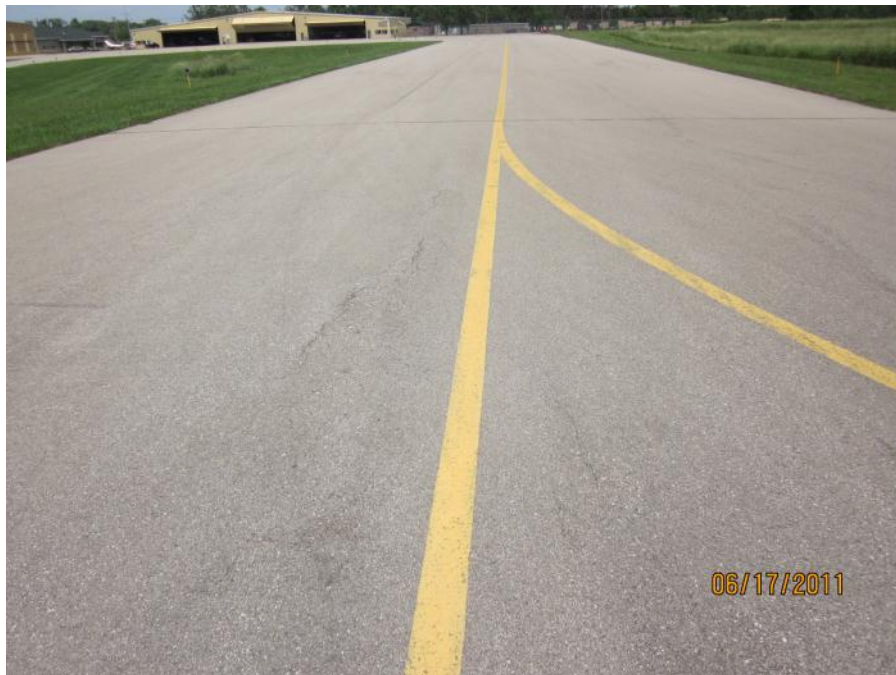
AUM PTA 002 (PCI = 93)

| Branch ID | Section ID | Surface type <sup>1</sup> | Section area (SF) | LCD <sup>2</sup> | 2008 PCI | 2011 PCI | Drop in PCI/Yr <sup>3</sup> | % Deduct due to | | Distress types |
|---|---|---|---|---|---|---|---|---|---|---|
| PTA | 2 | AC | 27,000 | 2006 | 100 | 93 | 1.4 | 0 | 100 | L&T cracking |

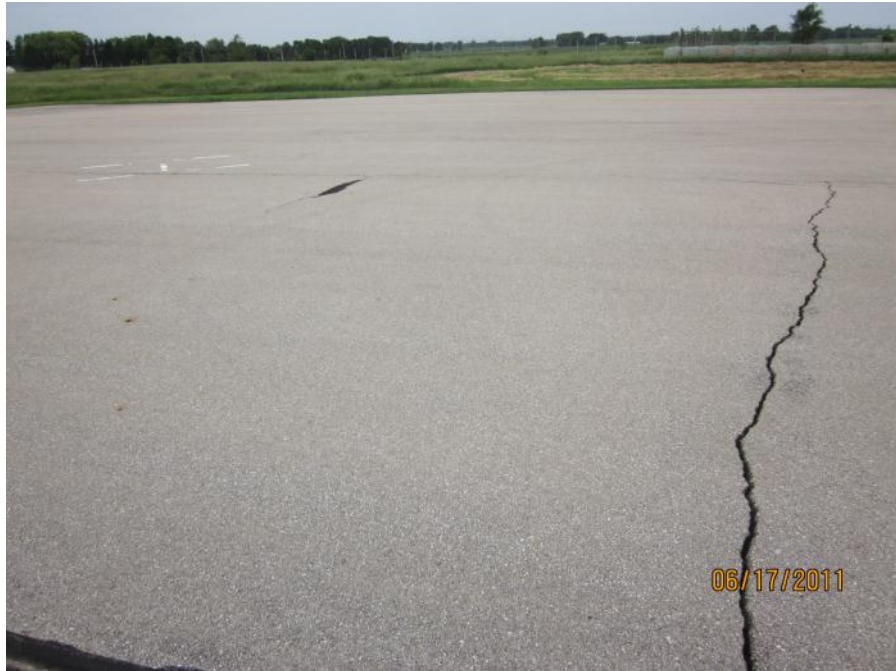
AUM RPA 001 (PCI = 83)

| Branch ID | Section ID | Surface type <sup>1</sup> | Section area (SF) | LCD <sup>2</sup> | 2008 PCI | 2011 PCI | Drop in PCI/Yr <sup>3</sup> | % Deduct due to | | Distress types |
|---|---|---|---|---|---|---|---|---|---|---|
| RPA | 1 | AAC | 19,267 | 2004 | 95 | 83 | 2.4 | 0 | 94 | Depression, L&T cracking, Raveling |

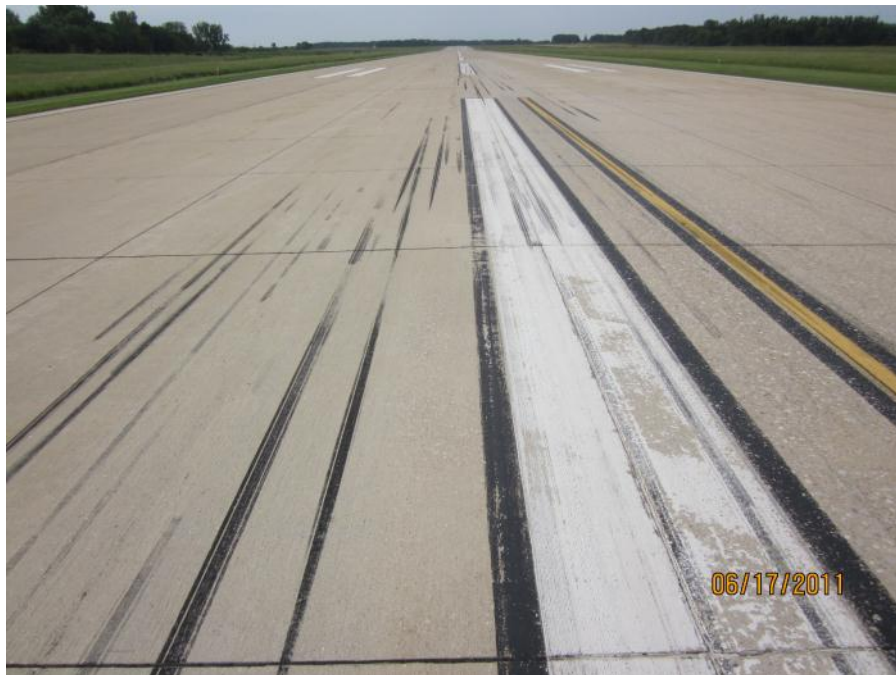
AUM RY1735 001 (PCI = 96)

| Branch ID | Section ID | Surface type <sup>1</sup> | Section area (SF) | LCD <sup>2</sup> | 2008 PCI | 2011 PCI | Drop in PCI/Yr <sup>3</sup> | % Deduct due to | | Distress types |
|---|---|---|---|---|---|---|---|---|---|---|
| RY1735 | 1 | PCC | 445,000 | 2005 | 96 | 96 | 0.7 | 43 | 0 | Linear Cracking, Small & Large patches, Corner spall |

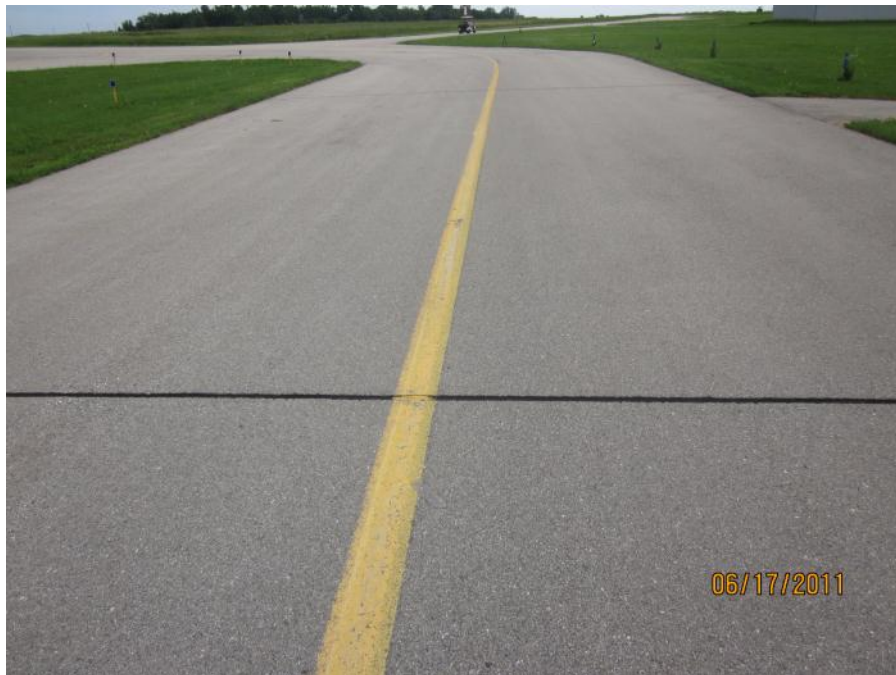
AUM TLA 001 (PCI = 95)

| Branch ID | Section ID | Surface type <sup>1</sup> | Section area (SF) | LCD <sup>2</sup> | 2008 PCI | 2011 PCI | Drop in PCI/Yr <sup>3</sup> | % Deduct due to | | Distress types |
|---|---|---|---|---|---|---|---|---|---|---|
| TLA | 1 | AAC | 15,325 | 2007 | 100 | 95 | 1.3 | 0 | 100 | L&T cracking |

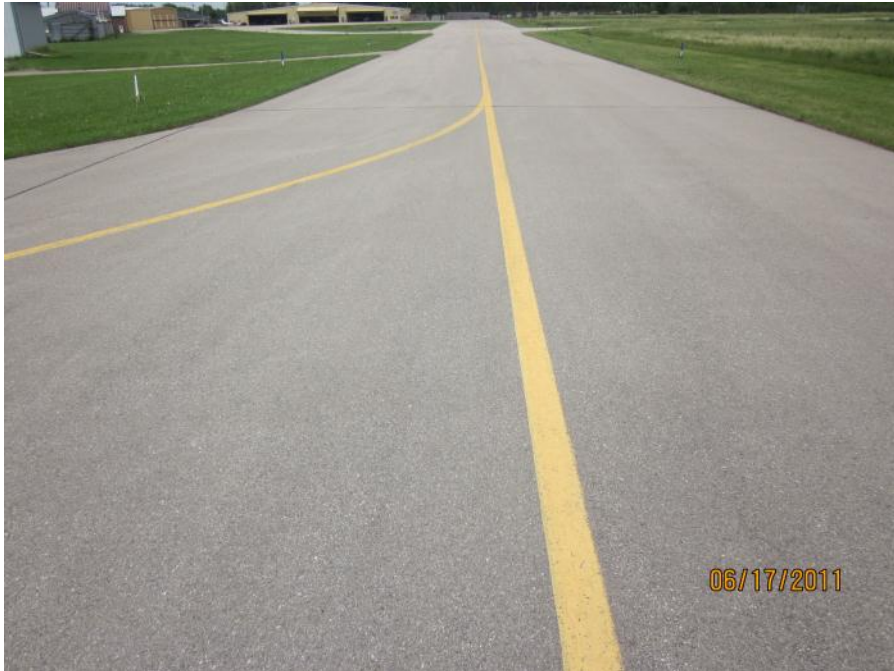
AUM TLB 001 (PCI = 94)

| Branch ID | Section ID | Surface type <sup>1</sup> | Section area (SF) | LCD <sup>2</sup> | 2008 PCI | 2011 PCI | Drop in PCI/Yr <sup>3</sup> | % Deduct due to | | Distress types |
|---|---|---|---|---|---|---|---|---|---|---|
| TLB | 1 | AC | 18,535 | 2007 | 100 | 94 | 1.5 | 0 | 100 | L&T cracking |

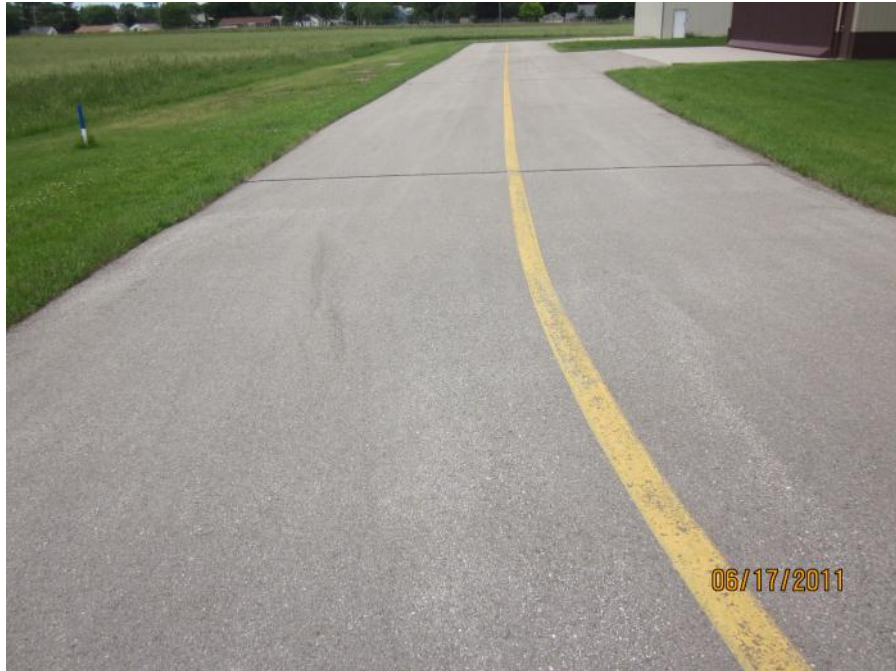
AUM TLB 003 (PCI = 96)

| Branch ID | Section ID | Surface type <sup>1</sup> | Section area (SF) | LCD <sup>2</sup> | 2008 PCI | 2011 PCI | Drop in PCI/Yr <sup>3</sup> | % Deduct due to | | Distress types |
|---|---|---|---|---|---|---|---|---|---|---|
| TLB | 3 | AC | 5,735 | 2007 | 100 | 96 | 1.0 | 0 | 100 | L&T cracking |
