Minnesota Airport System Pavement Evaluation 2011 Update

Baudette International Airport (BDE)

Baudette, Minnesota

January 2012

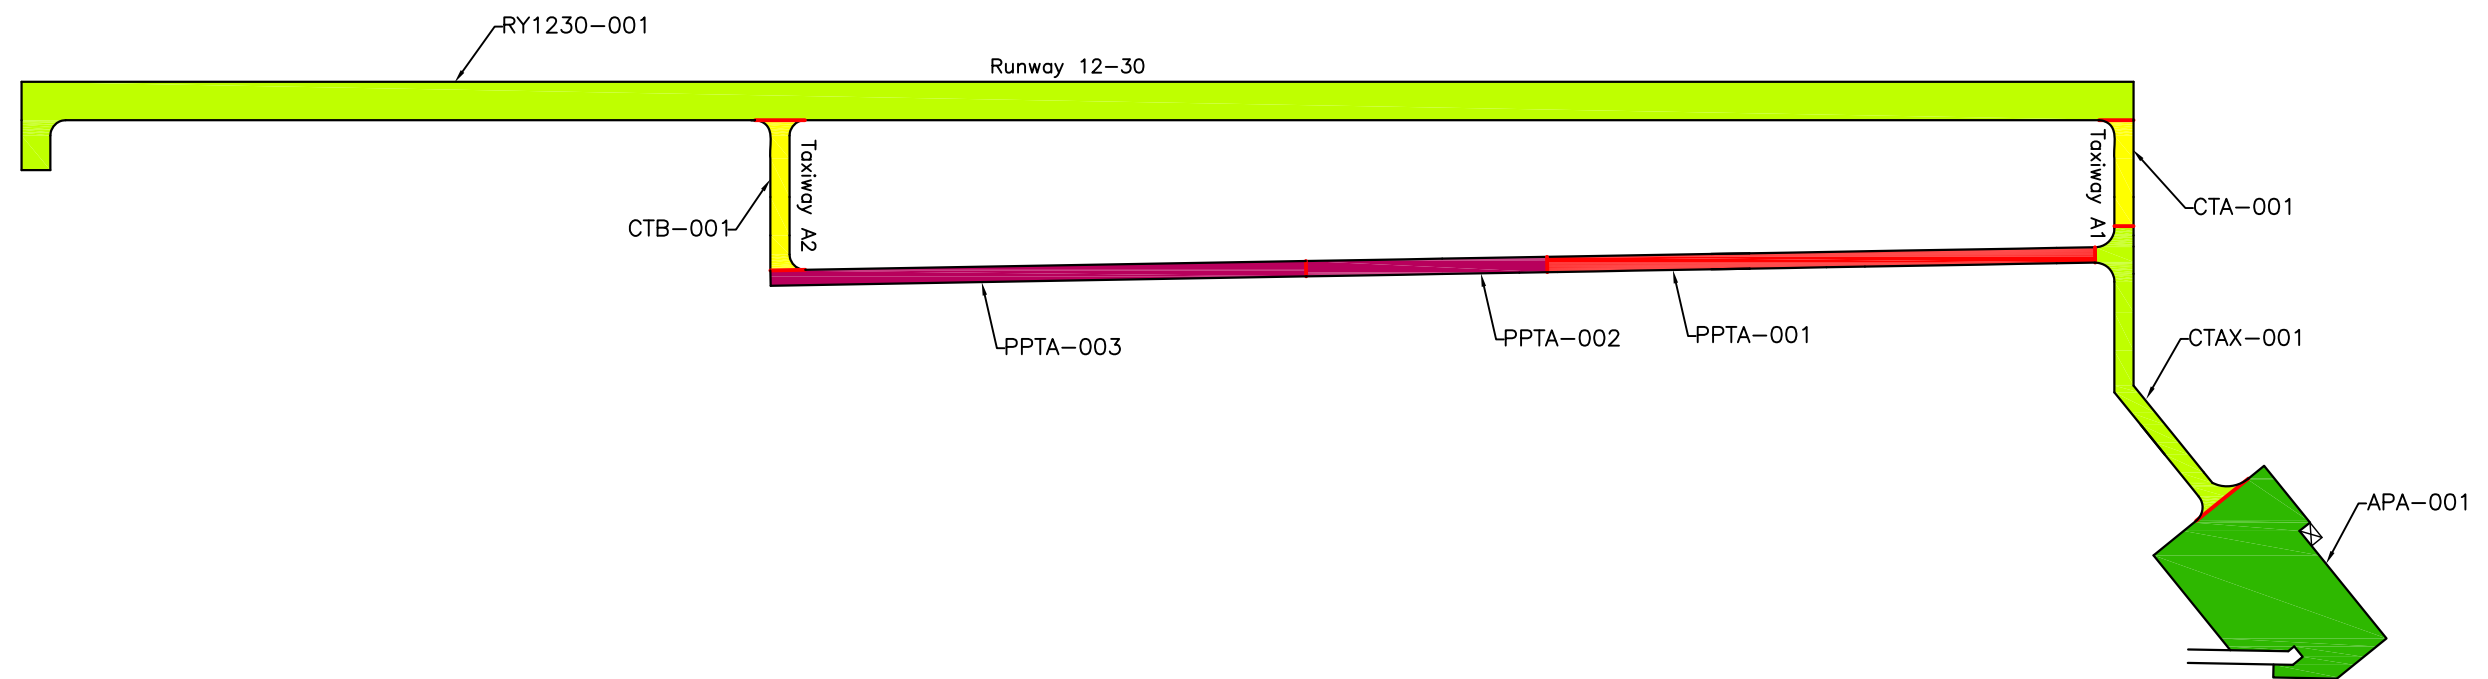
Figure 4. 2011 Pavement Condition Index Rating at Baudette International Airport (BDE).

Figures 5 and 6 present the overall PCI for BDE by area distribution and pavement use, respectively. Table 3 presents the PCI summary for each section at BDE, including the drop in PCI per year. Generally, pavement sections will deteriorate between 1 and 3 PCI points per year. Sections deteriorating at higher rates may need maintenance above the normal application rates and should be closely monitored in case major repairs become necessary.

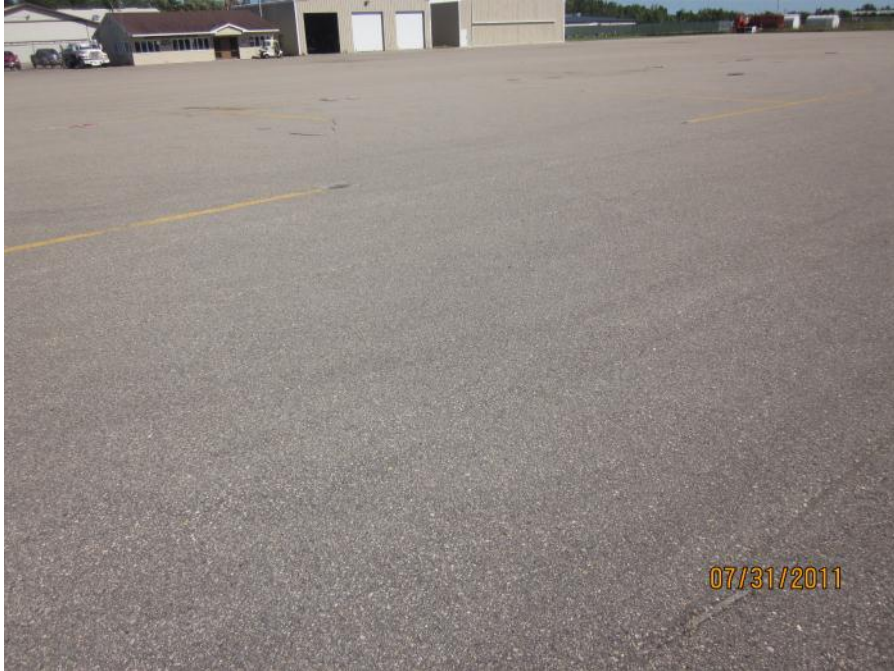
BDE APA 001 (PCI = 92)

Conditions: PCI : 92

Sample Number: 105 Type: R Area: 5,000.00SqFt PCI = 81
Sample Comments:
48 LONGITUDINAL/TRANSVERSE CRACKING L 13.00 Ft Comments:
53 RUTTING L 30.00 SqFt Comments:
57 WEATHERING L 72.00 SqFt Comments:
57 WEATHERING M 2.00 SqFt Comments:

Sample Number: 202 Type: R Area: 5,000.00SqFt PCI = 95
Sample Comments:
48 LONGITUDINAL/TRANSVERSE CRACKING L 2.00 Ft Comments:
57 WEATHERING M 110.00 SqFt Comments:

Sample Number: 303 Type: R Area: 5,000.00SqFt PCI = 98
Sample Comments:
48 LONGITUDINAL/TRANSVERSE CRACKING L 4.00 Ft Comments:

Sample Number: 502 Type: R Area: 5,000.00SqFt PCI = 80
Sample Comments:
48 LONGITUDINAL/TRANSVERSE CRACKING L 3.00 Ft Comments:
53 RUTTING M 1.00 SqFt Comments:
53 RUTTING L 1.00 SqFt Comments:

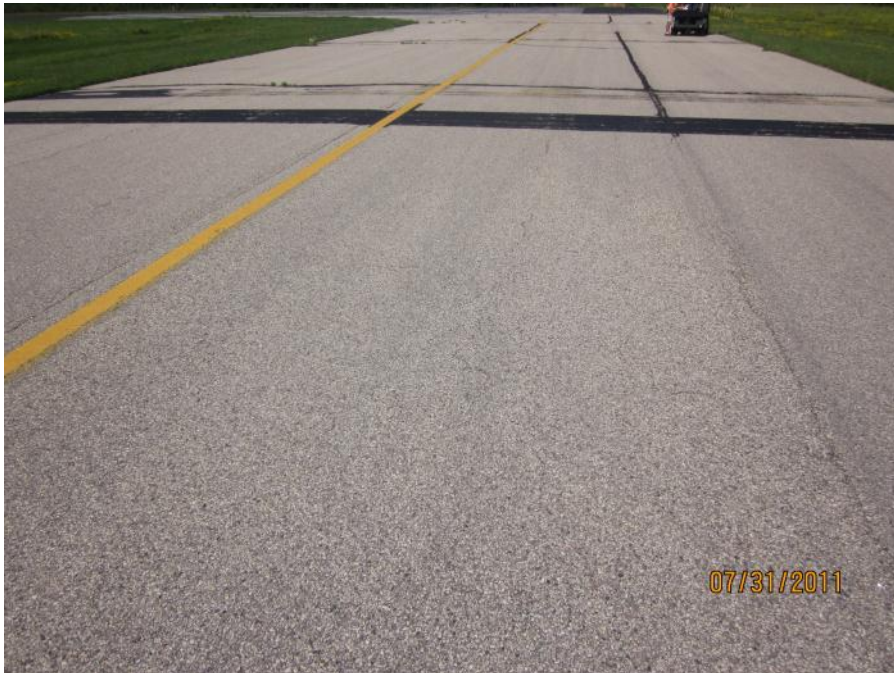
BDE CTA 001 (PCI = 68)

Conditions: PCI : 68

48	LONGITUDINAL/TRANSVERSE CRACKING	L	402.00 Ft	Comments:
48	LONGITUDINAL/TRANSVERSE CRACKING	M	89.00 Ft	Comments:
48	LONGITUDINAL/TRANSVERSE CRACKING	H	50.00 Ft	Comments:

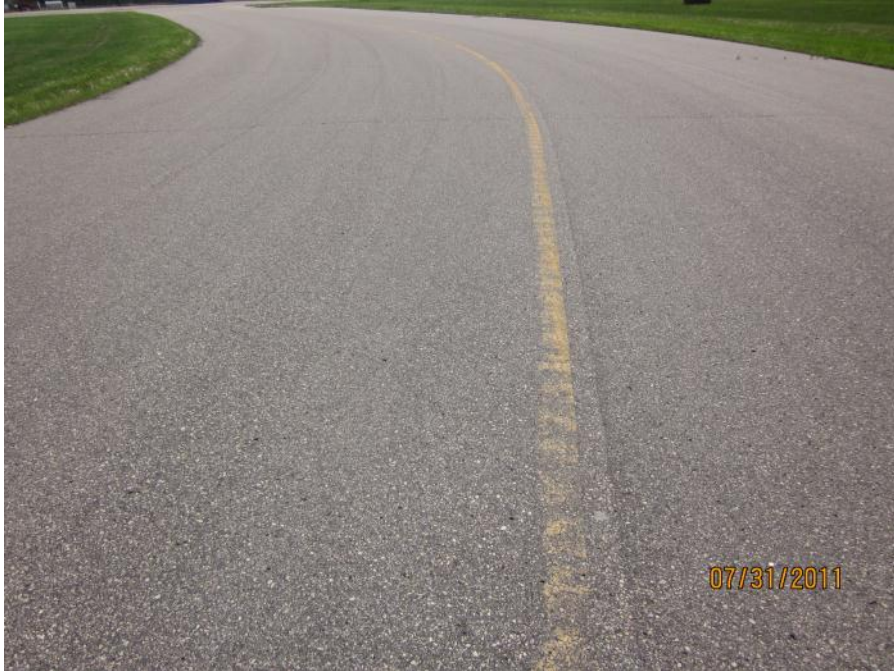
BDE CTAX 001 (PCI = 84)

Conditions: PCI : 84

48 LONGITUDINAL/TRANSVERSE CRACKING L 164.00 Ft Comments:

48 LONGITUDINAL/TRANSVERSE CRACKING M 49.00 Ft Comments:

48 LONGITUDINAL/TRANSVERSE CRACKING L 133.00 Ft Comments:

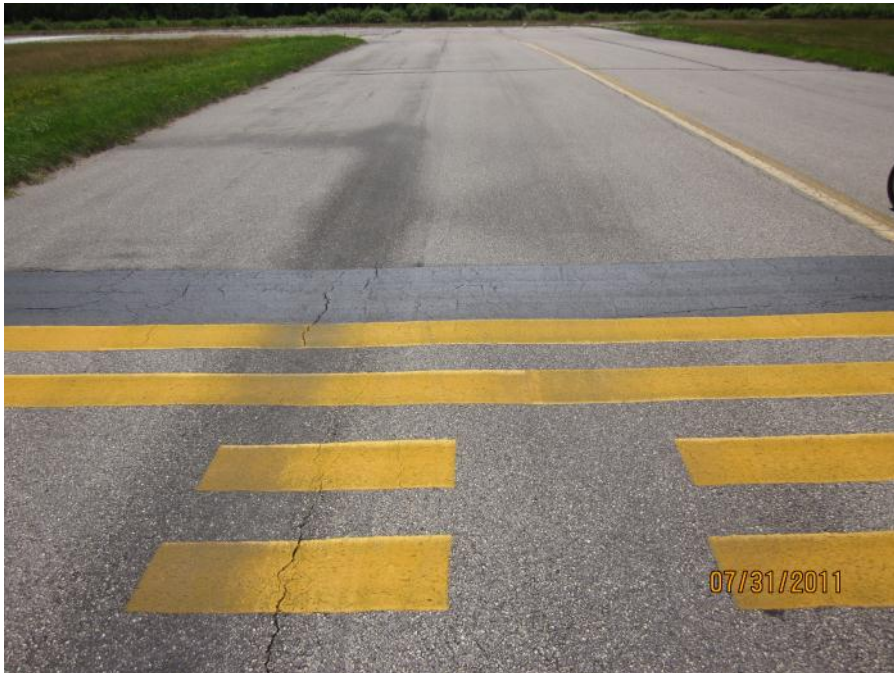
BDE CTB 001 (PCI = 70)

Conditions: PCI: 70

48 LONGITUDINAL/TRANSVERSE CRACKING L 375.00 Ft Comments:

48 LONGITUDINAL/TRANSVERSE CRACKING M 53.00 Ft Comments:

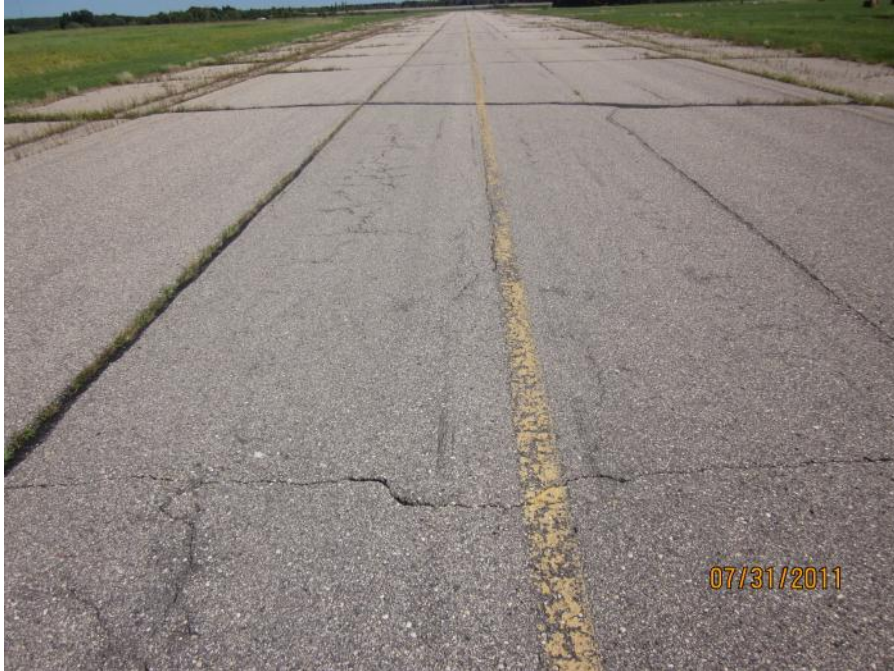
BDE PPTA 001 (PCI = 36)

Conditions: PCI : 36

52 RAVELING	L	1,967.00 SqFt	Comments:
52 RAVELING	M	2,000.00 SqFt	Comments:
52 RAVELING	H	33.00 SqFt	Comments:
48 LONGITUDINAL/TRANSVERSE CRACKING	L	401.00 Ft	Comments:
48 LONGITUDINAL/TRANSVERSE CRACKING	M	163.00 Ft	Comments:
48 LONGITUDINAL/TRANSVERSE CRACKING	H	40.00 Ft	Comments:

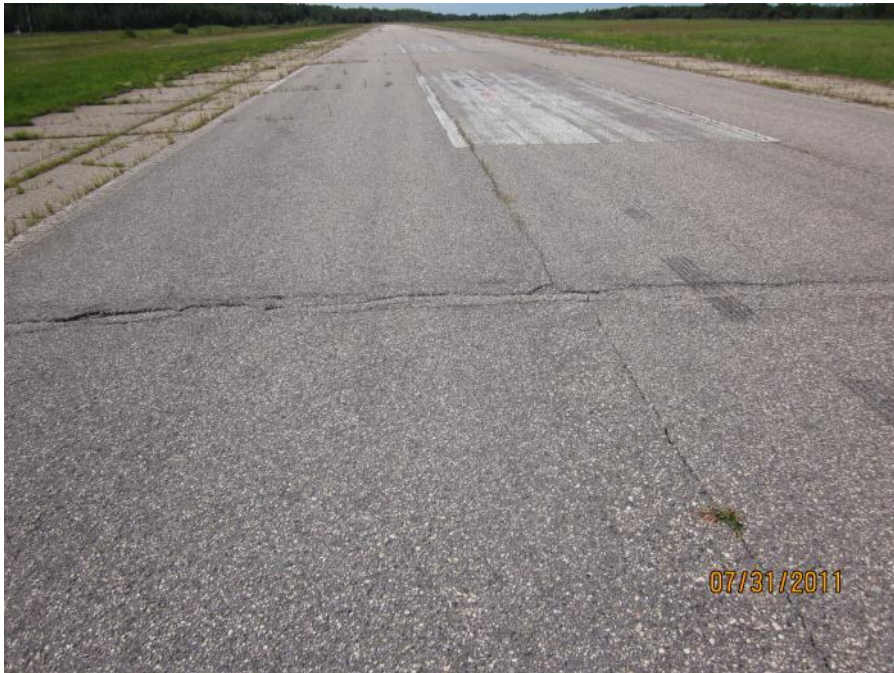
BDE PPTA 002 (PCI = 16)

Conditions: PCI: 16

48	LONGITUDINAL/TRANSVERSE CRACKING	L	119.00 Ft	Comments:
48	LONGITUDINAL/TRANSVERSE CRACKING	M	58.00 Ft	Comments:
48	LONGITUDINAL/TRANSVERSE CRACKING	H	42.00 Ft	Comments:
52	RAVELING	H	4,000.00 SqFt	Comments:

48	LONGITUDINAL/TRANSVERSE CRACKING	L	180.00 Ft	Comments:
48	LONGITUDINAL/TRANSVERSE CRACKING	M	213.00 Ft	Comments:
48	LONGITUDINAL/TRANSVERSE CRACKING	H	5.00 Ft	Comments:
52	RAVELING	H	4,000.00 SqFt	Comments:

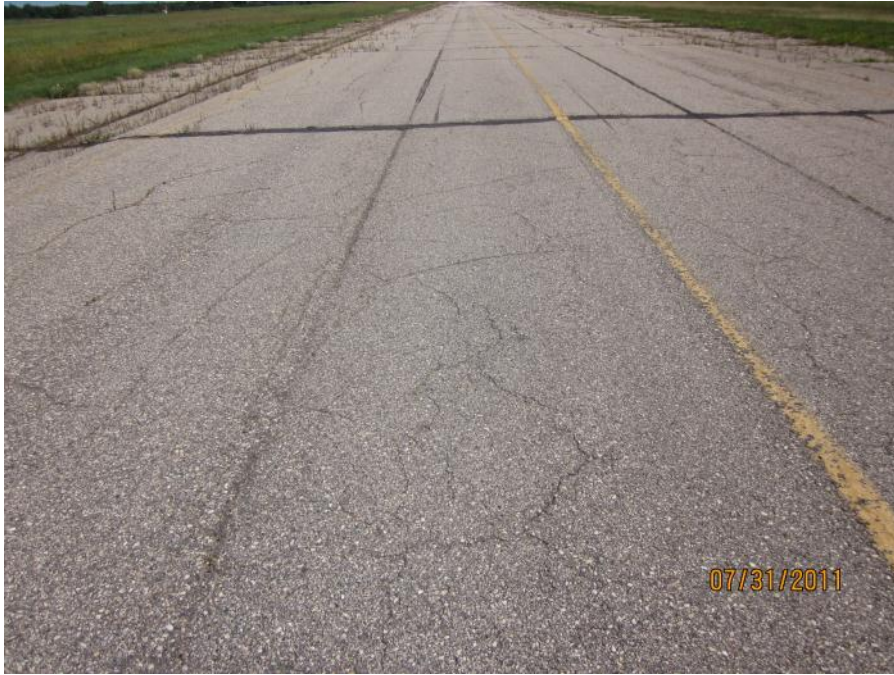
BDE PPTA 003 (PCI = 25)

Conditions: PCI : 25

41 ALLIGATOR CRACKING	L	12.00 SqFt	Comments:
48 LONGITUDINAL/TRANSVERSE CRACKING	L	96.00 Ft	Comments:
48 LONGITUDINAL/TRANSVERSE CRACKING	M	220.00 Ft	Comments:
48 LONGITUDINAL/TRANSVERSE CRACKING	H	93.00 Ft	Comments:
52 RAVELING	L	4,000.00 SqFt	Comments:

43 BLOCK CRACKING	M	4,000.00 SqFt	Comments:
52 RAVELING	M	3,200.00 SqFt	Comments:
52 RAVELING	H	800.00 SqFt	Comments:

43 BLOCK CRACKING	M	4,000.00 SqFt	Comments:
52 RAVELING	M	4,000.00 SqFt	Comments:

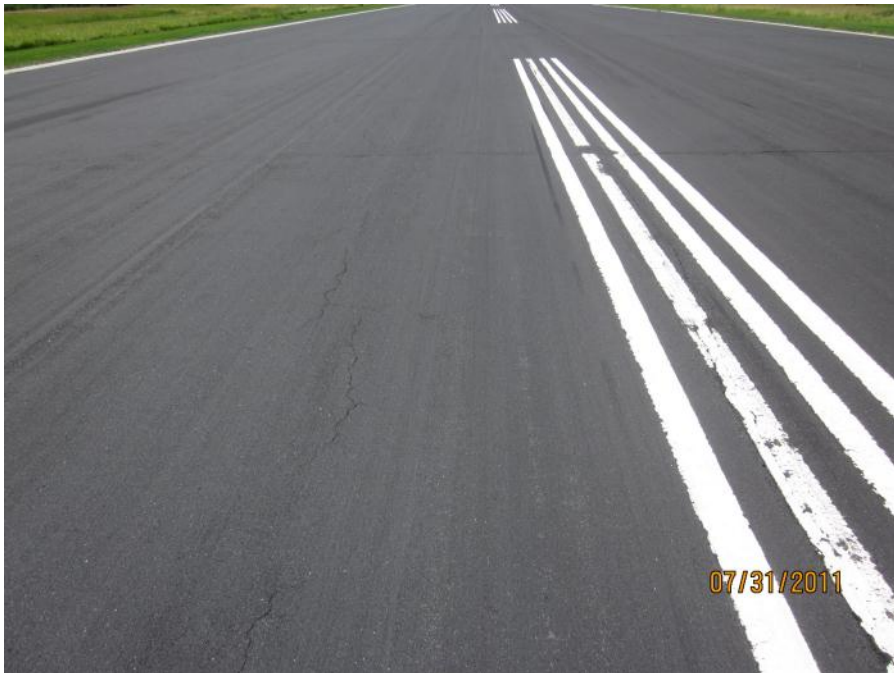
BDE RY1230 001 (PCI = 71)

Conditions: PCI: 71
