# Minnesota Airport System Pavement Evaluation 2011 Update

Houston County Airport (CHU)

Caledonia, Minnesota

January 2012

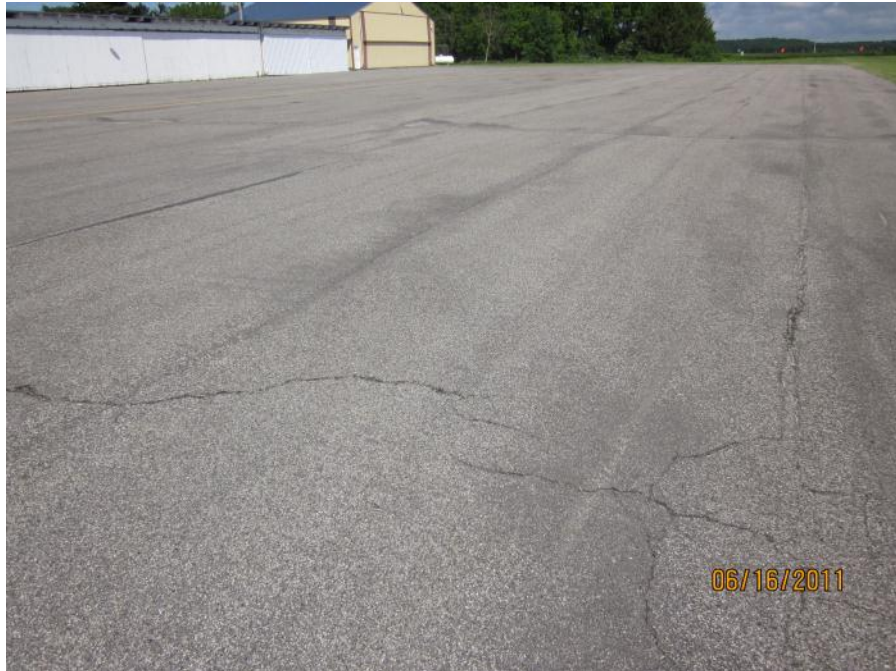
CHU APA 001 (PCI = 33)

| Branch ID | Section ID | Surface type <sup>1</sup> | Section area (SF) | LCD <sup>2</sup> | 2008 PCI | 2011 PCI | Drop in PCI/Yr <sup>3</sup> | % Deduct due to | | Distress types |
|---|---|---|---|---|---|---|---|---|---|---|
| APA | 1 | AAC | 75,600 | 1982 | 35 | 33 | 2.3 | 69 | 31 | Alligator cracking, Block cracking, Longitudinal & transverse (L&T) cracking, Rutting |

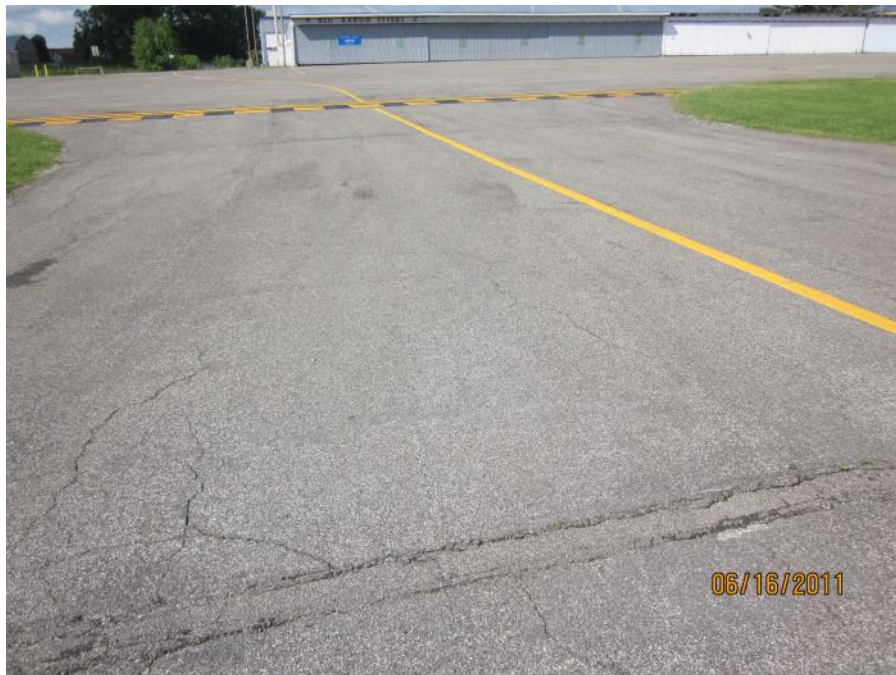
CHU CTA 001 (PCI = 24)

| Branch ID | Section ID | Surface type <sup>1</sup> | Section area (SF) | LCD <sup>2</sup> | 2008 PCI | 2011 PCI | Drop in PCI/Yr <sup>3</sup> | % Deduct due to | | Distress types |
|---|---|---|---|---|---|---|---|---|---|---|
| CTA | 1 | AAC | 6,950 | 1969 | 21 | 24 | 1.8 | 74 | 26 | Alligator cracking, L&T cracking, Patching |

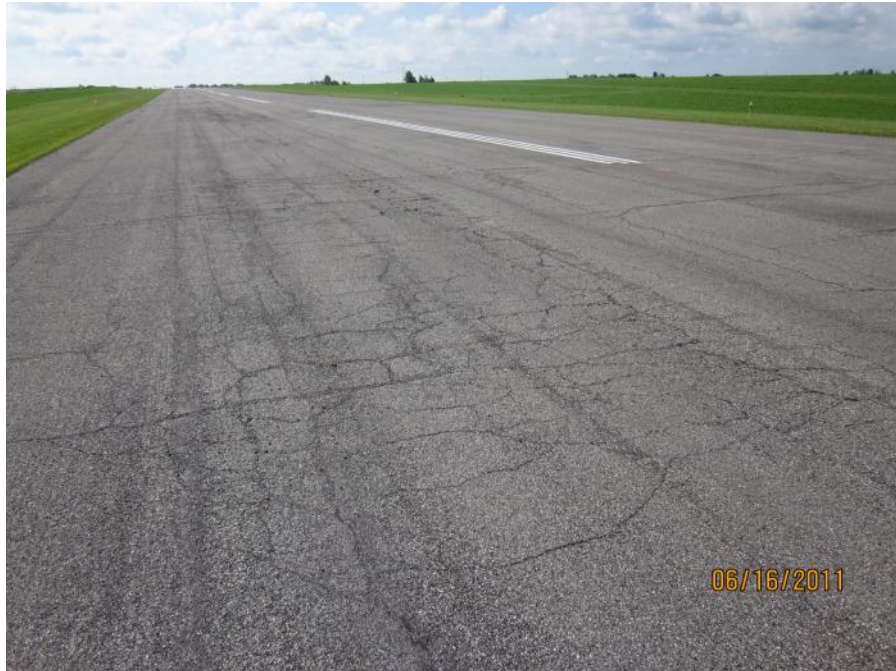
CHU RY1331 001 (PCI = 28)

| Branch ID | Section ID | Surface type <sup>1</sup> | Section area (SF) | LCD <sup>2</sup> | 2008 PCI | 2011 PCI | Drop in PCI/Yr <sup>3</sup> | % Deduct due to | | Distress types |
|---|---|---|---|---|---|---|---|---|---|---|
| RY1331 | 1 | AAC | 269,800 | 1982 | 37 | 28 | 2.5 | 57 | 43 | Alligator cracking, Block cracking, L&T cracking, Rutting |

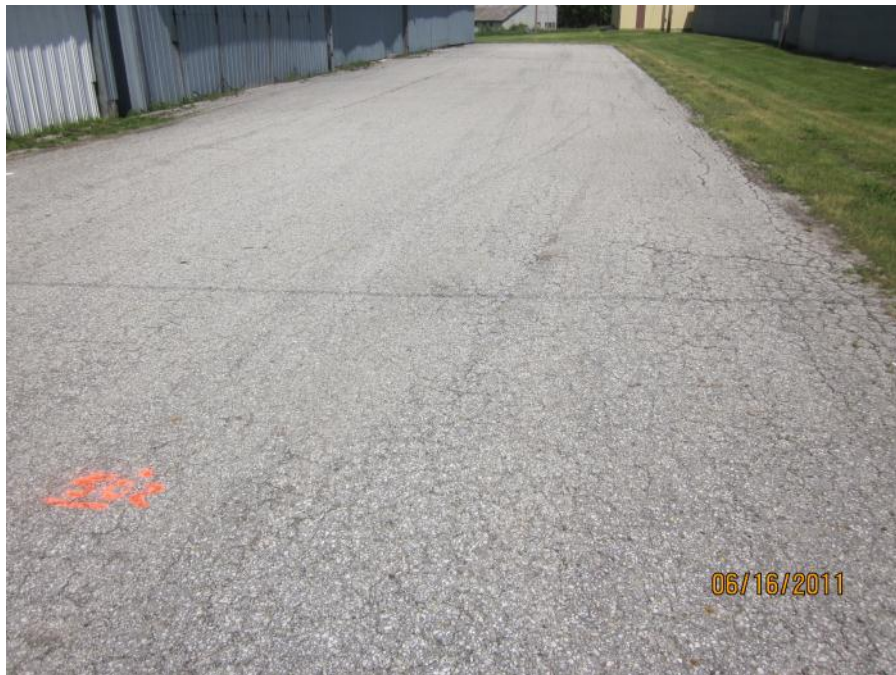
CHU TLA 001 (PCI = 0)

| Branch ID | Section ID | Surface type <sup>1</sup> | Section area (SF) | LCD <sup>2</sup> | 2008 PCI | 2011 PCI | Drop in PCI/Yr <sup>3</sup> | % Deduct due to | | Distress types |
|---|---|---|---|---|---|---|---|---|---|---|
| TLA | 1 | AC | 12,900 | 1977 | 0 | 0 | 2.9 | 78 | 22 | Alligator cracking, Raveling, Rutting |

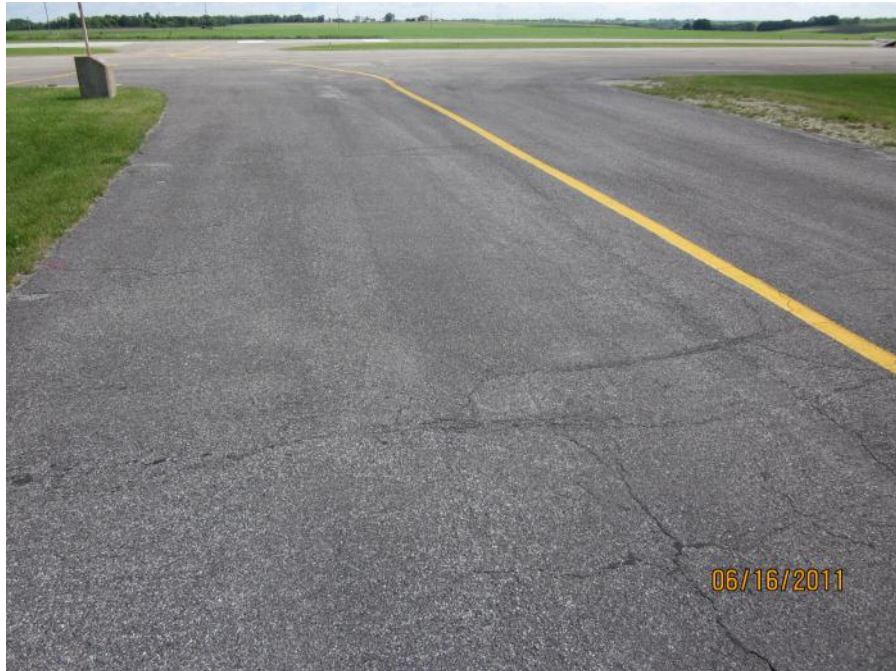
CHU TLA 002 (PCI = 5)

| Branch ID | Section ID | Surface type <sup>1</sup> | Section area (SF) | LCD <sup>2</sup> | 2008 PCI | 2011 PCI | Drop in PCI/Yr <sup>3</sup> | % Deduct due to | | Distress types |
|---|---|---|---|---|---|---|---|---|---|---|
| TLA | 2 | AC | 5,400 | 1977 | 14 | 5 | 2.8 | 100 | 0 | Alligator cracking, Rutting |
