# Minnesota Airport System Pavement Evaluation 2011 Update

Cloquet – Carlton County Airport (COQ)

Cloquet, Minnesota

January 2012

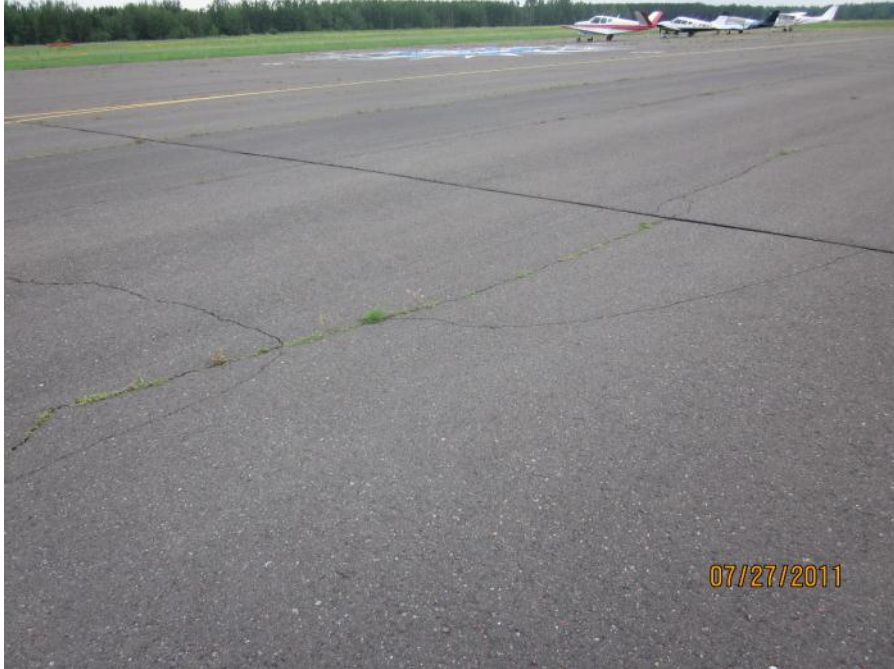
COQ APA 001 (PCI = 64)

48	LONGITUDINAL/TRANSVERSE CRACKING	L	250.00 Ft	Comments:
48	LONGITUDINAL/TRANSVERSE CRACKING	M	189.00 Ft	Comments:
41	ALLIGATOR CRACKING	L	79.00 SqFt	Comments:

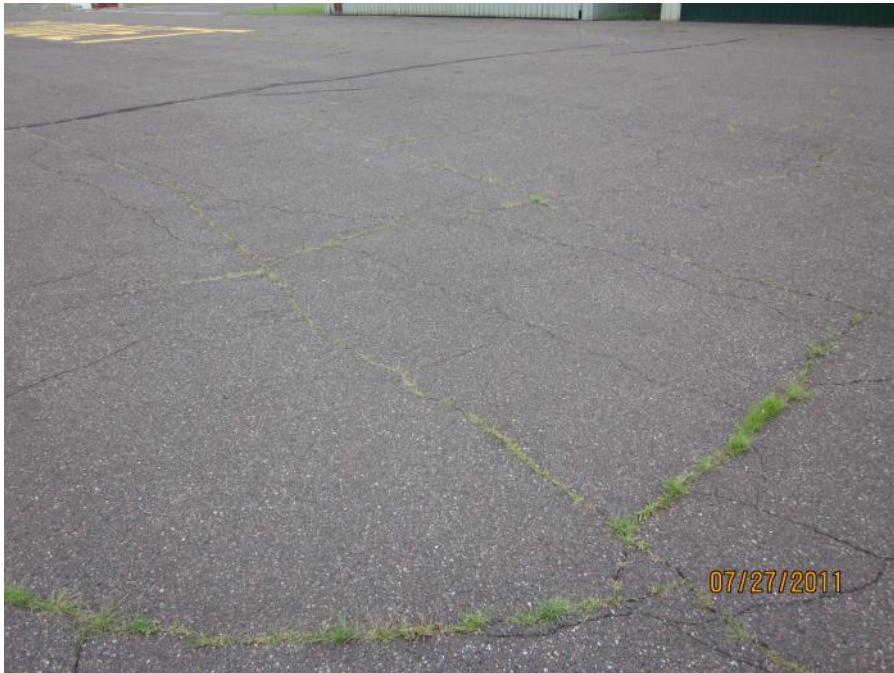
COQ APB 001 (PCI = 23)

41 ALLIGATOR CRACKING	M	480.00 SqFt	Comments:
43 BLOCK CRACKING	H	1,650.00 SqFt	Comments:
43 BLOCK CRACKING	M	3,350.00 SqFt	Comments:

43 BLOCK CRACKING	M	5,000.00 SqFt	Comments:
41 ALLIGATOR CRACKING	M	111.00 SqFt	Comments:

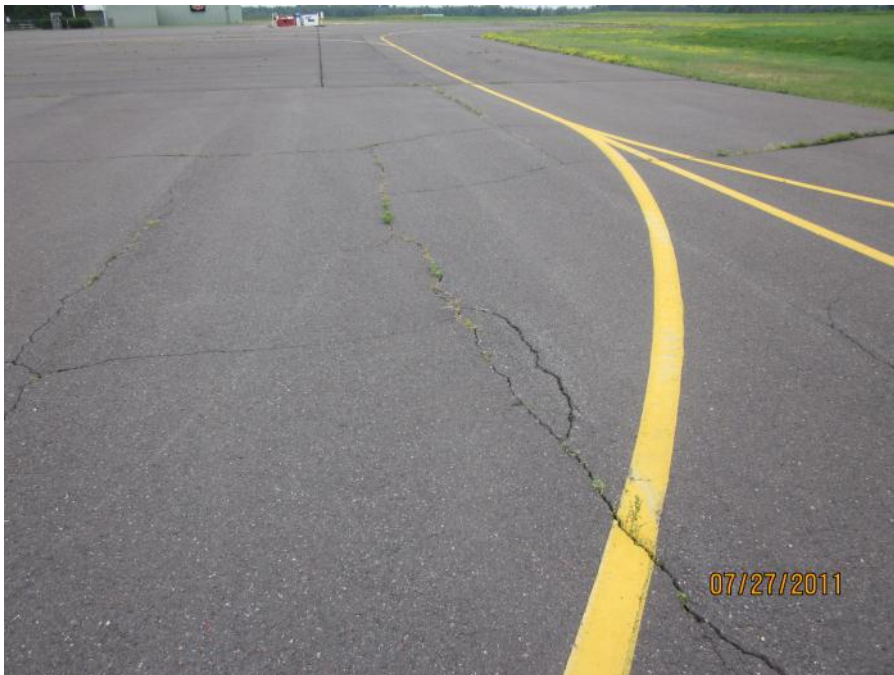
COQ CTA1X 001 (PCI = 77)

48 LONGITUDINAL/TRANSVERSE CRACKING            L            181.00 Ft            Comments:  
48 LONGITUDINAL/TRANSVERSE CRACKING            M            86.00 Ft            Comments:

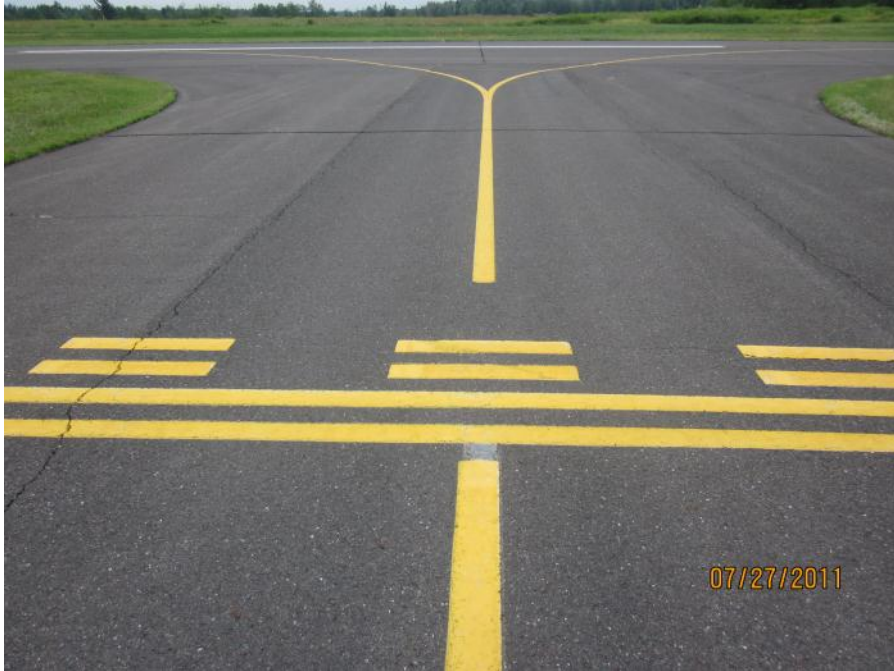
COQ CTB1 001 (PCI = 70)

48	LONGITUDINAL/TRANSVERSE CRACKING	L	464.00 Ft	Comments:
48	LONGITUDINAL/TRANSVERSE CRACKING	M	53.00 Ft	Comments:
41	ALLIGATOR CRACKING	L	10.00 SqFt	Comments:

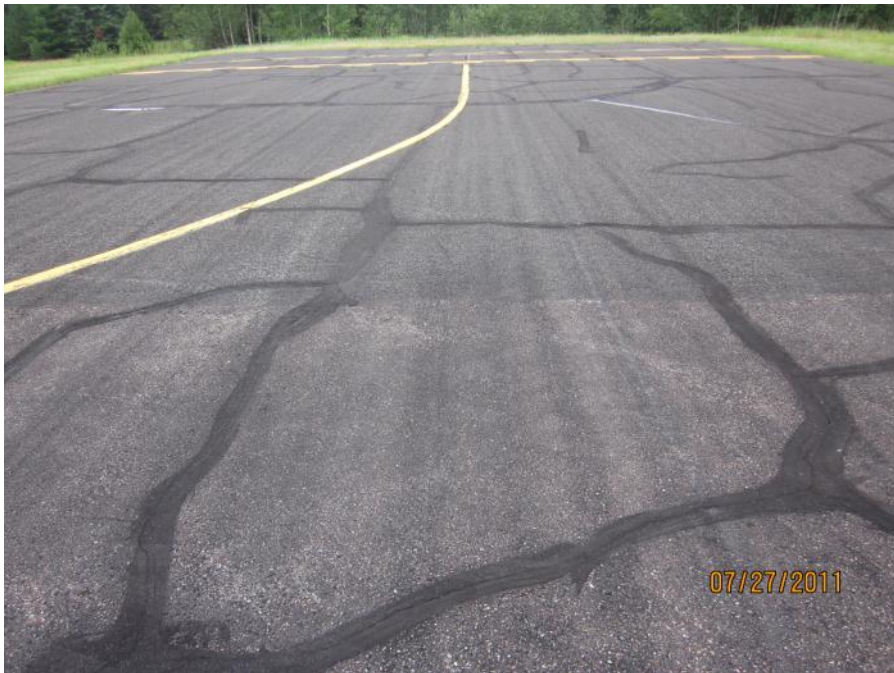
COQ RTA1 001 (PCI = 63)

43 BLOCK CRACKING	L	1,040.00 SqFt	Comments:
48 LONGITUDINAL/TRANSVERSE CRACKING	L	455.00 Ft	Comments:
57 WEATHERING	L	600.00 SqFt	Comments:
57 WEATHERING	M	400.00 SqFt	Comments:

Section Comments: cracksealed since 08 - delta from 52L to 57L

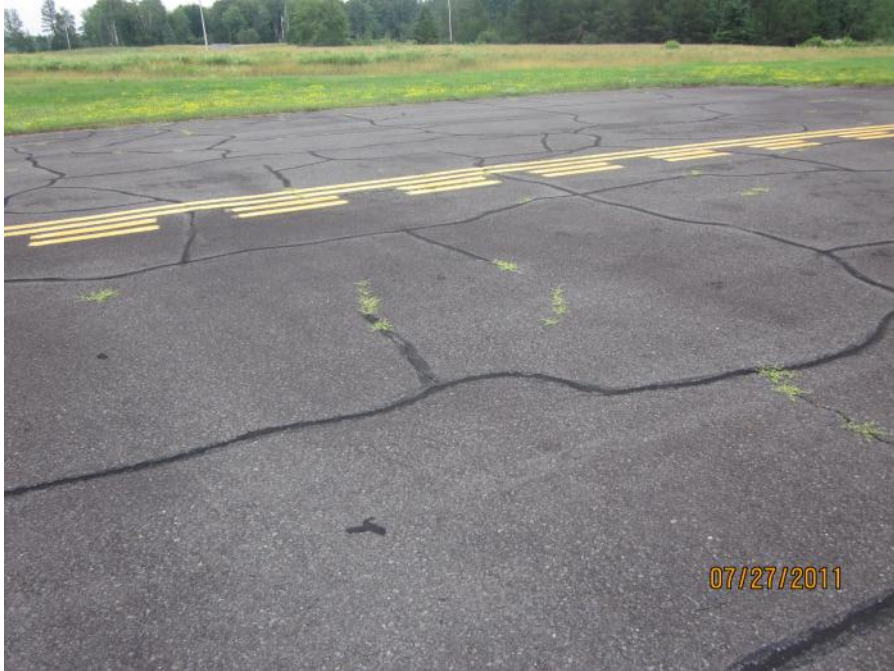
COQ RTA2 001 (PCI = 62)

43 BLOCK CRACKING L 3,850.00 SqFt Comments:

Section Comments: cracksealed since 08

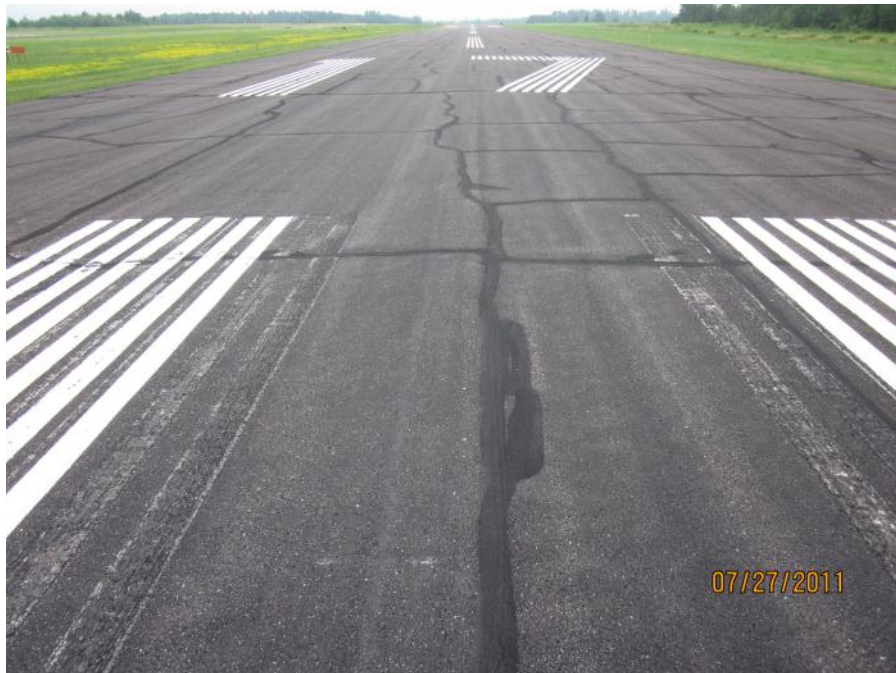
COQ RY1735 001 (PCI = 66)

48 LONGITUDINAL/TRANSVERSE CRACKING L 551.00 Ft Comments:

48 LONGITUDINAL/TRANSVERSE CRACKING M 32.00 Ft Comments:
