# Minnesota Airport System Pavement Evaluation 2011 Update

Sky Harbor Airport (DYT)

Duluth, Minnesota

January 2012

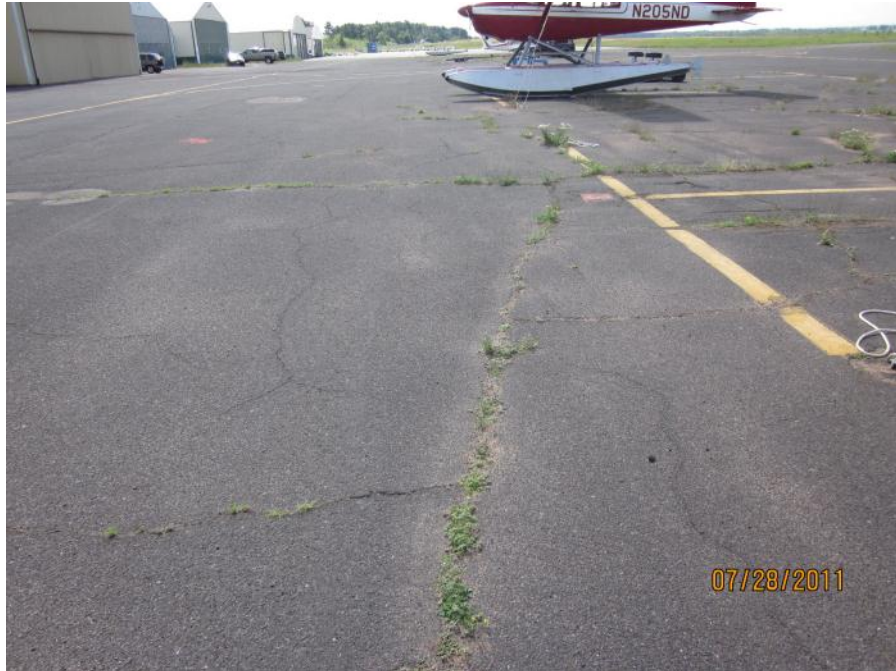
DYT APA 001 (PCI = 21)

| Branch ID | Section ID | Surface type <sup>1</sup> | Section area (SF) | LCD <sup>2</sup> | 2008 PCI | 2011 PCI | Drop in PCI/Yr <sup>3</sup> | % Deduct due to | | Distress types |
|---|---|---|---|---|---|---|---|---|---|---|
| APA | 1 | AC | 35,000 | 1984 | 43 | 21 | 2.9 | 28 | 72 | Alligator cracking, Block cracking, Longitudinal & transverse (L&T) cracking, Weathering |

| 43 BLOCK CRACKING | M | 2,010.00 SqFt | Comments: |
| 43 BLOCK CRACKING | H | 400.00 SqFt | Comments: |
| 41 ALLIGATOR CRACKING | M | 67.00 SqFt | Comments: |

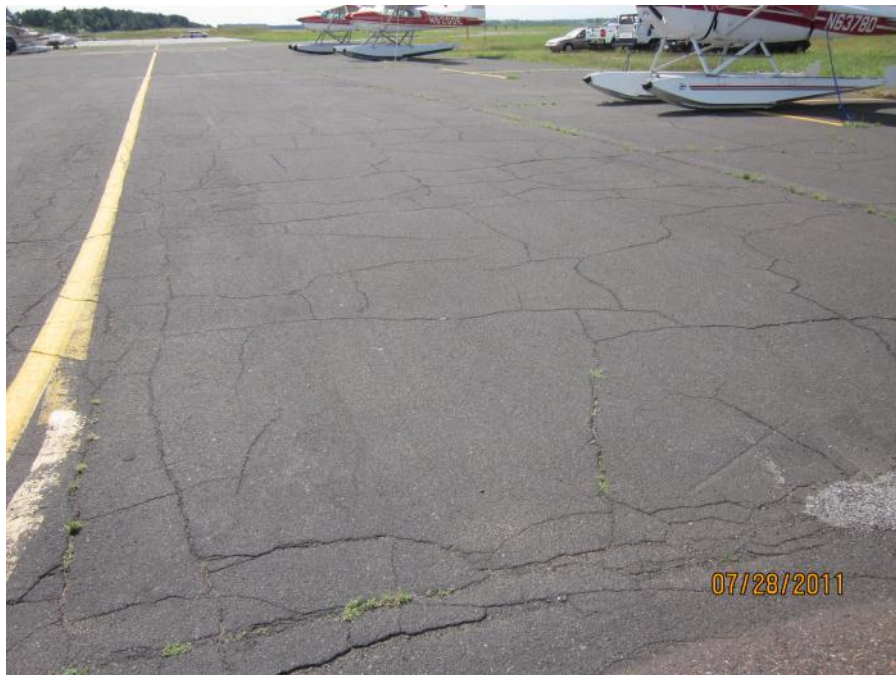
DYT APA 002 (PCI = 24)

| Branch ID | Section ID | Surface type <sup>1</sup> | Section area (SF) | LCD <sup>2</sup> | 2008 PCI | 2011 PCI | Drop in PCI/Yr <sup>3</sup> | % Deduct due to | | Distress types |
|---|---|---|---|---|---|---|---|---|---|---|
| APA | 2 | AC | 32,000 | 1984 | 34 | 24 | 2.8 | 22 | 67 | Alligator cracking, Depression, Raveling |

| 43 BLOCK CRACKING | M | 4,150.00 SqFt | Comments: |
| 43 BLOCK CRACKING | H | 400.00 SqFt | Comments: |

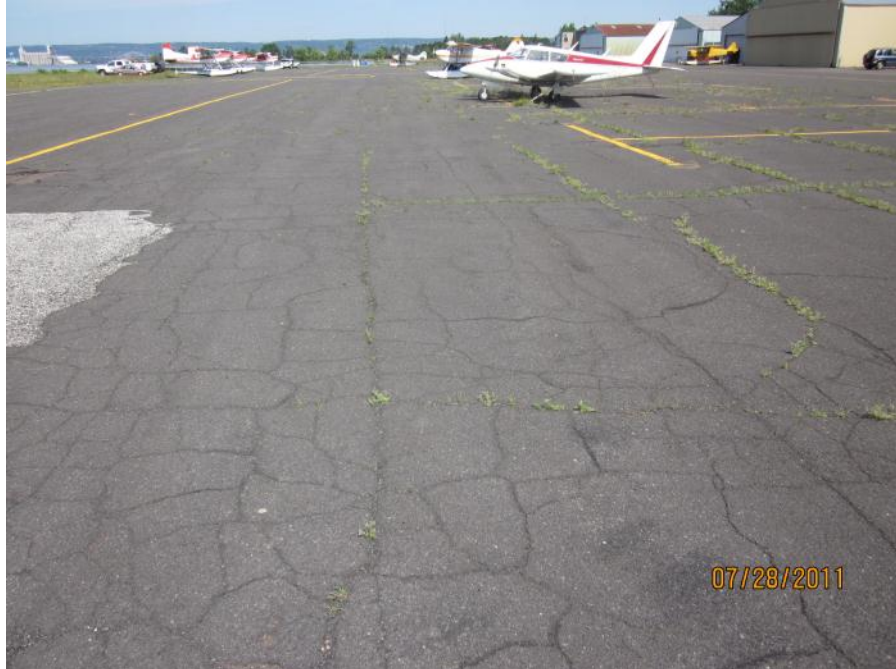
DYT APA 003 (PCI = 27)

| Branch ID | Section ID | Surface type <sup>1</sup> | Section area (SF) | LCD <sup>2</sup> | 2008 PCI | 2011 PCI | Drop in PCI/Yr <sup>3</sup> | % Deduct due to | | Distress types |
|---|---|---|---|---|---|---|---|---|---|---|
| APA | 3 | AC | 50,000 | 1984 | 30 | 27 | 2.7 | 29 | 69 | Alligator cracking, Block cracking, L&T cracking, Raveling, Rutting, Swelling |

| 43 BLOCK CRACKING | L | 4,000.00 SqFt | Comments: |
| 43 BLOCK CRACKING | M | 1,000.00 SqFt | Comments: |

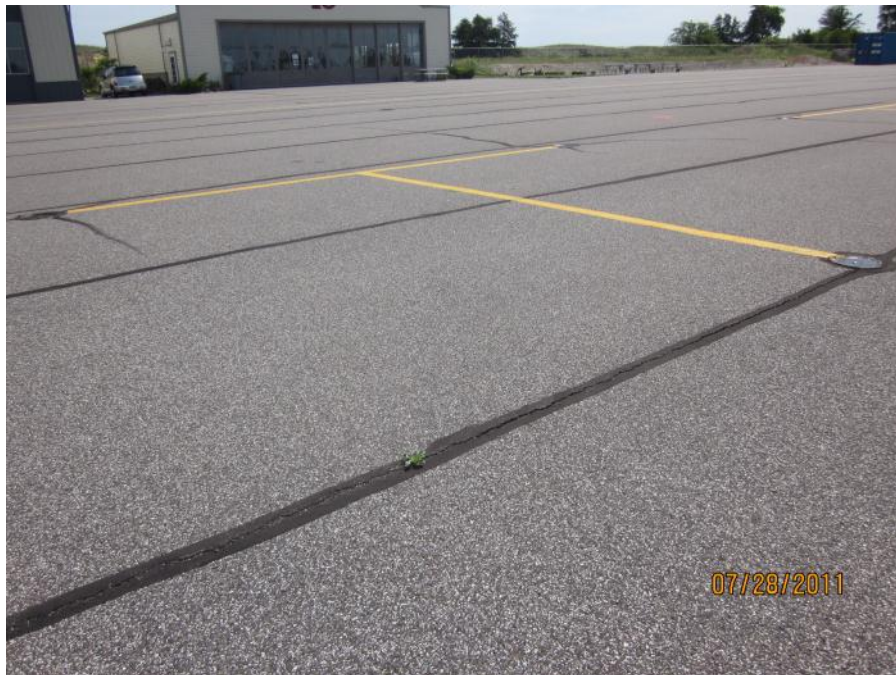
DYT APA 004 (PCI = 76)

| Branch ID | Section ID | Surface type <sup>1</sup> | Section area (SF) | LCD <sup>2</sup> | 2008 PCI | 2011 PCI | Drop in PCI/Yr <sup>3</sup> | % Deduct due to | | Distress types |
|---|---|---|---|---|---|---|---|---|---|---|
| APA | 4 | AC | 64,558 | 2004 | 85 | 76 | 3.4 | 0 | 100 | L&T cracking |

48 LONGITUDINAL/TRANSVERSE CRACKING L 243.00 Ft Comments:

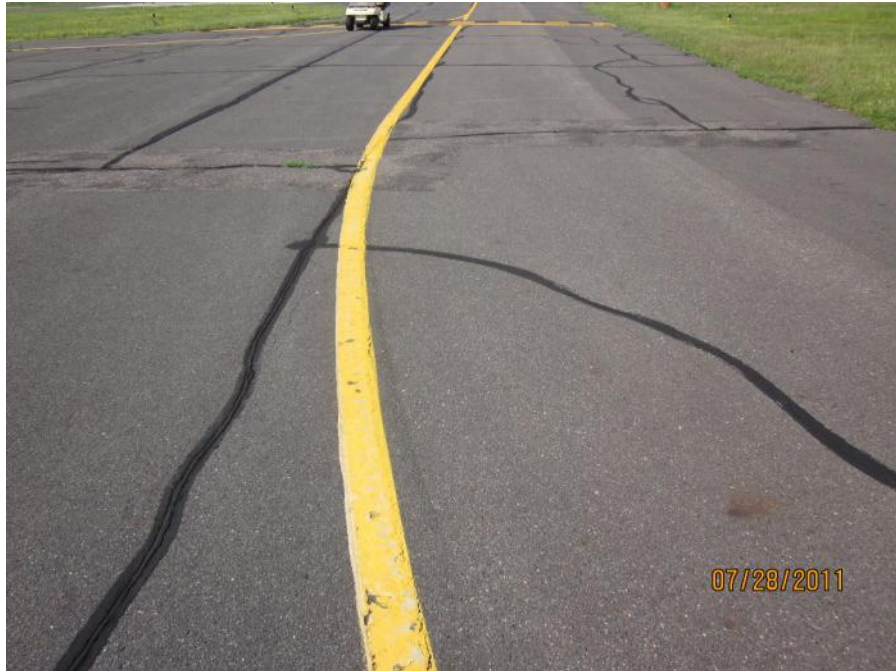
DYT CTA 001 (PCI = 71)

| Branch ID | Section ID | Surface type <sup>1</sup> | Section area (SF) | LCD <sup>2</sup> | 2008 PCI | 2011 PCI | Drop in PCI/Yr <sup>3</sup> | % Deduct due to | | Distress types |
|---|---|---|---|---|---|---|---|---|---|---|
| CTA | 1 | AC | 12,770 | 1984 | 62 | 71 | 1.1 | 0 | 100 | L&T cracking |

48 LONGITUDINAL/TRANSVERSE CRACKING L 431.00 Ft Comments:

48 LONGITUDINAL/TRANSVERSE CRACKING M 87.00 Ft Comments:

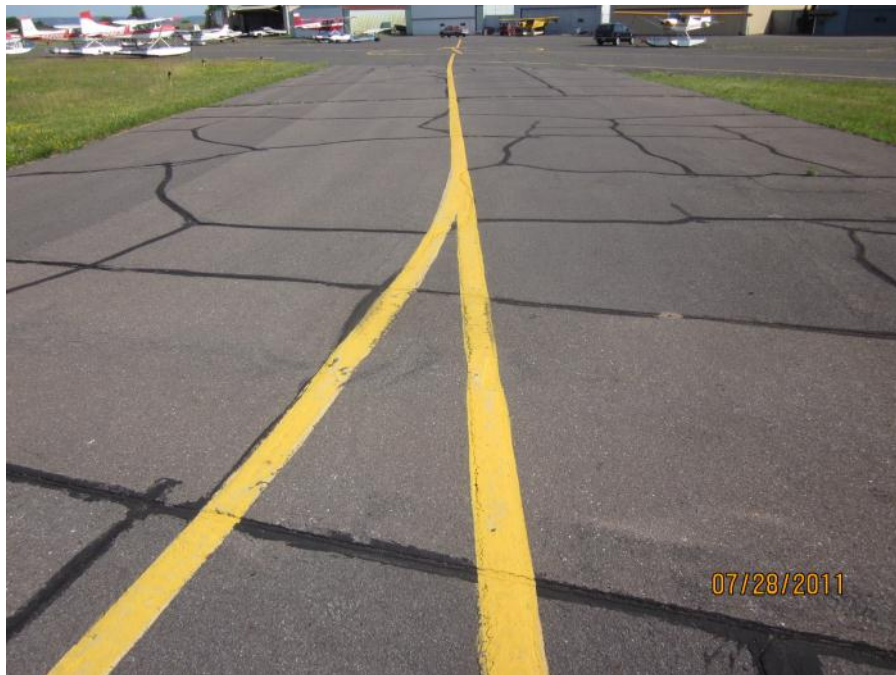
DYT CTA 002 (PCI = 52)

| Branch ID | Section ID | Surface type <sup>1</sup> | Section area (SF) | LCD <sup>2</sup> | 2008 PCI | 2011 PCI | Drop in PCI/Yr <sup>3</sup> | % Deduct due to | | Distress types |
|---|---|---|---|---|---|---|---|---|---|---|
| CTA | 2 | AC | 11,000 | 1984 | 51 | 52 | 1.8 | 0 | 100 | Block cracking, L&T cracking, Patching |

| 48 LONGITUDINAL/TRANSVERSE CRACKING | L | 210.00 Ft | Comments: |
| 48 LONGITUDINAL/TRANSVERSE CRACKING | M | 39.00 Ft | Comments: |
| 43 BLOCK CRACKING | L | 1,240.00 SqFt | Comments: |

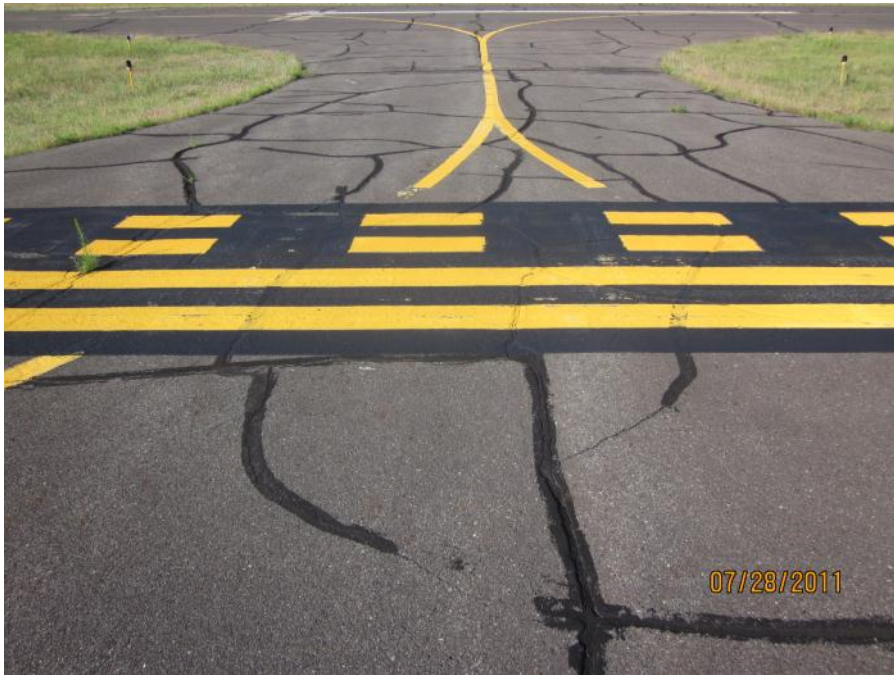
DYT CTB 001 (PCI = 51)

| Branch ID | Section ID | Surface type <sup>1</sup> | Section area (SF) | LCD <sup>2</sup> | 2008 PCI | 2011 PCI | Drop in PCI/Yr <sup>3</sup> | % Deduct due to | | Distress types |
|---|---|---|---|---|---|---|---|---|---|---|
| CTB | 1 | AC | 3,530 | 1984 | 54 | 51 | 1.8 | 0 | 100 | Block cracking, L&T cracking, Patching |

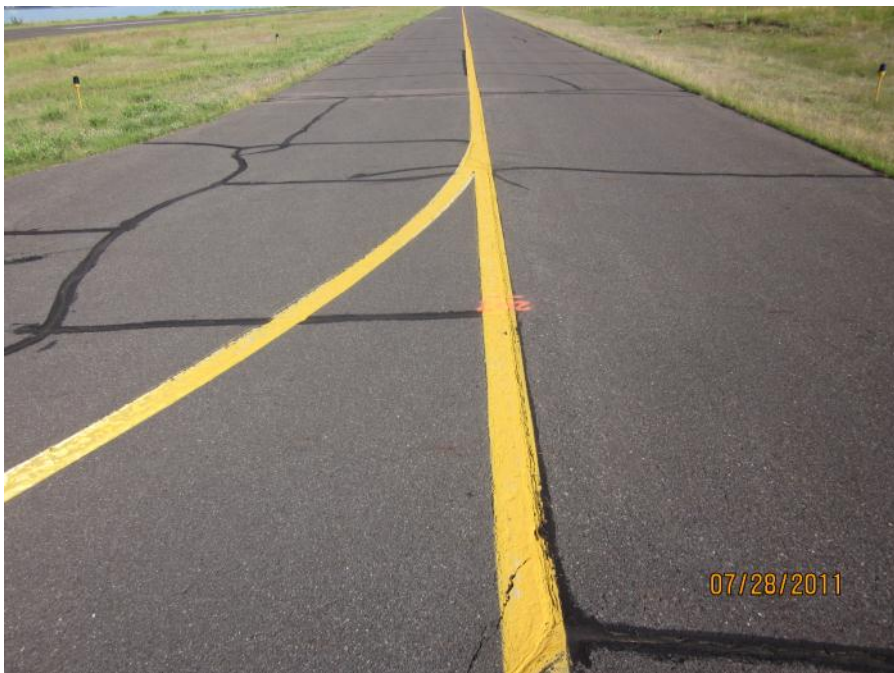
DYT PTA 001 (PCI = 60)

| Branch ID | Section ID | Surface type <sup>1</sup> | Section area (SF) | LCD <sup>2</sup> | 2008 PCI | 2011 PCI | Drop in PCI/Yr <sup>3</sup> | % Deduct due to | | Distress types |
|---|---|---|---|---|---|---|---|---|---|---|
| PTA | 1 | AC | 80,500 | 1984 | 63 | 60 | 1.5 | 0 | 100 | Block cracking, L&T cracking, Patching |

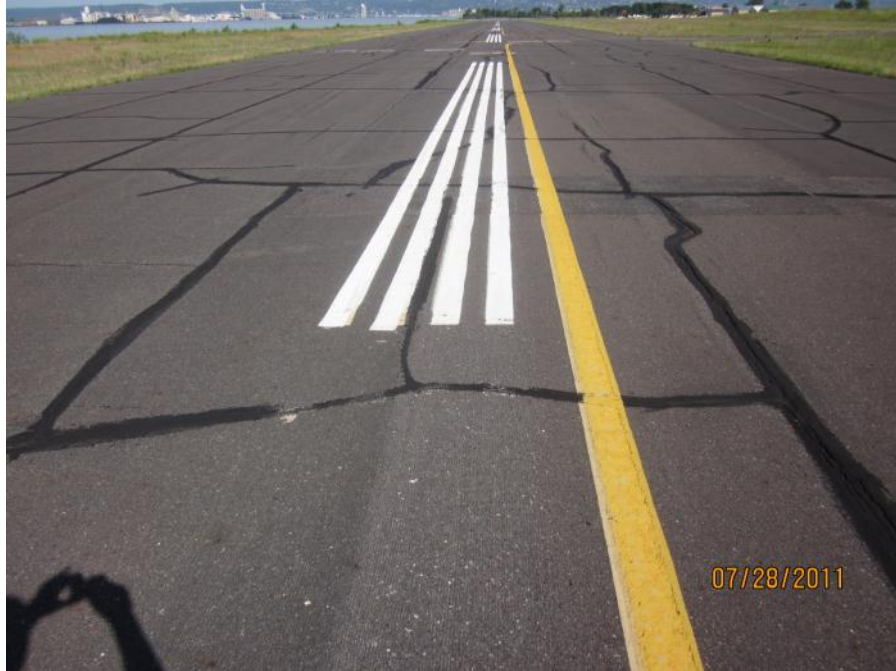
DYT RY1432 001 (PCI = 62)

| Branch ID | Section ID | Surface type <sup>1</sup> | Section area (SF) | LCD <sup>2</sup> | 2008 PCI | 2011 PCI | Drop in PCI/Yr <sup>3</sup> | % Deduct due to | | Distress types |
|---|---|---|---|---|---|---|---|---|---|---|
| RY1432 | 1 | AC | 228,750 | 1984 | 63 | 62 | 1.4 | 0 | 100 | L&T cracking, Patching |
