# Minnesota Airport System Pavement Evaluation 2011 Update

Wheaton Municipal Airport (ETH)

Wheaton, Minnesota

January 2012

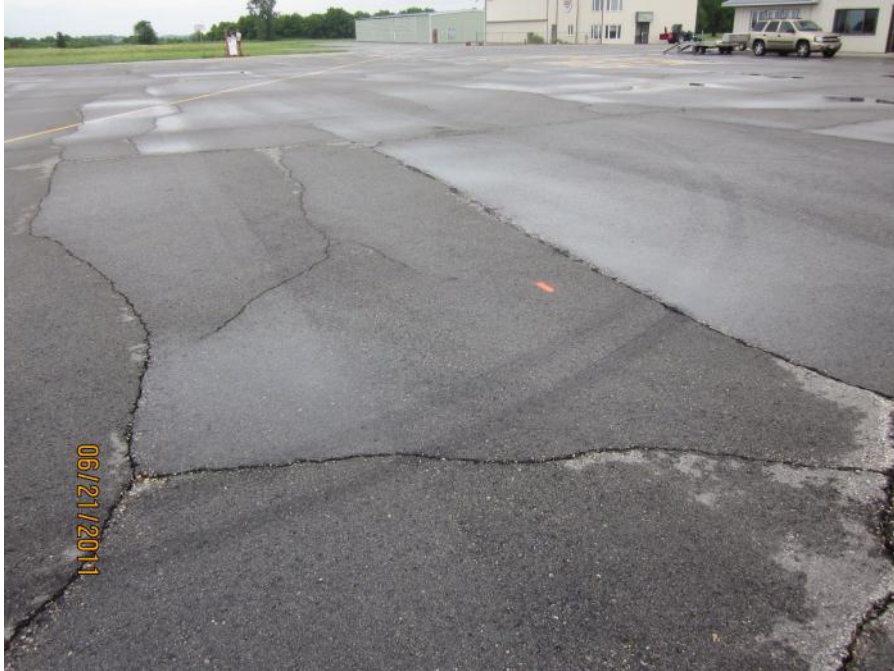
ETH APA 001 (PCI = 73)

| Branch ID | Section ID | Surface type <sup>1</sup> | Section area (SF) | LCD <sup>2</sup> | 2008 PCI | 2011 PCI | Drop in PCI/Yr <sup>3</sup> | % Deduct due to | | Distress types |
|---|---|---|---|---|---|---|---|---|---|---|
| APA | 1 | AC | 42,500 | 2008 | 100 | 73 | 9.0 | 0 | 77 | Longitudinal & transverse (L&T) cracking, Swelling |

48 LONGITUDINAL/TRANSVERSE CRACKING L 687.00 Ft Comments:

48 LONGITUDINAL/TRANSVERSE CRACKING L 573.00 Ft Comments:

48 LONGITUDINAL/TRANSVERSE CRACKING M 15.00 Ft Comments:

48 LONGITUDINAL/TRANSVERSE CRACKING H 10.00 Ft Comments:

48 LONGITUDINAL/TRANSVERSE CRACKING L 539.00 Ft Comments:

48 LONGITUDINAL/TRANSVERSE CRACKING L 459.00 Ft Comments:

48 LONGITUDINAL/TRANSVERSE CRACKING L 63.00 Ft Comments:

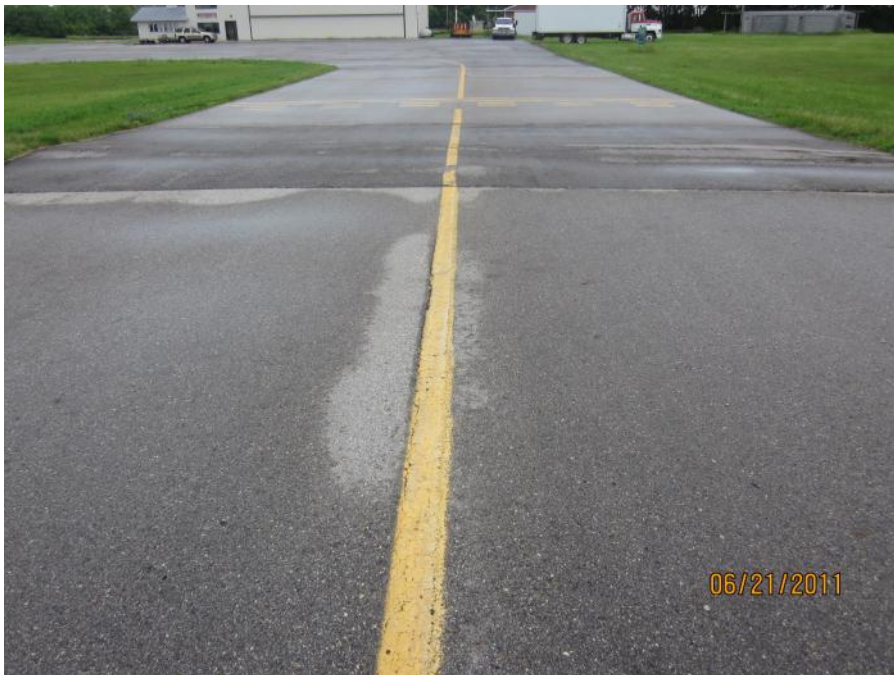
ETH CTA 001 (PCI = 84)

| Branch ID | Section ID | Surface type <sup>1</sup> | Section area (SF) | LCD <sup>2</sup> | 2008 PCI | 2011 PCI | Drop in PCI/Yr <sup>3</sup> | % Deduct due to | | Distress types |
|---|---|---|---|---|---|---|---|---|---|---|
| CTA | 1 | AC | 10,450 | 2007 | 76 | 84 | 4.0 | 0 | 100 | L&T cracking, Patching |

48 LONGITUDINAL/TRANSVERSE CRACKING L 84.00 Ft Comments:

48 LONGITUDINAL/TRANSVERSE CRACKING L 14.00 Ft Comments:

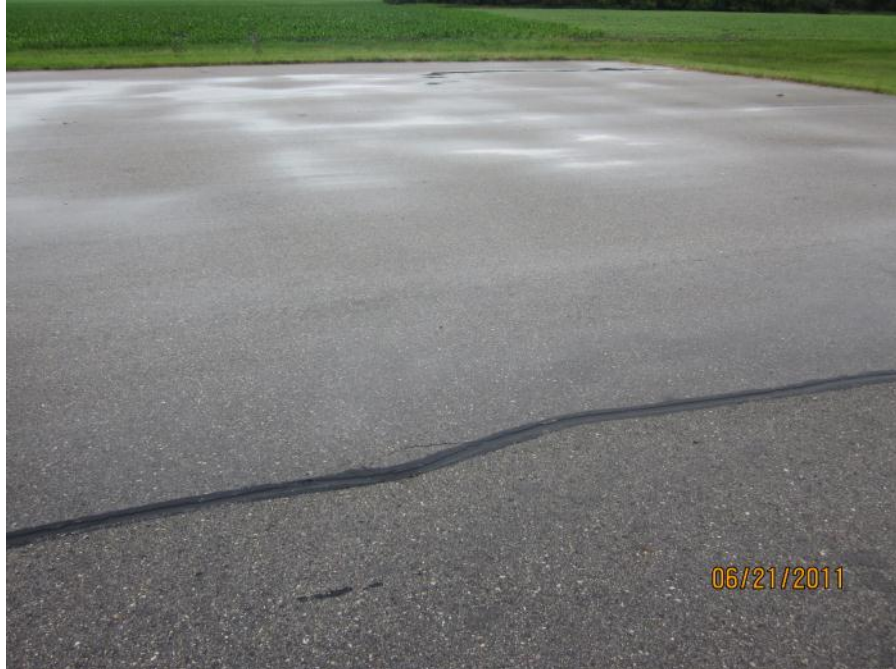
ETH RTA 001 (PCI = 90)

| Branch ID | Section ID | Surface type <sup>1</sup> | Section area (SF) | LCD <sup>2</sup> | 2008 PCI | 2011 PCI | Drop in PCI/Yr <sup>3</sup> | % Deduct due to | | Distress types |
|---|---|---|---|---|---|---|---|---|---|---|
| RTA | 1 | AC | 8,350 | 2007 | 100 | 90 | 2.5 | 0 | 100 | L&T cracking |

48 LONGITUDINAL/TRANSVERSE CRACKING L 69.00 Ft Comments:

48 LONGITUDINAL/TRANSVERSE CRACKING M 5.00 Ft Comments:

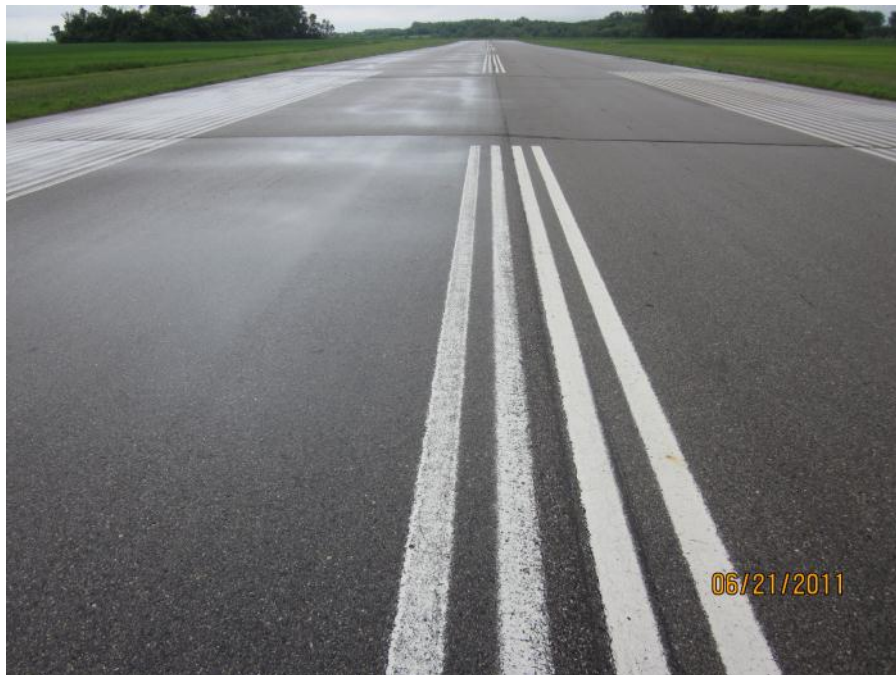
ETH RY1634 001 (PCI = 82)

| Branch ID | Section ID | Surface type <sup>1</sup> | Section area (SF) | LCD <sup>2</sup> | 2008 PCI | 2011 PCI | Drop in PCI/Yr <sup>3</sup> | % Deduct due to | | Distress types |
|---|---|---|---|---|---|---|---|---|---|---|
| RY1634 | 1 | AC | 247,500 | 2007 | 96 | 82 | 4.5 | 0 | 39 | L&T cracking, Swelling |

48 LONGITUDINAL/TRANSVERSE CRACKING L 283.00 Ft Comments:  
48 LONGITUDINAL/TRANSVERSE CRACKING M 15.00 Ft Comments:  
48 LONGITUDINAL/TRANSVERSE CRACKING L 59.00 Ft Comments:  
56 SWELLING H 5.00 SqFt Comments:at edge

48 LONGITUDINAL/TRANSVERSE CRACKING L 193.00 Ft Comments:  
56 SWELLING L 9.00 SqFt Comments:within 10-ft of edge

48 LONGITUDINAL/TRANSVERSE CRACKING L 143.00 Ft Comments:  
48 LONGITUDINAL/TRANSVERSE CRACKING M 6.00 Ft Comments:

48 LONGITUDINAL/TRANSVERSE CRACKING L 237.00 Ft Comments:  
48 LONGITUDINAL/TRANSVERSE CRACKING M 12.00 Ft Comments:

48 LONGITUDINAL/TRANSVERSE CRACKING L 167.00 Ft Comments:

48 LONGITUDINAL/TRANSVERSE CRACKING L 62.00 Ft Comments:

48 LONGITUDINAL/TRANSVERSE CRACKING L 96.00 Ft Comments:  
56 SWELLING L 12.00 SqFt Comments:

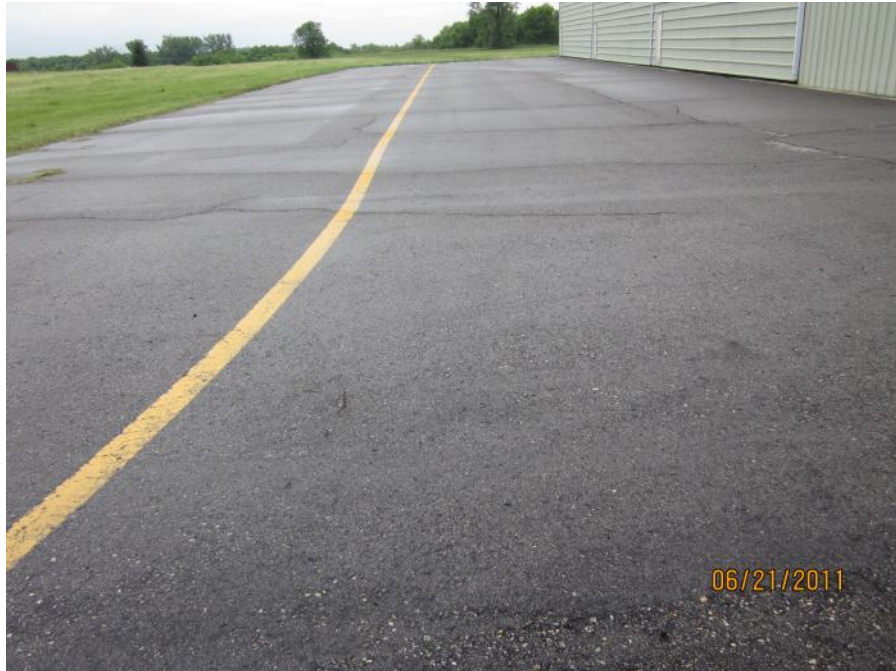
ETH TLA 001 (PCI = 69)

| Branch ID | Section ID | Surface type <sup>1</sup> | Section area (SF) | LCD <sup>2</sup> | 2008 PCI | 2011 PCI | Drop in PCI/Yr <sup>3</sup> | % Deduct due to | | Distress types |
|---|---|---|---|---|---|---|---|---|---|---|
| TLA | 1 | AC | 21,844 | 2008 | 100 | 69 | 10.3 | 0 | 97 | L&T cracking, Swelling |

| 48 | LONGITUDINAL/TRANSVERSE CRACKING | L | 531.00 Ft | Comments: |
| 48 | LONGITUDINAL/TRANSVERSE CRACKING | M | 3.00 Ft | Comments: |
| 48 | LONGITUDINAL/TRANSVERSE CRACKING | L | 61.00 Ft | Comments: |

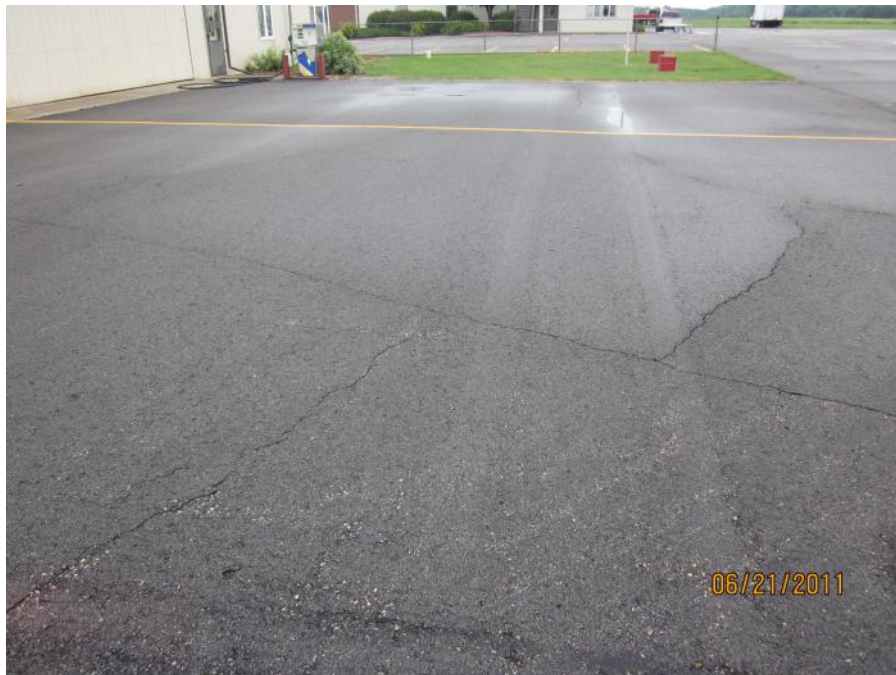
ETH TLA 002 (PCI = 74)

| Branch ID | Section ID | Surface type <sup>1</sup> | Section area (SF) | LCD <sup>2</sup> | 2008 PCI | 2011 PCI | Drop in PCI/Yr <sup>3</sup> | % Deduct due to | | Distress types |
|---|---|---|---|---|---|---|---|---|---|---|
| TLA | 2 | AC | 11,000 | 2008 | 100 | 74 | 8.7 | 0 | 100 | L&T cracking |

| 48 | LONGITUDINAL/TRANSVERSE CRACKING | L | 373.00 Ft | Comments: |
| 48 | LONGITUDINAL/TRANSVERSE CRACKING | L | 44.00 Ft | Comments: |
| 48 | LONGITUDINAL/TRANSVERSE CRACKING | M | 6.00 Ft | Comments: |
