# Minnesota Airport System Pavement Evaluation 2011 Update

Faribault Municipal Airport (FBL)

Faribault, Minnesota

January 2012

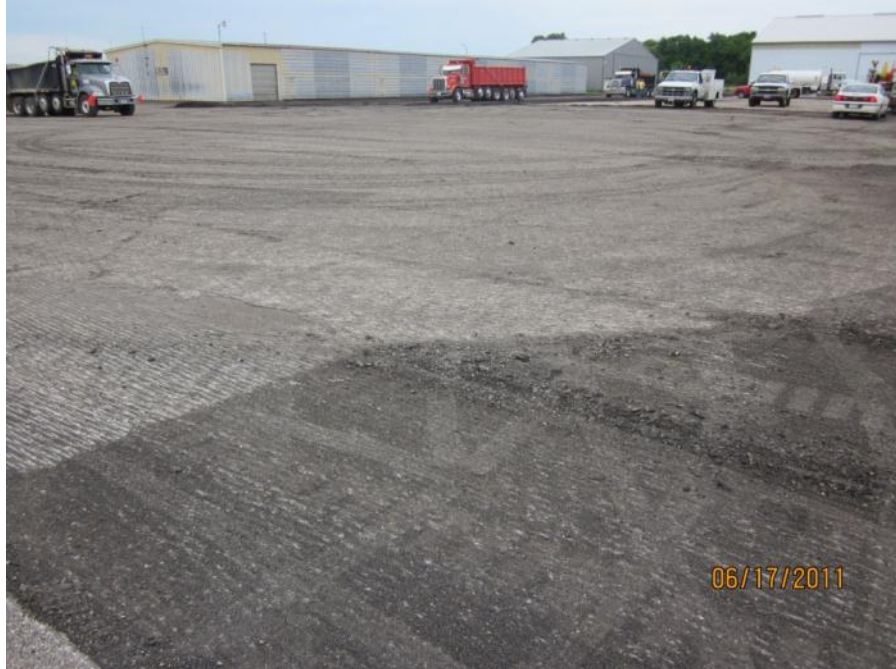
FBL APA 001 – prior to asphalt overlay (post construction PCI = 100)

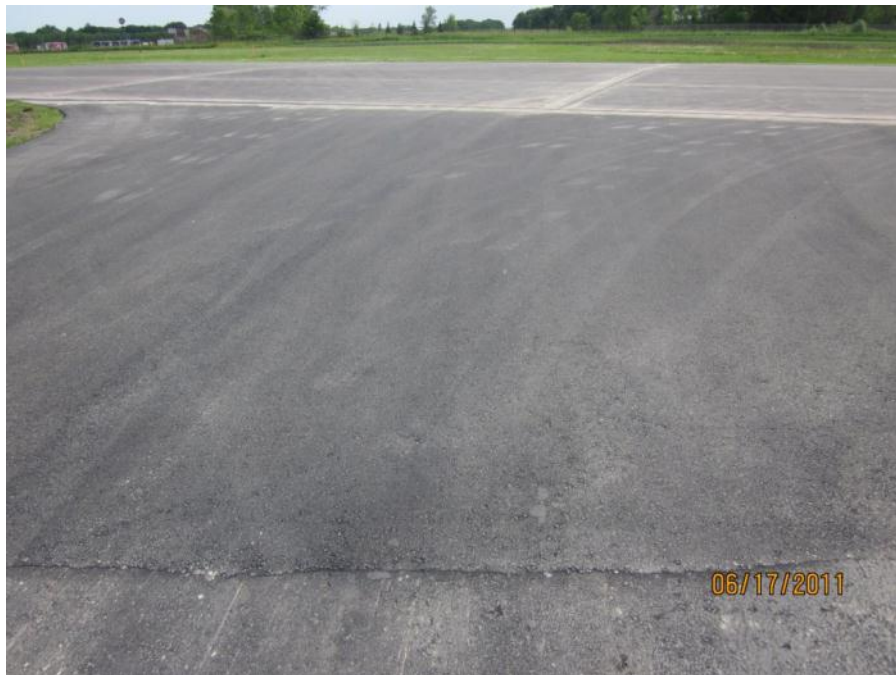
FBL CTA 001 (PCI = 100)

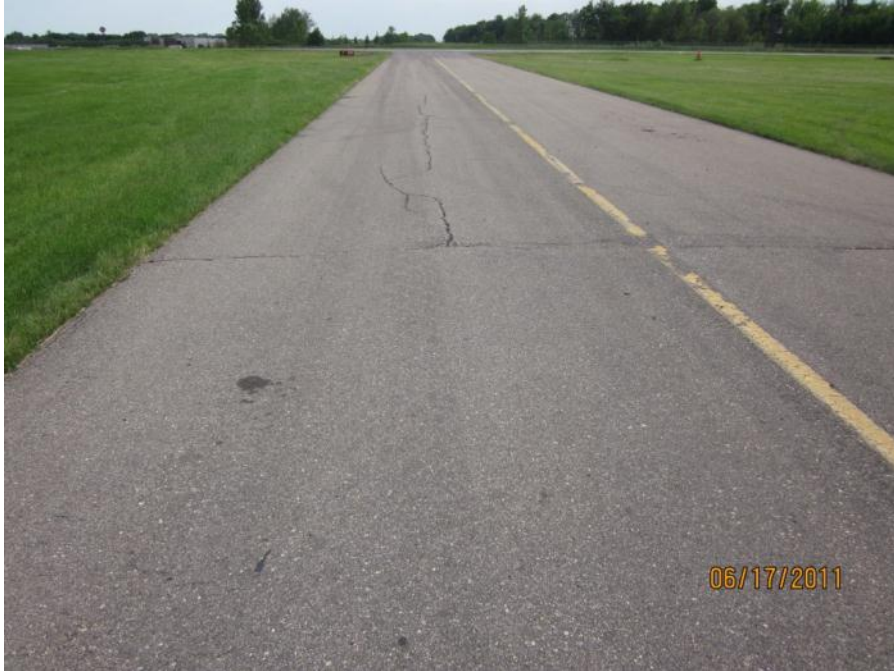
| Branch ID | Section ID | Surface type <sup>1</sup> | Section area (SF) | LCD <sup>2</sup> | 2008 PCI | 2011 PCI | Drop in PCI/Yr <sup>3</sup> | % Deduct due to | | Distress types |
|---|---|---|---|---|---|---|---|---|---|---|
| CTA | 2 | AC | 21,050 | 1980 | 81 | 66 | 1.1 | 38 | 62 | Alligator cracking, Longitudinal & transverse (L&T) cracking |

FBL CTA 002 (PCI = 66)

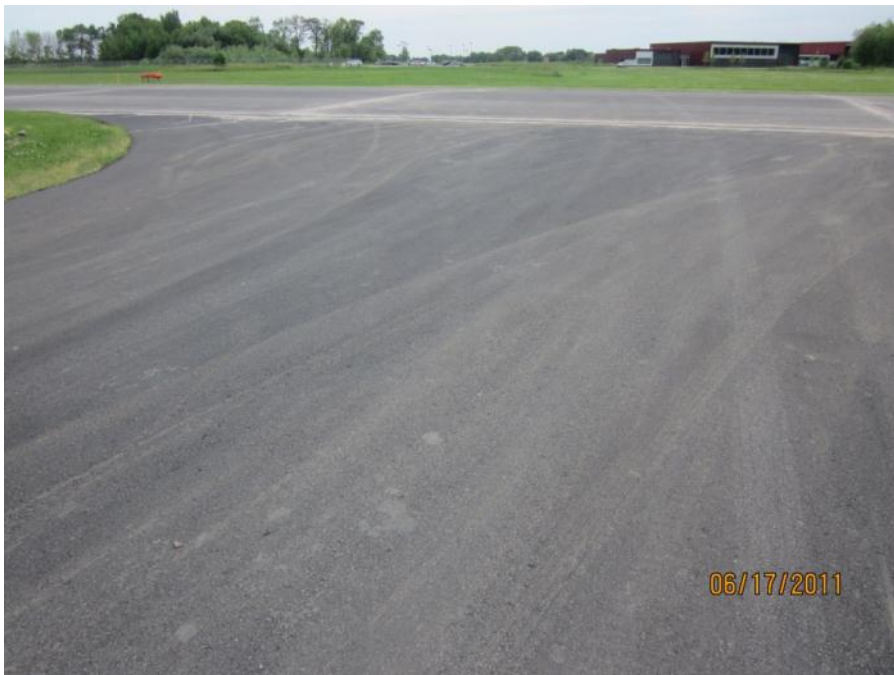
FBL CTB 001 (PCI = 100)

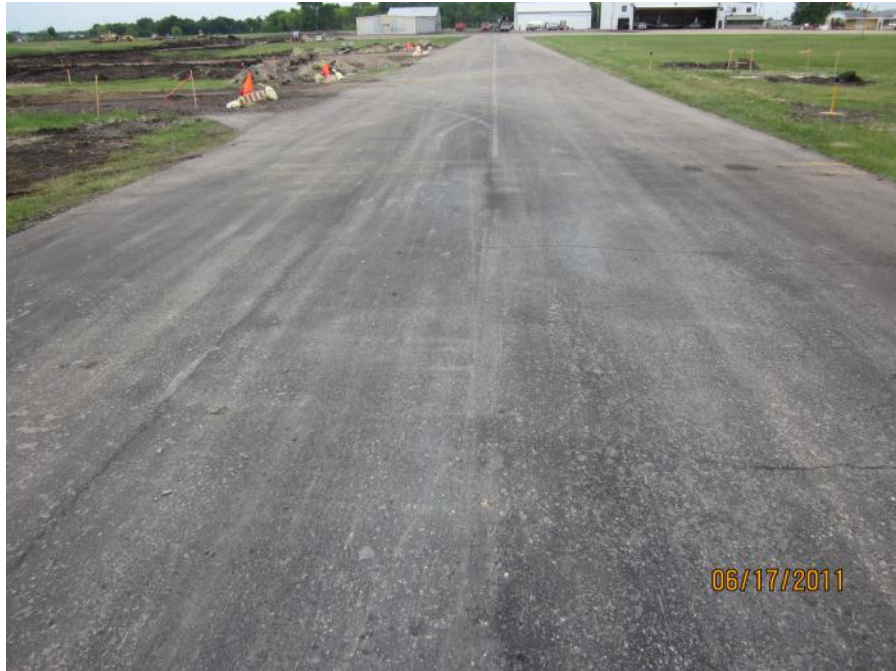
FBL CTB 002 (PCI = 100)

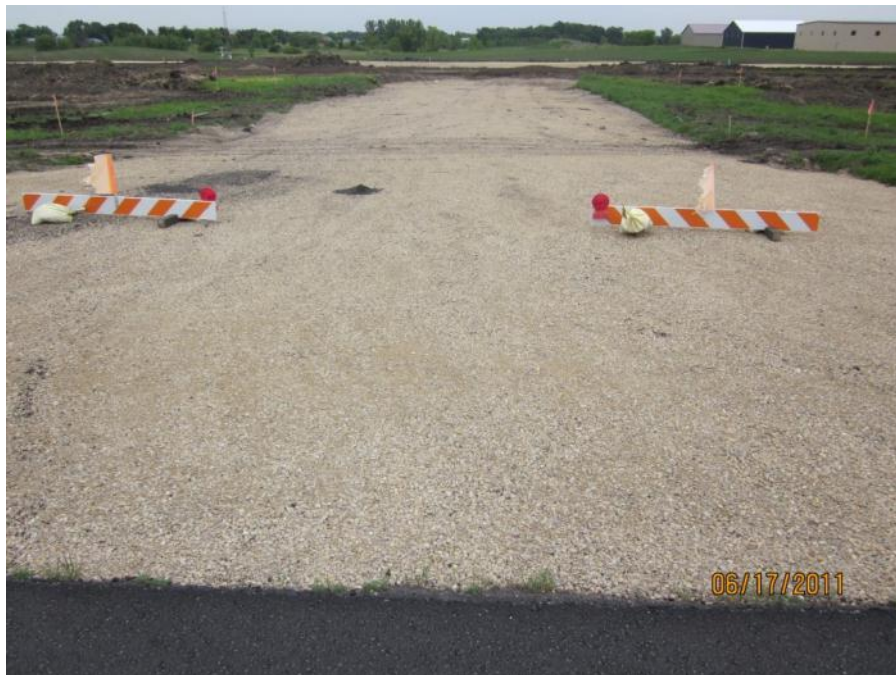
FBL CTC 001- prior to asphalt placement (post construction PCI = 100)

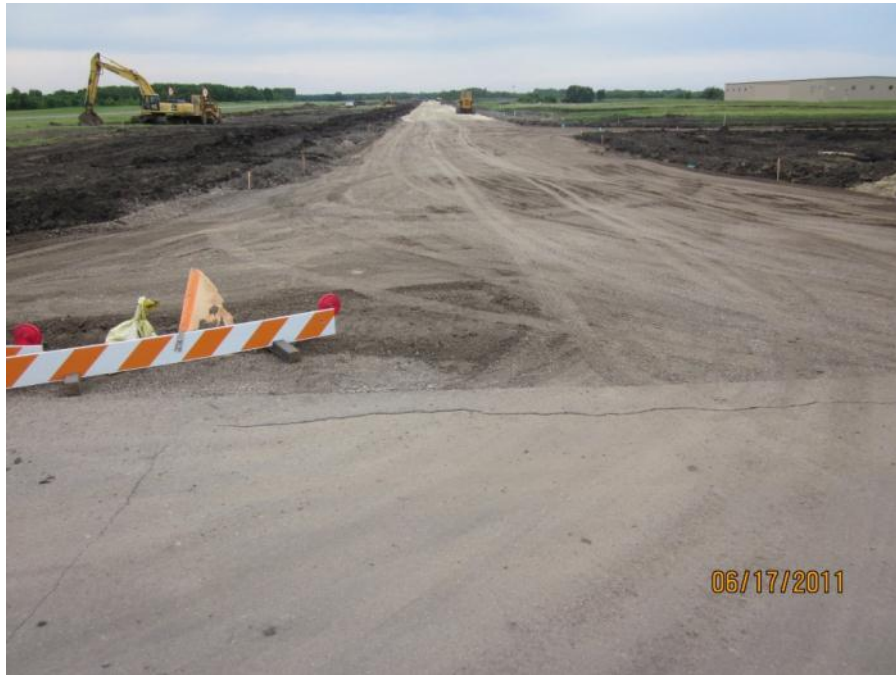
FBL PPTA 001 – prior to asphalt placement (post construction PCI = 100)

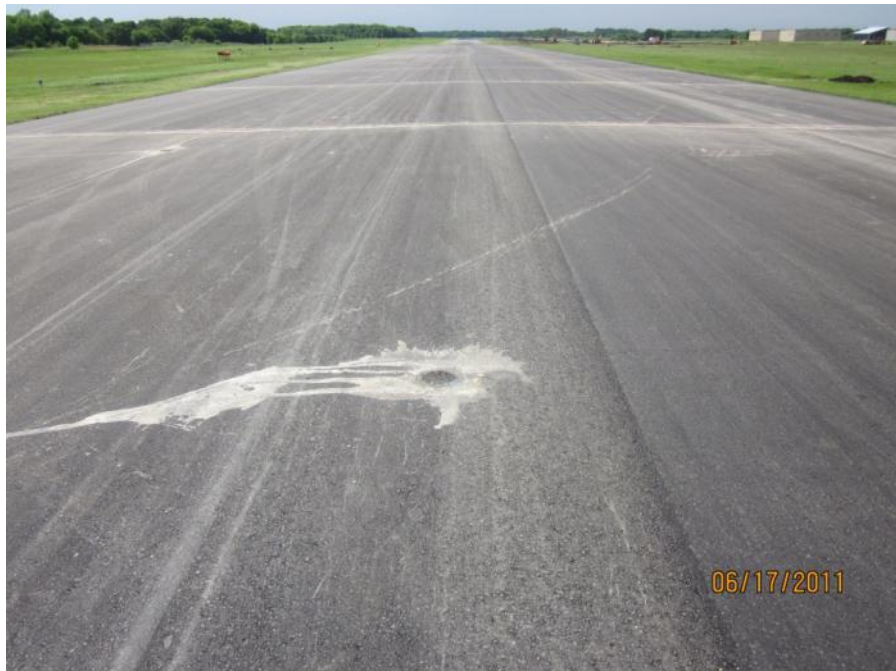
FBL RY1230 001 (PCI = 100)

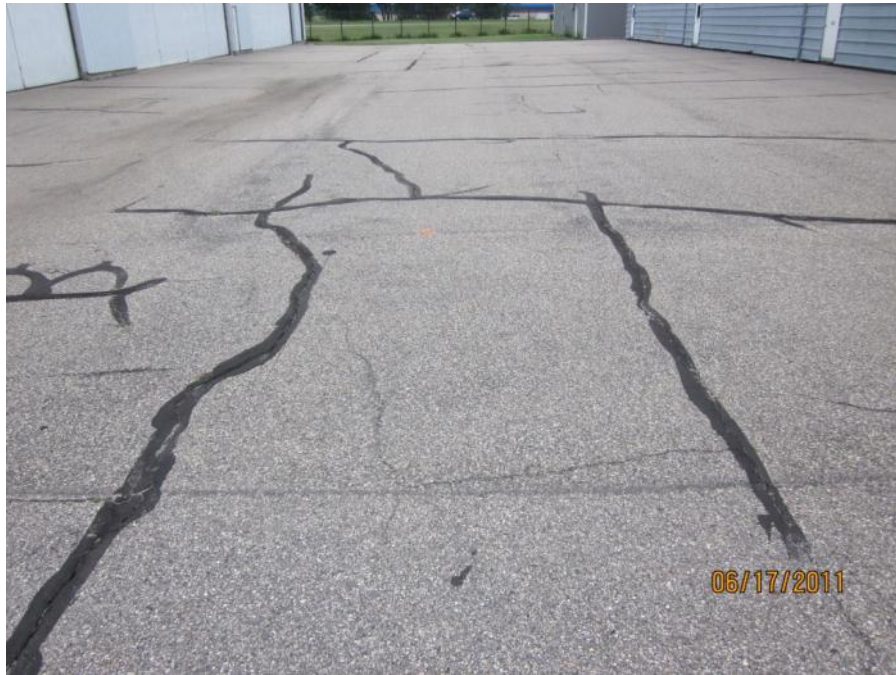
| Branch ID | Section ID | Surface type <sup>1</sup> | Section area (SF) | LCD <sup>2</sup> | 2008 PCI | 2011 PCI | Drop in PCI/Yr <sup>3</sup> | % Deduct due to | | Distress types |
|---|---|---|---|---|---|---|---|---|---|---|
| TLA | 1 | AC | 43,000 | 1993* | 72 | 59 | 2.3 | 14 | 84 | Alligator cracking, L&T cracking, Raveling, Swelling |

FBL TLA 001 (PCI = 59)

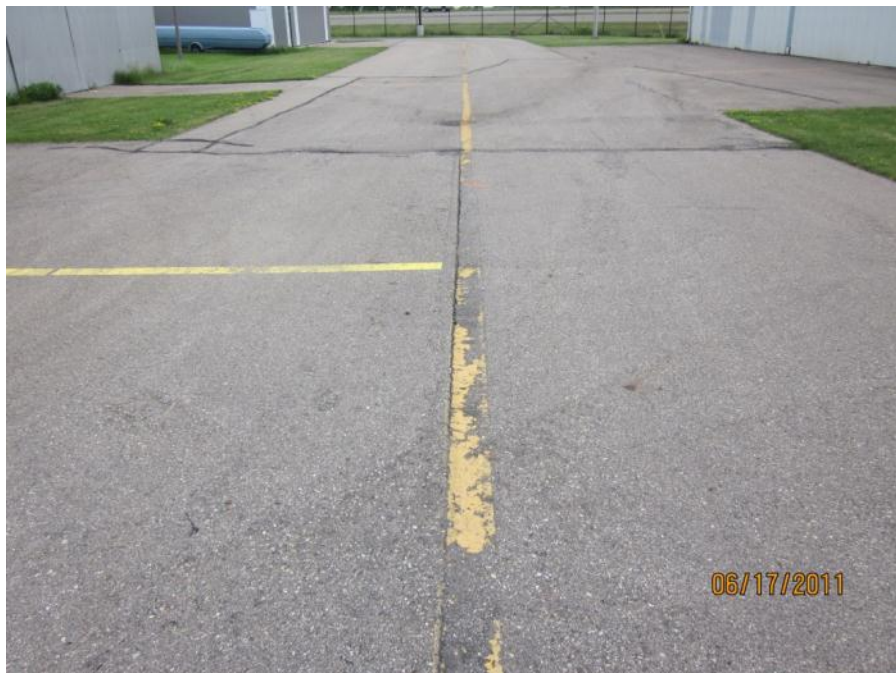
| Branch ID | Section ID | Surface type <sup>1</sup> | Section area (SF) | LCD <sup>2</sup> | 2008 PCI | 2011 PCI | Drop in PCI/Yr <sup>3</sup> | % Deduct due to | | Distress types |
|---|---|---|---|---|---|---|---|---|---|---|
| TLB | 1 | AAC | 16,500 | 2005* | 88 | 77 | 3.8 | 0 | 85 | L&T cracking, Swelling |

FBL TLB 001 (PCI = 77)

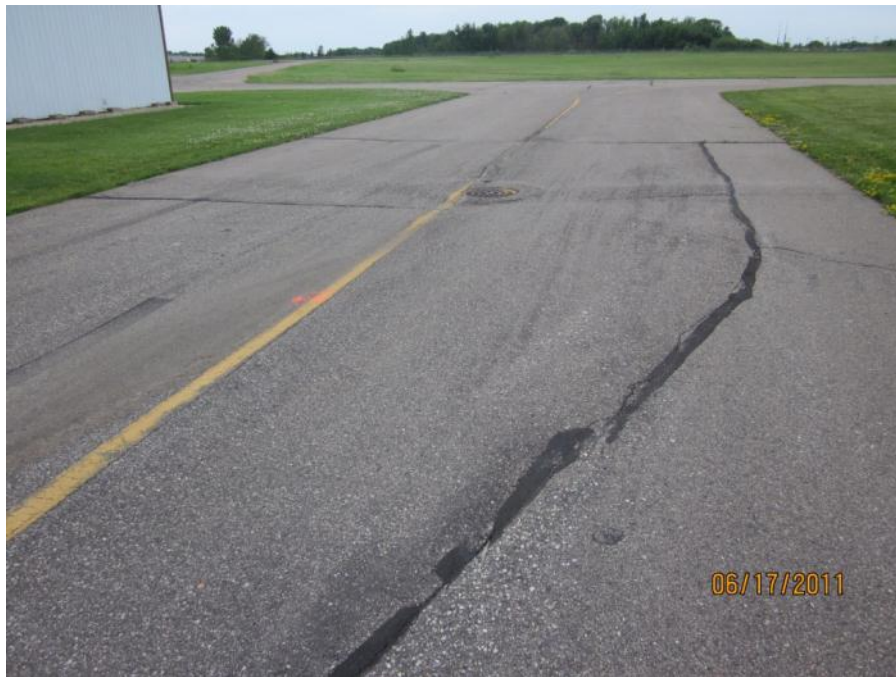
| Branch ID | Section ID | Surface type <sup>1</sup> | Section area (SF) | LCD <sup>2</sup> | 2008 PCI | 2011 PCI | Drop in PCI/Yr <sup>3</sup> | % Deduct due to | | Distress types |
|---|---|---|---|---|---|---|---|---|---|---|
| TLC | 1 | AAC | 11,250 | 2005* | 90 | 53 | 7.8 | 21 | 33 | Alligator cracking, Depression, L&T cracking, Swelling |

FBL TLC 001 (PCI = 53)

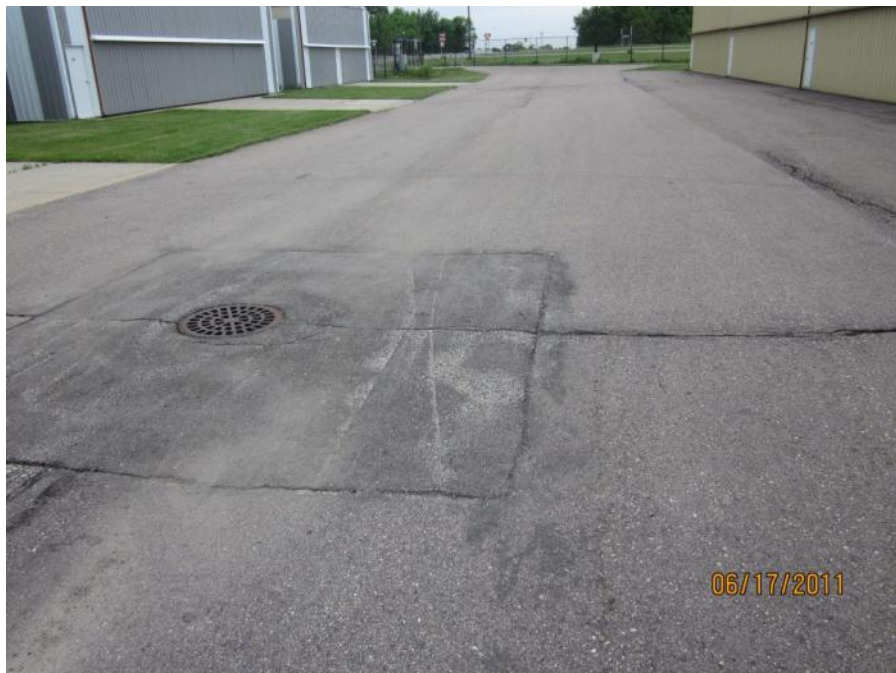
| Branch ID | Section ID | Surface type <sup>1</sup> | Section area (SF) | LCD <sup>2</sup> | 2008 PCI | 2011 PCI | Drop in PCI/Yr <sup>3</sup> | % Deduct due to | | Distress types |
|---|---|---|---|---|---|---|---|---|---|---|
| TLD | 1 | AAC | 12,000 | 2005* | 91 | 56 | 7.3 | 43 | 33 | Alligator cracking, L&T cracking, Patching, Swelling |

FBL TLD 001 (PCI = 56)

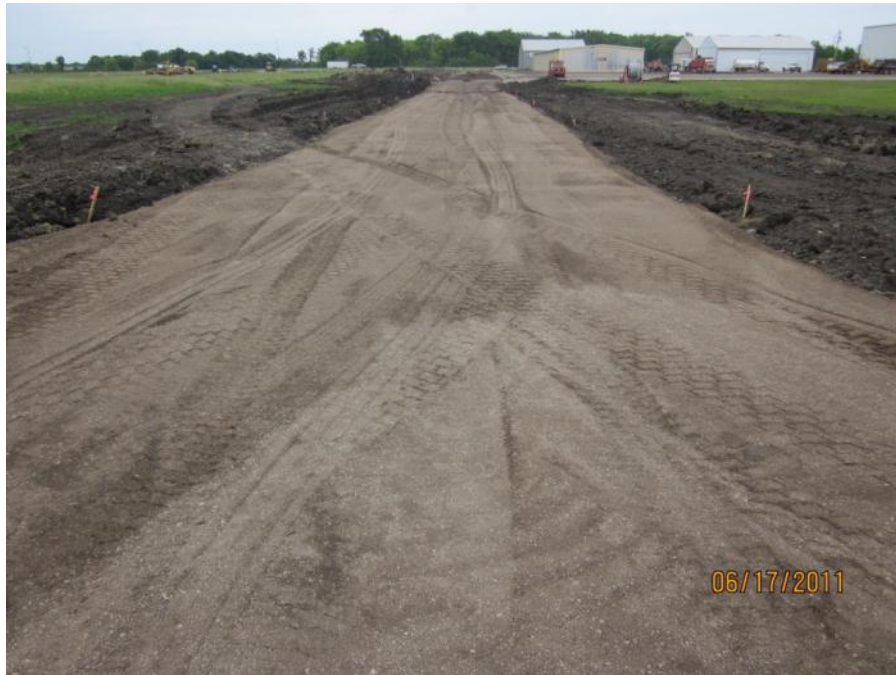
FBL TLF 001 prior to asphalt placement (post construction PCI = 100)

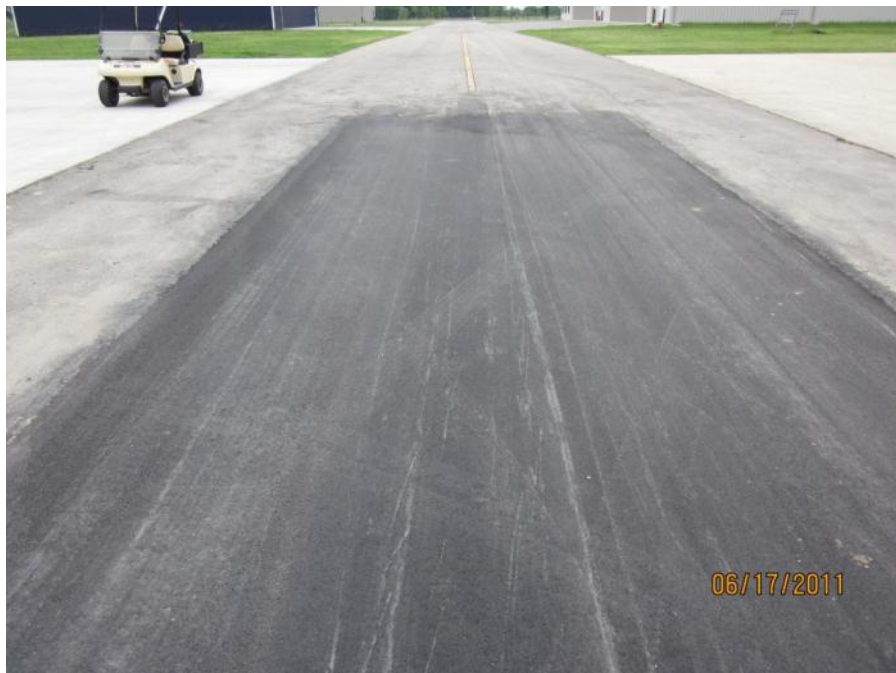
| Branch ID | Section ID | Surface type <sup>1</sup> | Section area (SF) | LCD <sup>2</sup> | 2008 PCI | 2011 PCI | Drop in PCI/Yr <sup>3</sup> | % Deduct due to | | Distress types |
|---|---|---|---|---|---|---|---|---|---|---|
| TLG | 1 | AC | 30,450 | 2006 | 100 | 71 | 5.8 | 31 | 59 | Alligator cracking, L&T cracking, Patching, Swelling |

FBL TLG 001 (PCI = 71)
