# Minnesota Airport System Pavement Evaluation 2011 Update

Fairmont Municipal Airport (FRM)

Fairmont, Minnesota

January 2012

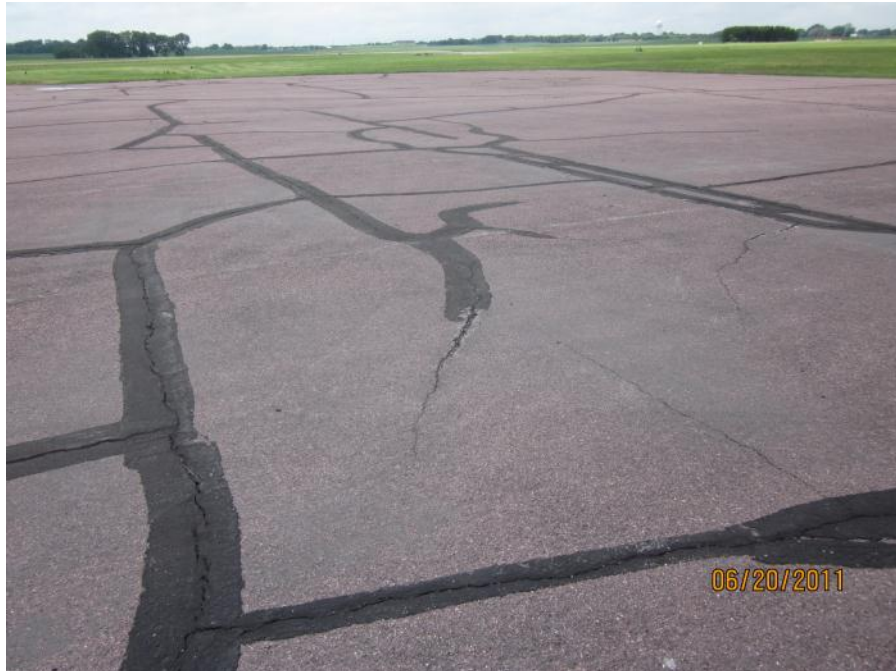
FRM APA 001 (PCI = 55)

| Branch ID | Section ID | Surface type <sup>1</sup> | Section area (SF) | LCD <sup>2</sup> | 2008 PCI | 2011 PCI | Drop in PCI/Yr <sup>3</sup> | % Deduct due to | | Distress types |
|---|---|---|---|---|---|---|---|---|---|---|
| APA | 1 | AC | 29,250 | 1984 | 72 | 55 | 1.7 | 0 | 100 | Longitudinal & transverse (L&T) cracking, Patching, Raveling |

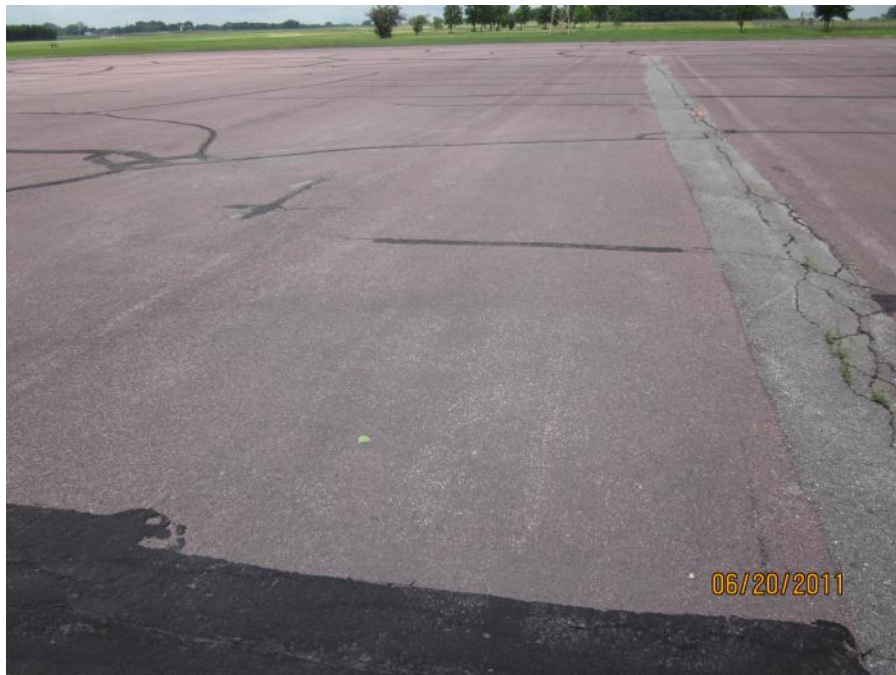
FRM APA 002 (PCI = 47)

| Branch ID | Section ID | Surface type <sup>1</sup> | Section area (SF) | LCD <sup>2</sup> | 2008 PCI | 2011 PCI | Drop in PCI/Yr <sup>3</sup> | % Deduct due to | | Distress types |
|---|---|---|---|---|---|---|---|---|---|---|
| APA | 2 | AAC | 31,050 | 1986 | 69 | 47 | 2.1 | 34 | 66 | Alligator cracking, L&T cracking, Patching |

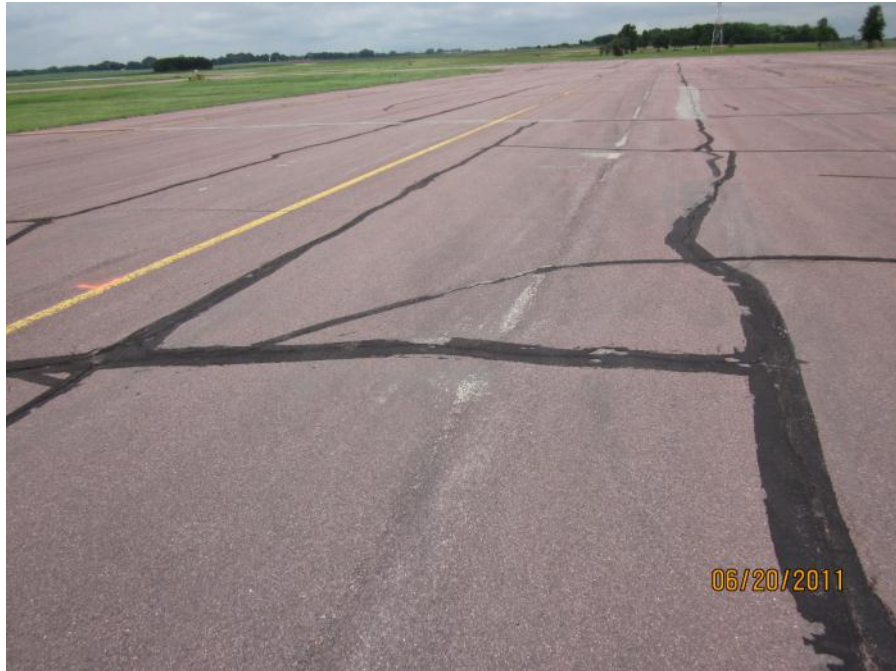
FRM APA 003 (PCI = 61)

| Branch ID | Section ID | Surface type <sup>1</sup> | Section area (SF) | LCD <sup>2</sup> | 2008 PCI | 2011 PCI | Drop in PCI/Yr <sup>3</sup> | % Deduct due to | | Distress types |
|---|---|---|---|---|---|---|---|---|---|---|
| APA | 3 | AAC | 40,000 | 1988 | 76 | 61 | 1.7 | 0 | 100 | L&T cracking, Patching |

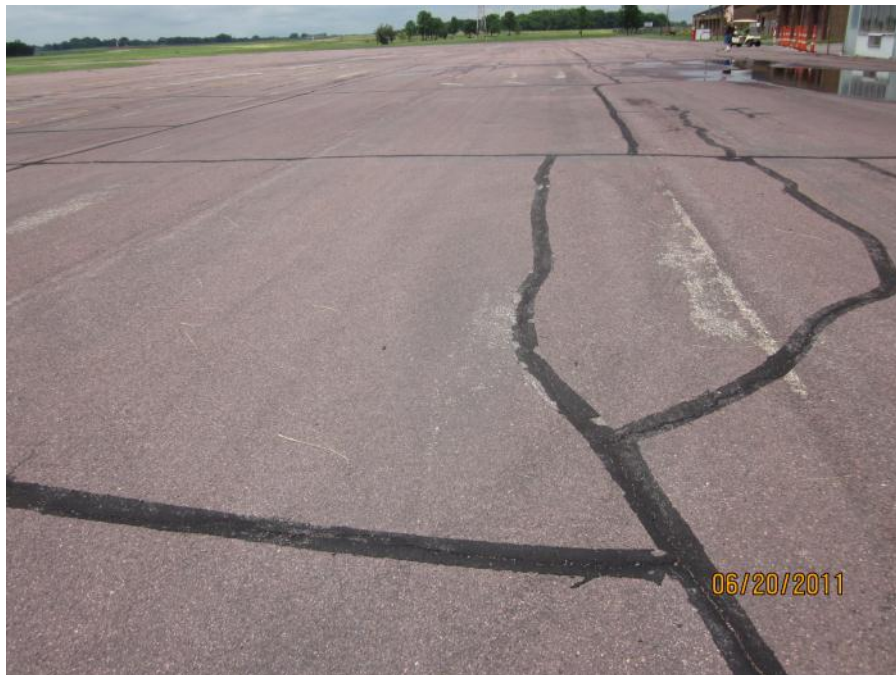
FRM APA 004 (PCI = 58)

| Branch ID | Section ID | Surface type <sup>1</sup> | Section area (SF) | LCD <sup>2</sup> | 2008 PCI | 2011 PCI | Drop in PCI/Yr <sup>3</sup> | % Deduct due to | | Distress types |
|---|---|---|---|---|---|---|---|---|---|---|
| APA | 4 | AAC | 44,000 | 1988 | 73 | 58 | 1.8 | 24 | 76 | Alligator cracking, L&T cracking |

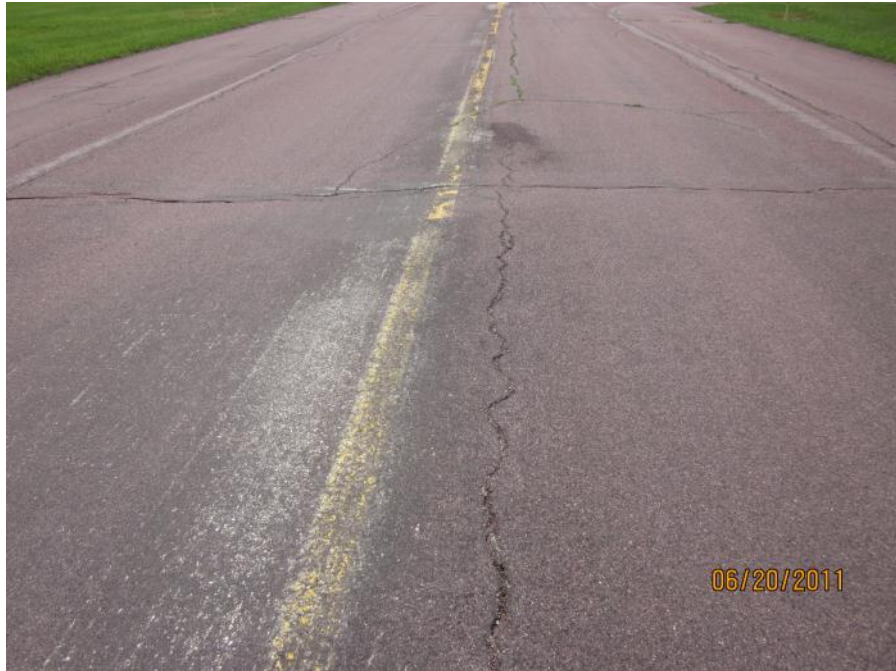
FRM CTB 001 (PCI = 63)

| Branch ID | Section ID | Surface type <sup>1</sup> | Section area (SF) | LCD <sup>2</sup> | 2008 PCI | 2011 PCI | Drop in PCI/Yr <sup>3</sup> | % Deduct due to | | Distress types |
|---|---|---|---|---|---|---|---|---|---|---|
| CTB | 1 | AAC | 16,000 | 1986 | 63 | 63 | 1.5 | 18 | 82 | Alligator cracking, L&T cracking |

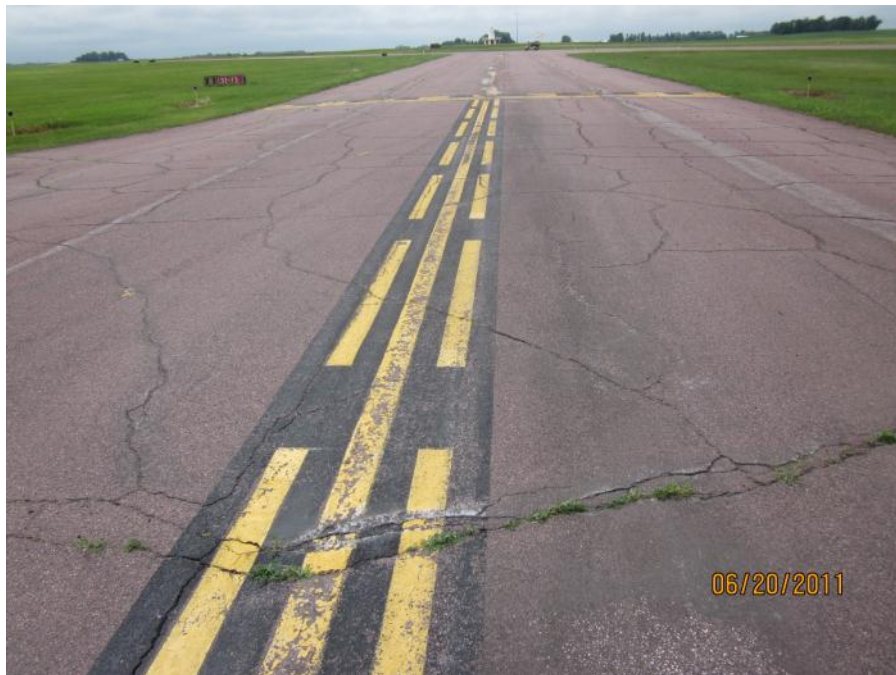
FRM CTB 002 (PCI = 42)

| Branch ID | Section ID | Surface type <sup>1</sup> | Section area (SF) | LCD <sup>2</sup> | 2008 PCI | 2011 PCI | Drop in PCI/Yr <sup>3</sup> | % Deduct due to | | Distress types |
|---|---|---|---|---|---|---|---|---|---|---|
| CTB | 2 | AAC | 13,750 | 1988 | 47 | 42 | 2.5 | 0 | 100 | Block cracking |

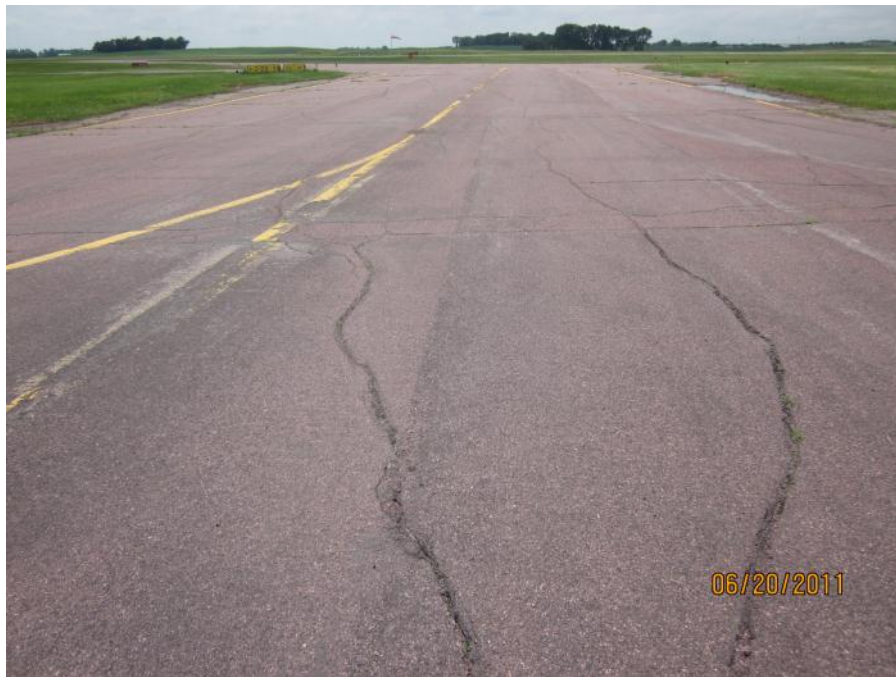
FRM CTBX 001 (PCI = 50)

| Branch ID | Section ID | Surface type <sup>1</sup> | Section area (SF) | LCD <sup>2</sup> | 2008 PCI | 2011 PCI | Drop in PCI/Yr <sup>3</sup> | % Deduct due to | | Distress types |
|---|---|---|---|---|---|---|---|---|---|---|
| CTBX | 1 | AAC | 11,450 | 1986 | 61 | 50 | 2.0 | 43 | 57 | Alligator cracking, Block cracking, L&T cracking |

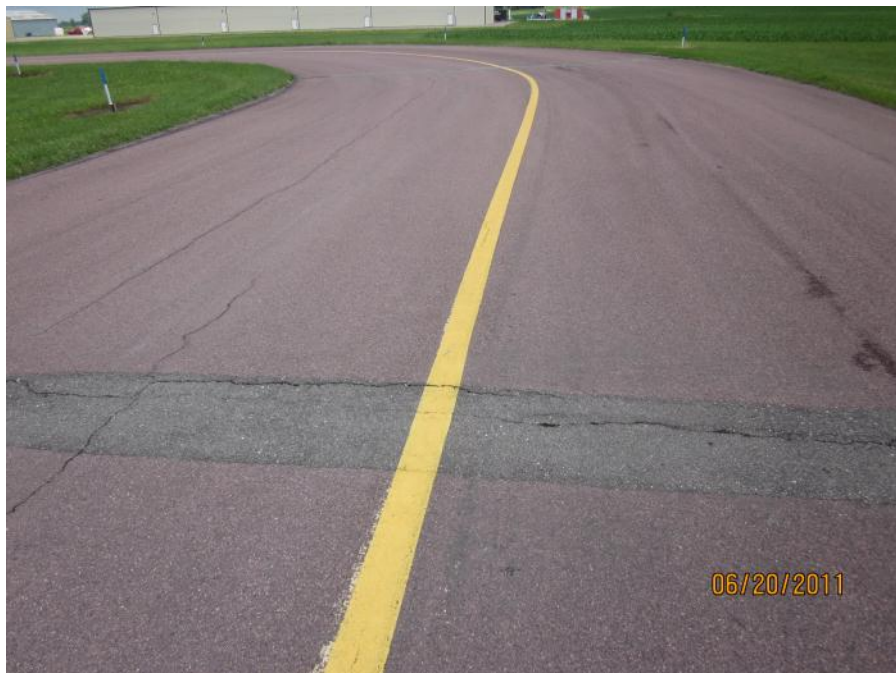
FRM CTC 001 (PCI = 49)

| Branch ID | Section ID | Surface type <sup>1</sup> | Section area (SF) | LCD <sup>2</sup> | 2008 PCI | 2011 PCI | Drop in PCI/Yr <sup>3</sup> | % Deduct due to | | Distress types |
|---|---|---|---|---|---|---|---|---|---|---|
| CTC | 1 | AAC | 22,100 | 1988 | 61 | 49 | 2.2 | 43 | 57 | L&T cracking, Patching, Rutting |

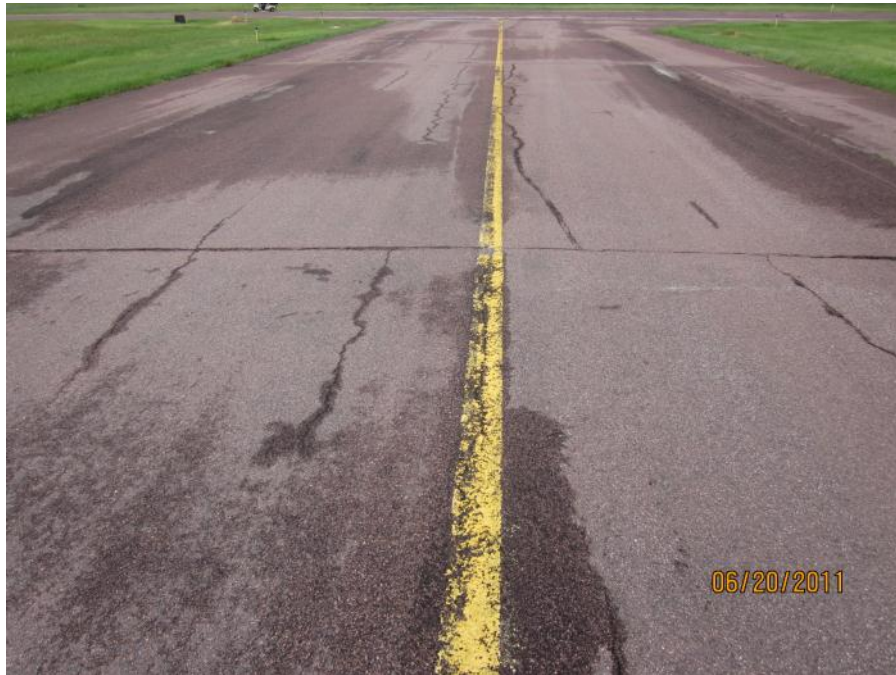
FRM CTE 001 (PCI = 66)

| Branch ID | Section ID | Surface type <sup>1</sup> | Section area (SF) | LCD <sup>2</sup> | 2008 PCI | 2011 PCI | Drop in PCI/Yr <sup>3</sup> | % Deduct due to | | Distress types |
|---|---|---|---|---|---|---|---|---|---|---|
| CTE | 1 | AAC | 18,600 | 1988 | 73 | 66 | 1.5 | 0 | 100 | L&T cracking |

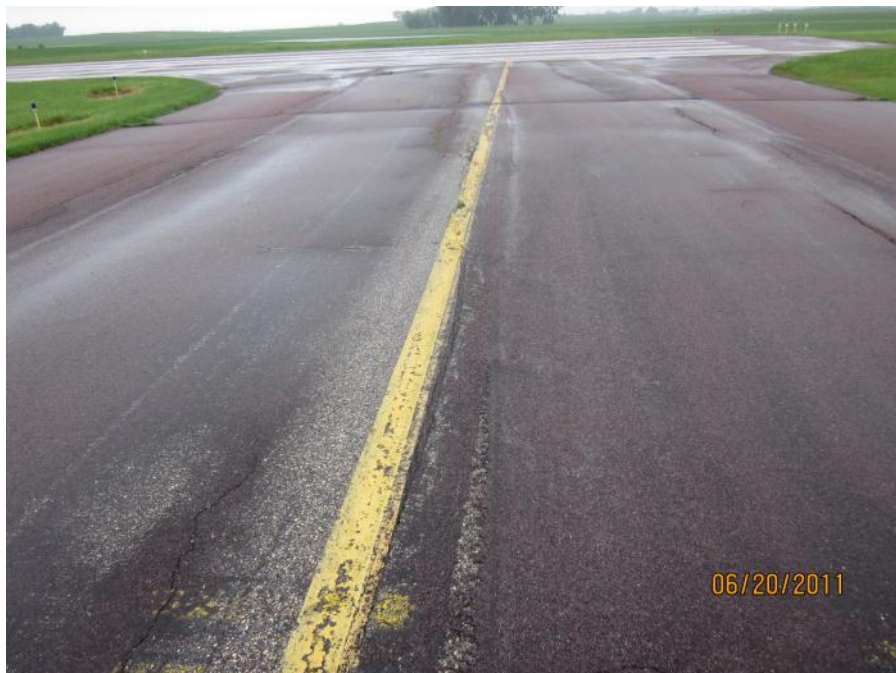
FRM PTA 001 (PCI = 53)

| Branch ID | Section ID | Surface type <sup>1</sup> | Section area (SF) | LCD <sup>2</sup> | 2008 PCI | 2011 PCI | Drop in PCI/Yr <sup>3</sup> | % Deduct due to | | Distress types |
|---|---|---|---|---|---|---|---|---|---|---|
| PTA | 1 | AAC | 5,880 | 1988 | 68 | 53 | 2.0 | 33 | 67 | Alligator cracking, L&T cracking |

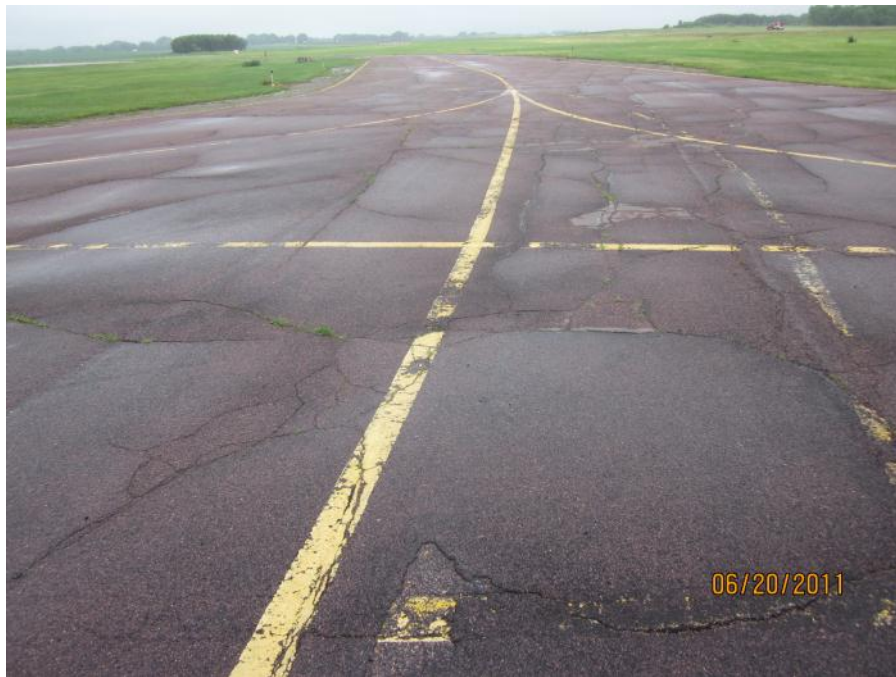
FRM PTA 002 (PCI = 21)

| Branch ID | Section ID | Surface type <sup>1</sup> | Section area (SF) | LCD <sup>2</sup> | 2008 PCI | 2011 PCI | Drop in PCI/Yr <sup>3</sup> | % Deduct due to | | Distress types |
|---|---|---|---|---|---|---|---|---|---|---|
| PTA | 2 | AAC | 33,500 | 1986 | 32 | 21 | 3.2 | 25 | 56 | Alligator cracking, Block cracking, L&T cracking, Rutting, Swelling |

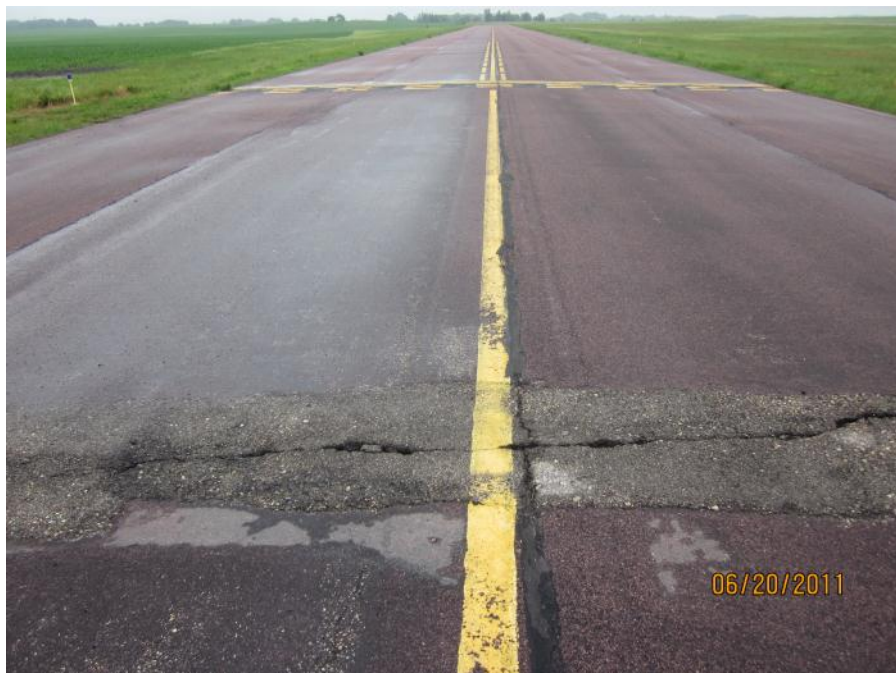
FRM PTA 003 (PCI = 58)

| Branch ID | Section ID | Surface type <sup>1</sup> | Section area (SF) | LCD <sup>2</sup> | 2008 PCI | 2011 PCI | Drop in PCI/Yr <sup>3</sup> | % Deduct due to | | Distress types |
|---|---|---|---|---|---|---|---|---|---|---|
| PTA | 3 | AAC | 220,000 | 1988 | 66 | 58 | 1.8 | 0 | 100 | Linear cracking, joint seal damage |

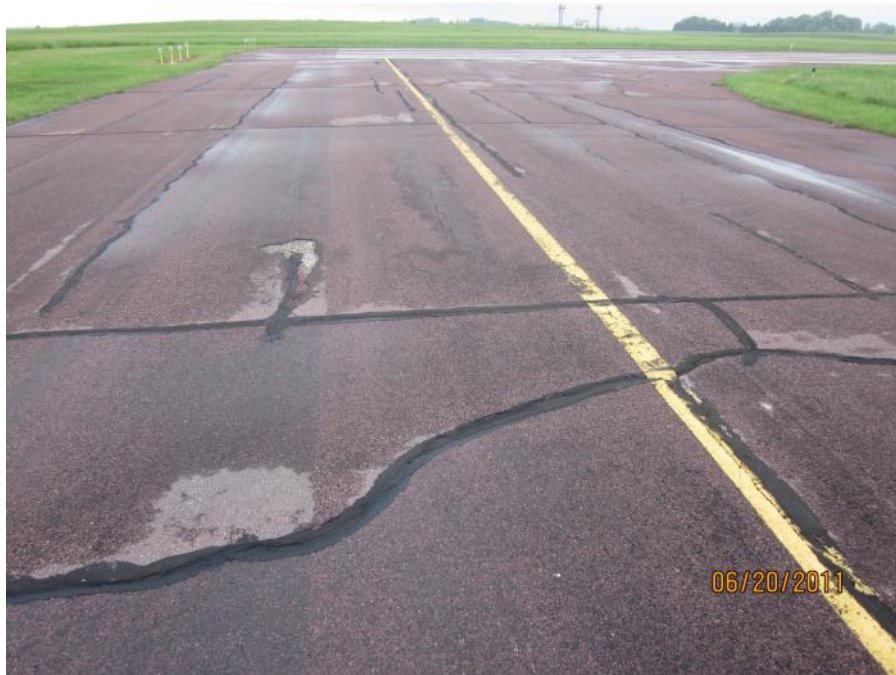
FRM PTA 004 (PCI = 66)

| Branch ID | Section ID | Surface type <sup>1</sup> | Section area (SF) | LCD <sup>2</sup> | 2008 PCI | 2011 PCI | Drop in PCI/Yr <sup>3</sup> | % Deduct due to | | Distress types |
|---|---|---|---|---|---|---|---|---|---|---|
| PTA | 4 | AAC | 41,850 | 1988 | 73 | 66 | 1.5 | 0 | 100 | L&T cracking, Patching |

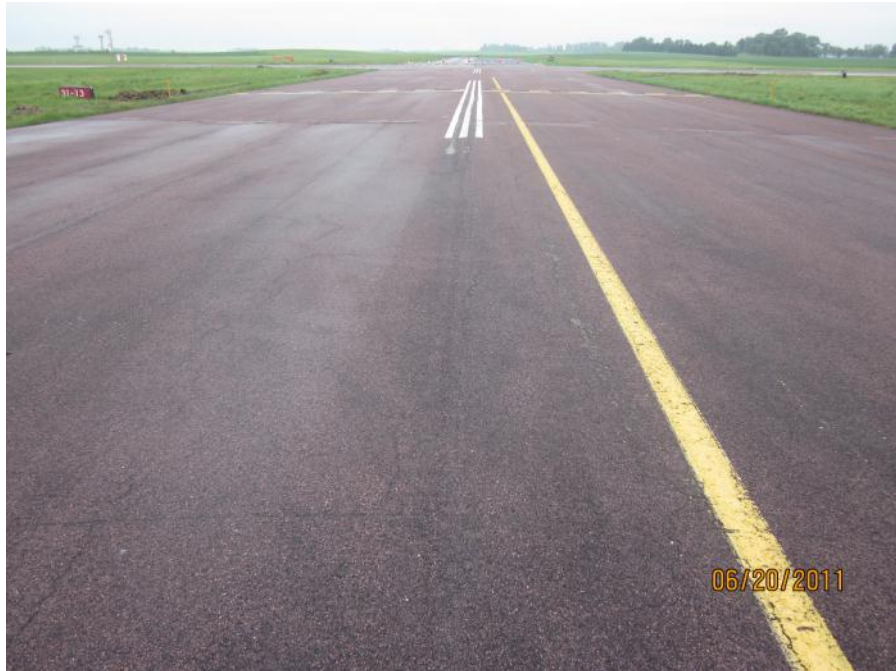
FRM RY220 002 (PCI = 61)

| Branch ID | Section ID | Surface type <sup>1</sup> | Section area (SF) | LCD <sup>2</sup> | 2008 PCI | 2011 PCI | Drop in PCI/Yr <sup>3</sup> | % Deduct due to | | Distress types |
|---|---|---|---|---|---|---|---|---|---|---|
| RY220 | 2 | AAC | 25,500 | 1988 | 65 | 61 | 1.7 | 0 | 100 | L&T cracking |

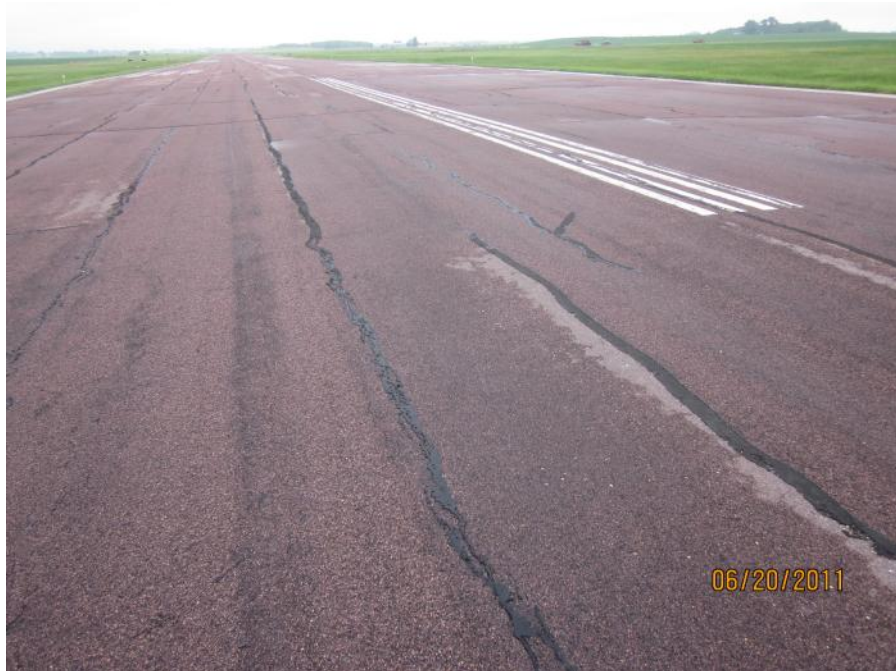
FRM RY1331 001 (PCI = 52)

| Branch ID | Section ID | Surface type <sup>1</sup> | Section area (SF) | LCD <sup>2</sup> | 2008 PCI | 2011 PCI | Drop in PCI/Yr <sup>3</sup> | % Deduct due to | | Distress types |
|---|---|---|---|---|---|---|---|---|---|---|
| RY1331 | 1 | AAC | 50,000 | 1988 | 64 | 52 | 2.1 | 24 | 76 | Alligator cracking, Block cracking, L&T cracking |

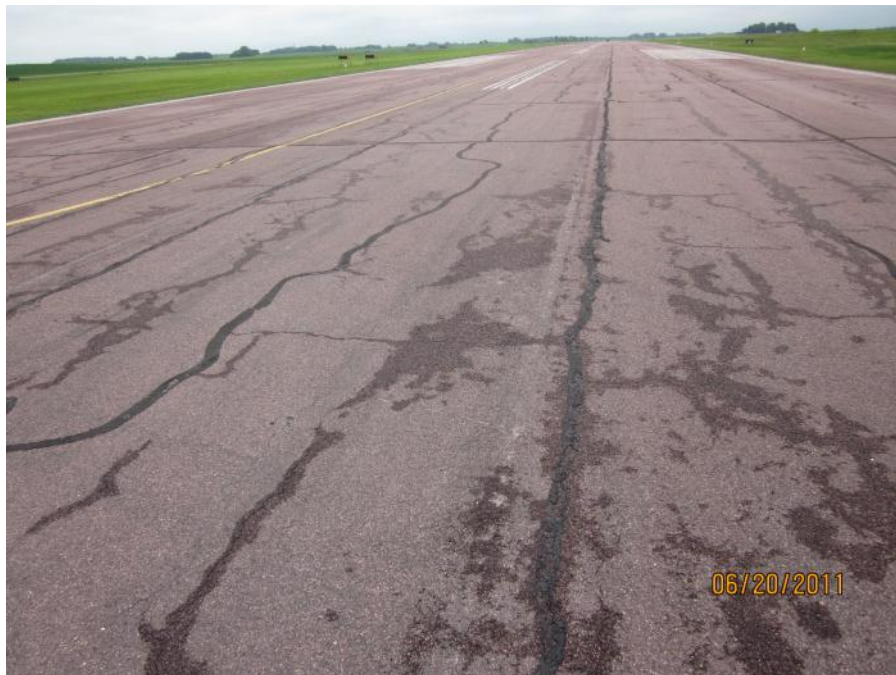
FRM RY1331 002 (PCI = 62)

| Branch ID | Section ID | Surface type <sup>1</sup> | Section area (SF) | LCD <sup>2</sup> | 2008 PCI | 2011 PCI | Drop in PCI/Yr <sup>3</sup> | % Deduct due to | | Distress types |
|---|---|---|---|---|---|---|---|---|---|---|
| RY1331 | 2 | AAC | 500,000 | 1988 | 64 | 62 | 1.7 | 0 | 98 | Block cracking, L&T cracking, Swelling |

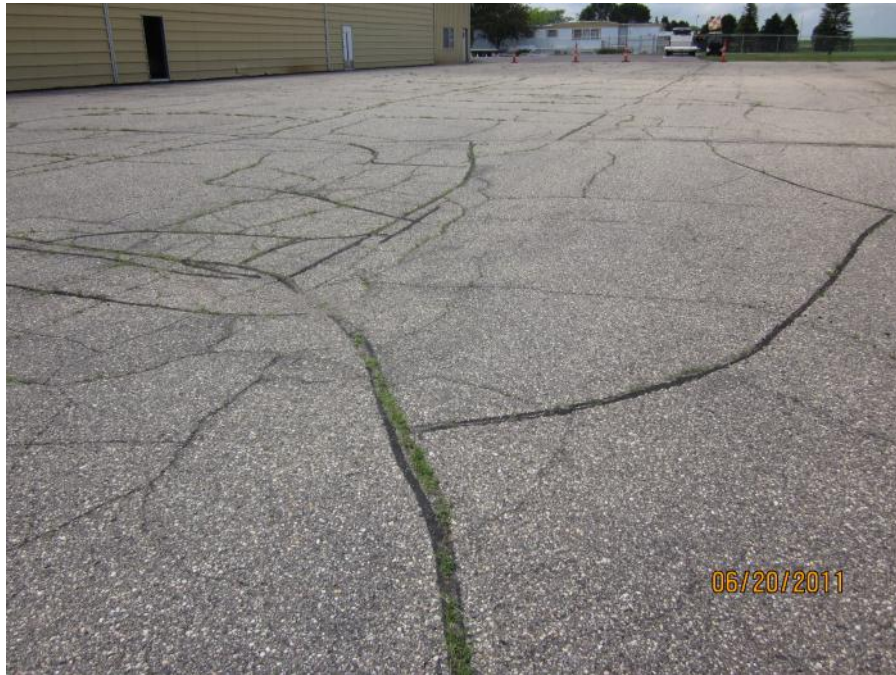
FRM TLA 001 (PCI = 24)

| Branch ID | Section ID | Surface type <sup>1</sup> | Section area (SF) | LCD <sup>2</sup> | 2008 PCI | 2011 PCI | Drop in PCI/Yr <sup>3</sup> | % Deduct due to | | Distress types |
|---|---|---|---|---|---|---|---|---|---|---|
| TLA | 1 | AC | 74,250 | 1977* | 35 | 24 | 2.2 | 45 | 50 | Alligator cracking, Block cracking, Depression, L&T cracking, Rutting, Weathering |

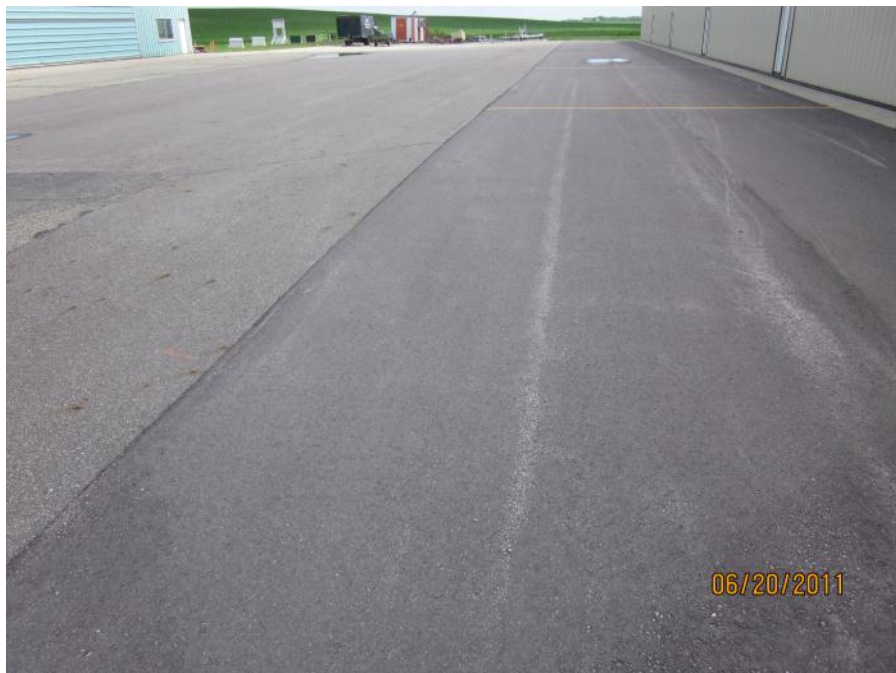
FRM TLA 002 (PCI = 92)

| Branch ID | Section ID | Surface type <sup>1</sup> | Section area (SF) | LCD <sup>2</sup> | 2008 PCI | 2011 PCI | Drop in PCI/Yr <sup>3</sup> | % Deduct due to | | Distress types |
|---|---|---|---|---|---|---|---|---|---|---|
| TLA | 2 | AC | 36,200 | 2008 | 100 | 92 | 2.7 | 0 | 100 | L&T cracking |
