Minnesota Airport System Pavement Evaluation 2011 Update

Glenwood Municipal Airport (GHW)

Glenwood, Minnesota

January 2012

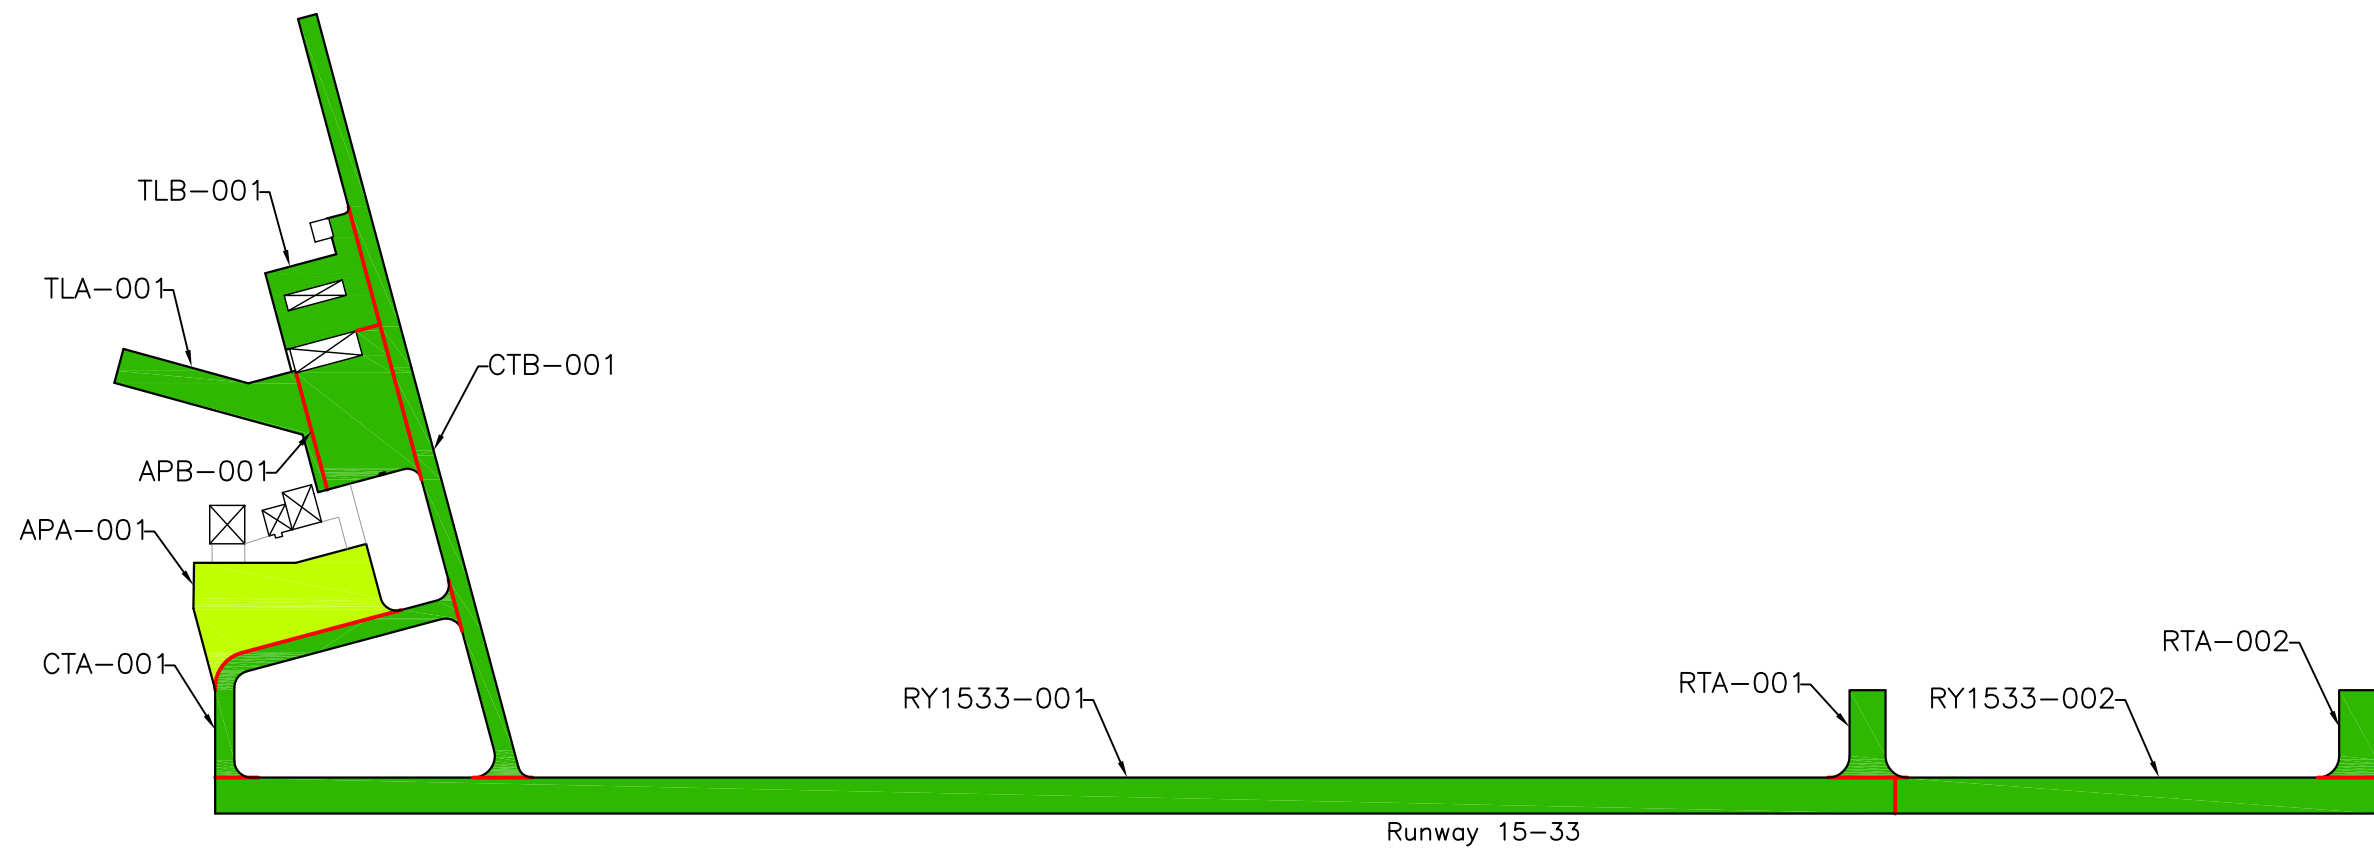
Figure 4. 2011 Pavement Condition Index Rating at Glenwood Municipal Airport (GHW).

Branch ID	Section ID	Surface type ¹	Section area (SF)	LCD ²	2008 PCI	2011 PCI	Drop in PCI/Yr ³	% Deduct due to		Distress types
								Load ⁴	Climate ⁵	
APA	1	AC	70,500	2008	-	83	5.7	36	64	Longitudinal & transverse (L&T) cracking, Rutting
APB	1	AC	52,500	2008	-	89	3.7	0	100	L&T cracking
CTA	1	AC	29,250	2008	-	96	1.3	0	100	L&T cracking
CTB	1	AC	64,615	2008	-	97	1.0	0	61	L&T cracking
RTA	1	AC	14,500	2008	-	100	0.0	0	0	-
RTA	2	AC	14,075	2008	-	100	0.0	0	0	-
RY1533	1	AC	262,500	2008	-	100	0.0	0	0	-
RY1533	2	AC	75,000	2008	-	99	0.3	0	100	L&T cracking
TLA	1	AC	30,670	2008	-	97	1.0	0	100	L&T cracking
TLB	1	AC	33,595	2008	-	96	1.3	0	100	L&T cracking

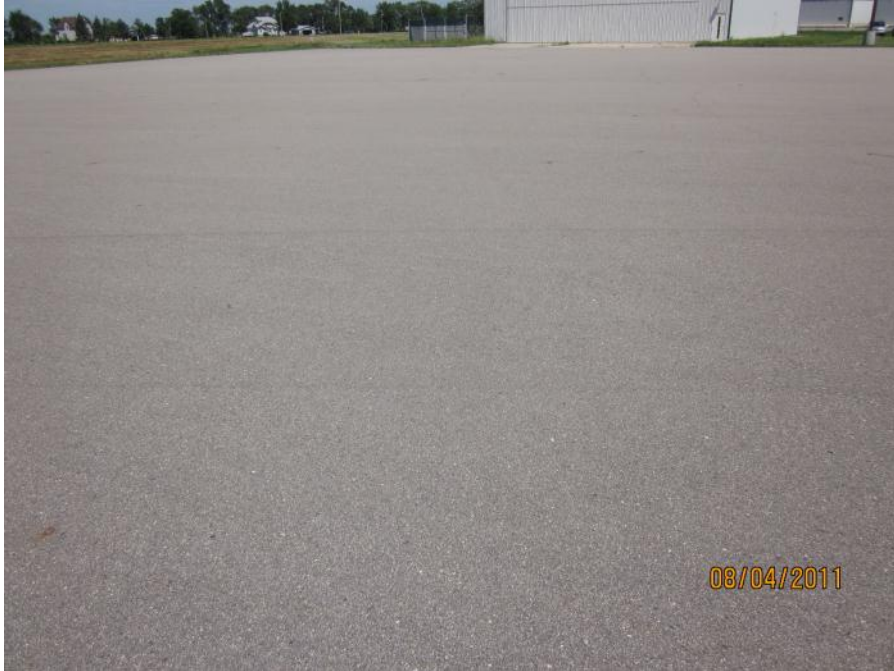
GHW APA 001 (PCI = 83)

Conditions: PCI : 83

48 LONGITUDINAL/TRANSVERSE CRACKING L 118.00 Ft Comments:

48 LONGITUDINAL/TRANSVERSE CRACKING M 4.00 Ft Comments:

48 LONGITUDINAL/TRANSVERSE CRACKING L 192.00 Ft Comments:

48 LONGITUDINAL/TRANSVERSE CRACKING L 188.00 Ft Comments:

Branch ID	Section ID	Distress Type	Severity	Treatment	Estimated Quantity	Unit	Cost
APA	1	L & T CR	M	Crack Sealing - AC	19	Ft	\$20
CTA	1	L & T CR	M	Crack Sealing - AC	12	Ft	\$13
CTB	1	OIL SPILLAGE	N	Patching - AC Shallow	170	SqFt	\$1,134
Airport Total							\$1,167

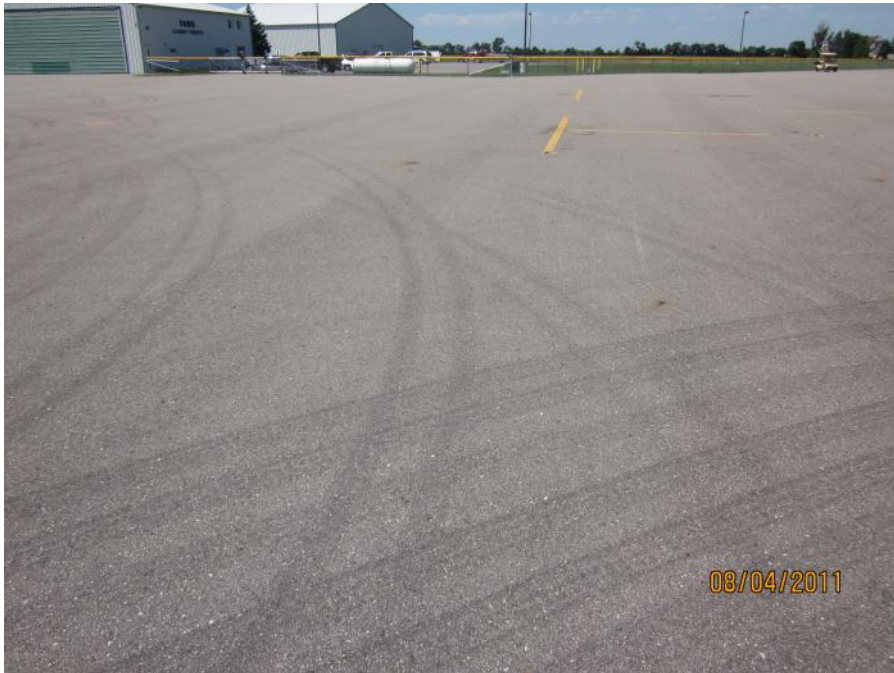
GHW APB 001 (PCI = 89)

Conditions: PCI : 89

48 LONGITUDINAL/TRANSVERSE CRACKING L 156.00 Ft Comments:

48 LONGITUDINAL/TRANSVERSE CRACKING L 192.00 Ft Comments:

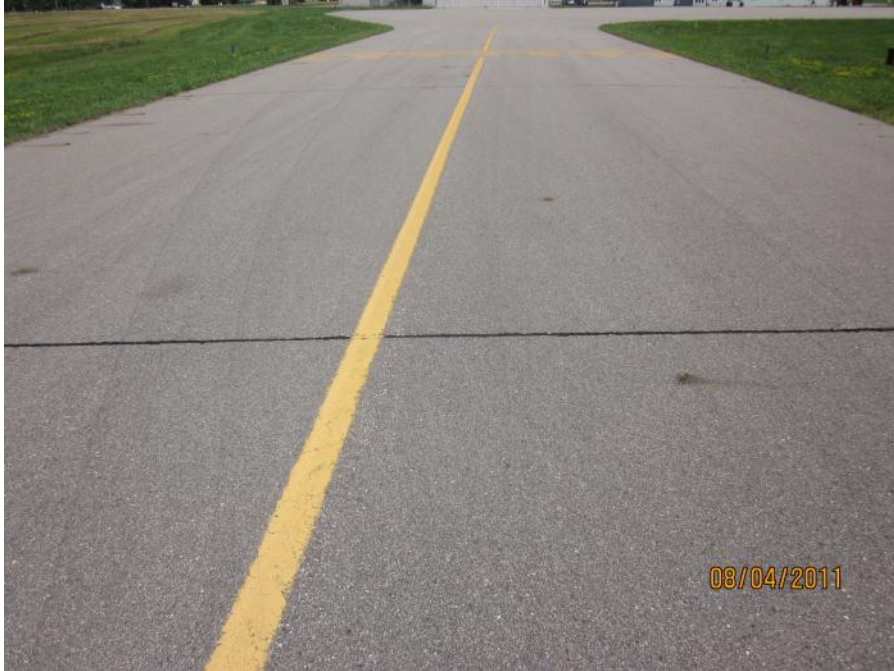
GHW CTA 001 (PCI = 96)

Conditions: PCI: 96

48 LONGITUDINAL/TRANSVERSE CRACKING L 96.00 Ft Comments:

48 LONGITUDINAL/TRANSVERSE CRACKING M 5.00 Ft Comments:

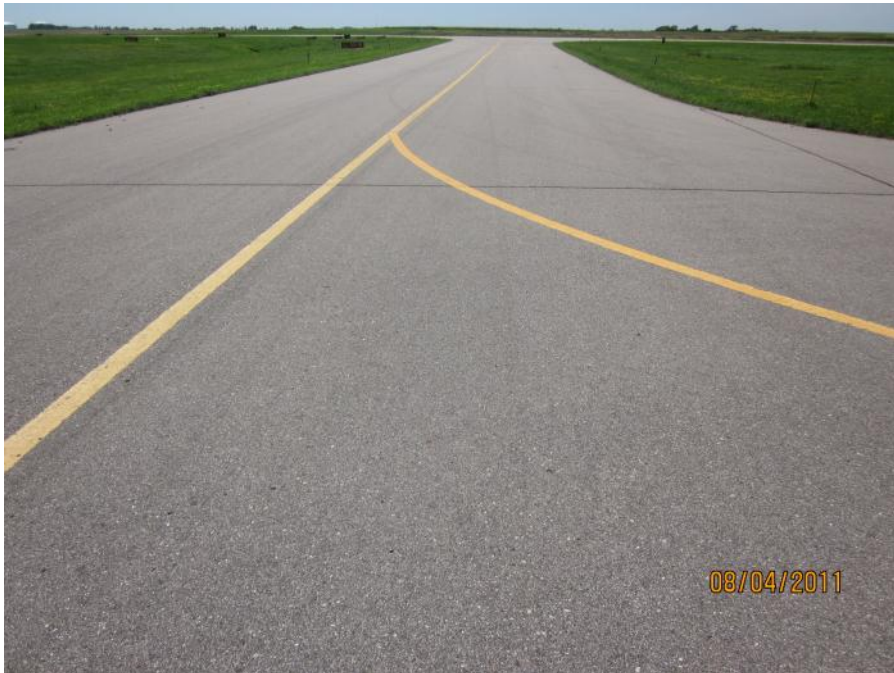
GHW CTB 001 (PCI = 97)

Conditions: PCI : 97

48 LONGITUDINAL/TRANSVERSE CRACKING L 15.00 Ft Comments:

48 LONGITUDINAL/TRANSVERSE CRACKING L 43.00 Ft Comments:

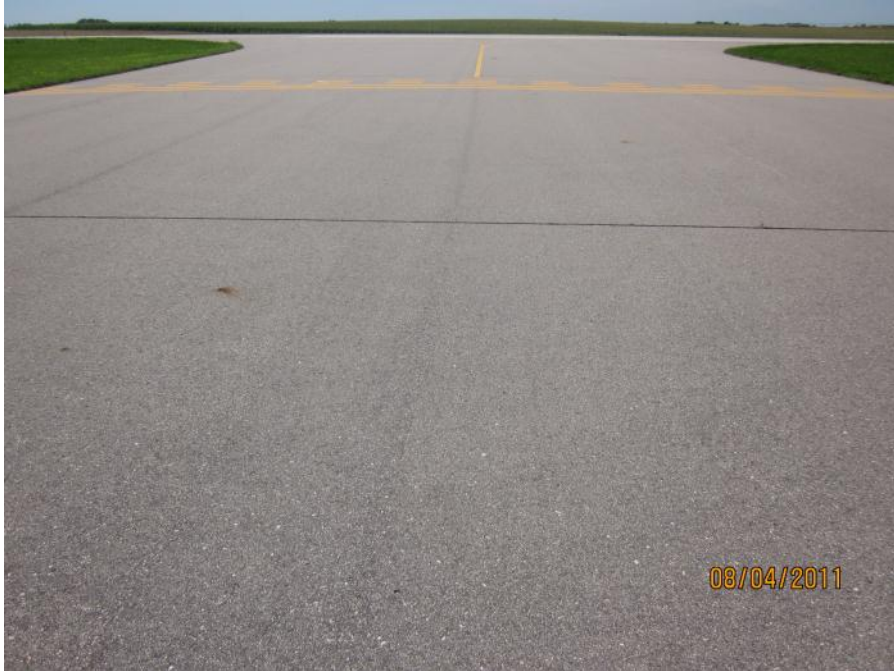
GHW RTA 001 (PCI = 100)

Conditions: PCI: 100

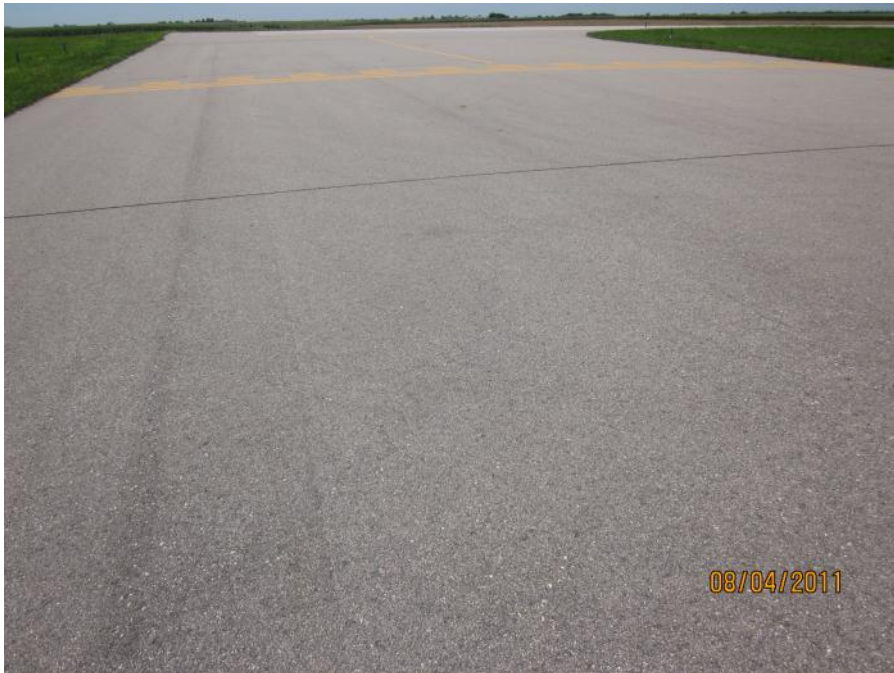
GHW RTA 002 (PCI = 100)

Conditions: PCI: 100

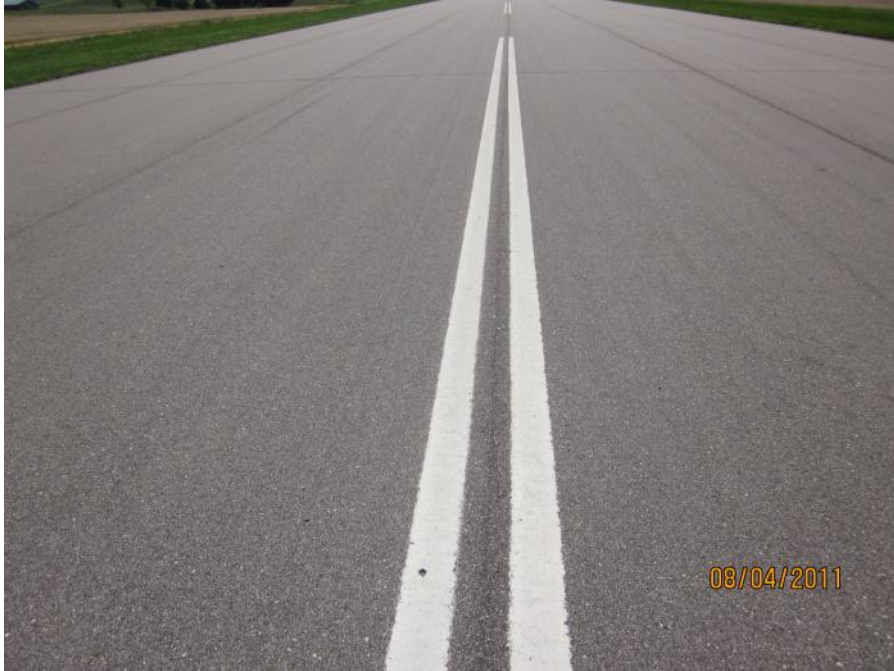
GHW RY1533 001 (PCI = 100)

Conditions: PCI: 100

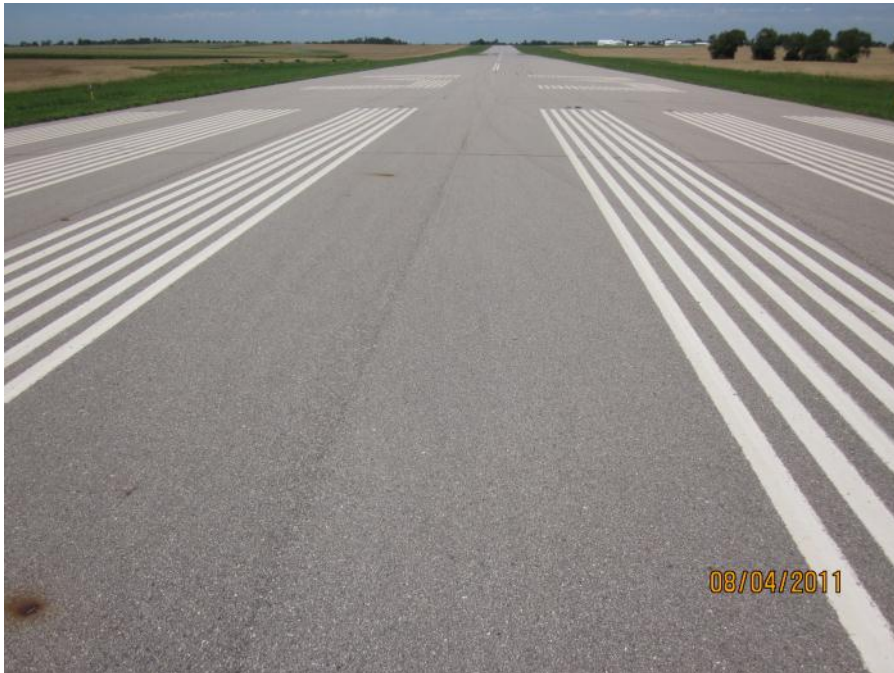
GHW RY1533 002 (PCI = 99)

Conditions: PCI: 99

48 LONGITUDINAL/TRANSVERSE CRACKING L 5.00 Ft Comments:

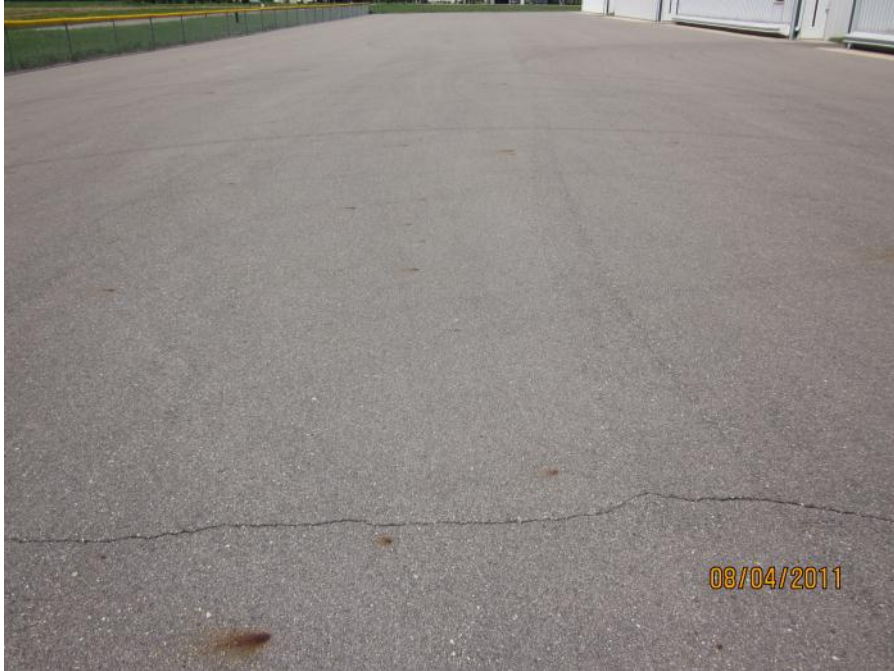
GHW TLA 001 (PCI = 97)

Conditions: PCI : 97

48 LONGITUDINAL/TRANSVERSE CRACKING L 42.00 Ft Comments:

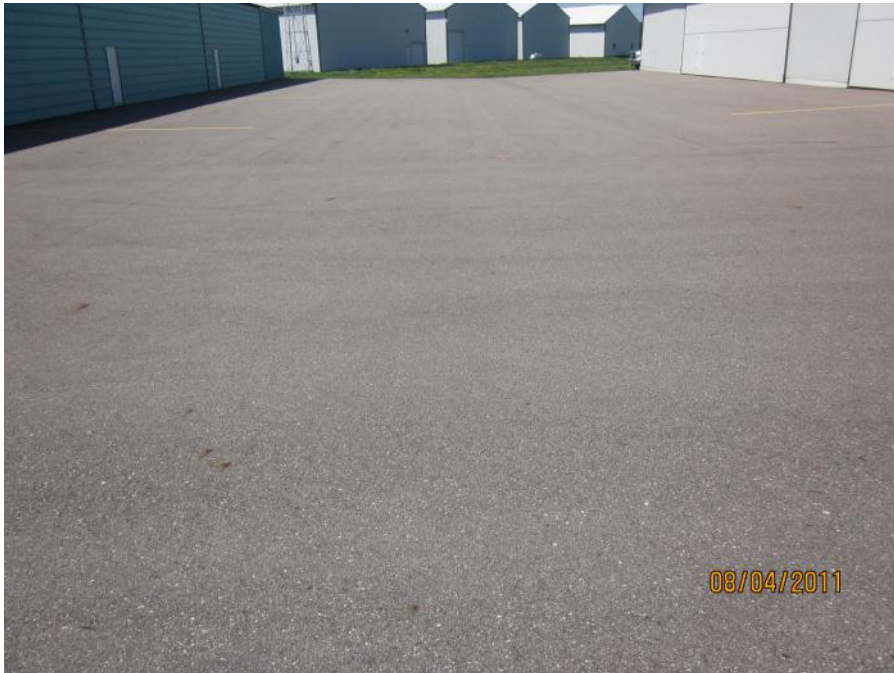
GHW TLB 001 (PCI = 96)

Conditions: PCI: 96

48 LONGITUDINAL/TRANSVERSE CRACKING L 105.00 Ft Comments:

48 LONGITUDINAL/TRANSVERSE CRACKING L 26.00 Ft Comments:
