# Minnesota Airport System Pavement Evaluation 2011 Update

Hallock Municipal Airport (HCO)

Hallock, Minnesota

January 2012

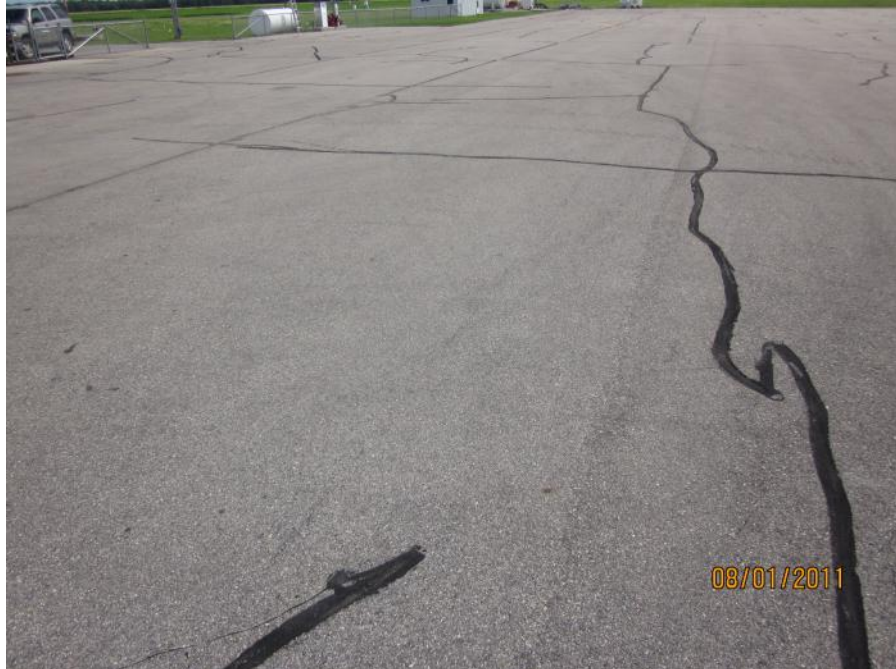
HCO APA 001 (PCI = 71)

| Branch ID | Section ID | Surface type <sup>1</sup> | Section area (SF) | LCD <sup>2</sup> | 2008 PCI | 2011 PCI | Drop in PCI/Yr <sup>3</sup> | % Deduct due to | | Distress types |
|---|---|---|---|---|---|---|---|---|---|---|
| APA | 1 | AAC | 60,000 | 2004 | 78 | 71 | 4.1 | 0 | 100 | Longitudinal & transverse (L&T) cracking |

48 LONGITUDINAL/TRANSVERSE CRACKING L 547.00 Ft Comments:  
48 LONGITUDINAL/TRANSVERSE CRACKING M 31.00 Ft Comments:

48 LONGITUDINAL/TRANSVERSE CRACKING L 553.00 Ft Comments:  
48 LONGITUDINAL/TRANSVERSE CRACKING M 10.00 Ft Comments:

48 LONGITUDINAL/TRANSVERSE CRACKING L 490.00 Ft Comments:  
48 LONGITUDINAL/TRANSVERSE CRACKING M 5.00 Ft Comments:

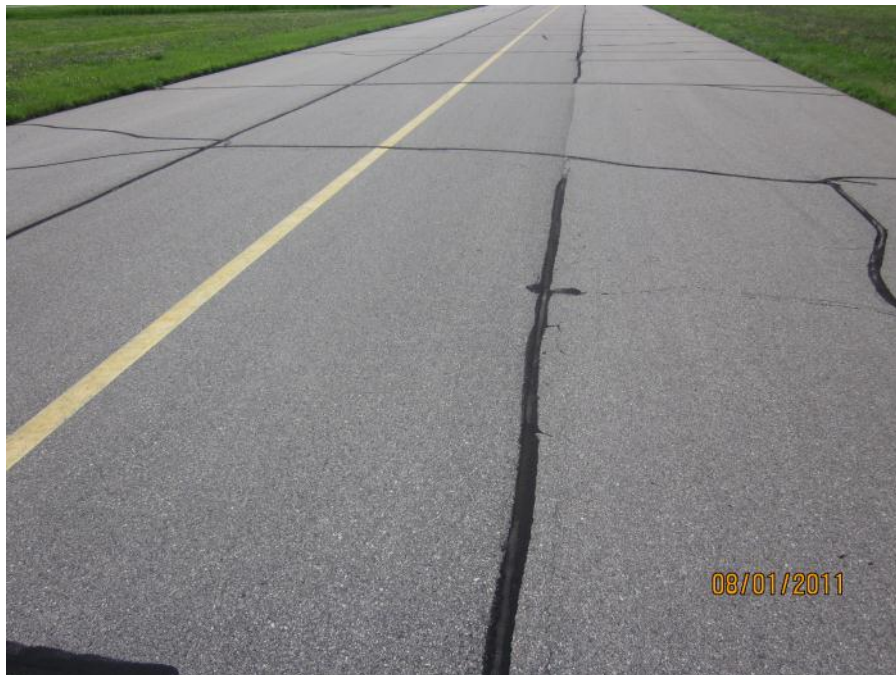
HCO CTA 001 (PCI = 68)

| Branch ID | Section ID | Surface type <sup>1</sup> | Section area (SF) | LCD <sup>2</sup> | 2008 PCI | 2011 PCI | Drop in PCI/Yr <sup>3</sup> | % Deduct due to | | Distress types |
|---|---|---|---|---|---|---|---|---|---|---|
| CTA | 1 | AAC | 24,435 | 2004 | 72 | 68 | 4.6 | 0 | 100 | L&T cracking |

48 LONGITUDINAL/TRANSVERSE CRACKING L 548.00 Ft Comments:  
48 LONGITUDINAL/TRANSVERSE CRACKING M 30.00 Ft Comments:

48 LONGITUDINAL/TRANSVERSE CRACKING L 503.00 Ft Comments:  
48 LONGITUDINAL/TRANSVERSE CRACKING M 48.00 Ft Comments:

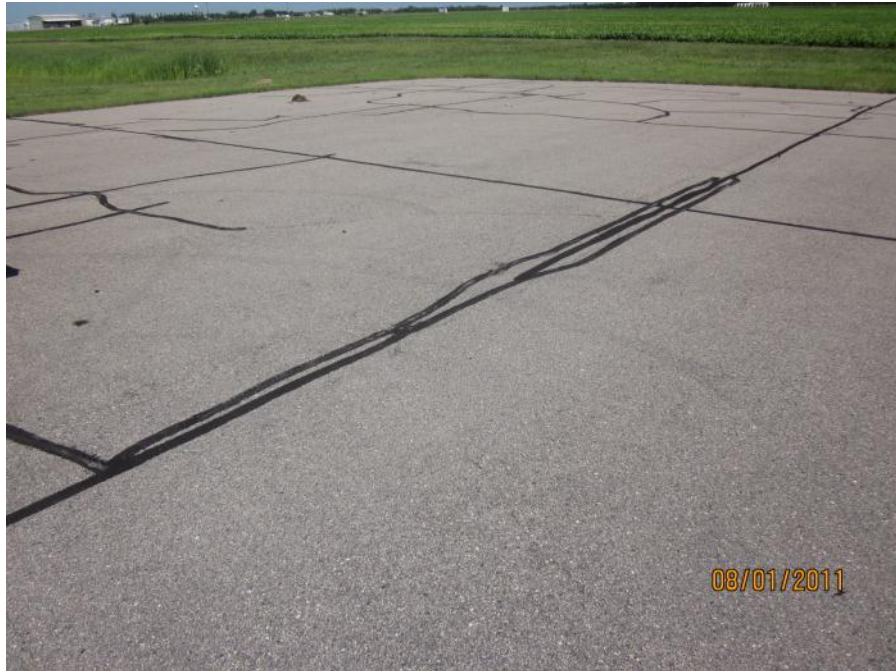
HCO RTA 001 (PCI = 67)

| Branch ID | Section ID | Surface type <sup>1</sup> | Section area (SF) | LCD <sup>2</sup> | 2008 PCI | 2011 PCI | Drop in PCI/Yr <sup>3</sup> | % Deduct due to | | Distress types |
|---|---|---|---|---|---|---|---|---|---|---|
| RTA | 1 | AAC | 8,525 | 2004 | 83 | 67 | 4.7 | 0 | 100 | L&T cracking |

48 LONGITUDINAL/TRANSVERSE CRACKING L 453.00 Ft Comments:

48 LONGITUDINAL/TRANSVERSE CRACKING M 68.00 Ft Comments:

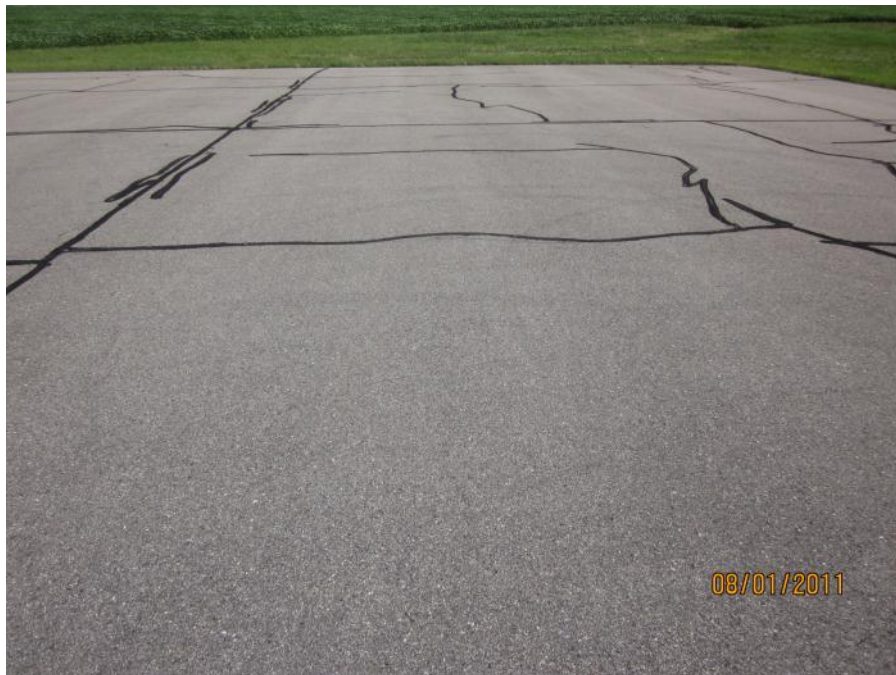
HCO RTA 002 (PCI = 65)

| Branch ID | Section ID | Surface type <sup>1</sup> | Section area (SF) | LCD <sup>2</sup> | 2008 PCI | 2011 PCI | Drop in PCI/Yr <sup>3</sup> | % Deduct due to | | Distress types |
|---|---|---|---|---|---|---|---|---|---|---|
| RTA | 2 | AAC | 8,525 | 2004 | 80 | 65 | 5.0 | 19 | 81 | Alligator cracking, L&T cracking |

48 LONGITUDINAL/TRANSVERSE CRACKING L 496.00 Ft Comments:

48 LONGITUDINAL/TRANSVERSE CRACKING M 44.00 Ft Comments:

41 ALLIGATOR CRACKING L 9.00 SqFt Comments:

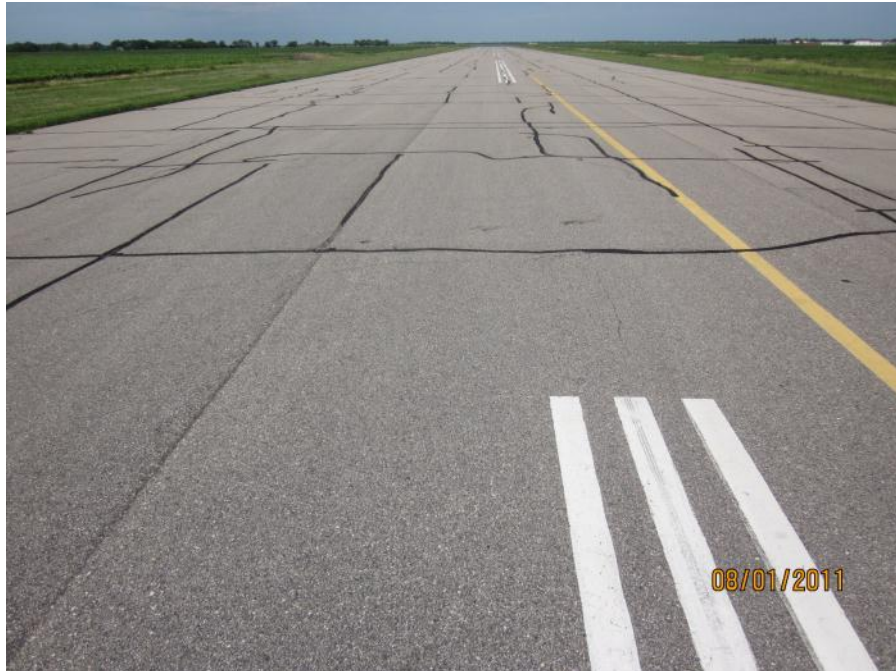
HCO RY1331 001 (PCI = 65)

| Branch ID | Section ID | Surface type <sup>1</sup> | Section area (SF) | LCD <sup>2</sup> | 2008 PCI | 2011 PCI | Drop in PCI/Yr <sup>3</sup> | % Deduct due to | | Distress types |
|---|---|---|---|---|---|---|---|---|---|---|
| RY1331 | 1 | AAC | 300,525 | 2004 | 71 | 65 | 5.0 | 0 | 100 | L&T cracking |

48 LONGITUDINAL/TRANSVERSE CRACKING L 713.00 Ft Comments:  
48 LONGITUDINAL/TRANSVERSE CRACKING M 62.00 Ft Comments:

48 LONGITUDINAL/TRANSVERSE CRACKING L 646.00 Ft Comments:  
48 LONGITUDINAL/TRANSVERSE CRACKING M 37.00 Ft Comments:

48 LONGITUDINAL/TRANSVERSE CRACKING L 557.00 Ft Comments:  
48 LONGITUDINAL/TRANSVERSE CRACKING M 58.00 Ft Comments:

48 LONGITUDINAL/TRANSVERSE CRACKING L 680.00 Ft Comments:  
48 LONGITUDINAL/TRANSVERSE CRACKING M 53.00 Ft Comments:

48 LONGITUDINAL/TRANSVERSE CRACKING L 549.00 Ft Comments:  
48 LONGITUDINAL/TRANSVERSE CRACKING M 51.00 Ft Comments:

48 LONGITUDINAL/TRANSVERSE CRACKING L 708.00 Ft Comments:  
48 LONGITUDINAL/TRANSVERSE CRACKING M 23.00 Ft Comments:

48 LONGITUDINAL/TRANSVERSE CRACKING L 609.00 Ft Comments:  
48 LONGITUDINAL/TRANSVERSE CRACKING M 40.00 Ft Comments:

48 LONGITUDINAL/TRANSVERSE CRACKING L 573.00 Ft Comments:  
48 LONGITUDINAL/TRANSVERSE CRACKING M 29.00 Ft Comments:

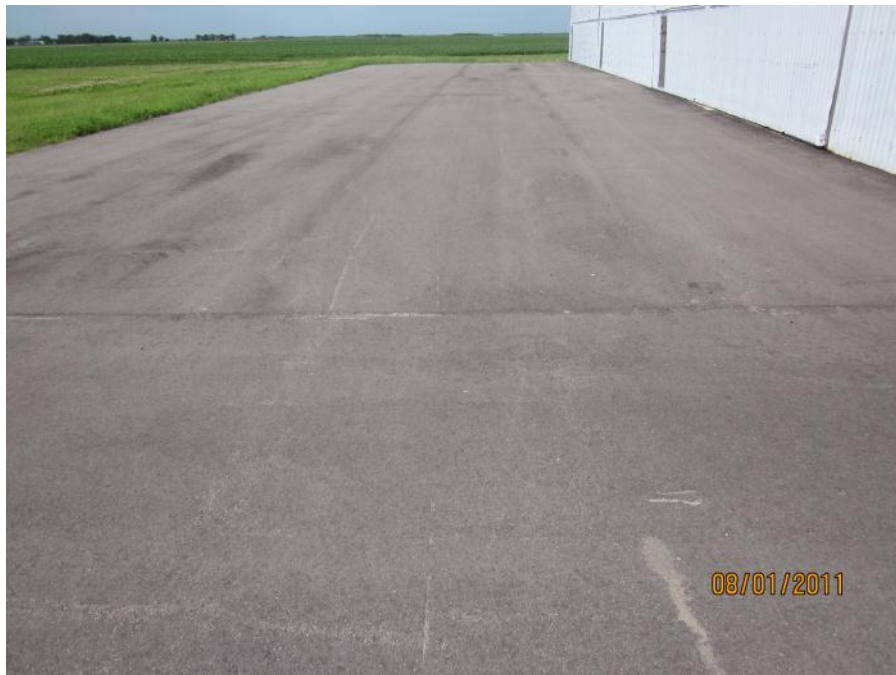
HCO TLA 001 (PCI = 100)

| Branch ID | Section ID | Surface type <sup>1</sup> | Section area (SF) | LCD <sup>2</sup> | 2008 PCI | 2011 PCI | Drop in PCI/Yr <sup>3</sup> | % Deduct due to | | Distress types |
|---|---|---|---|---|---|---|---|---|---|---|
| TLA | 1 | AAC | 18,750 | 2010 | - | 100 | 0.0 | 0 | 0 | L&T cracking |

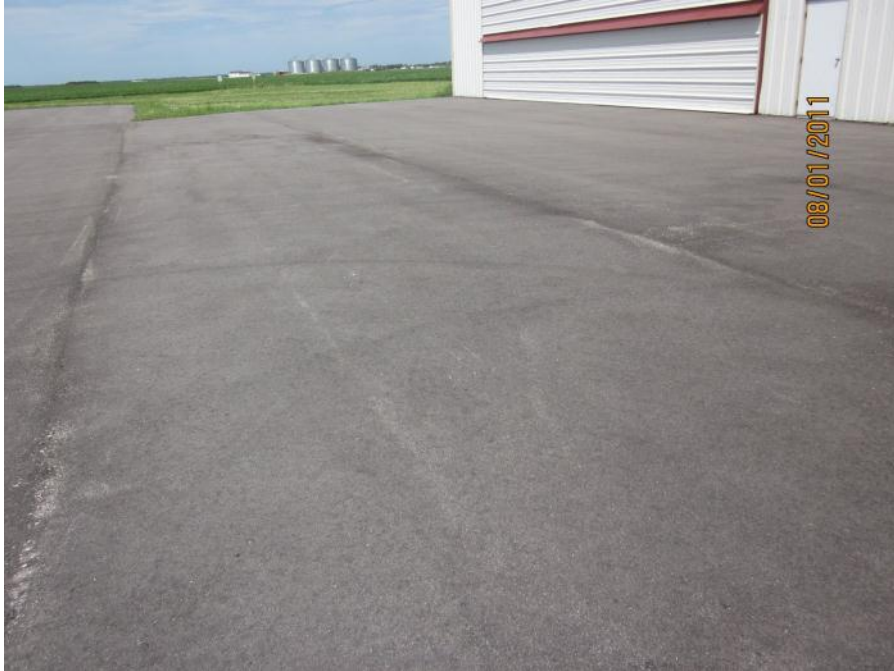
HCO TLA 002 (PCI = 100)

| Branch ID | Section ID | Surface type <sup>1</sup> | Section area (SF) | LCD <sup>2</sup> | 2008 PCI | 2011 PCI | Drop in PCI/Yr <sup>3</sup> | % Deduct due to | | Distress types |
|---|---|---|---|---|---|---|---|---|---|---|
| TLA | 2 | AAC | 5,200 | 2010 | - | 100 | 0.0 | 0 | 0 | L&T cracking |
