Minnesota Airport System Pavement Evaluation 2011 Update

Range Regional Airport (HIB)

Hibbing, Minnesota

January 2012

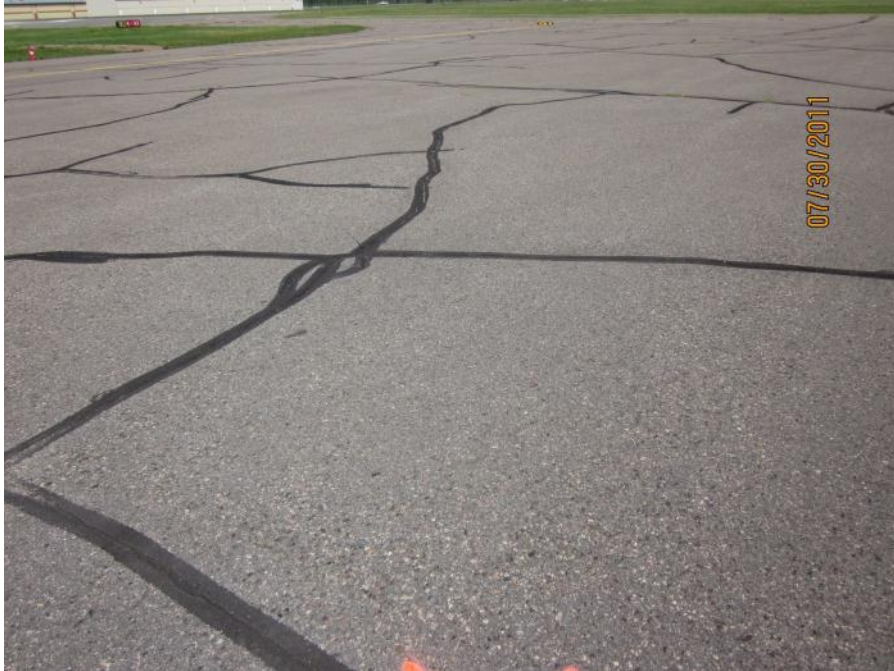
HIB ADNR 001 (PCI = 32)

Conditions: PCI : 32

41 ALLIGATOR CRACKING	L	215.00	SqFt	Comments:
48 LONGITUDINAL/TRANSVERSE CRACKING	L	418.00	Ft	Comments:
48 LONGITUDINAL/TRANSVERSE CRACKING	M	117.00	Ft	Comments:
52 RAVELING	L	5,190.00	SqFt	Comments:
45 DEPRESSION	L	168.00	SqFt	Comments:
53 RUTTING	L	80.00	SqFt	Comments:

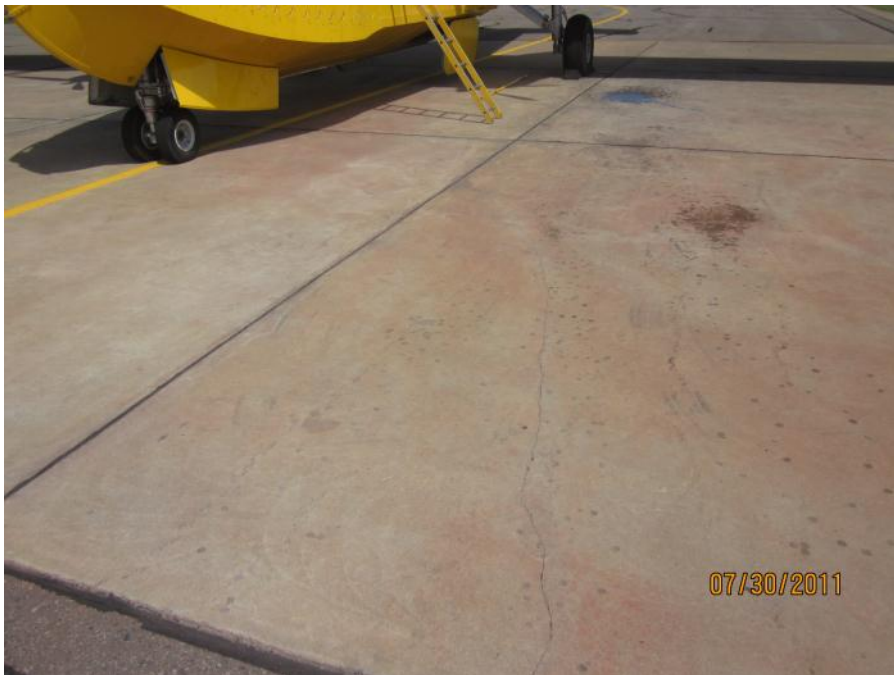
HIB ADNR 002 (PCI = 74)

Conditions: PCI : 74

63 LINEAR CRACKING L 5.00 Slabs Comments:
62 CORNER BREAK L 1.00 Slabs Comments:
73 SHRINKAGE CRACKING N 5.00 Slabs Comments:

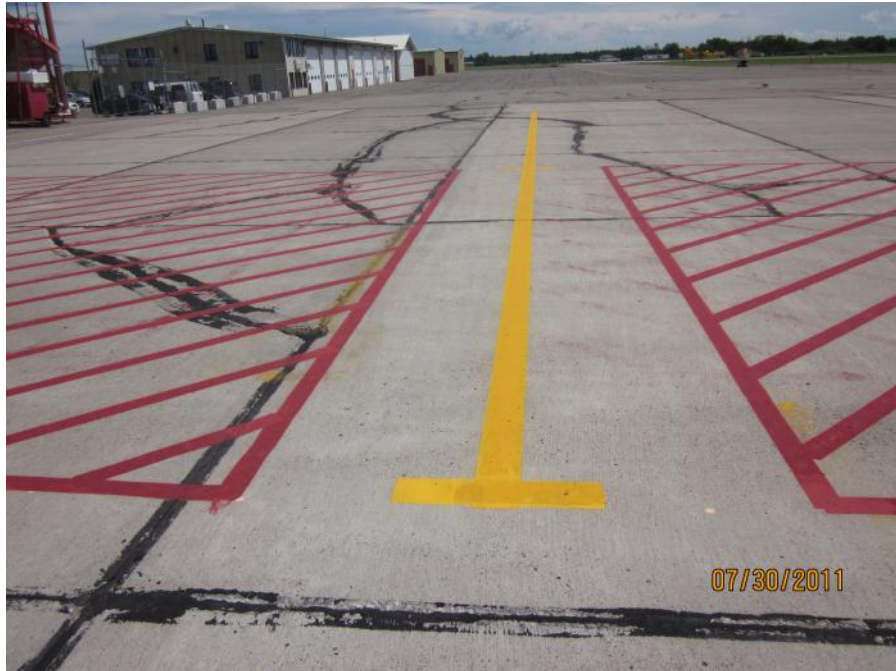
HIB APA 001 (PCI = 39)

Conditions: PCI: 39

63 LINEAR CRACKING	M	11.00 Slabs	Comments:
63 LINEAR CRACKING	L	1.00 Slabs	Comments:
64 DURABILITY CRACKING	L	4.00 Slabs	Comments:
71 FAULTING	L	2.00 Slabs	Comments:
72 SHATTERED SLAB	M	1.00 Slabs	Comments:
75 CORNER SPALLING	L	1.00 Slabs	Comments:
75 CORNER SPALLING	M	1.00 Slabs	Comments:
65 JOINT SEAL DAMAGE	H	20.00 Slabs	Comments:

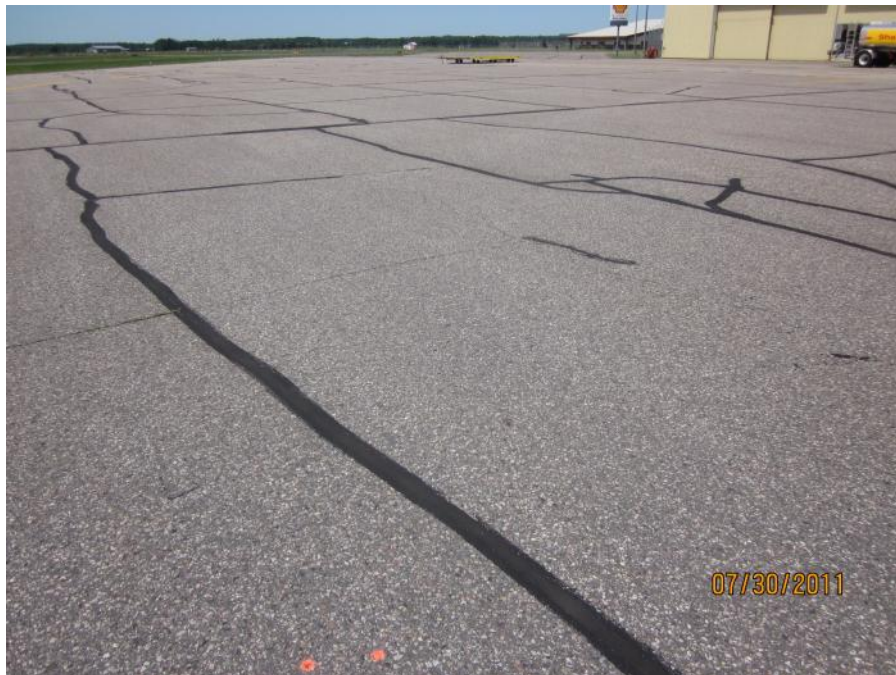
HIB APA 002 (PCI = 35)

Conditions: PCI : 35

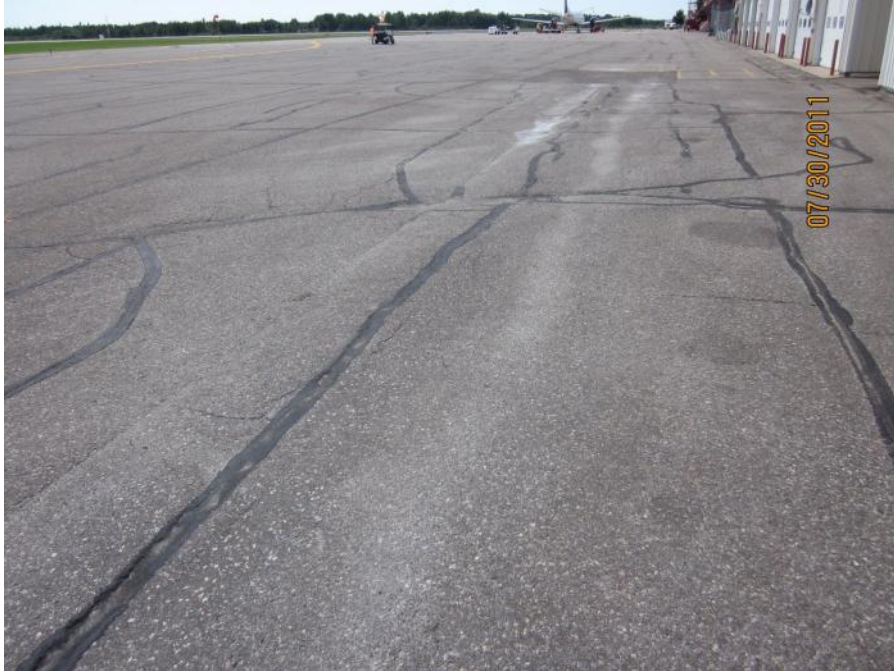
HIB APA 003 (PCI = 35)

Conditions: PCI : 35

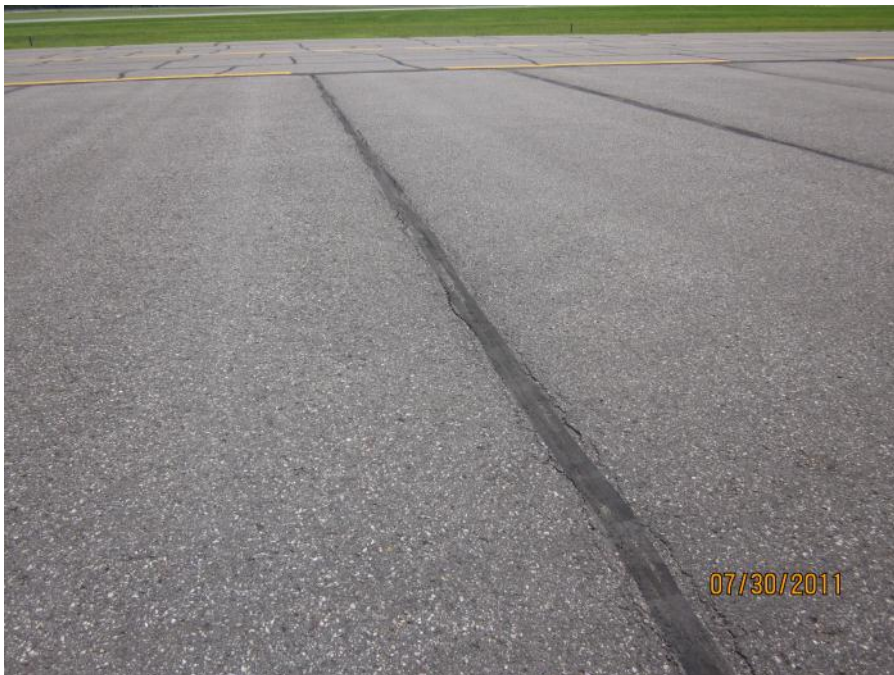
HIB APA 004 (PCI = 59)

Conditions: PCI : 59

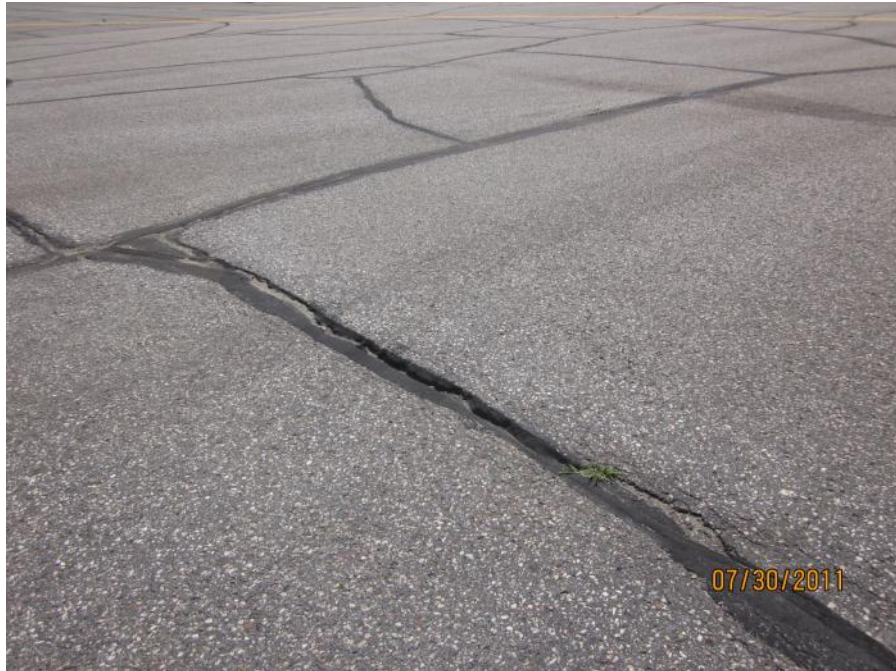
HIB APA 005 (PCI = 34)

Conditions: PCI : 34

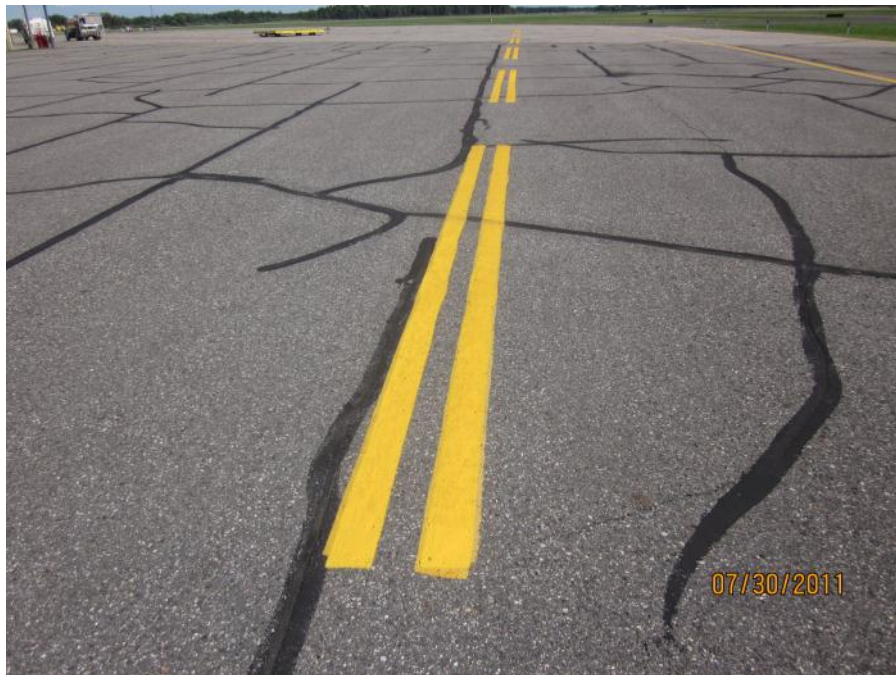
HIB APB 001 (PCI = 55)

APB	1	AC	45,900	1977	69	55	1.3	0	97	L&T cracking, Oil spillage, Raveling
APC	1	AAC	56,550	2000*	71	71	2.6	32	66	Alligator cracking, L&T cracking, Patching, Rutting, Swelling
APC	2	AAC	67,890	2000*	52	54	4.2	34	65	L&T cracking, Raveling, Rutting, Swelling
CTA	1	AAC	11,275	2009	-	100	0.0	0	0	-
CTA	2	AAC	68,100	1991	48	33	3.4	48	52	Alligator cracking, Block cracking, L&T cracking, Raveling, Rutting
CTA	3	AC	8,770	2008	100	100	0.0	0	0	-
CTA1	1	AC	43,500	2008	100	100	0.0	0	0	-
CTB	1	AC	75,720	2009	-	100	0.0	0	0	-
CTB	2	AC	145,250	1991	62	58	2.1	29	71	Alligator cracking, Block cracking, L&T cracking
CTB	3	AAC	10,400	2009	-	100	0.0	0	0	-

Conditions: PCI : 55

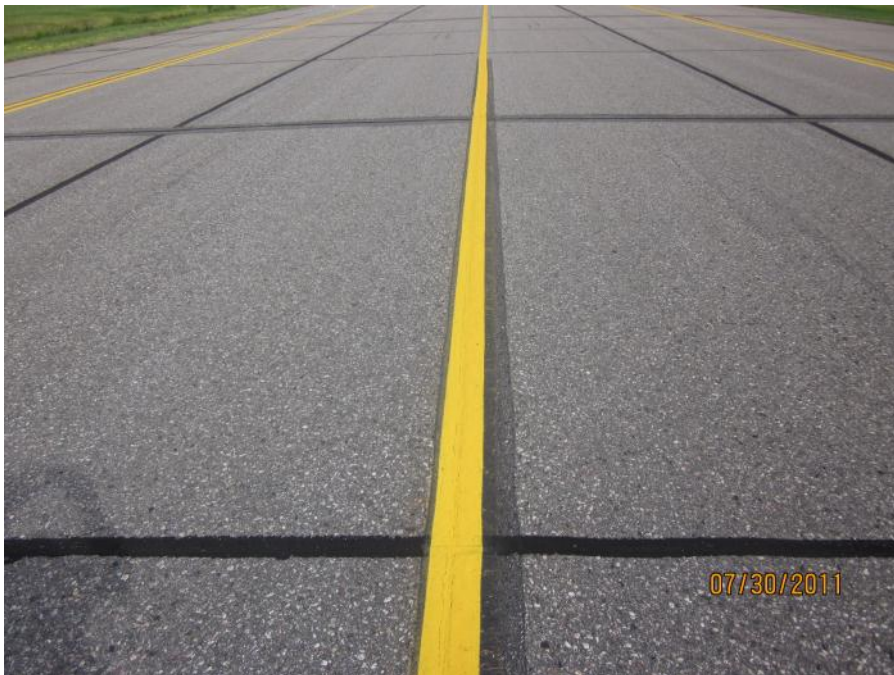
HIB PTC 001 (PCI = 62)

Branch ID	Section ID	Surface type ¹	Section area (SF)	LCD ²	2008 PCI	2011 PCI	Drop in PCI/Yr ³	% Deduct due to		Distress types
								Load ⁴	Climate ⁵	
PTC	1	AC	166,500	1984	73	62	1.4	0	98	Bleeding, L&T cracking, Patching, Raveling
PTC	2	AC	66,600	1984	71	58	1.6	0	100	L&T cracking, Patching, Raveling
PTC	3	AC	66,600	1984	73	59	1.5	0	100	L&T cracking, Patching, Raveling
PTC	4	AC	77,250	2008	100	100	0.0	0	0	-
PTC	5	AC	82,000	2008	100	100	0.0	0	0	-
RY1331	1	AC	85,000	2009	-	99	0.5	0	100	L&T cracking
RY1331	2	AC	85,000	2009	-	99	0.5	0	100	L&T cracking
RY1331	3	AC	85,000	2009	-	100	0.0	0	0	-
RY1331	4	AC	252,500	2009	-	100	0.0	0	0	-
RY1331	5	AC	252,500	2009	-	98	1.0	0	100	L&T cracking
RY1331	6	AC	252,500	2009	-	100	0.0	0	0	-
RY422	1	AC	61,500	2009	-	99	0.5	0	100	L&T cracking
RY422	2	AC	75,375	2009	-	99	0.5	0	100	L&T cracking
RY422	3	AC	109,500	2009	-	99	0.5	0	100	L&T cracking
TLA	1	AC	55,200	1975*	47	35	1.8	28	72	Block cracking, Depression, Patching, Raveling, Rutting

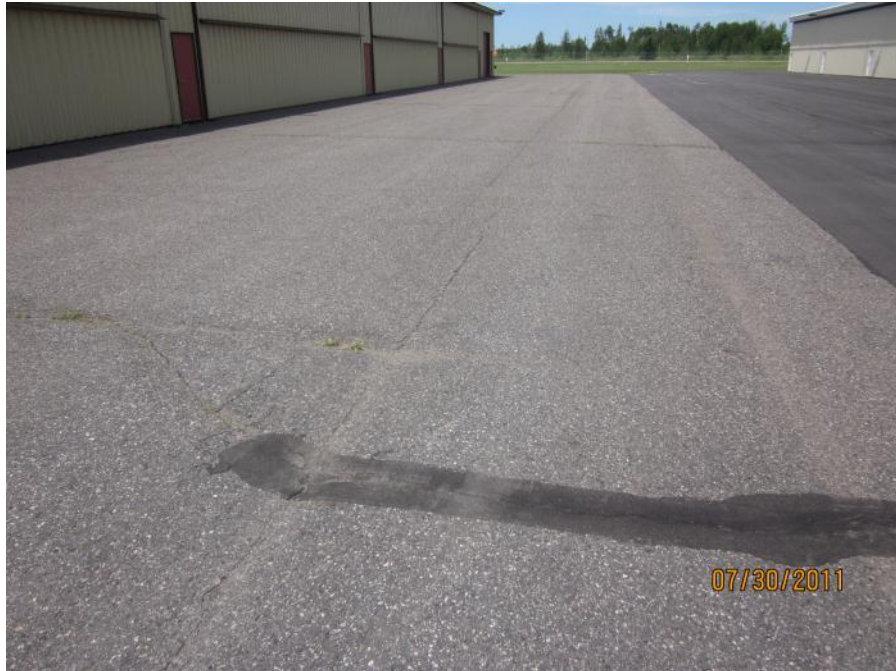
HIB TLA 002 (PCI = 45)

TLA	2	AC	39,400	1995*	45	45	3.4	52	48	Alligator cracking, L&T cracking, Raveling, Rutting
TLA	3	AC	14,850	2000*	45	40	5.5	18	82	L&T cracking, Patching, Raveling, Rutting
TLA	4	AC	43,565	2010	-	100	0.0	0	0	-
