# Minnesota Airport System Pavement Evaluation 2011 Update

Mankato Municipal Airport (MKT)

Mankato, Minnesota

January 2012

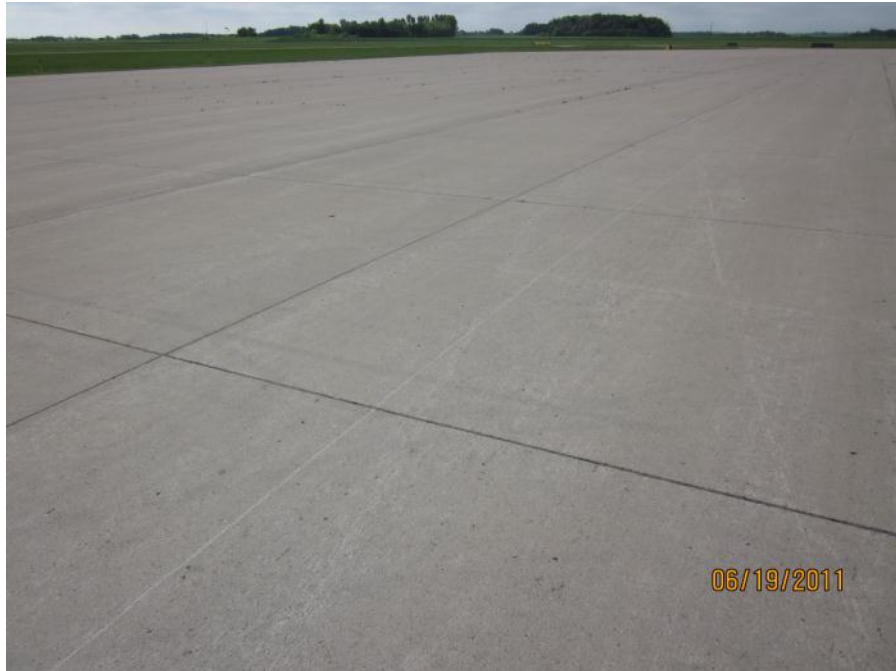
MKT APA 001 (PCI = 94)

| Branch ID | Section ID | Surface type <sup>1</sup> | Section area (SF) | LCD <sup>2</sup> | 2008 PCI | 2011 PCI | Drop in PCI/Yr <sup>3</sup> | % Deduct due to | | Distress types |
|---|---|---|---|---|---|---|---|---|---|---|
| APA | 1 | PCC | 143,000 | 1996 | 96 | 94 | 0.4 | 53 | 23 | Linear cracking, Joint seal damage, Small patch, Shattered slab, Corner spall |

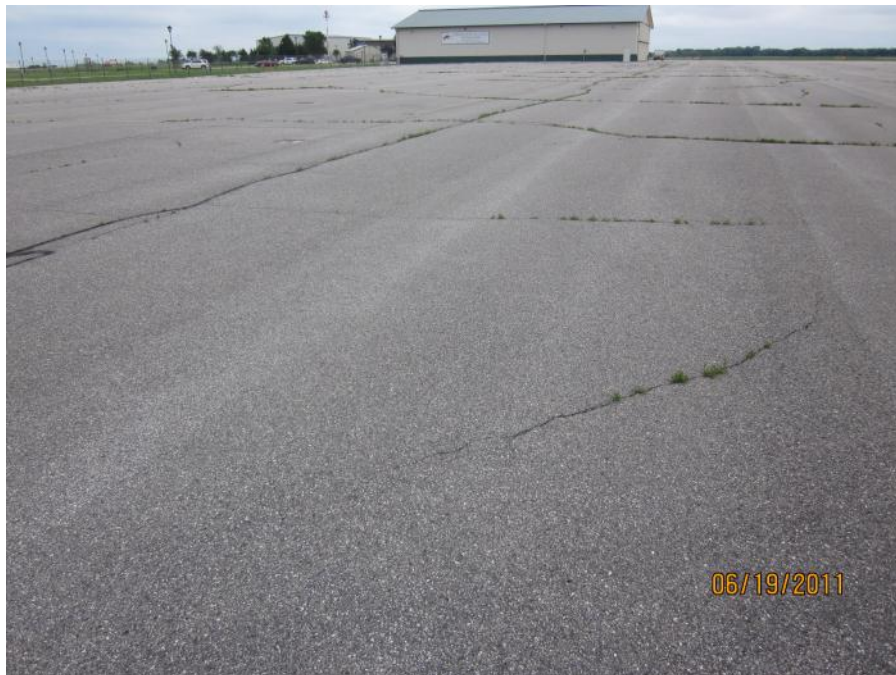
MKT APB 001 (PCI = 76)

| Branch ID | Section ID | Surface type <sup>1</sup> | Section area (SF) | LCD <sup>2</sup> | 2008 PCI | 2011 PCI | Drop in PCI/Yr <sup>3</sup> | % Deduct due to | | Distress types |
|---|---|---|---|---|---|---|---|---|---|---|
| APB | 1 | AAC | 99,000 | 2002* | 81 | 76 | 2.7 | 0 | 100 | Longitudinal & transverse (L&T) cracking |

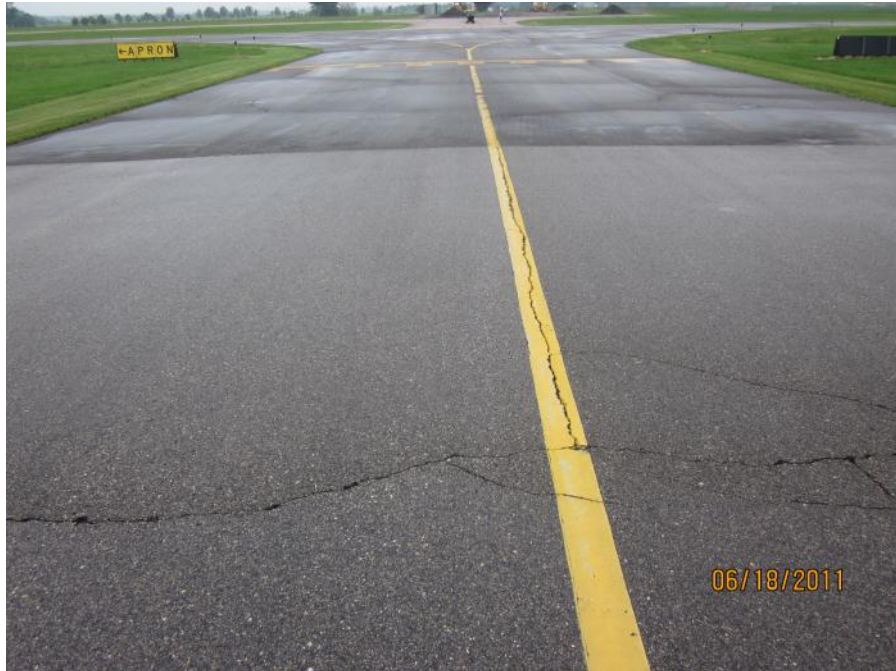
MKT CTA2 001 (PCI = 73)

| Branch ID | Section ID | Surface type <sup>1</sup> | Section area (SF) | LCD <sup>2</sup> | 2008 PCI | 2011 PCI | Drop in PCI/Yr <sup>3</sup> | % Deduct due to | | Distress types |
|---|---|---|---|---|---|---|---|---|---|---|
| CTA2 | 1 | AAC | 17,350 | 1997 | 80 | 73 | 1.9 | 0 | 100 | L&T cracking |

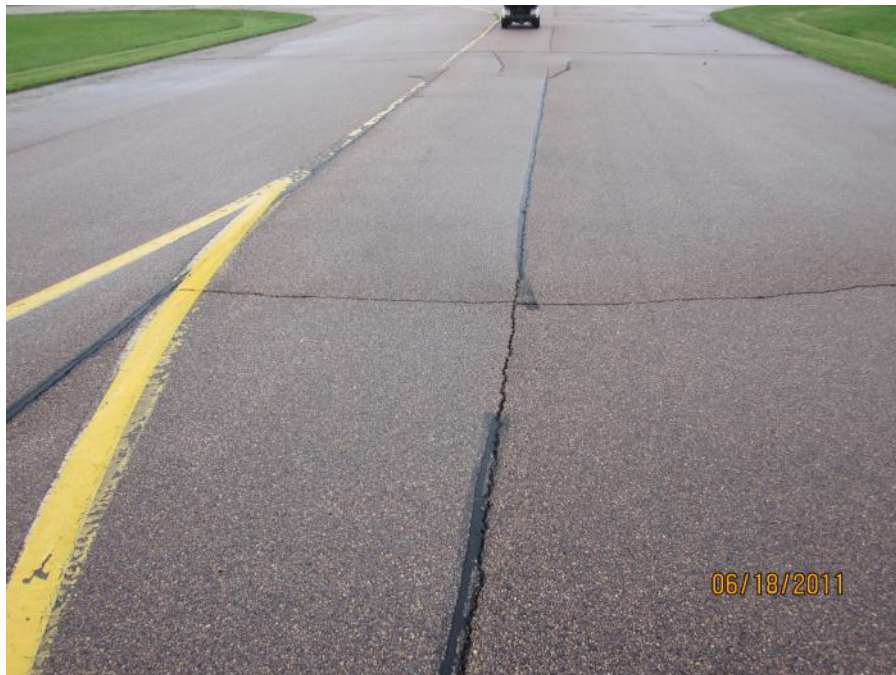
MKT CTA2X 001 (PCI = 72)

| Branch ID | Section ID | Surface type <sup>1</sup> | Section area (SF) | LCD <sup>2</sup> | 2008 PCI | 2011 PCI | Drop in PCI/Yr <sup>3</sup> | % Deduct due to | | Distress types |
|---|---|---|---|---|---|---|---|---|---|---|
| CTA2X | 1 | AC | 10,365 | 1997 | 78 | 72 | 2.0 | 0 | 100 | L&T cracking |

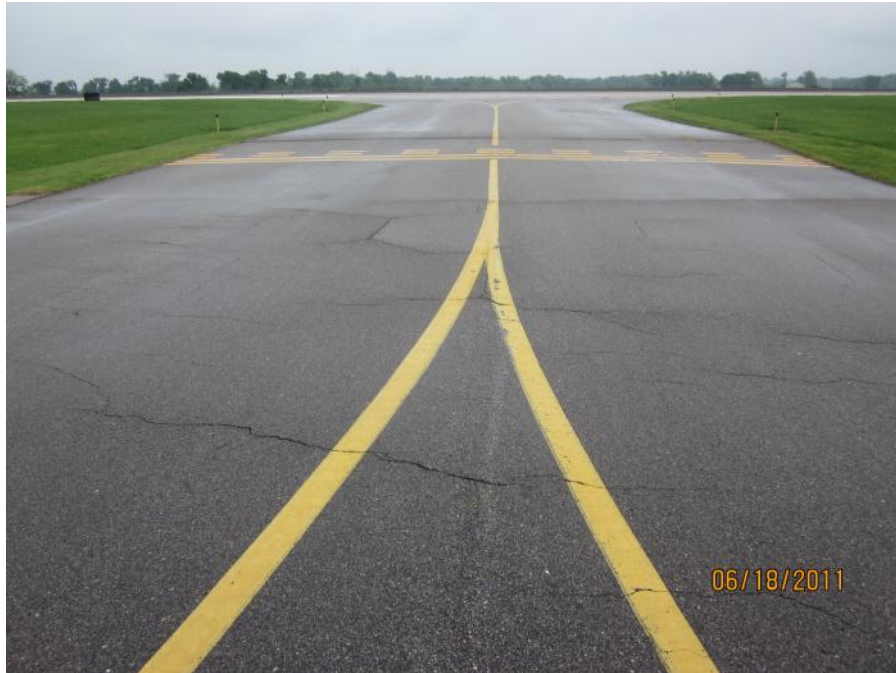
MKT CTA3 001 (PCI = 84)

| Branch ID | Section ID | Surface type <sup>1</sup> | Section area (SF) | LCD <sup>2</sup> | 2008 PCI | 2011 PCI | Drop in PCI/Yr <sup>3</sup> | % Deduct due to | | Distress types |
|---|---|---|---|---|---|---|---|---|---|---|
| CTA3 | 1 | AAC | 17,100 | 2007 | 100 | 84 | 4.0 | 0 | 100 | L&T cracking |

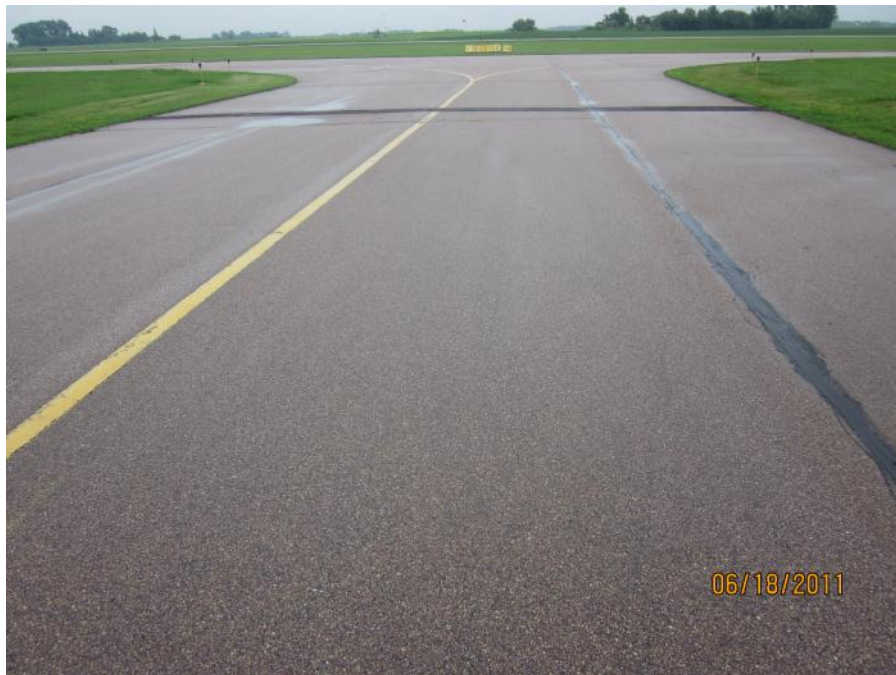
MKT CTB2 001 (PCI = 80)

| Branch ID | Section ID | Surface type <sup>1</sup> | Section area (SF) | LCD <sup>2</sup> | 2008 PCI | 2011 PCI | Drop in PCI/Yr <sup>3</sup> | % Deduct due to | | Distress types |
|---|---|---|---|---|---|---|---|---|---|---|
| CTB2 | 1 | AAC | 14,700 | 1997 | 81 | 80 | 1.4 | 0 | 100 | L&T cracking, Patching |

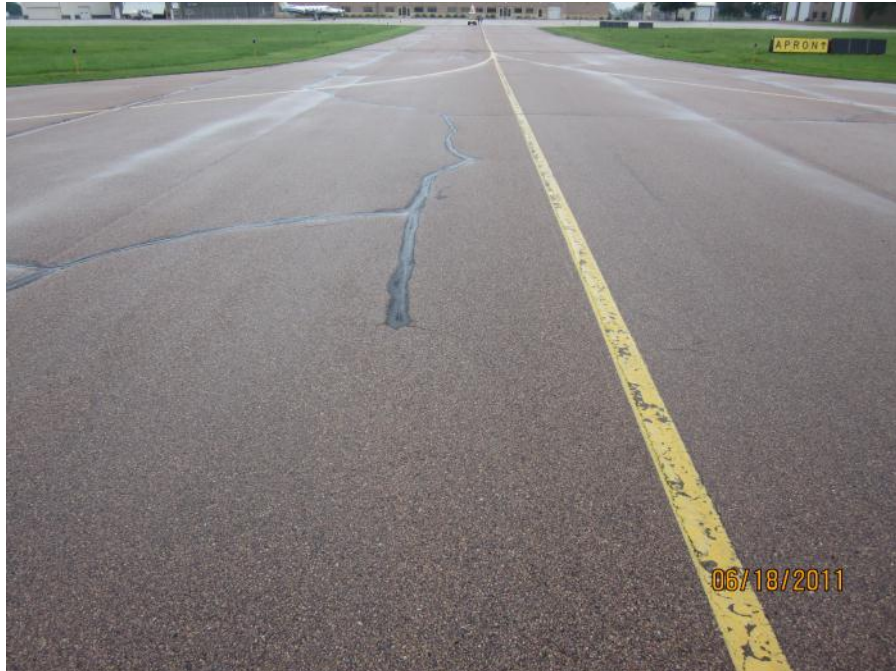
MKT CTC 001 (PCI = 74)

| Branch ID | Section ID | Surface type <sup>1</sup> | Section area (SF) | LCD <sup>2</sup> | 2008 PCI | 2011 PCI | Drop in PCI/Yr <sup>3</sup> | % Deduct due to | | Distress types |
|---|---|---|---|---|---|---|---|---|---|---|
| CTC | 1 | AAC | 35,500 | 1997 | 66 | 74 | 1.9 | 0 | 56 | Depression, L&T cracking, Patching |

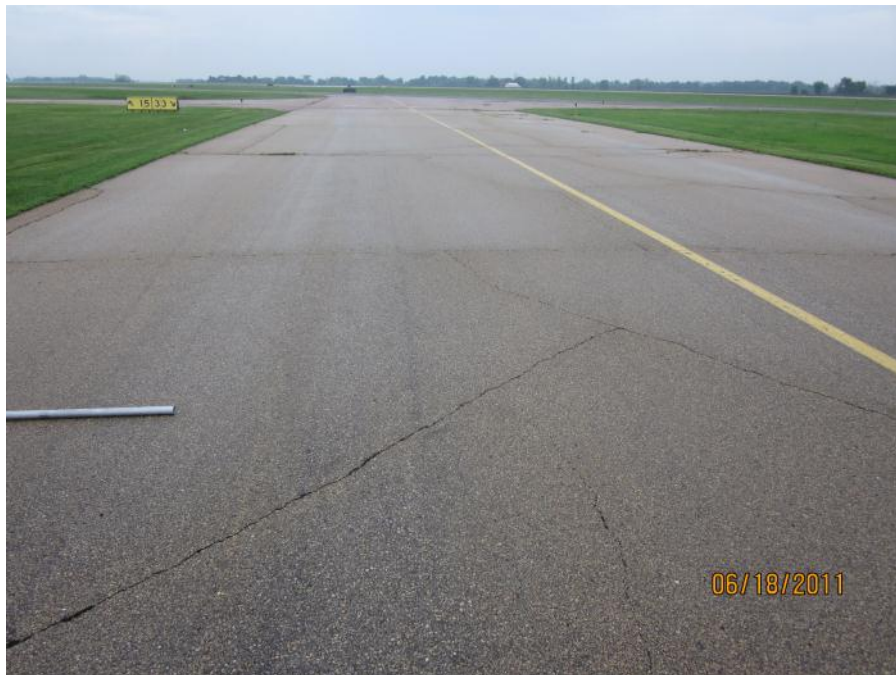
MKT CTD 001 (PCI = 66)

| Branch ID | Section ID | Surface type <sup>1</sup> | Section area (SF) | LCD <sup>2</sup> | 2008 PCI | 2011 PCI | Drop in PCI/Yr <sup>3</sup> | % Deduct due to | | Distress types |
|---|---|---|---|---|---|---|---|---|---|---|
| CTD | 1 | AAC | 14,485 | 1997 | 72 | 66 | 2.4 | 24 | 76 | Alligator cracking, L&T cracking |

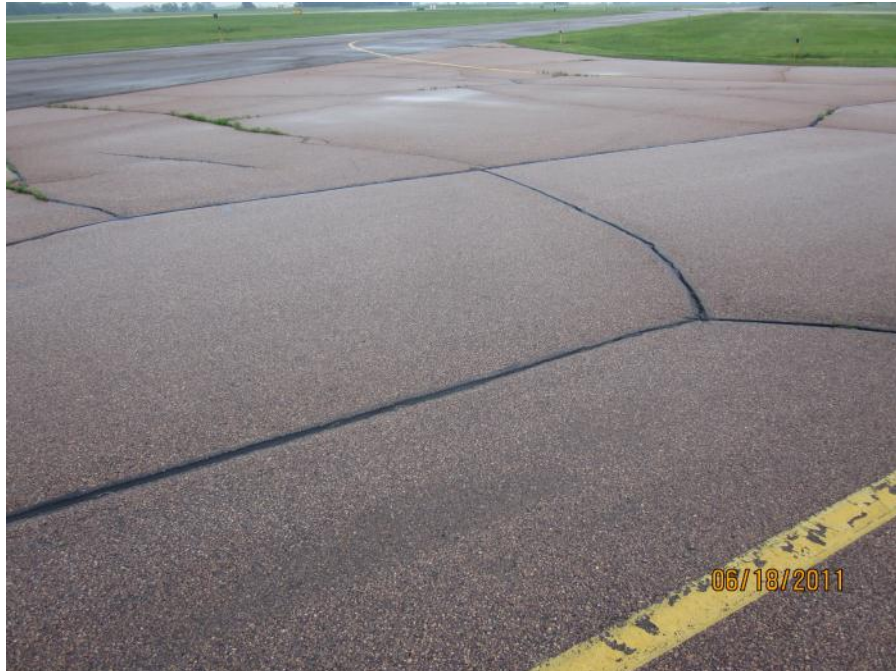
MKT CTD 002 (PCI = 64)

| Branch ID | Section ID | Surface type <sup>1</sup> | Section area (SF) | LCD <sup>2</sup> | 2008 PCI | 2011 PCI | Drop in PCI/Yr <sup>3</sup> | % Deduct due to | | Distress types |
|---|---|---|---|---|---|---|---|---|---|---|
| CTD | 2 | AAC | 13,500 | 1997 | 72 | 64 | 2.6 | 16 | 84 | Alligator cracking, L&T cracking |

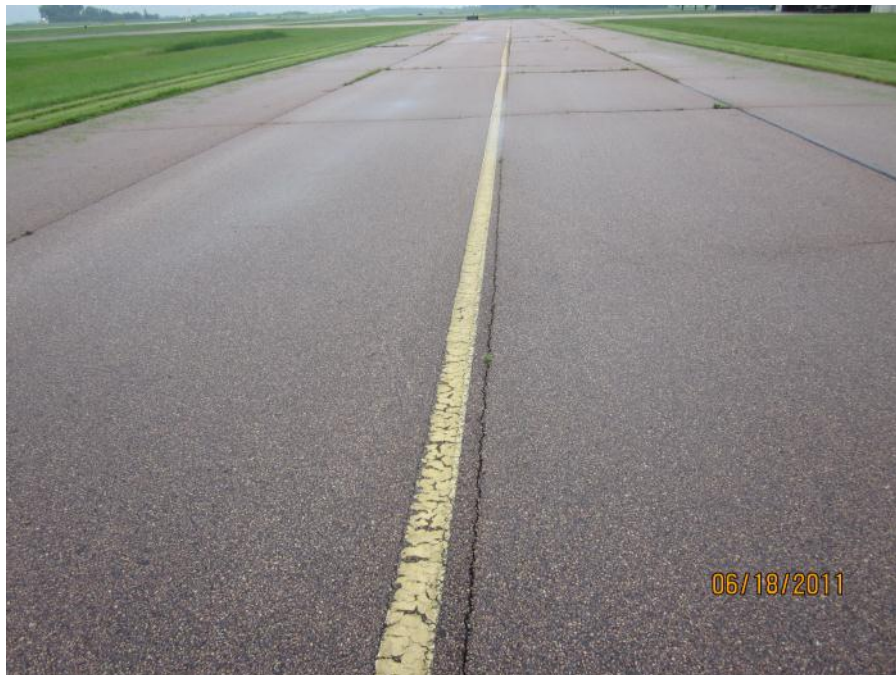
MKT CTE 001 (PCI = 71)

| Branch ID | Section ID | Surface type <sup>1</sup> | Section area (SF) | LCD <sup>2</sup> | 2008 PCI | 2011 PCI | Drop in PCI/Yr <sup>3</sup> | % Deduct due to | | Distress types |
|---|---|---|---|---|---|---|---|---|---|---|
| CTE | 1 | AC | 46,150 | 1997 | 75 | 71 | 2.1 | 0 | 100 | L&T cracking |

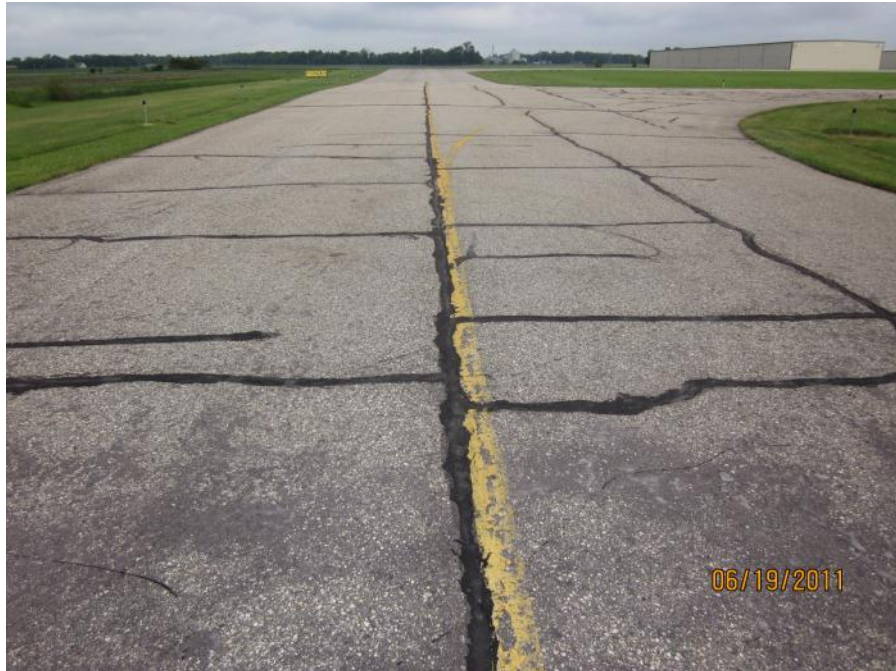
MKT PPTD 001 (PCI = 59)

| Branch ID | Section ID | Surface type <sup>1</sup> | Section area (SF) | LCD <sup>2</sup> | 2008 PCI | 2011 PCI | Drop in PCI/Yr <sup>3</sup> | % Deduct due to | | Distress types |
|---|---|---|---|---|---|---|---|---|---|---|
| PPTD | 1 | AAC | 9,000 | 1991 | 49 | 59 | 2.1 | 0 | 100 | L&T cracking, Raveling |

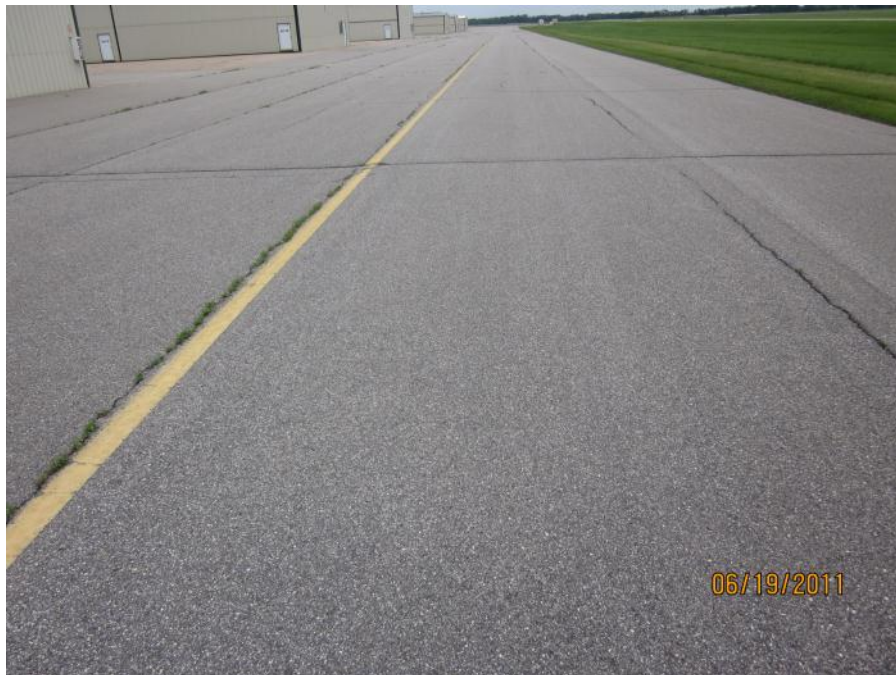
MKT PPTD 002 (PCI = 71)

| Branch ID | Section ID | Surface type <sup>1</sup> | Section area (SF) | LCD <sup>2</sup> | 2008 PCI | 2011 PCI | Drop in PCI/Yr <sup>3</sup> | % Deduct due to | | Distress types |
|---|---|---|---|---|---|---|---|---|---|---|
| PPTD | 2 | AC | 49,750 | 2002* | 77 | 71 | 3.2 | 0 | 100 | L&T cracking |

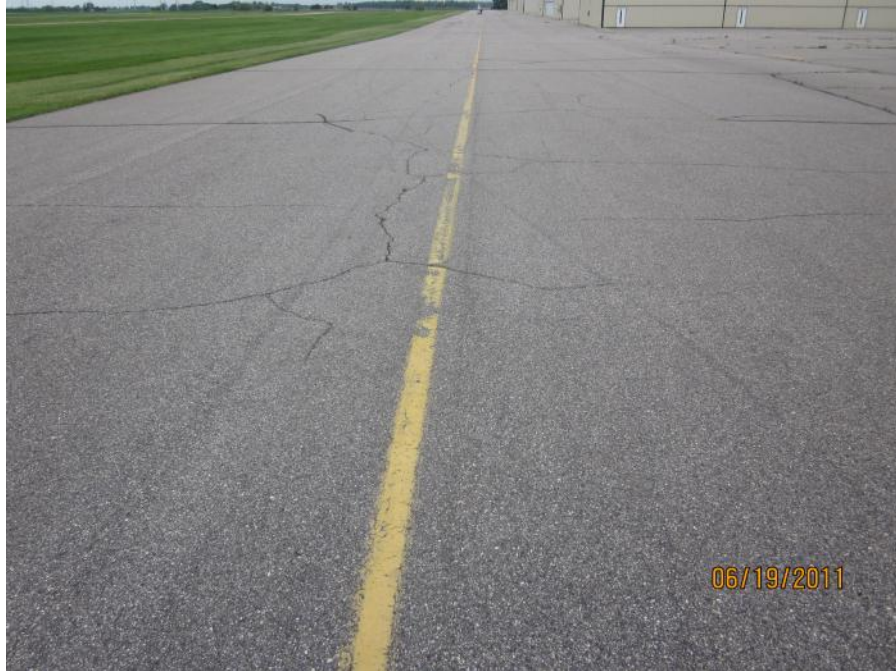
MKT PPTD 003 (PCI = 66)

| Branch ID | Section ID | Surface type <sup>1</sup> | Section area (SF) | LCD <sup>2</sup> | 2008 PCI | 2011 PCI | Drop in PCI/Yr <sup>3</sup> | % Deduct due to | | Distress types |
|---|---|---|---|---|---|---|---|---|---|---|
| PPTD | 3 | AAC | 50,500 | 2002* | 79 | 66 | 3.8 | 11 | 89 | Alligator cracking, L&T cracking, Raveling |

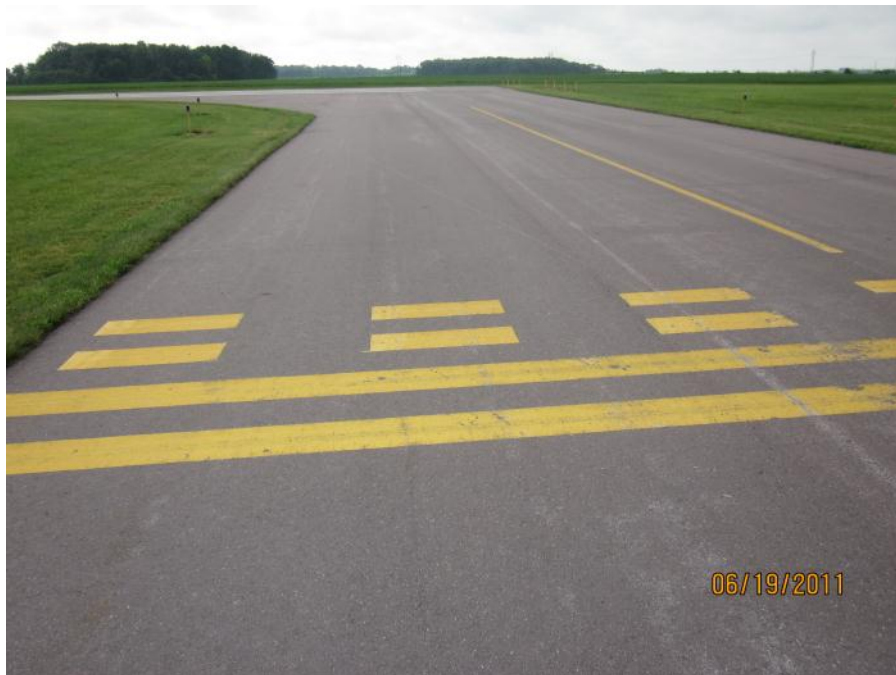
MKT PPTD 004 (PCI = 82)

| Branch ID | Section ID | Surface type <sup>1</sup> | Section area (SF) | LCD <sup>2</sup> | 2008 PCI | 2011 PCI | Drop in PCI/Yr <sup>3</sup> | % Deduct due to | | Distress types |
|---|---|---|---|---|---|---|---|---|---|---|
| PPTD | 4 | AAC | 8,925 | 2009 | - | 82 | 9.0 | 0 | 100 | L&T cracking |

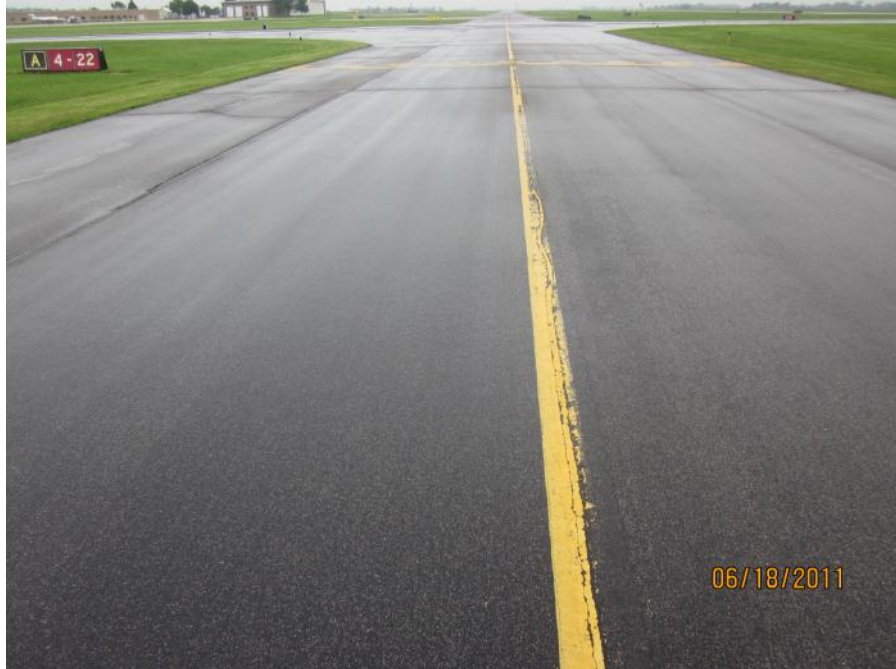
MKT PTA 001 (PCI = 74)

| Branch ID | Section ID | Surface type <sup>1</sup> | Section area (SF) | LCD <sup>2</sup> | 2008 PCI | 2011 PCI | Drop in PCI/Yr <sup>3</sup> | % Deduct due to | | Distress types |
|---|---|---|---|---|---|---|---|---|---|---|
| PTA | 1 | AAC | 256,250 | 1997 | 86 | 74 | 1.9 | 0 | 100 | L&T cracking |

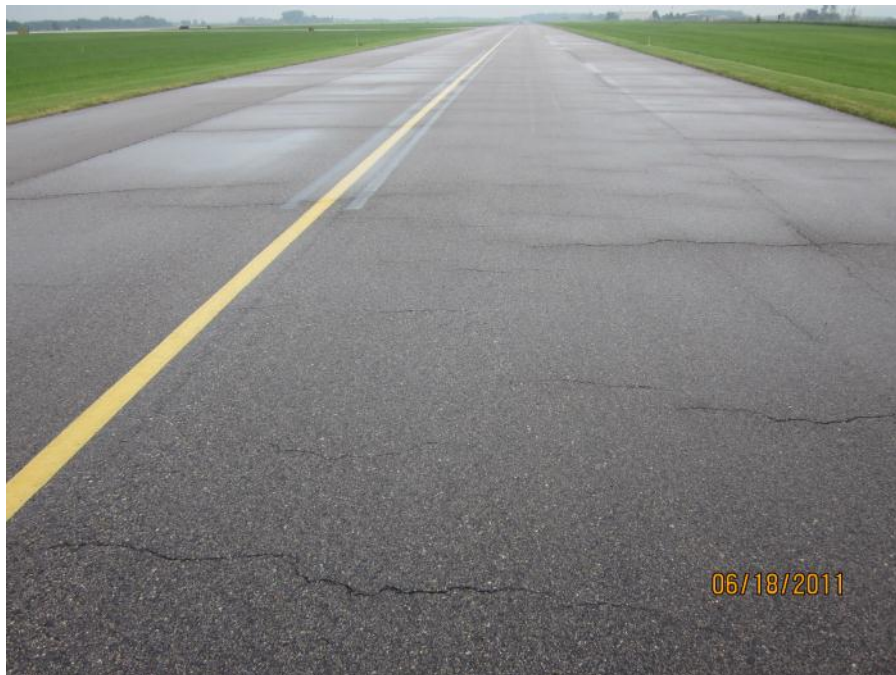
MKT PTA 002 (PCI = 73)

| Branch ID | Section ID | Surface type <sup>1</sup> | Section area (SF) | LCD <sup>2</sup> | 2008 PCI | 2011 PCI | Drop in PCI/Yr <sup>3</sup> | % Deduct due to | | Distress types |
|---|---|---|---|---|---|---|---|---|---|---|
| PTA | 2 | AC | 94,300 | 2007 | 100 | 73 | 6.8 | 0 | 100 | L&T cracking |

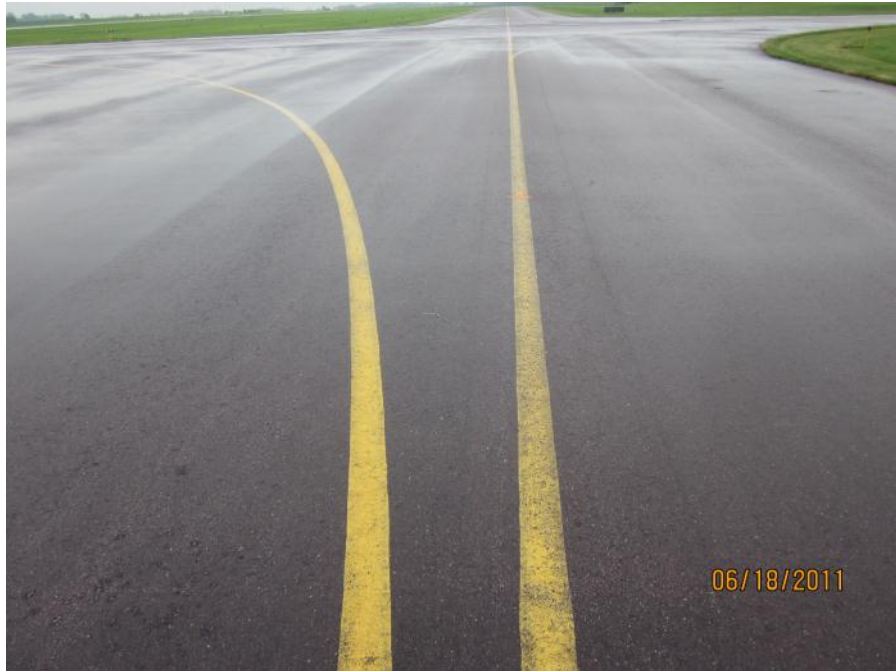
MKT PTA 003 (PCI = 94)

| Branch ID | Section ID | Surface type <sup>1</sup> | Section area (SF) | LCD <sup>2</sup> | 2008 PCI | 2011 PCI | Drop in PCI/Yr <sup>3</sup> | % Deduct due to | | Distress types |
|---|---|---|---|---|---|---|---|---|---|---|
| PTA | 3 | AAC | 13,750 | 1997 | - | 94 | 0.4 | 0 | 100 | L&T cracking |

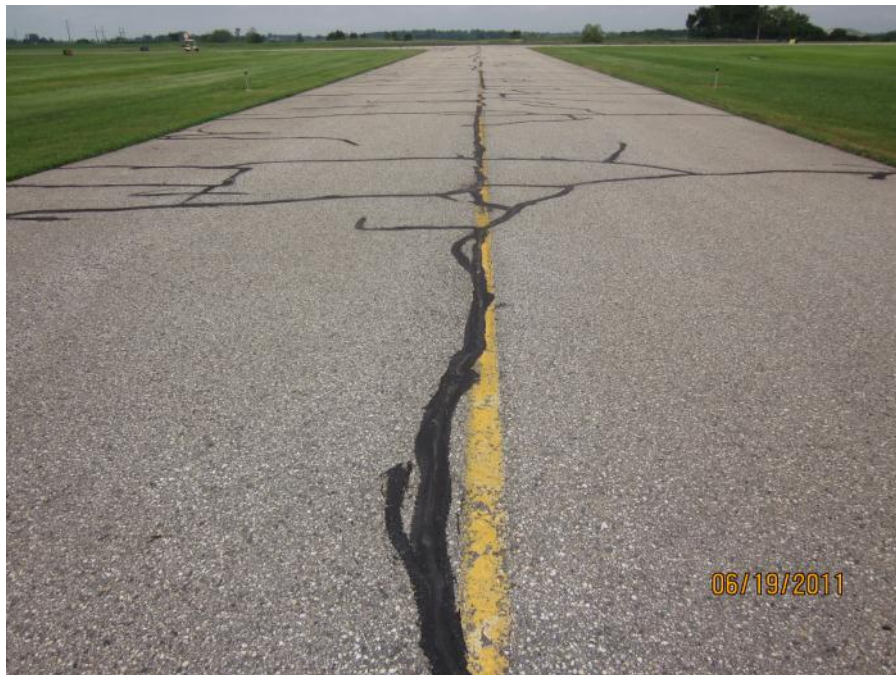
MKT PTB 001 (PCI = 48)

| Branch ID | Section ID | Surface type <sup>1</sup> | Section area (SF) | LCD <sup>2</sup> | 2008 PCI | 2011 PCI | Drop in PCI/Yr <sup>3</sup> | % Deduct due to | | Distress types |
|---|---|---|---|---|---|---|---|---|---|---|
| PTB | 1 | AAC | 17,370 | 1992 | 57 | 48 | 2.7 | 0 | 100 | L&T cracking, Raveling |

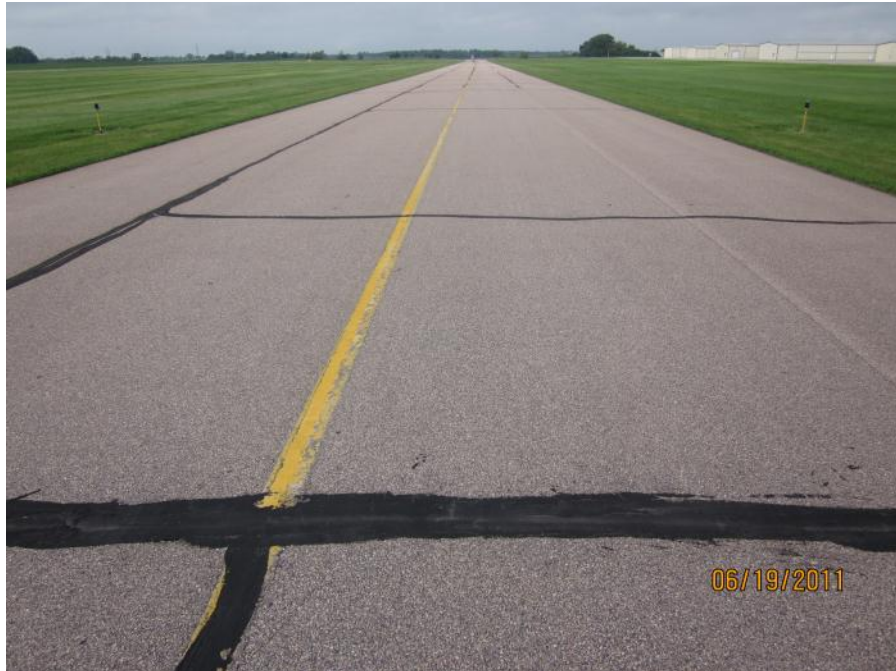
MKT PTB 002 (PCI = 77)

| Branch ID | Section ID | Surface type <sup>1</sup> | Section area (SF) | LCD <sup>2</sup> | 2008 PCI | 2011 PCI | Drop in PCI/Yr <sup>3</sup> | % Deduct due to | | Distress types |
|---|---|---|---|---|---|---|---|---|---|---|
| PTB | 2 | AAC | 60,000 | 1997 | 78 | 77 | 1.6 | 0 | 100 | L&T cracking |

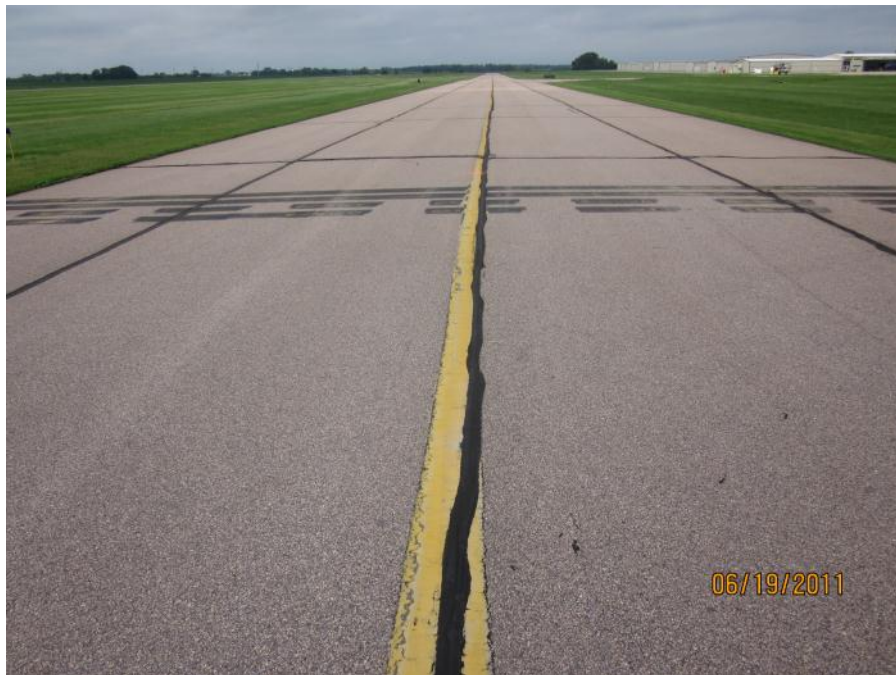
MKT PTB 003 (PCI = 72)

| Branch ID | Section ID | Surface type <sup>1</sup> | Section area (SF) | LCD <sup>2</sup> | 2008 PCI | 2011 PCI | Drop in PCI/Yr <sup>3</sup> | % Deduct due to | | Distress types |
|---|---|---|---|---|---|---|---|---|---|---|
| PTB | 3 | AAC | 57,000 | 1997 | 81 | 72 | 2.0 | 0 | 93 | L&T cracking, Swelling |

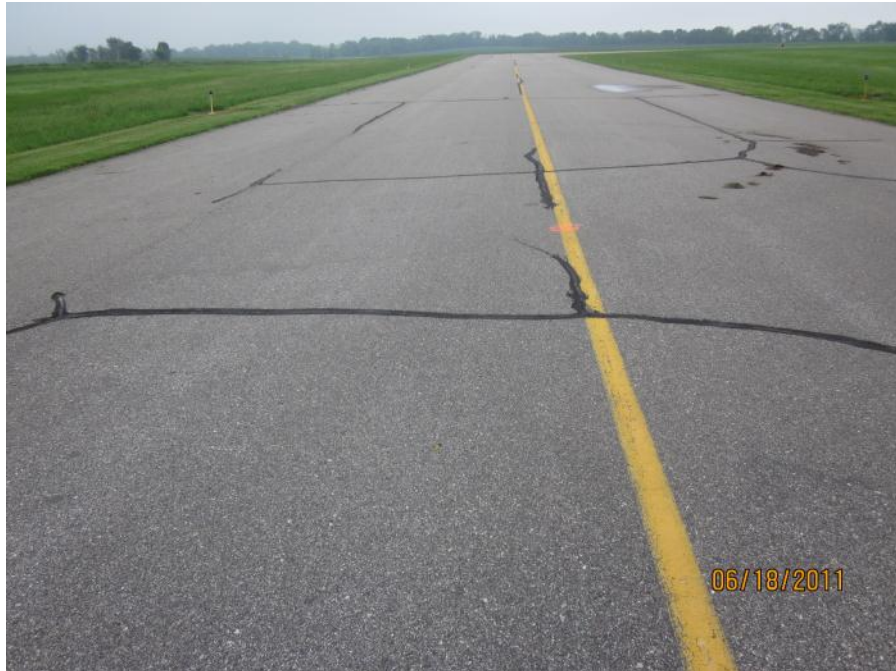
MKT PTB 004 (PCI = 81)

| Branch ID | Section ID | Surface type <sup>1</sup> | Section area (SF) | LCD <sup>2</sup> | 2008 PCI | 2011 PCI | Drop in PCI/Yr <sup>3</sup> | % Deduct due to | | Distress types |
|---|---|---|---|---|---|---|---|---|---|---|
| PTB | 4 | AAC | 45,950 | 2006 | 100 | 81 | 3.8 | 0 | 100 | L&T cracking |

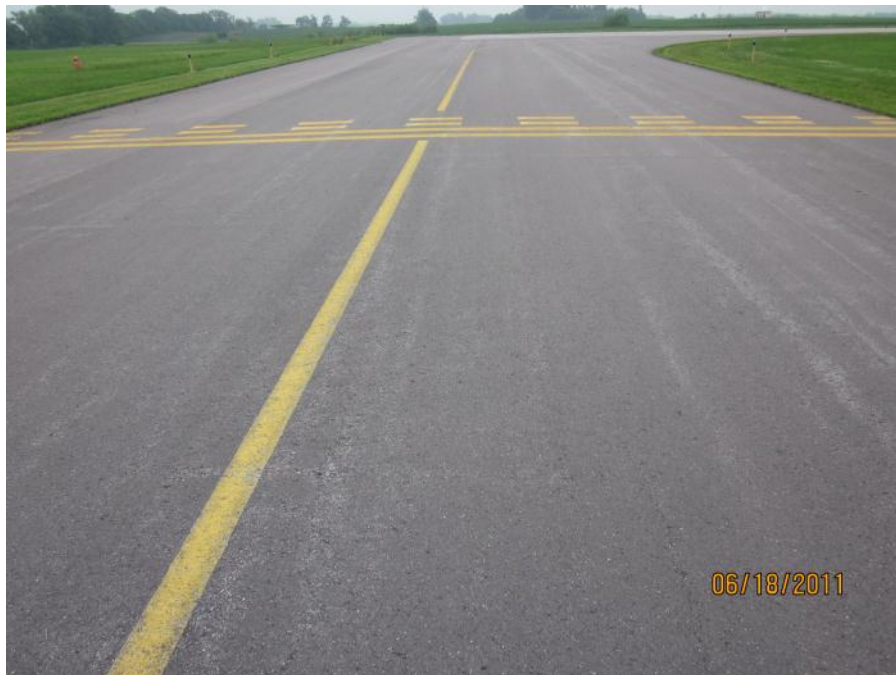
MKT PTB 005 (PCI = 94)

| Branch ID | Section ID | Surface type <sup>1</sup> | Section area (SF) | LCD <sup>2</sup> | 2008 PCI | 2011 PCI | Drop in PCI/Yr <sup>3</sup> | % Deduct due to | | Distress types |
|---|---|---|---|---|---|---|---|---|---|---|
| PTB | 5 | AC | 12,830 | 2009 | - | 94 | 3.0 | 0 | 100 | L&T cracking |

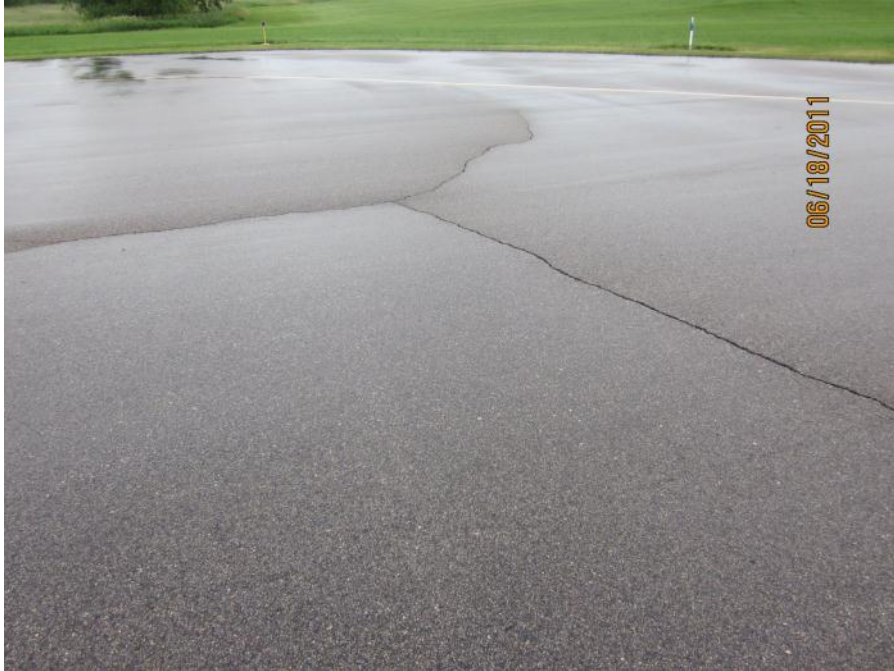
MKT RTA 001 (PCI = 94)

| Branch ID | Section ID | Surface type <sup>1</sup> | Section area (SF) | LCD <sup>2</sup> | 2008 PCI | 2011 PCI | Drop in PCI/Yr <sup>3</sup> | % Deduct due to | | Distress types |
|---|---|---|---|---|---|---|---|---|---|---|
| RTA | 1 | AC | 12,375 | 2006 | 100 | 94 | 1.2 | 0 | 100 | L&T cracking |

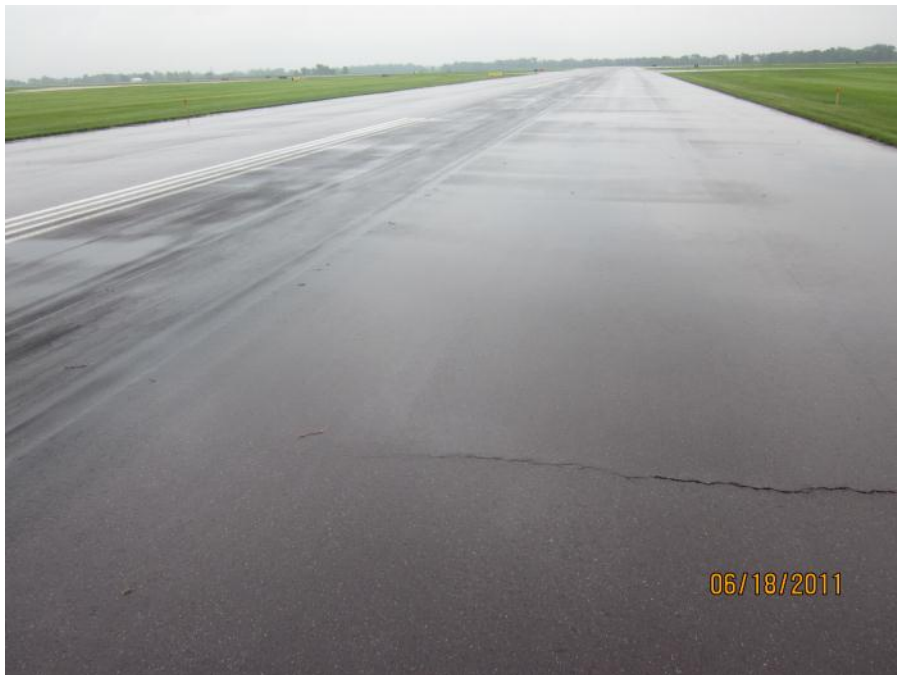
MKT RY422 001 (PCI = 94)

| Branch ID | Section ID | Surface type <sup>1</sup> | Section area (SF) | LCD <sup>2</sup> | 2008 PCI | 2011 PCI | Drop in PCI/Yr <sup>3</sup> | % Deduct due to | | Distress types |
|---|---|---|---|---|---|---|---|---|---|---|
| RY422 | 1 | AAC | 199,875 | 2009 | - | 94 | 3.0 | 0 | 100 | L&T cracking |

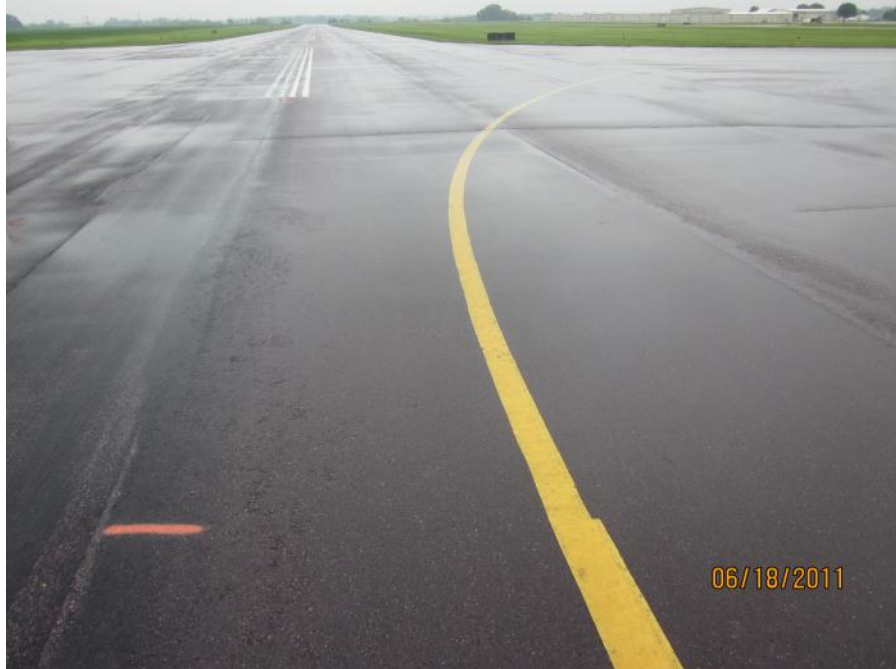
MKT RY422 002 (PCI = 88)

| Branch ID | Section ID | Surface type <sup>1</sup> | Section area (SF) | LCD <sup>2</sup> | 2008 PCI | 2011 PCI | Drop in PCI/Yr <sup>3</sup> | % Deduct due to | | Distress types |
|---|---|---|---|---|---|---|---|---|---|---|
| RY422 | 2 | AAC | 9,075 | 2009 | - | 88 | 6.0 | 0 | 100 | L&T cracking |

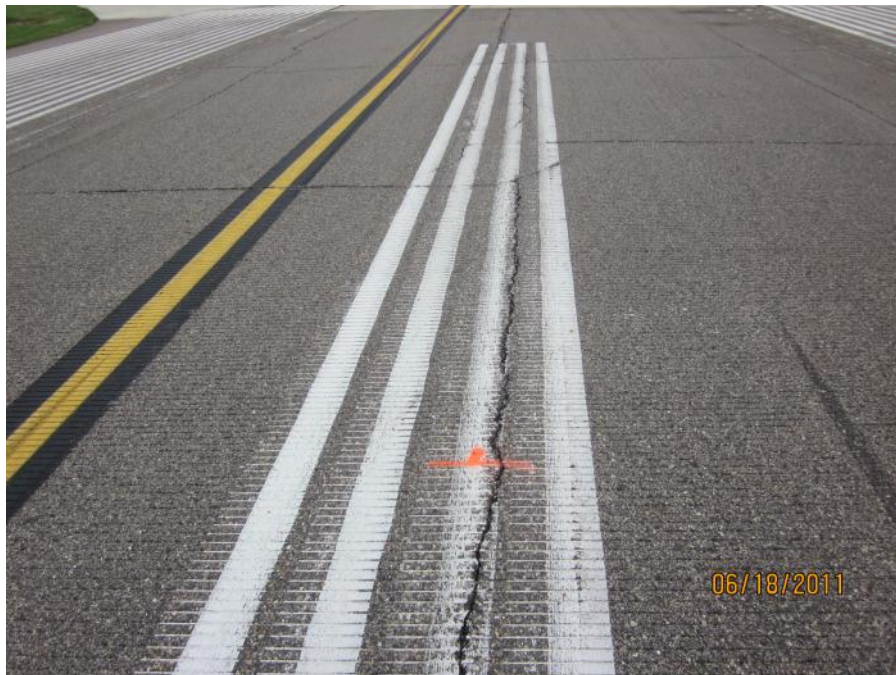
MKT RY422 003 (PCI = 85)

| Branch ID | Section ID | Surface type <sup>1</sup> | Section area (SF) | LCD <sup>2</sup> | 2008 PCI | 2011 PCI | Drop in PCI/Yr <sup>3</sup> | % Deduct due to | | Distress types |
|---|---|---|---|---|---|---|---|---|---|---|
| RY422 | 3 | AAC | 29,250 | 2007 | 92 | 85 | 3.8 | 0 | 100 | L&T cracking |

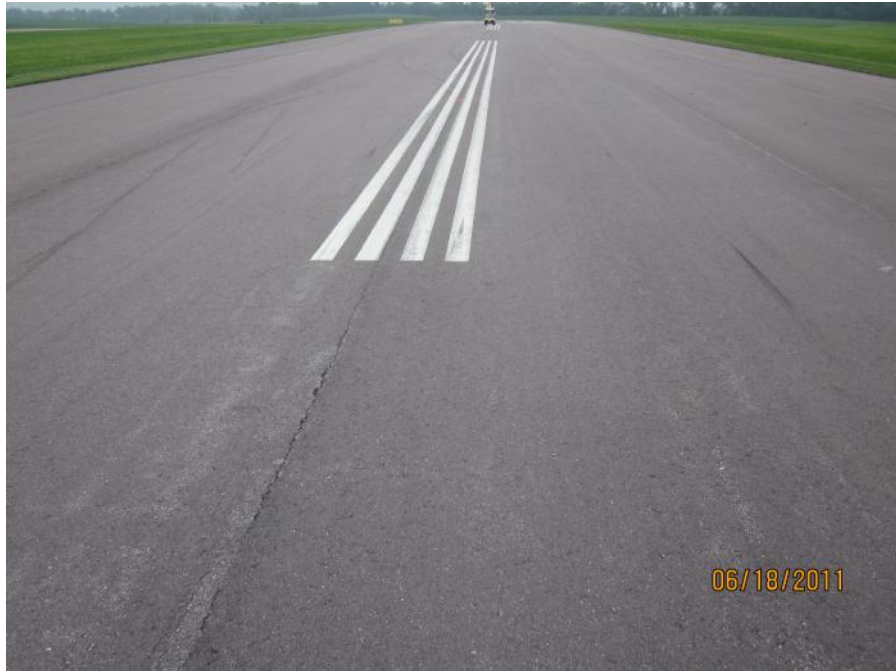
MKT RY422 004 (PCI = 91)

| Branch ID | Section ID | Surface type <sup>1</sup> | Section area (SF) | LCD <sup>2</sup> | 2008 PCI | 2011 PCI | Drop in PCI/Yr <sup>3</sup> | % Deduct due to | | Distress types |
|---|---|---|---|---|---|---|---|---|---|---|
| RY422 | 4 | AAC | 57,750 | 2009 | - | 91 | 4.5 | 0 | 100 | L&T cracking |

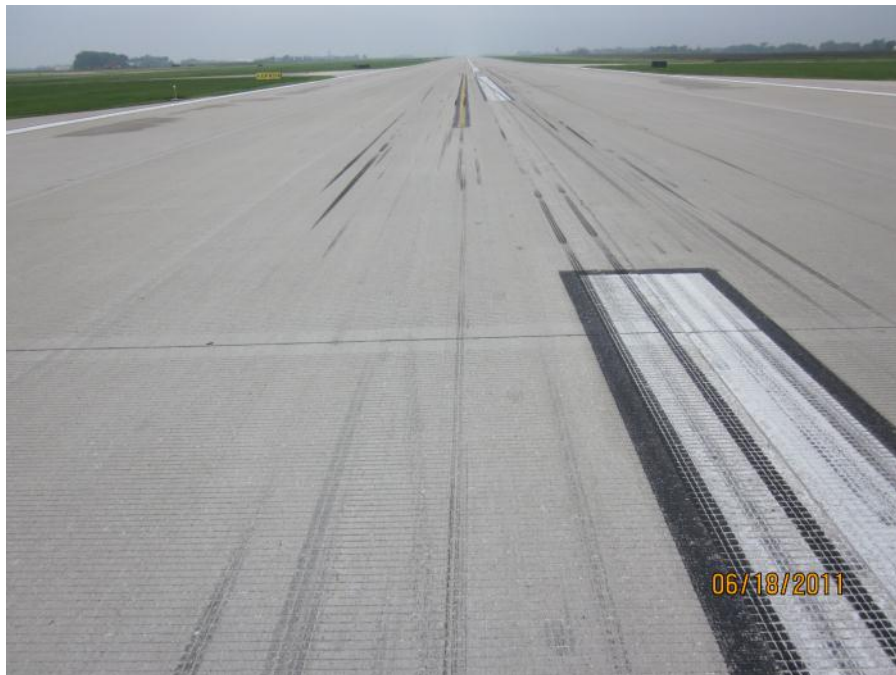
MKT RY1533 001 (PCI = 92)

| Branch ID | Section ID | Surface type <sup>1</sup> | Section area (SF) | LCD <sup>2</sup> | 2008 PCI | 2011 PCI | Drop in PCI/Yr <sup>3</sup> | % Deduct due to | | Distress types |
|---|---|---|---|---|---|---|---|---|---|---|
| RY1533 | 1 | PCC | 540,000 | 2007 | 96 | 92 | 2.0 | 86 | 12 | Corner break, Linear cracking, Joint seal damage, Shattered slab, Joint spall |

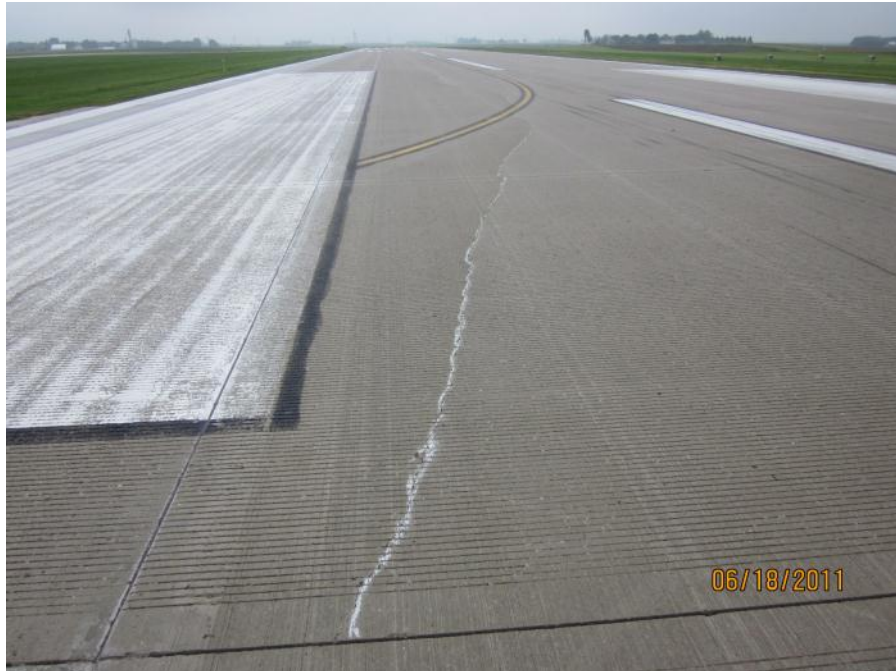
MKT RY1533 002 (PCI = 89)

| Branch ID | Section ID | Surface type <sup>1</sup> | Section area (SF) | LCD <sup>2</sup> | 2008 PCI | 2011 PCI | Drop in PCI/Yr <sup>3</sup> | % Deduct due to | | Distress types |
|---|---|---|---|---|---|---|---|---|---|---|
| RY1533 | 2 | PCC | 120,000 | 2007 | 96 | 89 | 2.8 | 100 | 0 | Corner break, Linear cracking, Shattered slab |

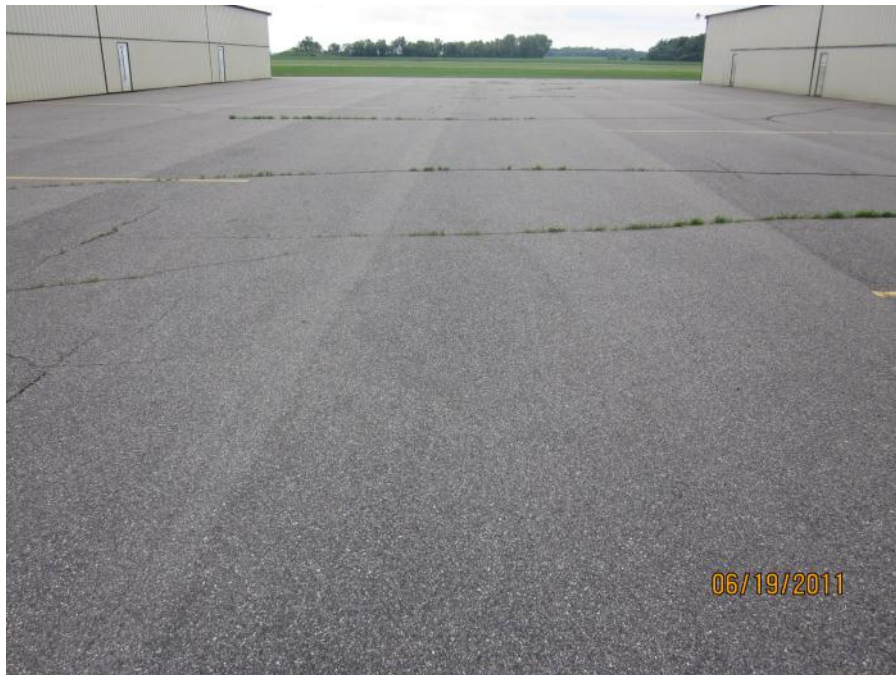
MKT TLA 001 (PCI = 72)

| Branch ID | Section ID | Surface type <sup>1</sup> | Section area (SF) | LCD <sup>2</sup> | 2008 PCI | 2011 PCI | Drop in PCI/Yr <sup>3</sup> | % Deduct due to | | Distress types |
|---|---|---|---|---|---|---|---|---|---|---|
| TLA | 1 | AC | 115,000 | 1997* | 81 | 72 | 2.0 | 42 | 43 | Alligator cracking, L&T cracking, Swelling |

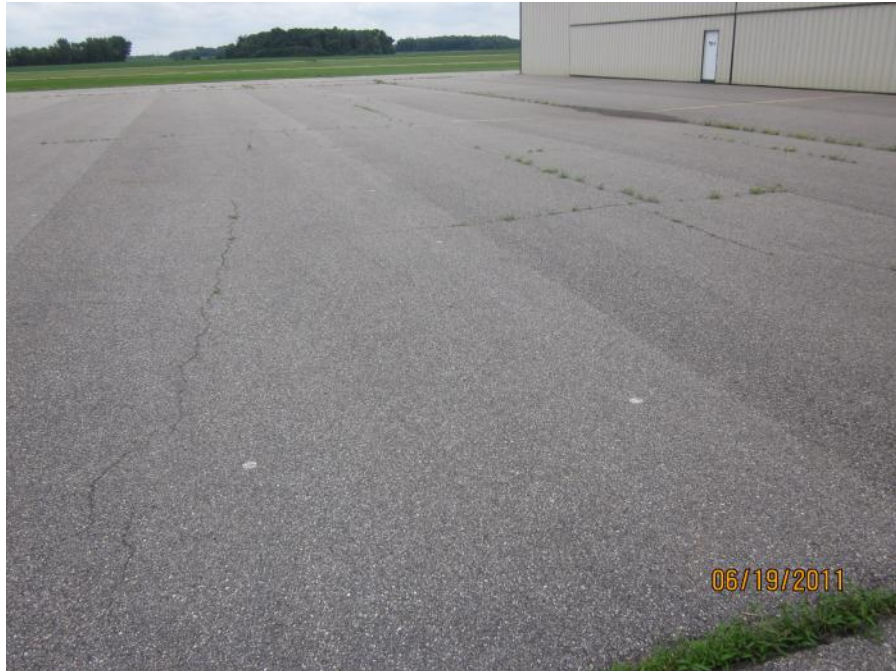
MKT TLB 001 (PCI = 81)

| Branch ID | Section ID | Surface type <sup>1</sup> | Section area (SF) | LCD <sup>2</sup> | 2008 PCI | 2011 PCI | Drop in PCI/Yr <sup>3</sup> | % Deduct due to | | Distress types |
|---|---|---|---|---|---|---|---|---|---|---|
| TLB | 1 | AAC | 16,650 | 1997* | 89 | 81 | 1.4 | 0 | 100 | L&T cracking |

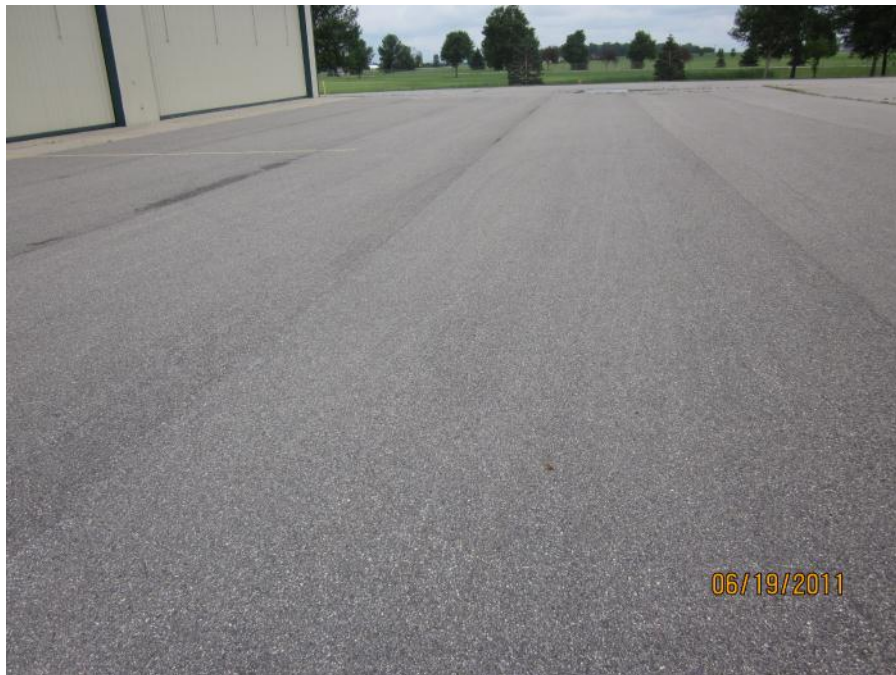
MKT TLC 001 (PCI = 79)

| Branch ID | Section ID | Surface type <sup>1</sup> | Section area (SF) | LCD <sup>2</sup> | 2008 PCI | 2011 PCI | Drop in PCI/Yr <sup>3</sup> | % Deduct due to | | Distress types |
|---|---|---|---|---|---|---|---|---|---|---|
| TLC | 1 | AAC | 26,925 | 2005* | 95 | 79 | 3.5 | 0 | 100 | L&T cracking, Raveling |

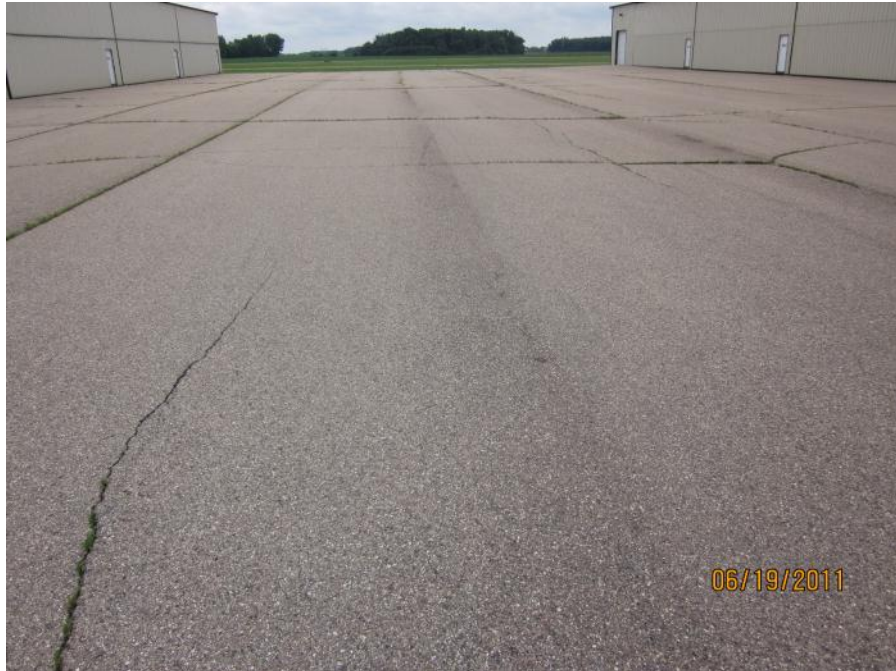
MKT TLD 001 (PCI = 48)

| Branch ID | Section ID | Surface type <sup>1</sup> | Section area (SF) | LCD <sup>2</sup> | 2008 PCI | 2011 PCI | Drop in PCI/Yr <sup>3</sup> | % Deduct due to | | Distress types |
|---|---|---|---|---|---|---|---|---|---|---|
| TLD | 1 | AC | 69,400 | 1991* | 70 | 48 | 2.6 | 0 | 100 | L&T cracking, Patching, Raveling |
