# Minnesota Airport System Pavement Evaluation 2011 Update

Mankato Municipal Airport (MKT)

Mankato, Minnesota

January 2012

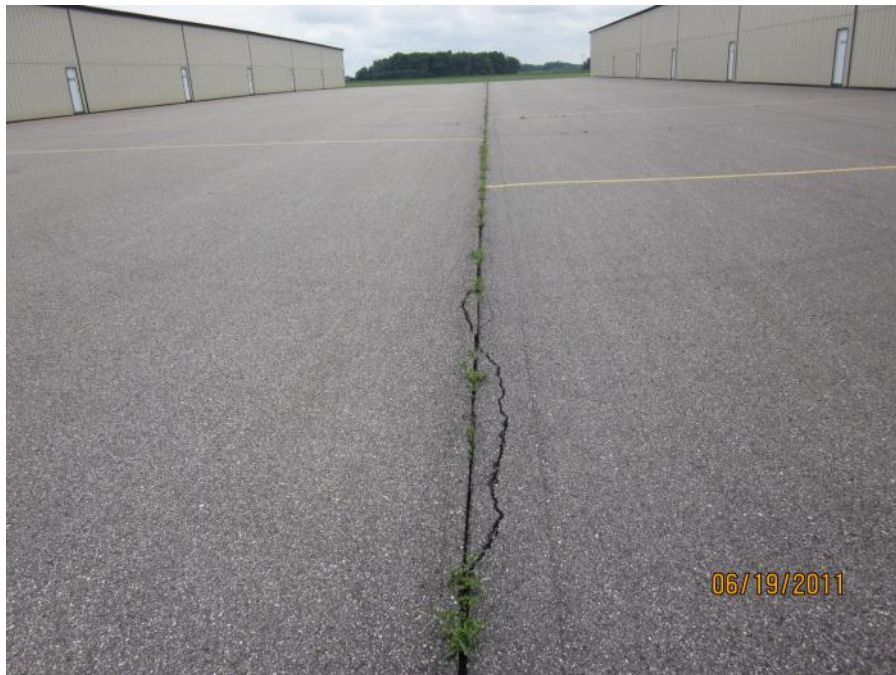
MKT TLE 001 (PCI = 81)

| Branch ID | Section ID | Surface type <sup>1</sup> | Section area (SF) | LCD <sup>2</sup> | 2008 PCI | 2011 PCI | Drop in PCI/Yr <sup>3</sup> | % Deduct due to | | Distress types |
|---|---|---|---|---|---|---|---|---|---|---|
| TLE | 1 | AC | 82,150 | 2007 | 100 | 81 | 4.8 | 0 | 100 | L&T cracking |
