Minnesota Airport System Pavement Evaluation 2011 Update

Red Wing Regional Airport (RGK)

Red Wing, Minnesota

January 2012

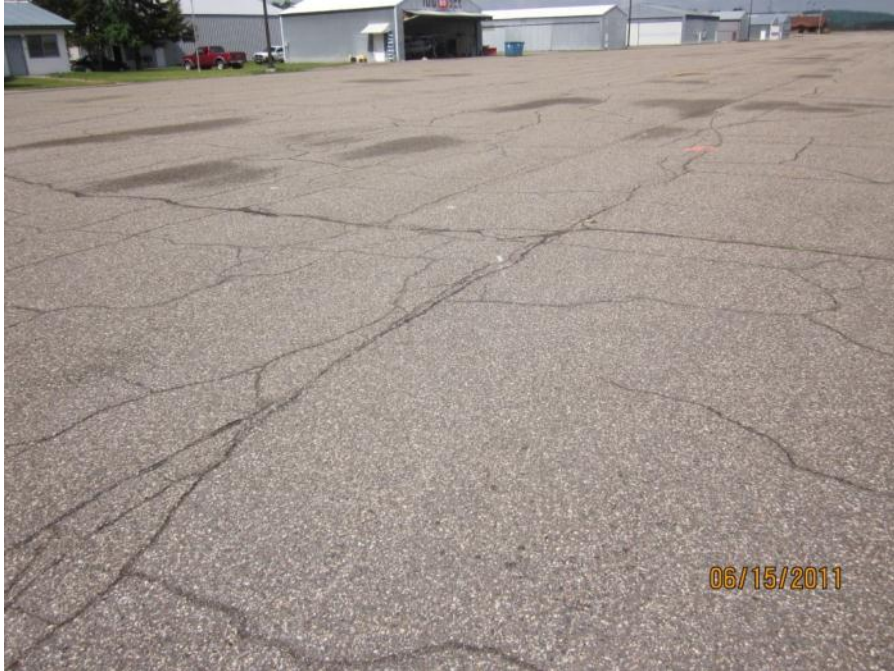
RGK APA 001 (PCI = 24)

Conditions: PCI : 24

43 BLOCK CRACKING M 5,000.00 SqFt Comments:
52 RAVELING M 5,000.00 SqFt Comments:

43 BLOCK CRACKING M 3,800.00 SqFt Comments:
52 RAVELING M 5,000.00 SqFt Comments:
48 LONGITUDINAL/TRANSVERSE CRACKING M 120.00 Ft Comments:

43 BLOCK CRACKING M 4,300.00 SqFt Comments:
52 RAVELING M 5,000.00 SqFt Comments:
48 LONGITUDINAL/TRANSVERSE CRACKING M 70.00 Ft Comments:

43 BLOCK CRACKING M 4,850.00 SqFt Comments:
52 RAVELING M 4,850.00 SqFt Comments:
50 PATCHING L 150.00 SqFt Comments:

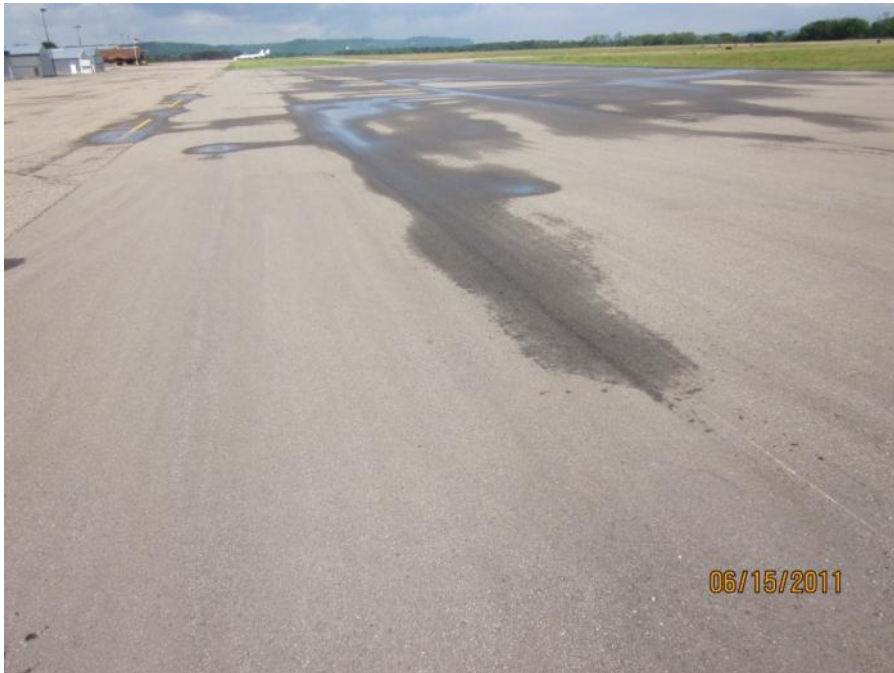
RGK APA 002 (PCI = 100)

Conditions: PCI : 100

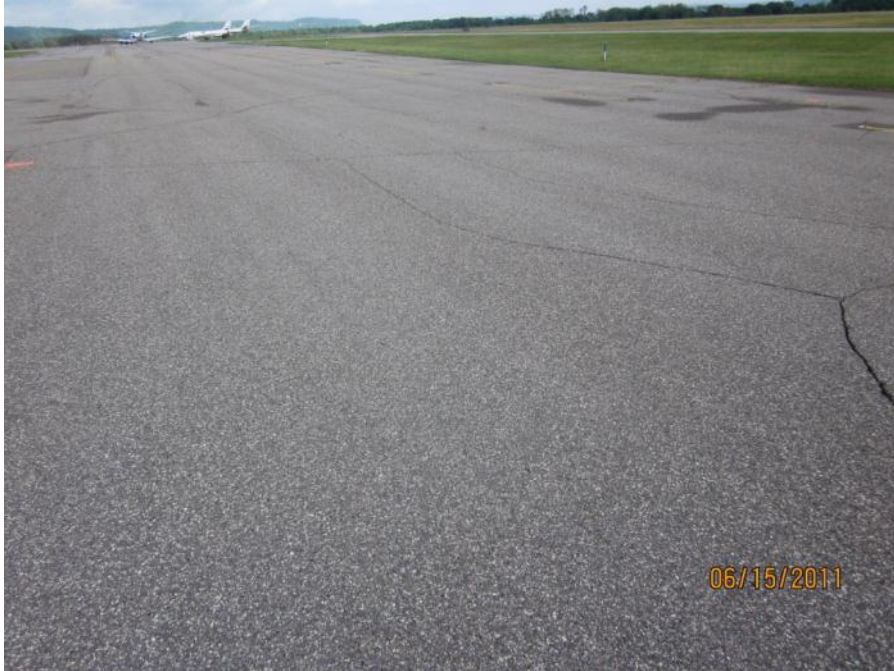
RGK APA 003 (PCI = 50)

Conditions: PCI: 50

48	LONGITUDINAL/TRANSVERSE CRACKING	L	370.00 Ft	Comments:
48	LONGITUDINAL/TRANSVERSE CRACKING	M	465.00 Ft	Comments:
48	LONGITUDINAL/TRANSVERSE CRACKING	H	40.00 Ft	Comments:
52	RAVELING	L	2,500.00 SqFt	Comments:

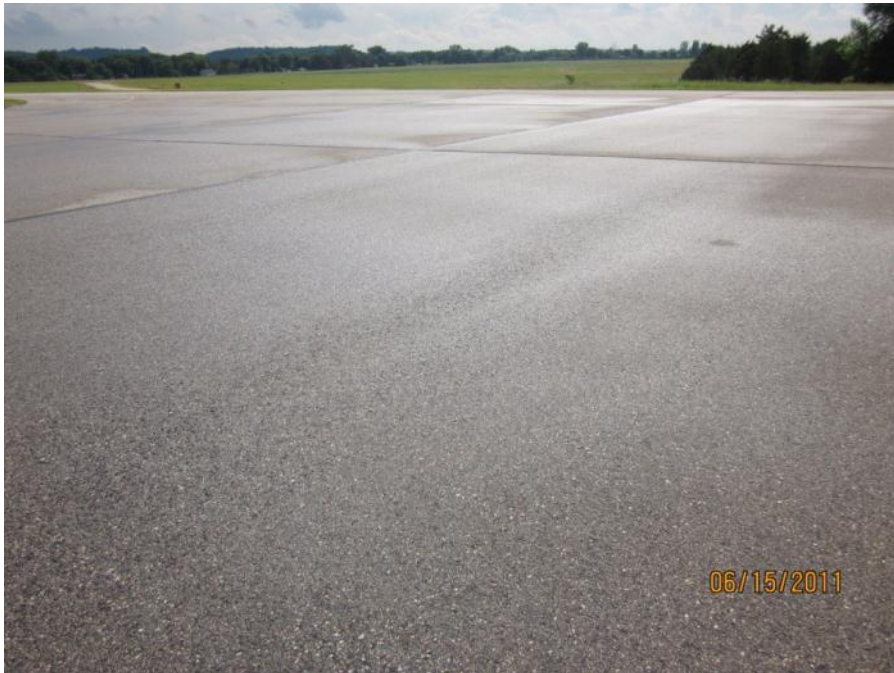
RGK APA 004 (PCI = 93)

Conditions: PCI: 93

48 LONGITUDINAL/TRANSVERSE CRACKING L 76.00 Ft Comments:

48 LONGITUDINAL/TRANSVERSE CRACKING L 10.00 Ft Comments:

48 LONGITUDINAL/TRANSVERSE CRACKING M 3.00 Ft Comments:

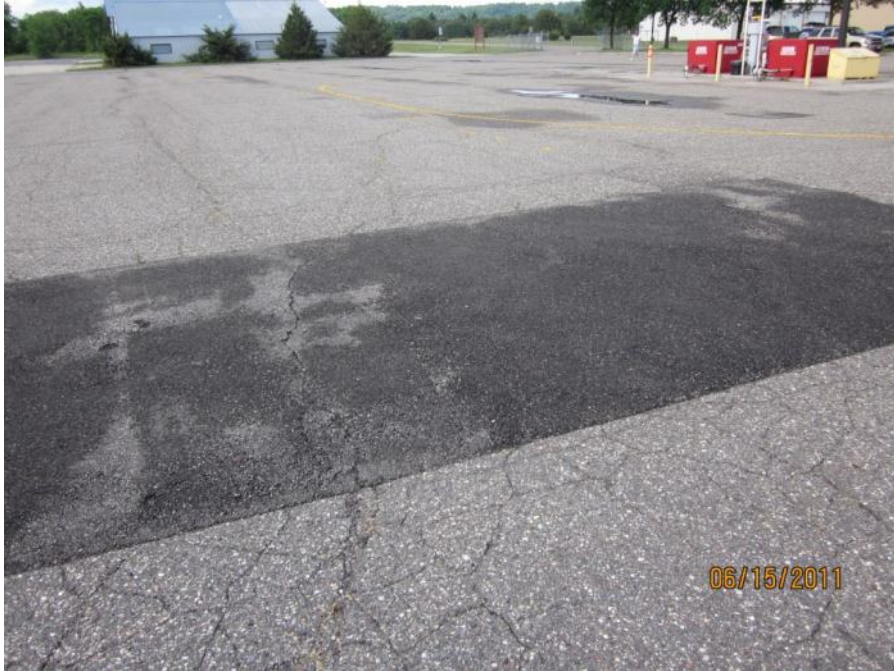
RGK APB 001 (PCI = 15)

Conditions: PCI: 15

41 ALLIGATOR CRACKING	M	15.00	SqFt	Comments:
48 LONGITUDINAL/TRANSVERSE CRACKING	L	219.00	Ft	Comments:
48 LONGITUDINAL/TRANSVERSE CRACKING	M	396.00	Ft	Comments:
48 LONGITUDINAL/TRANSVERSE CRACKING	H	15.00	Ft	Comments:
52 RAVELING	L	2,000.00	SqFt	Comments:
52 RAVELING	M	3,000.00	SqFt	Comments:

41 ALLIGATOR CRACKING	M	1,100.00	SqFt	Comments:
43 BLOCK CRACKING	L	3,700.00	SqFt	Comments:
48 LONGITUDINAL/TRANSVERSE CRACKING	L	100.00	Ft	Comments:
48 LONGITUDINAL/TRANSVERSE CRACKING	M	100.00	Ft	Comments:
50 PATCHING	L	48.00	SqFt	Comments:
52 RAVELING	L	200.00	SqFt	Comments:
52 RAVELING	M	4,700.00	SqFt	Comments:
41 ALLIGATOR CRACKING	H	120.00	SqFt	Comments:

45 DEPRESSION	L	120.00	SqFt	Comments:
41 ALLIGATOR CRACKING	M	330.00	SqFt	Comments:
43 BLOCK CRACKING	L	1,700.00	SqFt	Comments:
43 BLOCK CRACKING	M	2,000.00	SqFt	Comments:
52 RAVELING	M	4,800.00	SqFt	Comments:
50 PATCHING	M	12.00	SqFt	Comments:

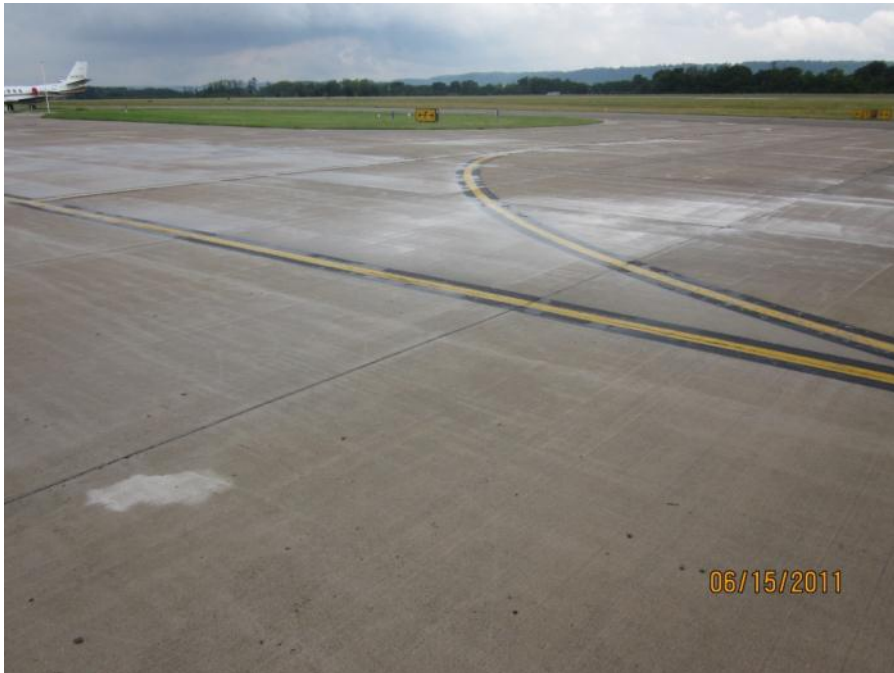
RGK APC 001 (PCI = 85)

Conditions: PCI : 85

71 FAULTING	L	1.00 Slabs	Comments:
75 CORNER SPALLING	L	1.00 Slabs	Comments:
75 CORNER SPALLING	M	1.00 Slabs	Comments:
65 JOINT SEAL DAMAGE	L	24.00 Slabs	Comments:

71 FAULTING	L	2.00 Slabs	Comments:
75 CORNER SPALLING	L	1.00 Slabs	Comments:
75 CORNER SPALLING	M	1.00 Slabs	Comments:
65 JOINT SEAL DAMAGE	M	19.00 Slabs	Comments:

71 FAULTING	L	2.00 Slabs	Comments:
73 SHRINKAGE CRACKING	N	1.00 Slabs	Comments:
75 CORNER SPALLING	L	1.00 Slabs	Comments:
65 JOINT SEAL DAMAGE	M	25.00 Slabs	Comments:

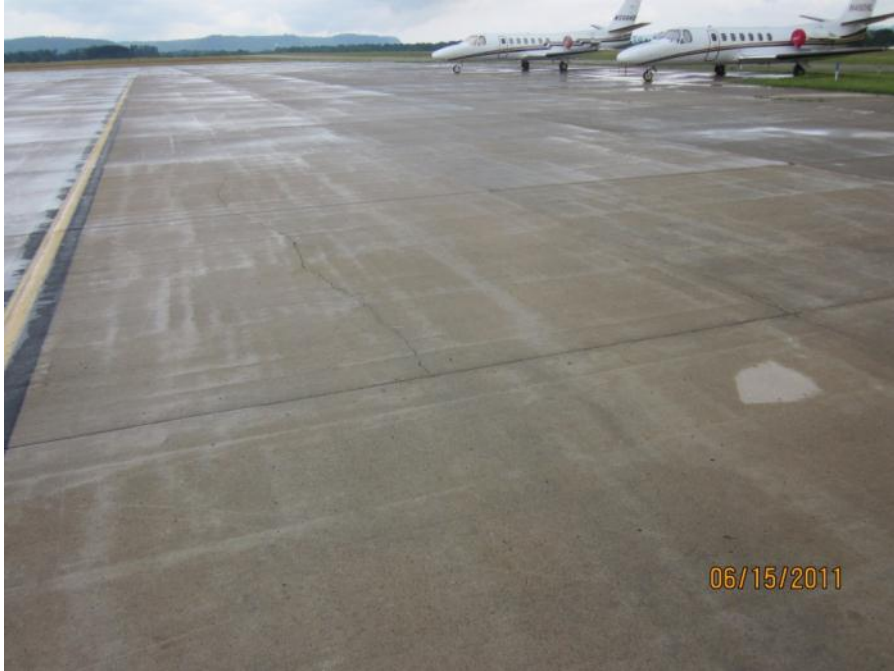
RGK APC 002 (PCI = 91)

Conditions: PCI : 91

63 LINEAR CRACKING L 2.00 Slabs Comments:

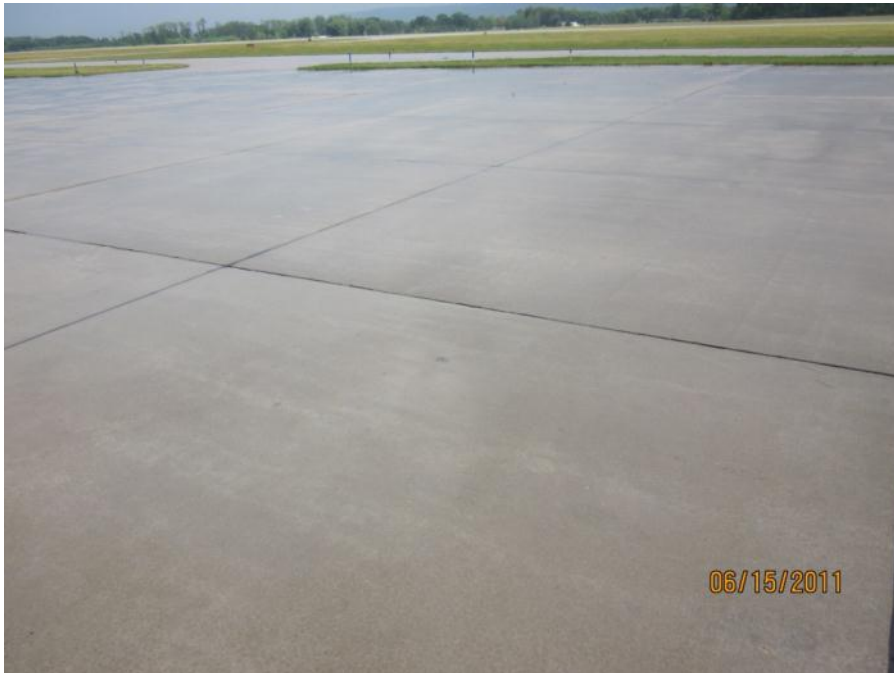
RGK APC 003 (PCI = 96)

Conditions: PCI : 96
