# Minnesota Airport System Pavement Evaluation 2011 Update

Roseau Municipal Airport (ROX)

Roseau, Minnesota

January 2012

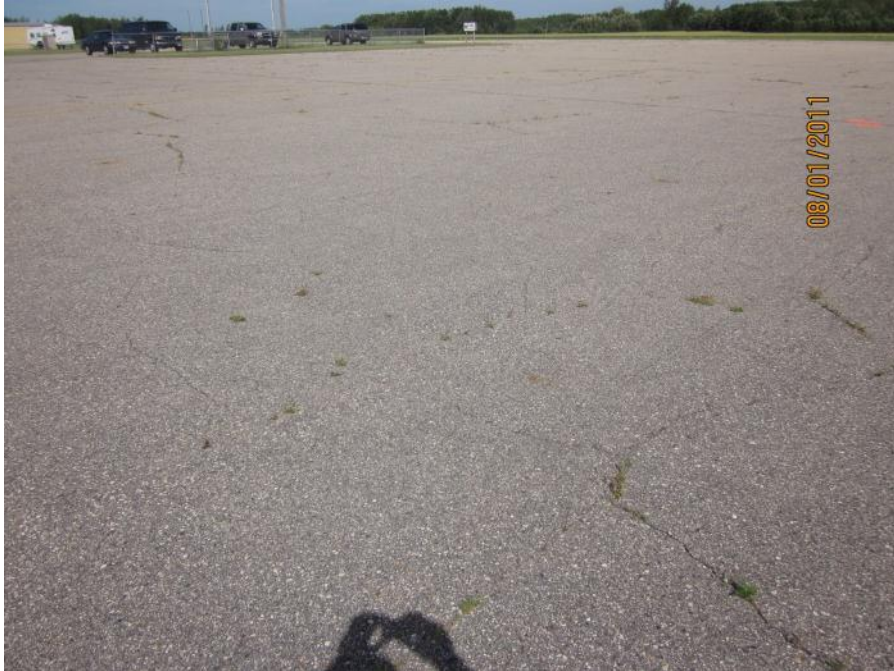
ROX APA 001 (PCI = 38)

| Branch ID | Section ID | Surface type <sup>1</sup> | Section area (SF) | LCD <sup>2</sup> | 2008 PCI | 2011 PCI | Drop in PCI/Yr <sup>3</sup> | % Deduct due to | | Distress types |
|---|---|---|---|---|---|---|---|---|---|---|
| APA | 1 | AC | 55,250 | 1975 | 63 | 38 | 1.7 | 9 | 86 | Block cracking, Depression, Longitudinal & transverse (L&T) cracking, Rutting |

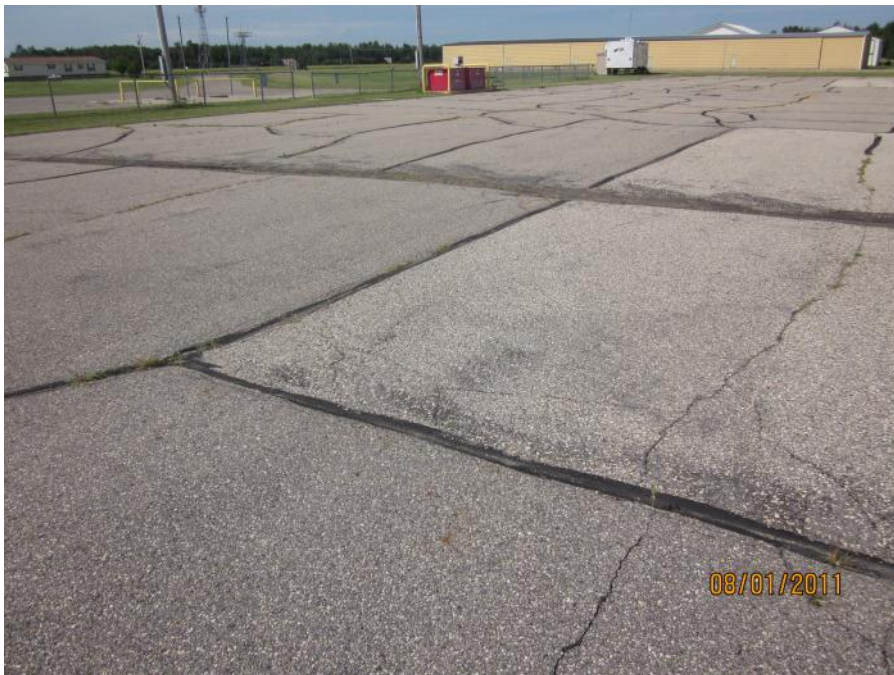
ROX APA 002 (PCI = 24)

| Branch ID | Section ID | Surface type <sup>1</sup> | Section area (SF) | LCD <sup>2</sup> | 2008 PCI | 2011 PCI | Drop in PCI/Yr <sup>3</sup> | % Deduct due to | | Distress types |
|---|---|---|---|---|---|---|---|---|---|---|
| APA | 2 | AC | 22,400 | 1990 | 32 | 24 | 3.6 | 47 | 37 | Alligator cracking, Depression, L&T cracking, Patching, Rutting |

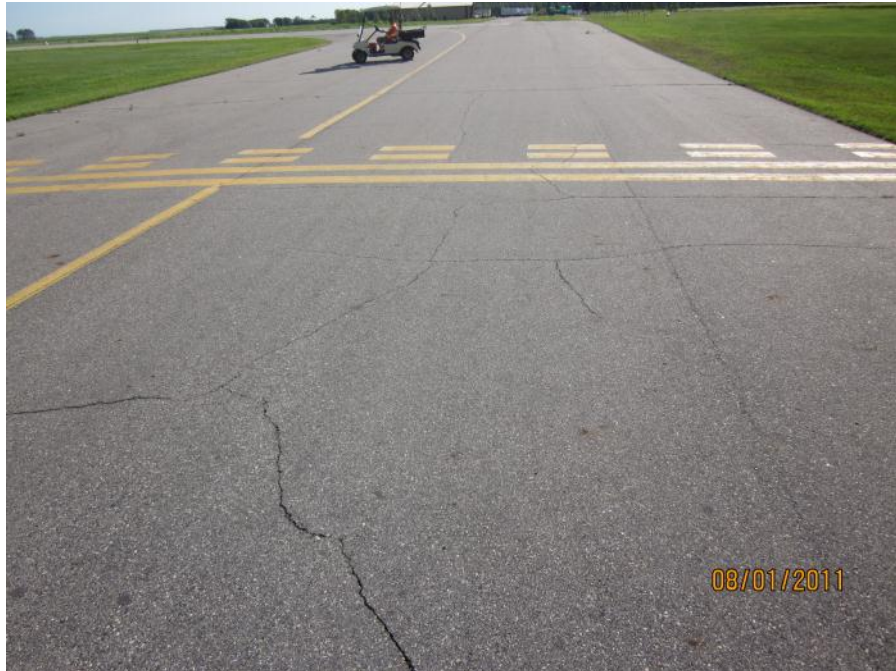
ROX CTA 001 (PCI = 63)

| Branch ID | Section ID | Surface type <sup>1</sup> | Section area (SF) | LCD <sup>2</sup> | 2008 PCI | 2011 PCI | Drop in PCI/Yr <sup>3</sup> | % Deduct due to | | Distress types |
|---|---|---|---|---|---|---|---|---|---|---|
| CTA | 1 | AAC | 13,755 | 2006 | 72 | 63 | 7.4 | 0 | 100 | L&T cracking |

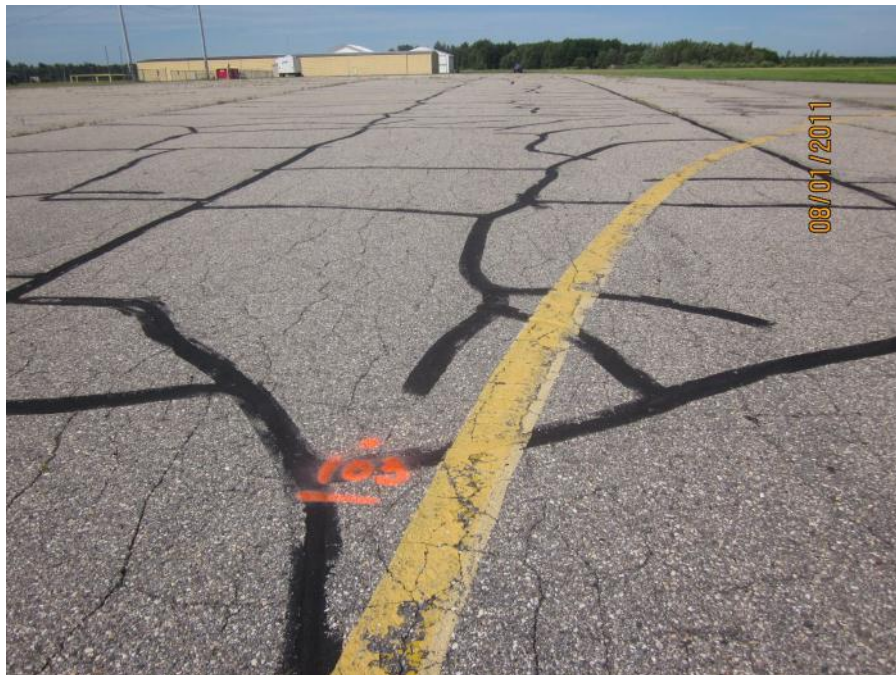
ROX CTA 002 (PCI = 12)

| Branch ID | Section ID | Surface type <sup>1</sup> | Section area (SF) | LCD <sup>2</sup> | 2008 PCI | 2011 PCI | Drop in PCI/Yr <sup>3</sup> | % Deduct due to | | Distress types |
|---|---|---|---|---|---|---|---|---|---|---|
| CTA | 2 | AC | 21,500 | 1990 | 15 | 12 | 4.2 | 69 | 14 | Alligator cracking, Depression, L&T cracking, Rutting |

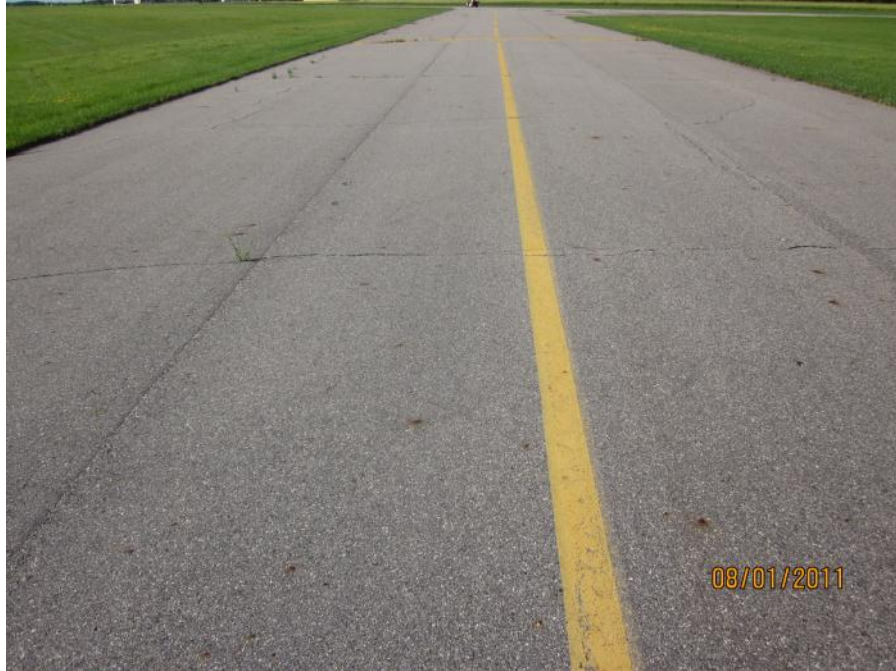
ROX CTB 001 (PCI = 78)

| Branch ID | Section ID | Surface type <sup>1</sup> | Section area (SF) | LCD <sup>2</sup> | 2008 PCI | 2011 PCI | Drop in PCI/Yr <sup>3</sup> | % Deduct due to | | Distress types |
|---|---|---|---|---|---|---|---|---|---|---|
| CTB | 1 | AAC | 32,230 | 2006 | 80 | 78 | 4.4 | 0 | 100 | L&T cracking |

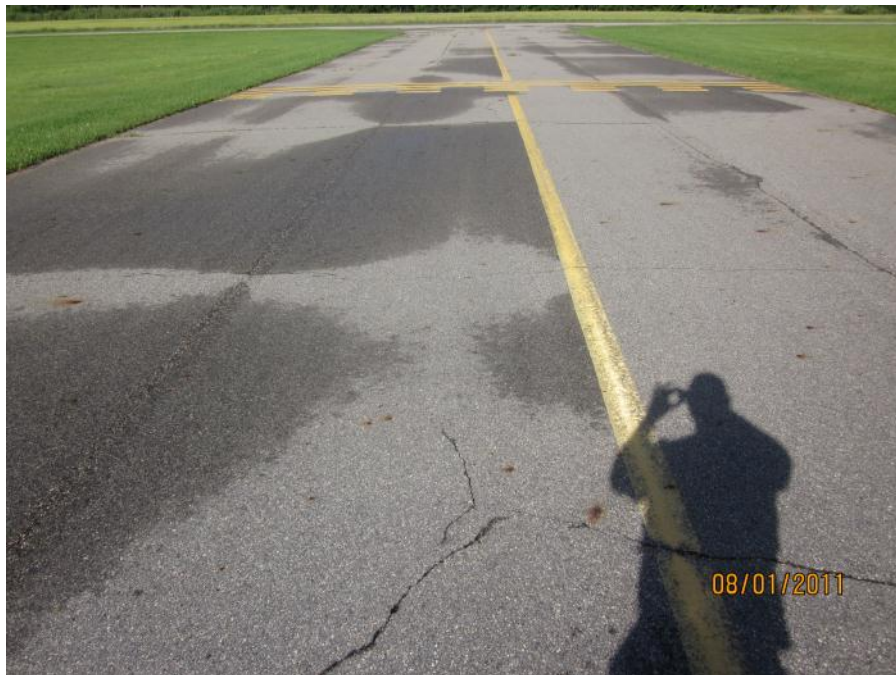
ROX CTC 001 (PCI = 77)

| Branch ID | Section ID | Surface type <sup>1</sup> | Section area (SF) | LCD <sup>2</sup> | 2008 PCI | 2011 PCI | Drop in PCI/Yr <sup>3</sup> | % Deduct due to | | Distress types |
|---|---|---|---|---|---|---|---|---|---|---|
| CTC | 1 | AAC | 14,800 | 2006 | 77 | 77 | 4.6 | 0 | 100 | L&T cracking |

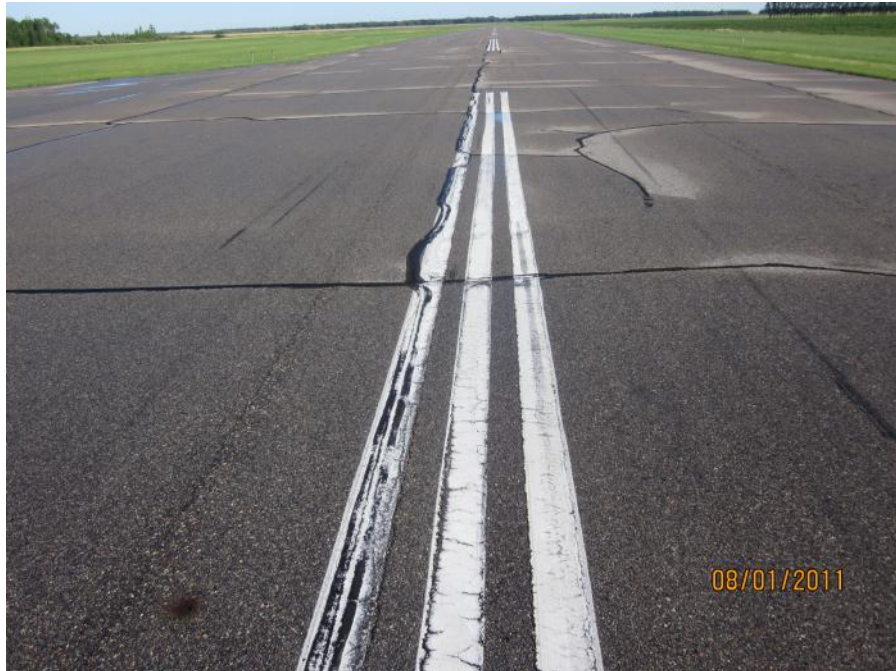
ROX RY1634 001 (PCI = 72)

| Branch ID | Section ID | Surface type <sup>1</sup> | Section area (SF) | LCD <sup>2</sup> | 2008 PCI | 2011 PCI | Drop in PCI/Yr <sup>3</sup> | % Deduct due to | | Distress types |
|---|---|---|---|---|---|---|---|---|---|---|
| RY1634 | 1 | AAC | 330,000 | 2006 | 76 | 72 | 5.6 | 0 | 100 | L&T cracking |

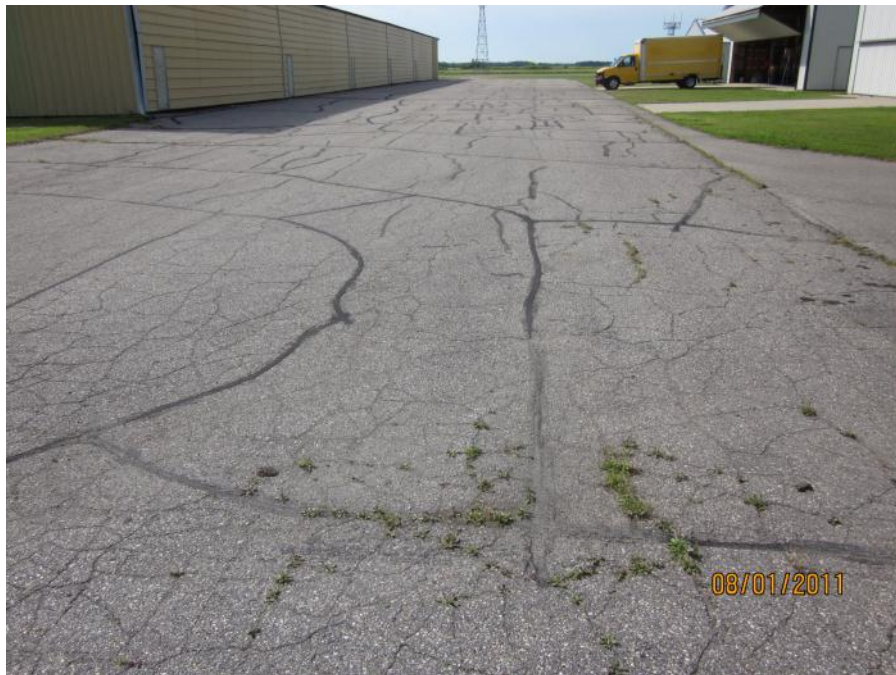
ROX TLA 001 (PCI = 43)

| Branch ID | Section ID | Surface type <sup>1</sup> | Section area (SF) | LCD <sup>2</sup> | 2008 PCI | 2011 PCI | Drop in PCI/Yr <sup>3</sup> | % Deduct due to | | Distress types |
|---|---|---|---|---|---|---|---|---|---|---|
| TLA | 1 | AC | 34,200 | 1975* | 41 | 43 | 1.6 | 41 | 59 | Alligator cracking, Block cracking, L&T cracking |

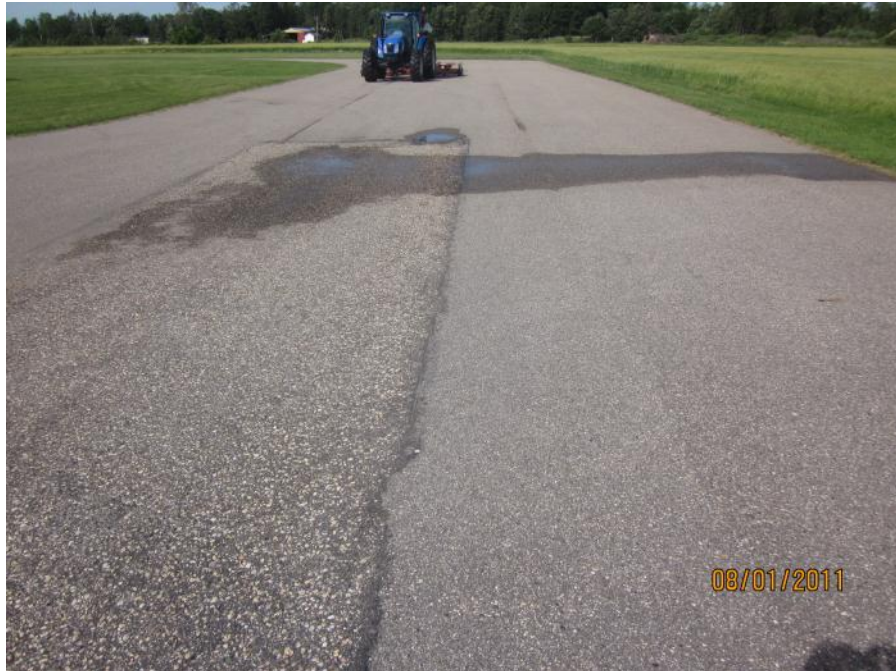
ROX TLA 002 (PCI = 92)

| Branch ID | Section ID | Surface type <sup>1</sup> | Section area (SF) | LCD <sup>2</sup> | 2008 PCI | 2011 PCI | Drop in PCI/Yr <sup>3</sup> | % Deduct due to | | Distress types |
|---|---|---|---|---|---|---|---|---|---|---|
| TLA | 2 | AC | 14,600 | 2003* | 91 | 92 | 1.0 | 0 | 100 | L&T cracking, Patching |
